# Higher Mill, Rawtenstall, Lancashire

## Documentary Research, Building Assessment, Watching Brief and Excavation Report

July 2008

**B&E Boys Ltd**

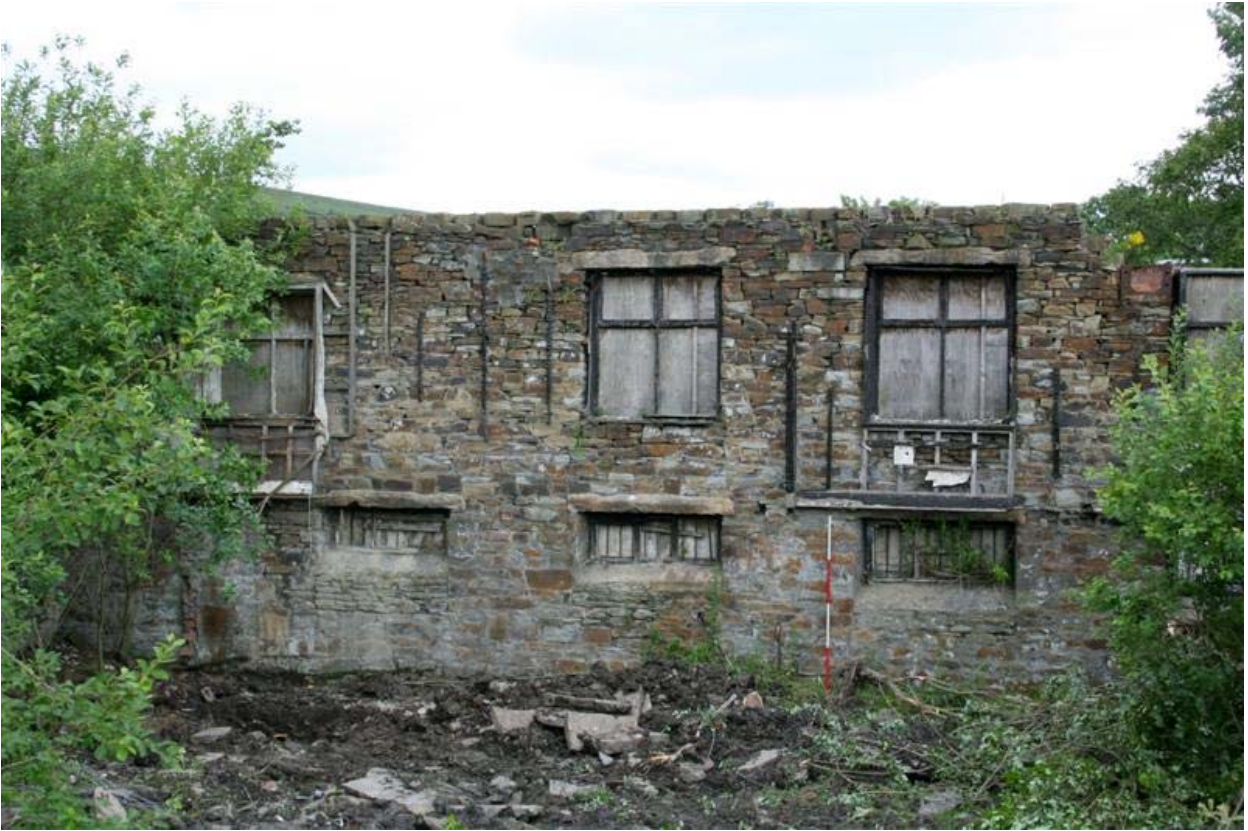
Plate 7: Internal view of the north wall of the spinning block

- 4.4.2 Internally, the ground floor windows had shallow reveals and those in the basement were shorter (by being partially infilled) and had sloping sills (Plate 7). It appears that all the window frames were timber casements, and the basement windows were barred. A scar highlighting the position of the removed ground floor/basement ceiling (ceiling height was approximately 2.1m) was observed. A cast-iron bearing box was present in the upper east part of the elevation, adjacent to the easternmost window (Plate 8).

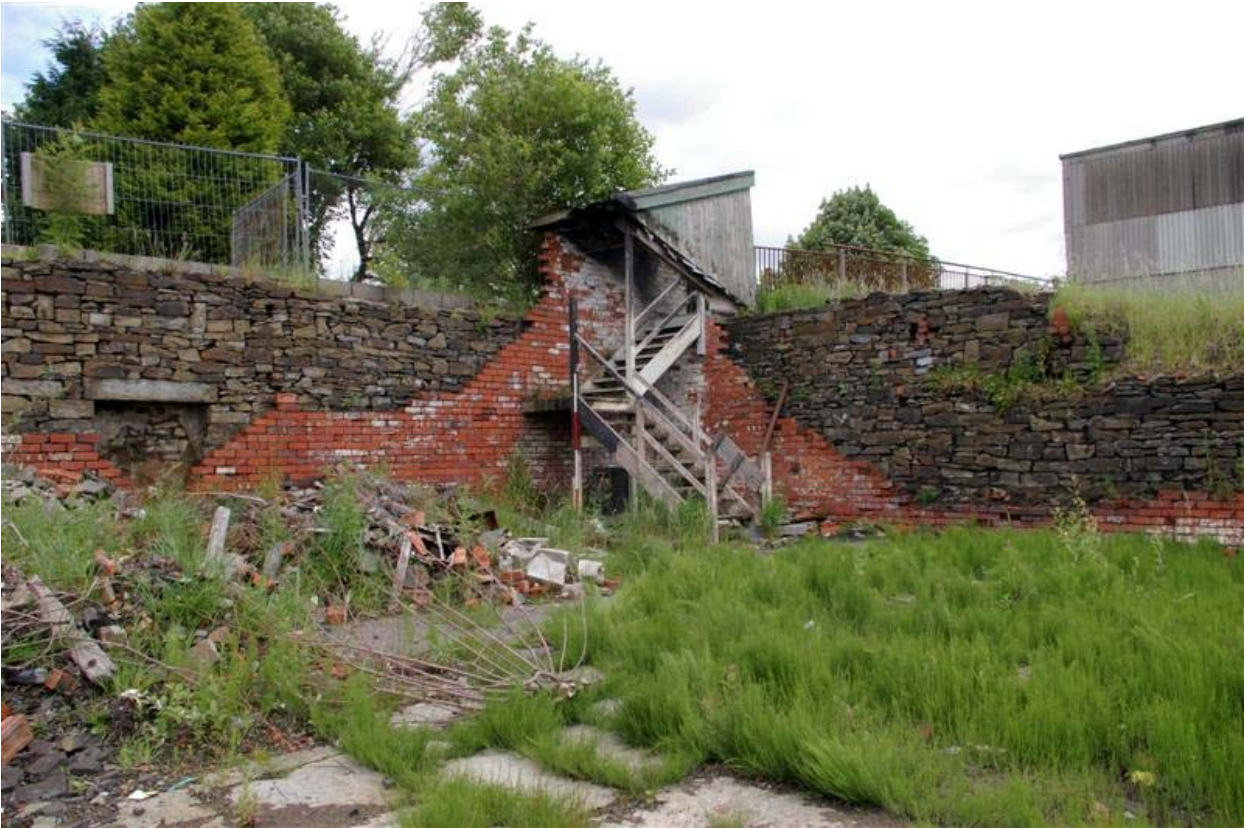
Plate 9: Internal view of the east and south walls of the weaving shed, together with stairs, showing brick lining of the stone walls

- 7.1.6 The building assessment recorded the addition of a brick-lining to the south and east walls of the weaving shed. The unlined stone walls would have allowed the movement of moisture through the structure, which was advantageous for weaving purposes. The lining of the walls suggests a change in use or emphasis of the function of the building. The cinder block modification seen at the south end of the west wall is thought to be the remains of a small, internal, early twentieth century structure. The loading bay appears to have undergone substantial remodelling, also in the twentieth century, perhaps reflecting a change in the material being transported and modern changes in transport-related requirements.

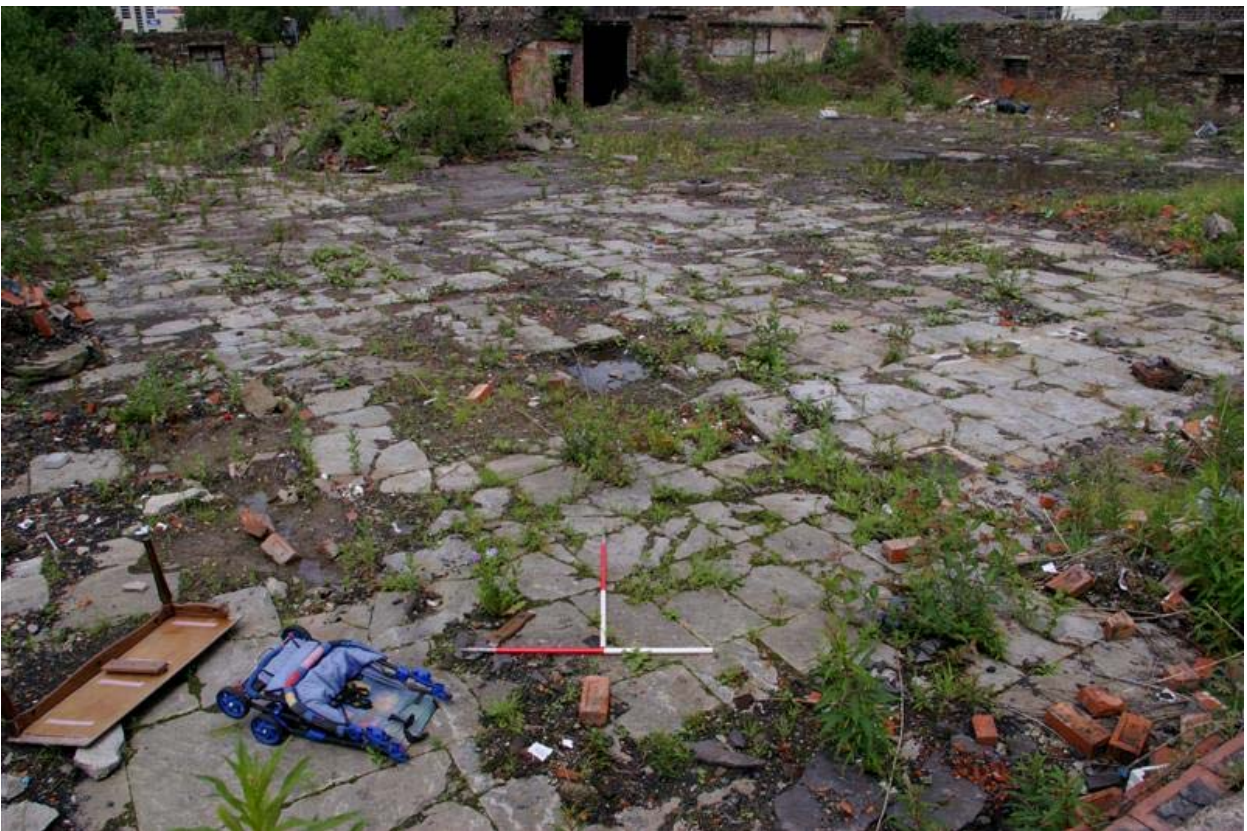
Plate 10: remains of the flagged floor of the waving shed

- 4.2.1 Almost the entire internal area of the mill complex appears to have been laid down to flagstones of varying sizes (Plate 10). These were sealed beneath asphalt at some point, which has since degraded and fragmented. The majority of the flagged area represented the internal floor space of the weaving shed. The slightly lower area of flags in the north-west corner of the site was the remains of the basement floor for the spinning block.

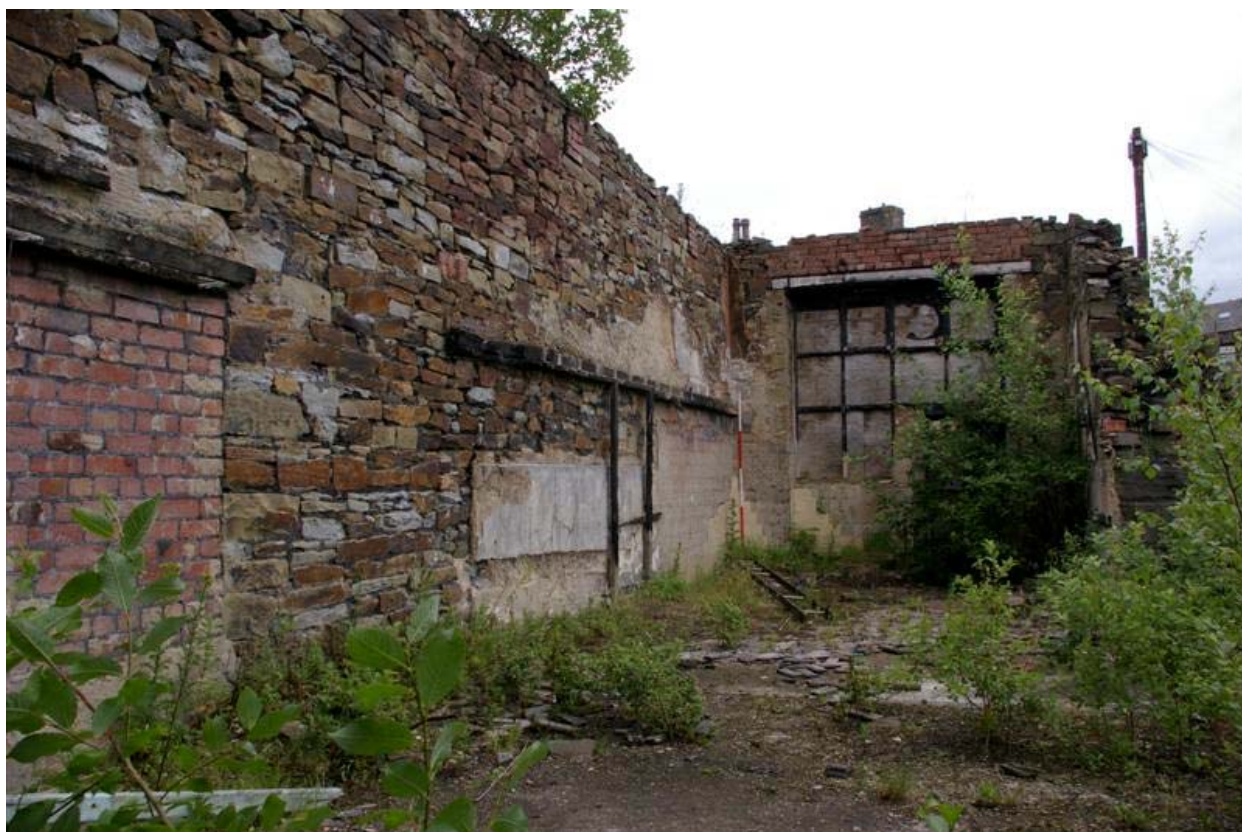
Plate 15: The remains of the engine house, facing east

- 4.6.1 This building was situated to the south of the chimney and was the hipped roof structure illustrated on the aerial photograph from c1950. Only the north, east and west walls remained (Plate 15). It was of random rubblestone construction with some brick patching and repair. The east elevation (facing Higher Mill Street) was of rock-faced construction (Plate 16). The floor was partly laid down to quarry tiles and concrete.

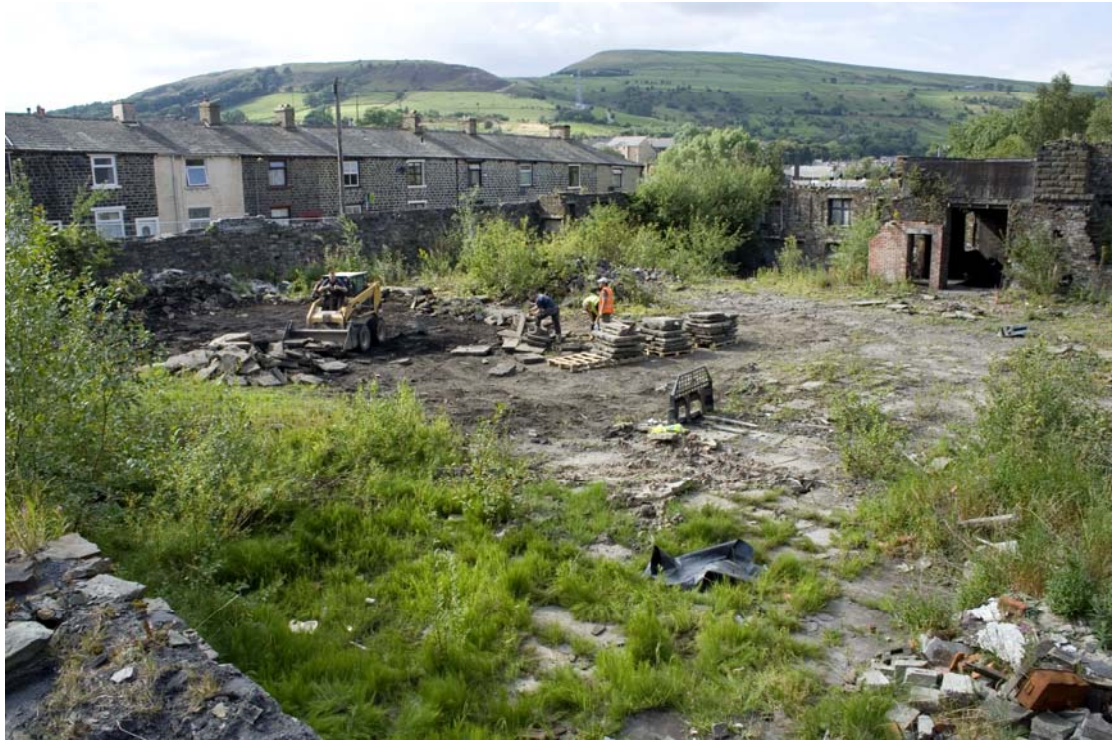
Plate 23: Removal of the flagged floor within the weaving shed, looking west

- 5.2.1 The flagged floor was removed by a Skid Steer Loader fitted with forks or a loading bucket (Plate 23). On average, the individual flagstones measured a maximum of 1.27m by 0.66m by 0.10m. Below the flags a very dark grey coarse sand-clay deposit was observed. This appears to have been bedding and levelling for the stones. No further features or structures were observed.

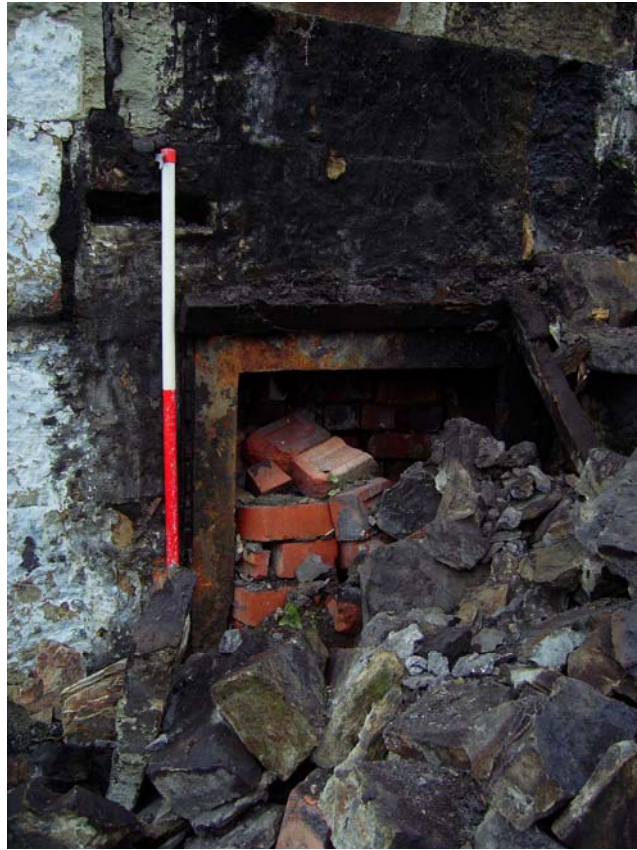
Plate 25: Bearing box within the south-eastern wall of the engine house, looking north

- 5.3.1 **Engine House:** during the demolition of the engine house a bearing box was observed in the south-eastern wall (Plate 25). It was located 5m above ground floor, adjacent to the east wall. It measured 0.90m wide and at least 1.0m high. Removal of the modern floor revealed a basement, and an engine bed. Further demolition of this structure ceased until a variation to the project design was agreed, in order to allow a detailed record of this structure to be compiled. The results of this further work are presented in *Section 6* of this report.

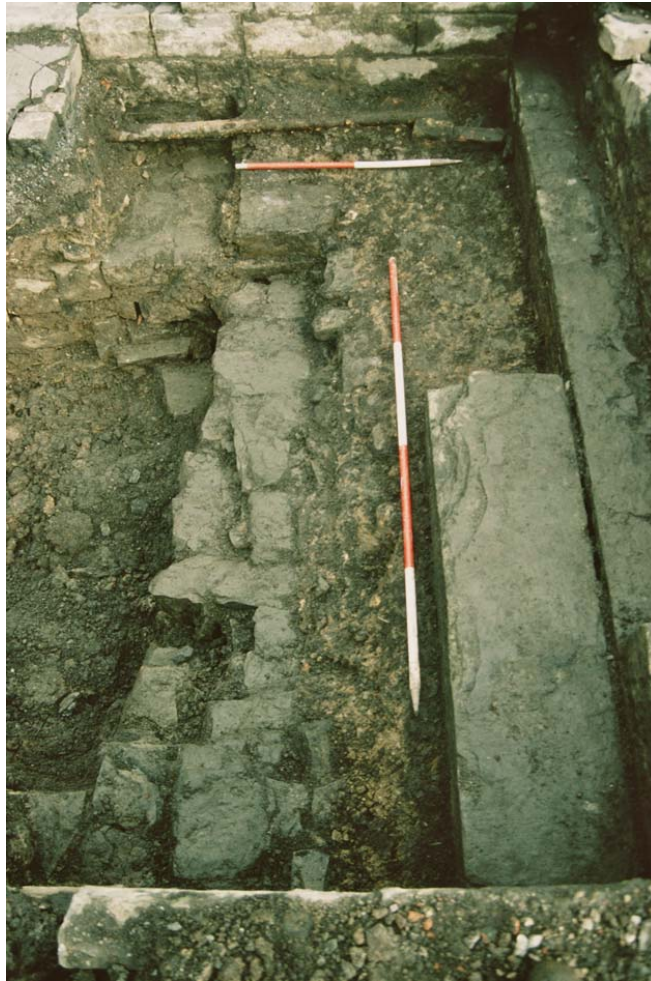
Plate 29: Foundation **10**, within the loading bay, looking north-east

- 6.2.4 A further foundation, **10**, was observed, however, this served no obvious function (Fig 9; Plate 29). It measured 0.60m wide and 0.9m in height. At the north-east it was keyed into wall **6** and to the south-west into wall **13**. The foundation (**10**) was overlain by a second layer of redeposited clay till, **3**, measuring a maximum of 0.55m thick. In turn, this was overlain by 0.30m of bedding material, **2**, for what would have been, prior to the construction of the loading bay, an external flagged surface, **1**. This comprised squared stones, each measuring 0.20m in length, 0.13m wide and 0.15m thick. Subsequently, this had been covered by a mid-grey concrete floor serving the loading bay.

| 10 | 1 | 0.90 | <p>Foundation. Comprised roughly squared a sandstone a maximum of 0.30m by 0.30m by 0.16m, roughly coursed, and bonded with a mid-orange brown coarse sand-clay.</p> <p>The north-east/south-west section of this appears to have no real function (Fig 9), as no wall is recorded as being in this position. It may have been a retaining wall associated with the levelling of the area. In this section in measures 0.60m wide.</p> <p>The north-eastern end turns north-east, where it essentially forms the foundation for wall 6, as the stone work is keyed into/the same construction as this wall, although giving a total width of 2.30m.</p> <p>Its south-western end also turns north-east, being keyed into wall 13, creating a foundation for wall 13 1.50m wide (Fig 9).</p> |
