# **Clitheroe Castle, Clitheroe, Lancashire**

## **Archaeological Investigation**

**Oxford Archaeology North**

February 2008

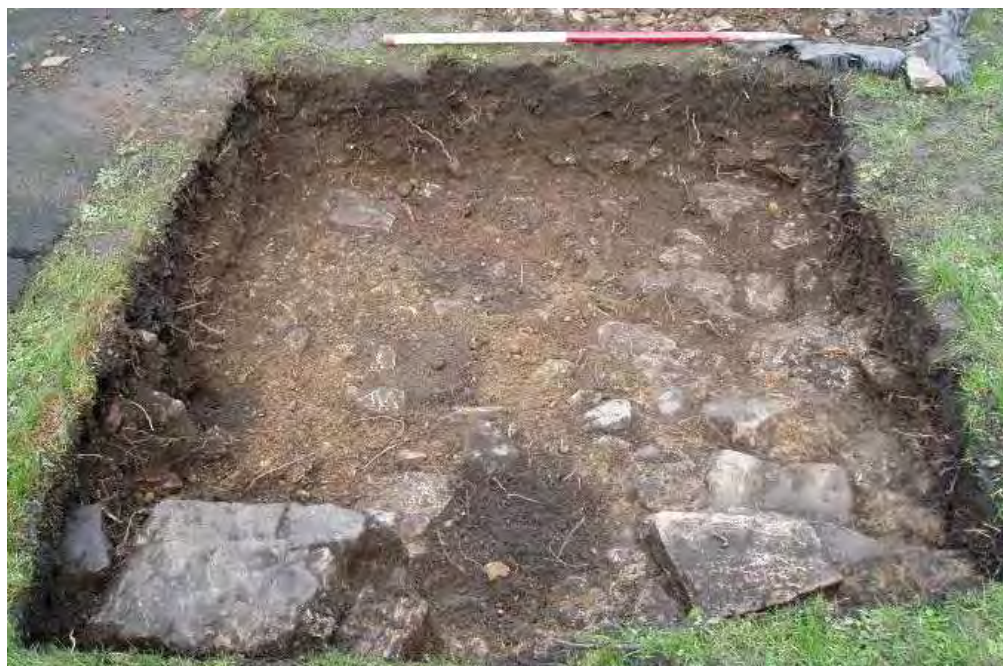
*Plate 5: Trench 1, looking north-east, showing the exposed features*

3.2.1 Trench 1 was located on the north-east side of the castle keep, and was aligned north-east/south-west (Fig 2). It measured 1.5m by 1.5m, and was excavated to a maximum depth of 0.70m. The modern ground level lies at a height of between 115.43m and 115.53m OD. The uppermost feature of archaeological significance was exposed at a height of 115.42m OD, and the solid geology (*114*) was encountered at a height of 115.01m OD.

- 3.2.2 **Phase 1:** the bedrock was sealed by a layer of brownish-yellow silty-sand (**111**) that in places was up to 0.20m thick. This layer probably represented a deliberate levelling episode, and had been cut by several features and a wall foundation (Plate 5). Two of these features, posthole **113** and pit **112**, were selected for partial excavation in order to assess the date, character and nature of the archaeological resource.

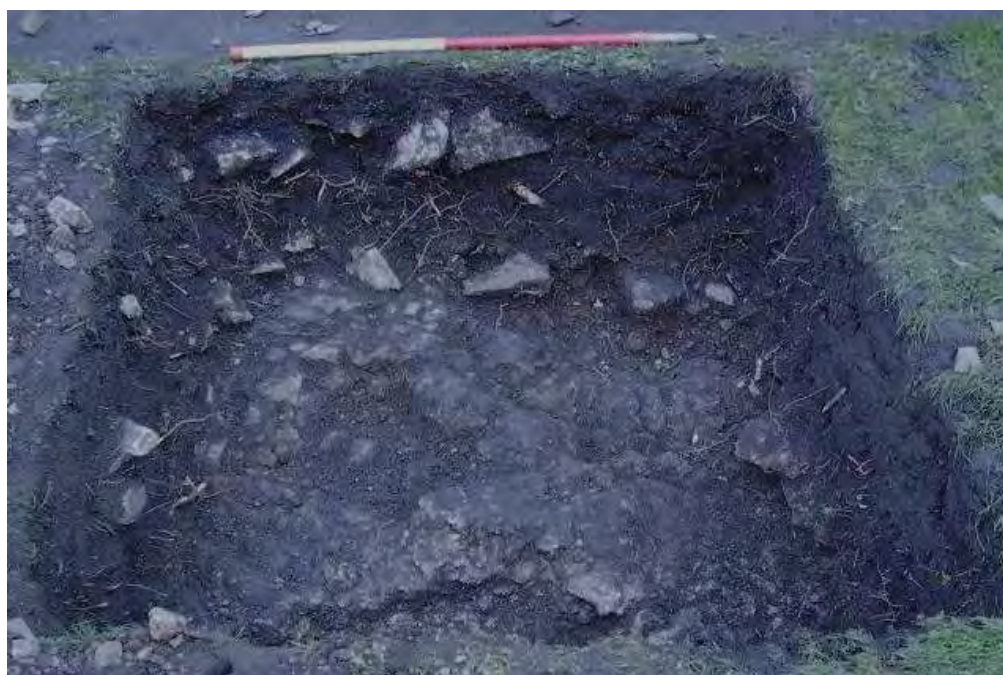
*Plate 6: Trench 2, looking south-west, showing features cut into the bedrock*

- 3.3.1 Trench 2 was located on the north-east side of the castle keep (Fig 2). It measured 1.5m by 1.5m, and was excavated to a maximum depth of 0.56m below the modern ground surface. The modern ground level lies at a height of between 115.28m and 115.39m OD. The first significant archaeological deposit lay at a depth of 0.40m below present ground level (114.99m OD). The solid geology, **210**, lay at a depth of between 0.45m and 0.50m below the present ground level (114.92m OD).

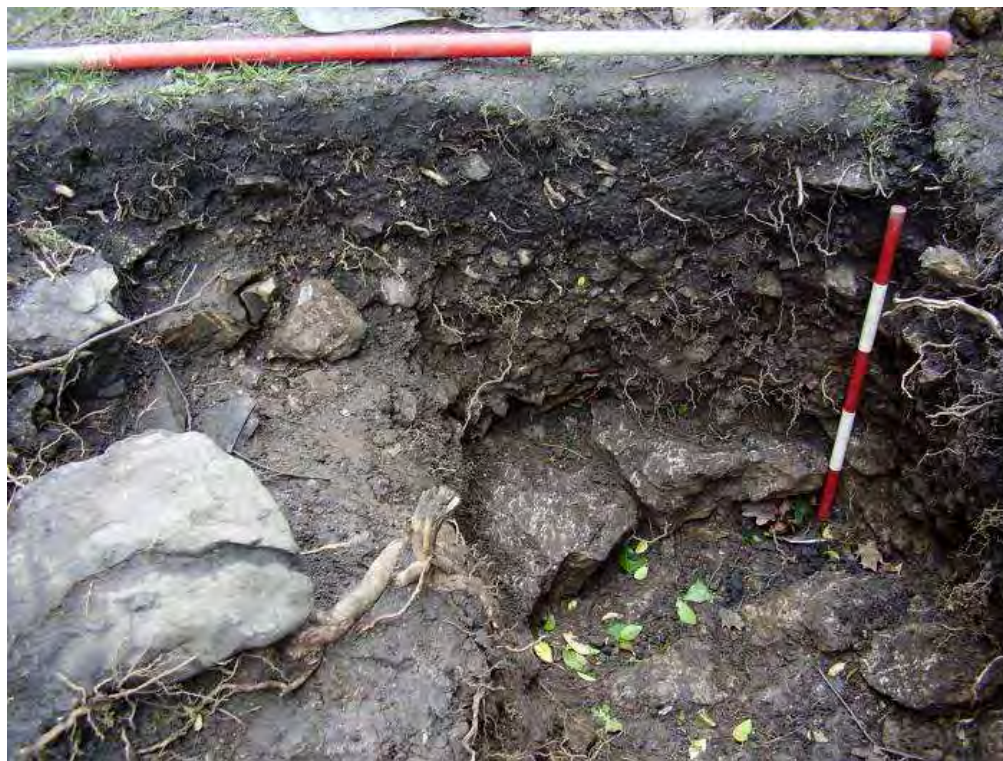
*Plate 7: North-west-facing section of Trench 3*

- 3.4.1 Trench 3 was located on the south-east side of the castle keep, but was of reduced dimensions (1m square) due to the space available and had a maximum depth of 0.60m (Fig 2). The modern ground level lies at a height of between 115.81m and 115.69m OD. The first significant archaeological deposit was encountered 0.10m below present ground level at a depth of 115.70m OD. The solid geology, **303**, was exposed at a depth of between 0.50m and 0.60m below the present ground level (Plate 7).

- 3.4.2 **Phase 1:** a fairly substantial deposit of silt and stone (**302**), which had a maximum depth of 0.45m and was seen to slope down to the south-east, overlaid the solid geology (Fig 5). It is likely that this deposit represented a deliberate levelling episode. The deposit produced fragments of animal bone and a single sherd of shell-tempered pottery. Such pottery was in use east of the Pennines for a considerable period, being found in Anglian York and into the thirteenth century. Here, given the date of the other pottery from the site and based on evidence from York itself, a twelfth- to thirteenth-century date would be applicable. The deposit also produced a bone disc, a stone needle sharpener/hone-stone, and a piece of antler, possibly representing working waste.

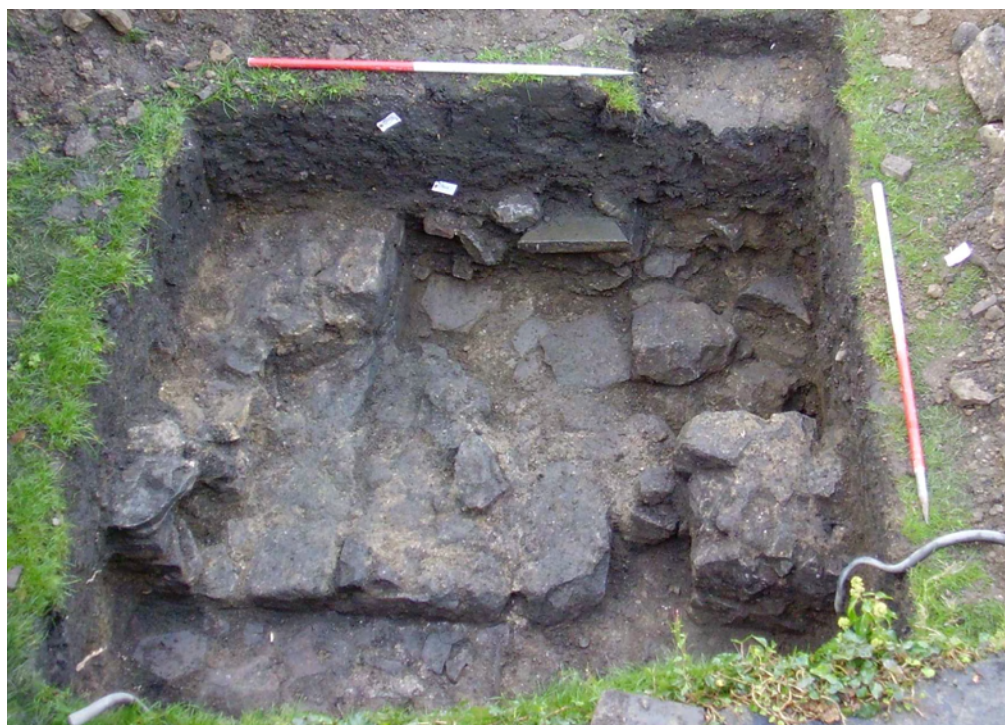
Plate 8: Looking south-west across Trench 5A

- 3.6.1 Trench 5 was the most south-easterly of the four evaluation trenches located to the rear of the museum (Fig 2). The original excavation of this trench in January 2007 revealed substantial structural remains, which were left *in-situ* and re-investigated during the mitigation phase (Trench 5A). The trench measured 2.07m by 2.1m, and was excavated to a depth of 1.13m (Plate 8). The modern ground surface was fairly level, and lay between 107.13m and 107.17m OD. Archaeologically-significant features lay at a depth of 0.15m below the present ground surface at 107.03m OD.

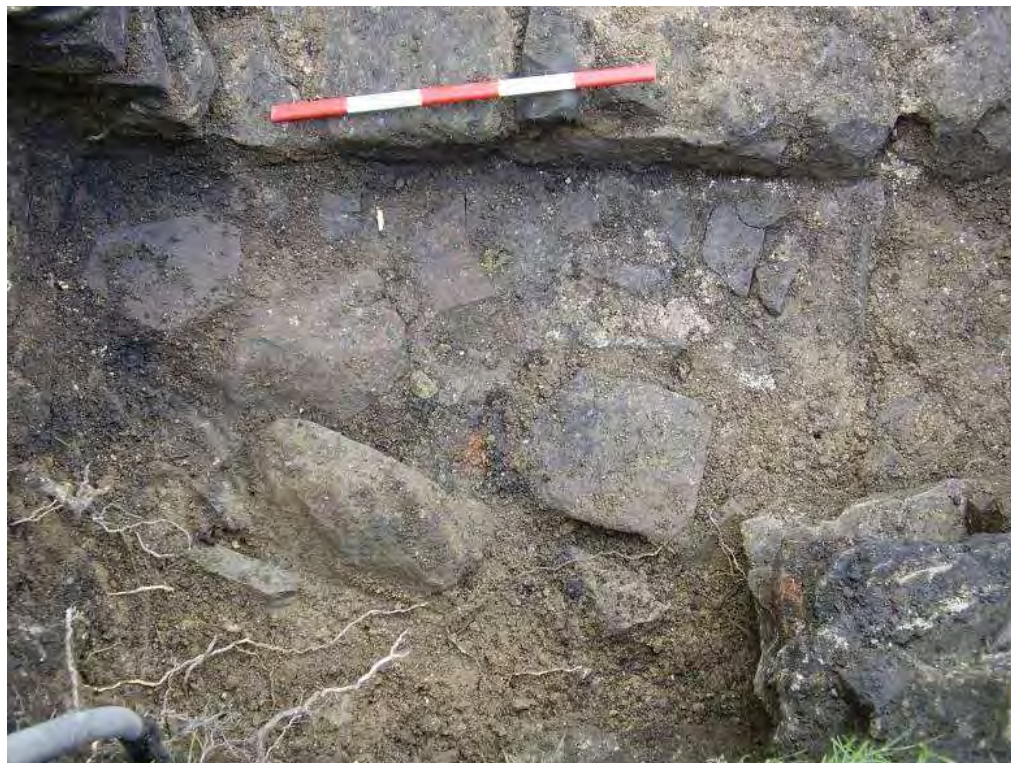
Plate 9: Trench 5a, showing the remains of fireplace **566**

- 3.6.4 Abutting wall **555/556** and **510** was a later fireplace (**566**) located on the north-eastern side of the wall (Plate 9). The feature survived as the hearth area only, and comprised a roughly rectangular structure extending 1.65m north-west from the edge of excavation and was 0.44m wide. Several re-used floor tiles were observed at the south-east end of the feature. These floor tiles, one of which exhibited splash glazing, were considered to be of a thirteenth-century date. A layer of charcoal-rich, slightly gritty sand (**565**) was contained within the fireplace/hearth.

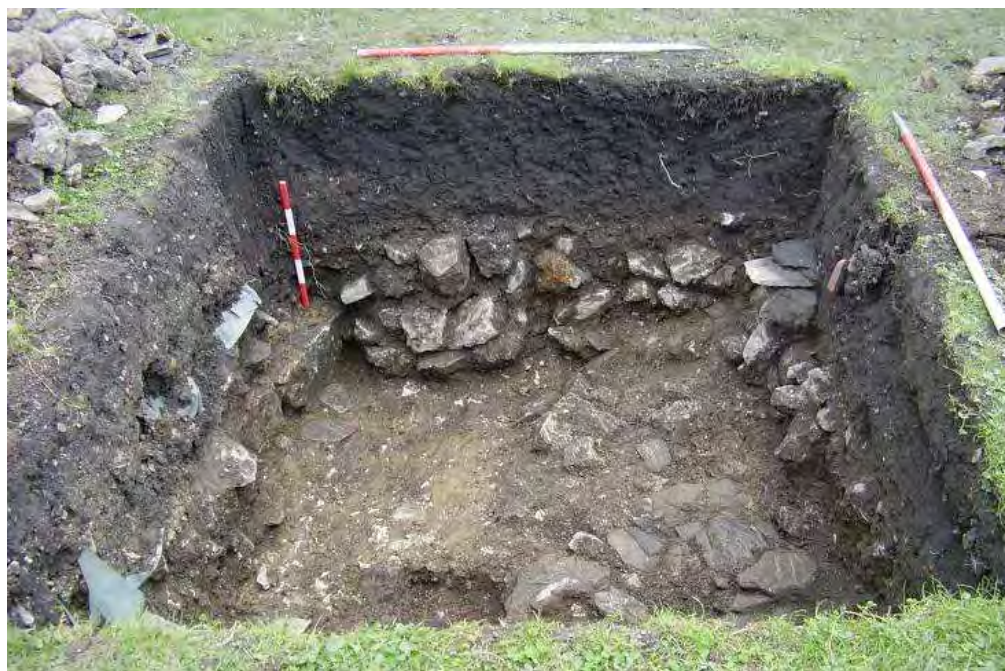
*Plate 10: General view of Trench 6A*

- 3.7.1 Trench 6/6A was located to the north-west of Trench 5, and to rear of the museum (Fig 2). Originally, it measured 1.50m by 1.50m, and was excavated to a depth of 0.98m (106.13m OD). The re-excavation as part of the mitigation strategy produced a trench measuring 2.3m by 1.75m, which was excavated down to the top of the solid geology (**660**) at a depth of 1.37m (165.71m OD) below the modern ground level (Plate 10). Archaeologically significant features lay at a depth of 0.37m below the present ground surface, at a level of 106.78m OD. The upper deposits within the trench were excavated down to approximately 1m below the present ground surface. Thereafter, the lower deposits were reached via a sondage placed in the centre of the trench (Fig 9).

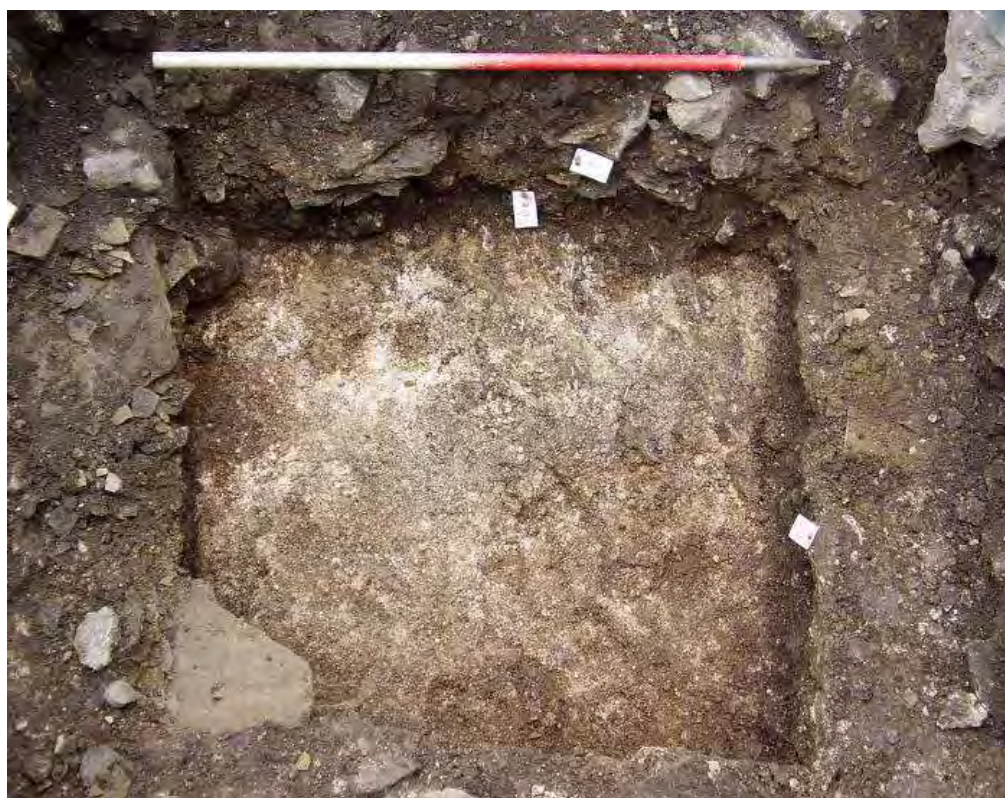
Plate 11: View north-west across Trench 6A, showing mortar deposit **658**

- 3.7.4 Overlying deposit **659** was a layer of creamy-white to light orangey-brown mortar, **658** (Plate 11). This deposit probably formed the foundation layer for a robbed floor. Cutting into this layer, and seen within the south-west-facing section of the excavated trench, was a V-shaped feature (**661**), possibly representing a posthole (Fig 10). This feature was backfilled with a deposit similar to the overlying layer (**609**), which had a maximum depth of 0.20m, and was composed of dark orangey-brown sandy-silt. This layer contained a relatively large group of animal bone fragments, probably representing food waste. The layer also yielded 13 sherds of medieval pottery, including six cooking pot fragments; a date no closer than between the twelfth and fourteenth century can be assigned to this pottery group. These finds, in addition to the organic nature of the deposit, suggest that part of the building had been abandoned and was used as a midden during the later medieval period.

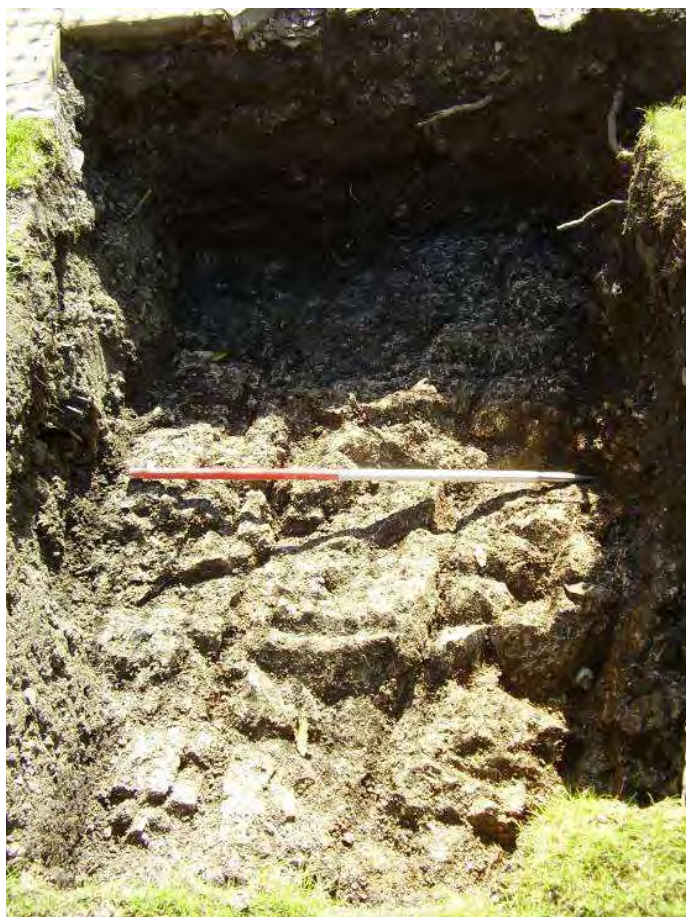
Plate 12: View across Trench 7A

3.8.1 Trench 7A was located to the north-west of Trench 6, and to the rear of the museum (Fig 2). It measured 1.5m square, and was excavated to the top of the solid geology (752), which lay at a depth of 0.78m (106.48m OD) below the modern ground surface (Plate 12). The present ground level lay at a height of between 107.11m and 107.29m OD.

3.8.2 **Phase 1:** lying above the solid geology was a layer reddish-brown clay-silt (754), lying within a possible rock-cut feature, 757. This was roughly L-shaped and aligned north-west/south-east by north-east/south-west and was 0.20m deep. It contained two sherds of medieval pottery.

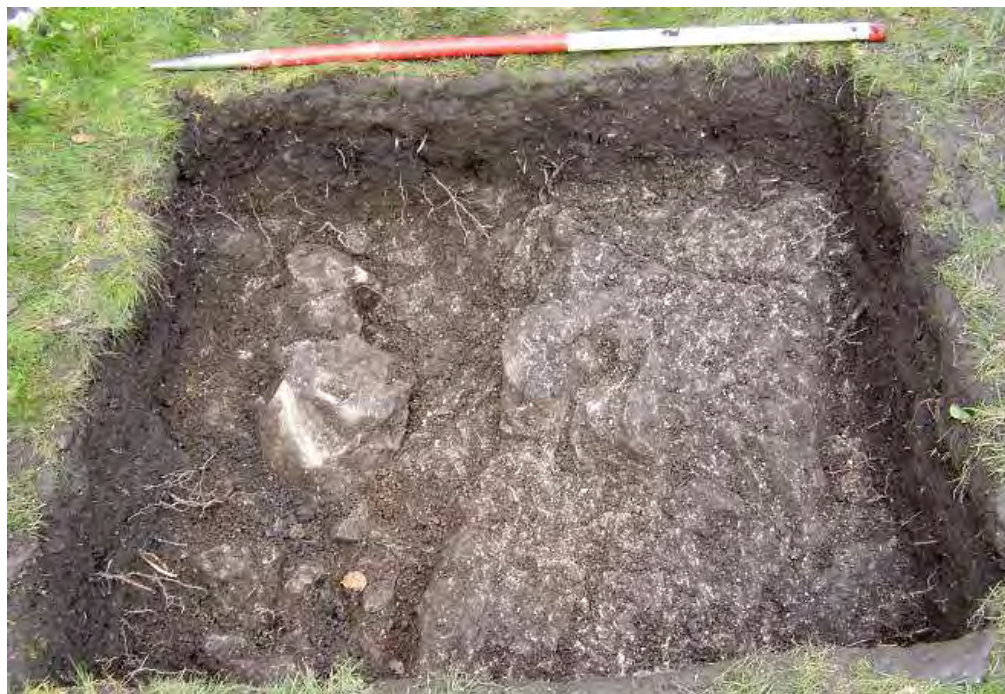
*Plate 13: Looking north across Trench 8*

- 3.9.2 A single feature was recorded within the trench (Fig 12). This comprised a north-west/south-east-aligned, shallow (0.11m) rock-cut linear feature (**804**), of which only the eastern edge and part of the base was visible within the excavated trench (Plate 13). The fill was composed of brownish-grey, clay-sand, and limestone rubble, **802/803**. This was probably either a robbed-out wall or a rock-cut gully, and whilst it was tempting to interpret **804** as a medieval structural feature, firm evidence was lacking.
- 3.9.3 **Phase 3:** the bedrock and feature **804** was sealed by a layer of garden soil (**801**). This layer yielded several sherds of pottery, to which nineteenth- and twentieth-century dates have been ascribed.

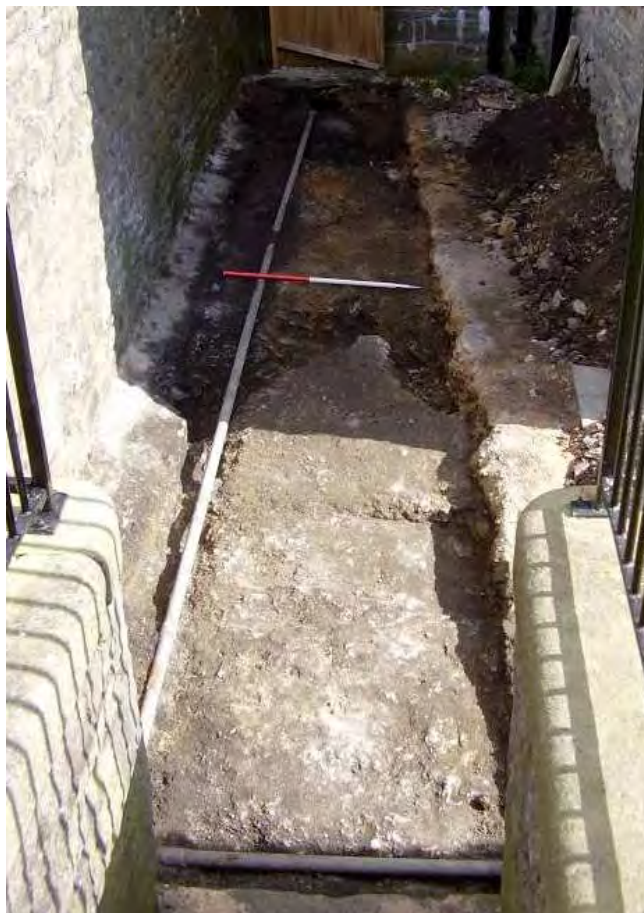
Plate 14: Trench 10 viewed from the south-west

- 3.11.2 **Phase 2:** the earliest features within the trench were a mortar-filled hollow (**1010**), and a V-shaped ditch (**1006**). The hollow was located towards the south-west end of the trench. It was not clear whether this feature was formed through human agency, or whether it was natural. Lying just to the north-east was ditch **1006**, which was aligned east/west (Fig 13). Where the ditch entered the trench from beneath the retaining wall, a lead pipe, within cut **1006**, had been cut flush with the side of the wall. It would appear likely that the pipe was fed from the nearby cistern/well, and supplied water to the museum.

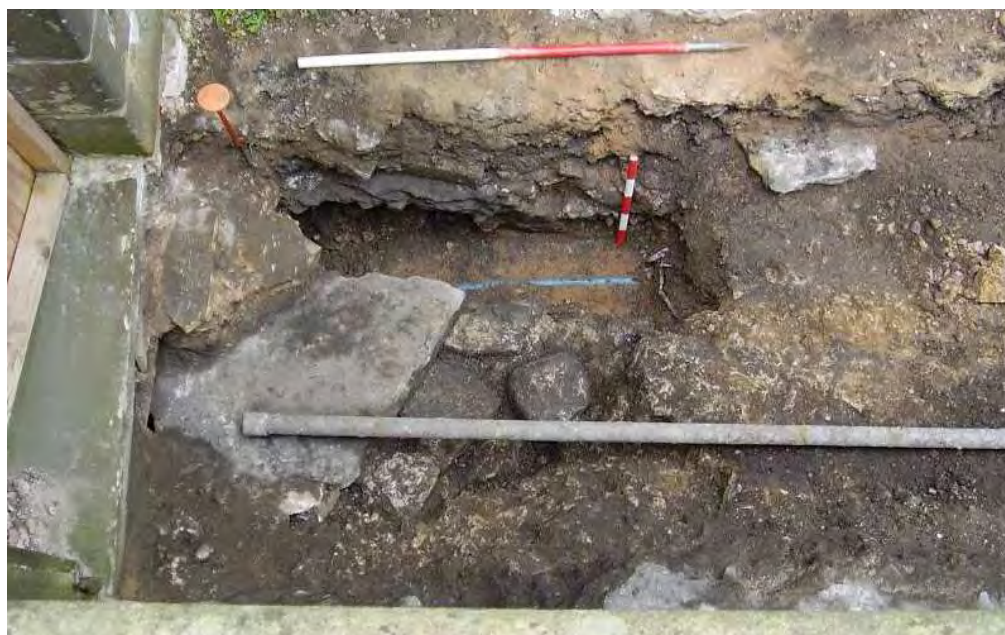
Plate 15: Culvert/conduit 1007 at the north-east end of the trench

- 3.11.3 **Phase 3:** a stone-built culvert or conduit (**1007**), 1.1m wide and 0.43m high, was exposed at the north-east end of the trench. This had been cut into the bedrock, and had stone walls with large slabs as capping (Plate 15); the culvert was still in use housing various more recent services. The trench was then sealed by a buried soil horizon, **1002**, which had a maximum depth of 0.15m.

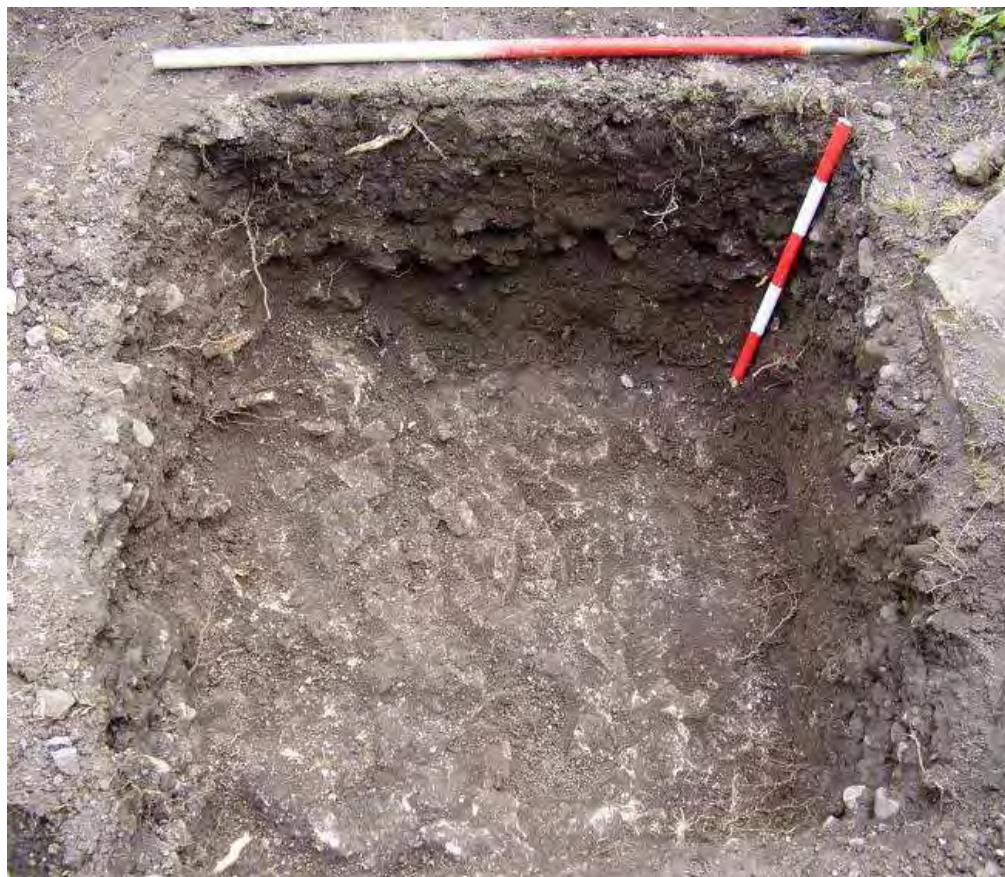
*Plate 16: Trench 12, showing rock-cut feature 1207*

- 3.13.2 **Phase 1:** a shallow-rock cut feature (**1207**) was noted running north-east/south-west across the trench (Plate 16). Although quite subtle in character, it extended in the same direction across Trench 14, where it was much more pronounced.
- 3.13.3 **Phase 2:** feature **1207** and the bedrock were sealed below a layer of dark-brown, sandy-silt, (**1205**).
- 3.13.4 **Phase 3:** layer **1205** was sealed below a coarse deposit (**1202**), which was some 0.30m deep, and contained a high percentage of stone. It seems possible that this may have been deposited as a levelling horizon for the overlying footpath (**1203/1204**). The uppermost deposit was topsoil layer **1201**.

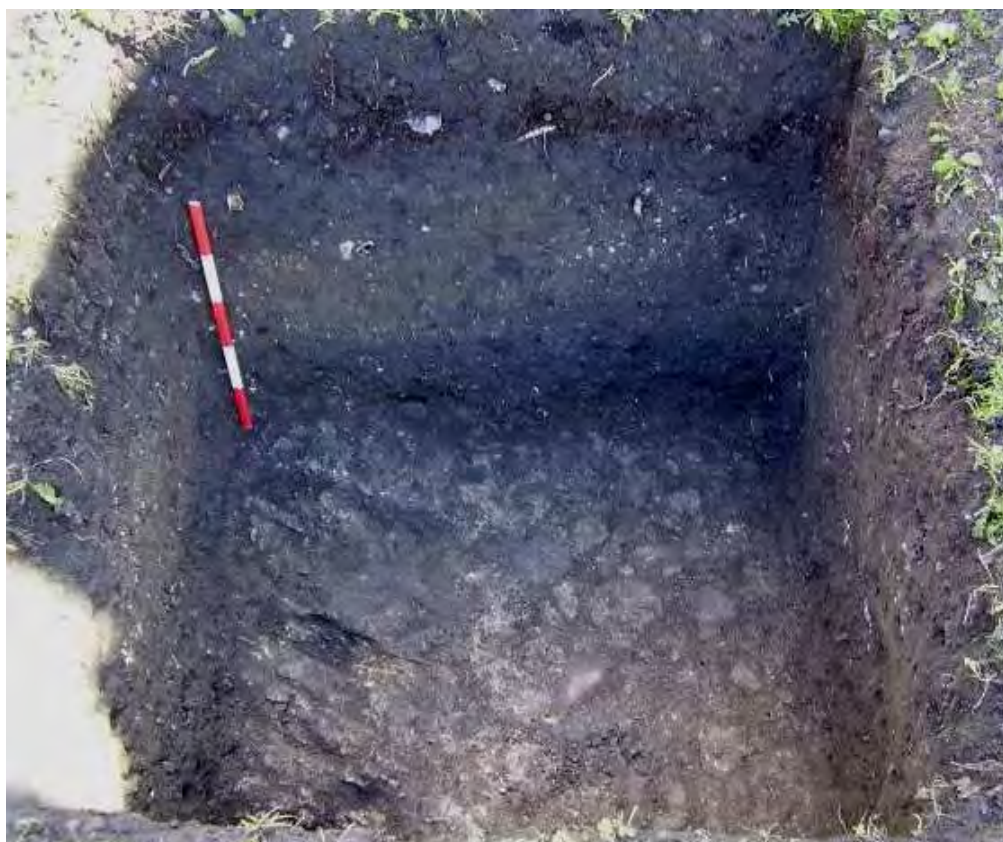
Plate 17: Trench 13, showing surface **1304**

- 3.14.1 Trench 13 was aligned north-east/south-west, and was located between the well and the retaining wall overlooking Trench 15 (Fig 2). The trench measured 1.05m by 1m, and was excavated to a maximum depth of 1.04m (106.57m OD). The modern ground level lies at a height of between 107.68m to the north-east and 107.40m OD to the south-west. The solid geology (**1307**) was exposed in the base of the trench, which lay at a minimum depth of 0.83m below the modern ground surface. The first significant archaeological deposits were encountered lay at 107.19 OD.

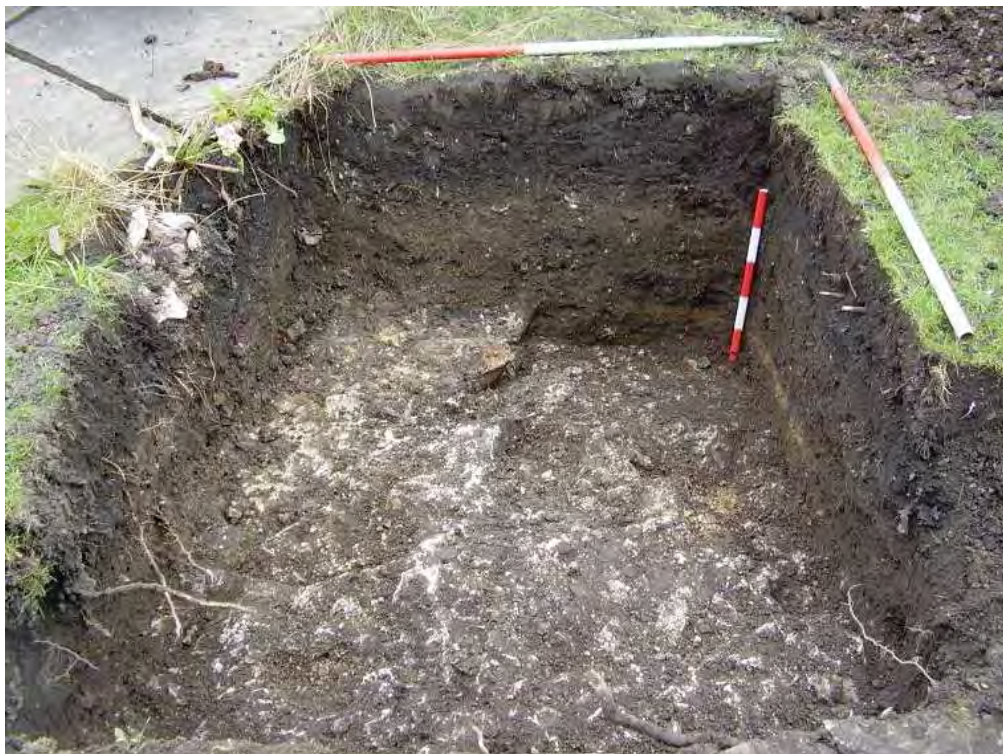
*Plate 18: Trench 14, showing feature **1404** and mortar deposit **1406***

3.15.3 **Phase 2/3:** cutting into **1403** at the south-east end was another rock-cut feature (**1407**), which was aligned south-east/north-west (Fig 15). It was filled with a deposit of degraded mortar (**1406**). This was overlain by fill **1405**, and sealed by layer **1402** (Fig 15). None of these deposits yielded any finds, and it has not been possible to ascribe firmly a date to their origin. The uppermost deposit comprised topsoil **1401**.

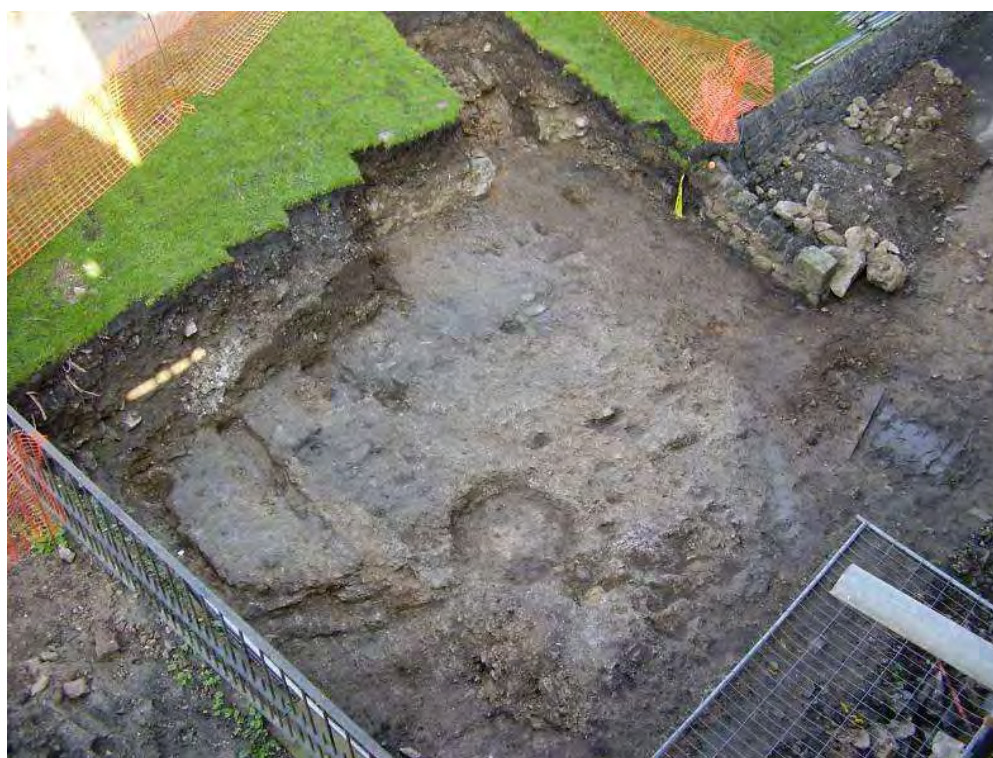
*Plate 19: View of Trench 15 from the roof of the museum, facing north.*

3.16.1 Trench 15 was aligned north-east/south-west, and was intended to investigate the grassed bank between the museum and former North West Sound Archive building (Fig 2); the trench incorporated Trench 9 that was excavated as part of the initial evaluation. Trench 15 measured 7.17m by a maximum of 5m wide, and was excavated to a maximum depth of 1.26m (Plate 19). The trench was placed on a steeply pitched gradient, which sloped down to the south-east. The modern ground level on the north-western edge lay between 107.46m and 107.6m OD, rising to 107.86m OD. The south-eastern edge of the trench at the base of the bank lay between 105.48m and 105.73m OD. Solid geology **1501** was exposed at a height of between 106.35m OD and 105.48m OD. The first significant archaeological deposits were encountered at a height of 106.00 OD on the north-west side of the trench, some 0.62m below the modern ground level, but significantly lower towards the south-east edge of the trench.

3.16.2 **Phase 1:** the excavation of Trench 15 revealed the remains of a building, probably medieval in origin and likely to have resulted from several developmental phases, although the absence of significant vertical stratigraphy precluded any detailed analysis of the structure. However, it was clear that several different building techniques had been employed, including a masonry wall, timber cill beam, and wooden post construction; it was not clear whether the stone wall, which also acted as a retaining wall, was contemporary with the wood-bearing features, or whether it represented a later phase.

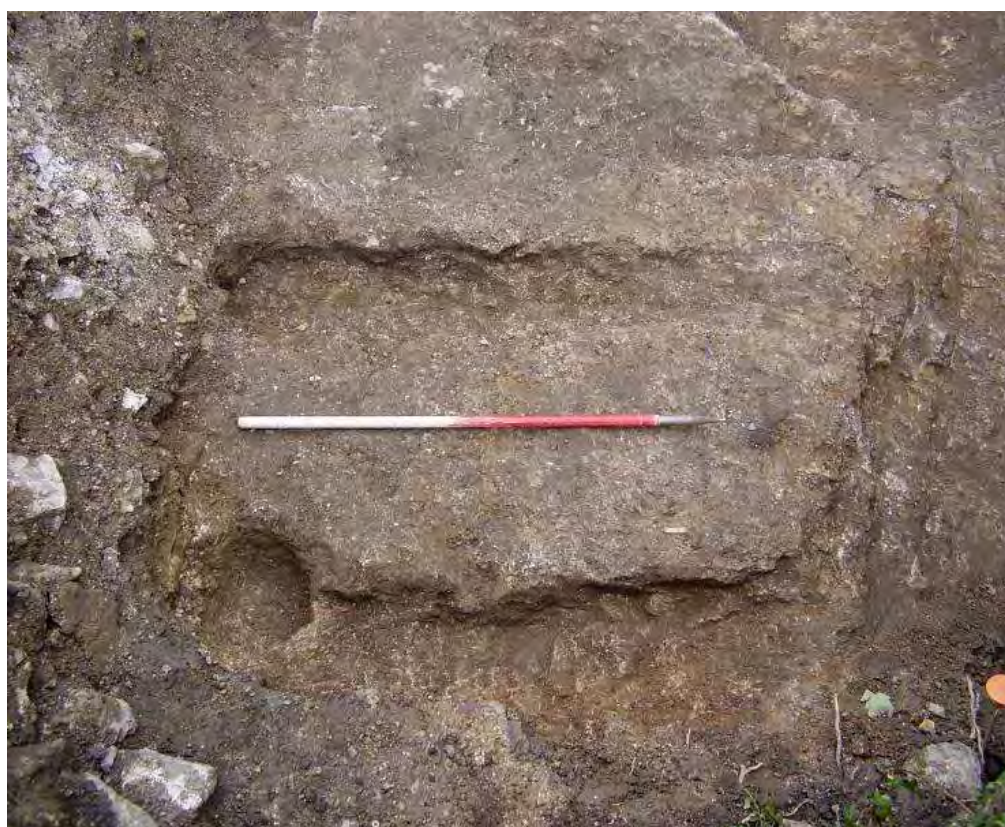
*Plate 20: Beam slots **1510** and **1514**, and posthole **1512***

- 3.16.4 Located toward the south-west end of the trench and partially truncated by later activity, was a group of four north-west/south-east-aligned, shallow beam slots (Plate 20). The most south-westerly (**1510**) was 1.1m long and 0.25m wide, and incorporated a circular posthole (**1512**) at the north-west end (Fig 16). Beam-slot **1514** was somewhat longer, and spaced equidistant from **1510** and the adjacent beam slot to the north-east (**1524**). Beam slot **1524** was just over 1m long, and was only well defined on three sides. The last beam slot of the group (**1522**) extended beyond the limits of excavation (Fig 16). It was not clear whether the slots represented several different phases of activity, or whether the slots supported timber cill beams used for bearing walls and also for supporting floors.

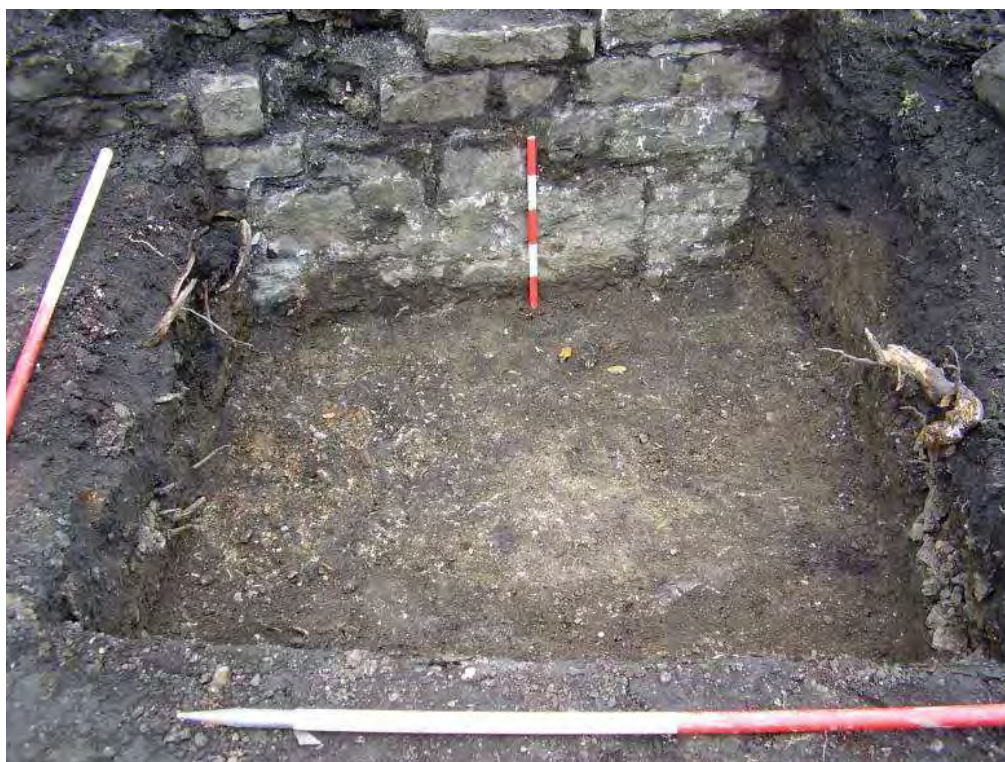
Plate 21: Trench 17, looking north-east

3.18.2 **Phase 1:** the bedrock in the south-western half of the trench was sealed beneath a layer (**1705**) of dark-grey, slightly gritty silt, which contained numerous fragments of medieval pottery. Partially overlying deposit **1705**, and extending to the north, was a dark grey, clay sandy-silt, **1704** (Fig 17). This layer also yielded medieval pottery, and also contained a large amount of crushed shell, the latter characteristic probably indicating that it was in use as a surface. Layer **1704** was overlain in the central part of the trench by a discrete patch of mortar, **1703** (Fig 17), which possibly represented the remains of a surface.

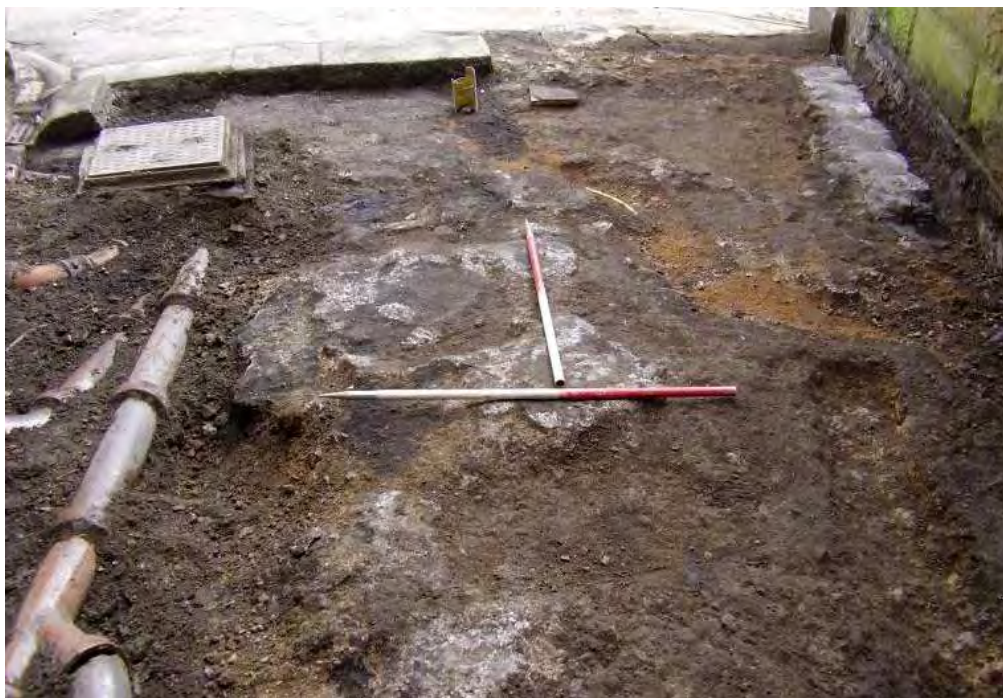
Plate 22: Looking east across Trench 18, showing beam slot **1815** to the right

- 3.19.1 Trench 18 was aligned approximately east/west, and was placed between the former Sound Archives building and the north/south-aligned range of outbuildings (Fig 2). The trench measured 6.7m by a maximum of 4.35m, and was excavated to a maximum depth of 0.59 m (108.09 OD). The modern ground level lay at 108.79m OD. The trench was excavated down to the base of the solid geology, **1817** (Plate 22). The first significant archaeological deposits were at a depth of 0.11m below modern ground level (108.68m OD).

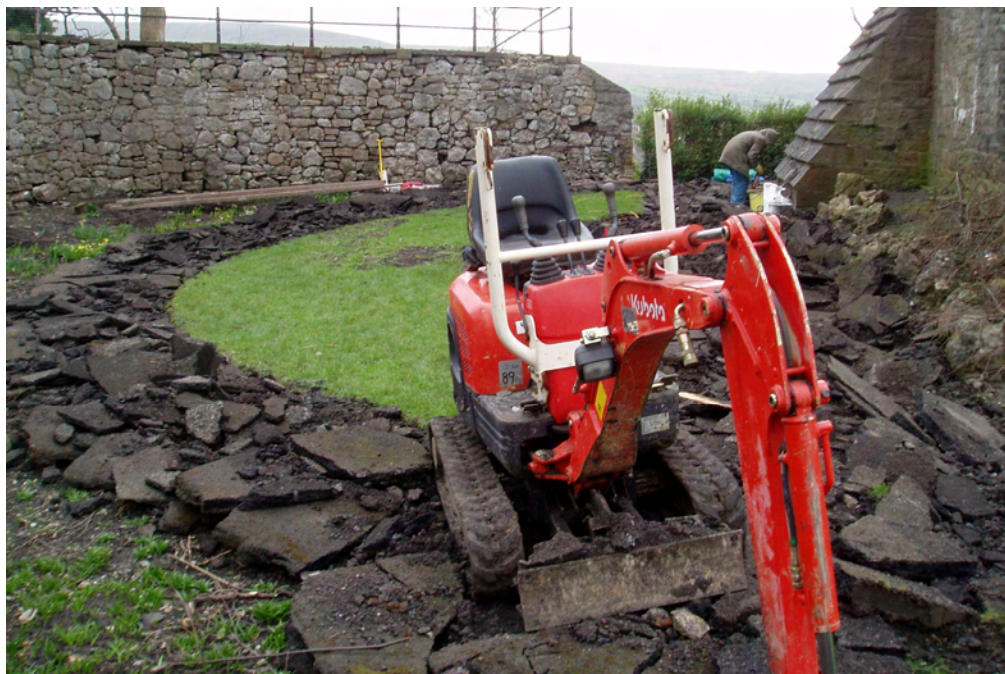
Plate 23: Removing the tarmac surfacing from around the castle keep

3.20.1 **Castle keep:** several stages of archaeological watching brief were implemented during the course of the development programme (Fig 2). The first of these was carried out in March 2007, and monitored the removal of the tarmac footpath around the northern part of the castle keep (Plate 23). The tarmac had been laid on a modern levelling layer, which was left *in-situ*; no archaeological remains were exposed.

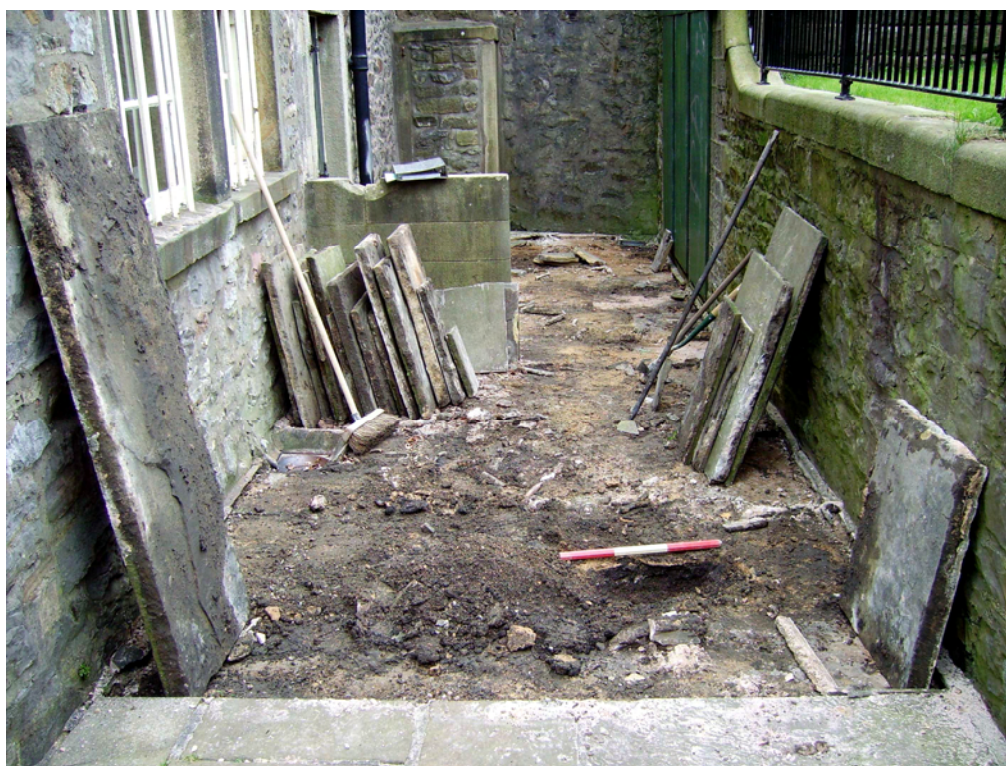
*Plate 24: Removal of the flagstones to the rear of the museum in April 2007*

3.20.2 **Museum area:** in April 2007, a second stage of the watching brief monitored the removal of the flagstones that formed a surfaced path to the rear of the museum (Fig 2). This work was carried out in advance of the installation of a new drainage system. The flagstones were removed manually, and the underlying deposit was cleaned to allow for the identification of any archaeological deposits. The path lies at a reduced level, so it was anticipated that any archaeological remains beneath the path would have been destroyed during the construction of the present museum. However, whilst the solid geology was exposed immediately beneath the flagstones, one sub-circular feature was identified (Plate 24). This feature was very shallow, and had almost certainly been heavily truncated when the ground had been reduced, which was presumably associated with the construction of the present museum. Partial excavation of the exposed feature yielded no finds, precluding close dating, although it is possible that the exposed feature was of medieval origin.

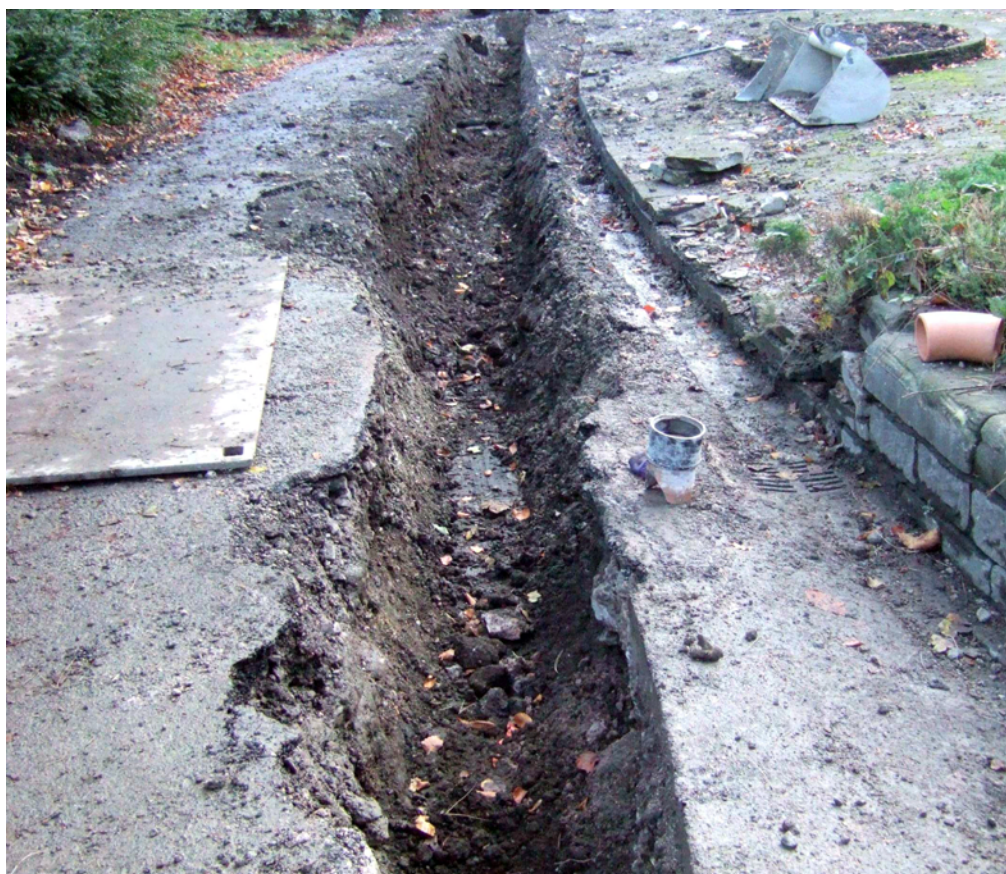
*Plate 25: The service trench excavated along the upper part of the driveway*

3.20.4 **Driveway works:** the replacement of an existing drain that lay beneath the main driveway was also monitored by an archaeological watching brief. This work was carried out in November 2007, and necessitated the excavation of a trench measuring 1m wide with a maximum depth of 1.08m along the driveway between the museum and the main entrance gateposts. Initially, a 11.9m long section was excavated mechanically along the upper part of the entrance driveway (Plate 25). The solid geology was exposed at a maximum depth of 0.65m, and was overlain by a light greyish-brown layer. This was sealed beneath a layer of small and medium-sized stones, which presumably represented a make-up for the modern driveway surfacing. The excavation of this section of the trench yielded no finds and no archaeological features were identified, although a gas pipe was visible in the north-west section of the trench at a depth of 0.30m.

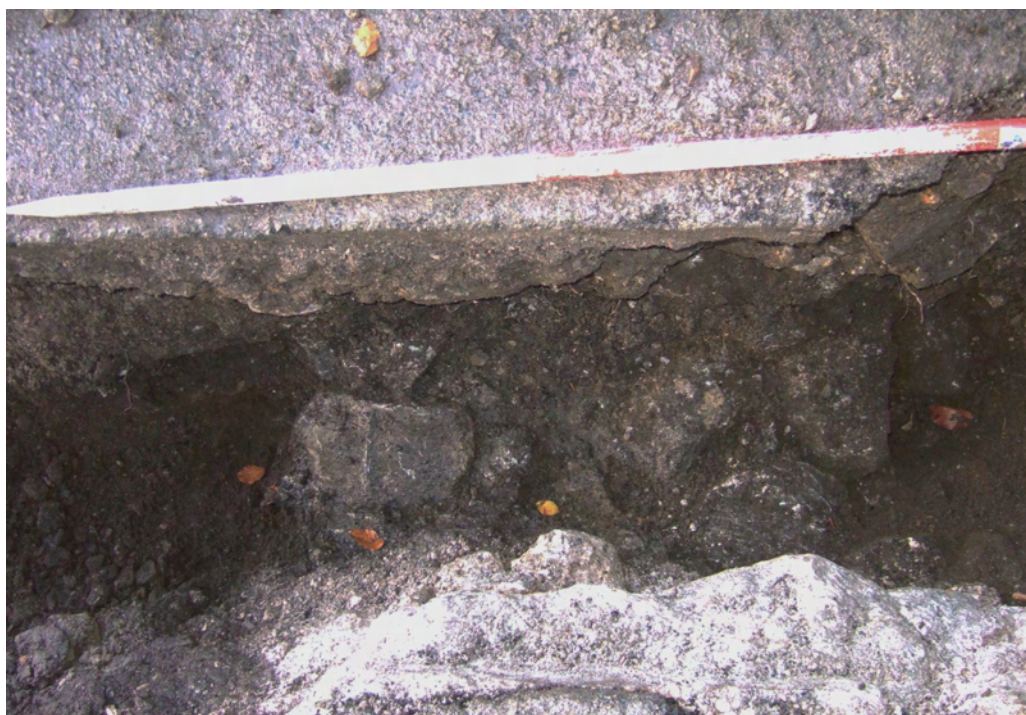
*Plate 26: Stone exposed in base of trench*

- 3.20.7 Further along the trench towards the museum, a small patch of compacted clay with traces of burning was exposed at a depth of 1m (Fig 19). The clay extended for a distance of 0.6m along the trench, although this clearly did not represent the full dimensions of the deposit. Some 3m to the south of the clay, and at a maximum depth of 1.08m below the modern ground surface, several large, squared stone blocks were exposed (Plate 26). These lay in the layer of loose, light brown soil, and were seemingly distributed randomly, suggesting that they represented a demolished stone wall. A single fragment of thirteenth-century pottery was recovered from between the stones, although no other artefacts were recovered.

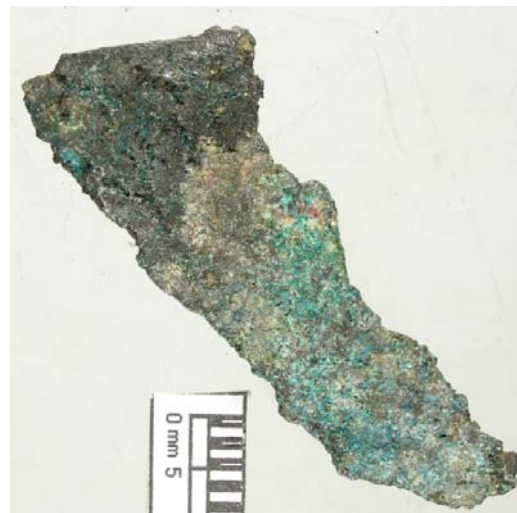
11 irregularly shaped fragments of CuA sheet, probably associated or from the same object. The two largest, non-joining fragments (designated ii & iii) (dimensions 50x41 and 53x21mm, 4-6mm thick max) are the only pieces with an original surviving (?top) edge, which is flat on the inner surface and has a rounded bevel on the outside. These may be vessel fragments. The pieces are undecorated. Surfaces are variable in colour, from very dark/black to black/green. The pieces may have been exposed to heat, but only 1 piece (designated vii) shows possible heat related distortion.

Surface EDXRF (energy dispersive X-ray fluorescence) found the alloy composition to be sufficiently similar to suggest that all the fragments are from the same object.

Highly corroded but stable, some pieces appearing to be totally mineralised. Corroded surfaces are uneven and slightly warty.

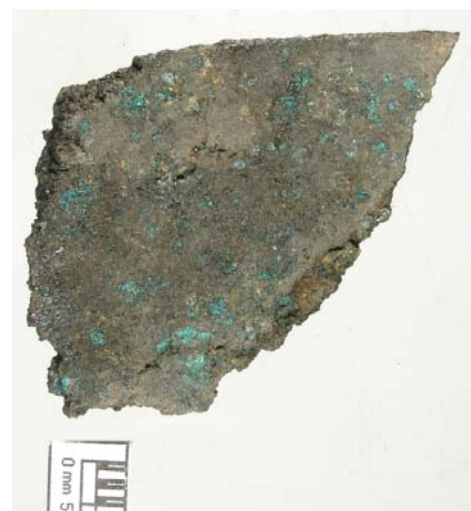
Fragments with an original ?top  
edge
