# Lowther Castle Chicken Sheds, Cumbria

## Archaeological Watching Brief

**Oxford Archaeology North**

November 2008

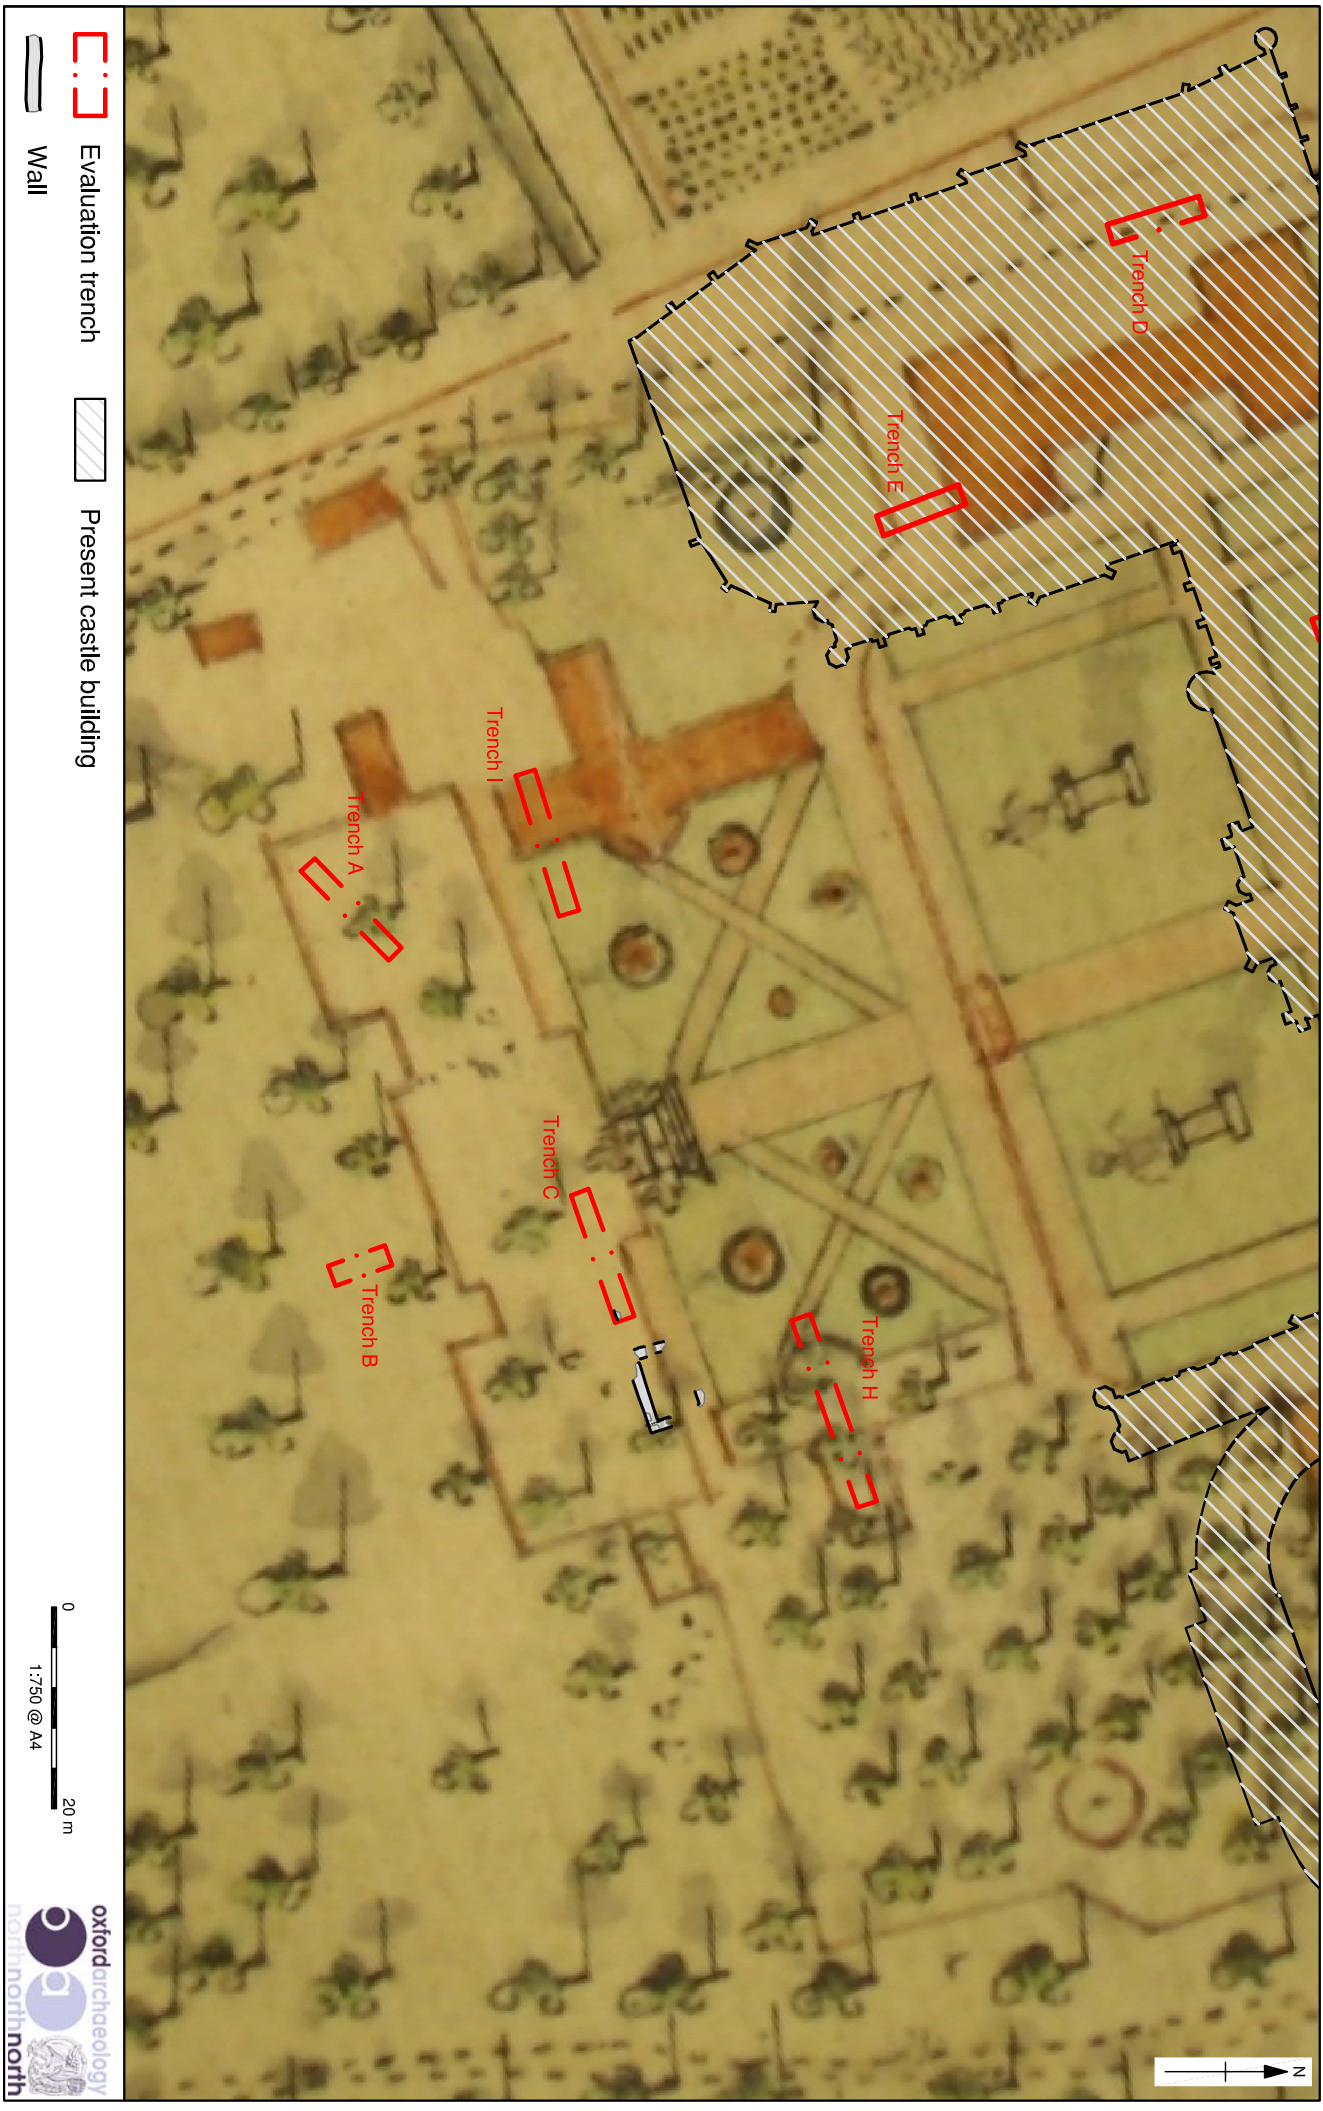
Figure 3: Excerpt of Richardson's map, 1754, with the archaeological remains superimposed

- 3.2.4 The remains of a possible wall foundation were revealed in Trench H, in broadly the position of the eastern wing of Lowther II, as extrapolated from Richardson's survey of 1754 (Fig 3). A deposit containing mortar and a channel cut into the bedrock were the only features within Trench B, suggesting that any features relating to the castles, that may have once existed, had been truncated by later activity. No archaeological features were revealed in Trench I and it is possible that the levelling carried out for the concrete surface in the vicinity of this trench had truncated any early remains. The full results of these investigations and a summary of the key events of the development of the Lowther Estates is reproduced in the evaluation report (OA North 2007a).

- 4.2.8 The structure was comprised of a paler sandstone than that seen in the rubble spread beneath chicken shed 2, immediately to the south, and was observed to have at least two courses of masonry intact. As much of the feature as possible was cleared of rubble by hand but it was considered likely that more of the structure remained buried intact. A full photographic record was produced of the structural remains (Plates 3 and 4) and the outline of the walls were surveyed (Fig 3).

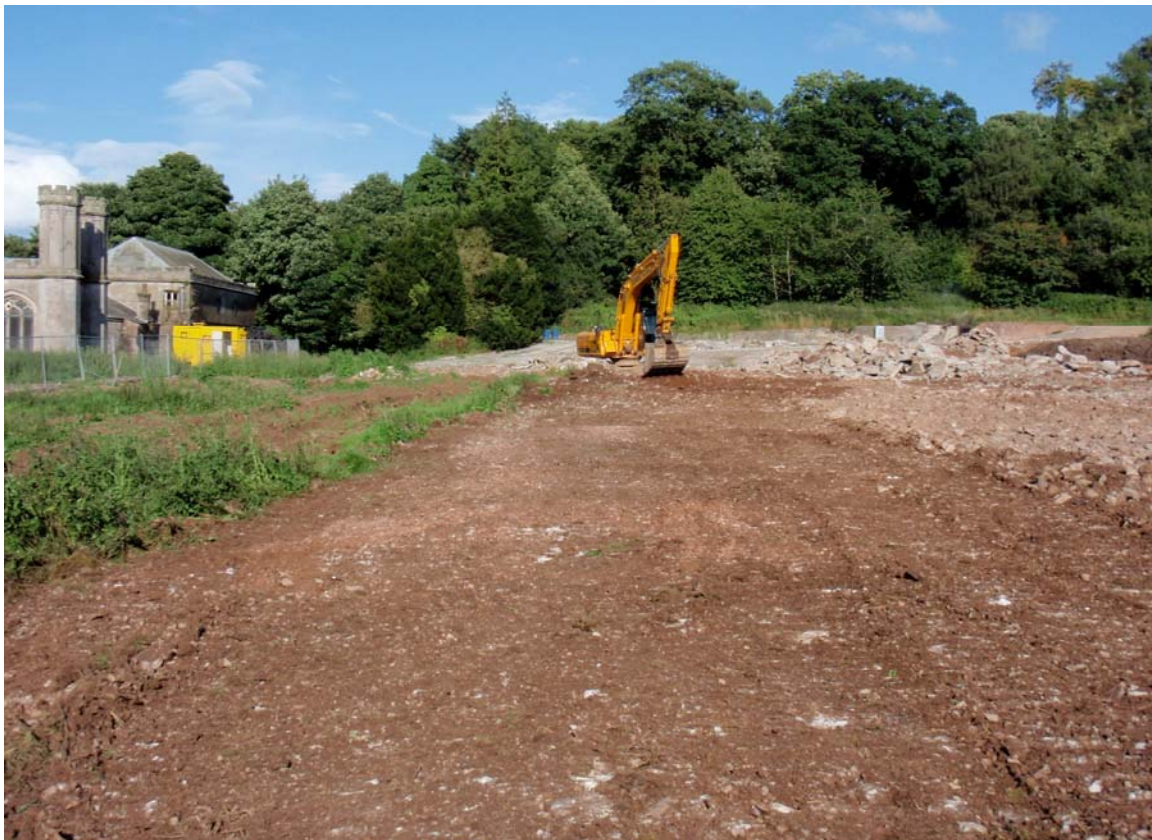
Plate 2: Spread of fragmented red stone beneath chicken shed 2

- 4.2.2 **Chicken shed 2:** the base of chicken shed 2 also comprised two separate layers of concrete totalling 0.3m in thickness and their removal was again facilitated by a mechanical breaker. The removal of the fragmented concrete revealed similar rubble deposits to those underneath chicken shed 1 at the far eastern end of the area, with cleaner natural clays at the western end. In the centre of the area of chicken shed 2, extending for approximately 20m east to west and beyond its limits north and south, was a concentration of fragmented red sandstone (Plate 2). This stone spread comprised sub-angular and angular pieces with faces measuring up to 0.45m long, some of which appeared to have been dressed. Although concentrated in one area none of this stone was *in situ* and it would appear to be demolition debris, although it was not evident which building had been demolished to produce it. No further archaeological deposits, features, structures or artefacts were observed in this area.
