**SHILLA AND BOG  
HEAD BASTLES,  
KIELDER FOREST  
NORTHUMBERLAND**

**Fabric Survey Report**

**Oxford Archaeology North**

October 2008

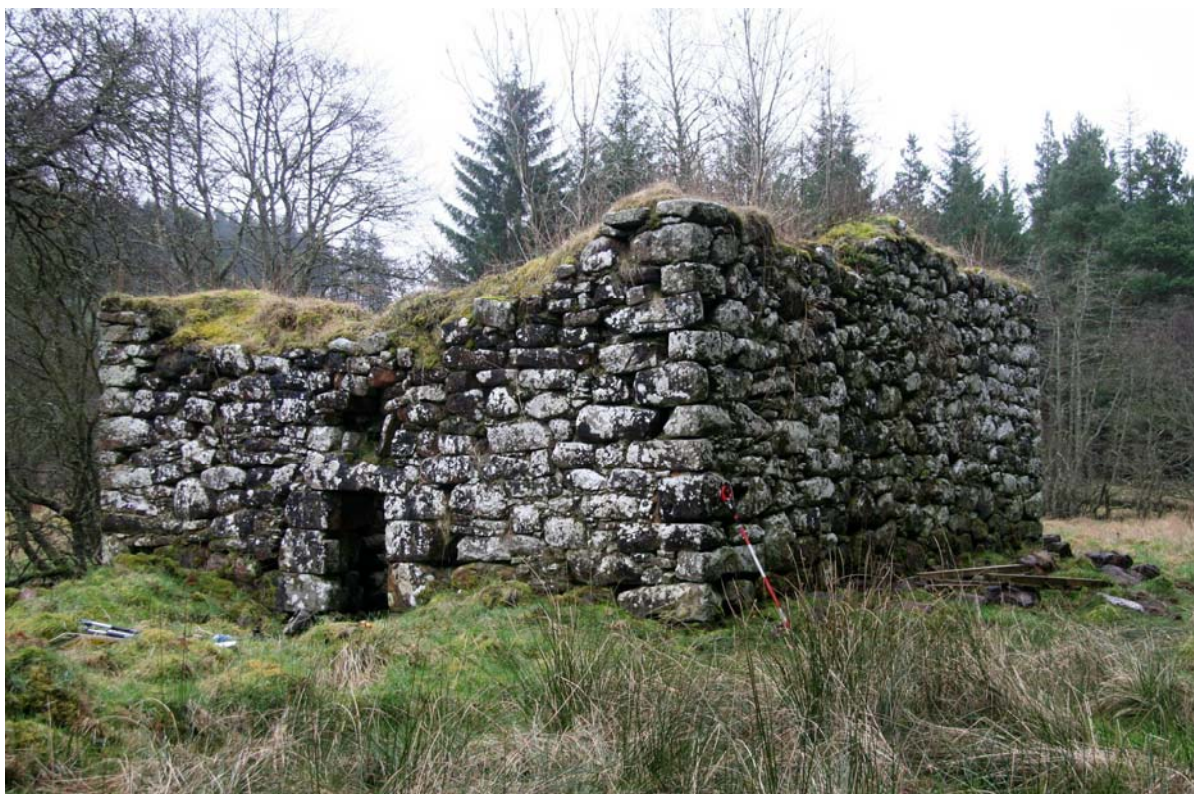
Plate 1: General view of Bog Head bastle looking south-east

- 3.3.1 Legend has it that Bog Head Bastle was the residence of Barty Milburn, and / or Corbitt Jack, correspondingly the alternative names for the building are either Barty's Pele or Corbie's Castle (<http://homepage.mac.com/philipdavis/English%20sites/2816.html>). The four walls of the bastle (Figs 2-5) survive for the most part to just above ground floor level, but there are also the mostly-collapsed remains of a barrel vault surviving (Plates 7 and 8). It is 9.8m x 7.01m in size and has walls that are 1.24m thick. The maximum surviving height of the structure is 3.8m on the southern elevation (Fig 5). It is constructed of large, uncoarsed field stones, with crudely-dressed quoin stones; the latter are not as well squared as those of the nearby Shilla bastle. The entrance was in the west wall (Fig 2), and has substantial, but crudely-dressed jams, with an irregular shaped lintel; a relieving arch survives over the lintel. The jambs have checks for two doors, one in front of the other and two tunnels to allow for drawbars for both doors. There is a single voussoir aperture in the centre of the east elevation (Fig 4), constructed of undressed field stones. There are fragments of walling extending above the part-collapsed vault, but these are extensively covered in vegetation and internal features of the first floor elevations were not evident (Plate 7). There was no indication of an external stair.

- 3.3.2 Comparisons with photographs taken as part of the RCHM(E) survey in the late 1960s (Ramm *et al* 1970) reveal that the west elevation has not changed significantly since the earlier survey. There are a couple of stones that have gone from the top course. The most substantial difference is the loss of a patch of about six small facing stones, from near the top of the northern side of the elevation. Adjacent to this patch the present top quoin stone of the northern corner is a different stone to that on the earlier photograph. It has markedly less lichen cover than the other stones on the elevation and it was evidently a later insertion; it may be the product of limited repair works to prevent the spread of the localised collapse indicated by the loss of the patch of stones. The entrance has not deteriorated significantly since the late 1960s photography; however, looking through it, the interior of the bastle in the 1960s had more debris than

present and there was no natural light internally, which would indicate that substantial amount of clearance has been undertaken of the interior during the intervening period. In general, the comparisons of the photographs show that the bastle has survived relatively well since the late 1960s.

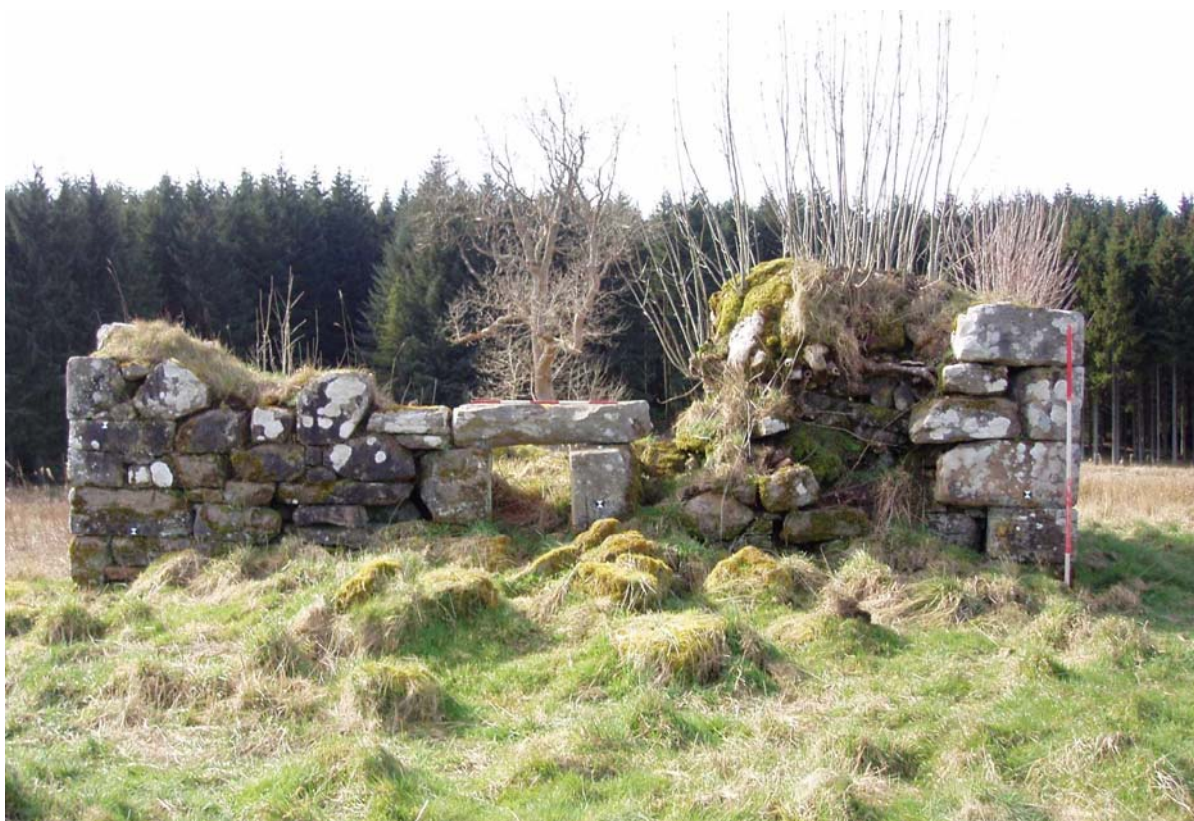
Plate 2: The principal façade of Shilla Bastle looking north-east

- 3.2.1 This is a substantially decayed bastle, which has extant walling on the northern and eastern sides (Figs 6 and 7), while the southern and western sides (Figs 8 and 9) are marked by earthworks with occasional fragments of walling exposed (Plate 2). At its highest (1.8m high), on the eastern face (Fig 7), it has only four courses of random rubble walling surviving, and the corners incorporate coarsely, squared quoins. The wall width is 1.25m thick, and the building is 10.1m x 6.9m in size. In the centre of the elevation is a small entrance with a substantial lintel on the internal face, but the equivalent lintel on the external

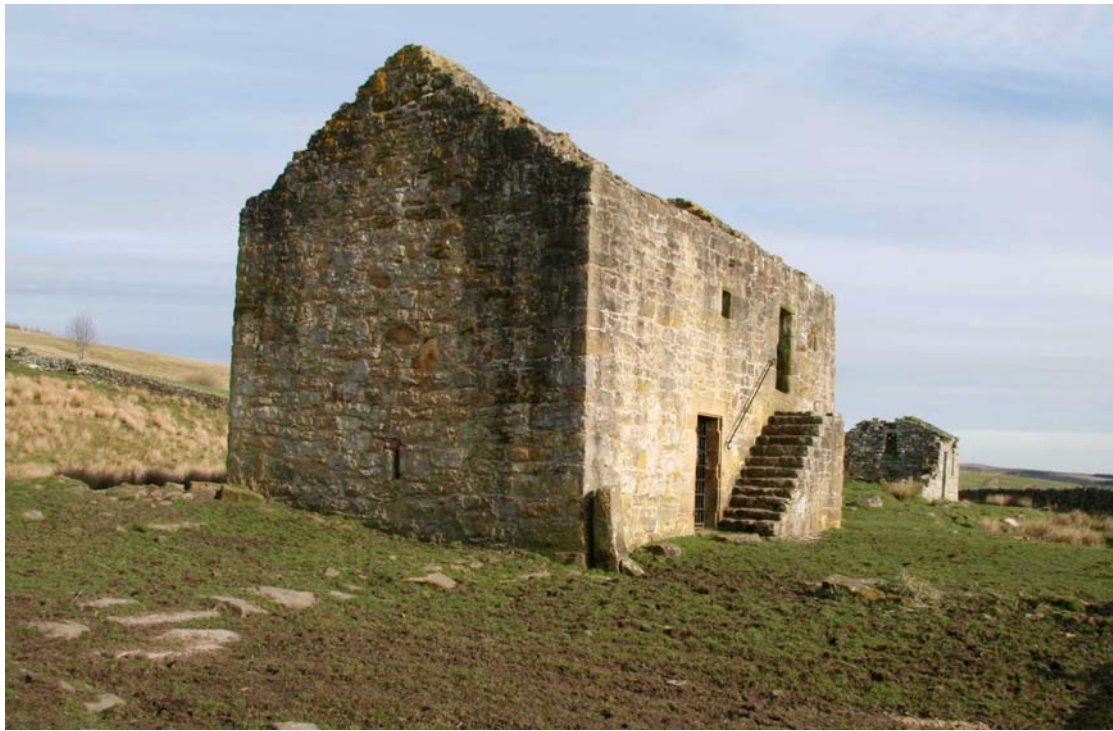
Plate 3: Nearby Black Middens bastle

- 1.2.1 Shilla and Bog Head bastles (Plates 1 and 2) are part of a group of three bastles extending along the Tarsset Burn valley, itself a tributary of the Upper Tyne (Fig 1). The best surviving example of the group is the Black Middens bastle at NY 775898 (Plate 3). The group is only 15km from the present Scottish border and is on the gentle sloping southern foothills of the Cheviots. Presently it is an area of forestry plantation, but was formerly an area of isolated agricultural intakes amidst an expanse of moorland.

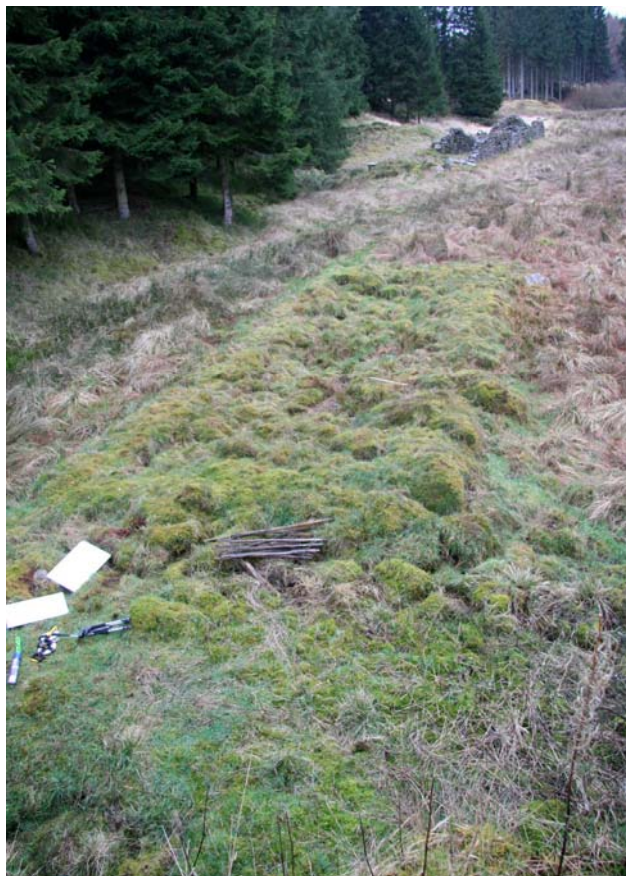
Plate 4: Overgrown foundations and standing remains of buildings to the immediate west of Bog Head bastle

- 1.2.2 Bog Head bastle is on the flood plain at the confluence of Tarsset Burn and Highfield Burn, and the area around the bastle is generally poorly drained. Adjacent to the bastle is a group of further ruined domestic and agricultural structures, and the bastle was evidently part of a small hamlet (Plate 4).

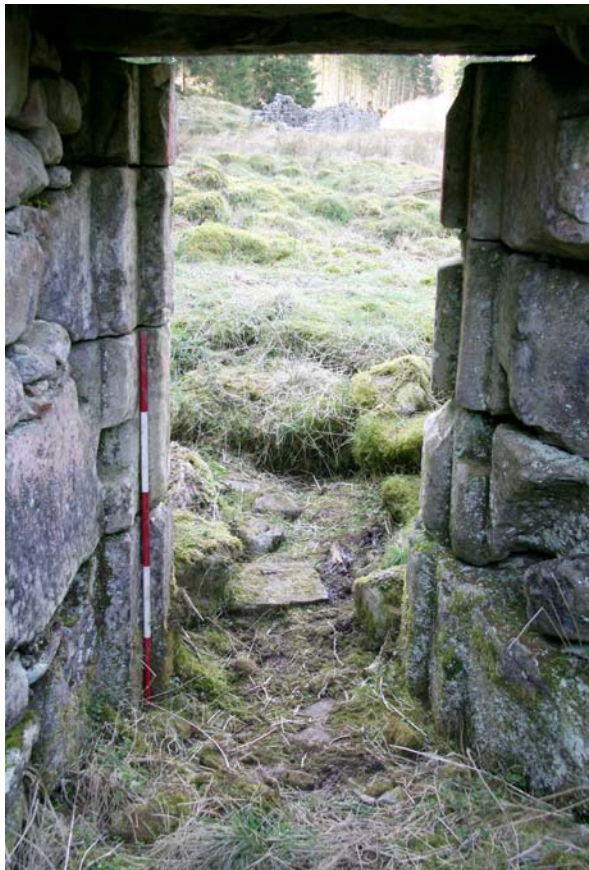
Plate 5: Principal entrance of Bog Head bastle showing the checks for two doors and the tunnels for drawbars

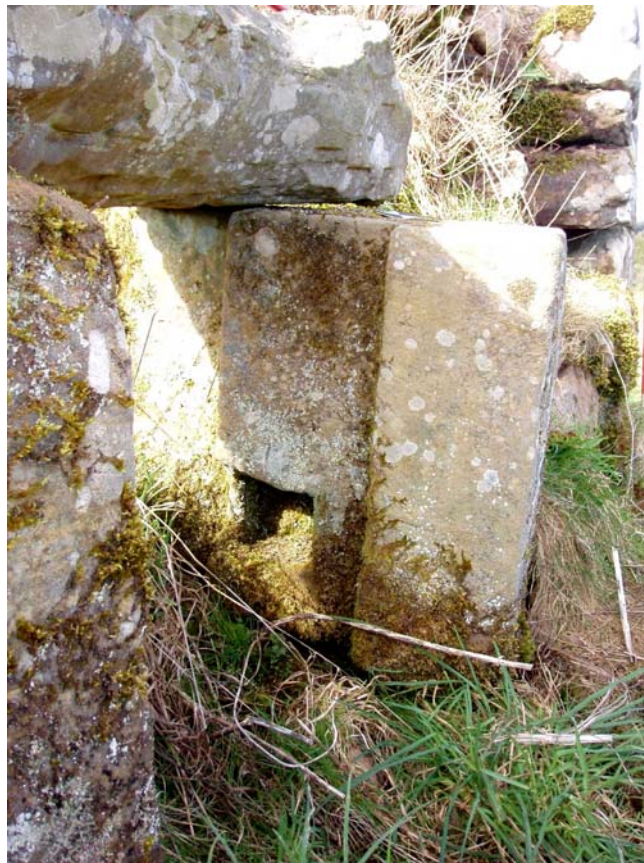
Plate 6: Entrance to Shilla bastle showing the tunnel for the drawbar

face is no longer extant. The substantial door jambs incorporate tunnels for a drawbar (Plate 6). The jambs have checks for two doors, one in front of the other, to afford additional security.

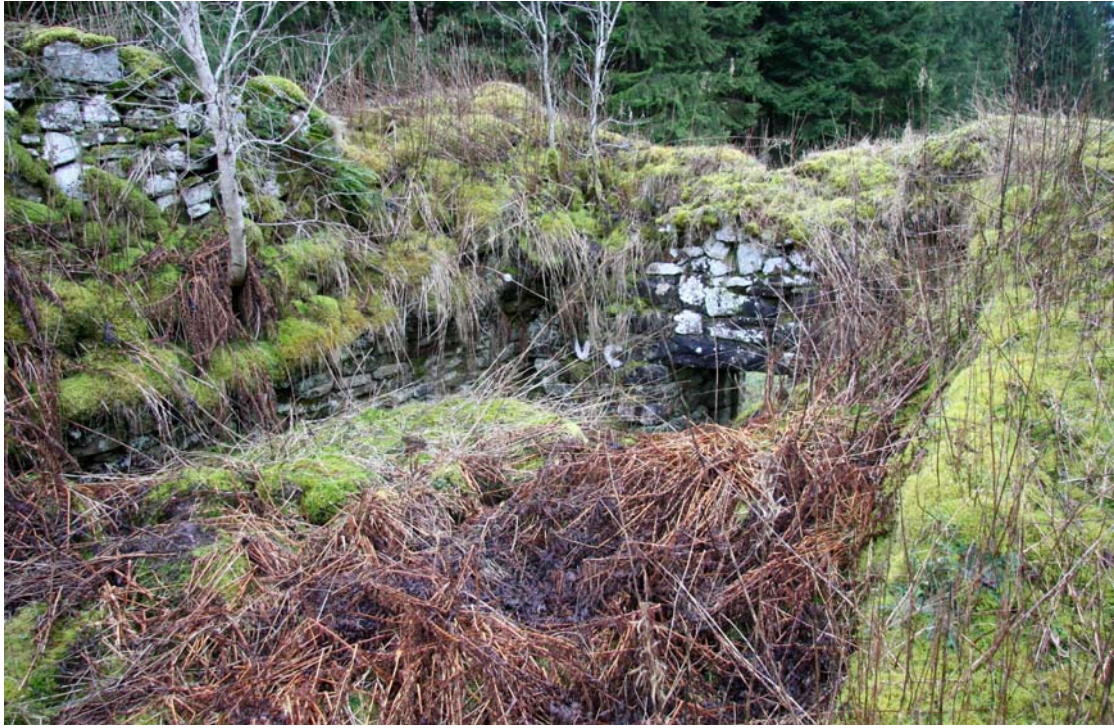
Plate 7: Interior of Bog Head bastle looking west

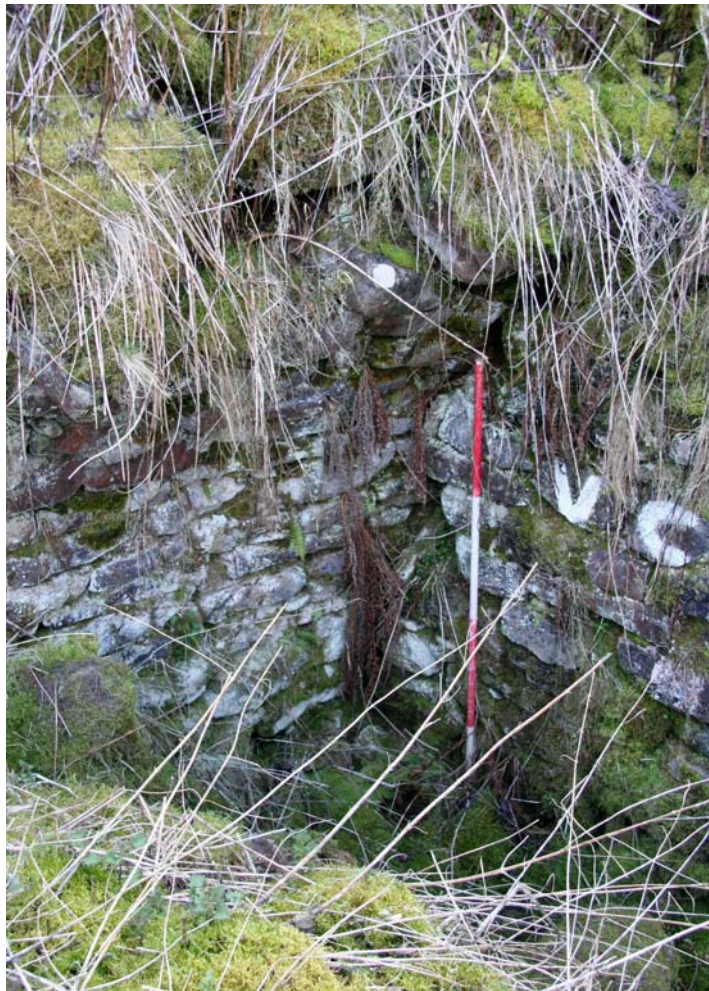
Plate 8: Remains of the barrel vault in the western corner of Bog Head bastle
