HOLLAND FOLD FARM, HEATH CHARNOCK LANCASHIRE

Archaeological Building Investigation

**Frank Whittaker Town
Planning Consultants and
Mr G Berry**

Document Title: HOLLAND FOLD FARM, CHORLEY LANCASHIRE

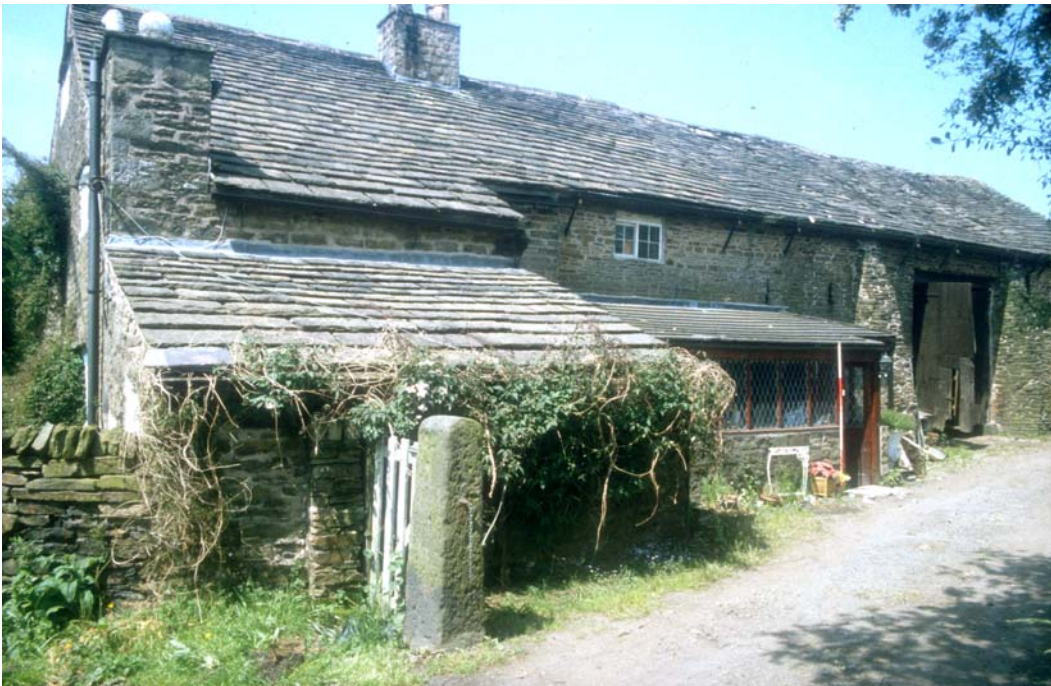
Plate 2: The rear (east) elevation of the cottage, featuring the two extensions

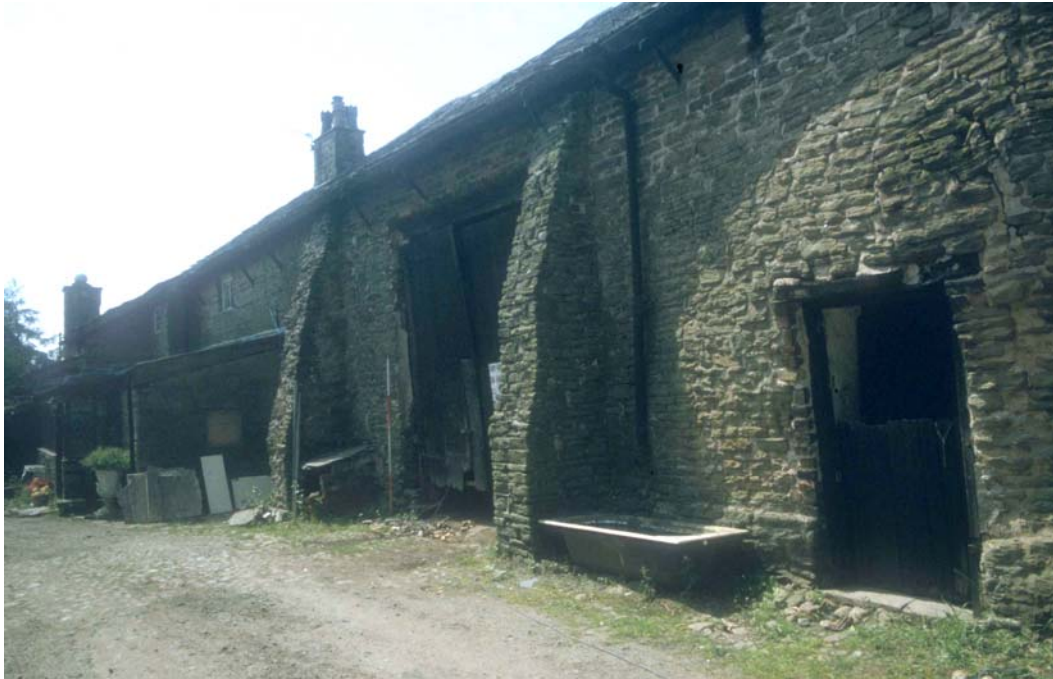
Plate 3: The rear (east) elevation of the barn

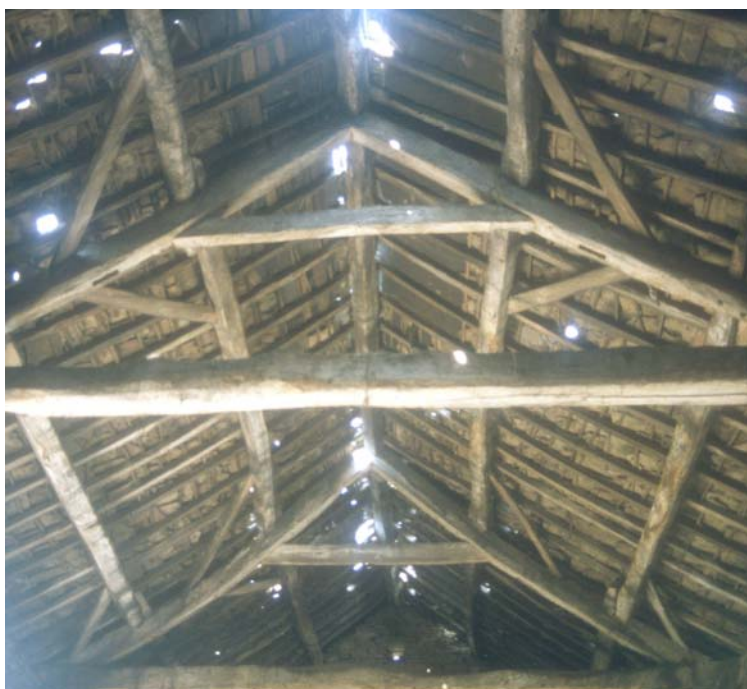
Plate 8: North-facing view of the queens-post trusses in the barn

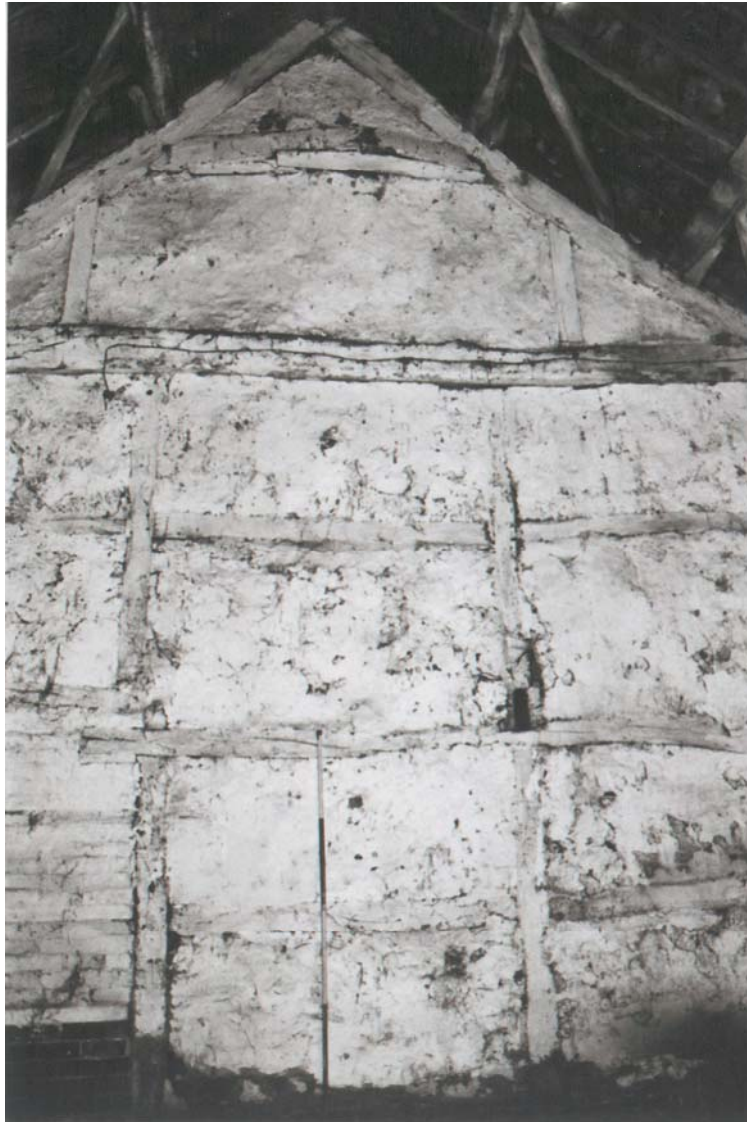
- 4.3.1 The walls are coursed sandstone rubble with lime mortar as on the exterior of the barn, whilst the wall on the south elevation is of wattle and daub construction, which incorporates a roughly-hewn queen-post truss comparable with the others in the barn (Plate 9). At the east end of this wall, there is a patch of cinnabar red brick laid in a stretcher bond, which measures approximately 2m². The purpose of this patch is unclear, as it may represent a blocked door leading into room 13, or simply indicate much needed repairs to the wattle and daub. Towards the centre of the barn, there is a brick partition, again of cinnabar red brick in a stretcher bond, which forms the south wall of the tack rooms (4) and a small holding pen or storage space (5) (Plate 13). The interior of the other tack rooms (2 and 3) are constructed from brick and feature both flagstones and cobbled floors (Plate 14). These rooms are accessed by heck doors at the north-west corner of the building and at the west end of the stalls partition within the barn.

Plate 9: The wattle and daub wall, featuring the truss with queen struts in place

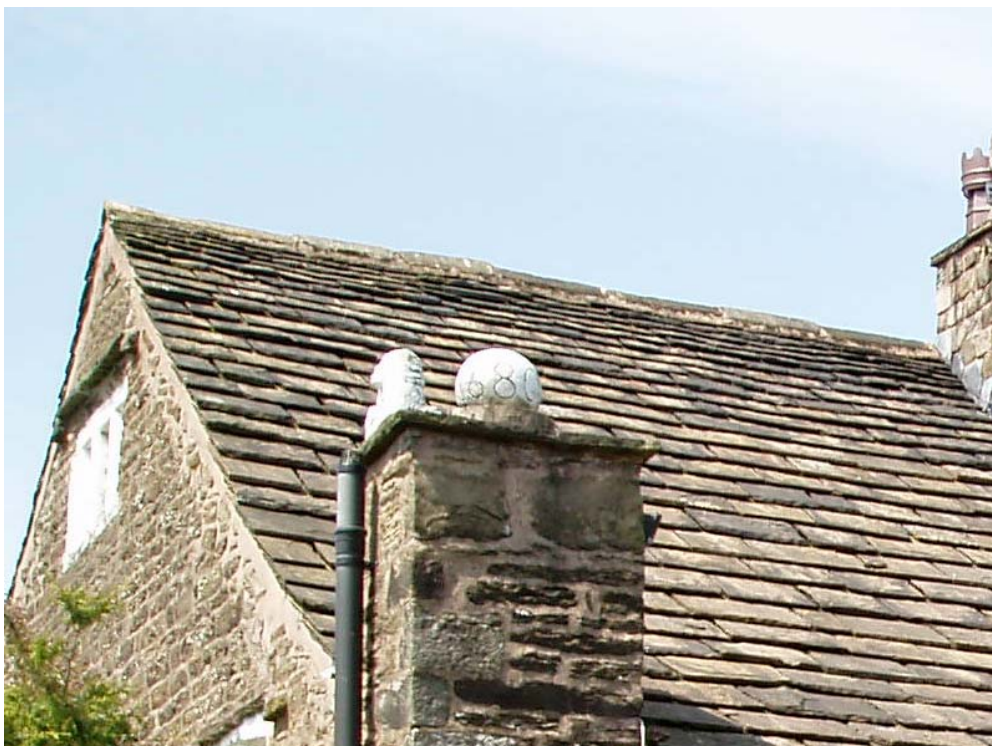
- 4.1.2 The roof of the barn and cottage consists of a moderately-pitched gable roof of diminishing courses of sandstone slate, which is supported by roughly-hewn tie-beam and collar trusses with straight wind-braces (Plate 8). The trusses would appear to have originally featured queen struts, but these have subsequently been removed. Certainly, the truss within the wattle and daub wall on the east elevation of the barn has retained its queen struts and testifies to this alteration. In addition, the ridge purlin, the four trenched through-purlins, and the rafters are all similarly roughly-hewn. The roof of the cottage has a simple rectangular stack in its centre with three bishop style pots and a further hooded bishop pot. Similarly, the roof of the extension on the south-east corner of the cottage is also laid with diminished courses of sandstone slate. In addition, the adjacent, later extension, the stone tack room extension and the brick outshut at the north end of the barn, all feature moderately-pitched roofs of concrete slate. On the small extension at the south-west corner, there is a ball finial bearing the rather questionable date of 1680 (Plate 10).

- 5.2.2 Moreover, under normal circumstances, the ball finial with the date 1680, would be treated with suspicion, being clearly a later addition, which references the inscription on the interior. However, this date would appear to coincide with key architectural features observed during the investigation. The chamfered and rebated stone-mullioned windows and the label mouldings on the cottage, are consistent with the mid to late seventeenth century (Brunskill 2002), and have been encountered during previous investigations of farm buildings from this period (OAN 2004, 2006). Additionally, the inglenook fireplace on the ground floor of the cottage, with its stone heels and chamfered bressummer beam, is indicative of a similar time frame.

Plate 10: The ball finial carved with the date 1680, on the south-east corner of the cottage

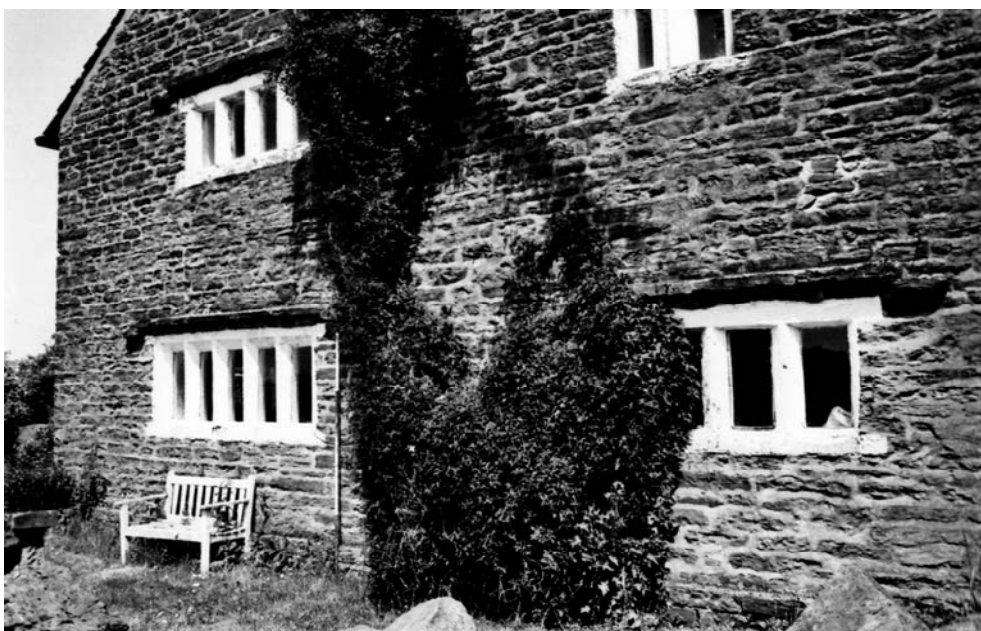
- 4.1.4 The windows on the barn, the porch and the extensions are all casements, which feature simple, deep flush lintels and anywhere between two and eight lights. Conversely, the windows of the cottage are more decorative, featuring chamfered and rebated, stone mullion casements, which are typical of the mid to late seventeenth century. All of these casements vary between one and five lights, whilst those on the south gable are furnished with label moulds (Plate 11).

Plate 11: The label mouldings and stone mullioned windows on the south elevation of the cottage

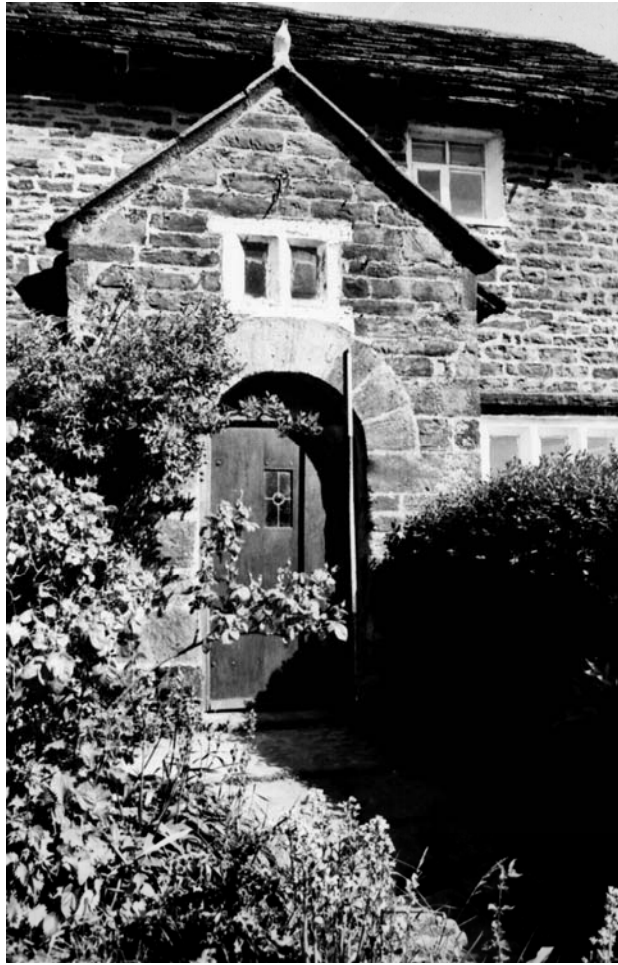
- 4.2.2 On the front (west) of the cottage, there is a small porch with a dove or-pigeon ornament on the gable of the roof, which is laid with diminished courses of sandstone tiles (Plate 12). The door is a panel door, which is surrounded by a round stone voussoir of well-cut stonework.

Plate 12: The porch on the west elevation of the cottage

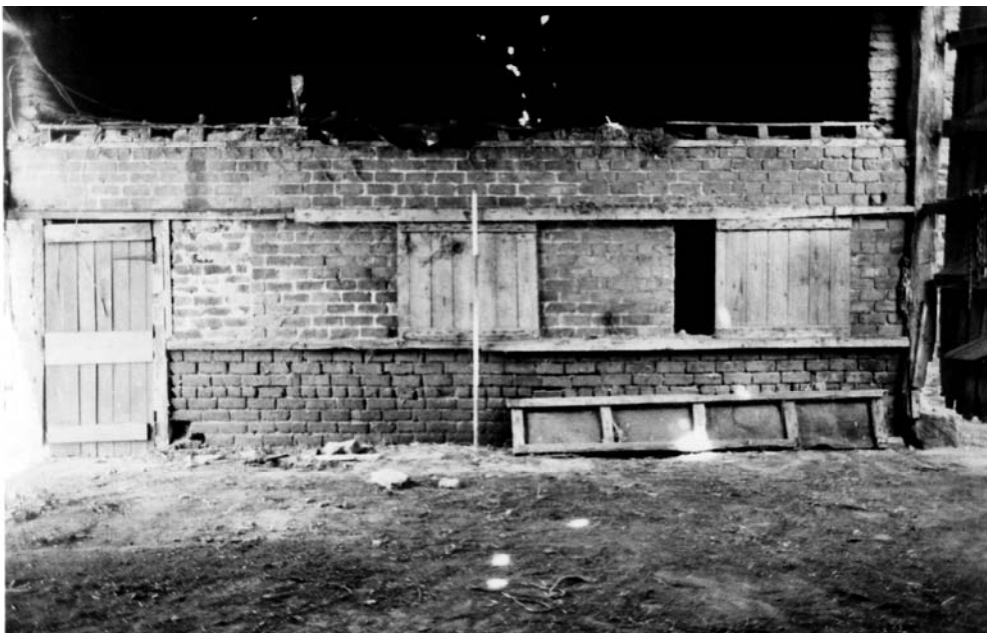
Plate 13: The brick stalls within the barn

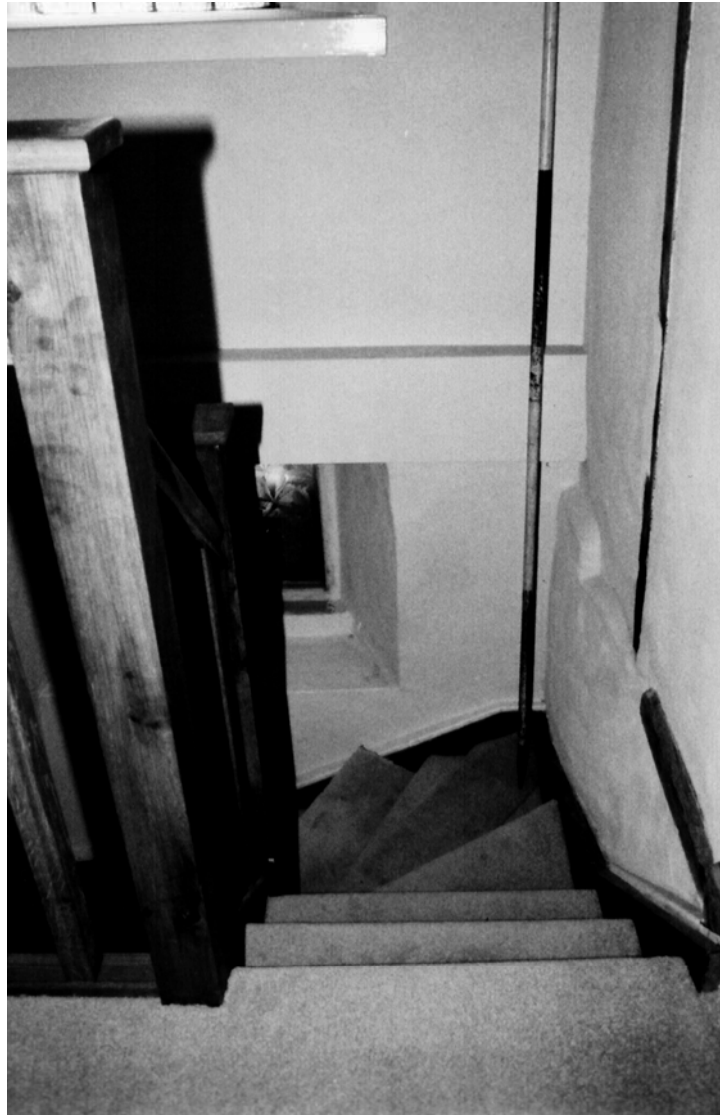
- 4.4.1 The cottage is arranged as a two-bay, two-storey, baffle-entry house with a converted attic space. There are four rooms on the ground and first floors, access to which is provided by a dog-leg staircase with winders at the rear

Plate 15: The stairs leading down to the ground floor

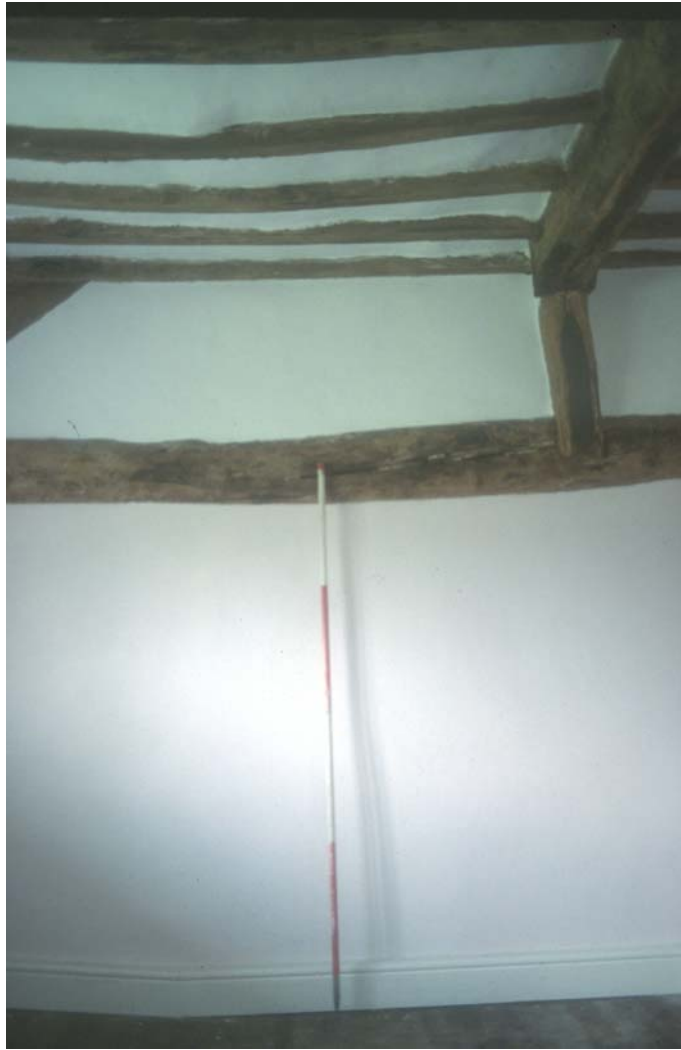
- 4.4.2 The interior walls of the cottage are stone with painted plaster and exposed timbers (Plate 16), which are decorated with plain or roll-moulded modern skirting boards. This includes the rooms at the north end of the cottage (**12**, **13**, **17** and **18**), which have the wattle and daub wall as their north elevation. The only room which does not have a painted plaster finish is the extension (room **7**), which has bare stone walls and a timber-panelled partition on its north elevation, in order to create a small storage cupboard (**7a**). Additionally, in room **15**, there is a small niche in the east wall, which may be a blocked window, but there is certainly no compelling evidence on the exterior of the building to confirm this.

Plate 16: General view of the interior within the cottage

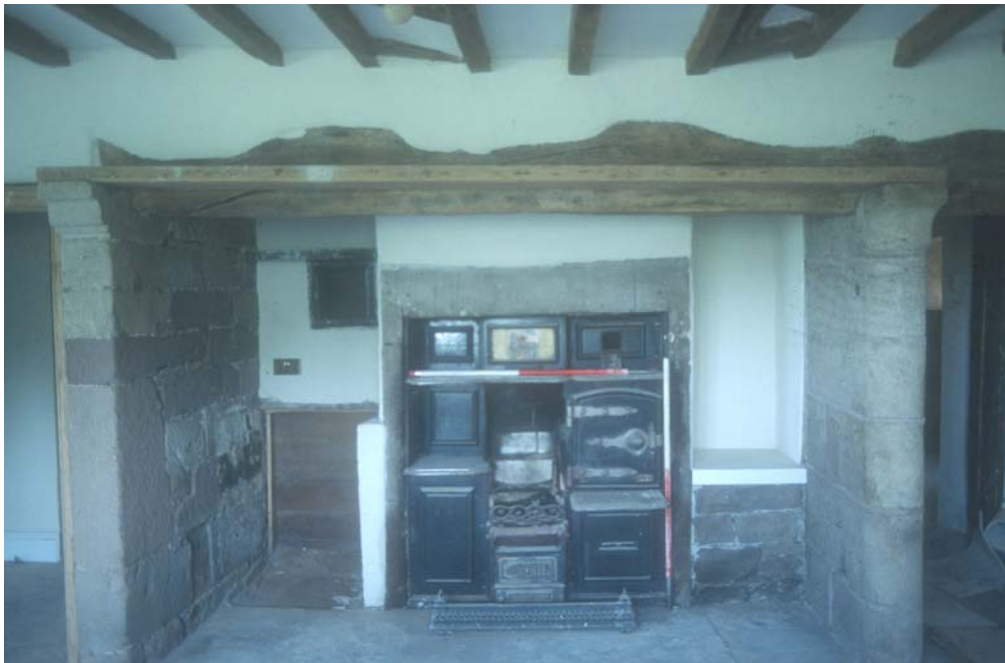
- 4.4.5 In room **10**, there is a seventeenth century inglenook fireplace with a chamfered bressummer beam, which is supported by two hecks of well dressed stone (Plate 18). The heck to the right hand side of the fireplace has a rounded end, with a faux console beneath the bressummer, whilst the left heck has a square end with a bolection moulding. In the middle of the fireplace, there is a range with a stone surround, and to the left, there are the remains of a spice cupboard, which has since been removed.. In addition, there is a carved salt cupboard lettered in relief 'T H I 1680'. Elsewhere, in room **12** there is a corner fireplace, featuring a roughly-coursed stone surround with a segmental voussoir arch and two small rectangular niches, which flank the woodburner in the centre (Plate 19). In room **16** on the first floor, there is a Victorian style, cast-iron fire on the north wall, complete with round arch and dog grate (Plate 20), whilst in the adjacent room **17**, there is another corner fireplace, featuring a plain stone surround and hearth, and a stepped chimney breast (Plate 21).

Plate 18: The inglenook fireplace in room **10**

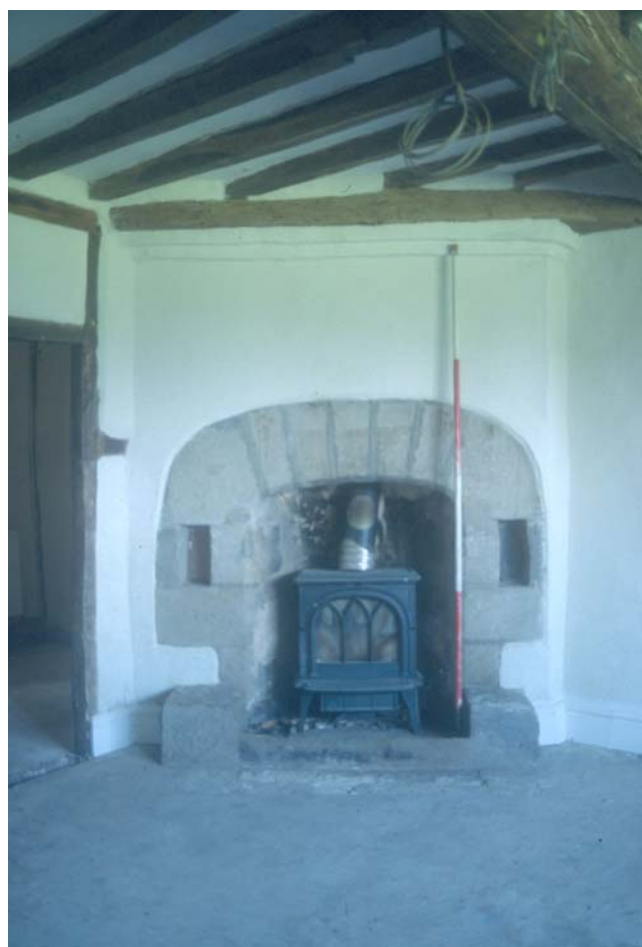
Plate 19: The corner fireplace in room **12**

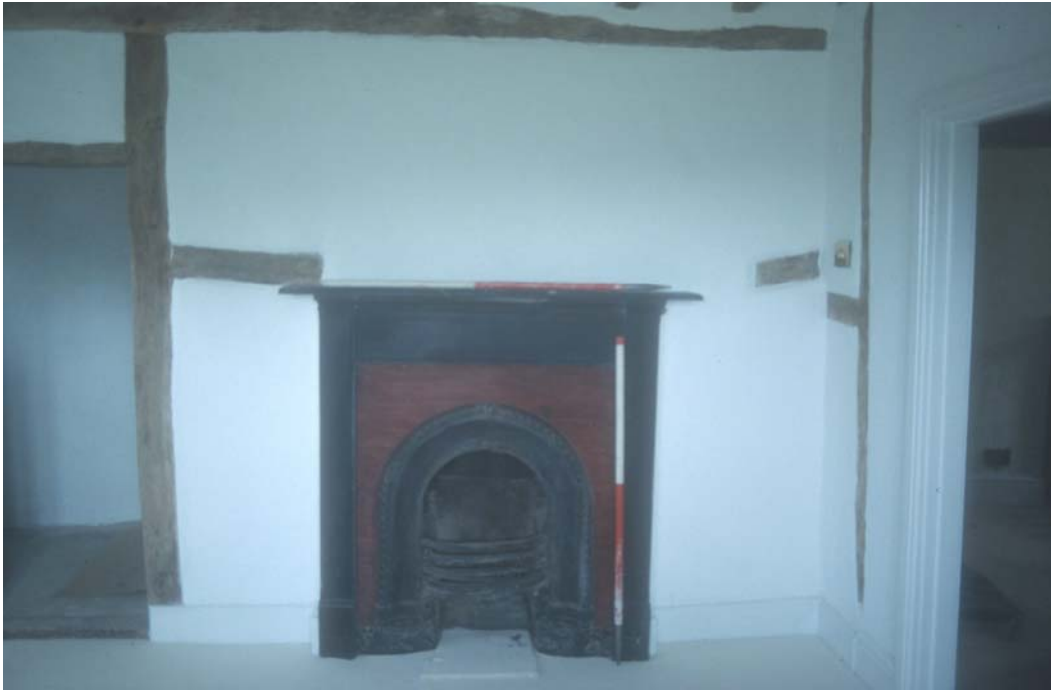
Plate 20: The cast-iron Victorian fireplace in room **16**

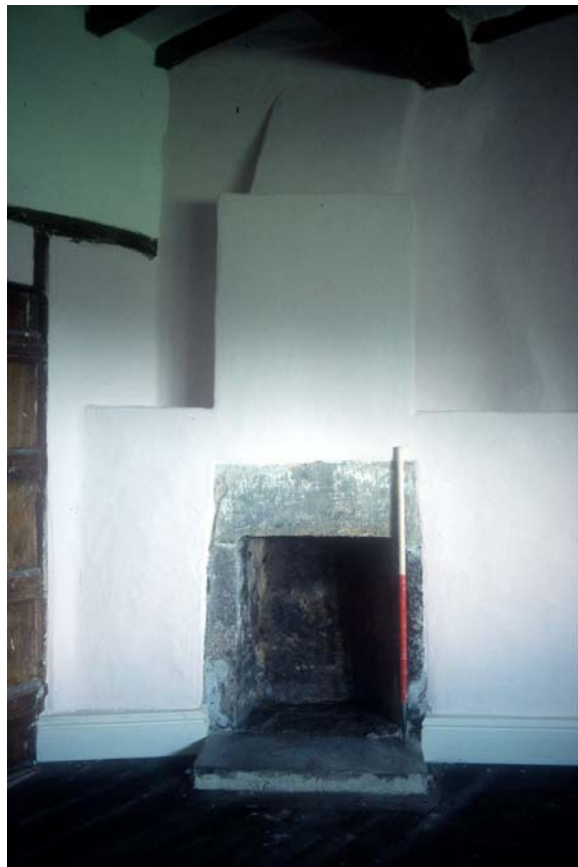
Plate 21: The corner fireplace in room **17**
