HODDER SERVICE RESERVOIR AND ACCESS WORKS, Slaidburn, Lancashire

**Archaeological Desk-
Based Assessment,
Walkover Survey and
Topographic Survey**

August 2007

United Utilities

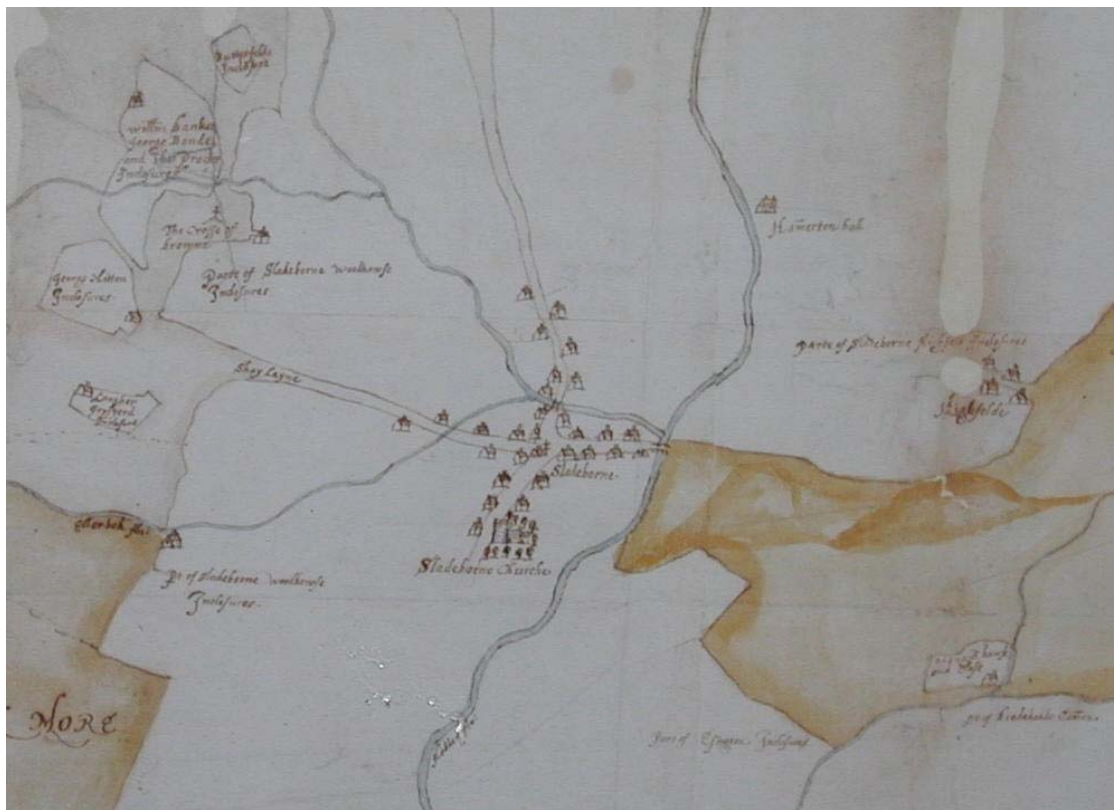
- 3.3.1 **Saxton 1577**: this map is very general and provides very little detail, but does illustrate main routes and topographical features, such as the River Hodder (Plate 1). Although stylised, it does depict the village of Slaidburn to the south as being quite significant in size, and set out around a crossroads. Hammerton Hall (Site 02) is also shown on the eastern side of the River Hodder. No other features are shown in the area of the proposed works.

Plate 1: Extract from Saxton's 1577 map showing Hammerton Hall north of Slaidburn

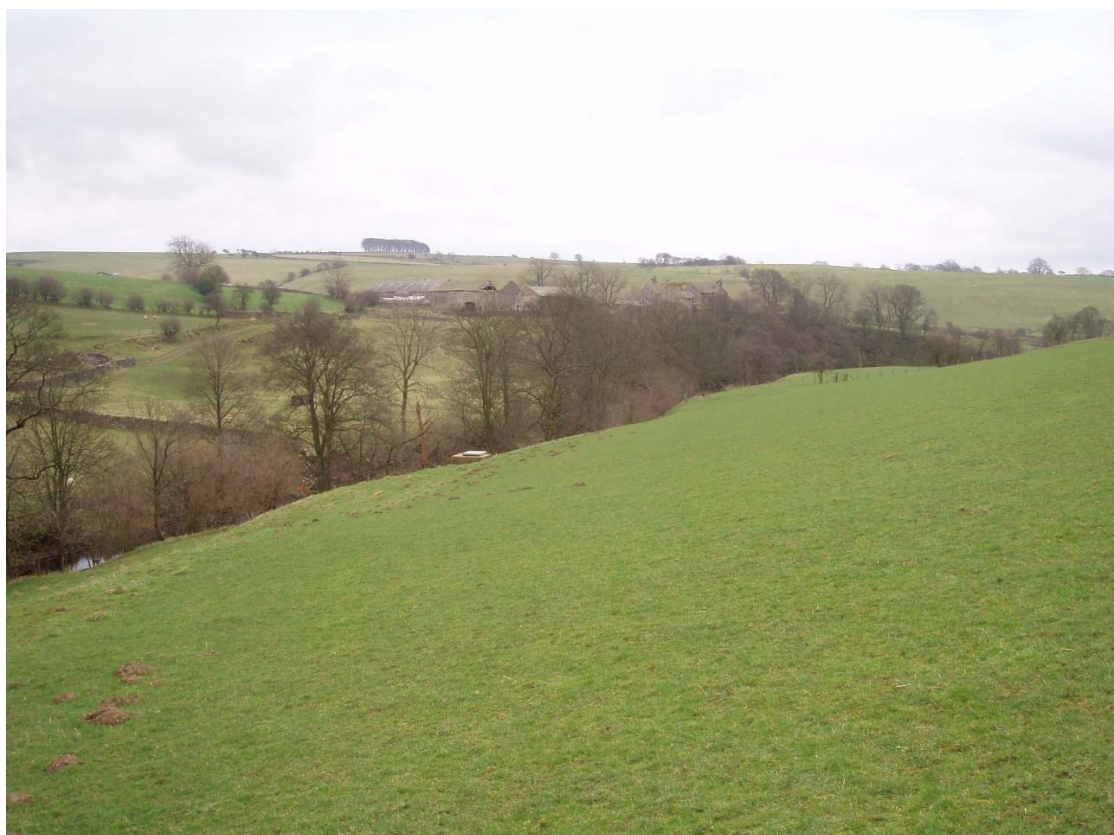
- 3.2.7 Hammerton Hall (Site **02**) is a Grade II* Listed Building (Plate 2), and a building is first depicted in a similar location on Saxton's 1577 map (Plate 1). The hall was the home of the '*de Hamerton*' family (Mitchell 2004, 57), and the hall and lands remained in the Hammerton family for about 300 years,

Plate 2: Hammerton Hall, Site 02 in the distance, looking south-east

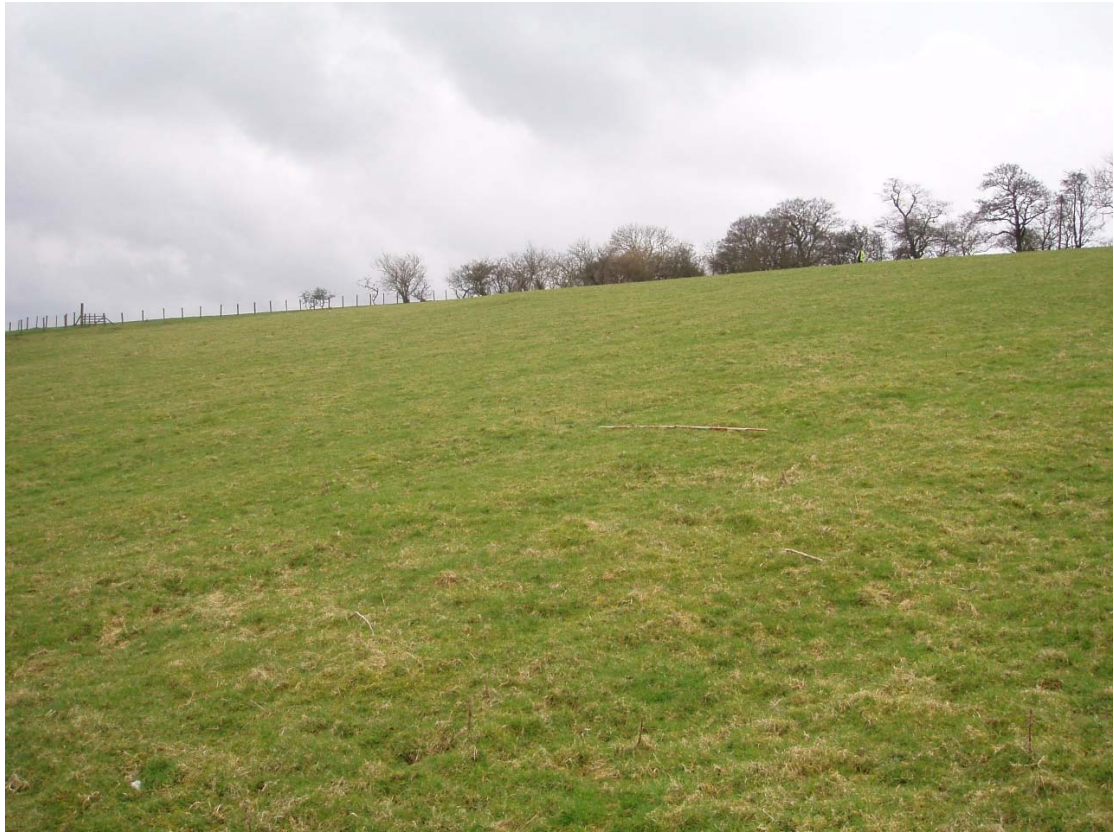
- 3.5.3 **Field 2:** this field was located to the east of Field 1. It contained a large area of ridge and furrow (Site **04**).
- 3.5.4 **Field 3:** a pair of gate posts (Site **35**) was located south of the wood near the site of the proposed new reservoir, but not within the area of proposed works. The extreme eastern side of Field 3 had been disturbed during installation of water pipes relating to Stock Reservoir in the 1920s and 30s, visible as a line of access and inspection hatches within the field (Plate 10).

Site number **04**
Site name **Phynis 255**
NGR SD 71530 54170
Site type Earthworks
Period Post-medieval
HER No **13000**
Sources HER, LUAU 1997
Description Ridge and furrow in Field 2 measuring 3m to 3.5m wide with a height of 0.10-0.15m. It is aligned east/west, extending beyond a former field boundary. The ridge and furrow is straight and quite regular suggesting a later date. The alignment is concurrent with the direction of the slope so that the earthworks run up and down the slope. These earthworks are characteristic of horse ploughing, and are most likely post-medieval in date created as an aid to drainage.
Assessment The site lies within the development area and will be affected.

Plate 3: Site **04**, ridge and furrow, looking south-west

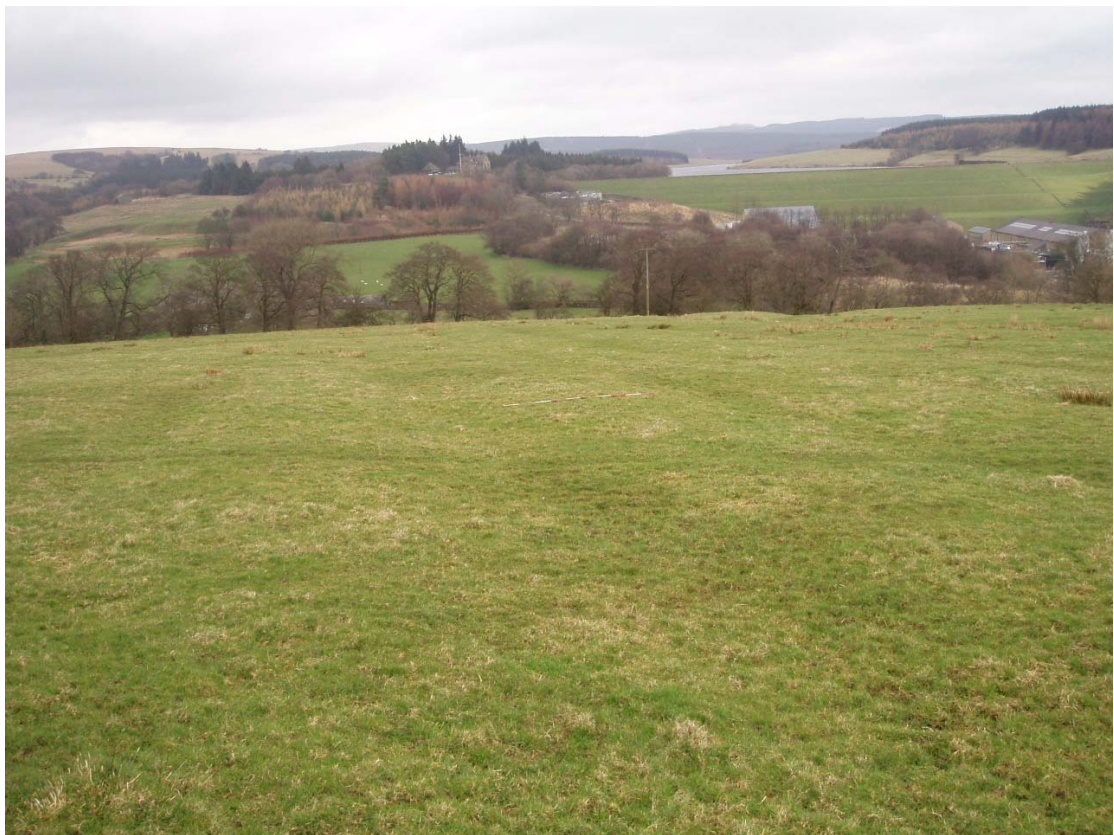
Site number **05**
Site name **Phynis 256**
NGR SD 71340 54170
Site type Earthworks
Period Post-medieval
HER No **13001**
Sources HER, LUAU 1997
Description Ridge and furrow in Field 1 measuring 3m to 3.5m wide with a height of 0.05m. It is aligned approximately north-east/south-west, extending beyond the hollow way (Site **11**) to the south to the east of the ditch/bank earthwork representing a former field boundary (Site **36**). These earthworks are characteristic of horse ploughing, and are most likely post-medieval in date created as an aid to drainage.
Assessment The site lies within the development area and will be affected.

Plate 4: Site **05**, ridge and furrow, looking north

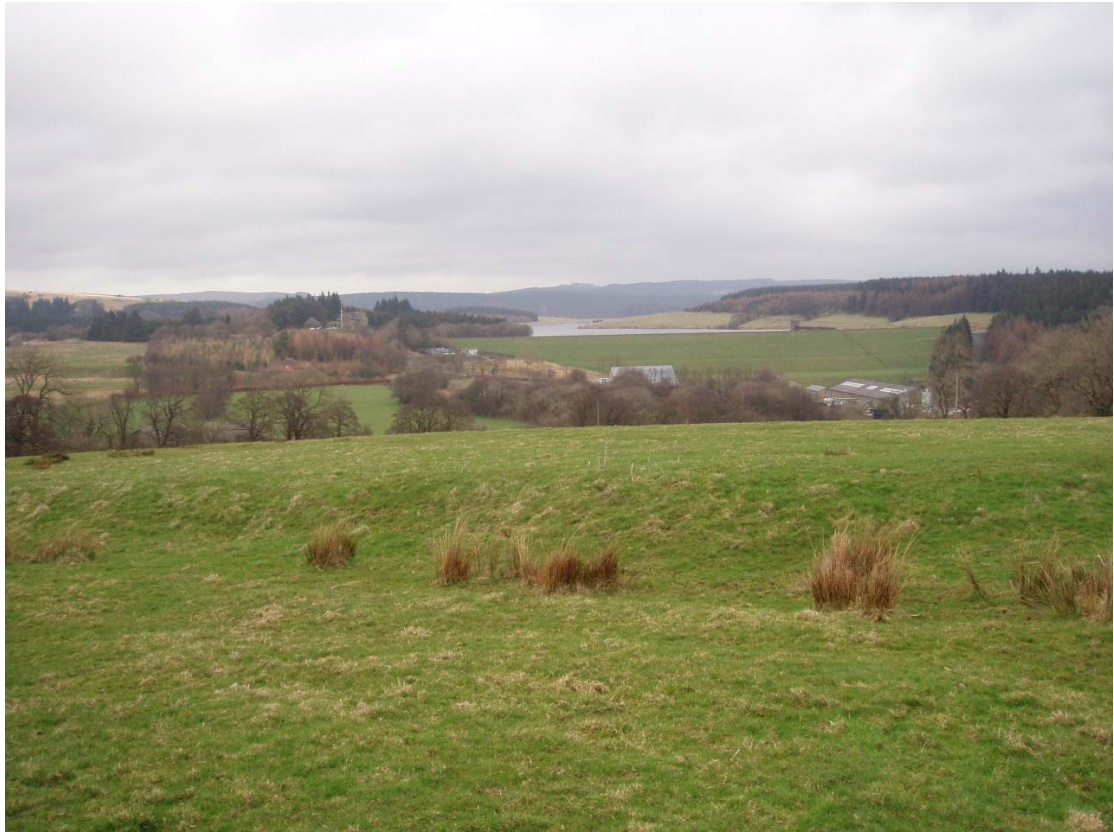
Description Old field boundary within Field 1, noted as a hollow way in the 1997 survey. It measures 4m wide and 0.75-1m in height. It is aligned approximately north/south. Its location seems to correspond to a previous field boundary visible on the First Edition Ordnance Survey. This feature currently serves as a land drain, with an active culvert exiting the ditch from its northern extent, and flowing into the adjacent stream. Two branches of this drainage system were also surveyed during the topographic survey, one feeding into the north/south-aligned former field boundary from the west, and another to the north-east, drawing water from the former field boundary (Fig 5). There is no evidence that these additional linear features, which form part of the drainage system, represent former field boundaries.

Plate 5: Site **11**, old field boundary, looking north-east

Assessment The site lies within the development area and will be affected.

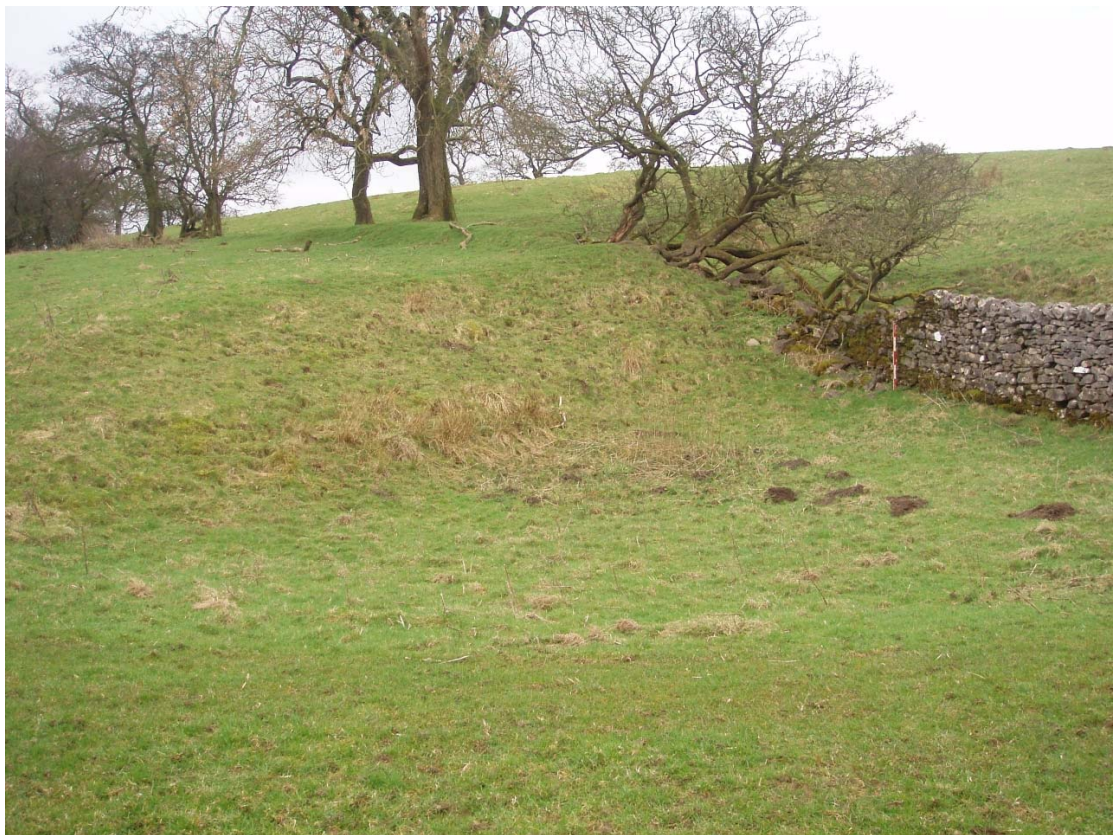
- 3.6.5 **Site 20:** an area of quarrying activity. Three quarries were identified (Fig 5), varying in size from 7m by 8.8m to 21m by 13m, and reaching depths of 2-3m. Each extraction appears to have been cut into the natural geology of the hillside to access underlying millstone grit.

Plate 6: Site **20**, possible quarry and field wall, looking south-west

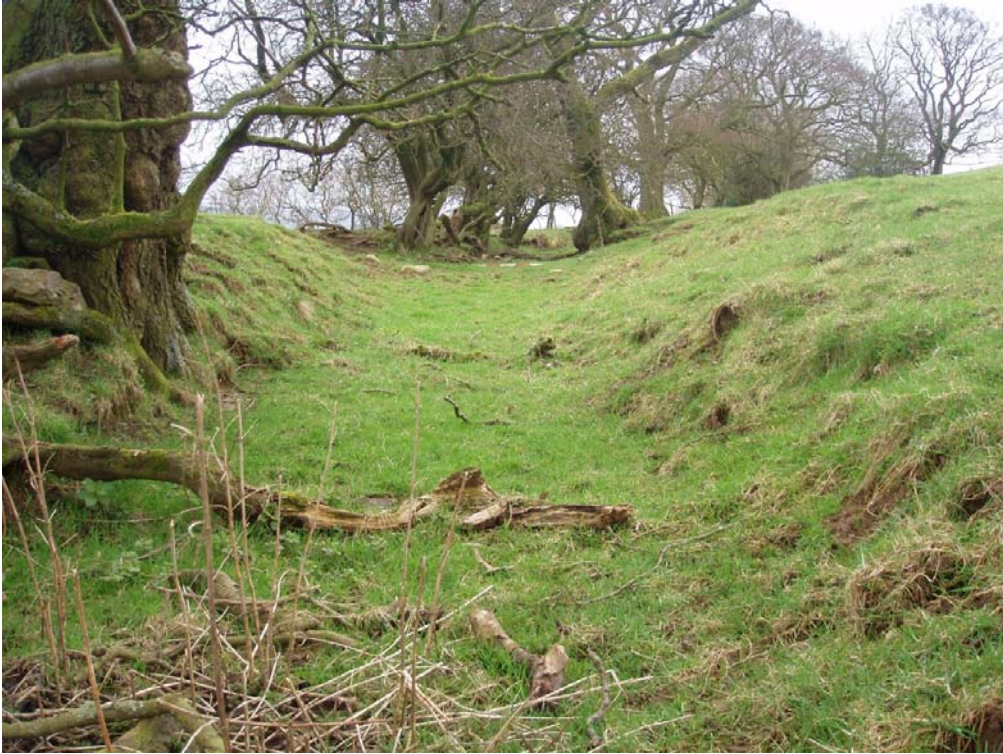
- 3.5.2 **Field 1:** ridge and furrow features (Sites **05** and **11**) and a field boundary (Site **36**) were recorded within this field. A possible quarry (Site **20**) and a hollow way with plashed/laid trees (Rackham 1997) along the fringe (Site **34**) were observed on the boundary between Fields 1 and 2.

Plate 7: Site **34**, hollow way, looking south-east

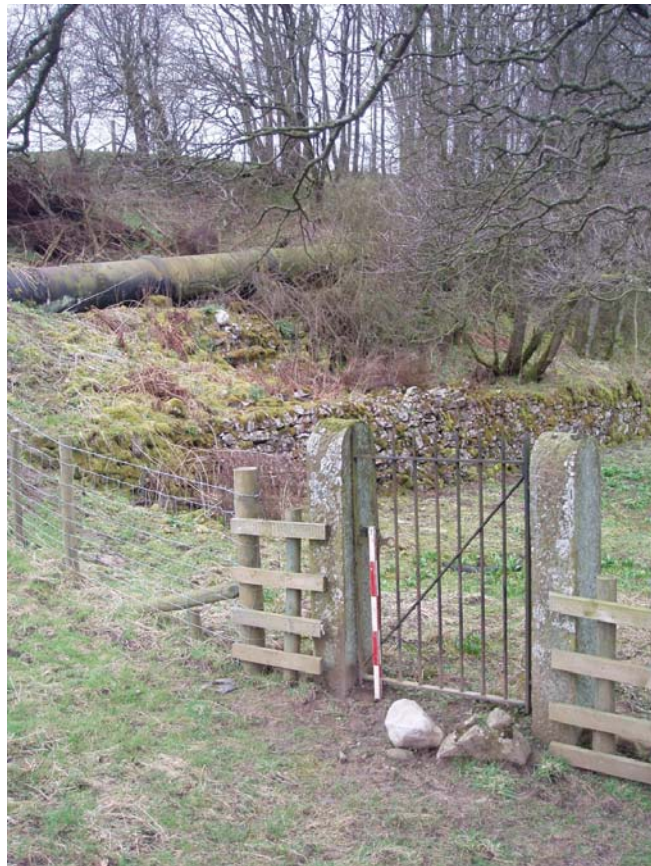
Site number	35
Site name	Hammertone Gate
NGR	SD 71646 53982
Site type	Structure
Period	Post-medieval
HER No	-
Sources	Walkover Survey
Description	A pair of upright stone gate posts measuring 1.55m x 0.37m x 0.25m, set 1.1m apart. There is a wrought iron gate hung in place. The posts have incised panels with a rustic finish and the tops are rounded. They possibly relate to Hammerton Hall footpaths as seen on the opposite bank of the River Hodder, in which case they are likely to be Victorian in date.
Assessment	The site lies in close proximity but will not be affected by the development.

Plate 8: Site **35**, gateposts and gate with water pipes in the background, looking north

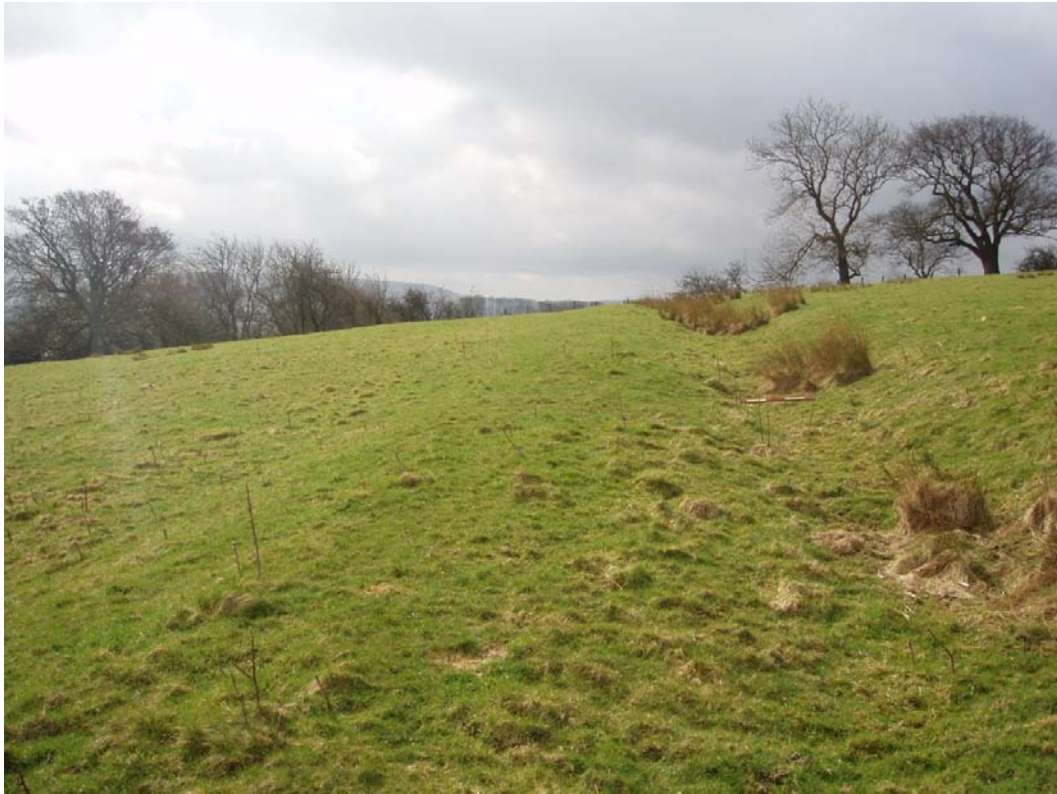
- 3.6.4 **Site 36:** this shallow ditch aligned north-east/south-west, was identified by the desk-based assessment and walkover survey as part of a former field boundary. In common with Site **11**, this still serves as a land drain. The culvert within the ditch was collapsed in places, exposing the drain inside.

Plate 9: Site **36**, old field boundary visible as bank and ditch, looking south-east

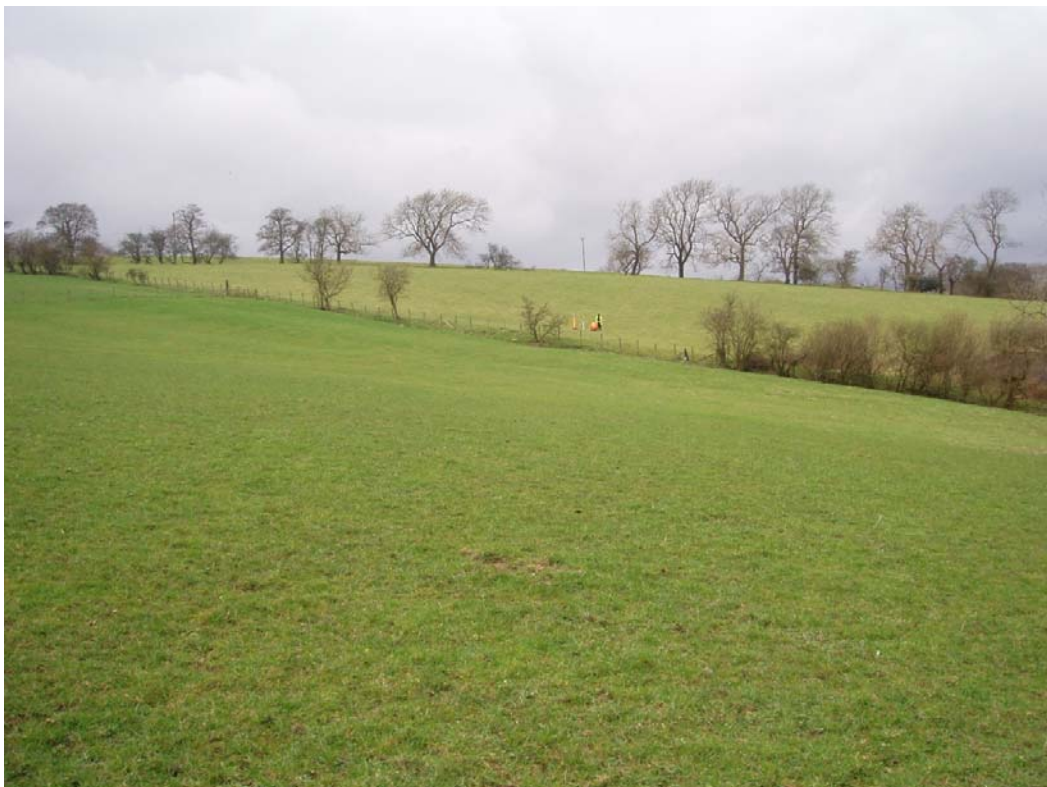
Plate 10: General view of the field where the proposed new Hodder Service Reservoir will be sited, with ridge and furrow (Site **04**) in the field beyond, looking north-west
