Radcliffe Tower, Radcliffe, Greater Manchester

Archaeological Evaluation Report

Oxford Archaeology North

May 2007

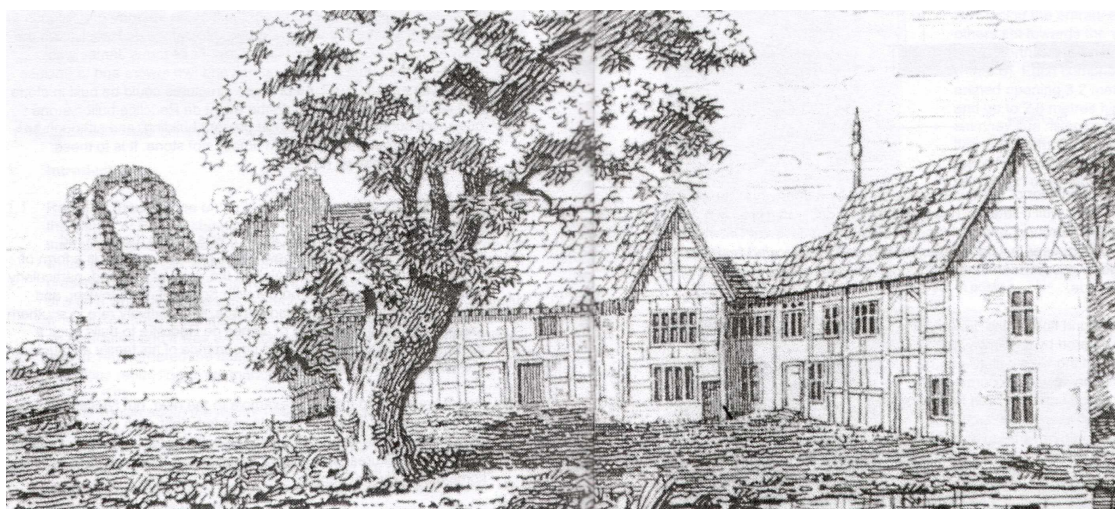
Engraving of Radcliffe Tower in 1781 (MCL L1/60/2/111)

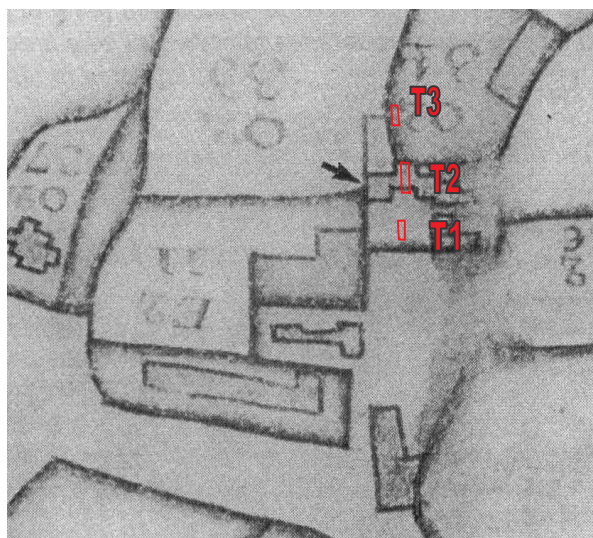
Extract from a map of Radcliffe (1767), showing the approximate location of evaluation trenches

4.1.2 **Phase 1:** the earliest remains encountered in Trench 1 comprised metallised surface **119** and potential occupation deposit **118**. Whilst it was not excavated, surface **119** had seemingly been laid directly onto the natural geology, thereby representing a primary phase of activity on the site. The character of the surface suggested that it had been external to any buildings, whilst its position corresponds with an enclosed area, perhaps a courtyard, depicted on the map of Radcliffe Tower of 1767.

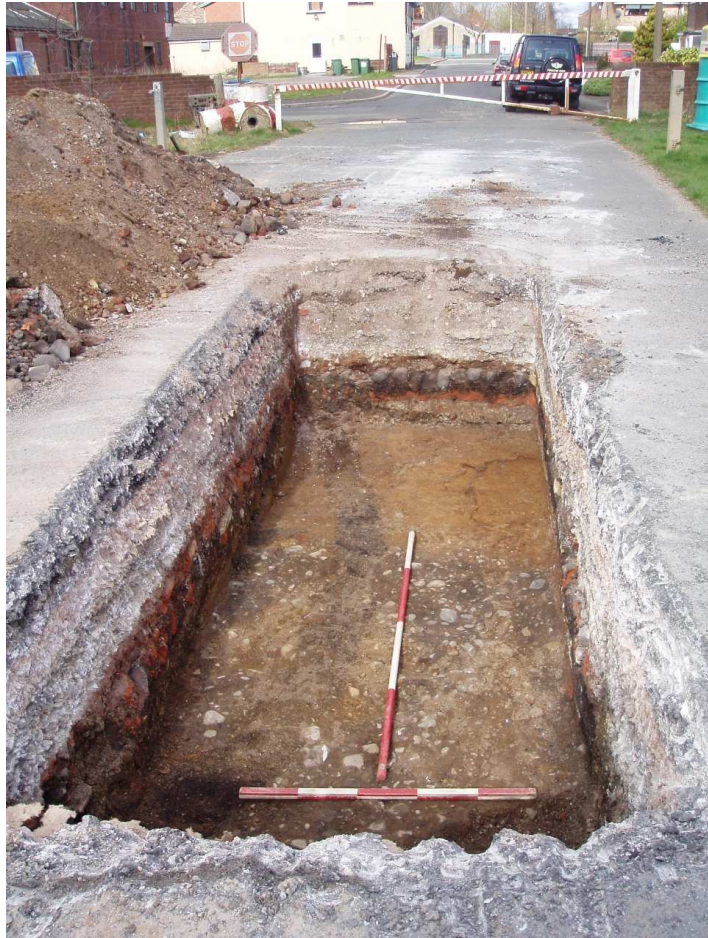
Plate 1: General view of Trench 1, looking north and showing cobble surface *119*

3.2.1 Trench 1 was located at the northern end of the haulage road (Plate 1), and was targeted on the projected alignment of a ditch exposed during the archaeological investigations carried out in 1979-80. The trench was oriented north/south, and was excavated to a length of 5.08m and a maximum depth of 1.07m.

3.2.3 The natural geology was overlain by a fine cobbled surface (**119**), which extended along the length of the trench on the western side but had been truncated to the north-east (Plate 2). The surface was formed of densely packed rounded pebbles/cobbles, mostly 0.05m diameter, but with some ranging up to 0.12m diameter. The surface had been subject to a degree of compaction and wear, although there was no clear indication for it having ever been repaired or modified. Surface **119** was overlain by a thin layer of grey silty-clay (**118**) which appeared to be material trampled onto the surface, representing occupation of the site. The dating of this putative occupation was hampered by an absence of finds from surface **119** and layer **118**, although it would seem likely that they were of late medieval/early post-medieval origin.

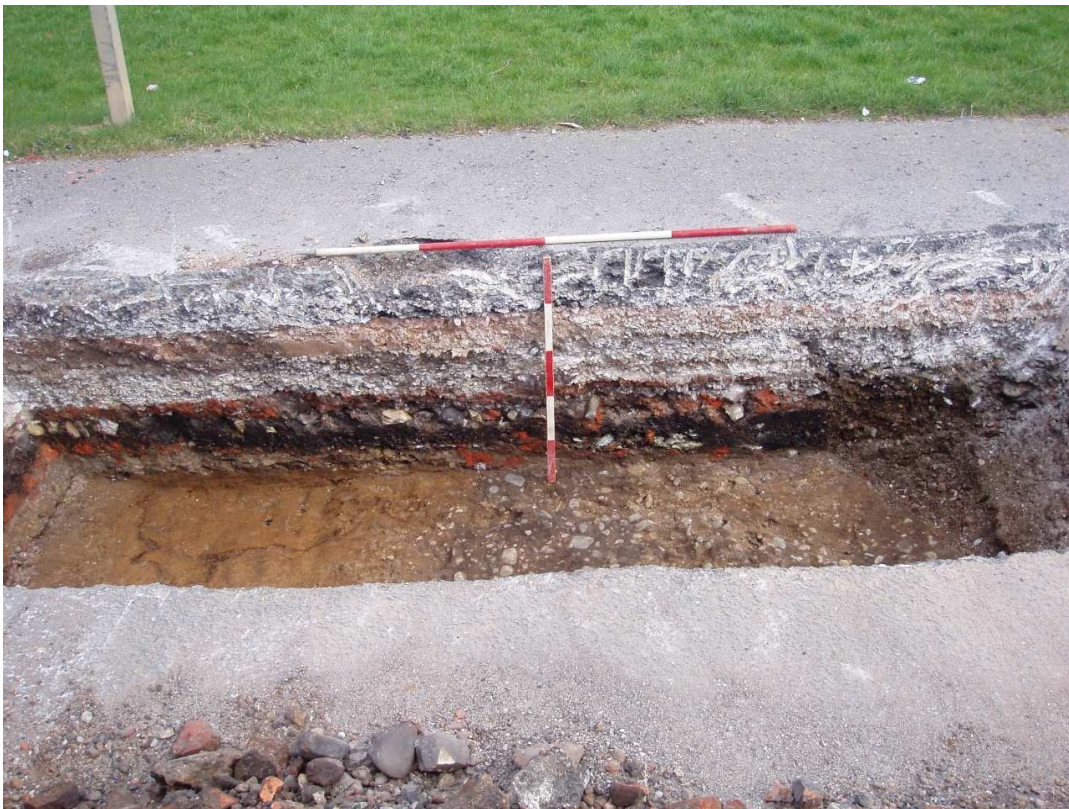
Plate 2: West-facing section of Trench 1, showing deposits *110-128*

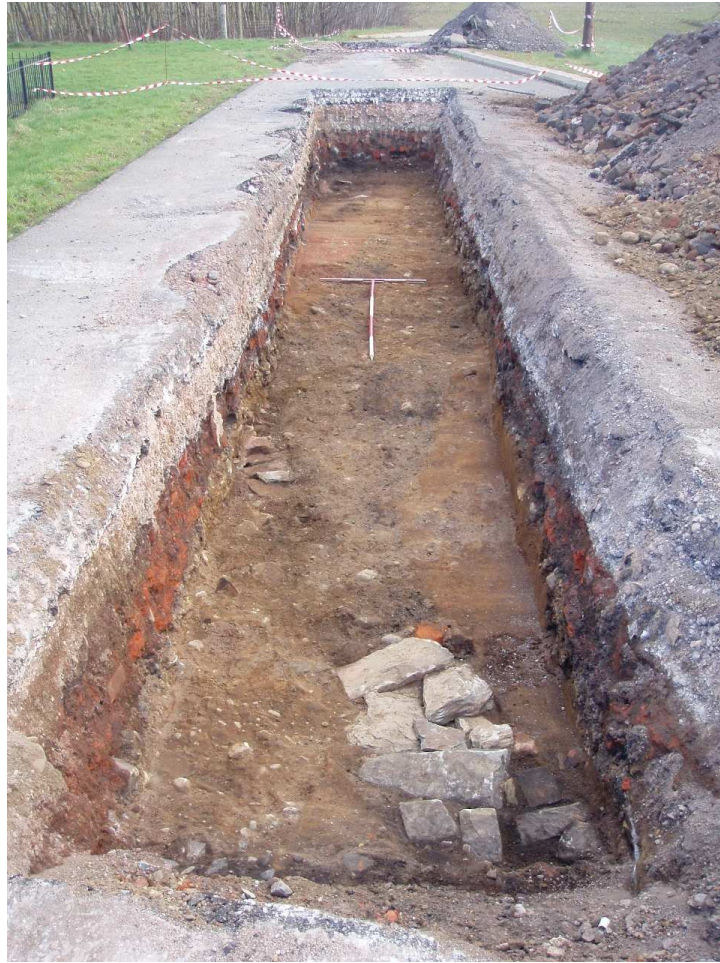
Plate 3: General view of Trench 2, looking south

3.3.6 The culvert was cut by a linear feature (**150**) which was aligned north-east/south-west and measured over 12m long, 1.4m wide, and in excess of 0.3m

deep (Plate 3). It was filled with a mid-brown sandy gravel material (**144**), which overlay a mixed silty-clay (**143**) with gravel inclusions. A small sherd of post-medieval pottery, which has been dated to the late 18th or 19th century was recovered from layer **144**. Deposit **143** contained flecks of reddish clay, which may have been derived from hearth **141**. Feature **150** could not be excavated in its entirety, and its intended function remains unclear, although it was almost certainly post-medieval in date.

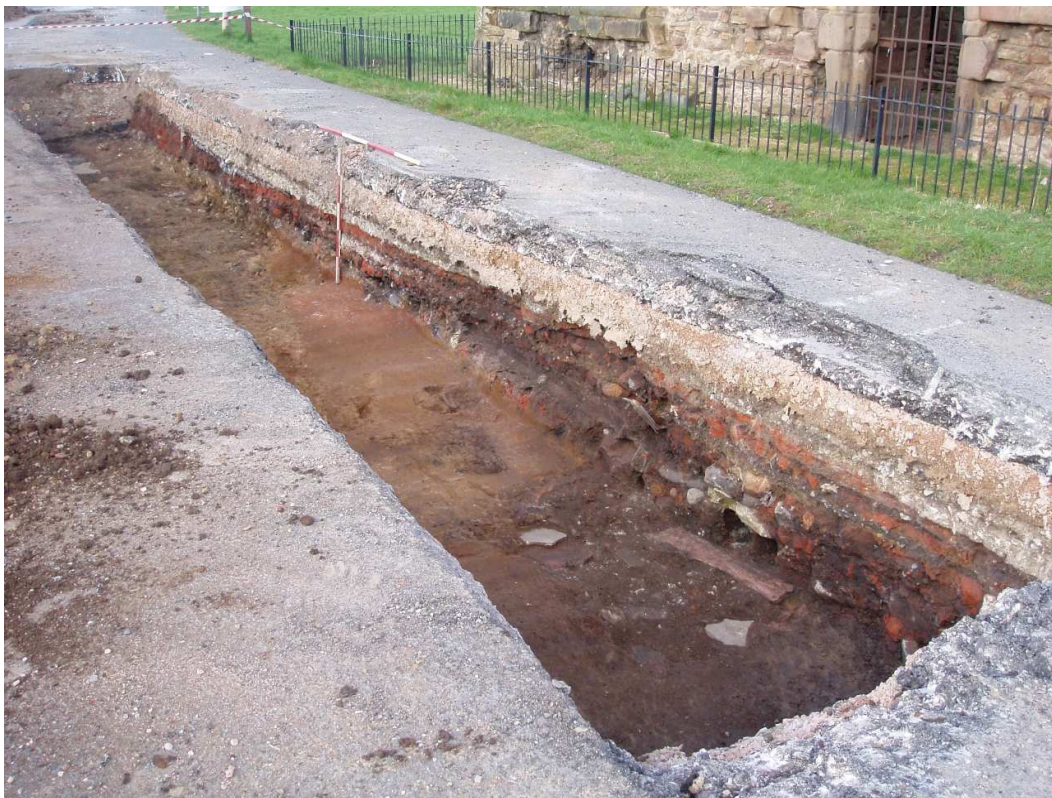
Plate 4: West-facing section of Trench 2, showing deposits *129-151*

- 3.3.8 A deposit of compacted rubble, hardcore, and tarmac (**135**) sealed drain **140** (Plate 4). It contained numerous brick fragments, stones, and clinker, and was overlain by a thin layer of hardcore (**148**), although this was only identified in the central part of the trench, and presumably represented the levelling of a hollow in the ground surface. Above that was an extensive layer of brick rubble (**134**), which was equivalent to **114** in Trench 1, and varied in depth, with the extreme northern and southern visible ends being up to 0.45m thick. Fragments of brick formed the main component of this layer, and these varied from mould-thrown to modern machine-made variants, with frogs and stamped 'Accrington'. This layer possibly represented the demolition of structures during the 20th century.

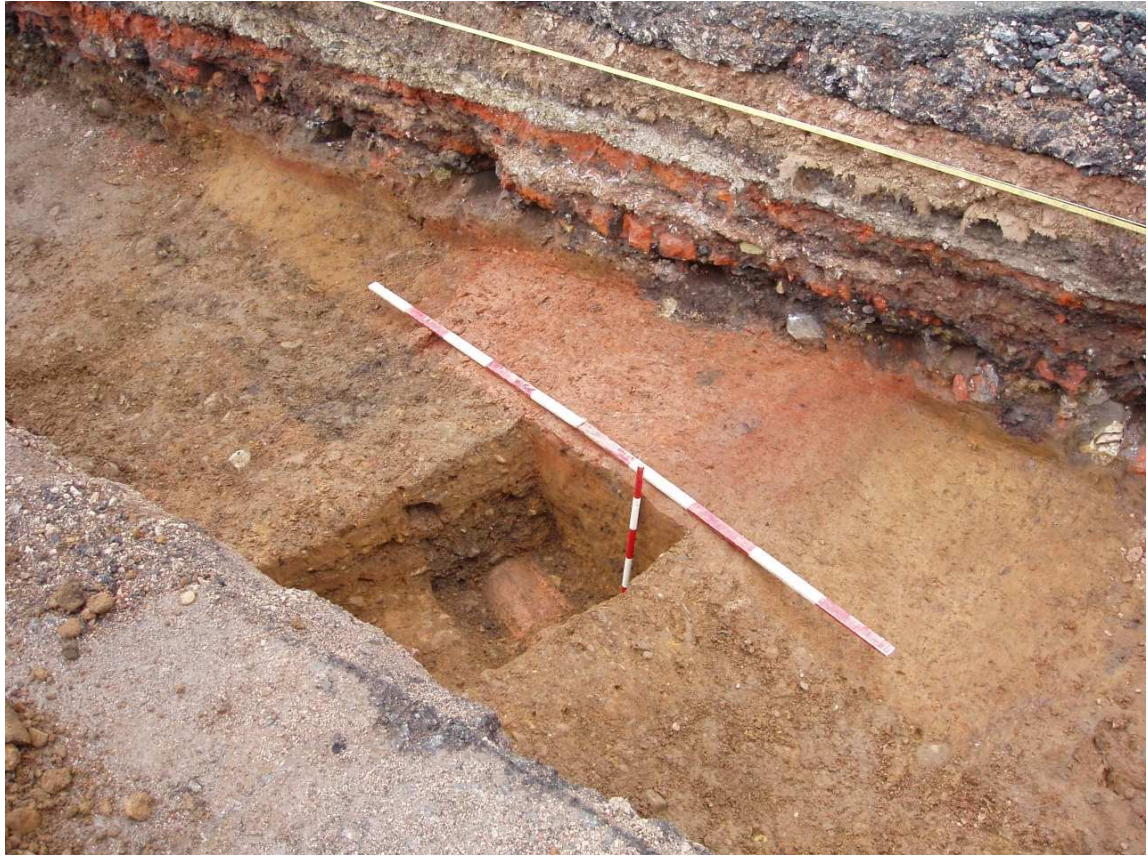
Plate 5: Land drain *139/140* in Trench 2, excavated partially to reveal hearth *141*

3.3.3 A deposit of mid-reddish-pink clay (**141**) overlay the natural geology within the central part of the trench (Plate 5), at a depth of 0.99m below the modern ground surface. This 0.04m thick deposit was slightly mounded and measured 1.6m by 0.7m, and continued eastwards beyond the limit of the excavated trench. The darker colour and slightly brittle texture of the clay implied that it had been subjected to high temperatures, which was reinforced by a distinct discolouration of layer **142** in the vicinity of **141**. These factors suggested feature **141** to have been the remains of a hearth, whilst its position implied that it had been inside the great hall.

- 3.3.7 Another linear feature (**140**) truncated much of the eastern side of feature **150**. Excavation revealed feature **140** to be a foundation trench for a ceramic land drain (Plate 5). This was similarly aligned north-east/south-west and measured over 11m long, 0.38m wide, and over 0.4m deep. The segmented components of the land drain were unglazed, and a small sherd of blue and white transfer-printed ware vessel of a probable 19th-century date was recovered from the backfill (**139**). The drain was presumably inserted after the timber-framed hall had been demolished, and was used to aid drainage of the land while in use for agricultural purposes.

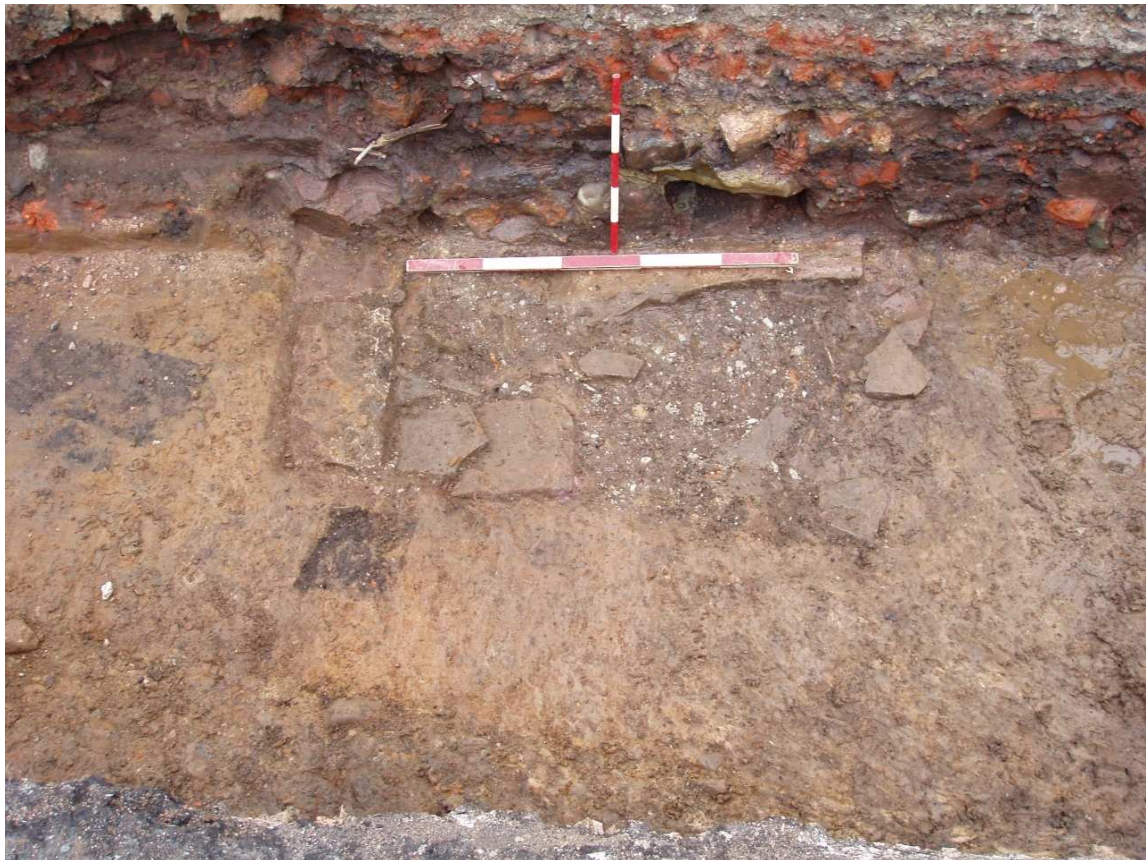
Plate 6: Possible foundation *146*, Trench 2, looking east

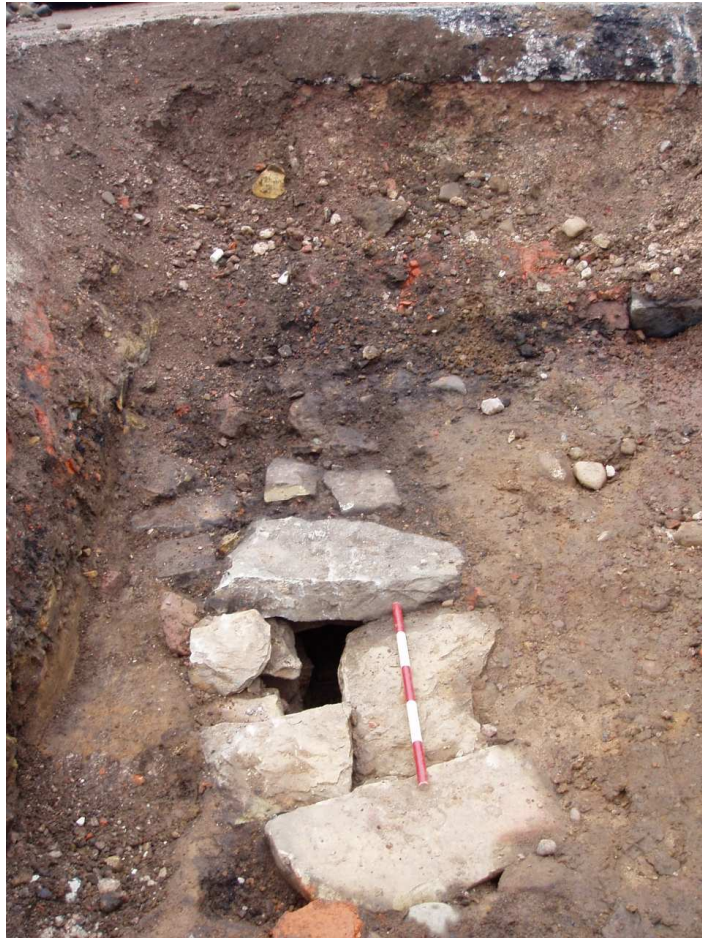
Plate 7: Detail of culvert *137*, Trench 2, looking north

3.3.5 A culvert (**137**) of stone and brick construction was exposed at the northern end of Trench 2, at a depth of 0.99m (Plate 7). This 0.8m wide structure was aligned north-west/south-east, and had been cut into the natural geology (**142**). It was composed of up to four courses of small, roughly hewn stone blocks along the western side, with mould-thrown bricks forming the eastern side (Plate 8), although it is possible that the brick component represented a later repair. The flat capping of the culvert comprised sandstone slabs, creating an internal channel that was approximately 0.3m deep and 0.2m wide. The culvert contained a 0.05m thick mid-brown deposit (**149**).

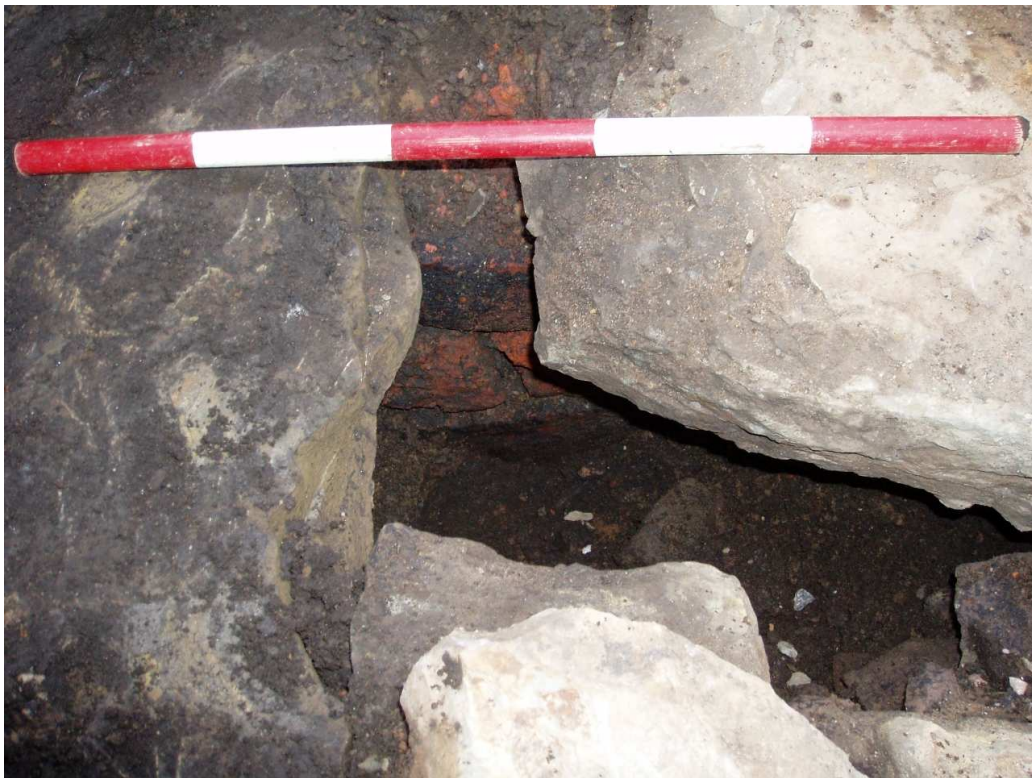
Plate 8: Detail of culvert *137*, Trench 2

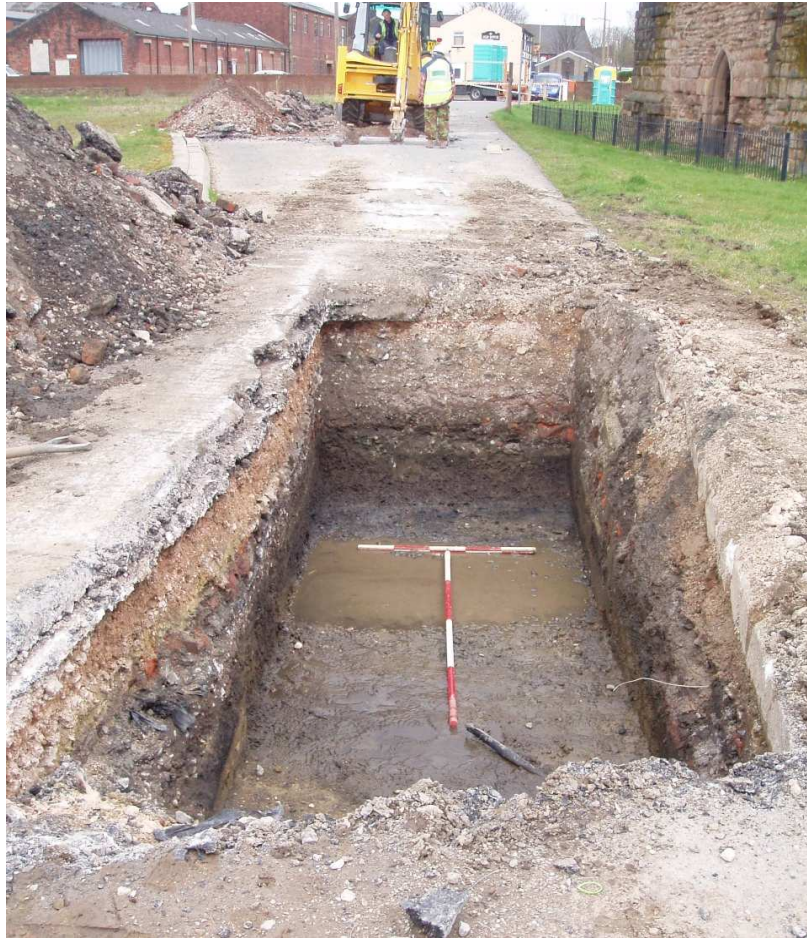
Plate 9: General view of Trench 3, looking north

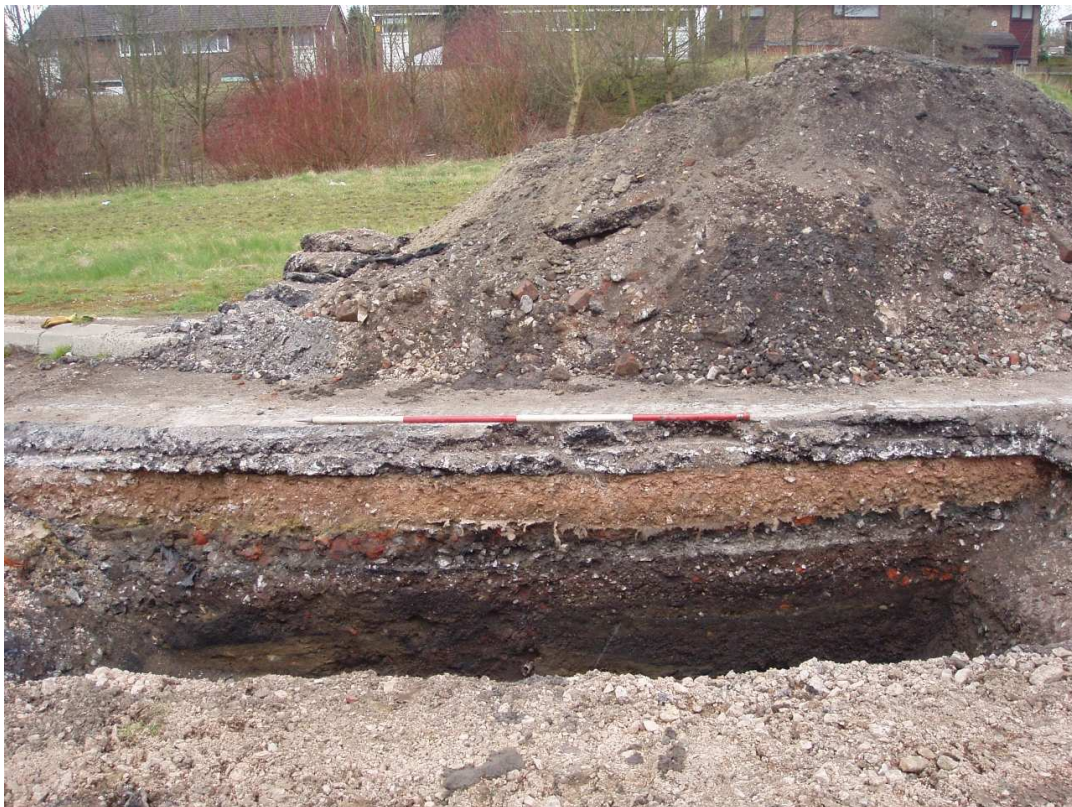
Plate 10: East-facing section of Trench 3, showing deposits *100-109*

Directly above this layer was a mottled, dark blackish-brown deposit (**106**), which became thicker towards the northern end of the trench. It contained a large proportion of clinker, which had presumably been imported to the site as a levelling material. It was overlain by a compacted but uneven layer of brick rubble, gravel, and lenses of sand (**105**), which was similarly likely to have been intended as levelling (Plate 10).
