LEVENS HALL KENDAL CUMBRIA

Archaeological Building Investigation

Oxford Archaeology North

November 2005

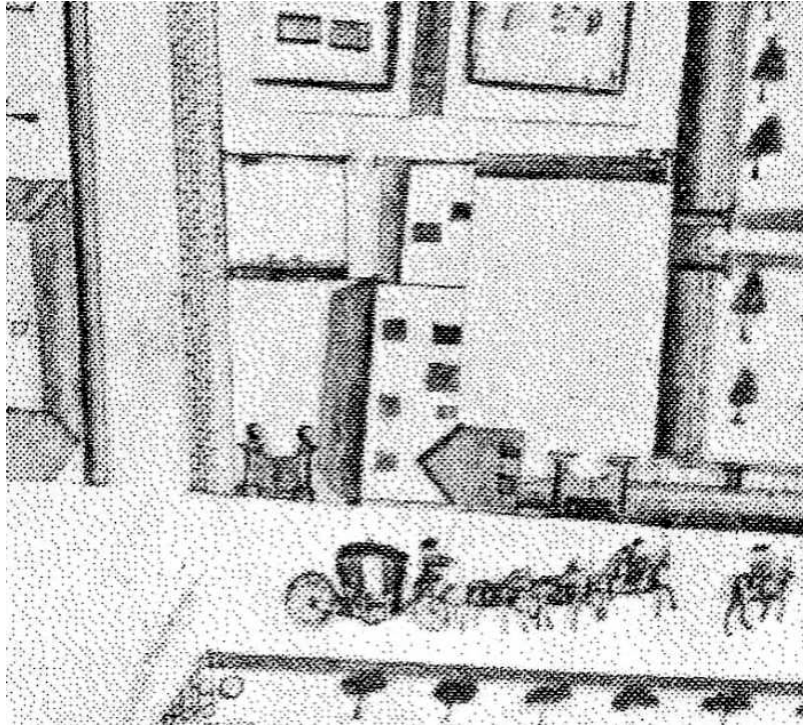
Plate 1: Part of Skyring's plan of c1750 showing the stables (after Curwen 1898, 33)

- 3.4.1 ***Eighteenth Century***: the earliest depiction of the stables is Skyring’s map of c1750 (Plate 1). This shows the building much as it now appears, including the small lodges/cottages at the north and south ends, although the tower on the north-east corner has not been added (Historic Buildings Consultants 2003, 6). A small walled enclosure is also present to the east of the south end of the stables. This plan also depicts the west elevation, which shows some differences in the arrangement of windows and doorways compared to the present day (see *Section 4*).
- 3.4.2 ***Ordnance Survey 1862***: this map, at a scale of 6” : 1 Mile, was surveyed in 1858 (Plate 2), and shows the stables in much the same form as they are depicted in c1750. The tower on the north-east corner is present by this date, as is a smaller building to the east of this, perhaps a gatehouse. There is no

5.2.3 *Phase 3:* the documentary evidence from Skyring's Map of 1750 and the Ordnance Survey Map of 1862 demonstrate that the Water Tower was built between the mid-eighteenth and mid-nineteenth centuries, though it is likely to be nearer the former. In addition, the lath and plaster partition in Rooms 13 and 14 were inserted on the second floor.

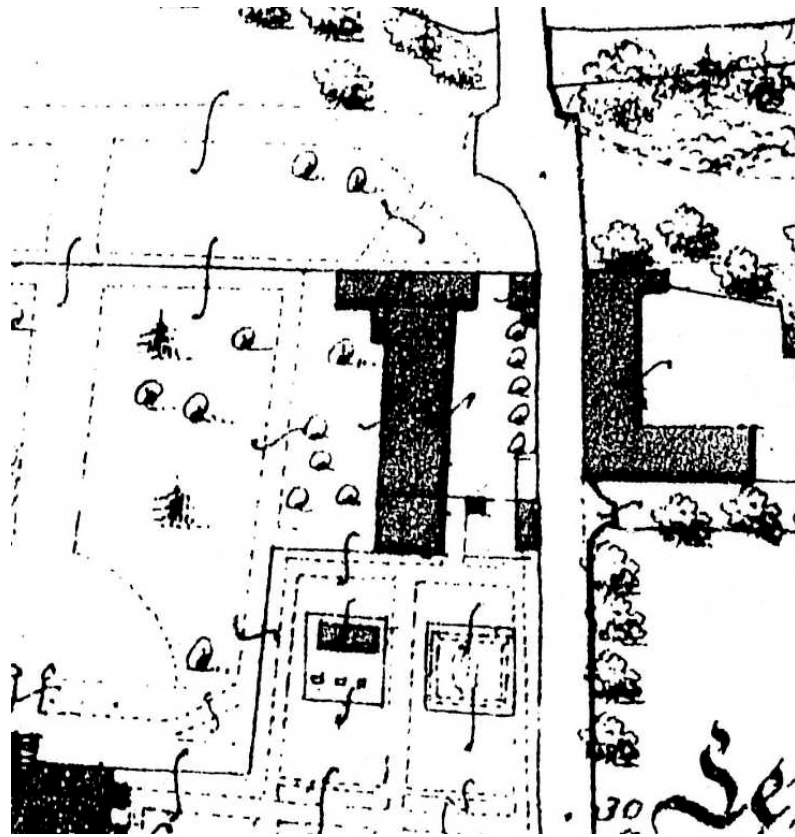
Plate 3: Part of the Ordnance Survey map of c1859 showing the stables

- 3.4.3 **Ordnance Survey c1859**: although probably published at around the same time as the 6" map this was probably surveyed slightly later. The stables themselves and associated buildings are shown much the same, the only difference being that the divisions between the stables and the attached cottages and lodge are shown (Plate 3). The walled enclosure to the south-east also has two small outbuildings within it.

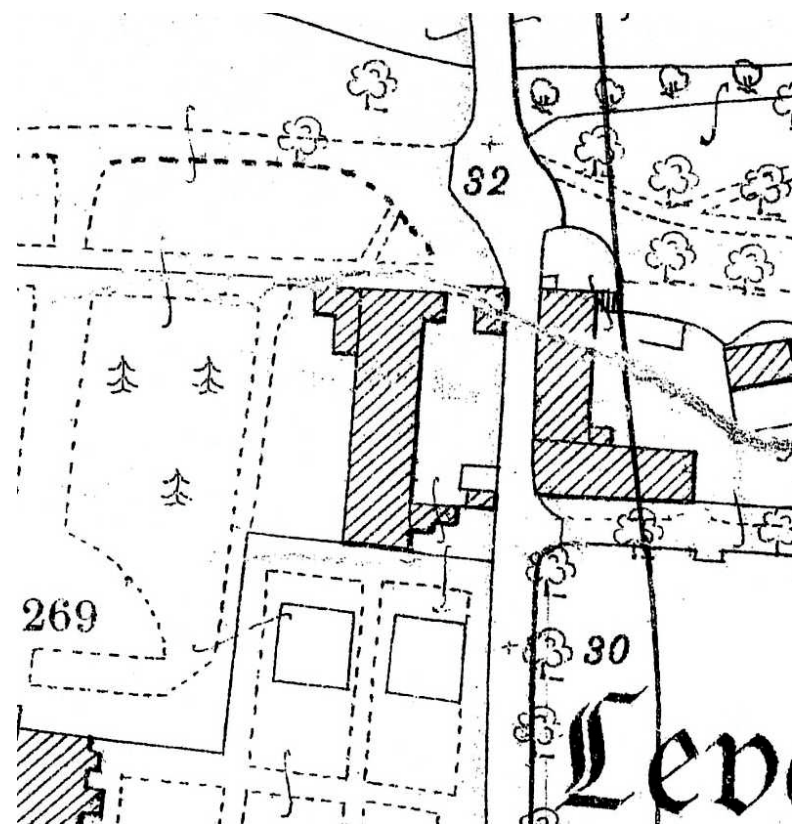
Plate 4: Part of the Ordnance Survey map of 1898 showing the stables

- 3.4.4 **Ordnance Survey 1898**: again, the stables themselves are shown much as before (Plate 4). The only significant difference is that the small walled enclosure to the south-east has effectively been removed due to the addition of an extension to the south-east end of the building and alterations to the outbuildings.

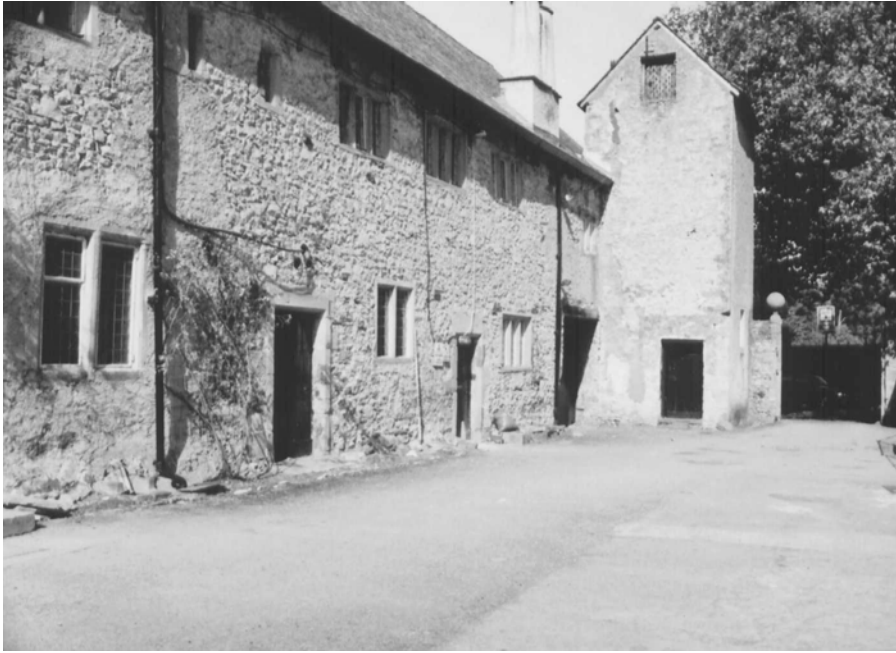
- 4.1.1 The stable block at Levens Hall in Cumbria is a stone-built, three-storey, rectangular building (Plates 5 and 6), which is aligned north to south and measures 34.17m (112 feet) long by 10.01m (33 feet) wide. It originally housed the coach house, tack room, stables and the gardeners' bothy for the main hall, but this space has since been converted into three self-contained dwellings. As it presently stands, only three elevations of the building are now visible as the south elevation is all but obscured by the addition of the late seventeenth century Gardener's Cottage. In addition to the original structure, two extensions were constructed at the north end of the building. On the eastern side, a three-storey, rectangular water tower has been added, whilst on the north-west corner of the building, a single-storey L-shaped annex or 'Lodge' has been appended. Whether the Water Tower deserves this labelling is questionable as its function is not proven. However, for the purposes of the report the term will be retained. In addition, a retaining wall of coarse rubble stands adjacent to the north-east corner of the tower. It has moulded sandstone gateposts, which are capped with ball finials and an unadorned, round-arch niche lies on either side. Finally, to the rear of the building, there is a semi-circular stone terrace and balustrade, which overlooks the attached garden, and the grounds of Levens Hall itself.

Plate 5: North-west-facing view of the front of the Old Stables and Water Tower

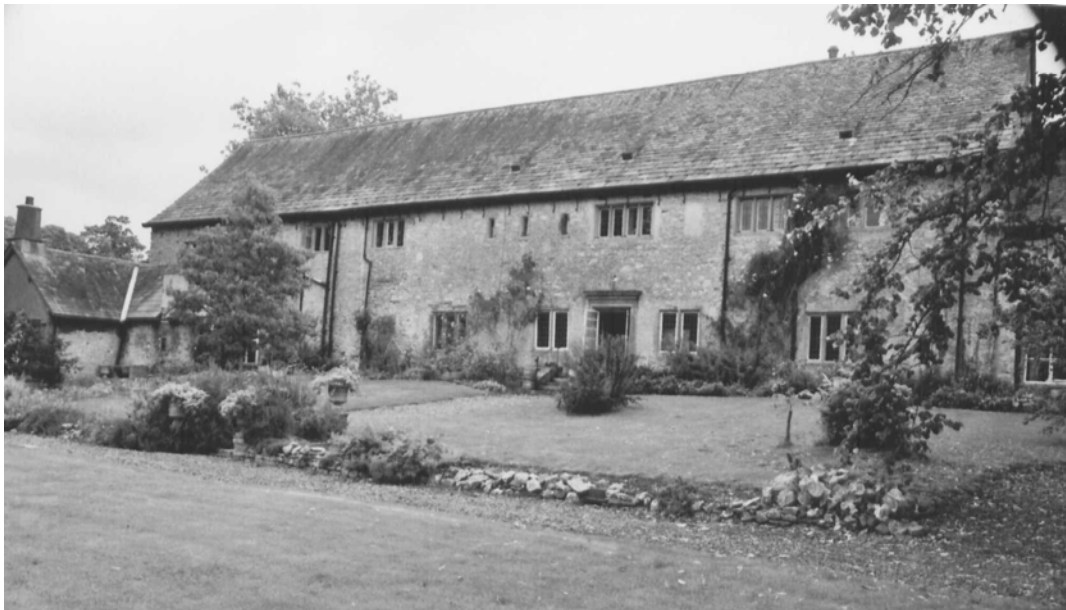
6: North-east-facing view of the rear of the Old Stables and later annex

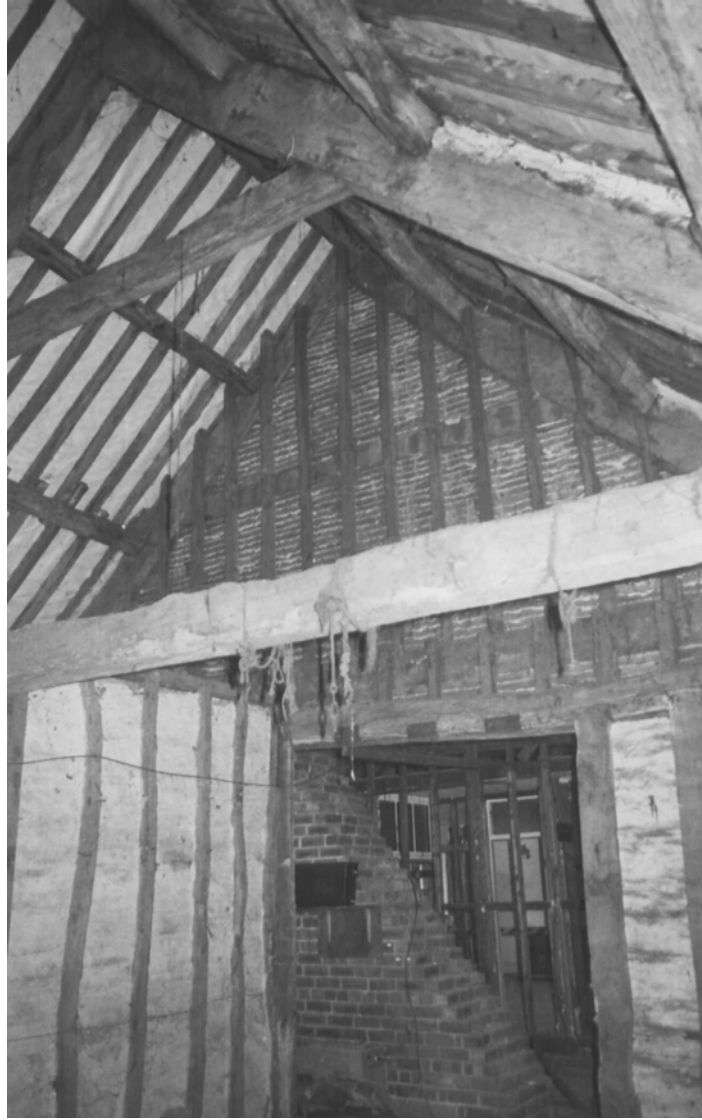
Plate 7: South-east-facing view of the roof truss and modern chimney-breast in Room 12

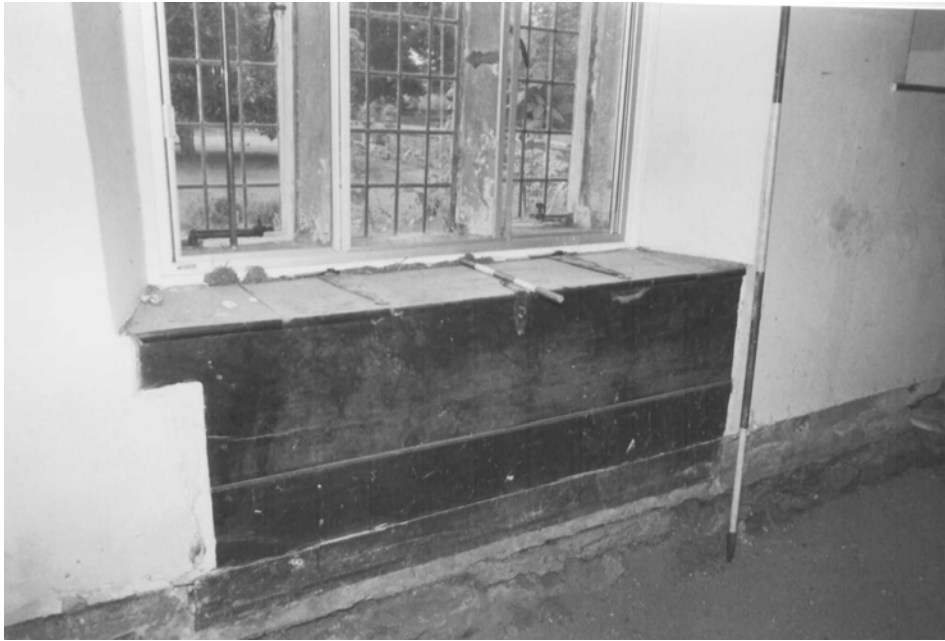
- 4.3.2 The majority of the windows in the old stable block have infilled embrasures, but the windows at the rear of the building on the ground floor have some striking features added. The embrasure of the window in the north-west corner of the stables section has a fitted oak chest (Plate 8), which would appear to be original or a relatively early addition. Similarly, the window lying immediately to the north of the French windows has an oak window seat with concentric lozenge motif added, and probably dates to the nineteenth or early twentieth century

Plate 8: Timber chest in the rear window of Room 4

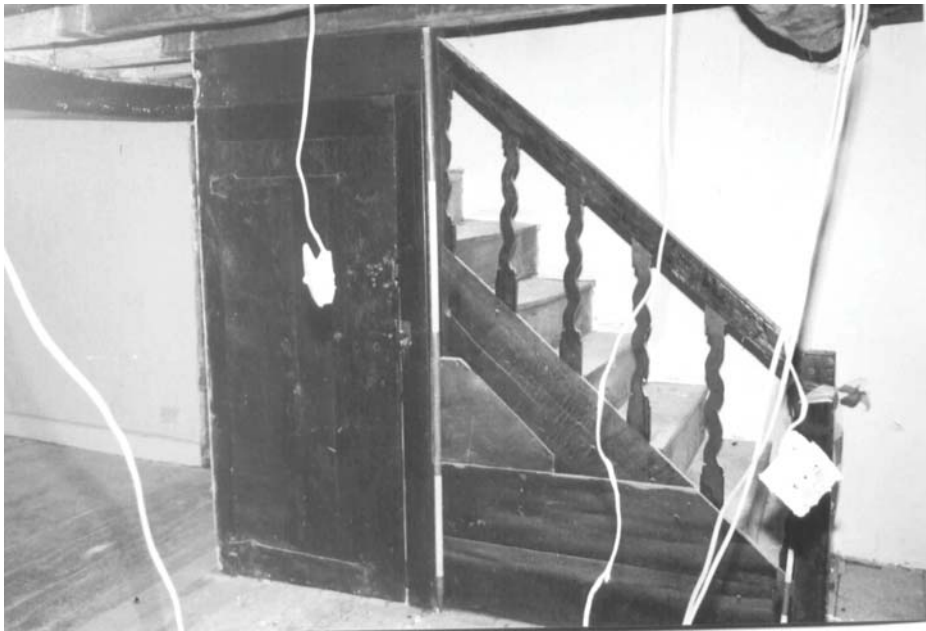
- 4.3.4 Access to the first and second floors is provided by stairs located at either extent of the building. The single-flight staircase at the south extent of the stable complex is twentieth century and of minor significance. In addition, at the north end of the building, there is a quarter-turn staircase with winders, which replaced and marginally repositioned an earlier flight, and this is still partially visible on the ground floor. In addition, the scars on the west elevation and the recess on the north elevation of the tack room illustrate a further staircase has been removed. Most interesting is the seemingly antique staircase in Room 16 that provides access to the footmen's quarters on the second floor. It is constructed from oak, again in a quarter-turn with winders form, and incorporates an oak panel door (Plate 9), which is likely to be original to the building. However, the main components of the staircase including the newels and the rail are likely to be nineteenth century, whilst the

balusters appear to be incongruous repairs or renovations from the early twentieth century.

9: Original oak door and nineteenth century staircase in Room 16

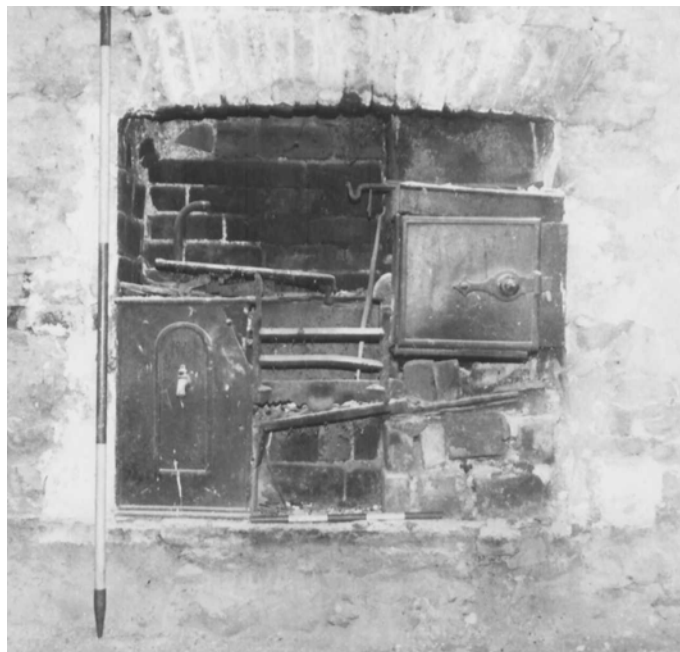
Plate 11: The nineteenth century cast-iron range in the old tack room
