# **Maulds Meaburn, Cumbria**

## **Archaeological Watching Brief and Excavation**

**United Utilities**

**Document Title:** Maulds Meaburn, Cumbria  
**Document Type:** Report on an Archaeological Watching Brief and Excavation  
**Client Name:** United Utilities

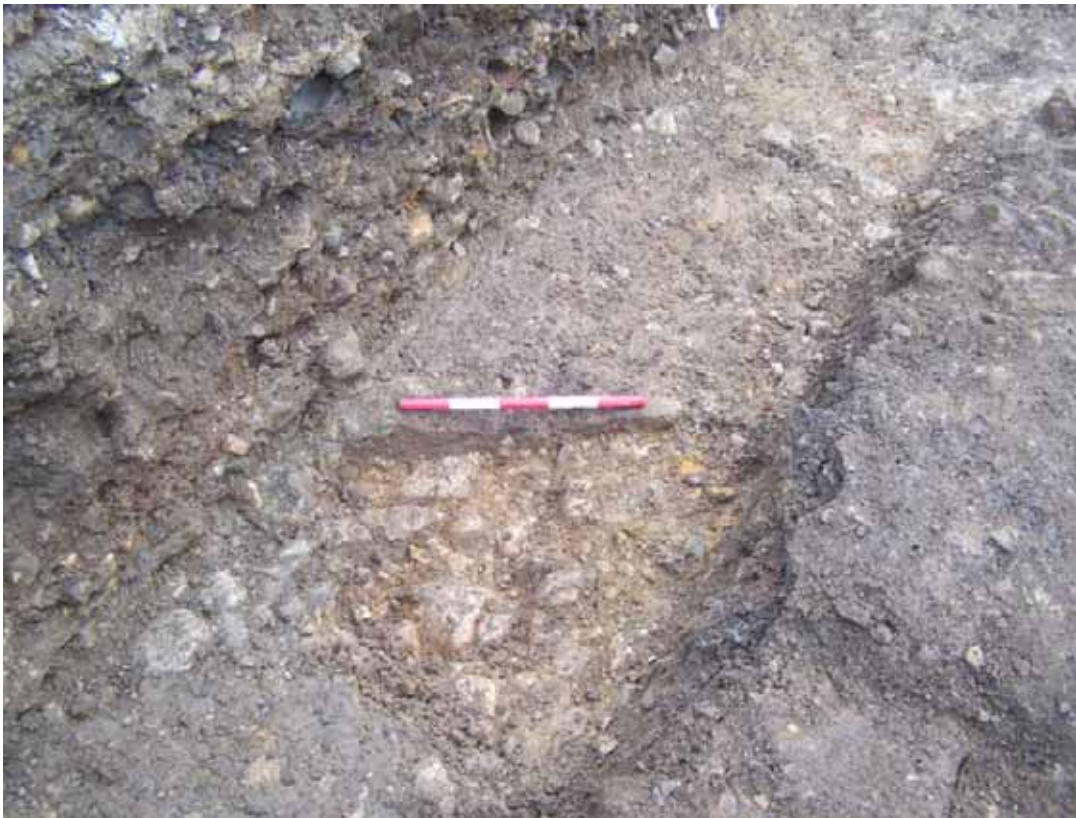
3.2.1 The stratigraphically earliest features recorded were a small ditch or gully (**139**), located in the extreme north-east corner of the trench, and what may have been either the southern terminal of a second ditch, or a pit (**164**), which extended into the site from the north (Fig 2). Both these features had been dug into the natural gravels (**137**). Ditch **139** was 0.6m wide and 0.1m deep (Pl 1), and was aligned north-west/south-east, roughly parallel to the tail-race itself (SG **168**; *Section 3.5*). The latter lay *c* 3.5m to the west, though the two features had no direct stratigraphic relationship. Because of its location, within the extreme north-east corner of the site, the ditch was traced for only 1.5m, but extended north-west and south-east beyond the limits of the investigation. It was filled with mid-grey silt (**138**), from which a small fragment of fourteenth-sixteenth century pottery was recovered. The ditch was ultimately sealed by deposits associated with the earliest of the two phases of cobbled road surface (SG **172**; *Section 3.3*). Its precise significance remains unclear, but it could conceivably represent part of a medieval property boundary or field boundary. However, the presence of a single medieval sherd in the fill does not prove a medieval date for the feature.

*Plate 1: Ditch 139, fully excavated, looking south*

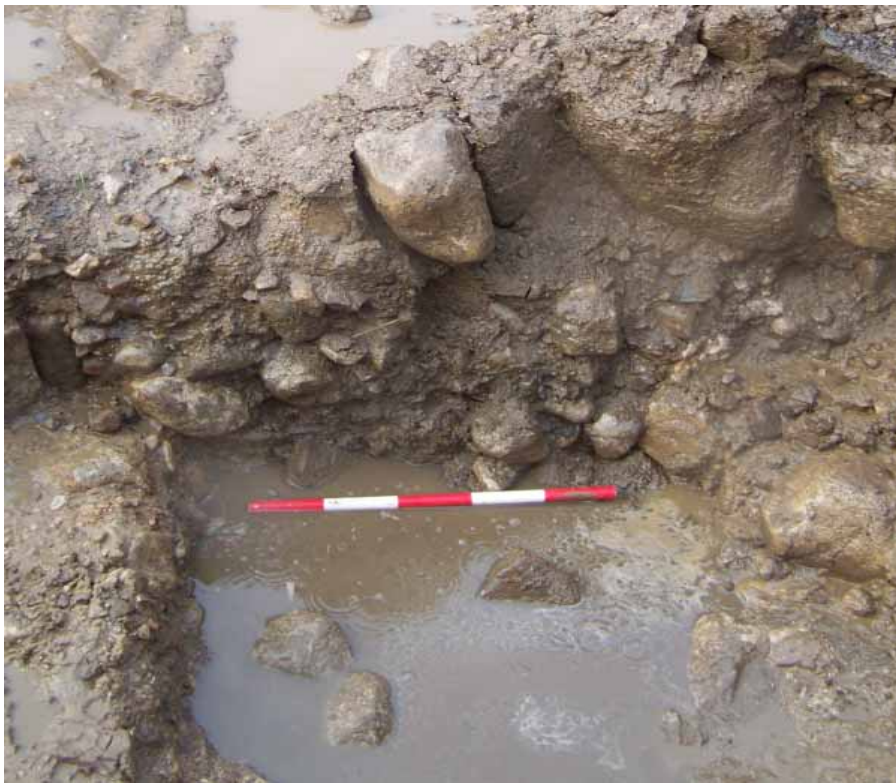
3.2.2 Feature **164** was located on the northern edge of the site (Fig 2). It may have lain largely north of the excavated area, since it extended into the trench for only 0.7m. If part of a ditch, the excavated fragment must have represented the south terminal, though it might equally have been a small pit, the northern half of which lay outside the site. Whatever its precise form, that part of the feature available for investigation was 0.66m wide and 0.3m deep (Pl 2), and was filled with cobbles and gravel (**163**). It had been dug into the natural gravel (**137**) and was sealed by cobbles associated with a probable widening of the first phase of the cobbled road (deposit **124**, SG **172**; *Section 3.3.2*). Indeed, it is possible that its filling was associated with this episode of road widening. Significantly, fill **163** yielded nineteenth-century pottery (together with some animal bones), demonstrating that not only this feature, but also all other stratigraphically later features and deposits recorded on the site (including the widened phase of primary road surface SG **172** and secondary surface SG **169**) must date to the nineteenth century or later.

*Plate 2: Feature 164, looking north*

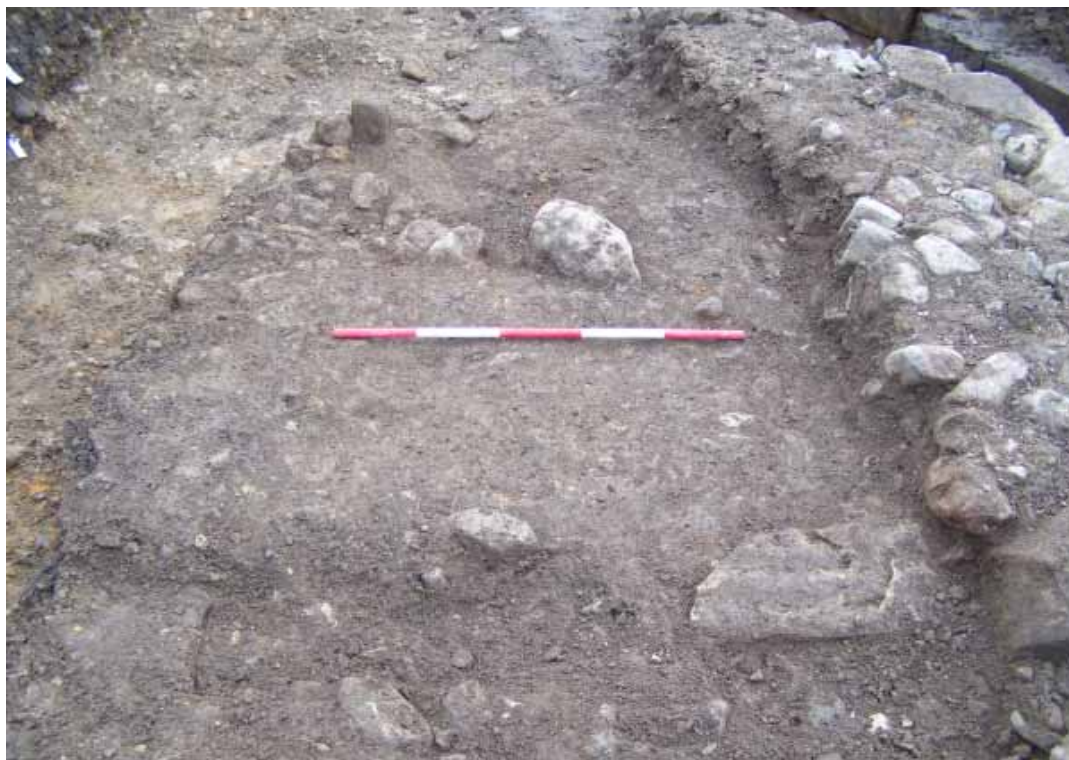
- 3.3.1 Ditch **139** (*Section 3.2.1*) was sealed by a deposit of grey-brown sandy gravel (**136**; not illustrated), up to 0.15m thick, which lay directly above the natural gravel. This was in turn overlain by a 0.2m-thick layer of compacted material (**135**; Pl 3) comprising blue-grey clay mixed with degraded shale and stone fragments. These deposits were confined largely to the area beneath the later cobbled road surfaces (*Section 3.3.2*), and it is possible that they represented the remains of a road or track surface that pre-dated the earliest cobbling, though this is far from certain.

Plate 3: Putative surface **135**, looking south

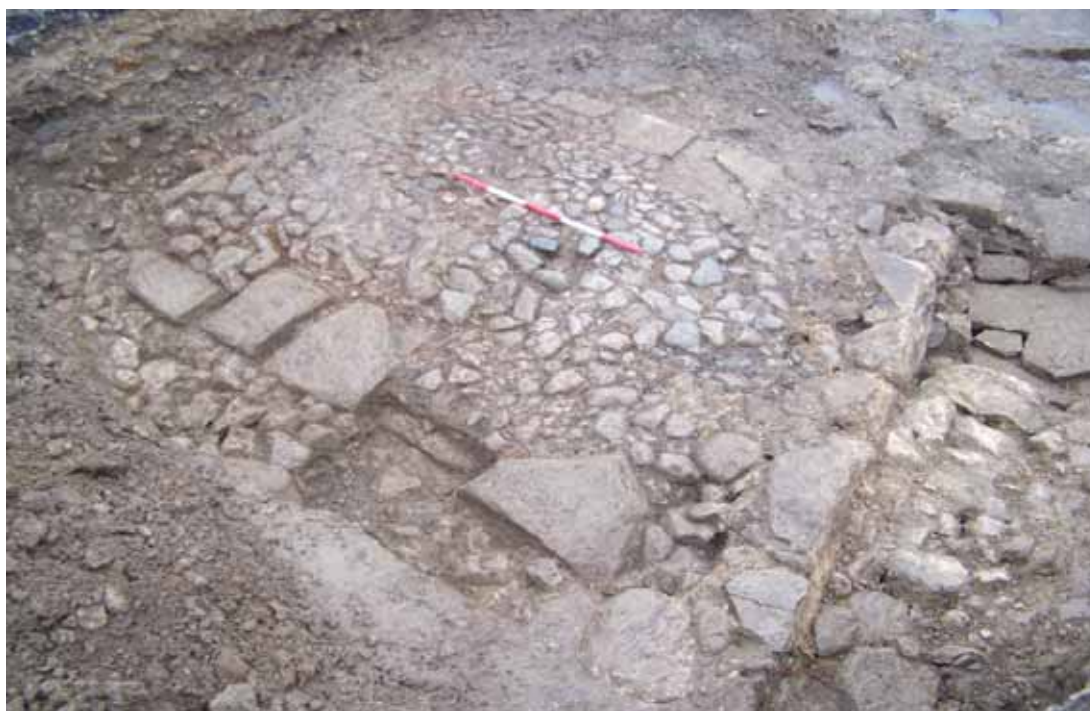
- 3.3.2 Directly overlying **136** was a well-laid cobbled surface (**123**), up to 0.3m thick (Fig 2; Pl 4), edged on the north and south by kerbs constructed of large, roughly-squared sandstone slabs and blocks (**122**). In total, the surface of this east/west-aligned road or lane (SG **172**) was approximately 2.4m (or around eight feet) wide, including the kerb stones. Later, however, the road appears to have been widened, which was effected by the laying of another cobbled surface (**124**) on the north (Fig 2), beyond (but abutting) the northernmost kerb. This surface was located on the extreme northern edge of the site, and extended beyond the investigated area in that direction, so the full width of the road at this time is not known, though it was in excess of 3m. The primary cobbled surface, together with deposits **135** and **136** beneath it, yielded no dating evidence, but nineteenth-century pottery came from the road widening (surface **124**), and this deposit also sealed feature **164**, which itself contained pottery of nineteenth-century date (*Section 3.2.2*).

Plate 4: Primary road SG 172, looking south-east, showing cobbled surface **I23** and stone kerbs **I22**. Note removal of road surface on the west (right) by disturbance associated with maintenance of tail-race SG 168

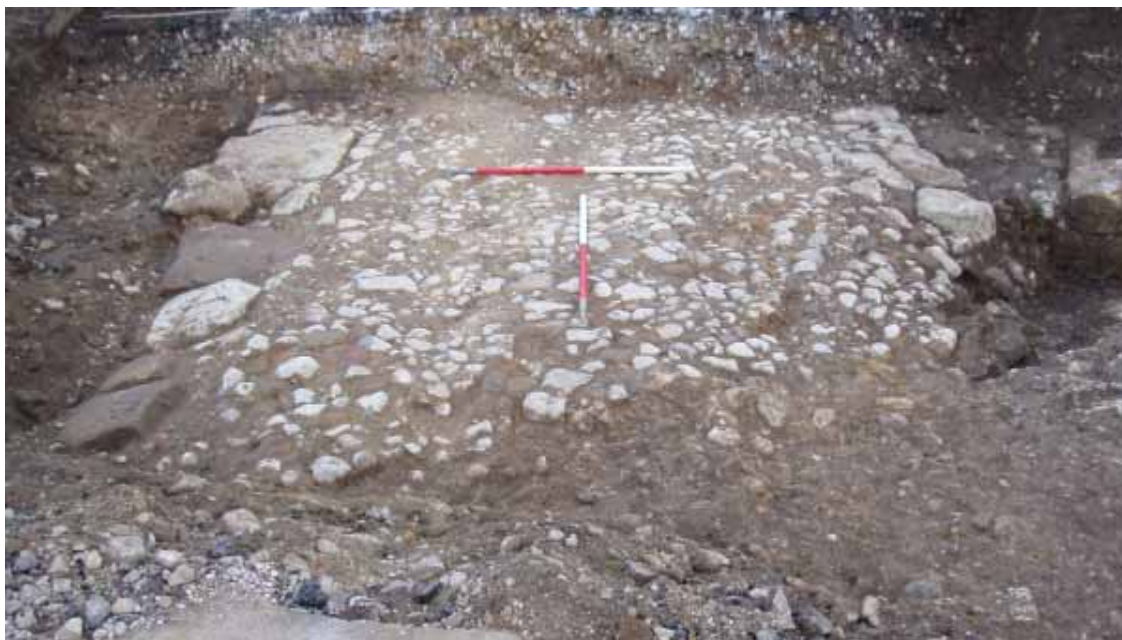
- 3.4.1 Overlying SG 172 was a 0.2m-thick deposit of clay-sand and cobbles (**I26**; not illustrated), which also extended (as deposit **I16=I25**) up to 1m south of the road's southern kerb (Fig 2). What may have been a fragment of the same deposit (**I29**) was also recorded on the extreme western edge of the trench. With the exception of **I29**, which was both stratigraphically isolated and truncated by later disturbance associated with refurbishment of the tail-race (Section 3.5.4), this material was in turn overlain by a new road surface (SG 169; Pl 54) of cobbles (**I05**), up to 0.2m thick, edged by stone kerbs (**I06**, **I07**). In this phase, the road, though very similar in character to the construction of primary road SG 172, was considerably wider, at c 3.8m, including the kerbs. Two parallel wheel-ruts (**I13**), 2.2-2.4m long, 80-120mm wide and 0.1m deep, were visible in the surface of the cobbling (Pl 5), aligned east to west and set 0.9-1m apart. These had been infilled with a stony deposit (**I15**), probably to effect a repair to the road surface. Finds included nineteenth-

century pottery and a highly eroded, illegible, copper alloy coin from underlying deposit **126**.. As was the case with the primary road, **SG 169** extended beyond the limit of the investigation to the east, and was cut away on the west by disturbance associated with maintenance of the tail-race (**SG 168**; *Section 3.5.4*).

*Plate 5: Road **SG 169**, looking east, showing cobbled surface **105** and stone kerbs **106**, **107**. Two parallel wheel ruts (**113**) are just visible in the road surface*

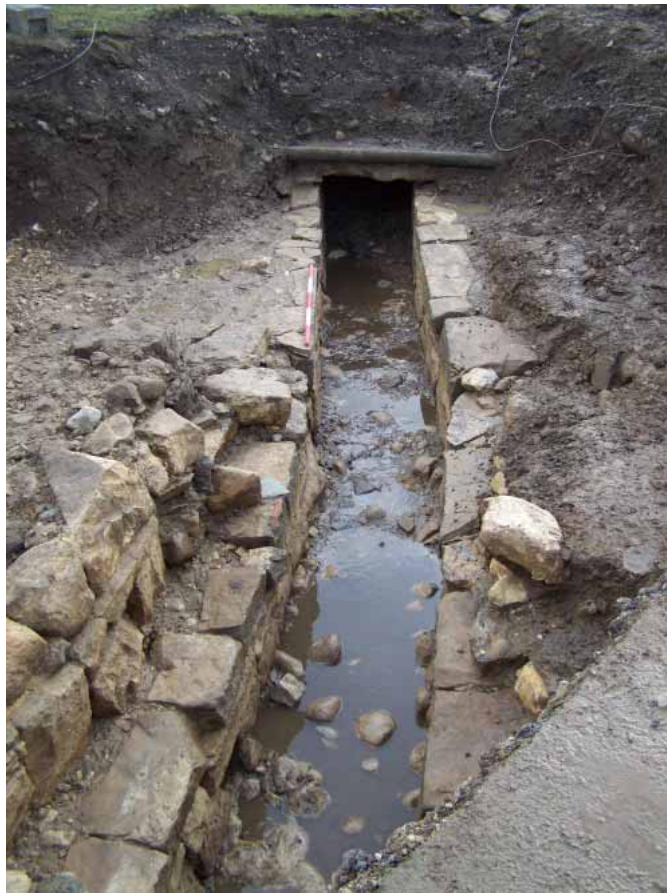
3.5.1 The tail-race for the corn and saw mill at Maulds Meaburn ran diagonally, north-west to south-east, across the entire site, a distance of *c* 7m, and was fully exposed within the excavated area. Although the mill itself is known to date back at least to the late seventeenth century (*Section 1.3.9*), the precise date at which the excavated segment of the tail-race was constructed is unclear, since later disturbance, seemingly associated with a nineteenth- or twentieth-century refurbishment of the feature (*Section 3.5.4*), had removed all primary stratigraphic relationships between the surviving fabric of the race and the adjacent archaeological deposits, including those associated with roads **SG 172** and **SG 169**. However, the channel itself proved to be generally well preserved (Fig 2; Pl 6), its sides lined with up to three courses of unmortared, dressed, sandstone blocks (**170**, on the eastern edge of the channel, **171**, on the west; Fig 3). The largest blocks used (mostly, but not exclusively, in the lower course) measured up to 1 x 0.4 x 0.3m, but most were smaller, with considerable variation evident in both size and shape. Internally, the channel was 0.6-0.65m wide and up to 0.6m deep, and it had been capped with large, roughly-dressed, rectangular sandstone slabs (**134**; Pl 7). Most of the latter were 1-1.2m long, 0.35-0.4m wide, and 0.1-0.2m thick..

*Plate 6: The tail-race for the former corn and saw mill (SG 168), looking south-east, with capping stones removed, showing stone lining 170/171*

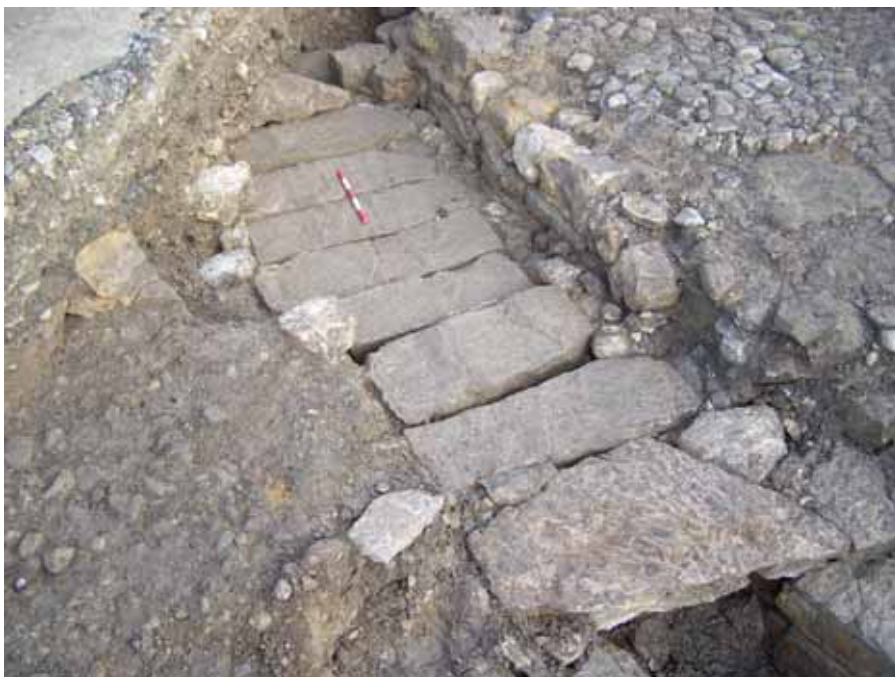
*Plate 7: Tail-race SG 168, looking north-west, showing capping stones 134*

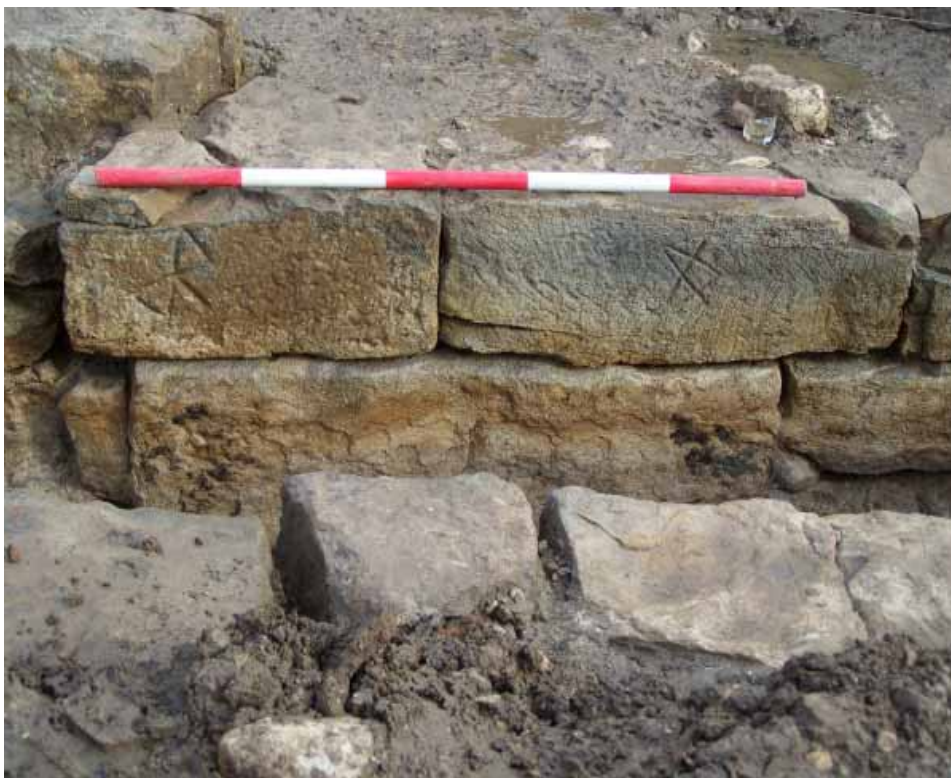
- 3.5.2 In the stonework of the the channel's eastern edge (**170**), two masons' marks were recorded on adjacent stone blocks that had been built into the uppermost course (Fig 3: Pl 8). It is of some interest that identical marks are visible on the masonry of Low Bridge, which spans the River Lyvennet only 30m or so west of the excavation (*Section 5.3.3*). The bridge dates to the seventeenth century, and what may be some of the original stonework is visible in the arch on the north side of the bridge. It was, however, extensively rebuilt in 1853, and much of the extant masonry clearly dates to this period. Unusually, masons' marks of the kind found in the tail-race occur on both the putative seventeenth-century masonry and on the nineteenth-century work. The possible reasons for this are discussed elsewhere (*Section 5.3.3-4*), but, in terms of dating the construction of the tail-race, it means that it is not possible to know whether the masons' marks indicate a definite nineteenth-century date for the surviving stonework, or if the extant channel is potentially much earlier.

Plate 8: Masons' marks on stonework (**170**) in the eastern side of the tail-race channel (SG **168**)

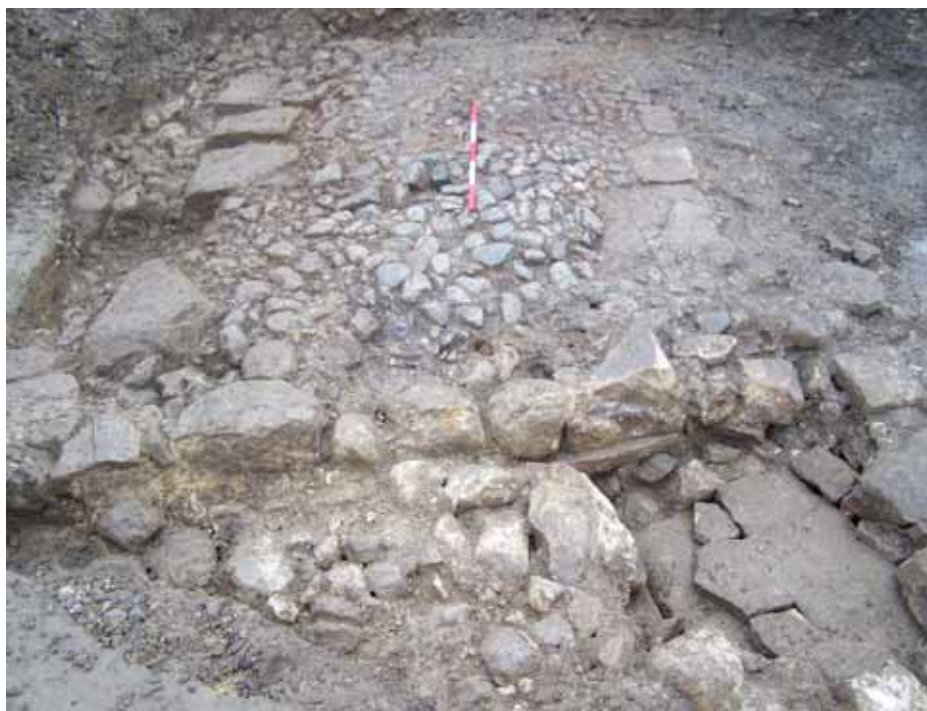
- 3.5.4 The late date of the channel silts accords with the stratigraphic evidence from within the excavated area, which demonstrated that the exposed section of the tail-race was refurbished at a relatively late date, certainly no earlier than the nineteenth century, and quite possibly during the twentieth century, perhaps even immediately prior to the construction of the modern tarmac road. To access the channel, a trench (**118**), up to 2.5m wide was dug along the line of the tail-race, down to the top of the capping stones (Fig 2). This cut through the cobbled surface and kerb stones of road SG **169**, the latest of the two

recorded cobbled roads (which was itself of nineteenth-century or later date), removing the road surface completely, as well as the underlying surface of the primary road (SG 172). Presumably, this was done in order to clean out the channel, and/or to effect repairs, though, apart from the fact that the silts remaining in the channel had clearly accumulated fairly recently (Section 3.5.3), no clear evidence for this was noted. Before the trench was infilled, a single course of very crude, unmortared stonework, comprising large, roughly-squared sandstone blocks set, in some instances, on flat sandstone slabs (Pl 9) was laid on either side of the tail-race channel (119 on the east, 120 on the west), offset slightly outside the line of the channel's original stone lining and above the level of the capping stones. On both sides, the remaining space between this masonry and the edge of the trench cut was filled with gravel and cobbles (127, 128), whilst the space between stonework 119 and 120 was filled with coarse rubble and cobbles (121 beneath 109/132). This had been deposited on top of the capping stones of the tail-race channel (Pl 9), and may have been retained on the south by two large, roughly-dressed sandstone blocks (117), laid laterally across the tail-race, which also sat directly on top of the capping stones (Fig 2; Pl 10). Both 109/132 and 117 lay beneath make-up and hardcore deposits (110, 111, 150-7, 159-162, 165) associated with the construction of the modern tarmac road surface (112).

Plate 9: Disturbance to road SG 169 caused by a late refurbishment of tail-race SG 168, looking east. Note stone 'lining' 119 on the east side of cut 118, and rubble fill 121 overlying the tail-race capping stones (134)

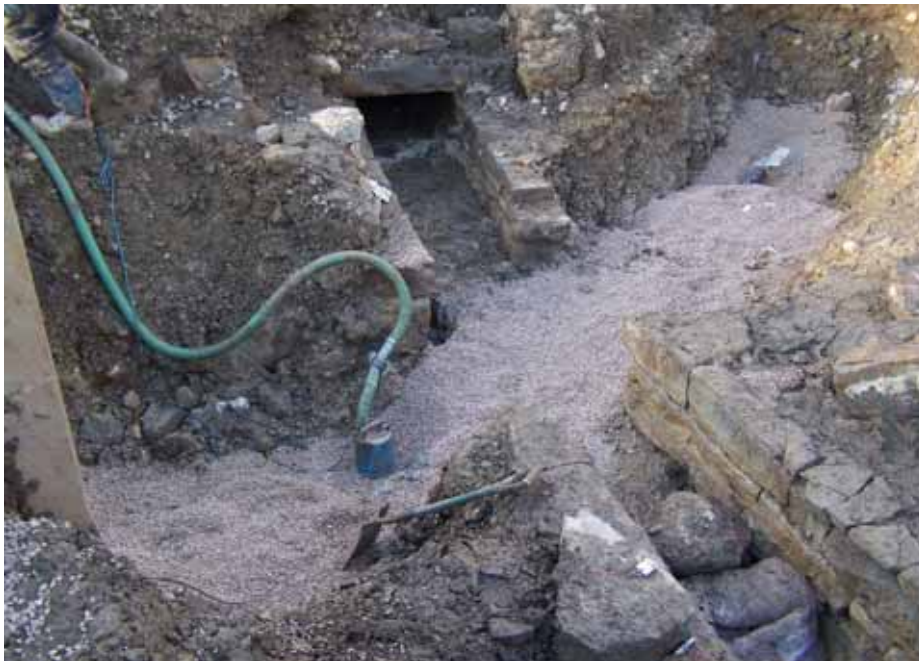
- 3.6.1 Upon completion of the archaeological excavation, the new pipeline was inserted across the tail-race of the former corn and saw mill (Pl 11). Following completion of this, and in accordance with English Heritage's requirements, the lining and capping of the channel were carefully rebuilt, utilising, wherever possible, the original materials (Pl 12; Pl 13). Finally, the modern road surface and adjacent ground were reinstated above the monument.

*Plate 11: Construction of pipeline across the tail-race channel (SG 168)*

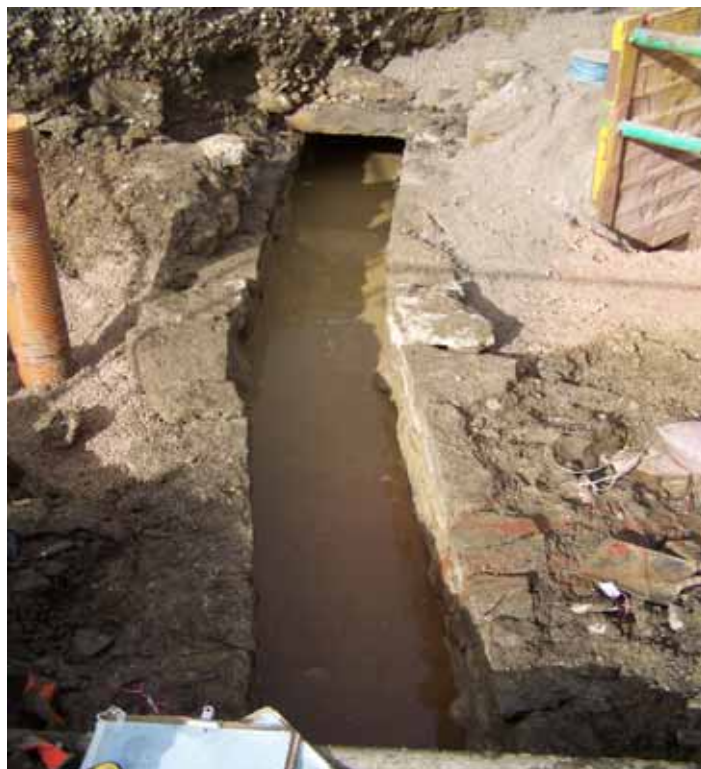
*Plate 12: The stone lining (170/171) of tail-race channel SG 168 rebuilt following insertion of pipe*

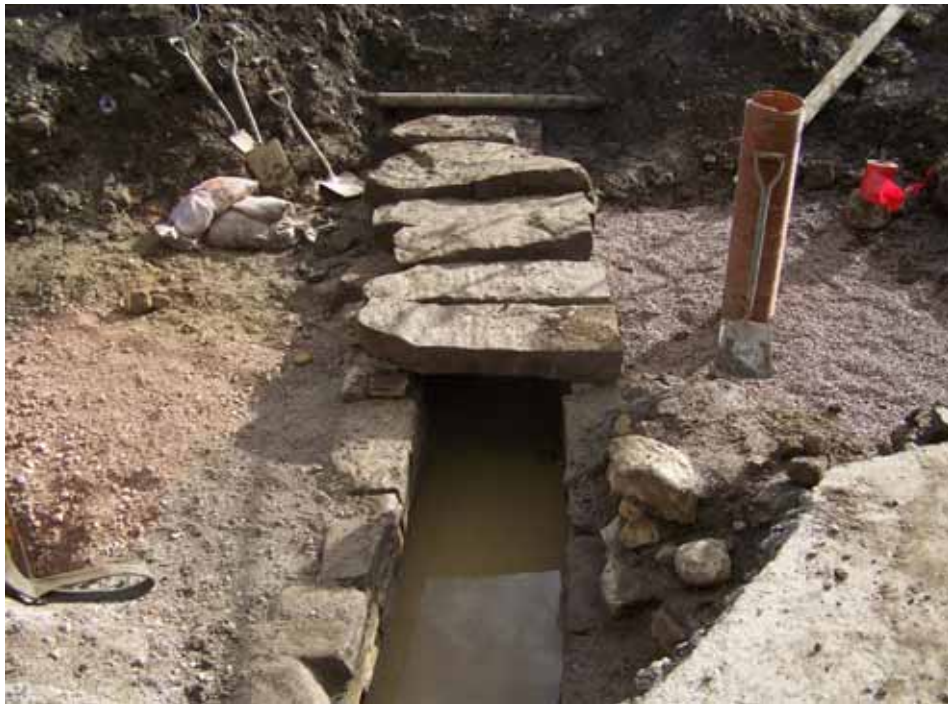
*Plate 13: Reinstatement of capping stones 134 over tail-race channel SG 168 following insertion of pipe*

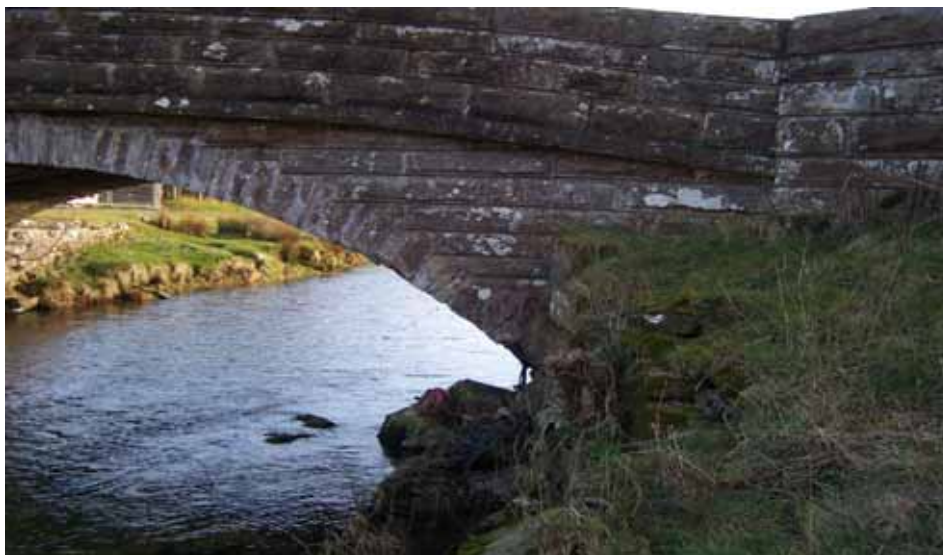
Plate 14: Low Bridge from the north, showing possible seventeenth-century masonry in this side of the arch

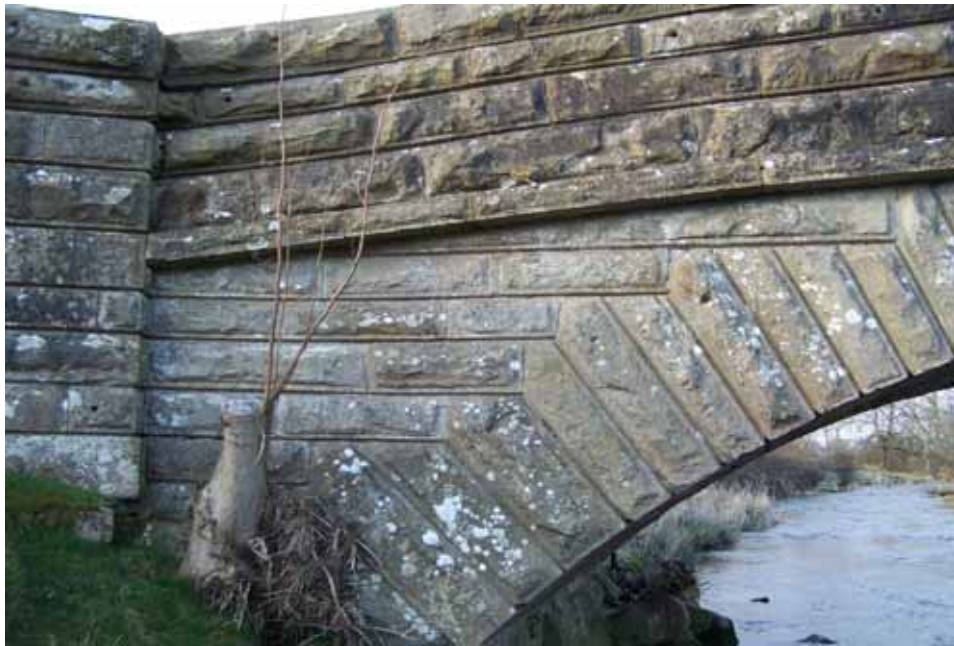
Plate 15: Low Bridge from the south, showing the mid-nineteenth century masonry on this side of the arch

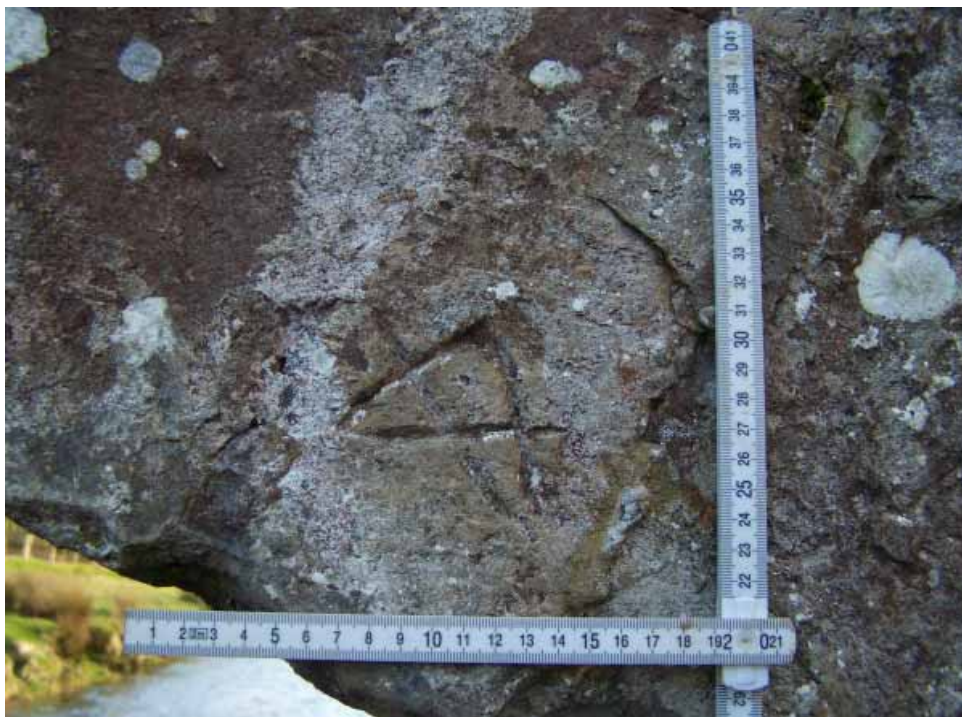
Plate 16: Low Bridge: mason's mark on possible seventeenth-century masonry on the north side of the arch

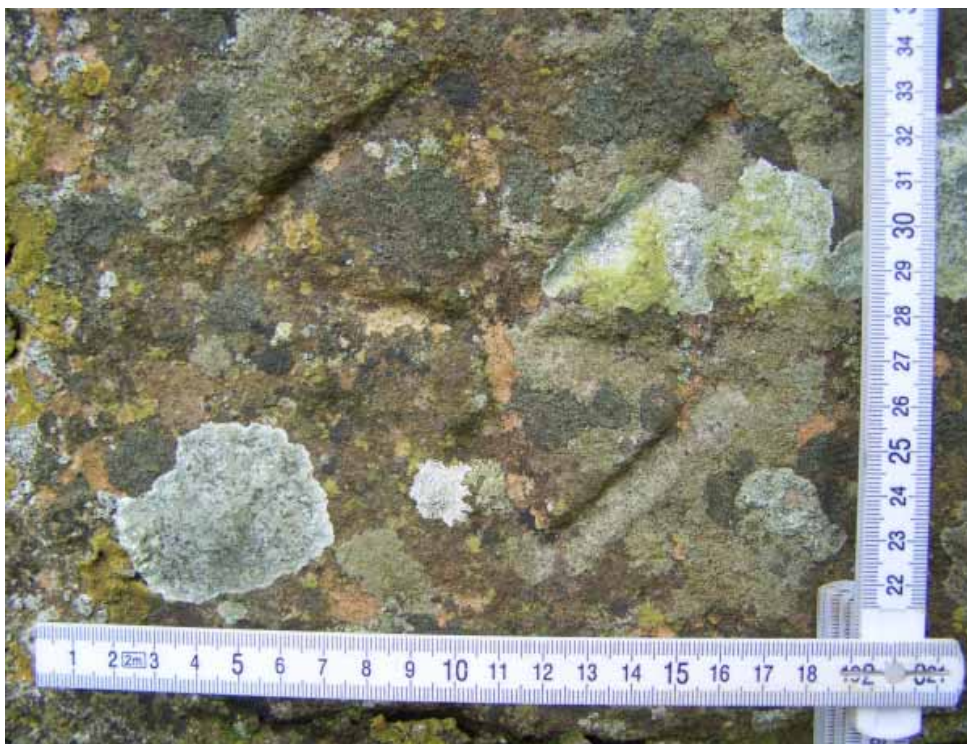
*Plate 18: Low Bridge: mason's mark on mid-nineteenth-century masonry on the south side of the bridge*

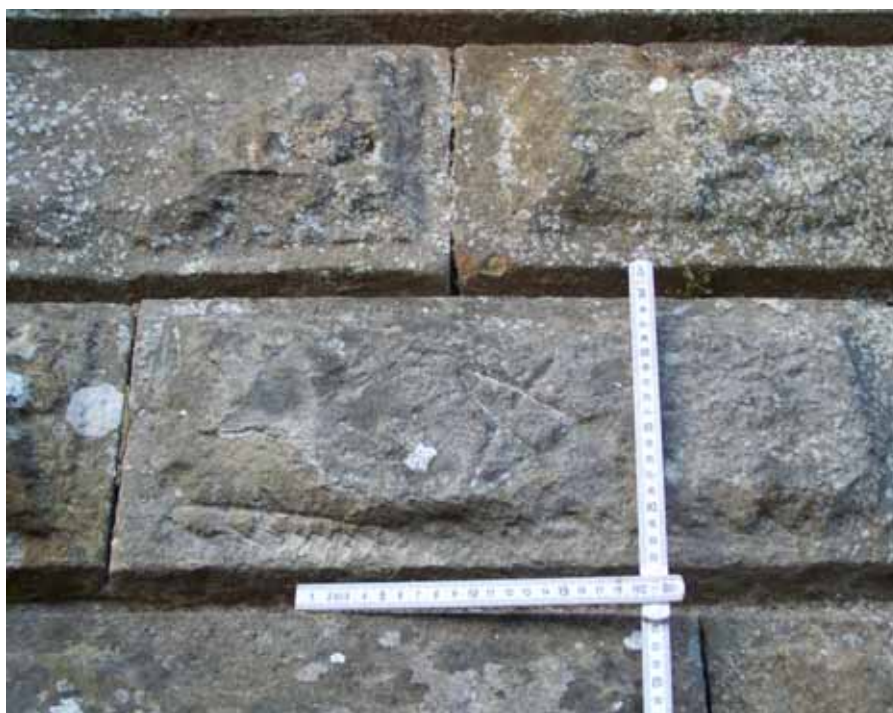
Plate 19: Low Bridge: another mason's mark on mid-nineteenth-century masonry on the south side of the bridge
