DIDSBURY FLOOD STORAGE BASIN, GREATER MANCHESTER

Archaeological Watching Brief Report

August 2009

Environment Agency

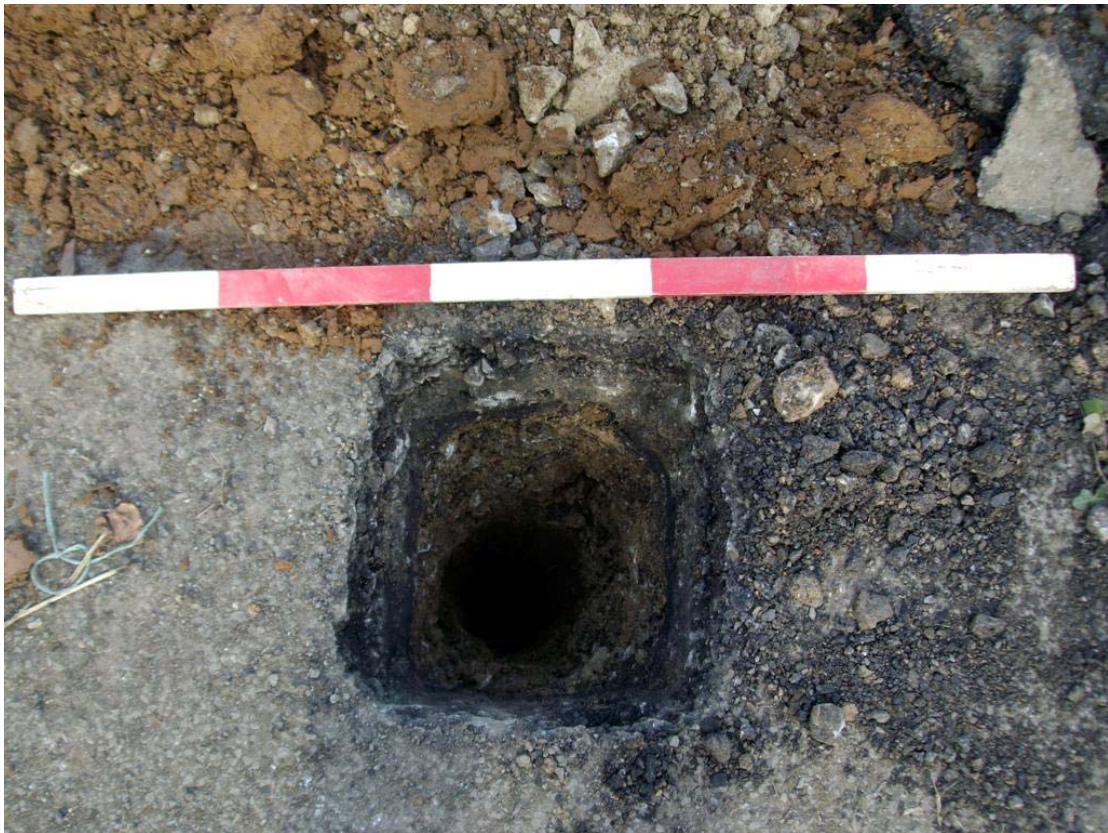
Plate 2: View of WS110

- 3.1.2 WS101 to WS104 and WS110 were excavated initially through tarmac (Plate 2) and hardcore, onto a dark organic silty-clay subsoil **101**. This subsoil was present across the whole site, except for WS104, WS106 and WS108, with little variation, and was seen to contain modern building material and general refuse; no subsoil was present in WS106 and WS108 and a deposit of mid grey-brown silty-clay with modern brick fragments (**108**) was seen in WS104 below the modern overburden. WS103, WS104 and WS110 were situated on the paths surrounding the allotment, and WS101 and WS102 were within the Rugby Club car park. WS111 was also situated in the car park but did not contain any surfacing material. In the remainder of the pits the subsoil was overlain by a dark brown topsoil, **100** (Plate 3).
