Sandygate Mills, Weavers' Triangle, Burnley

Heritage Appraisal

September 2010

Burnley Borough Council

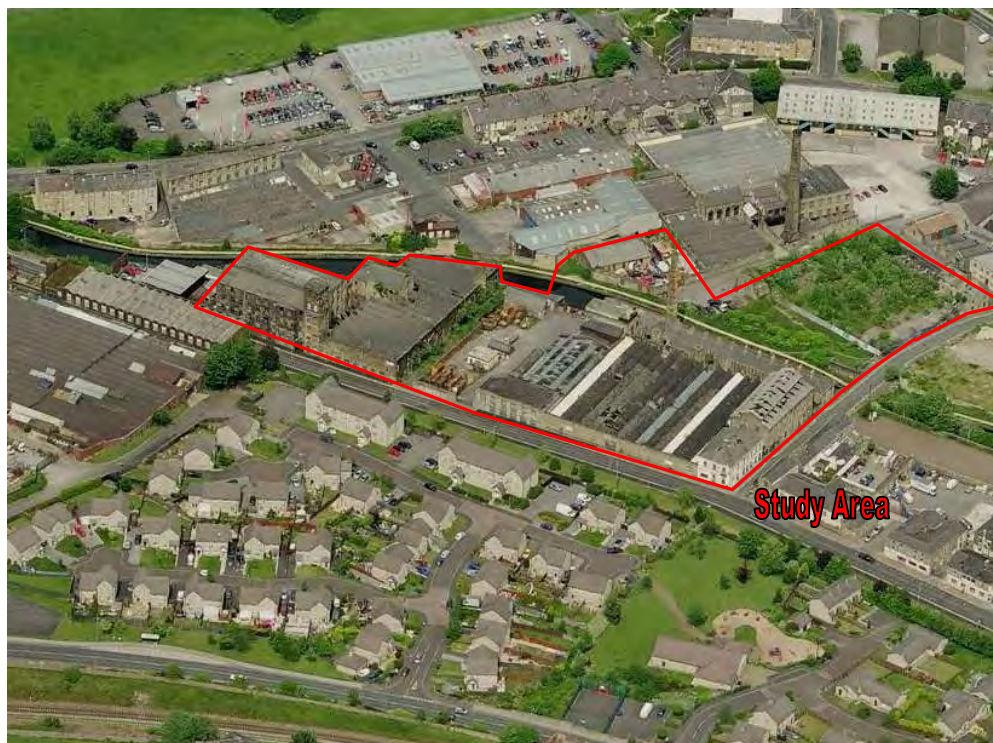
Plate 1: Recent aerial view of the study area

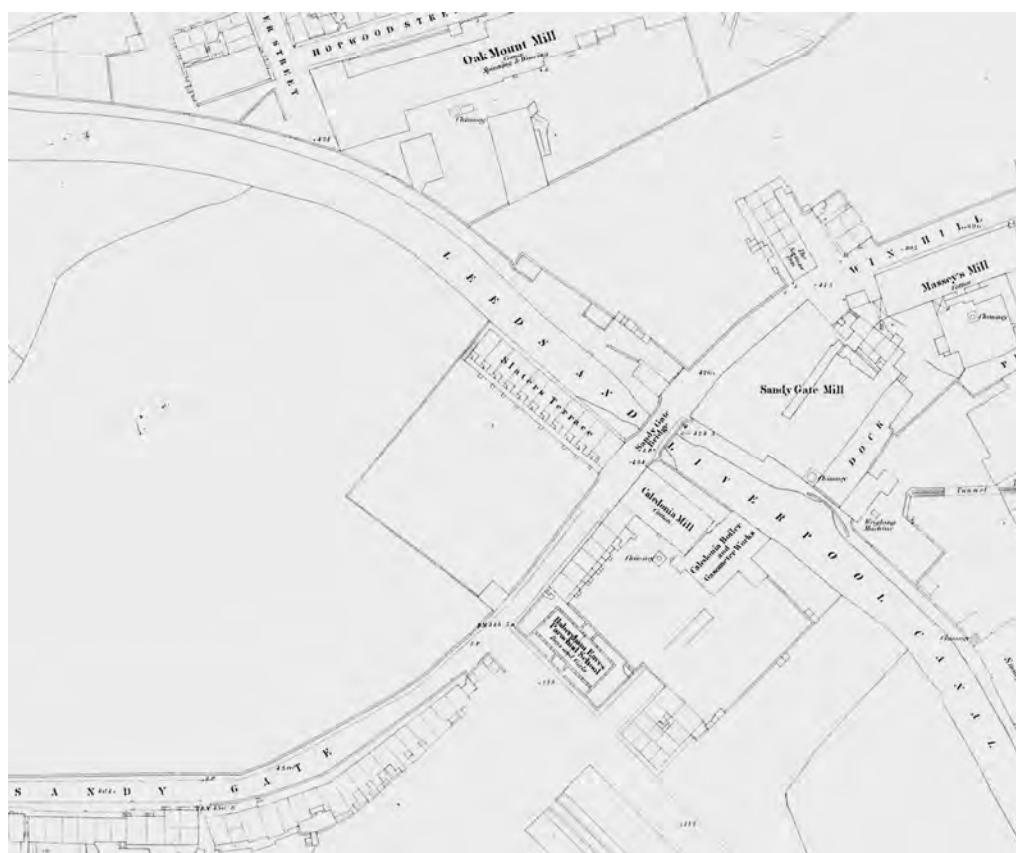
Plate 2: Extract from the Ordnance Survey 60": 1 mile map of 1851

- 3.2.2 The first available published map to show the study area is that produced by the Ordnance Survey in 1848, at a scale of 6": 1 mile. This was based on a survey completed in 1844, and affords a high degree of accuracy. This shows some development of the study area relative to Fishwick's map. The detail shown on the 1848 Ordnance Survey map is replicated on the 1851 edition, which was produced at a scale of 60": 1 mile (Plate 2).

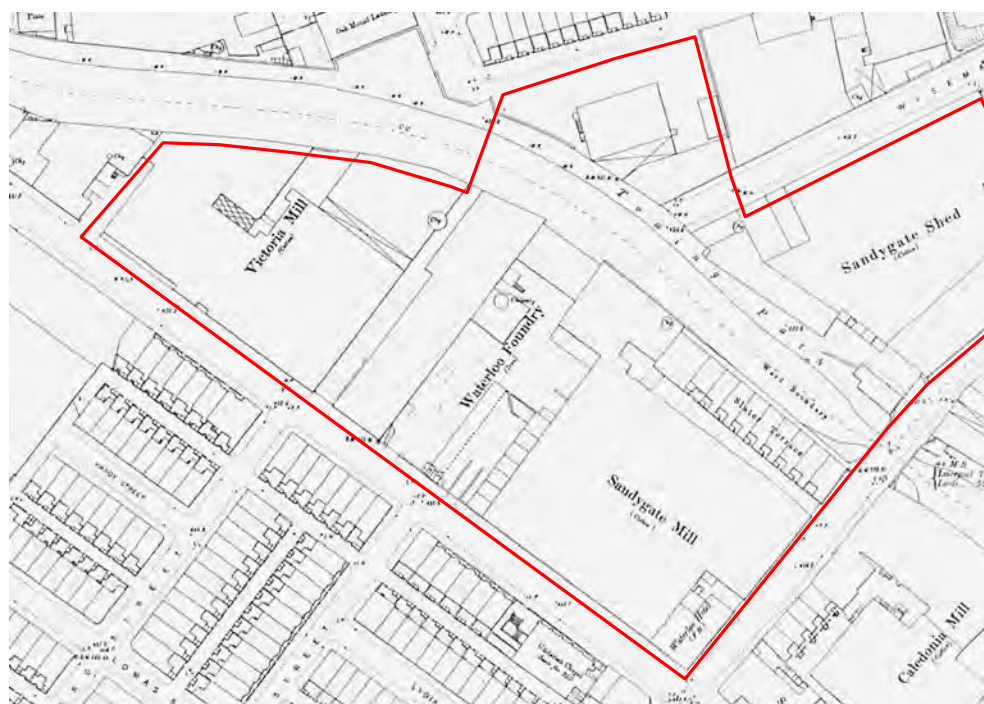
Plate 4: Extract from the Ordnance Survey 1:500 map of 1892

- 3.2.4 The next edition of Ordnance Survey mapping for the area was published in 1892 at a scale of 1:500 (Plate 4); the survey was also published at 1:2500 in 1894. This shows the study area to have been developed fully, containing the core of the present buildings.

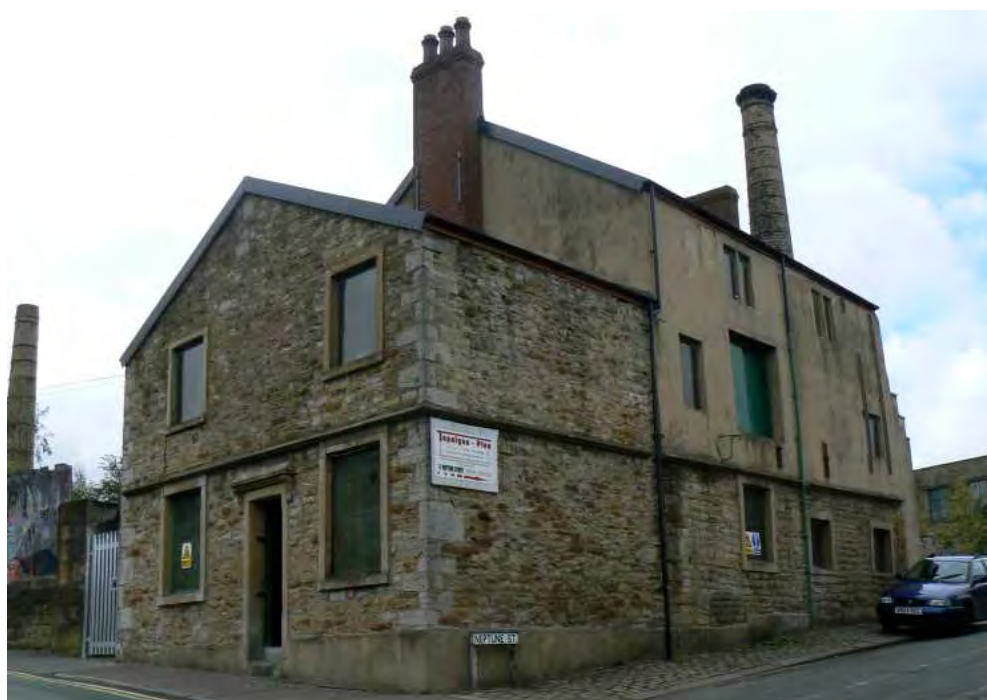
Plate 6: Neptune House, viewed from the south-west

- 4.2.2 **Description:** Neptune House was originally a three-storey structure plus a cellar, with a two-storey addition fronting onto Sandygate (Plate 6). The earliest fabric appears to be of brick construction, with a stone façade below a string course at ground-floor level, suggesting that the present rendered external wall finish elsewhere reflects the original appearance of the building. The use of hand-made bricks in buildings is unusual in the area, particularly in those of a late eighteenth- or early nineteenth-century date. Neptune House originally had a stone flag covered timber-framed roof, although this has been replaced recently with temporary corrugated metal sheeting. However, two original wooden trusses survive *in-situ*, which are of a note in that they have two braces on each pitch from the king post to the principal rafter, typical of earlier examples of such trusses (Brunskill 1994, 149).

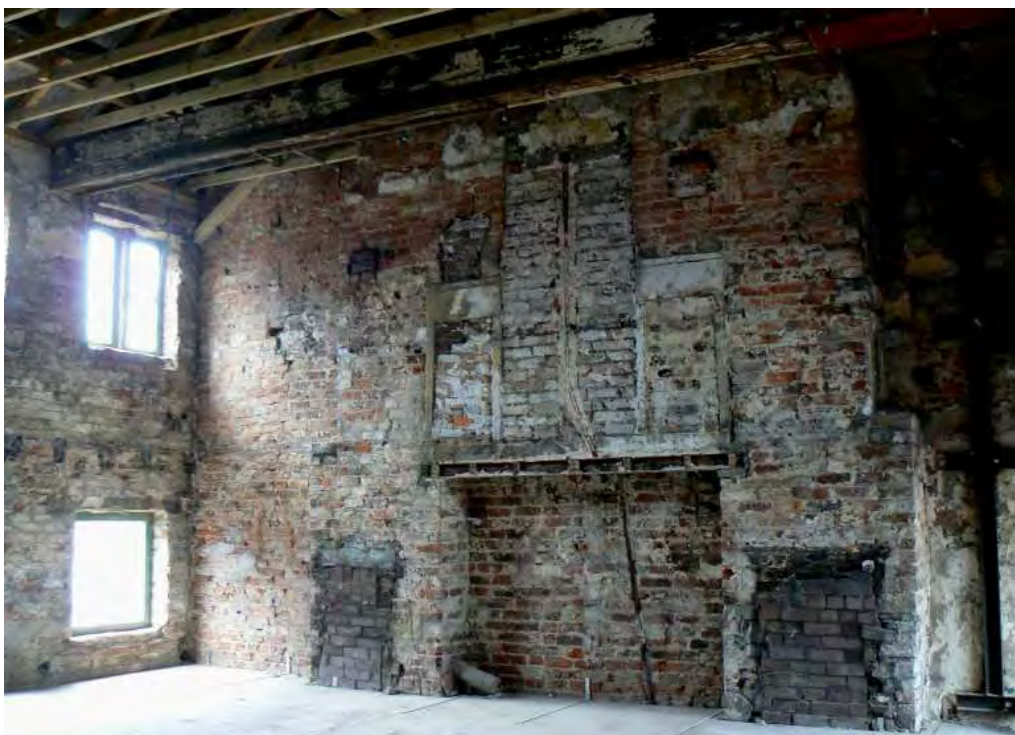
- 4.2.3 The surviving fabric provides physical evidence for several developmental phases. The taller, north-western portion is clearly the oldest part of the building, where evidence for at least 11 windows, including an oriel window unusual in this type of structure, is visible above the ground floor. Many of the windows have been blocked with brick, although the large number of windows suggests that the upper part of the building may have been used at some point as a domestic workshop. Although originally a three-storey building, the upper floor has been removed, and the level of the first floor raised, leaving it open to the rafters. The north-east-facing elevation on the first floor also incorporates a taking-in door at present floor level, suggesting that the building had a warehousing function in a later stage of its development.

Plate 7: View across the upper floor in the oldest part of Neptune House

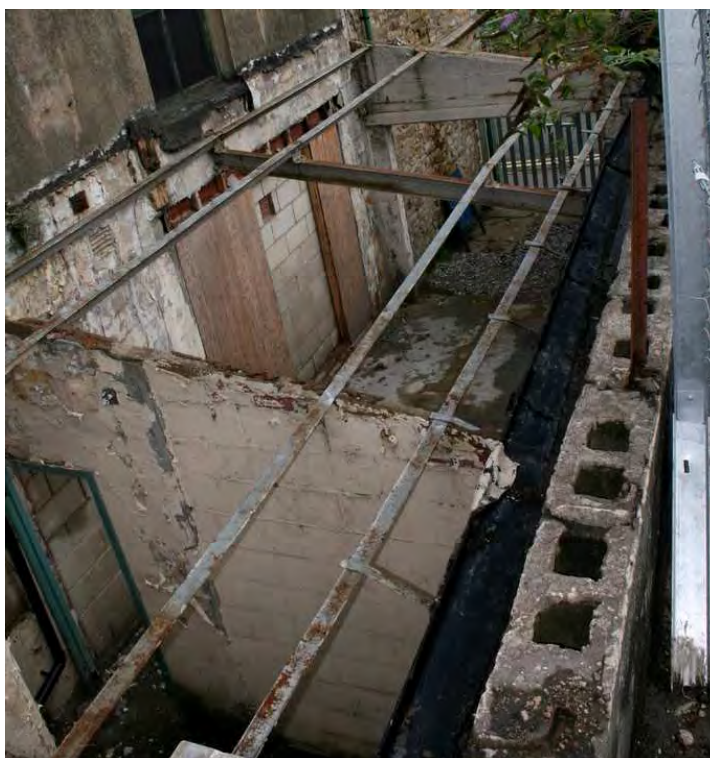
- 4.2.7 Neptune House is thus considered to be of *Some Significance*, although elements of the oldest portion to the rear of the building could be seen to be of *Great Significance*. Conversely, the twentieth-century outshut on the western side of the building may be considered as a *Negative element* (Plate 8).

Plate 8: Clinker-block outshut to Neptune House

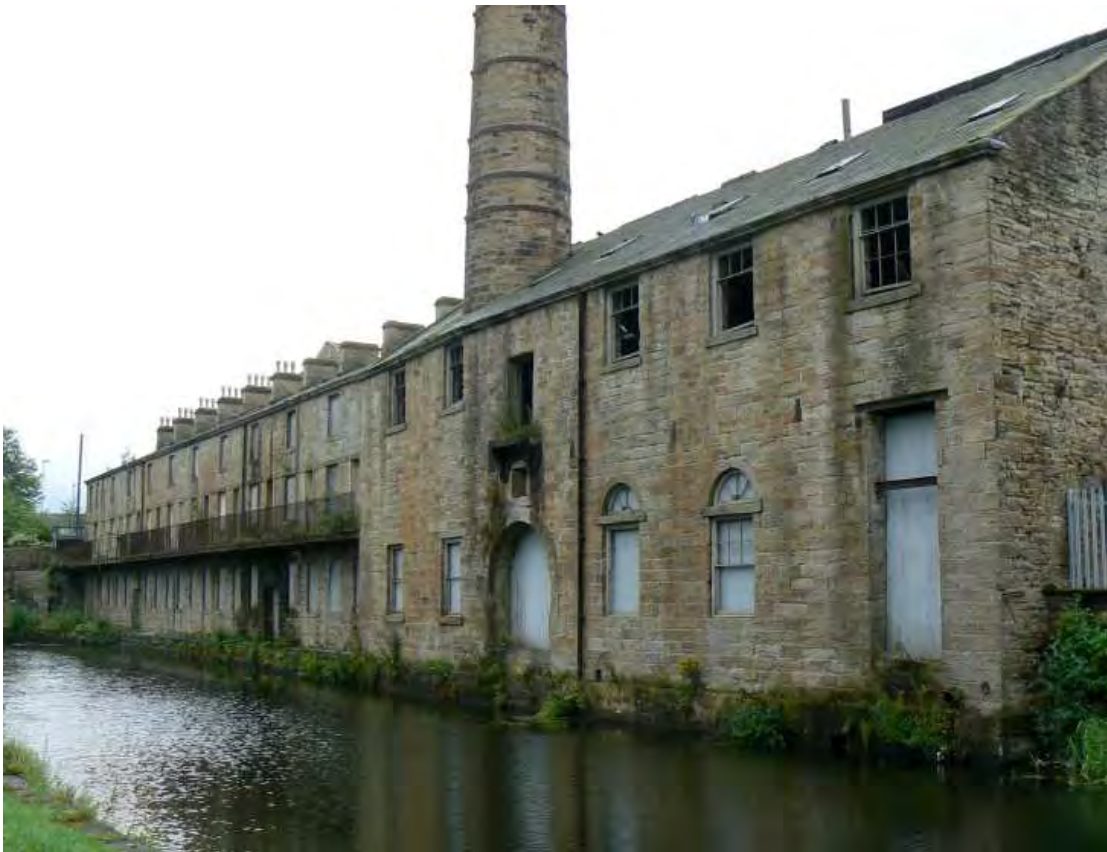
Plate 9: Iconic view of Slater's Terrace and adjacent warehouse, overlooking the canal

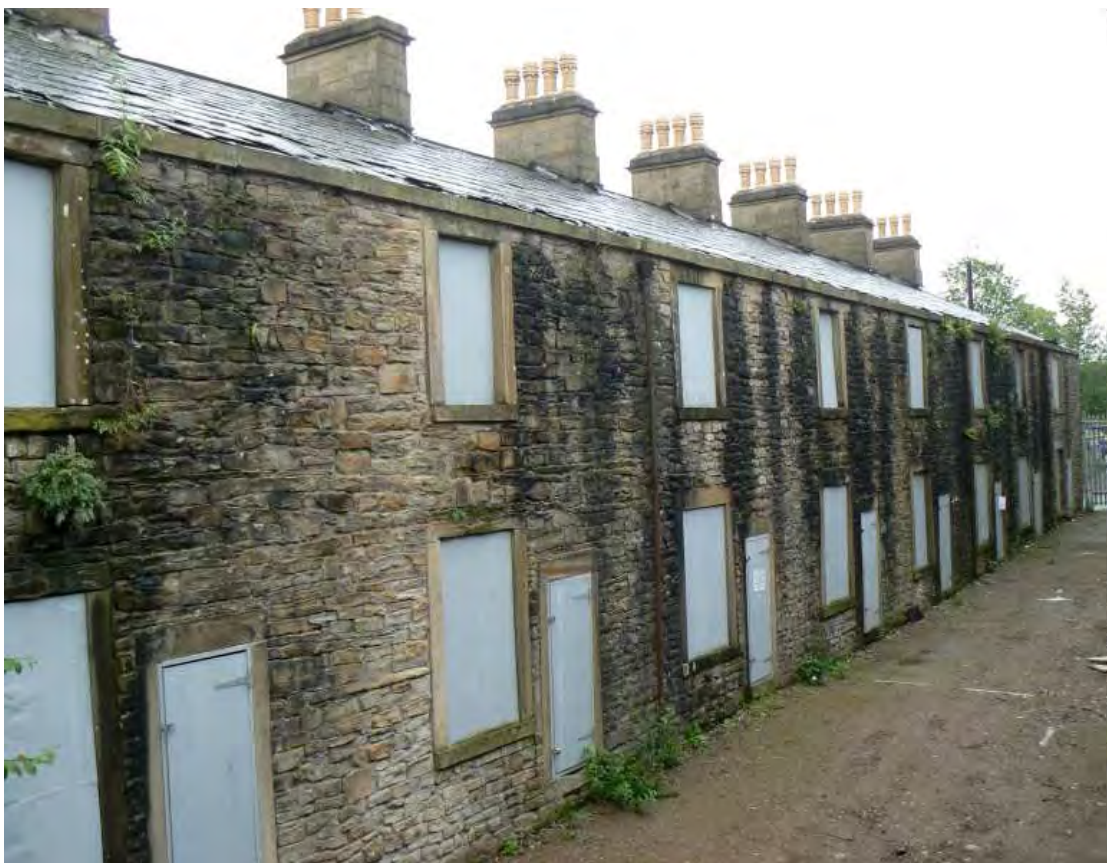
Plate 10: View along the rear of Slater's Terrace, looking towards Sandygate

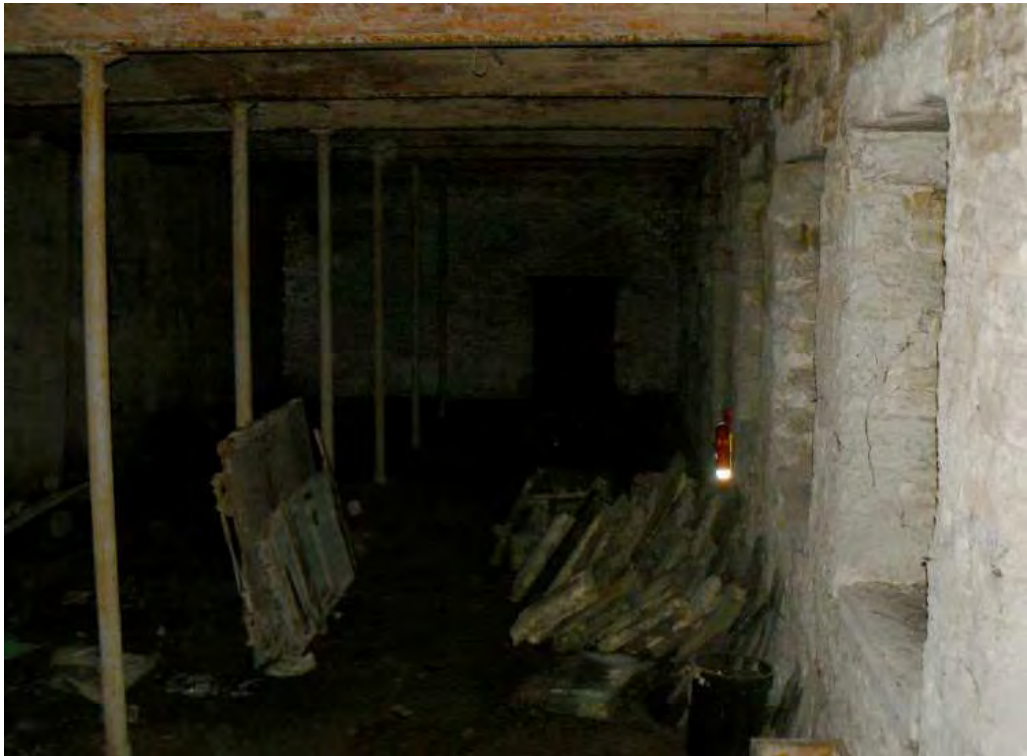
Plate 11: Interior of the warehouse on the lower ground floor of Slater's terrace

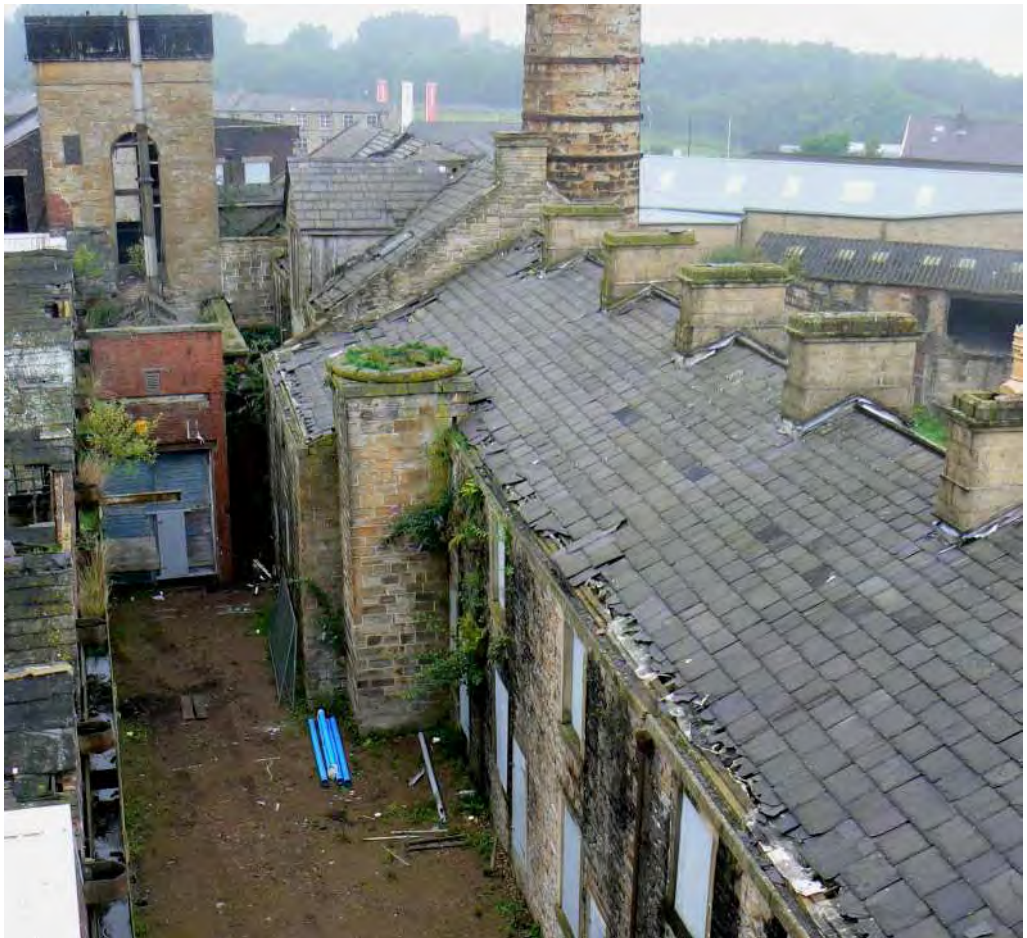
- 4.3.13 The engine house is surmounted by an iron-panelled water tank (Plate 12), which is presumably an original feature. Internally, the foundation bed for the steam engine has been removed, although the building retains physical evidence for the engine it once housed, including a flywheel guard and elements of the power transmission system.

Plate 12: The rear of Slater's Terrace, abutted by the original chimney. The original boiler house was situated behind the chimney, whilst the associated engine house may have occupied the yard area in front of the late, brick-built boiler house.

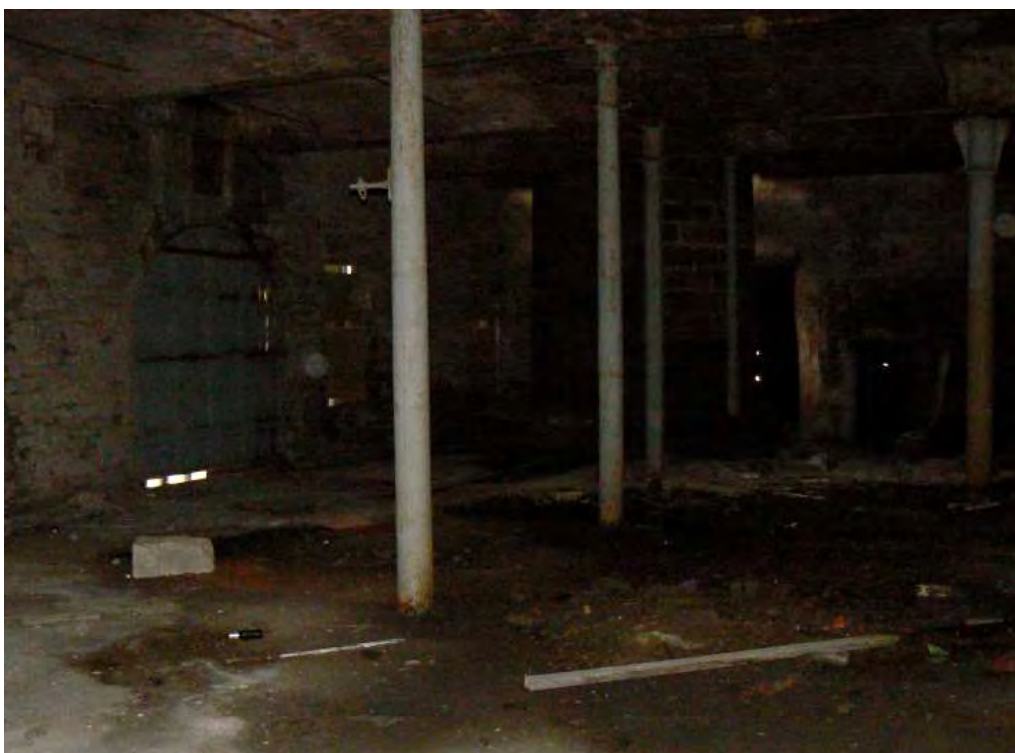
4.3.17 The warehouse adjacent to Slater's Terrace has very high *Vulnerability* and *Group value* ratings (Plate 13). Its status as a canal-side warehouse does not lead to a high *Rarity* value *per se*, although this is increased from its 'documented' conversion to a boiler house, and the stone-built chimney rising through its roof. There is almost complete *Survival* of the chimney and the shell of the warehouse, including the cast-iron columns and large brick arches, although there is little, if any, surviving physical evidence for its use as a boiler house. *Documentation* for this building is lacking, and its precise date, chronology, and functions do not appear to have been established with complete confidence. This factor perhaps increases the *Potential* of the building as an archaeological/historical resource.

Plate 13: The ground floor of the warehouse adjacent to Slater's terrace

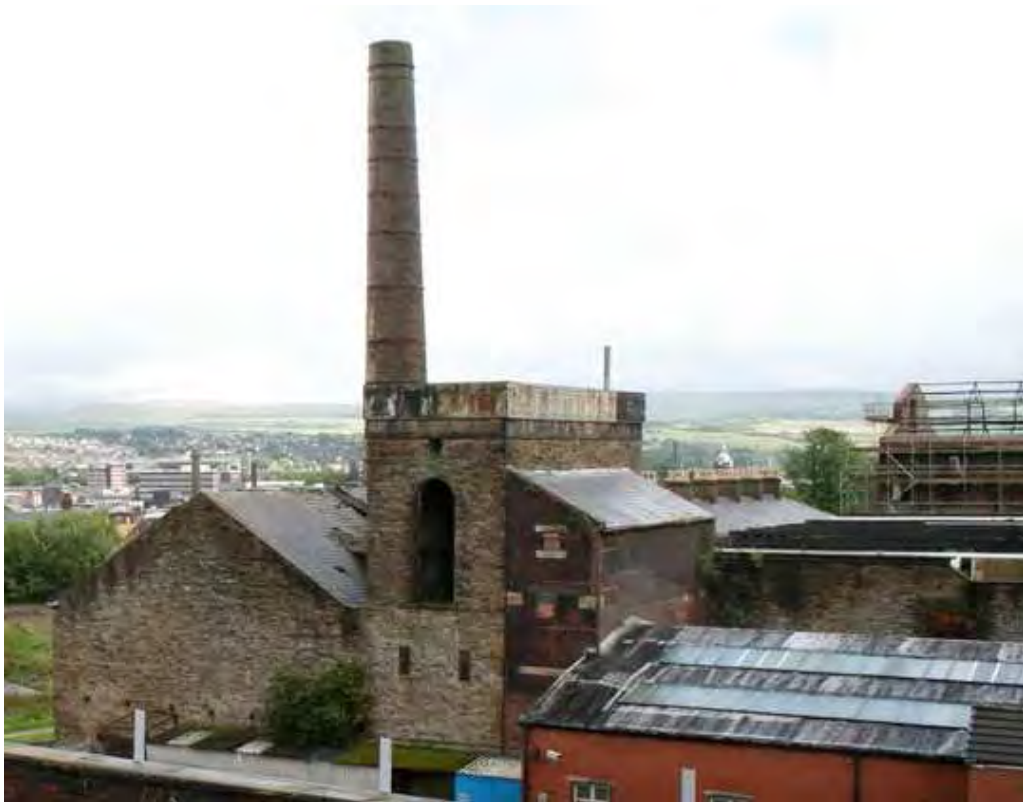
4.3.18 The engine house to the rear of Slater's Terrace provided the power to Sandygate Mill, although it may not have been a primary feature of the mill complex (Plate 14). The building retains considerable physical evidence for the engine it once housed, including elements of the flywheel guard and the remains of the power transmission system (Plate 15), together with the iron-panelled water tank on the roof of the building. These features add to the *Period* and *Rarity* value of the engine house, which either housed a developed example of a beam engine, or an early example of a horizontal-type engine. The Sandygate Mill engine house has high *Vulnerability* and *Group value* ratings, although as with the adjacent warehouse *Documentation* for this building is lacking.

Plate 14: The north-west-facing elevation of the engine house

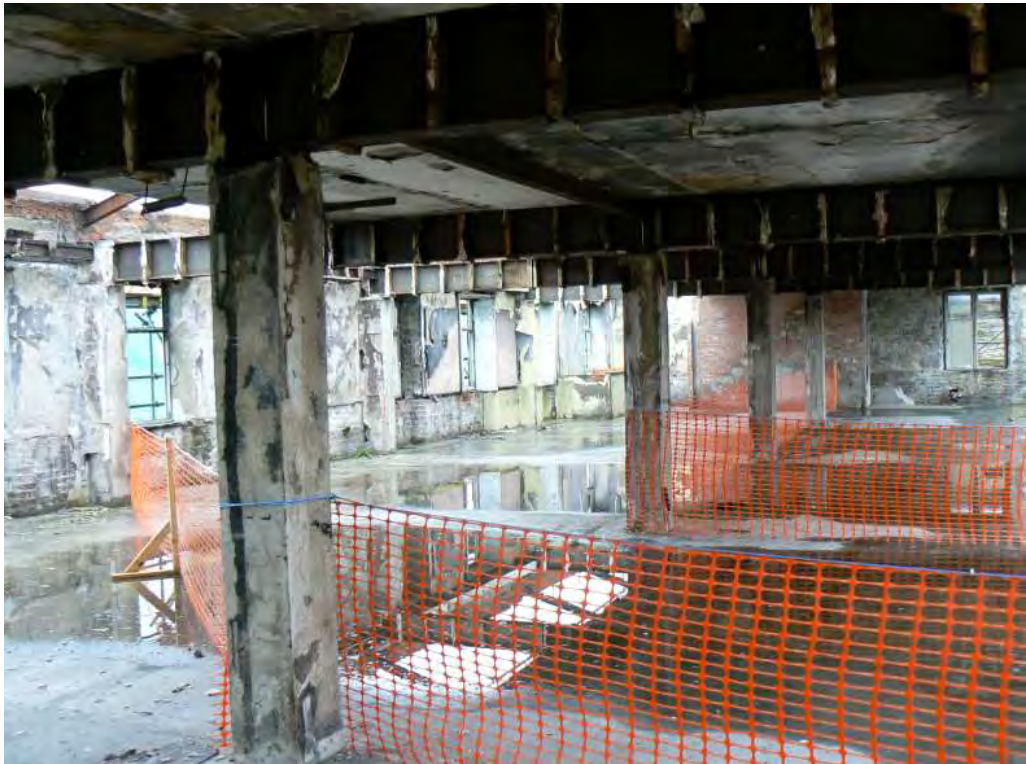
Plate 16: View across the second floor of the former spinning block

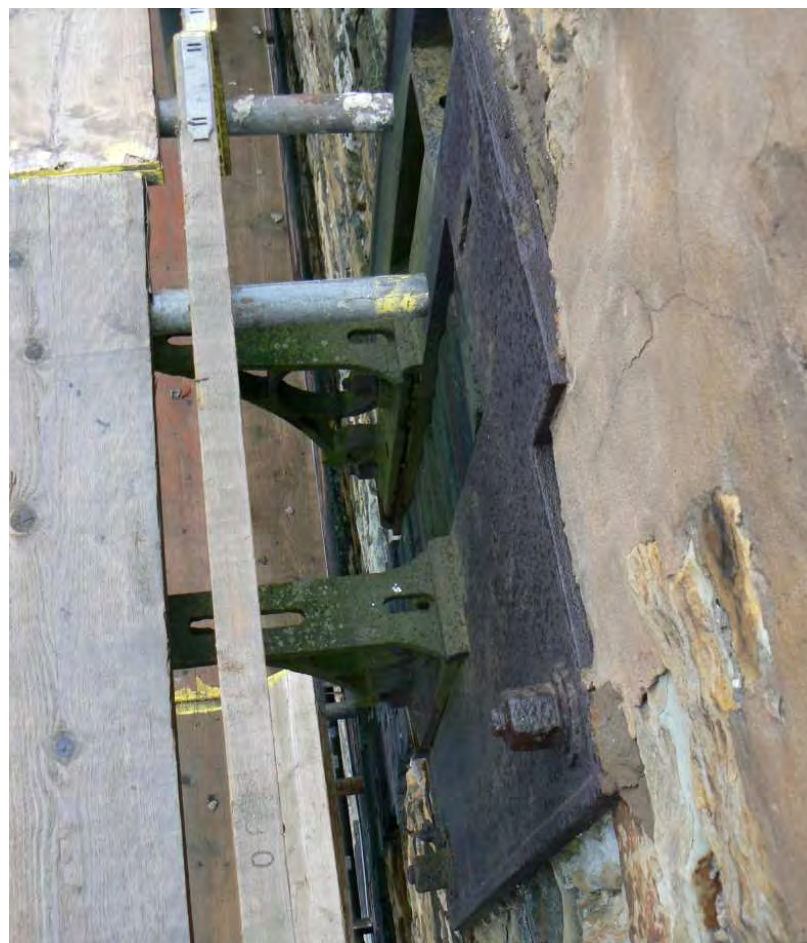
- 4.4.4 The spinning block is a three-storey, stone-built structure fronting onto Sandygate, and forming the south-east part of the mill complex. Erected in 1858-9 as a key component of the original mill complex, it was largely remodelled in the twentieth century with the insertion of an internal steel frame, which supported pre-cast concrete beam and block upper floors (Plate 16). As part of this remodelling, the roof was raised centrally along the line of the former ridge, and rebuilt using steel beams and lightweight trusses clad in asbestos cement sheeting. The building was recently damaged by fire. Despite its remodelling, the building retains some interesting physical evidence for the original power transmission system (Plate 17).

Plate 17: Cast-iron housing, probably for a vertical shaft, affixed to the north-west-facing wall of the spinning block at third-floor level

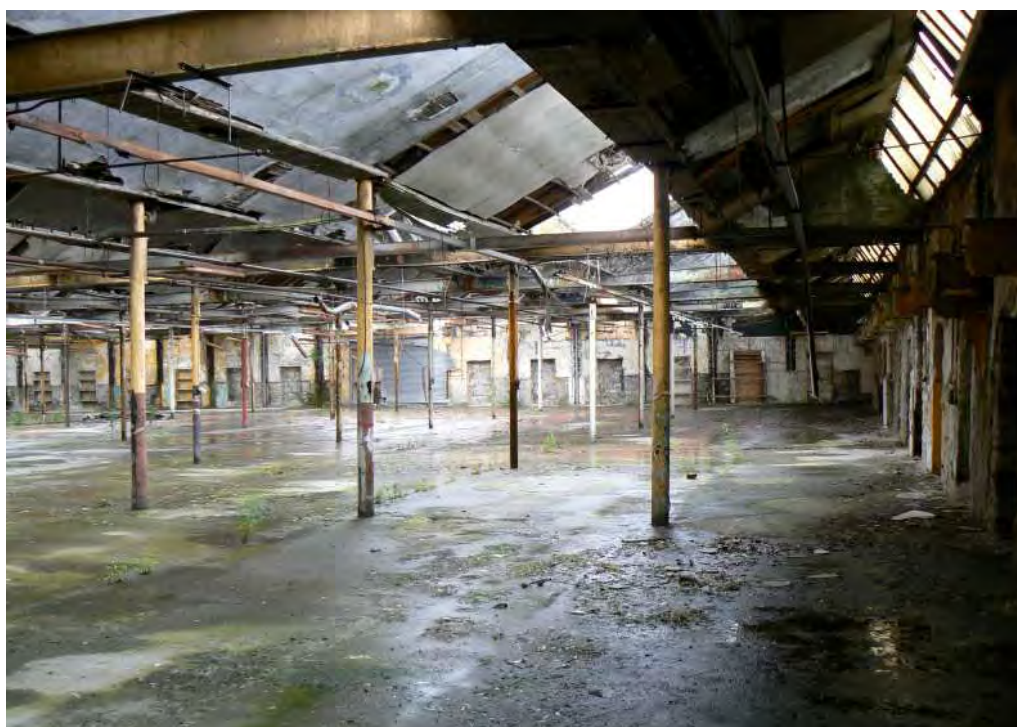
- 4.4.5 The mill complex is dominated by the original weaving block of 1858-9 (Plate 18), which is mainly a single-storey structure, although a narrow warehouse/workshop lies below the north-eastern part of the building. Despite recent fire damage, the weaving shed survives largely intact and retains important evidence for its original layout and the power transmission system (Plate 19). The north-eastern part of the shed was rebuilt and extended slightly in the 1920s over the warehouse/workshops that face the rear of Slater's Terrace, and now form a partial basement to the weaving shed. It is possible that this structure originated as a two-storey warehouse, which was reduced in height before the weaving shed was extended to the north-east; the stone-built rear wall of this basement almost certainly represents part of the original building.

Plate 18: The weaving shed, showing the twentieth-century extension in the foreground

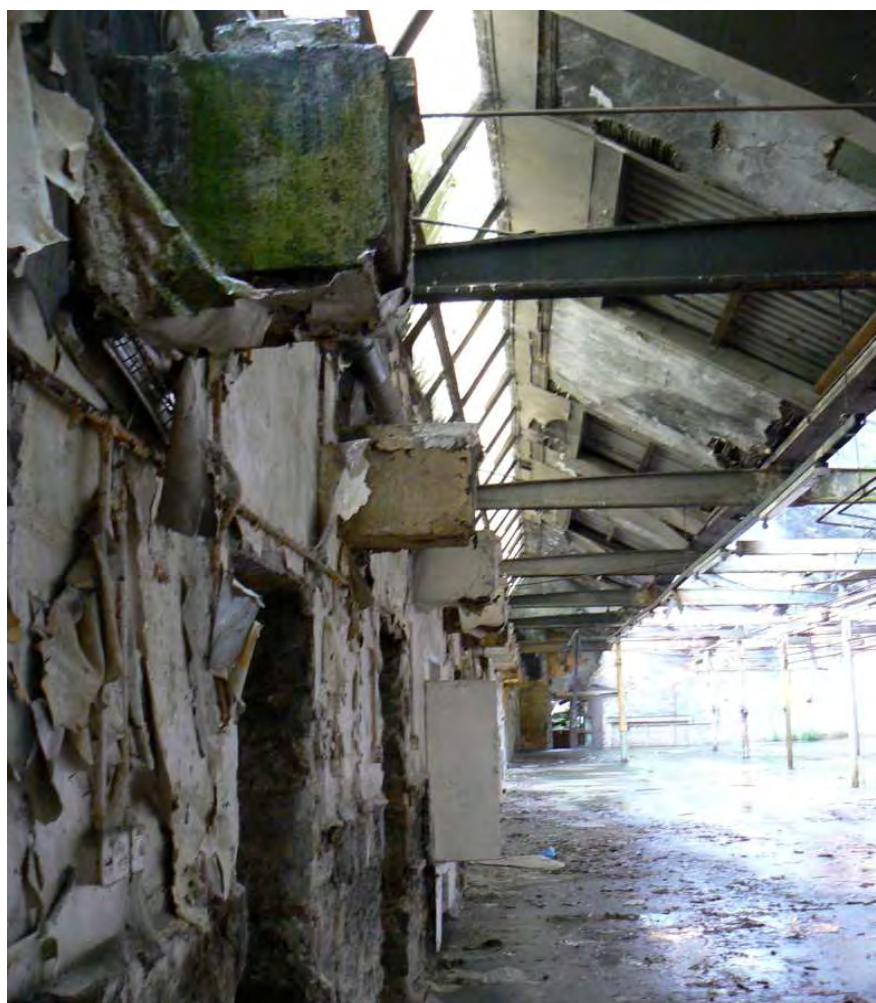
Plate 19: View across the weaving shed, showing the lineshaft bevel-gear housings

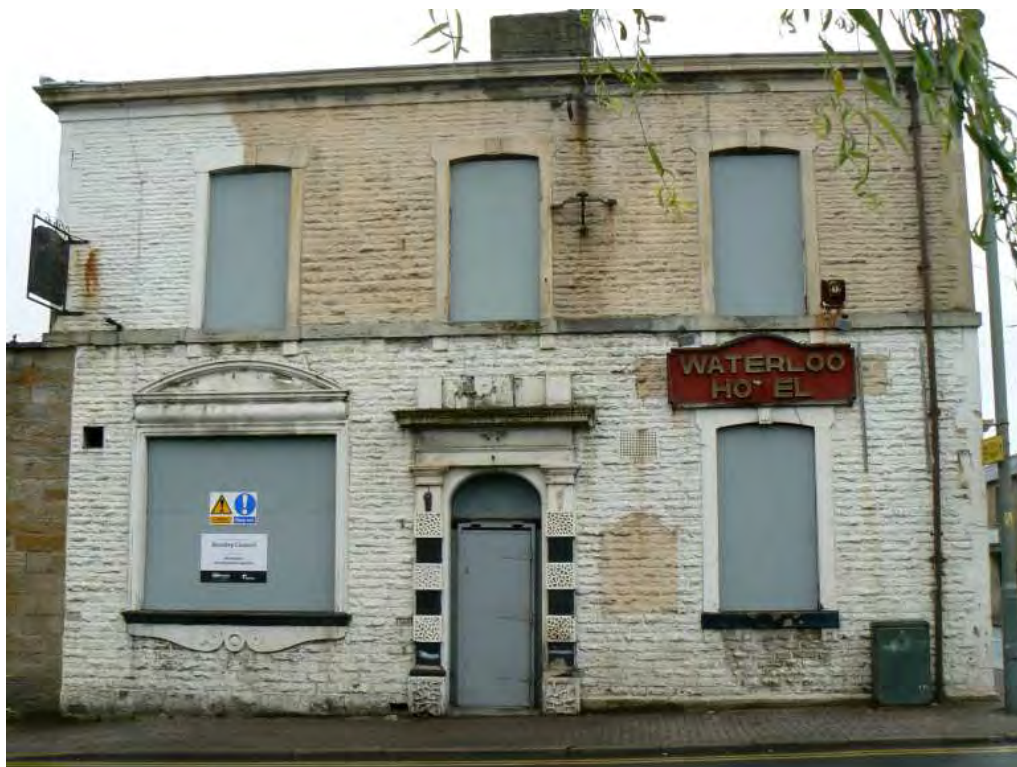
window above the weaving shed in the north-western elevation. Whilst the bar area has been remodelled, possibly on several occasions, the remainder of the structure may retain its original layout, although it was recently badly damaged by fire.

Plate 20: The Trafalgar Street elevation of the Waterloo Hotel

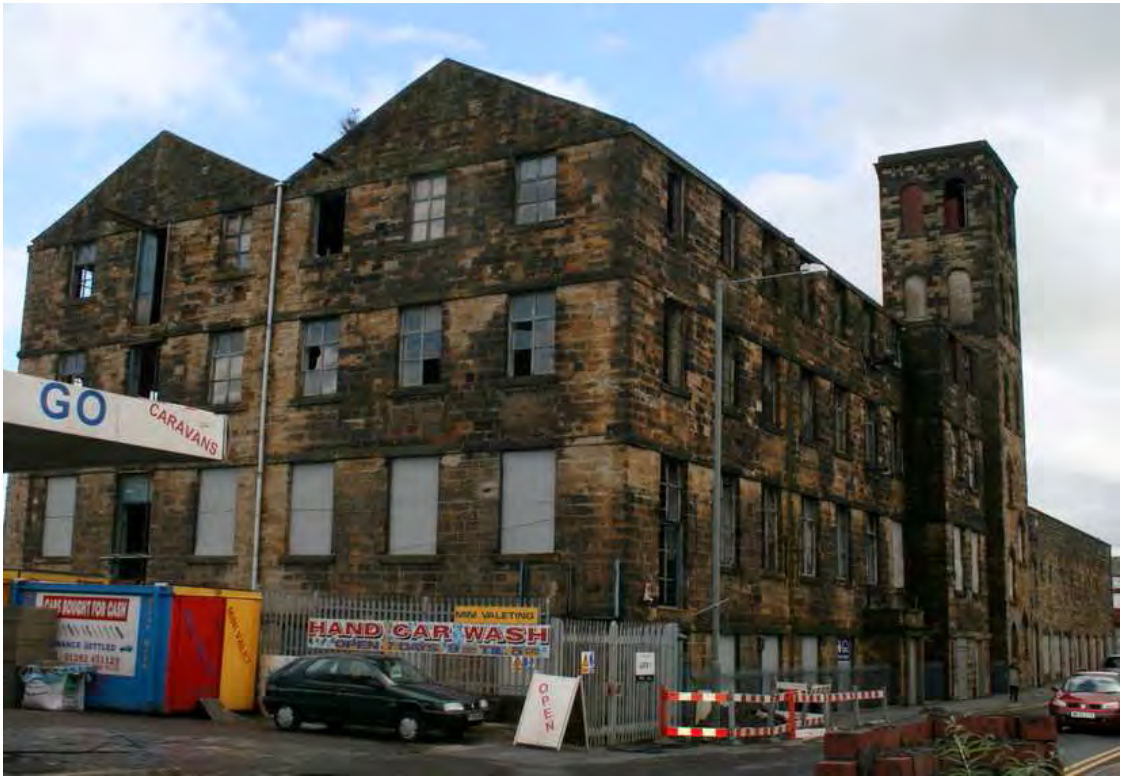
Plate 21: Victoria Mill from Trafalgar Street

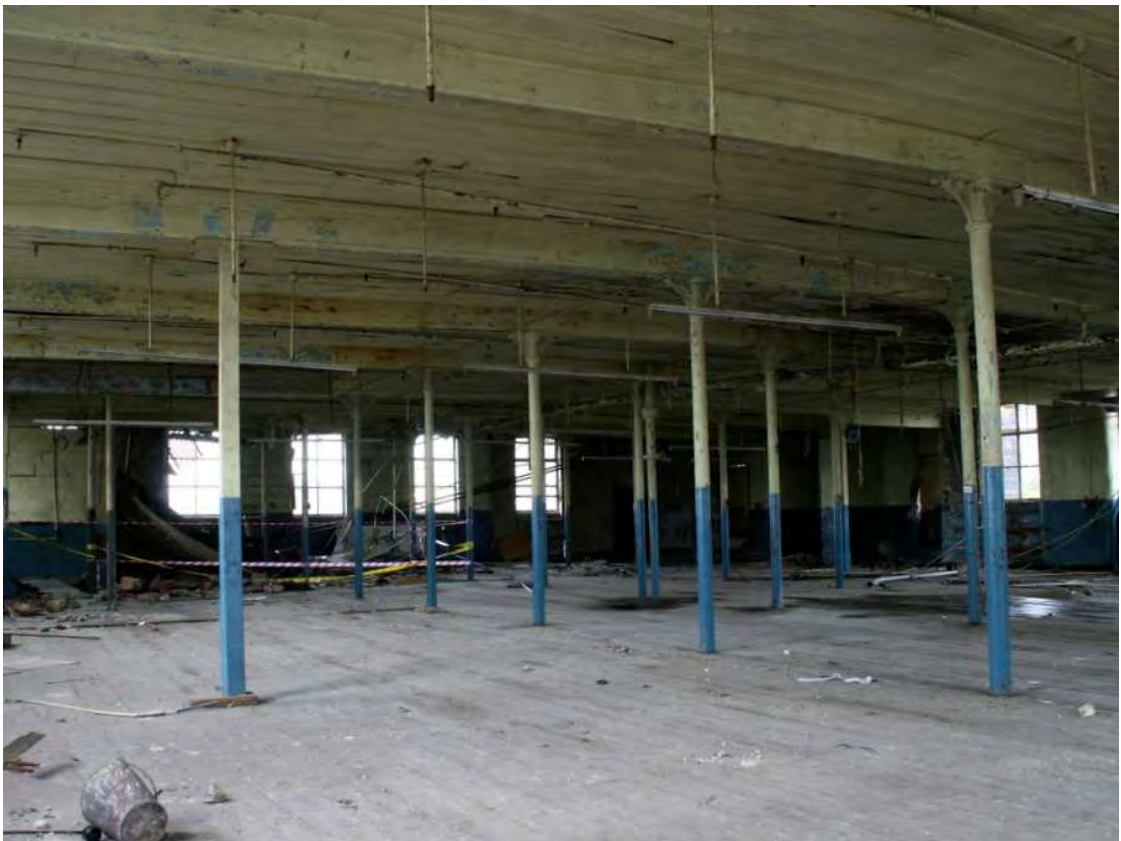
Plate 22: Second floor in the spinning block, showing density of columns and timber props

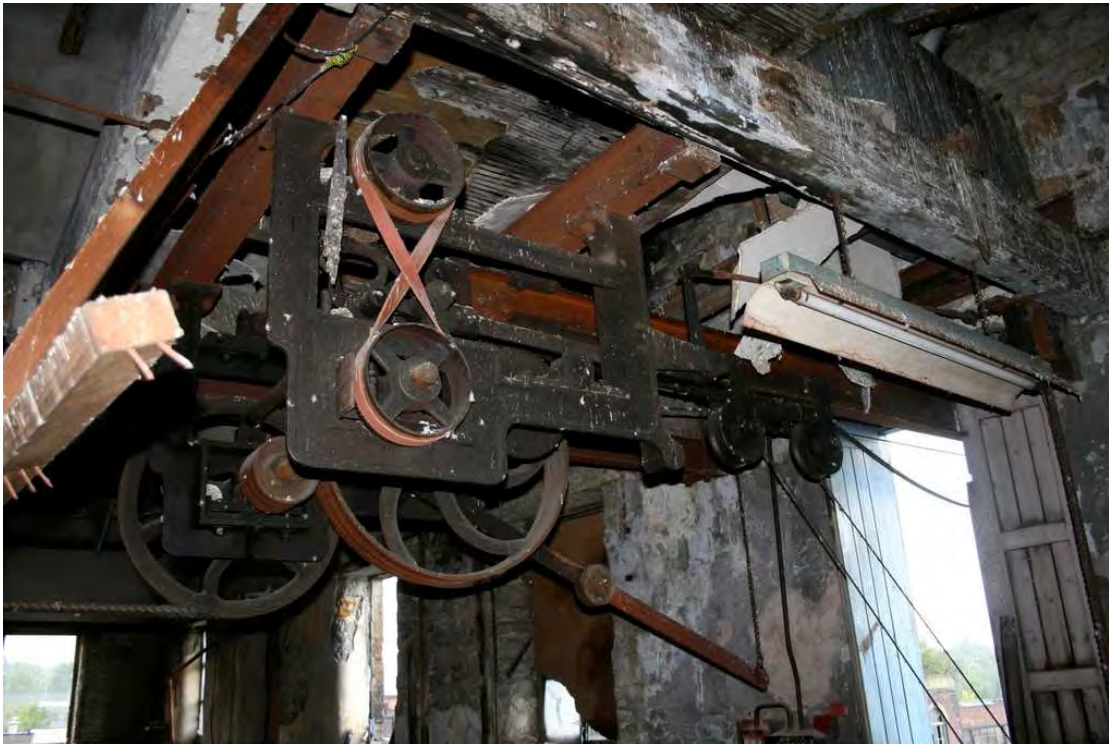
- 4.6.7 Power appears to have entered the spinning block at second-floor level at the north end of the east wall, from where it was transferred to the upper floor. The original privy tower was retained, with access inserted from the new structure. At top floor level, however, an alternative access to the privy was afforded from the adjacent bay, via a cast-iron balcony (Plate 23), although the reason for this remains unclear.

Plate 23: The original hoist, situated on the top floor of the spinning block

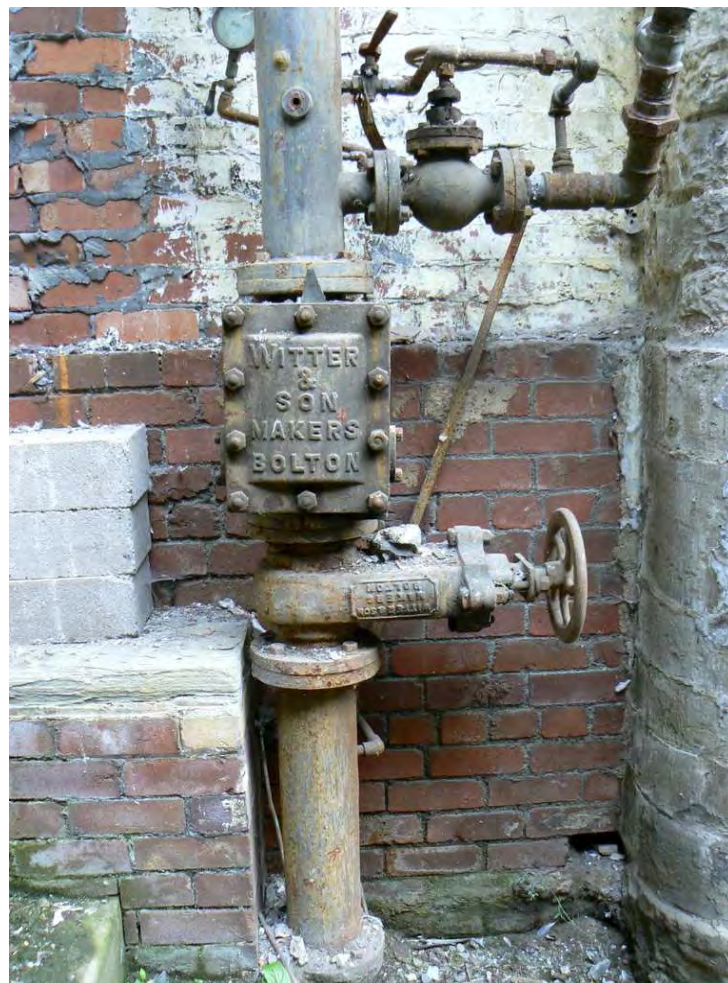
Plate 24: The main valve for the sprinkler system

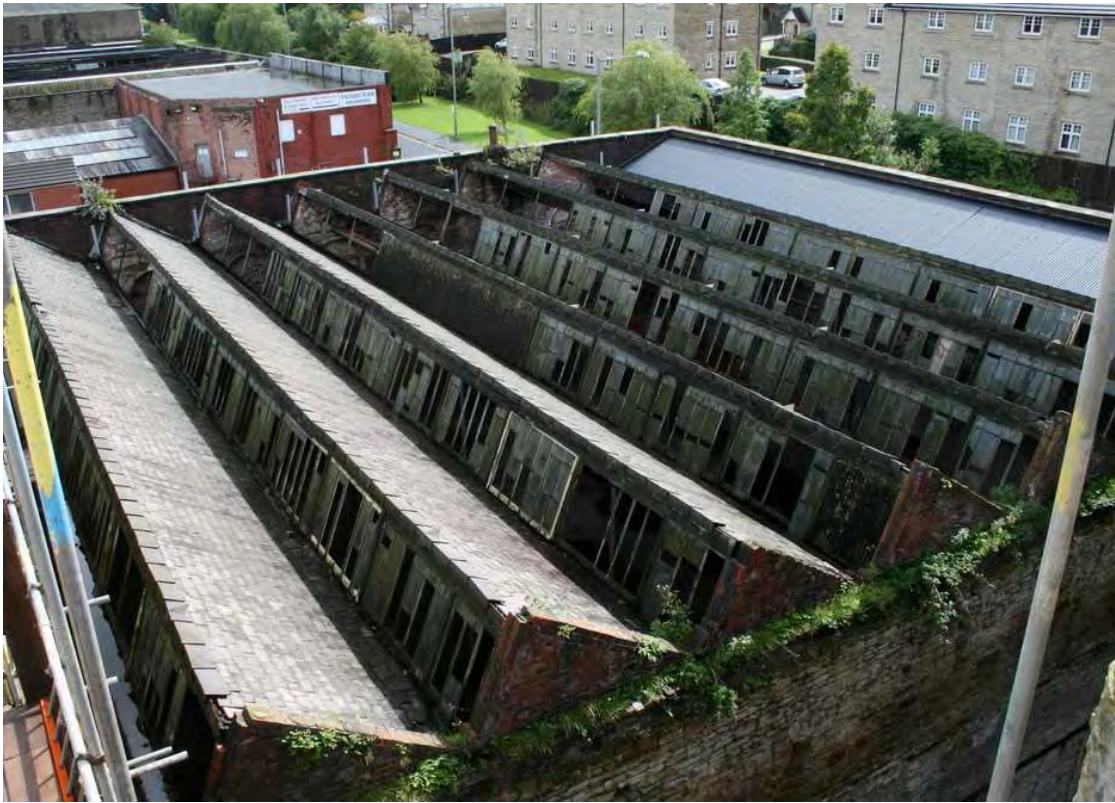
- 4.6.11 The first floor of the structure comprises a large weaving shed (Plate 25), with north-light multi-span roofing, supported on joists that are probably of wrought iron. These are carried on cylindrical cast-iron columns to the south and east of the engine house, each column having lineshaft mounting surfaces on their eastern side (Plate 26), whilst in the northern part of the shed, the valleys were carried on transverse whale-backed cast-iron beams, supported by similar columns to alternate bays, thus increasing the floor area available for looms.

Plate 25: The first-floor weaving shed

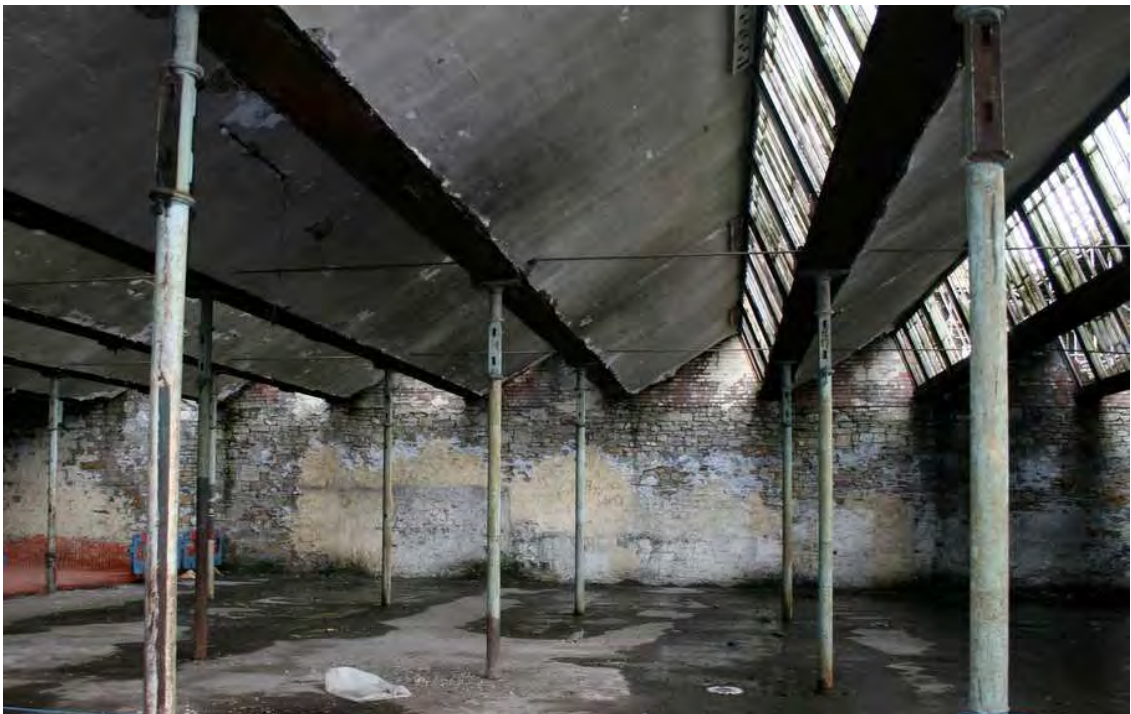
Plate 26: The interior of the weaving shed in Victoria Mill, showing the lineshaft mounting surfaces on the cast-iron columns

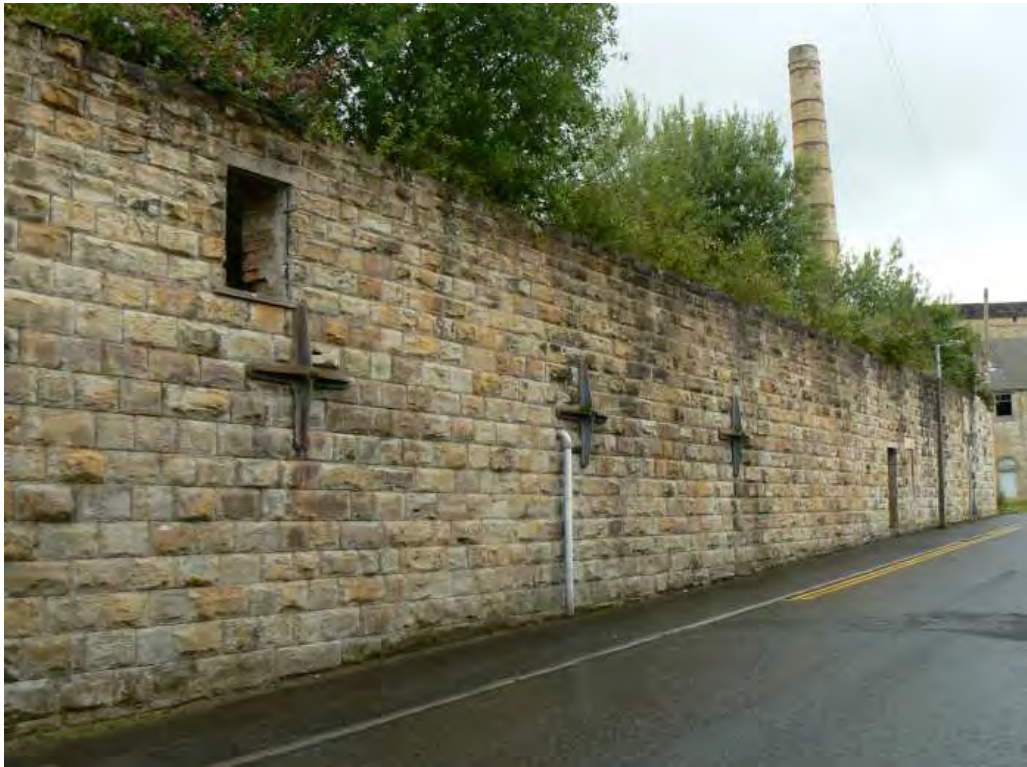
4.7.2 ***Description:*** the site of the large weaving shed has been largely cleared, although the north-western stone-built wall survives along the south side of Wiseman Street (Plate 27).

Plate 27: Surviving elements of Sandygate Shed, looking south-west along Wiseman Street

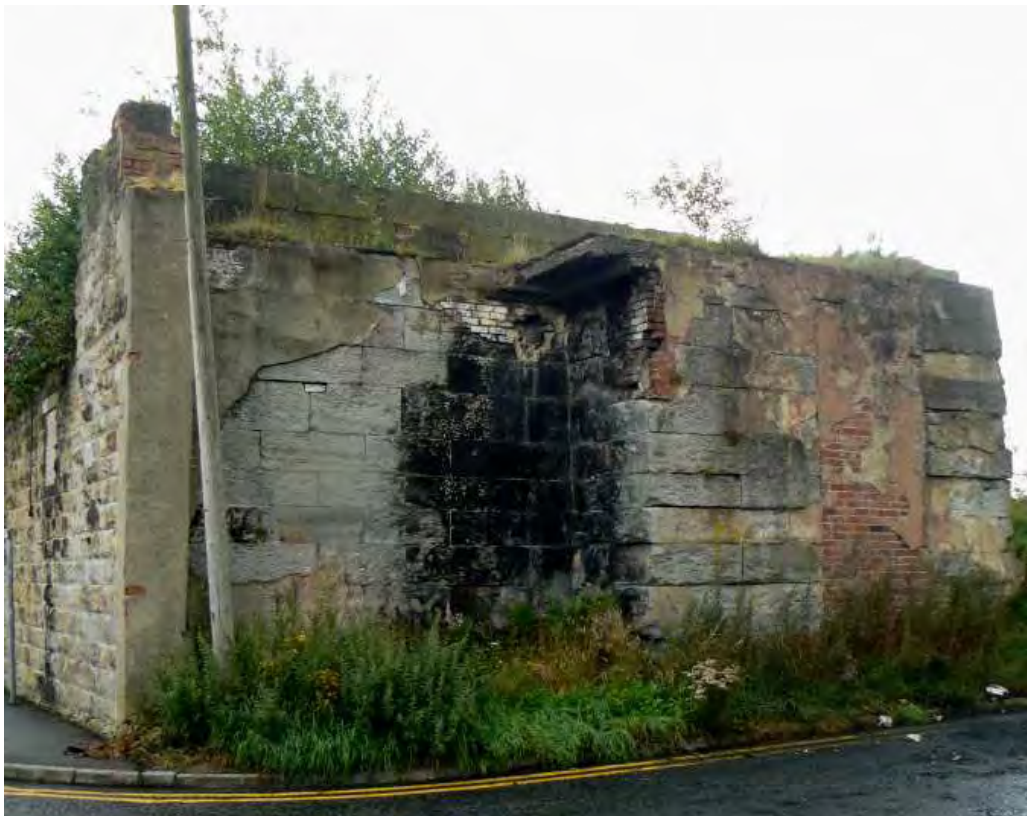
4.7.3 The remains of the demolished engine house survive in the south-western corner of the mill site (Plate 28). These remains comprise huge stone ashlar blocks that formed the foundation bed for the mill steam engine; some of these blocks incorporate original tool marks representing rare evidence of engineer-erector's marks (Plate 29). Whilst incomplete, the surviving elements of the engine bed form a tall and imposing structure, which incorporates some evidence for the system of power transmission from the engine to the machinery in the weaving shed. These remains are integral to the surviving wall of the weaving shed along Wiseman Street.

Plate 28: Surviving elements of the engine house for Sandygate Shed
