Sandygate Mills, Weavers' Triangle, Burnley

Heritage Appraisal

September 2010

Burnley Borough Council

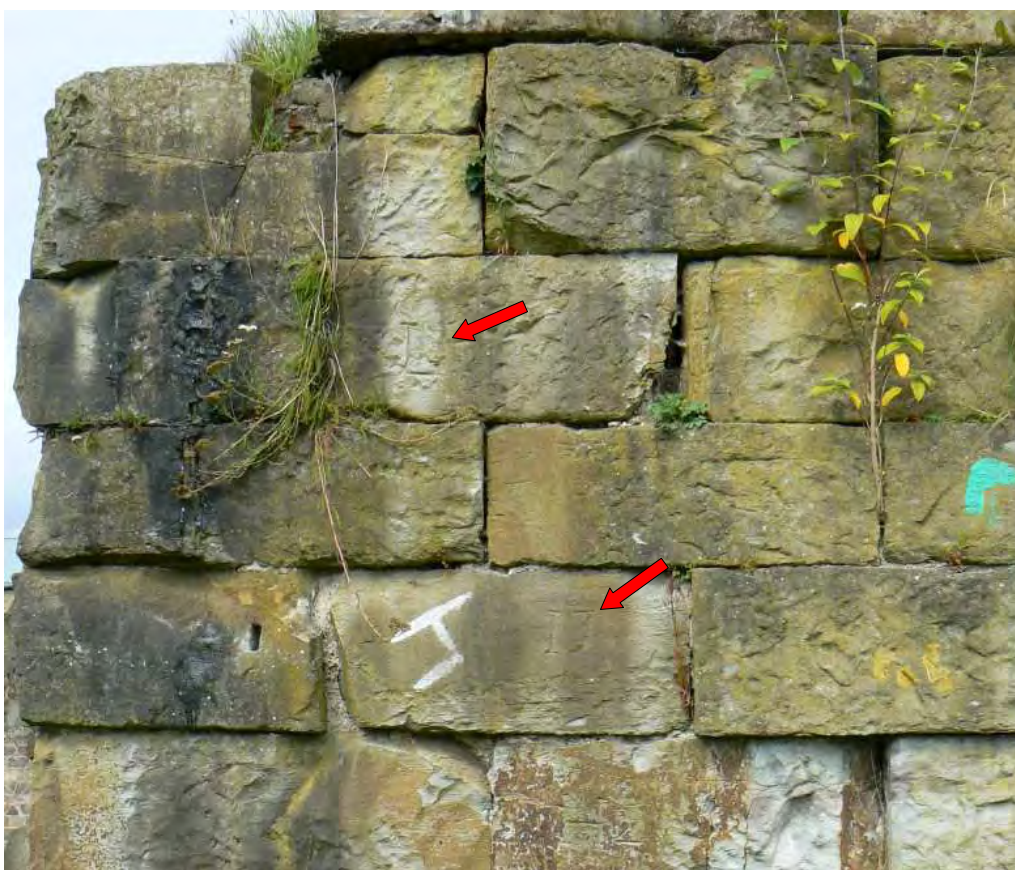
Plate 29: Engine-erector's marks in the foundation bed masonry

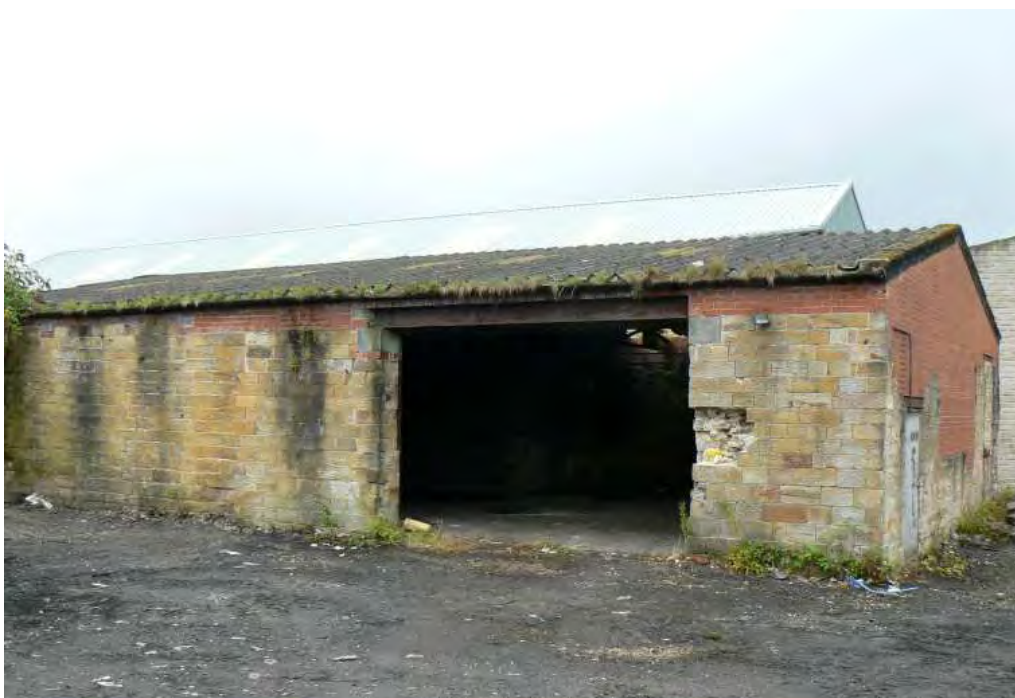
- 4.8.3 The surviving fabric testifies several developmental phases in the surviving building, and provides some evidence for power transmission through the approximate centre of the structure. However, whilst some original fabric survives, represented by the stone-built elements, the building has been subject to considerable remodelling, which detracts from an understanding of the intended function of the building.

Plate 30: Surviving building in the Wiseman Street complex

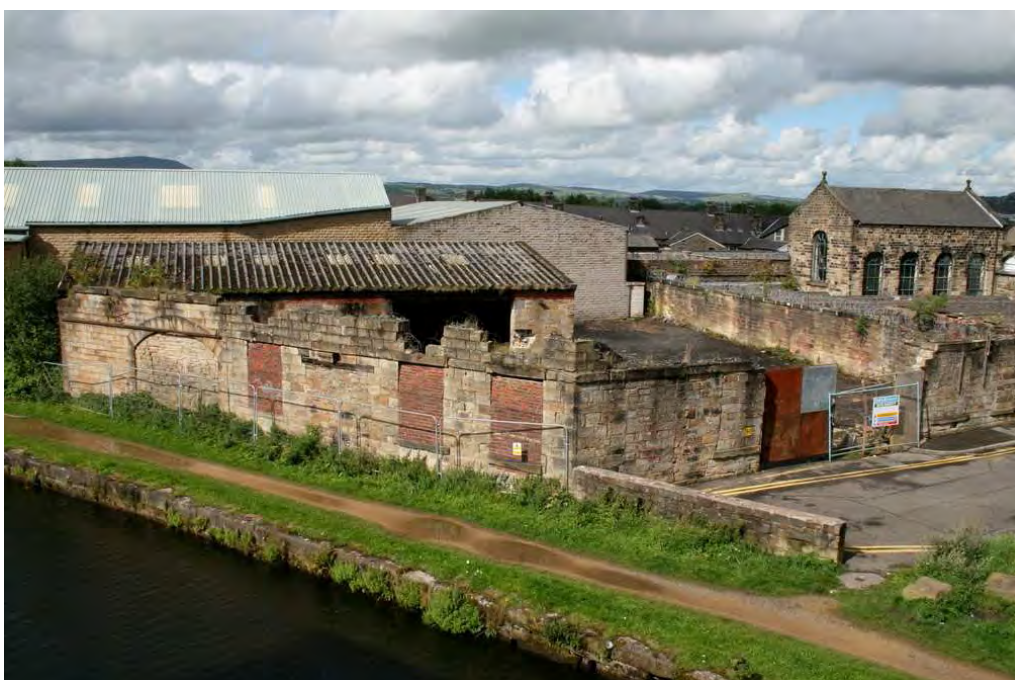
Plate 31: Fragmentary remains of the covered entrance and building fronting onto the canal

- 4.8.4 **Summary of significance:** the surviving fabric of the Wiseman Street Works has some *Evidential* value as the vestiges of a textile-machinery works, which represented a crucial element of the industrial townscape associated with the manufacture of cotton goods. The surviving fabric, and particularly that fronting onto the canal, adds a positive contribution to the historical character of the area, specifically a sense of the canal corridor being lined with industrial buildings for its entire route through the Weavers' Triangle (Plate 31).
