Blocks 6 and 11, The Moor, Sheffield

Archaeological
Excavation

Oxford Archaeology North

September 2009

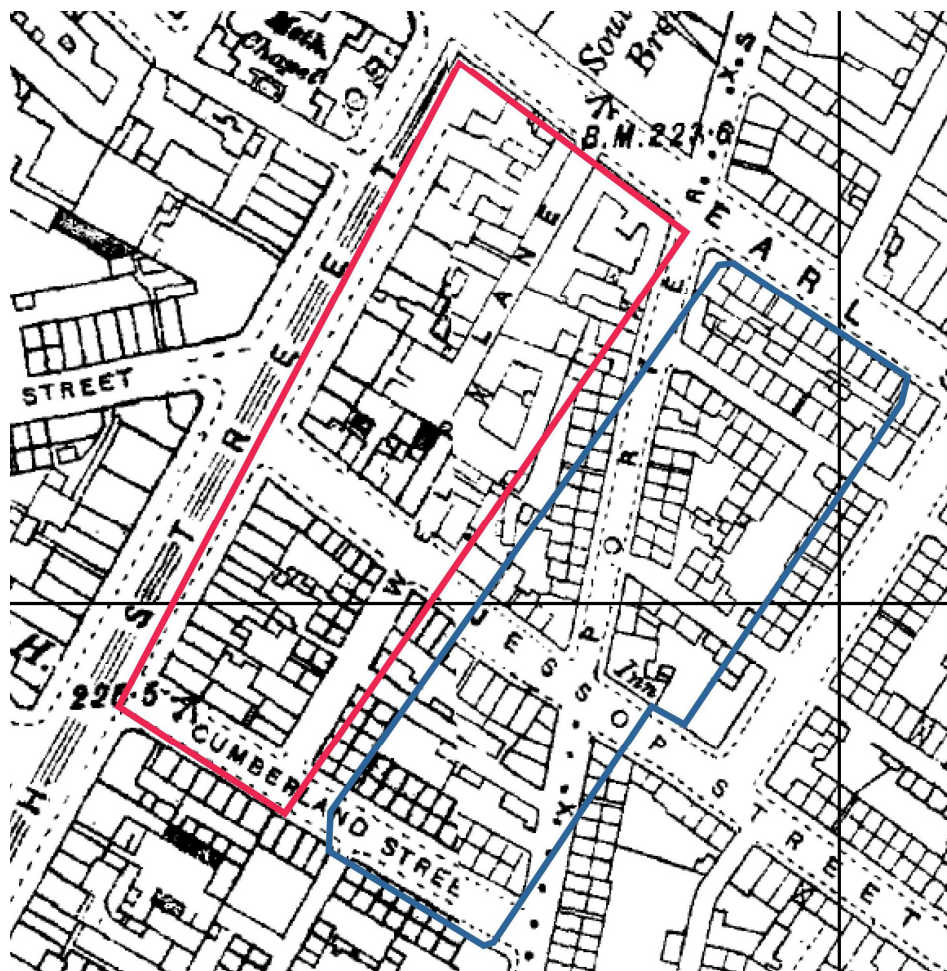
Plate 4: Extract from the 1894 1:2500 Ordnance Survey map (Blocks 6 and 11 outlined in red and blue respectively) (after CgMs 2007)

3.2.11 The 1894 OS map (*ibid*) indicates that by the late nineteenth century some infilling had occurred, with the construction of additional domestic properties within the yard areas found to south of Earl Lane, in Block 11 (Plate 4). This infilling continued with the construction of a further property in this area, which the cartographic sources indicate dates to between 1894 and 1905 (*ibid*). The 1894 OS map also plots the position of an additional building immediately to the east of the Globe Tavern, which was constructed during the latter half of the nineteenth century.

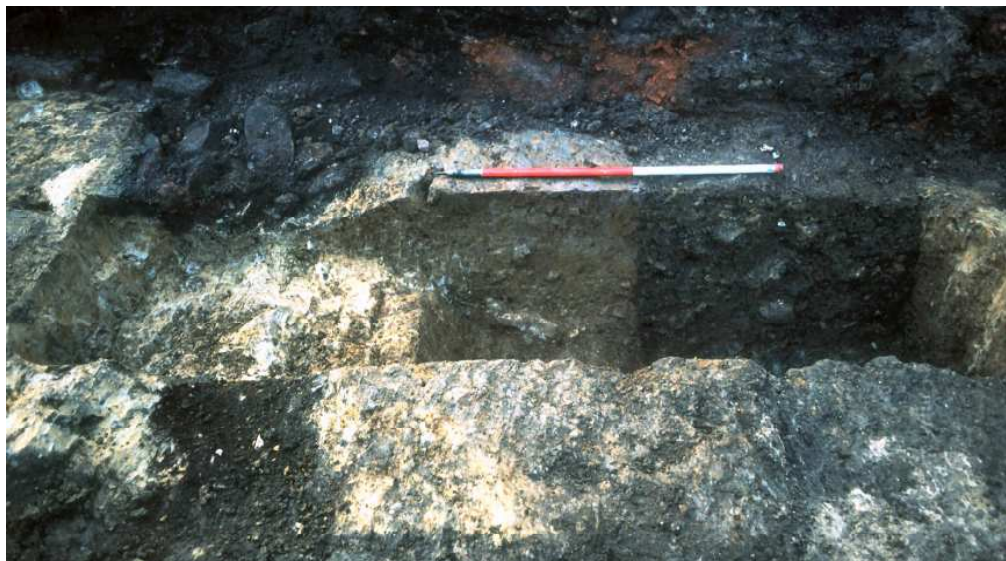
4.2.2 Ditch **543** was the more westerly of the two and a *c* 15m length of this feature was exposed. This ditch was found to be aligned north/south, running along the approximate line of the former route, known as Porter Street, and had been filled with a deposit of clay (**544**) (Figs 3 and 6; Plate 6). However, due to later truncation by an eighteenth- or nineteenth-century drain only the western edge of this ditch survived, and it was not, therefore, possible to determine its complete profile or extent.

Plate 6: The truncated remains of ditch **543** (left) following sectioning

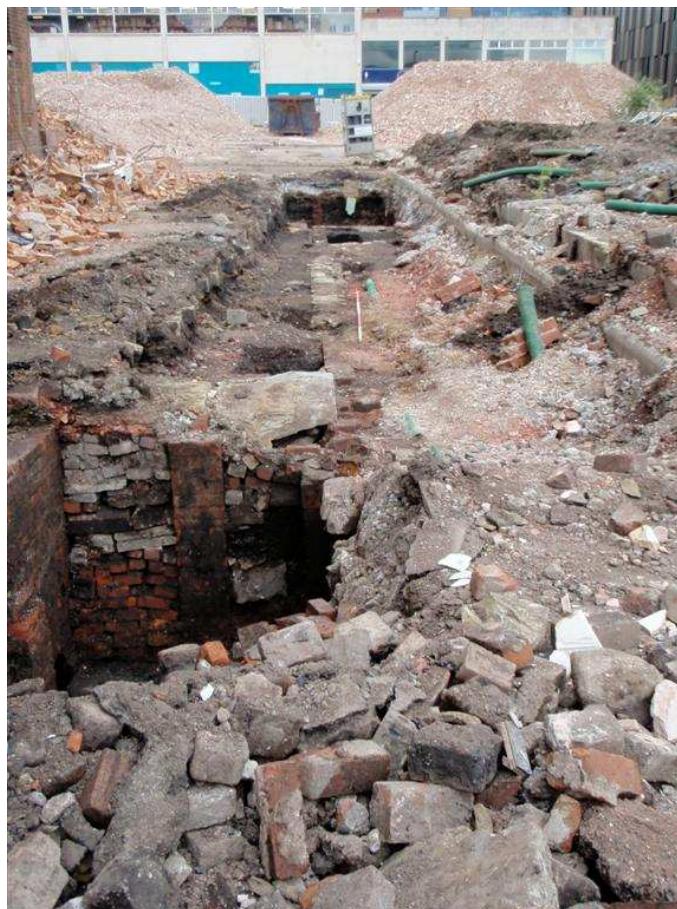
- 4.3.2 The passageway leading into the interior courtyard of the building was located at the northern end of Trench 3. It measured 2m wide and beneath its surface ran a drain (6017). This drain was constructed of stone slabs and was found at a depth of 2m below the present ground surface. Either side of the passageway, the remains of the exterior walls of the building were discovered, which were constructed partially of brick and partially of stone. The exterior walls (6000 and 6001) exposed to the north of the passageway were constructed of handmade bricks, laid in a stretcher bond, two bricks wide, and bonded with lime mortar. To the south of the passageway, the portion of the building was also partially defined by brick walling (6003 and 6004). This

again was two bricks in width, constructed of handmade bricks, bonded with a lime mortar, and laid in a stretcher bond. A stone wall (**6006**) was also discovered forming a continuation of the exterior wall fronting Well Lane, and butted the southern end of the exterior brick wall (**6003**). It was 0.3m wide and was constructed of stone blocks, with an average size of 0.3m x 0.3m x 0.8m. Within the interior of this portion of the industrial building one internal partition wall (**6005**) was identified constructed of stone blocks with an average size of 0.35m x 0.28m x 0.8m, and along with the exterior brick walls, defined a 3.2m wide ground floor room located at the northern end of Trench 3. A deposit of ash and clinker (**6021**) was also discovered within the room, which in turn sealed two made ground deposits (**6022** and **6024**). Unlike the majority of the excavated site, there was no evidence for a basement within this part of the building.

Plate 9: General view of the remains in Trench 3, Block 6, following excavation, viewed from the south-west

- 4.3.1 *Industrial premises fronting Well Lane:* potentially, the earliest structural remains uncovered during the excavations were located in Block 6, particularly as one area of this site, examined by Trench 3 (Fig 4), is known from the cartographic sources to have been developed by 1797. The remains of a building were uncovered that would seem to have originally fronted Well Lane, which correlated with a building plotted on the large-scale First Edition 1850-1 OS map (*ibid*). This building comprised four linear ranges, enclosing a central courtyard, which could be accessed via a covered passage leading from Well Lane (Plate 8). The layout suggests that this building functioned as an industrial premises and it is possible, based on the excavated remains, that it was one of the early buildings plotted on Fairbank's 1797 survey of this area of Sheffield. The below-ground remains comprised principally the building's exterior walls fronting Well Lane, along with an internal partition wall and the remains of a passageway, allowing access into the interior courtyard of the premises. In addition, a small subterranean room was also discovered, which originally lay beneath Well Lane (Fig 4; Plate 9).

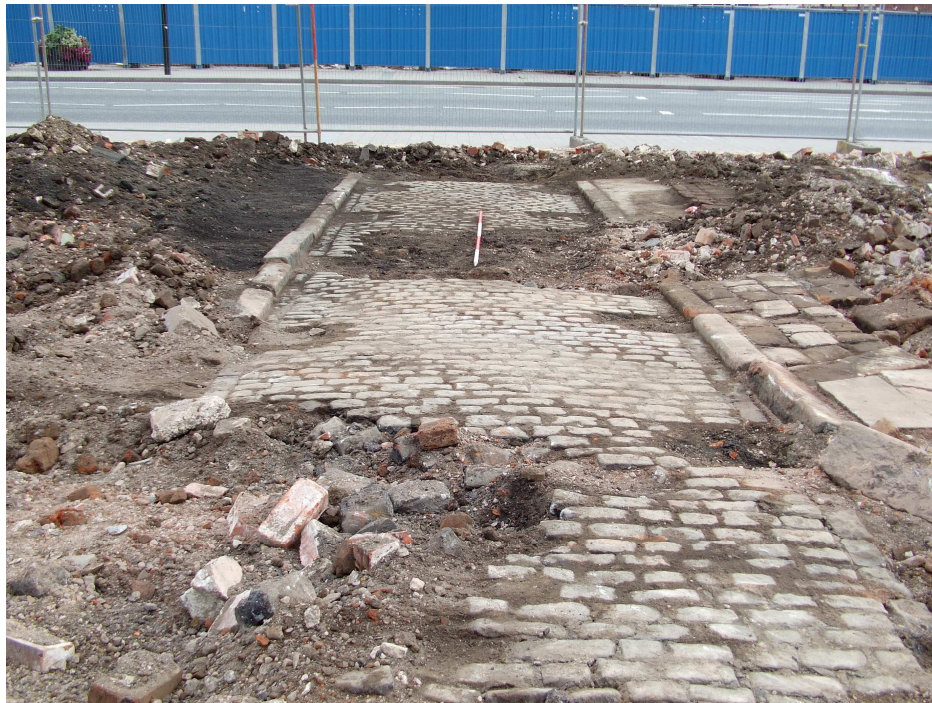
- 4.4.5 **Earl Lane:** in the northern half of Block 11 the remains of Earl Lane were uncovered (Fig 2; Plate 11) comprising cobbled paving (**108**) and cobbled road surface (**105**), beneath which ran a drain capped with sandstone slabs. It is possible that these remains date to Period 3, particularly as the historic map sequence (Section 3.2) indicates that this lane had been established during this phase.

Plate 11: Earl Lane following excavation, viewed from the west

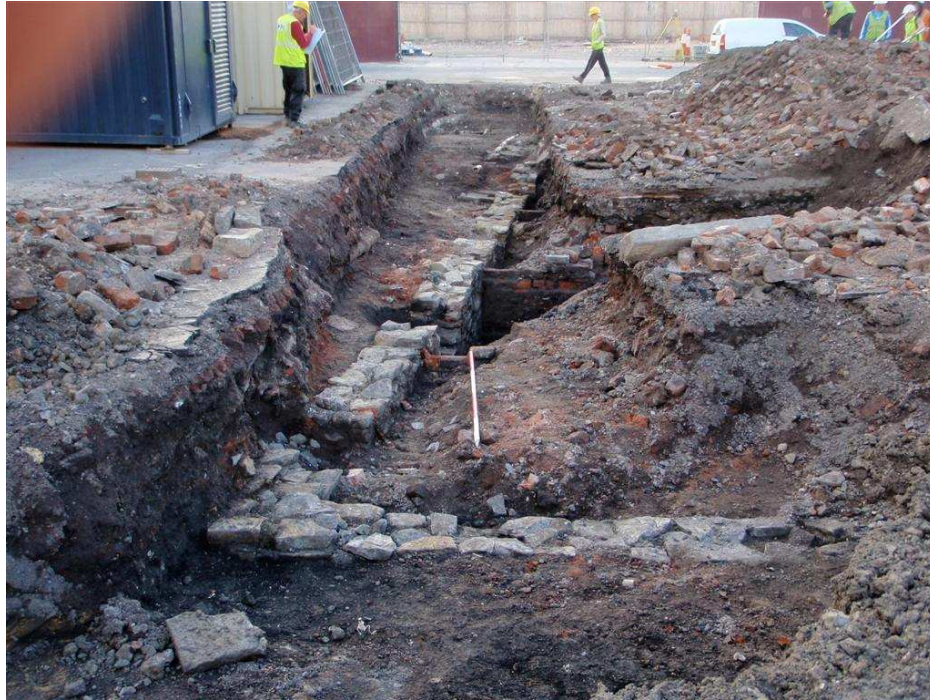
- 4.5.3 The excavation indicated that the interior of the four terraced dwellings contained four basement rooms (Rooms **6039**, **6041**, **6040** and **6049**), located at the front of the properties. Each basement room was c 3m wide and, within the limits of Trench 1, these rooms were defined by the exterior stone wall (**6032**) of the dwellings, and three separate lengths of brick walling (**6033**, **6034** and **6037**). These walls were only a single-skin thick and were constructed of handmade bricks, measuring 0.23m x 0.11m x 0.07m, joined with a lime mortar and laid in a stretcher bond. Each of the basements had also

been provisioned with a cellar light, positioned towards the western side of each of the rooms, facing onto Jessop Street. The lights were defined by a c 0.8m wide gap discovered on the exterior wall of the terraces (**6032**). The demolition rubble contained within the interior of one the basement rooms (**6041**) was completely removed in order to establish the depth and character of the basement. This revealed a flagstone floor (**6045**), located over 2m below the modern tarmac surface.

Plate 12: Remains of the Jessop Street dwellings exposed in Trench 1, Block 6, following excavation, viewed from the west

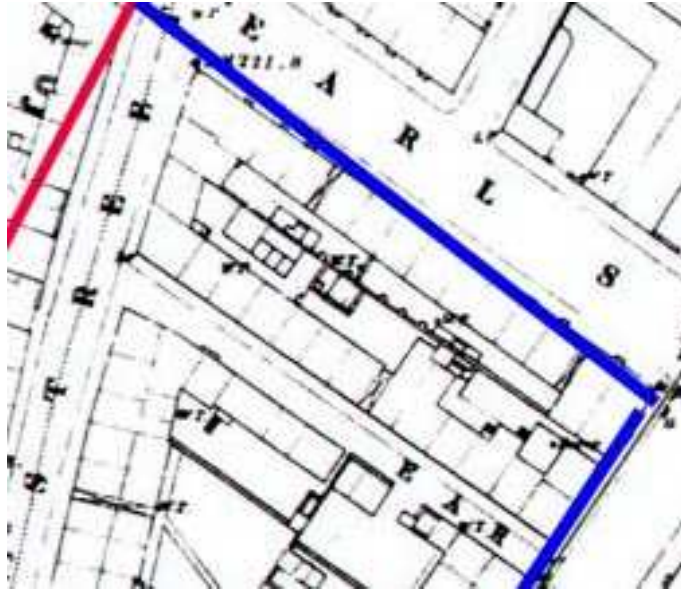
Plate 13: Extract from the 1850-1 Ordnance Survey 5ft to 1 mile map, showing the early nineteenth-century domestic dwellings located between Earl Street and Earl Lane, and to the south of Earl Lane

- 4.5.15 Attached to the northern side of the outshut, a number of brick walls were also exposed that formed the remains of a probable privy (**241**), whose position is plotted on the large-scale First Edition 1850-1 OS map (Plate 13). The privy measured *c* 1.4m by 2m, and was provisioned with a drain and two internal subdivisions formed by lengths of handmade brick walling.

- 4.5.16 *Dwellings to the south of Earl Lane:* the early cartographic sources indicate that by 1823 properties had also been constructed fronting the southern side of Earl Lane. The large-scale First Edition 1850-1 OS map depicts these properties as single-depth domestic dwellings (Plate 13). However, during the excavation, all that was found to survive of these properties was a *c* 0.5m thick sandstone wall (**292**), which formed their rear wall. The absence of any further remains is presumably due to an absence of basements contained within these properties, and hence it would appear that their more ephemeral ground floor remains have been destroyed during later periods of activity.

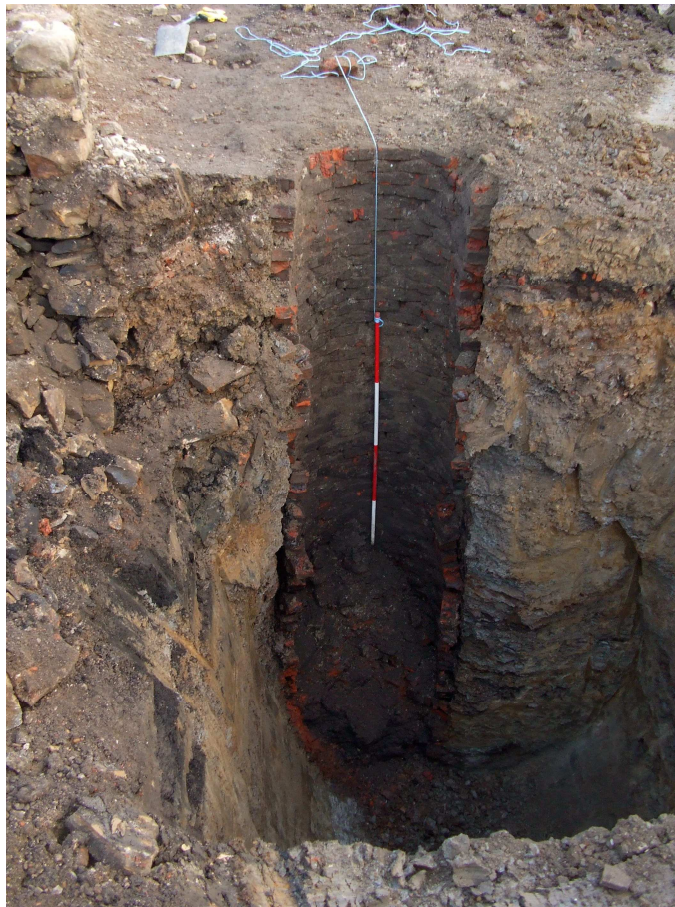
- 4.5.9 To the rear of the properties fronting Earl Street a *c* 0.5m wide stone wall (**152**) was discovered, and this originally enclosed and divided a yard area associated with both the Earl Street and Earl Lane properties. Within the yard area associated with the Earl Street properties, a short section of right-angled brick walling was discovered, which corresponds with the position of a structure depicted on the large-scale First Edition 1850-1 OS map, together with a brick-lined well (**613**). This had a *c* 1m diameter and extended for a depth of at least 4m below the original surface of the yard (Plate 15).

Plate 15: Well **603**, following half-sectioning, viewed from the east

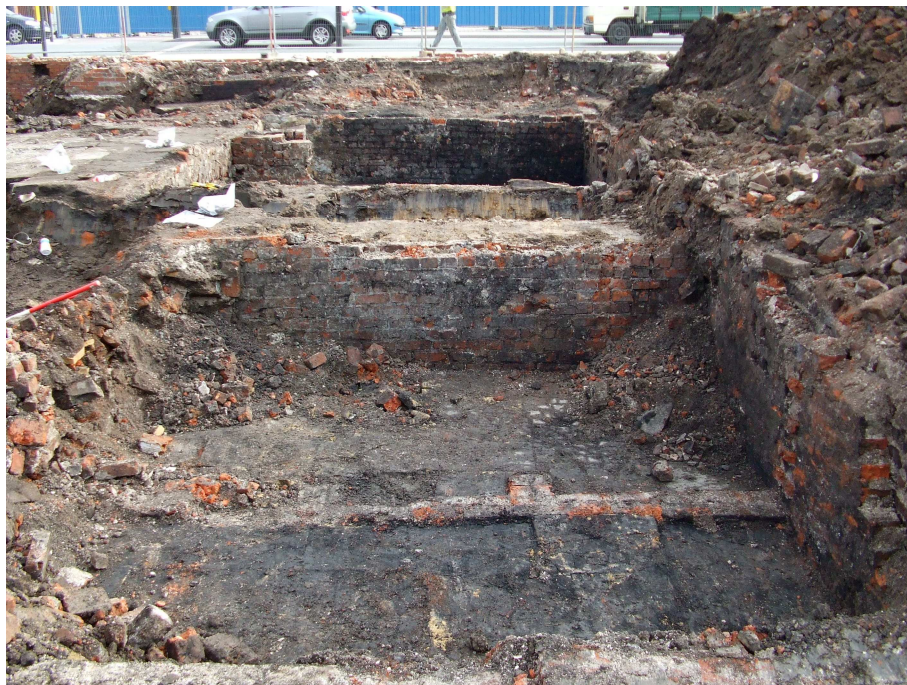
- 4.5.11 Those rooms positioned to the west of the passageway (**246-8**) were all of comparable size, measuring 2m wide by 4m deep, and comprised handmade brick exterior and interior partition walls (**250**, **263**, **264** and **266**), which were all two bricks in width (Plate 16). The interiors of the rooms were paved with sandstone-flagged floors (**265** and **267**), whilst the position of a fireplace, or the foundations for a chimney which also served a fireplace in a room above, also survived in one of the basement rooms (**246**). This feature was defined by two small protruding brick piers spaced 0.8m apart.

Plate 16: The basement rooms of the Earl Lane dwellings found to the west of the passageway, viewed from the west

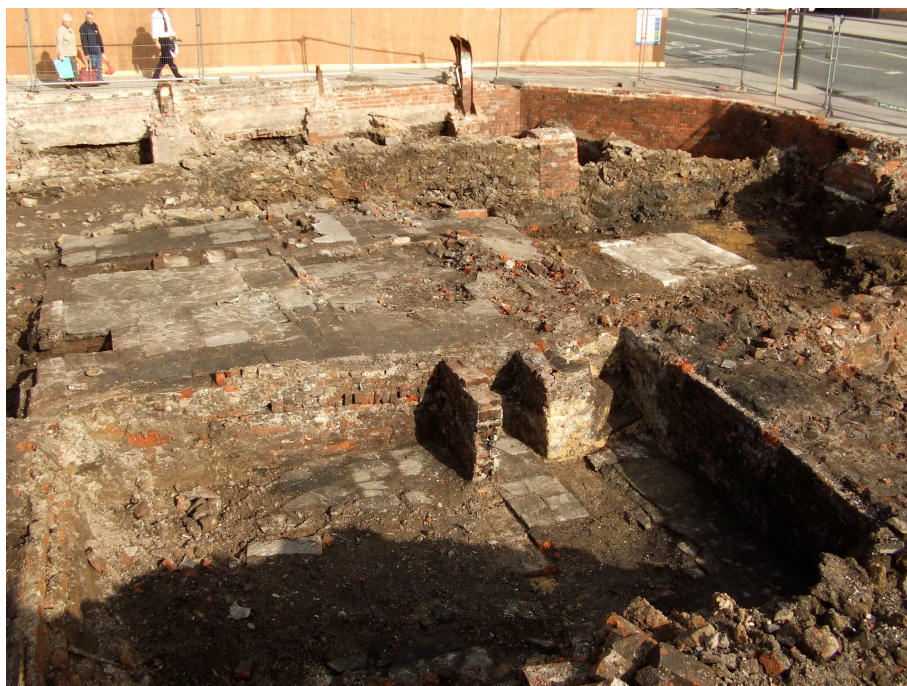
- 4.5.12 The remains of the three basement rooms (**244**, **245** and **602**) sited to the east of the passageway were similarly composed of handmade brick exterior and interior partition walls, and they had all been provisioned with sandstone-

flagged floors (Fig 2). The internal size of these rooms did, however, vary. Although all were *c* 4.8m deep, two of the rooms (**244** and **245**) measured 1.9m wide, whilst the remaining room (**602**) was only 1.4m wide. One of the rooms also contained the remains of a handmade brick staircase, supporting stone steps, which was positioned at the north-eastern corner of the room (Plate 17).

Plate 17: The basement rooms of the Earl Lane dwellings found to the east of the passageway (foreground), and the associated outshut (background), viewed from the south-west

- 4.5.14 The remains of an outshut, linked to the properties fronting Earl Lane, was also discovered immediately to the east of the passageway (Fig 2; Plate 17). It abutted the rear walls of these properties and it was defined by one and two brick wide, handmade brick walls (164, 211, 213, 216 and 218). The outshut had a sandstone-flagged floor and contained two separate rooms (214 and 219), measuring *c* 4.4m by 2.4m and *c* 3.6m by 2.4m respectively. Access into its interior was through a 0.6m wide doorway positioned on its north-western side, whilst the outshut also had an internal *c* 1m wide doorway allowing access between its two rooms. A small ceramic drain cover was also observed in the south-eastern corner of the outshut. Following removal of the outshut flooring a number of subterranean structures were also exposed. These included a brick-lined drain (251), capped with sandstone, which led from the drain cover within the outshut and linked with a system of drainage features discovered immediately to the west. These latter features included two linear drains (268 and 269). Apart from the drainage system a small square structure (271) was also located beneath the flagged floor of the outshut (Plate 18). This measured *c* 1.2m sq and was constructed of handmade brick walls. Although

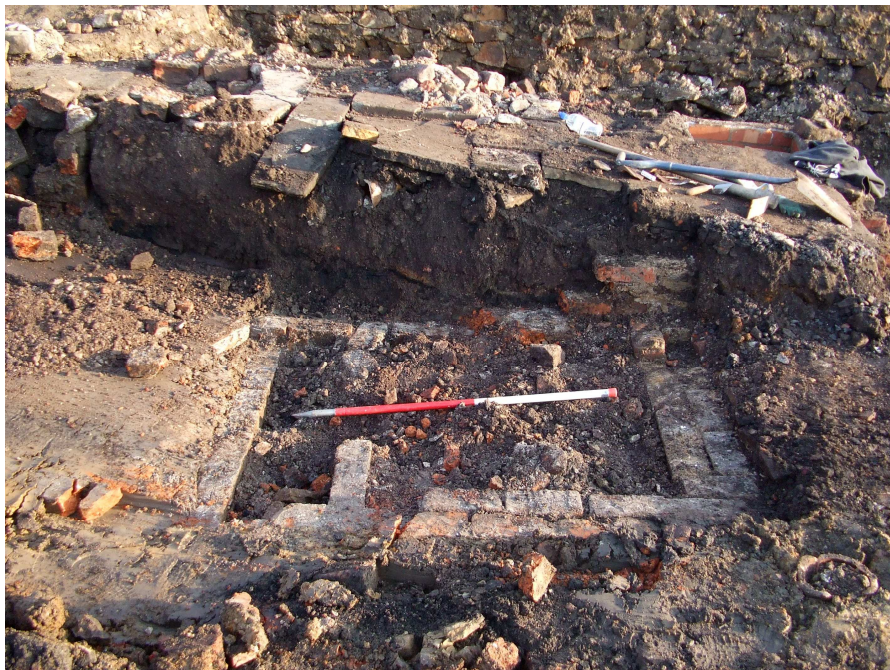
- 4.5.13 To the east of the basement rooms (244, 245 and 602), positioned to the east of the covered passageway, the fragmentary remains of a further property, fronting Earl Lane, were also exposed (Fig 2). This property incorporated a basement room (242), which was defined by handmade brick walls (252-4), though due to later truncation it was not possible to determine the size, form or character of this room. Immediately to the rear of this property, a sunken handmade brick rectangular structure (243), measuring 2.1m by 1.6m, was also discovered. Although it was not possible to determine the function of this structure, it enclosed an area of flagged flooring, and presumably formed a small subdivision located within a possible outshut found to the rear of the adjacent property fronting Earl Lane.

Plate 18: The structure discovered beneath the outshut floor, viewed from the south-west

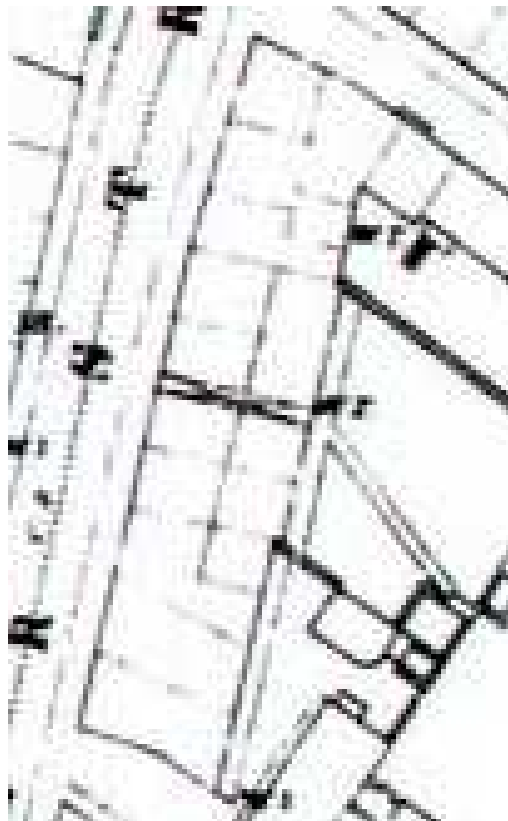
Plate 19: Extract from the 1850-1 Ordnance Survey 5ft to 1 mile map, showing the early nineteenth-century dwellings fronting Porter Street

- 4.5.17 *Dwellings fronting Porter Street:* close to the western margin of Block 11 the remains of a number of properties were uncovered that were constructed in the early nineteenth century as back-to-back dwellings, which originally fronted Porter Street and a courtyard area, positioned between Porter Street and Eyre Street (Plate 19). Porter Street was a well-established road prior to the nineteenth century, so much so that the new properties still respected its course despite the more grid-like layout of roads and blocks of buildings surrounding it. Furthermore, it is likely that these properties are first depicted on Leather's 1823 map of this area. The remains exposed by the excavation included a narrow, *c* 0.8m wide, passageway and elements of four buildings suspected to date to Period 4 (Fig 2; Rooms **553**, **578**, **585**, **586** and **593**). One of the exposed dwellings was positioned to the south of the passageway, and its remains included a basement. In plan, this basement measured *c* 2.9m by 4.6m, and was defined by a two brick wide exterior wall (**555**), constructed of handmade bricks bonded with lime mortar, and a comparable wall (**556**) forming a partition with the adjacent property to the south. The interior of this basement was subdivided into two rooms by a single-skin handmade brick wall (**558**). To the north of the passageway, three further Period 4 basements were uncovered. Although the full extent of one of these partitioned basements was not established (Room **593**), two of the basements were fairly identical in size, measuring in plan *c* 4.6m by *c* 3m. All of the basements were also defined by exterior and partition handmade brick walls (**580**), which were two bricks thick. The interior of one of the basements, located immediately north of the passageway, contained a sandstone-flagged floor and had been subdivided into two separate rooms (**585** and **578**) by a single-skin handmade brick wall (**583**). Within the more northerly of the rooms (**578**) the remains of a brick staircase, supporting a number of stone steps, was also discovered.

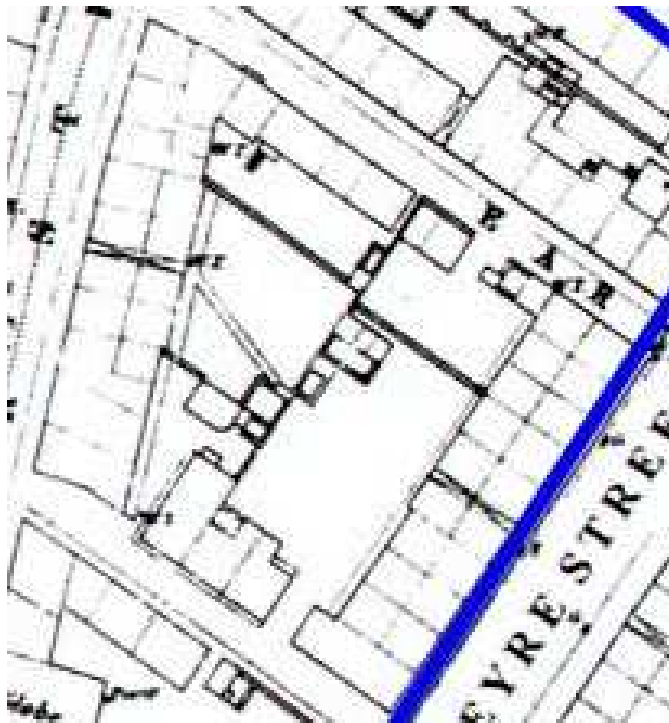
Plate 20: Extract from the 1850-1 Ordnance Survey 5ft to 1 mile map, showing the early nineteenth-century courtyard

- 4.5.19 ***Courtyard:*** the large-scale First Edition 1850-1 OS map suggests that during the early nineteenth century a large courtyard existed in the plot of land bounded by Earl Lane, Eyre Street, Jessop Lane and Porter Street, which was enclosed by back-to-back and single depth domestic dwellings (Plate 20). Close to the eastern boundary of Block 11 a paved surface was identified, which may represent the remains of this early nineteenth-century yard. Historic mapping indicates that this surface would have been located directly west of a row of back-to-back dwellings, which fronted the courtyard area. This section of yard (**325**) was composed predominantly of yellow sandstone setts, although one area was paved with sandstone flags. Within the yard surface a north-east/south-west aligned drainage gully could also be seen that would have originally run to the front of the back-to-back dwellings situated on this yard. A sondage was also excavated through the yard surface and indicated that it had been laid above a series of thin bedding layers (**485-90**, **507-11** and **515-18**) composed of varying proportions of sand, silt and ash/clinker.

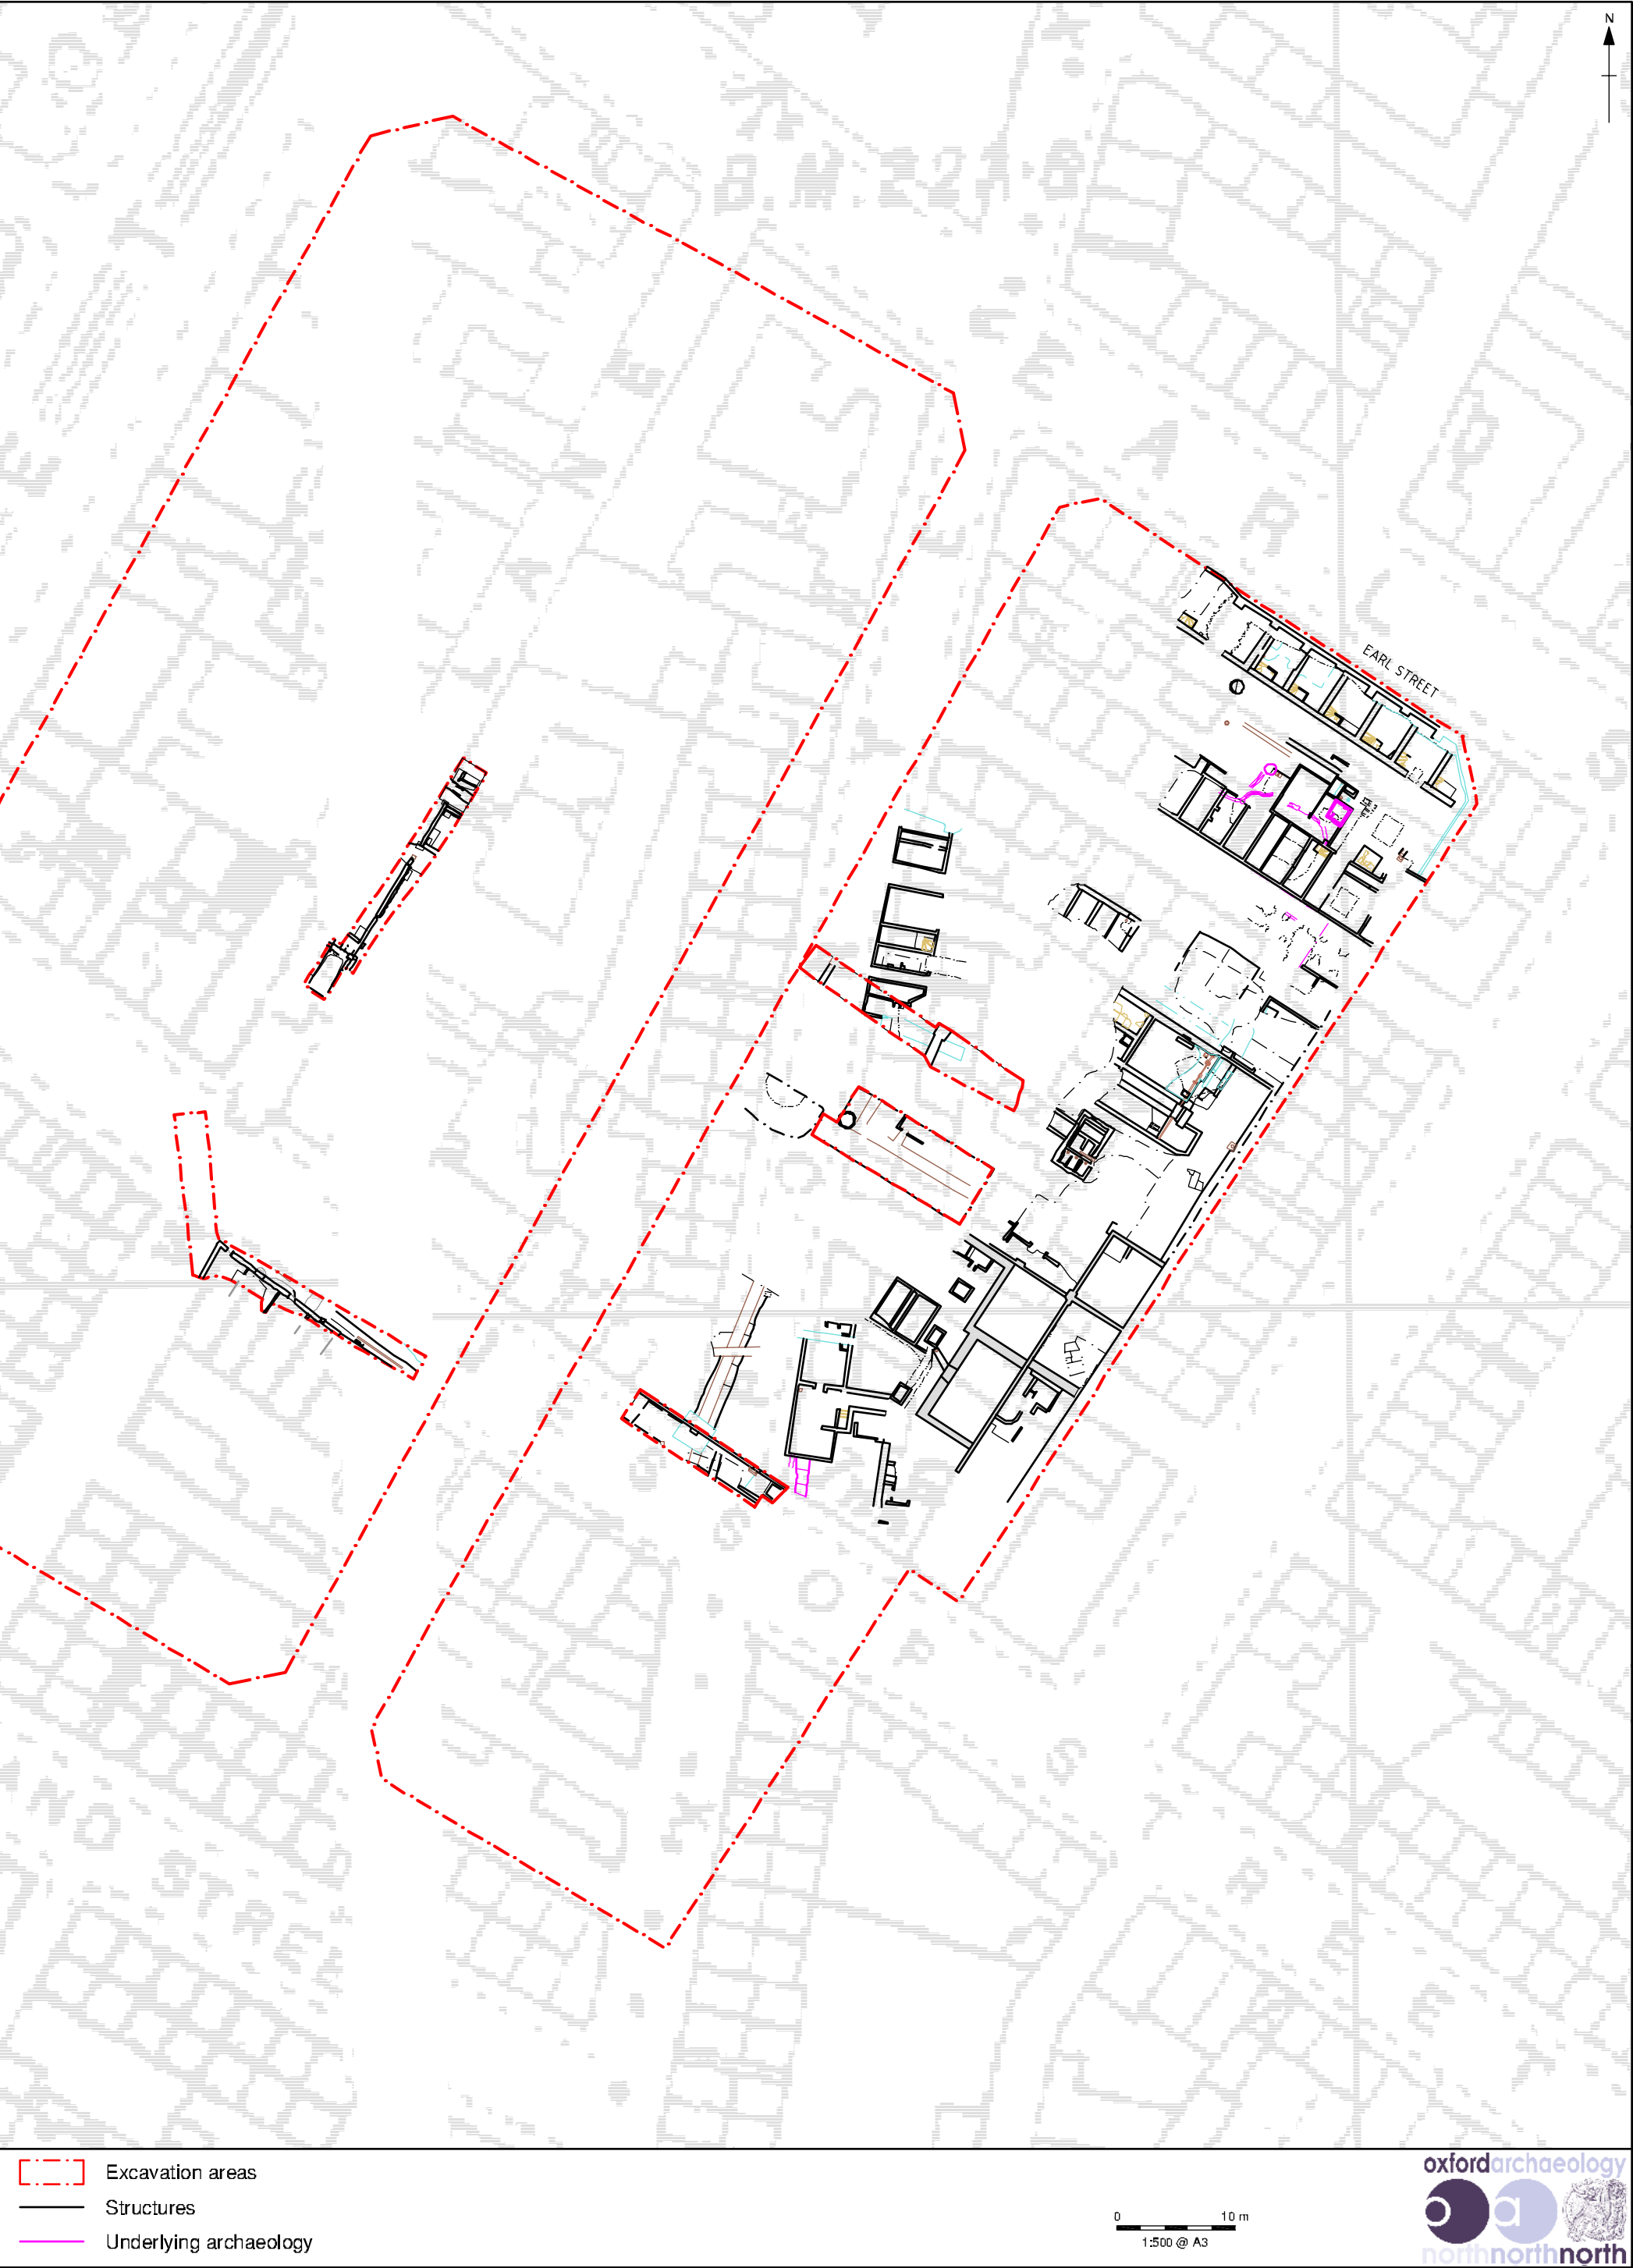
Figure 5: Archaeology superimposed on the 1894 Ordnance Survey 1:2500 map
