**PHILIPS PARK  
HOUSE,  
PRESTWICH  
GREATER  
MANCHESTER**

**Archaeological  
Evaluation**

**Oxford Archaeology North**

October 2008

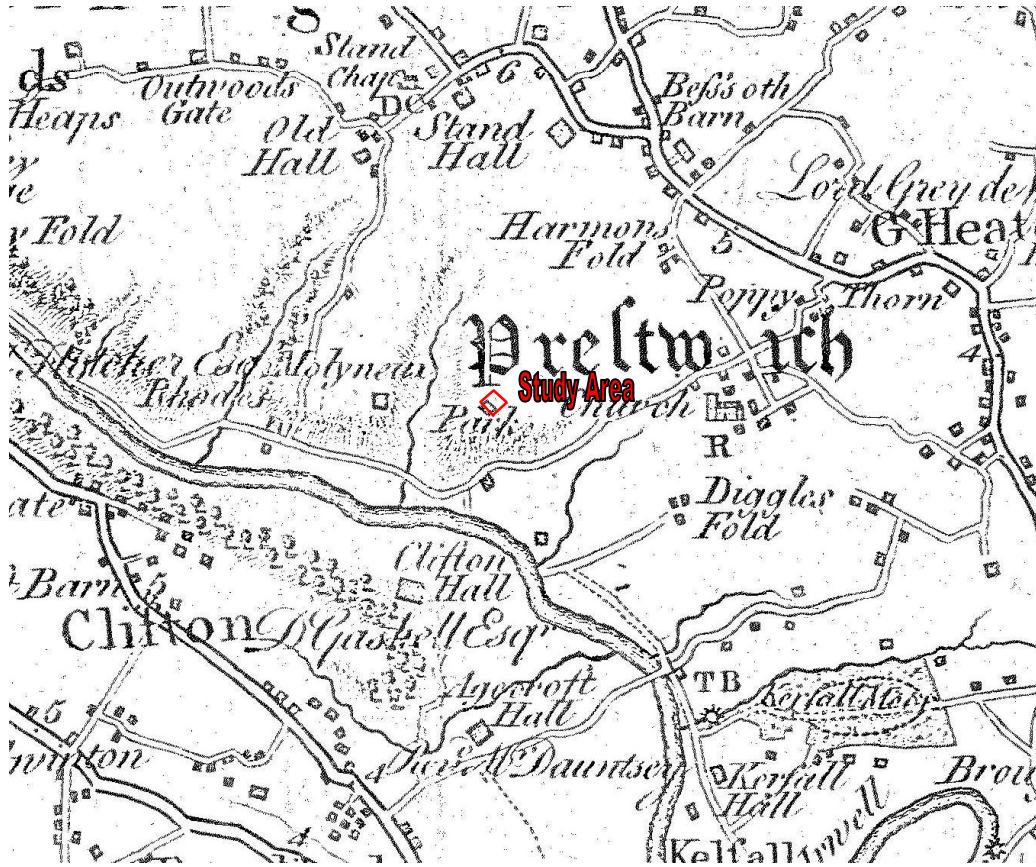
Plate 2: Extract from Yates' Map of the County Palatine of Lancaster, 1786

- 3.1.10 ***Development of Philips Park during the eighteenth and nineteenth centuries:*** Yates' *Map of the County Palatine of Lancaster*, published in 1786, does not show the deer park, suggesting that the original Pilkington Park Pale had fallen into disuse by the late eighteenth century (Plate 2). Philips Park is marked as 'Park', with a building shown on the map, which may have been used as a park lodge during the seventeenth or eighteenth centuries (North West Archaeological Surveys 1993).

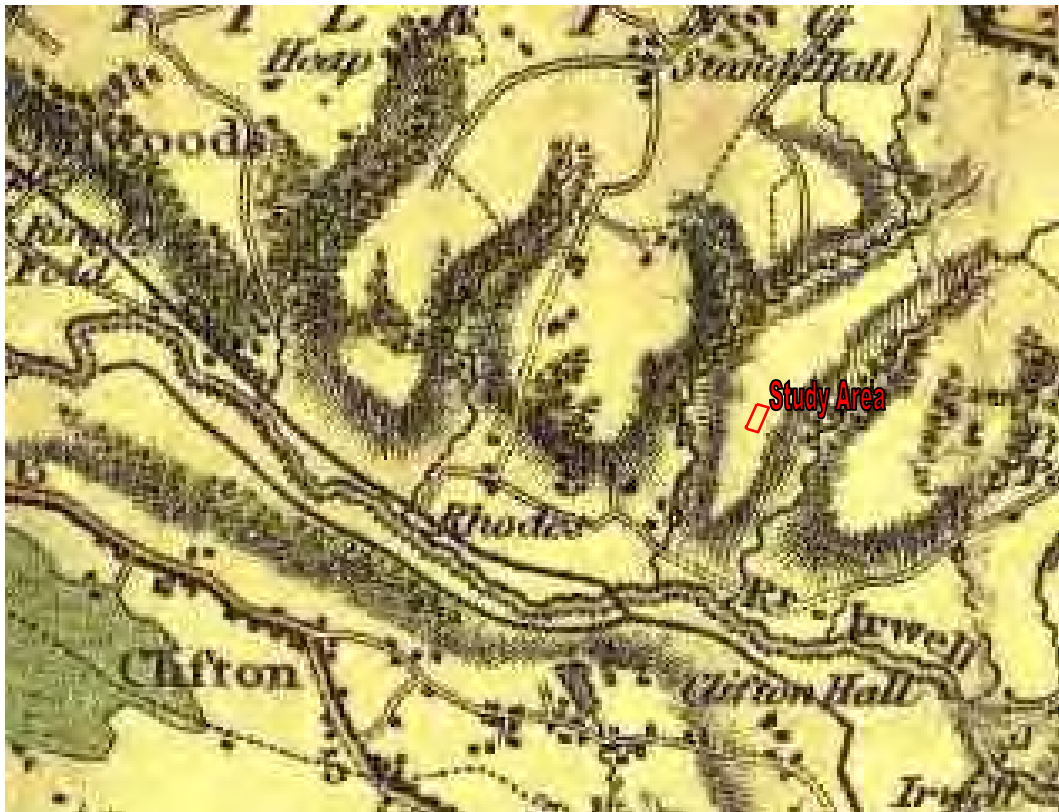
Plate 3: Extract from Greenwood's Map of Lancashire, 1818

- 3.1.11 Greenwood's map, published in 1818 but surveyed at a slightly earlier date (Plate 3), does not depict The Park or any of the associated estate buildings. This omission of detail may reflect the small scale at which Greenwood's map was produced or, more likely, indicates that The Park had not actually been built at the time of Greenwood's survey, and the site chosen was previously undeveloped. It is also of note that Greenwood did not depict Park Lane, which became the main access route into the estate. The map does show steep slopes to the north and east of the site of the house, now occupied by the formal garden and the ancient beech, holly and rhododendron woodland (Chris Burnett Associates 1998)

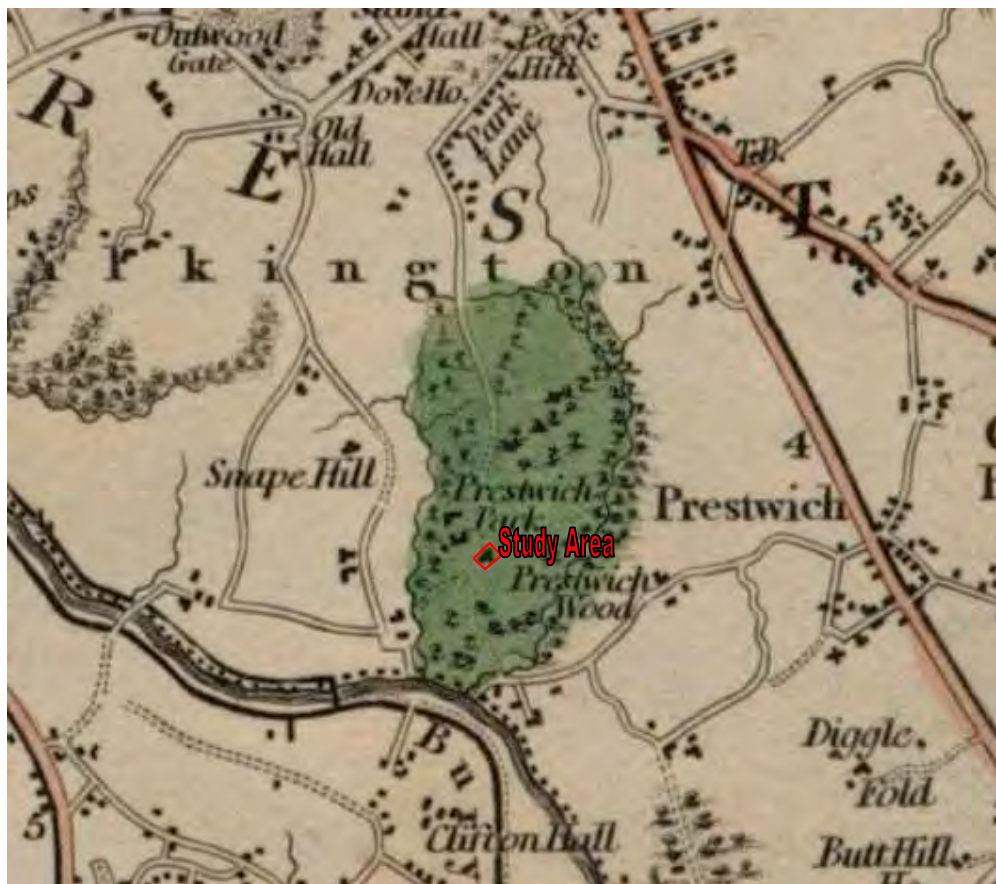
Plate 5: Extract from Hennett's map of 1830

- 3.1.14 Hennett's map of 1830 shows the location of Park Lane connecting to a group of buildings within a wooded area named Prestwich Park (Plate 5); this improved access lane replaced the earlier drive from Ox Gap. The outline of The Park is shown on Hennett's map as a T-shaped building, bordered by several tracks; it is not possible to ascertain from the detail of the map whether it is the remodelled house that is depicted. Two rectangular-shaped buildings, located north-west of the house, are also shown, possibly representing the conservatory and quadrangle.

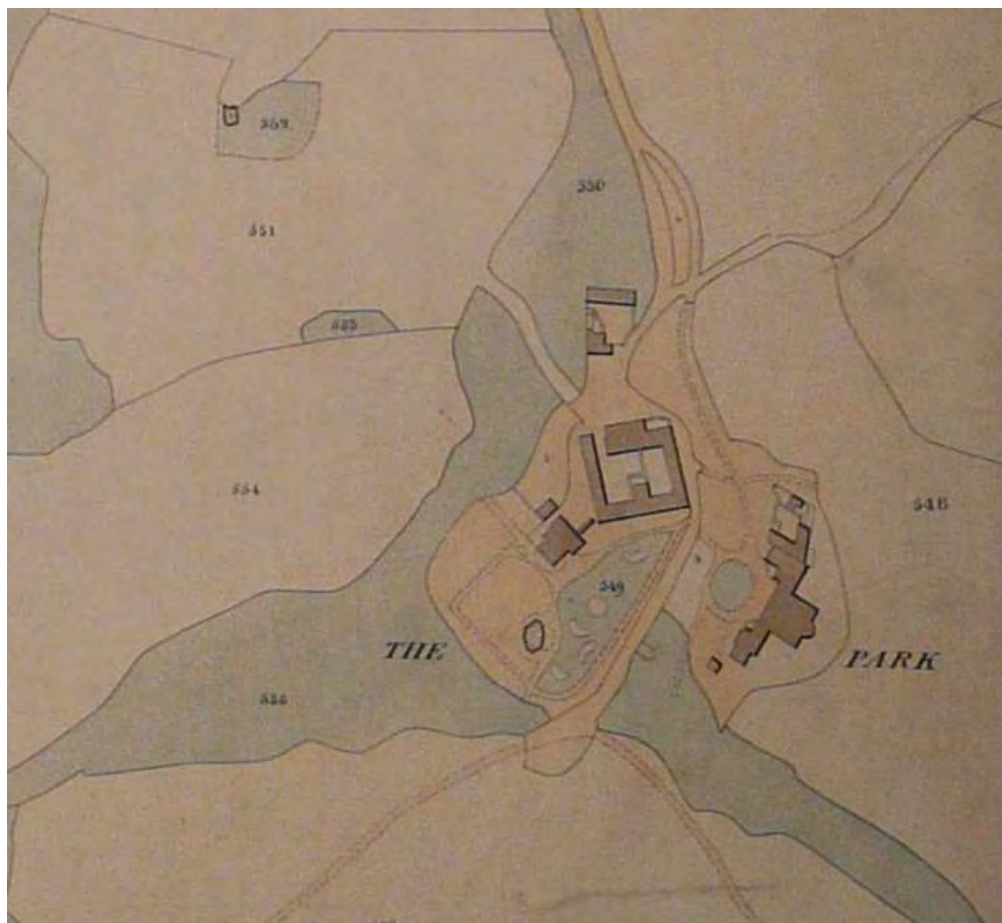
Plate 6: Extract from the tithe map of Outwood, Pilkington dating to 1835-40

3.1.15 A useful cartographic source of the site is a tithe map for Outwood, Pilkington, which was drawn between 1835 and 1840 (Plate 6). This plan shows the main structure of the park, if not the formal garden area, was in place by 1840. The main elements of the estate at this time included The Park, outbuildings, conservatory, the lodges, kitchen garden, formal garden areas with lawns and shrubbery, woodland, and large pasture fields. By this date, The Park had been remodelled in brick with plaster finish and a stone-decorated facade, with the roof finished with denticulated decorated stone. The house faced north-west, with a five-bay elevation, large Georgian-style windows, and a central doorway with extensive eastern and western wings added; the eastern wing contained the servants' quarters; after the 1890s, Anna Maria Philips retained at least eight indoor servants, who resided in quarters along the eastern side of the house. The southern elevation of The Park was seemingly extended along its eastern side with an additional ground floor circular bay window added, although this did not extend to the upper storey. The western wings contained a labyrinth of cellars, connected by numerous passages, many with dead ends; it has been suggested that two of these cellars contained boilers (Price and Moorman 1973). A small garden area to the south of the house was contained by a curving fence line. Further to the south was a walled kitchen garden with curving walls, which contained a bath and two hot houses. A large lawn is shown to the west of the conservatory, including five irregular-shaped plant beds and a small pond. By this time, a rectangular-shaped building had been erected on the south-western side of the house, which possibly represented an ice house.

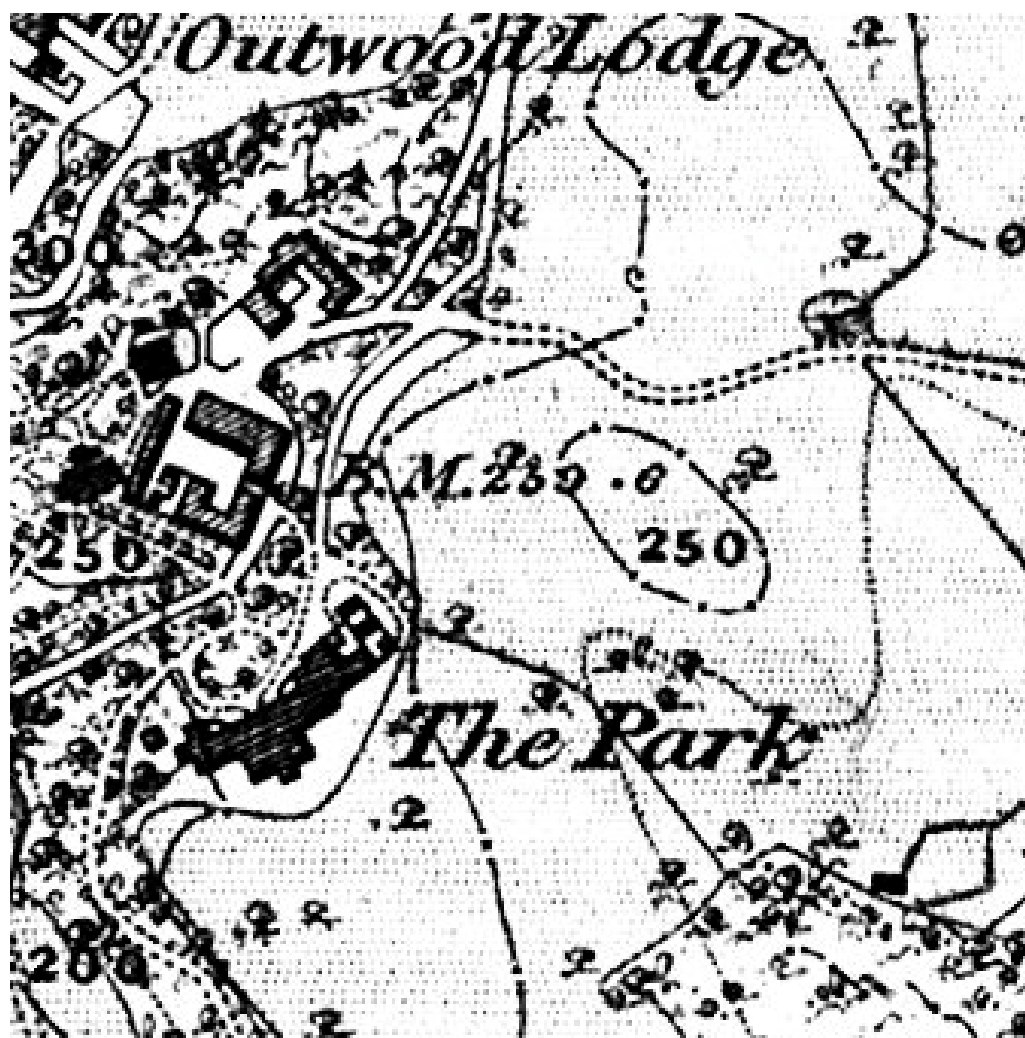
Plate 7: Extract from the Ordnance Survey map, published in 1848

- 3.1.17 After the death of Robert Philips in 1844, the estate passed into the hands of his son, Robert Needham Philips, who moved into The Park with his first wife in 1845. This heralded a new phase of development, particularly in the formal gardens; the layout of the gardens is shown on the 1848 Ordnance Survey map (Plate 7). The main drives into the estate were well in place by this time, although a significant improvement in 1852 was the creation of Philips Park Road, jointly funded by the Philips' and the Lancashire and Yorkshire Railway to serve Molyneux Brow station. It included a seven-arch viaduct across the small valley to the east of the park, and linked the main drive with the recently opened Bury New Road. This was reported to be a ‘boon to those visiting the park in their carriages’ (Jackson 1991). The map also shows a network of paths through woodland, and avenue planting along the main north drive. A gradual clearance of the site was undertaken to create pasture, leaving some trees which were added to subsequently by new planting (Chris Burnett Associates 1998). By 1852, the conservatory was refitted with a fountain along with a new planting scheme (Price and Moorman 1973). Two statues that belonged to the house were put into the conservatory when the house was

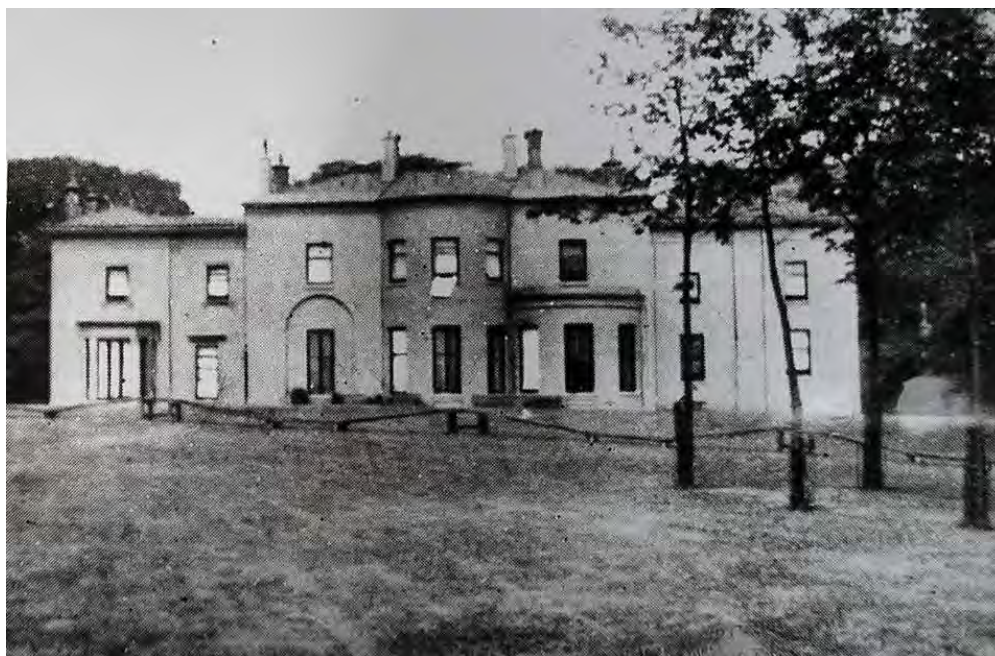
Plate 9: South elevation of the house in the early twentieth century

3.1.19 **Twentieth-century development:** by the early twentieth century, it is likely that the neglected nature of the kitchen garden had become prominent in the view from the front of the house (Plate 9). The kitchen garden and the hot houses were eventually closed when pollution from the increasingly industrial valley made growing conditions impossible. New planting was carried out in an attempt to both soften the impact, and to create a more pleasing woodland boundary to the previous straight lines (Chris Burnett Associates 1998). The Ordnance Survey map of 1910 show a slight rearrangement of the paths and boundary surrounding the western side of the house. Subsequent Ordnance Survey mapping, published in 1912 and 1927, show few changes.

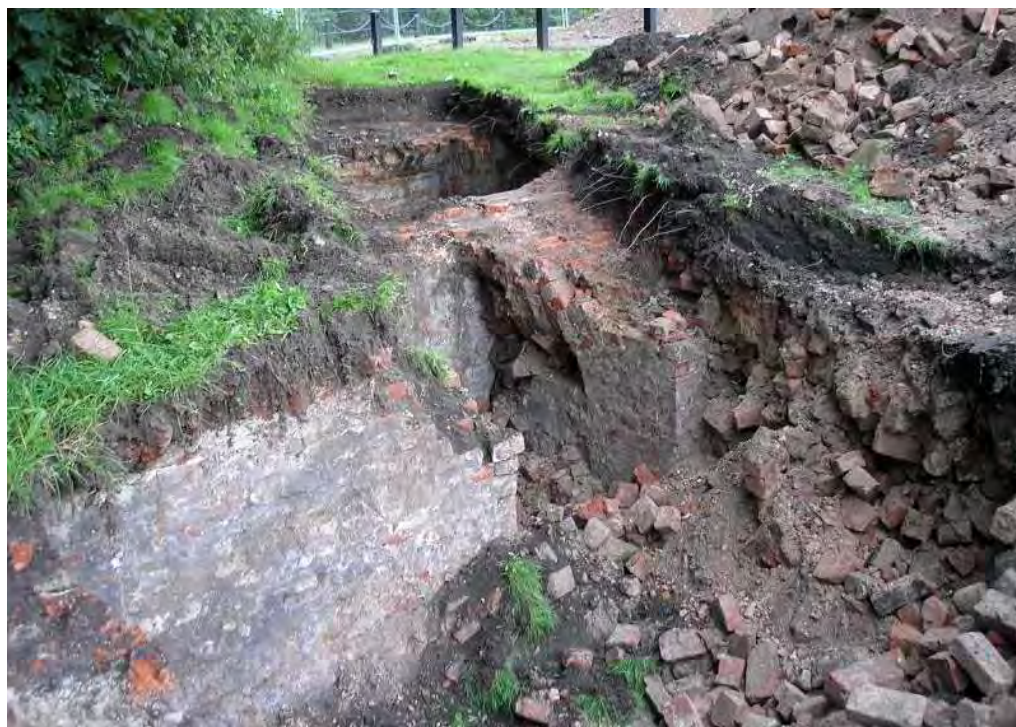
4.2.1 This north/south-aligned trench was placed across the former west wing of the house, and was excavated to a length of 14m (Plate 13). It was placed between the western side of the present car park, and an earthen bank along the south-western side of the site. It was excavated to a maximum depth of 1.7m to reveal a cellar floor within the central part of the trench. Several cellars and passages were exposed, demonstrating at least two phases of construction. Documentary evidence has indicated that two boilers were located in cellars within this part of the house (*Section 3.1.23 above*), although physical remains of these were not encountered within the excavated trench (Fig 3).

*Plate 13: View of Trench 1, looking north-west*

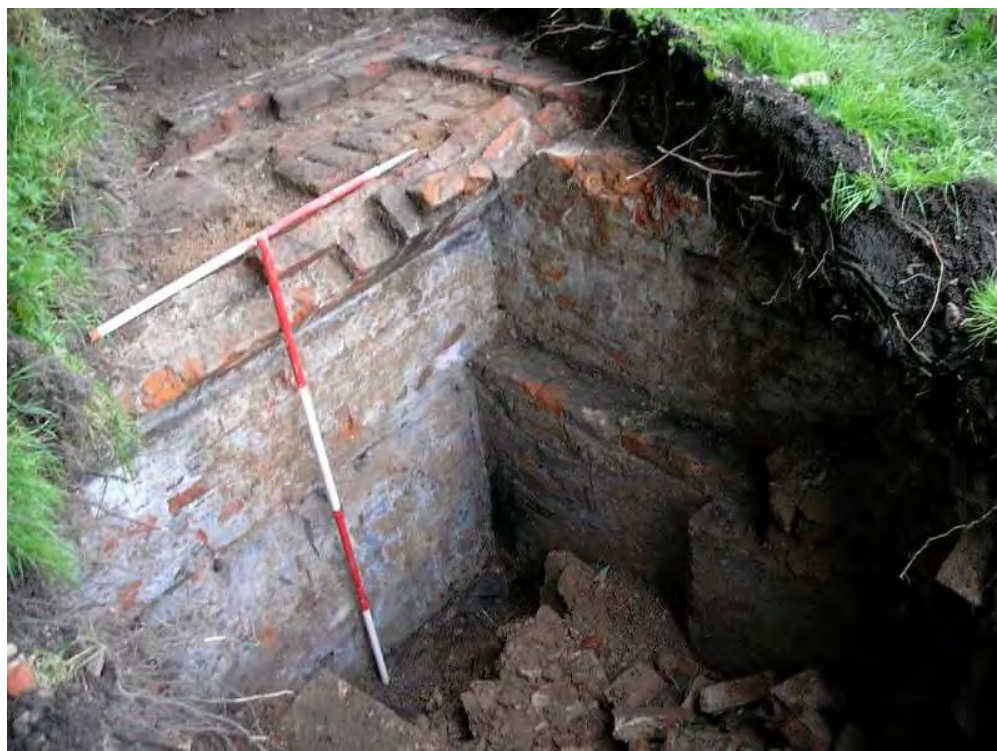
- 4.2.3 The eastern wall (**81**) was exposed across the eastern side of the trench for a distance of 1.1m, and seemingly continued to the east beyond the edge of the excavated trench. The upper surface of the wall retained pink lime mortar, although the lower section had grey mortar, suggesting an area of repair. The wall stepped out by 0.23m at a depth of 0.5m below the spring of the barrel-vaulted roof, creating a narrow shelf (Plate 14). Wall **81** was bonded to wall **77**, which was aligned north-east/south-west, and was three brick-skins wide, bonded with light grey mortar. The position of the wall corresponds with the northern wall of the western wing shown on historical mapping. Wall **72** formed the southern boundary of the cellar, and also served as a retaining wall for the passageway along its southern side. The wall was aligned north-east/south-west, measured 0.54m wide, and was at least five brick-skins thick. It survived to a height of 1.63m above a flagstone floor. The wall returned to the north-west near the western limit of excavation (Fig 3). Wall **74** formed the northern extent of the cellar, and was situated some 2m north of wall **72**, with which it was parallel. Part of the barrel-vaulted roof (**76**) remained intact along the northern part of the room, bonded to wall **74** with cement-based mortar (Plate 14). Wall **74** returned to the south-east at its western end to form a doorway with the north-western return of wall **72**, thus creating a 0.9m wide entrance. The wall was rendered with lime wash to a height of 0.97m above the floor (**83**). A layer of brick (**76**) set within the upper surface of walls **74** and **77** possibly represented a surface on the ground floor.

Plate 14: View of the northern corner within cellar **99**

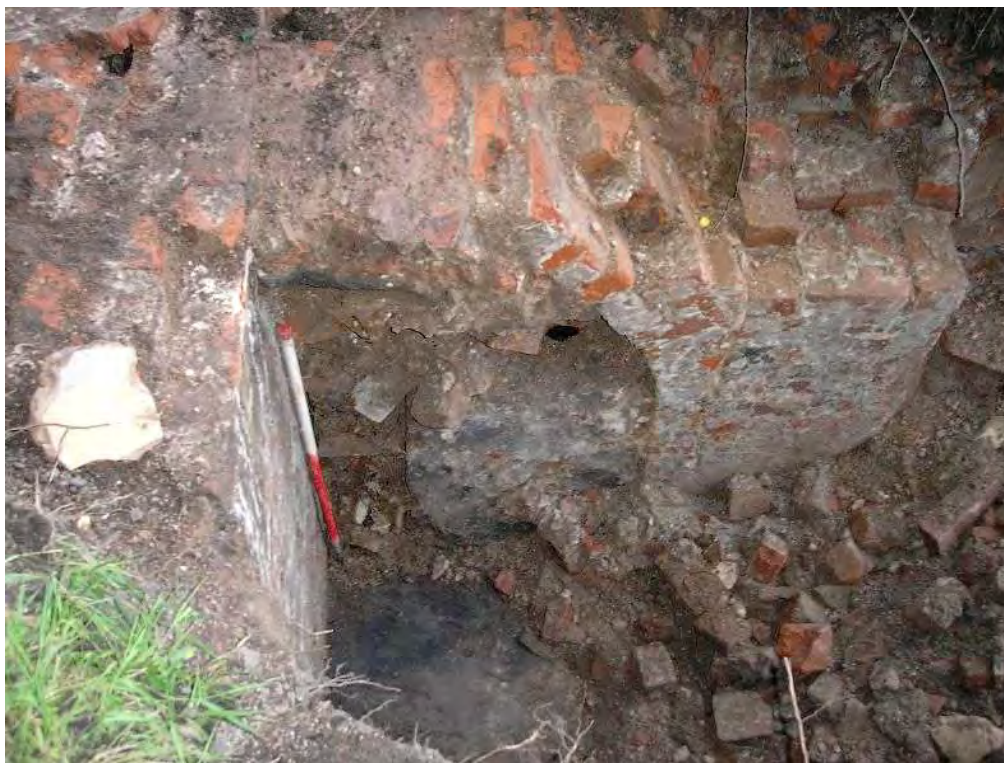
- 4.2.4 An east/west-aligned passage afforded access to the cellar from beneath the house. The passage had a width of 1.5m and a barrel-vaulted roof (Plate 15), and seemingly continued beyond the western side of the house.

Plate 15: View of the passage along the southern-eastern wall of cellar 99, looking north

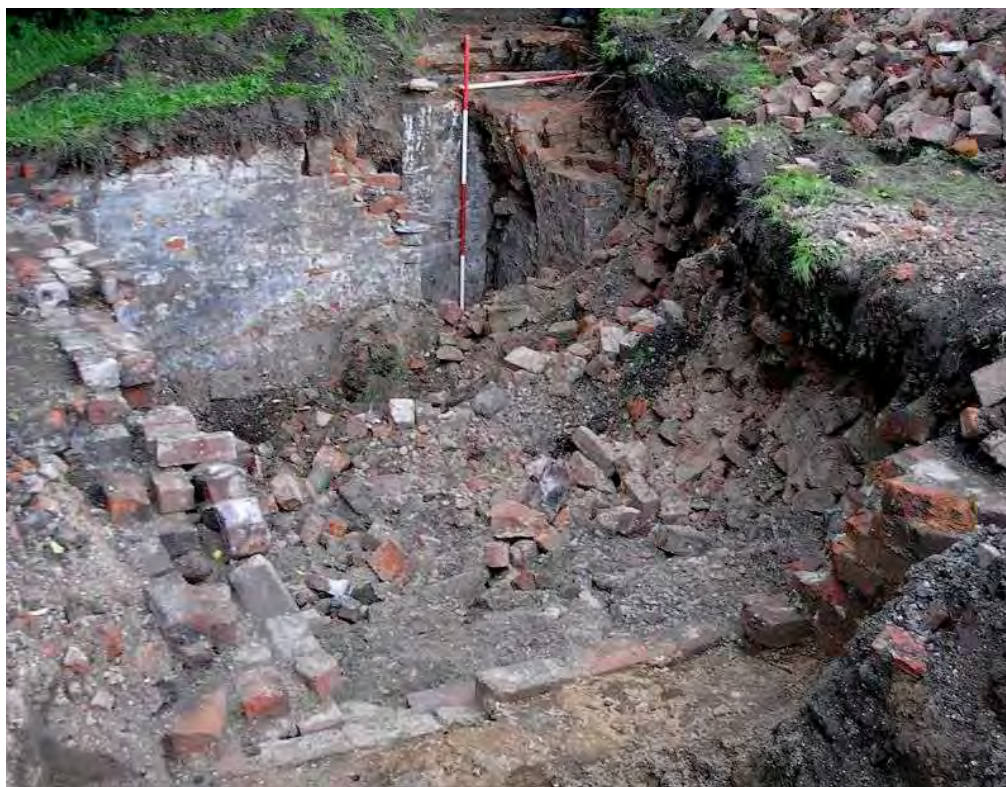
- 4.2.8 Wall **73** was located opposite wall **71**, forming an entrance to the arched passageway that was formed from walls **71** and **72**, as well as the passage formed by walls **72** and **73**. Wall **73** was four-bricks thick, with the remains of a barrel-vaulted ceiling attached to the upper surface of the wall, bridging to wall **72**. This passageway had been blocked at the bottom by a 0.5m high brick wall. An *in-situ* stone-flagged floor (**69**) was partially exposed, and measured 0.8m x 0.58m. The sandstone flags were laid above mid-brown sand (**70**).

*Plate 16: View of cellar 100, looking north-west*

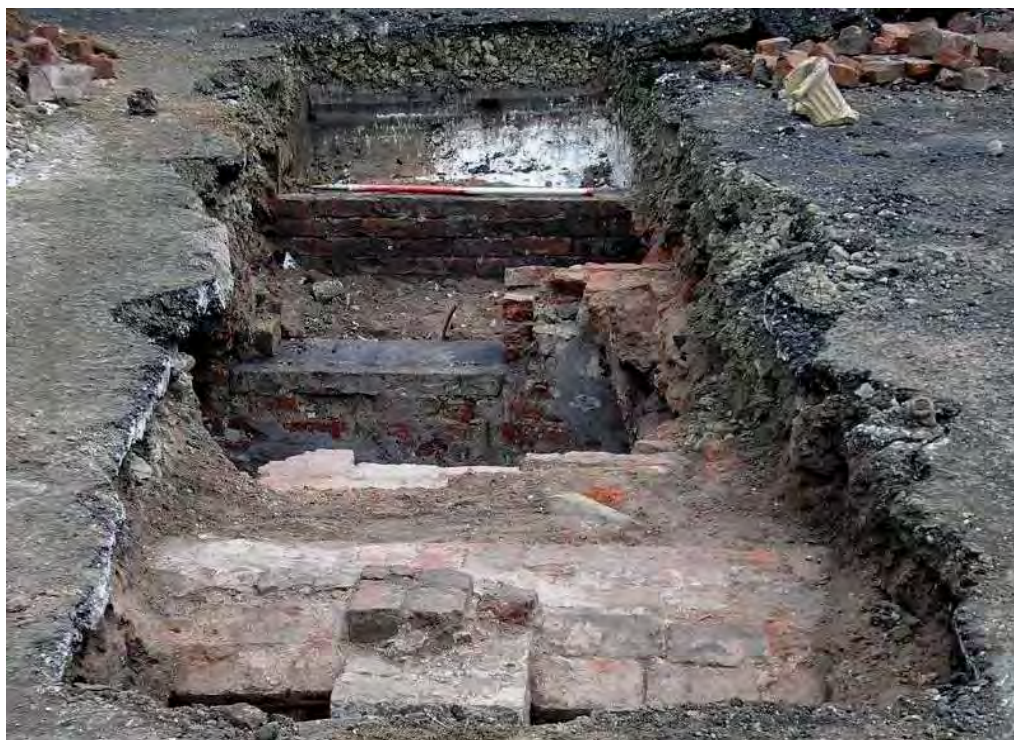
4.3.1 Trench 2 was placed across the eastern side of the house, approximately beneath the former kitchen and dining room (Plate 17). The trench was aligned north-west/south-east, measured 8.4m long, and was excavated a maximum depth of 1.7m into a layer mid-brown sand (**21**). The exposed structural remains included a probable toilet located along the southern edge of the cellar (Fig 4). The deposits in the trench comprised a layer of mid-orange-brown sand (**21**), representing the natural geology, which was sealed by demolition rubble (**17** and **20**) within the northern part of the trench. Another horizon of natural origin (**12**), comprising yellow sand, was observed at a depth of 0.5m beneath the modern ground surface at the southern end of the trench. This was located in an area across the southern front of the house, which had seemingly never been disturbed by any development. The sand was partially sealed by a dump of lime (**11**), measuring 0.9m in diameter and up to 0.3m thick, and perhaps represented the mortar that had been used during the construction of the housed.

Plate 18: View of Trench 2, looking south-east

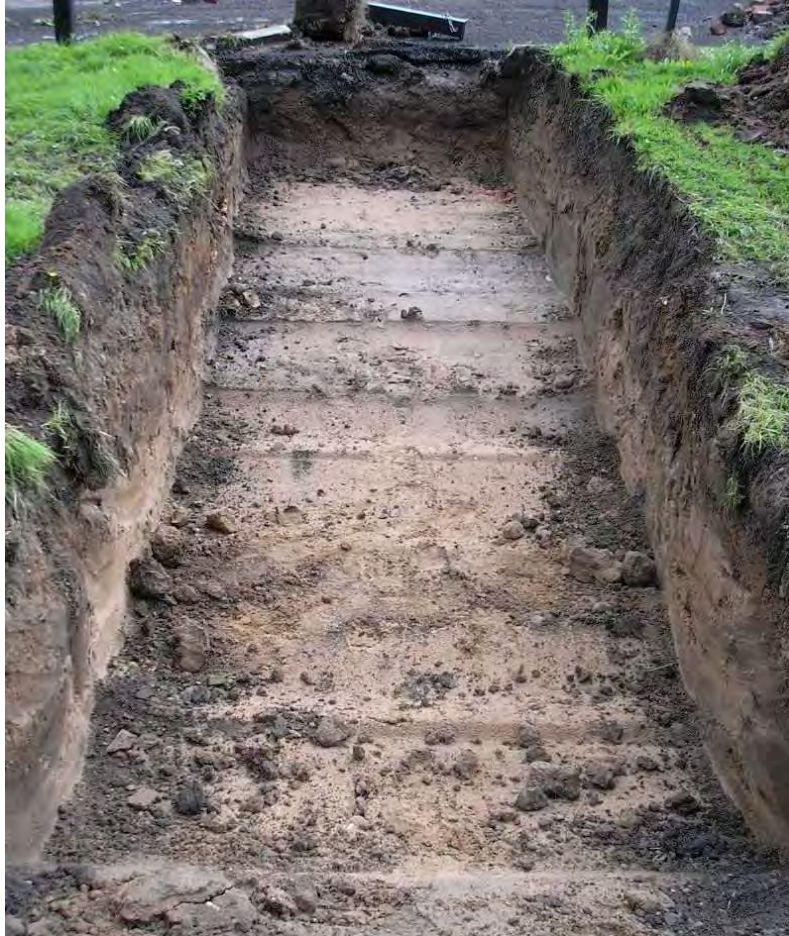
*Plate 18: View of Trench 3, looking north*

4.4.1 This trench was aligned north-east/south-west, and was excavated to a length of 6m (Plate 18). The trench was intended to establish the presence or absence of the external wall along the western side of the house. However, the western wall was not encountered in the trench, or any other structural remains, except for a land drain. The trench was excavated to a maximum depth of 0.9m onto the surface of red sand (**62**) at the western end of the trench, levelling up to 0.5m throughout the remainder of the trench.

4.4.2 The excavated deposits comprised red saturated sand (**62**), which was sealed beneath a 0.2m thick layer of cream-yellow sand (**61**); these sand deposits represented the natural geology (Plate 19). The sand was overlaid by dark red-brown sandy-clay (**60**), which extending for a length of 3m across the trench and was 0.16m thick. This deposit represented a well-drained and naturally formed subsoil. The clay was in turn sealed by 0.12m thick yellowish-red firm clay (**59**), which was observed beneath the topsoil (**58**).

- 4.4.3 Sand **61** was cut by the north/south-aligned ceramic drain (**63**). The drain had been repaired during the last century, as indicated by a re-cut of the foundation trench.

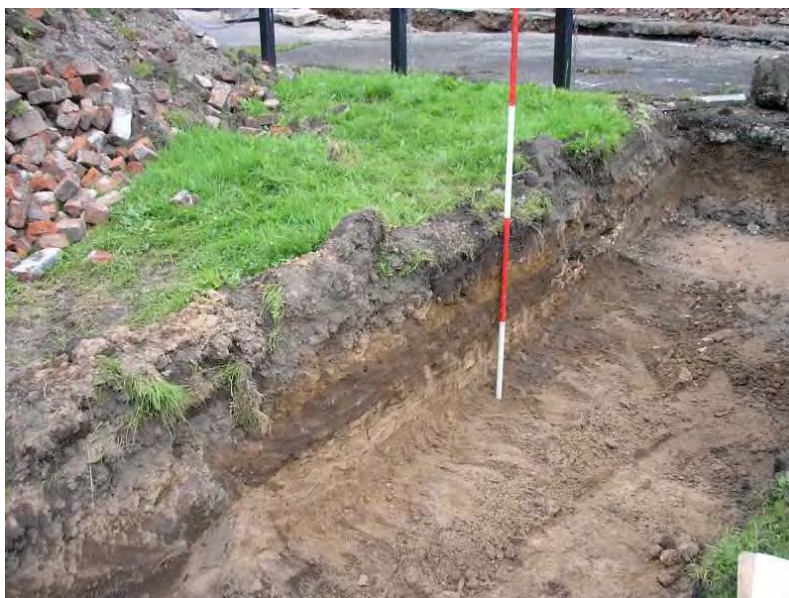
*Plate 19: South-east facing section through Trench 3, looking north*

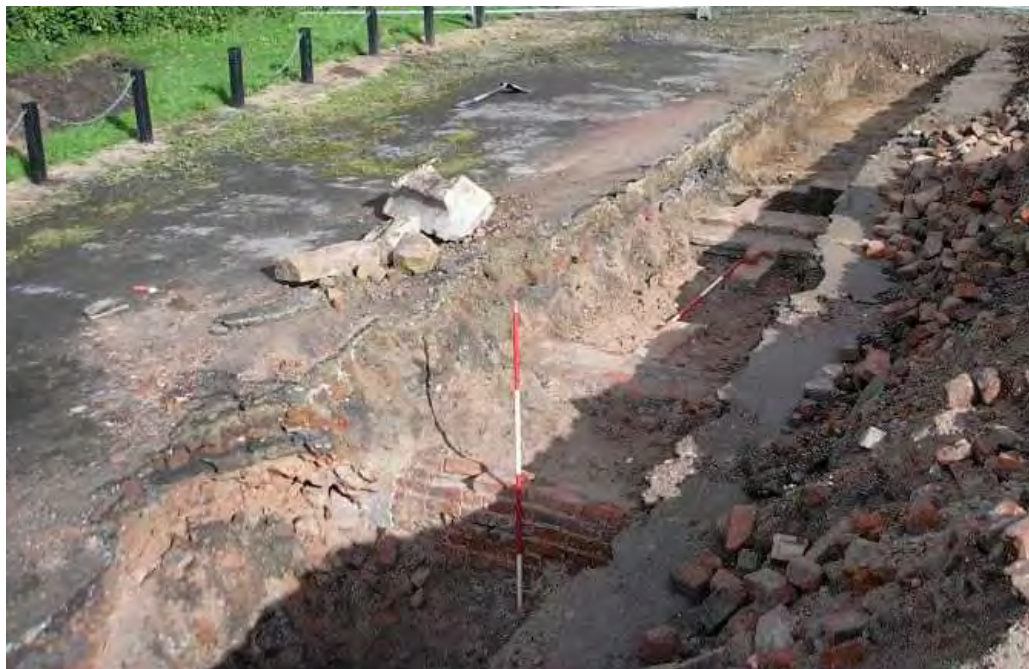
- 4.5.3 The earliest deposit encountered in the trench comprised pale brown/red sand (39), representing natural geology. This was cut by the external walls 41, 48 and 49, and a ceramic drain (40), which was contained within a north-east/south-west-aligned cut, and was 0.17m in diameter. Sand 39 was overlain by a layer of gravel, 0.15m thick, and sealed by thick layers of demolition material that had been crushed and compacted to form levelling for the modern ground surface. No *in-situ* floors survived in the trench.

Plate 20: View of the central area of the trench

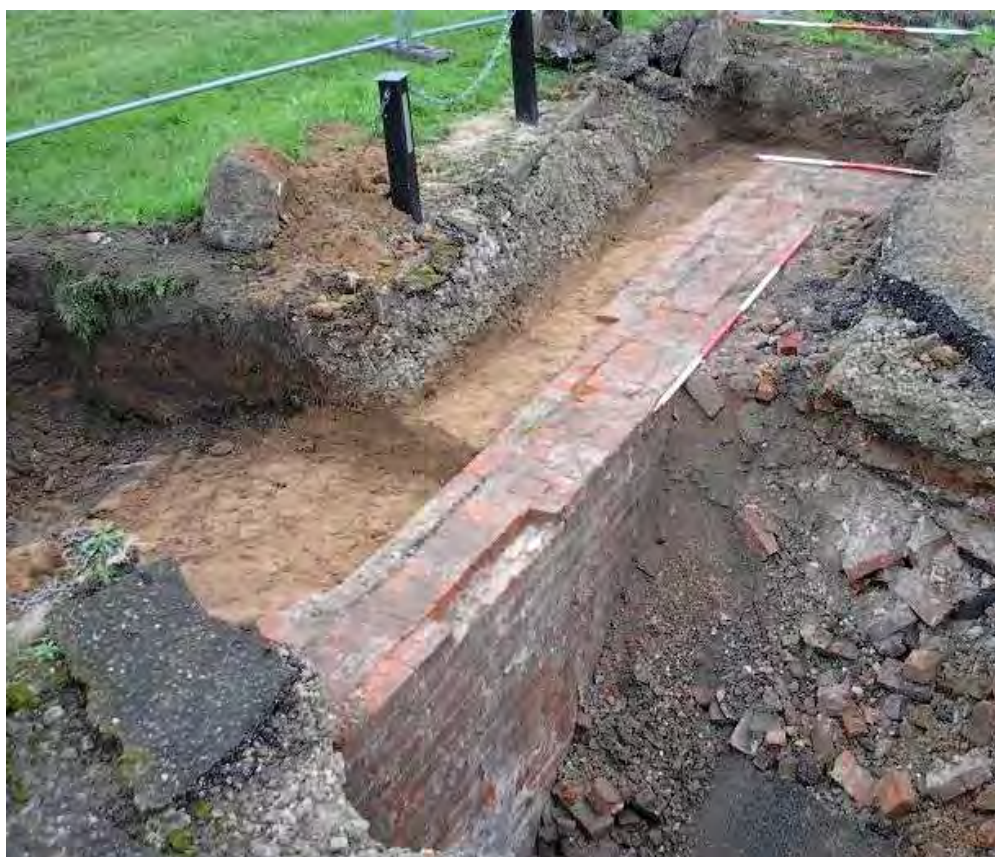
4.5.5 Wall **48** was located at the southern end of the trench, and was aligned parallel to wall **41** (Fig 5). At least 15 brick courses were exposed, providing a height of 2m (Plate 21). It measured 0.64m wide, and was generally three brick-skins wide, and bonded with off-white lime-based mortar. The southern side of the wall incorporated a small bay, measuring 2.32m by 0.16m, which may have represented part of the foundations of the window visible on historical photographs of the house (Plate 9). The wall was keyed into the north-west/south-east-aligned section of the western external wall **49**. This was exposed for a length of 1m, and was four bricks thick at the junction of the walls. The foundations exposed in this part of the house lay beneath the library.

*Plate 21: South-western external corner of the main house*

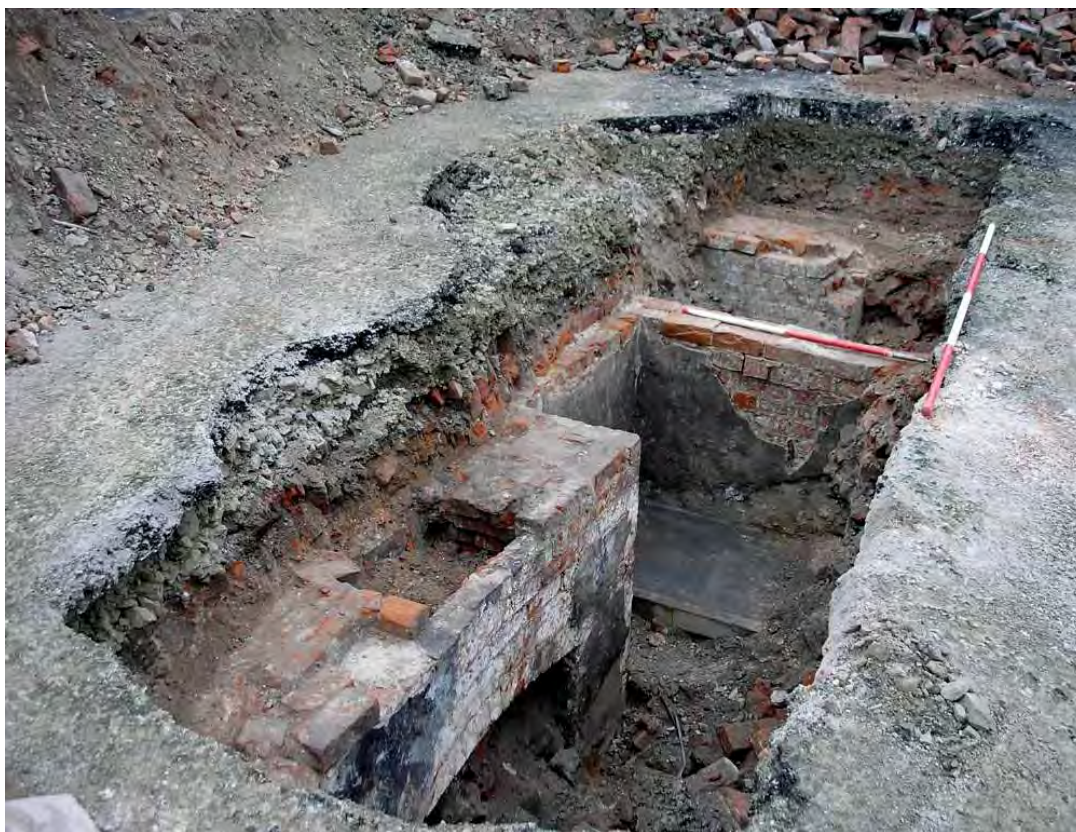
Plate 22: View of Trench 5, looking south-east

4.6.3 The eastern cellar contained a fireplace (**54**) and a stone sink (**52**). The fireplace was located in the eastern corner of the trench, projecting 0.53m from wall **53**, and facing to the north (Fig 4). It measured 2.08m long with a centrally positioned internal flue measuring 0.64m by 0.4m (Plate 23). The northern face of the fireplace was intact, with at least six brick courses beneath a thick lime-washed render.

4.6.4 Sink **52** comprised a single piece of rectangular-shaped limestone, measuring 0.78m wide and at least 1.6m long, aligned along the eastern side of wall **51**. It was 0.12m thick, and contained a chamfered edge, forming an internal recess thus providing an internal width of 0.67m and 40mm deep, with a centrally positioned hole measuring 25mm in diameter. Its proximity to the fireplace (less than 1m east) suggested that room was used as a washroom, or for the preparation of food.

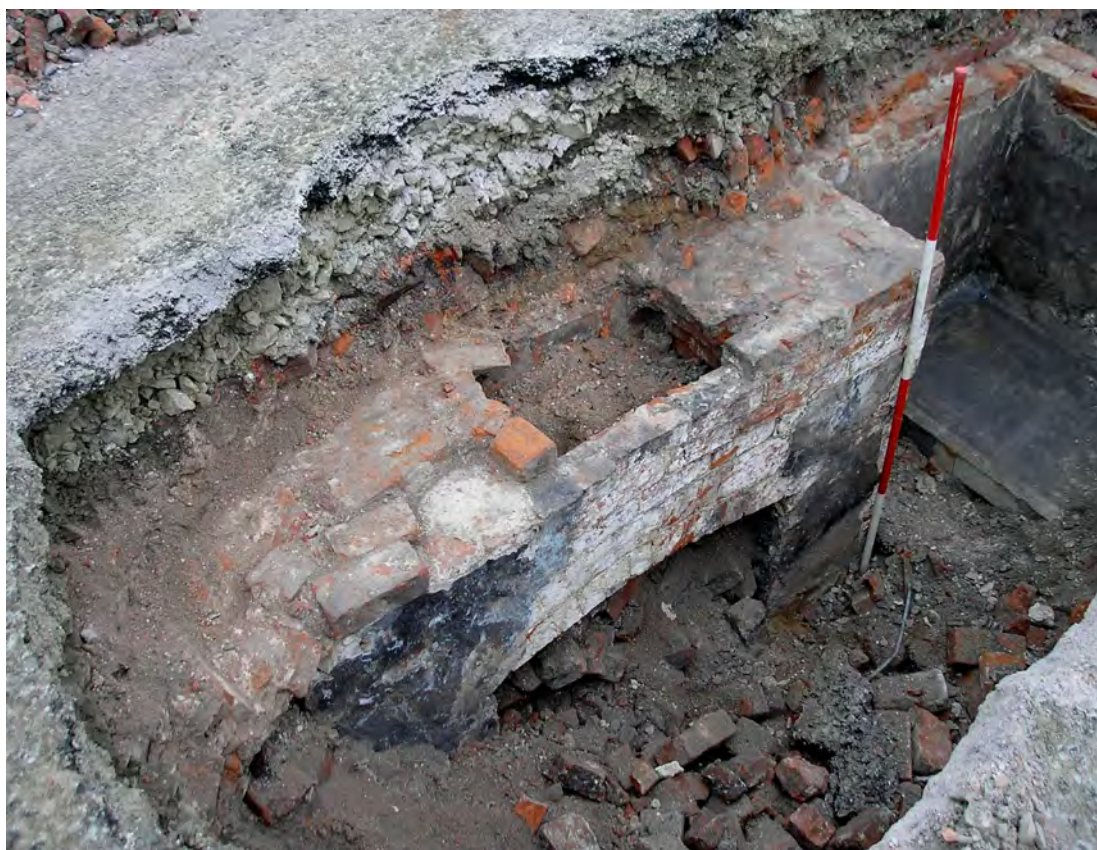
Plate 23: Fireplace 54 and sink 52, Trench 5

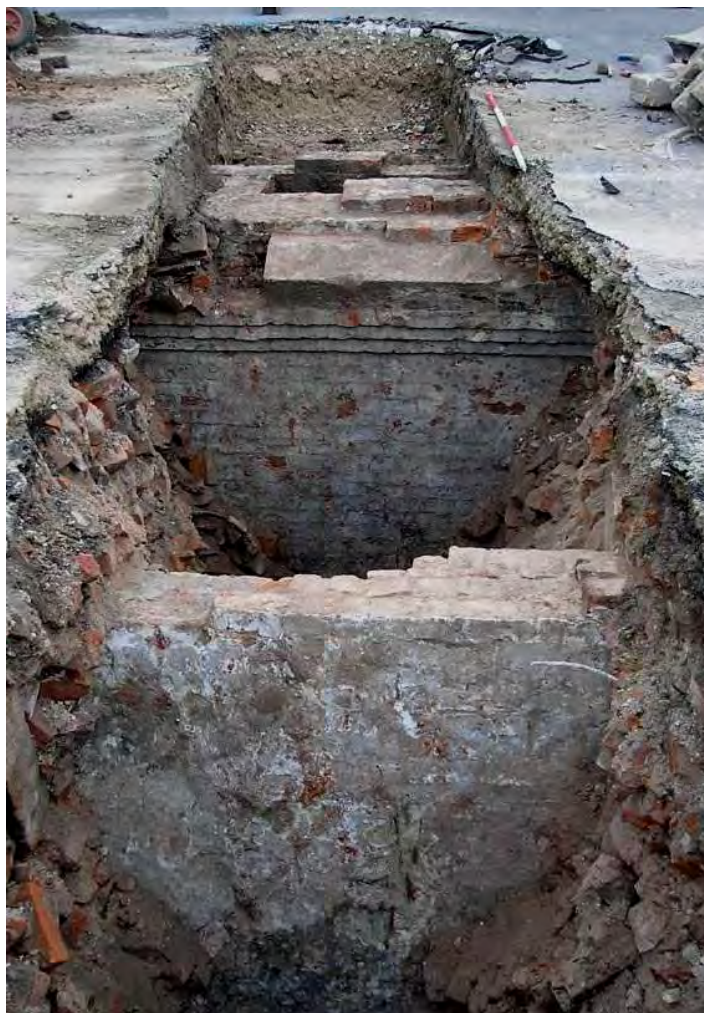
Plate 24: View of the trench, looking north-west

- 4.7.1 Trench was aligned north-west/south-east, and was placed across the eastern part of the main house (Plate 24). It measured 12m long, and was excavated to a maximum depth of 2.38m. The trench was intended to establish the presence or absence of the northern external wall (33) of the house, and any surviving internal features. The natural geology (38) was exposed at the northern end of the trench. Several well-preserved structural remains were exposed, including two cellars (35 and 36), separated by a partition wall (32), which were situated beneath the dining room. An east/west-aligned pipe (34), located to the north of wall 33, had presumably been intended as a drain. No flooring survived in either of the cellars, which had been backfilled with demolition debris.

- 4.7.2 The northernmost cellar (36) measured c 3.5m long, and was defined by wall 33 to the north and wall 32 to the south (Fig 4). The full extent of cellar 35 was not exposed, although excavation demonstrated it to be of a similar length to cellar 36. Wall 33 was aligned north-east/south-west across the northern part of the trench, and survived to a height of 2.4m. It comprised mould-thrown bricks, each measuring 230mm x 110mm x 70mm and bonded with lime-based mortar. The wall incorporated some stone components, representing elements of a vaulted ceiling for the adjoining cellar (36). The wall also incorporated a 0.4m wide cavity, similar to those in Trench 4.

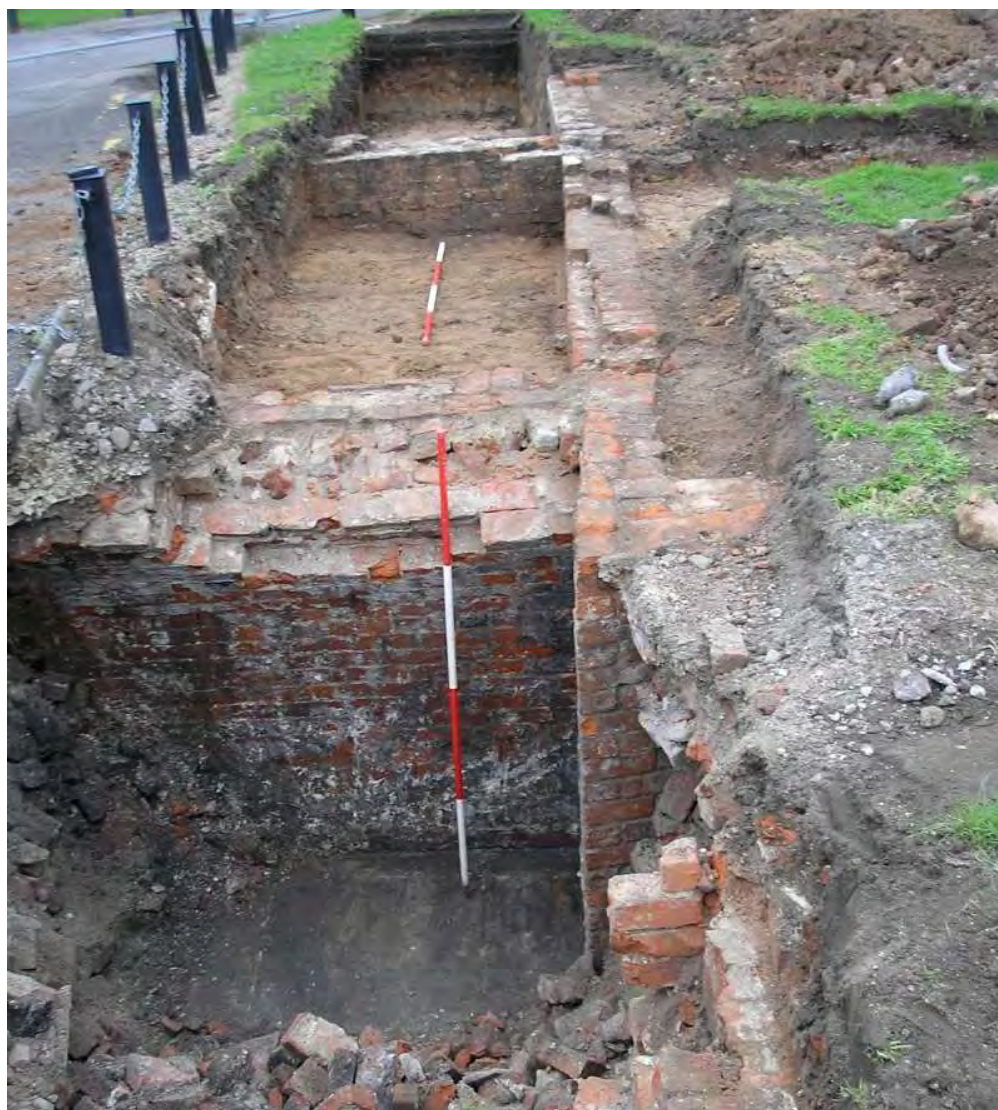
*Plate 25: View of the trench, looking north-west*

4.8.1 The trench was aligned north-west/south-east across the footprint of the eastern wing of the house, and adjoined the western end of Trench 8 (Fig 2). It was intended to locate the external walls of the building, and any internal structures. It was excavated for a length of 14.5m, and to a maximum depth of 2.20m (Plate 25). The natural geology was represented by pale brownish-red sand (22), which was exposed at a depth of 0.5m beneath dark grey-brown sandy-clay topsoil (31) at the north-western end of the trench. In total, three external walls (23, 24, and 27) and a cellar (28) were encountered (Fig 6), which demonstrated at least two phases of construction pertaining to the development of the eastern wing during the mid- to late nineteenth century.

4.8.2 Wall 23 was located along the eastern side of the trench, cutting sand 22. The wall was aligned north-west/south-east, and was exposed for a length of 6.5m. It measured three bricks thick, and survived to a height of nine courses (0.6m), with a single stepped footing along its foundation. The south-eastern section of the wall was constructed entirely from hand-made, mould-thrown bricks

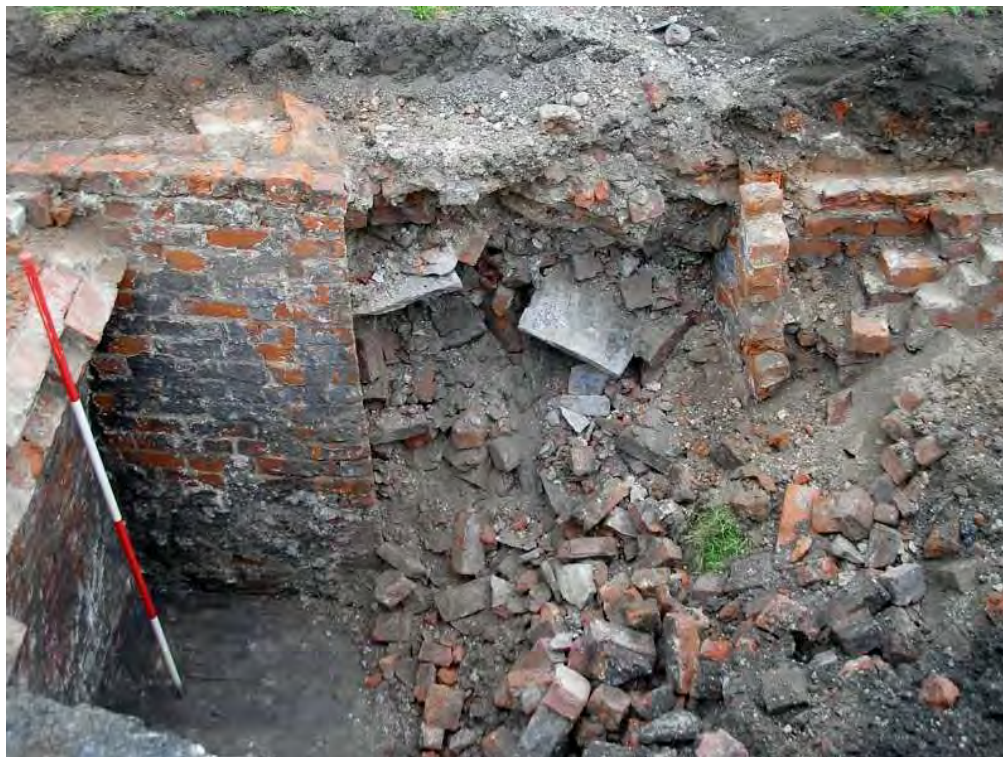
4.8.4 The floor of the cellar was exposed at a depth of 1.7m beneath the uppermost brick arch, although the projected profile of the cellar ceiling suggests a probable floor depth beneath the roof exceeding 2m. The floor was composed of large rectangular flags, each measuring at least 1m by 0.5m, which were exposed along the western side of the cellar. The entrance measured 1.35m wide bordered by a 0.5m long by 0.4m wide wall (**26**), which was keyed into the eastern end of wall **30**. The wall represented the northern boundary of a passage which continued north-east beneath the eastern limit of excavation, probably connecting to a passage revealed in Trench 8 (*Section 4.9.5 below*). The southern wall of the passage was not fully exposed.

Plate 26: Doorway within the northern wall (29 and 30) of cellar 28

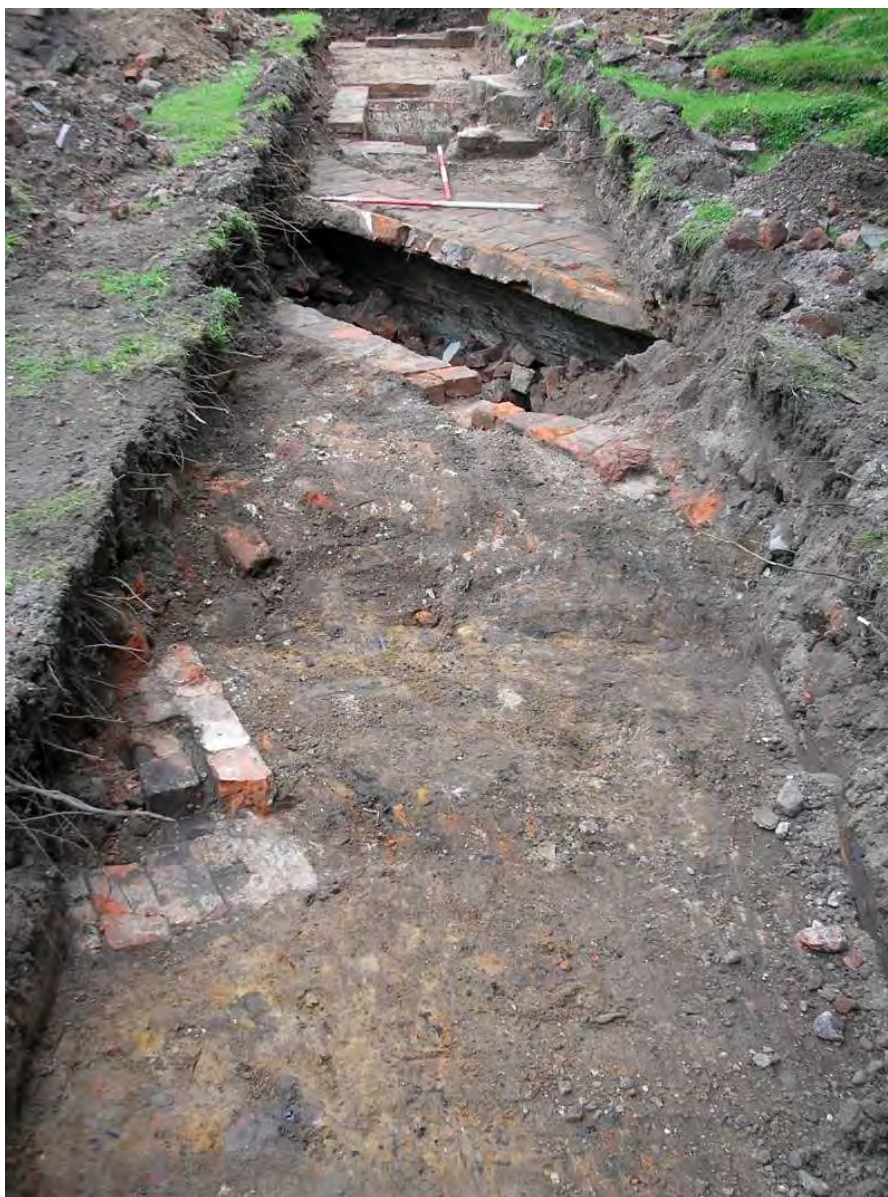
*Plate 27: View of Trench 8, looking west*

4.9.1 The trench was placed approximately north-east/south-west across the footprint of the eastern wing of the house, and aimed to establish the presence or absence of its eastern external wall. The trench measured 12.8m long and 1.6m wide (Fig 6), and was excavated to a maximum depth of 2.2m to the surface of a floor in a roofed passageway (08). For the most part, however, the trench was excavated to the surface of a layer of yellow sand (02), representing natural geology, which was exposed at an average depth of 0.5m below the modern ground surface (Plate 27).

4.9.2 The natural geology was sealed by a layer of sand (09), which contained frequent inclusions of brick rubble, presumably representing the demolition of the eastern wing, but was otherwise very similar to the underlying natural geology. Layer 09 was 0.2m thick, and was overlain by a 0.10m thick deposit of topsoil. The natural geology was cut by three structures (01, 08 and 10). These comprised a possible toilet (01), a roofed passage (08), and a man-hole (10).
