**PHILIPS PARK  
HOUSE,  
PRESTWICH  
GREATER  
MANCHESTER**

**Archaeological  
Evaluation**

**Oxford Archaeology North**

October 2008

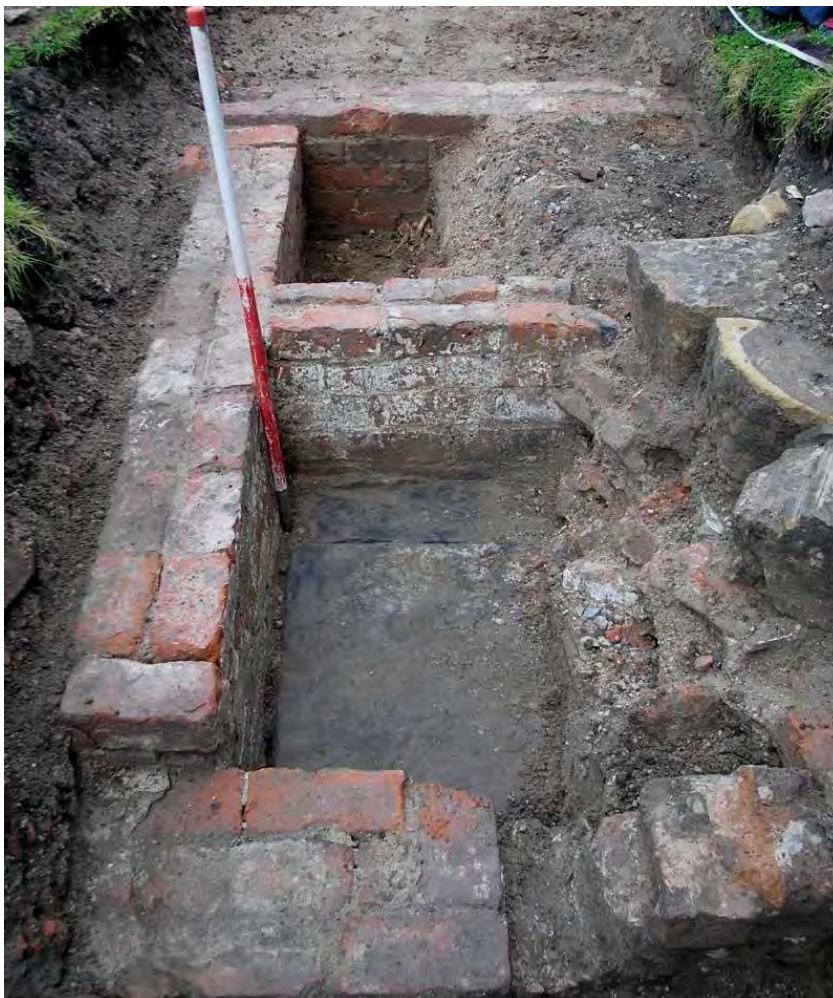
- 4.9.4 The structure had been sub-divided by a one-skin wide partition, thus creating two chambers of equal size (Plate 28). No floor was present in the western chamber, although the eastern chamber contained a sloping flagged floor at its base. Both chambers were filled with brick rubble, which was overlain by a row of four sandstone blocks. However, these were unlikely to have formed part of the structure, and probably derived from the demolition of the façade surrounding the eastern wing. The intended function of structure **01** remains uncertain, although it seems possible that it might have been a water closet for use by the servants.

Plate 28: Remains of a possible toilet foundation (01), looking west

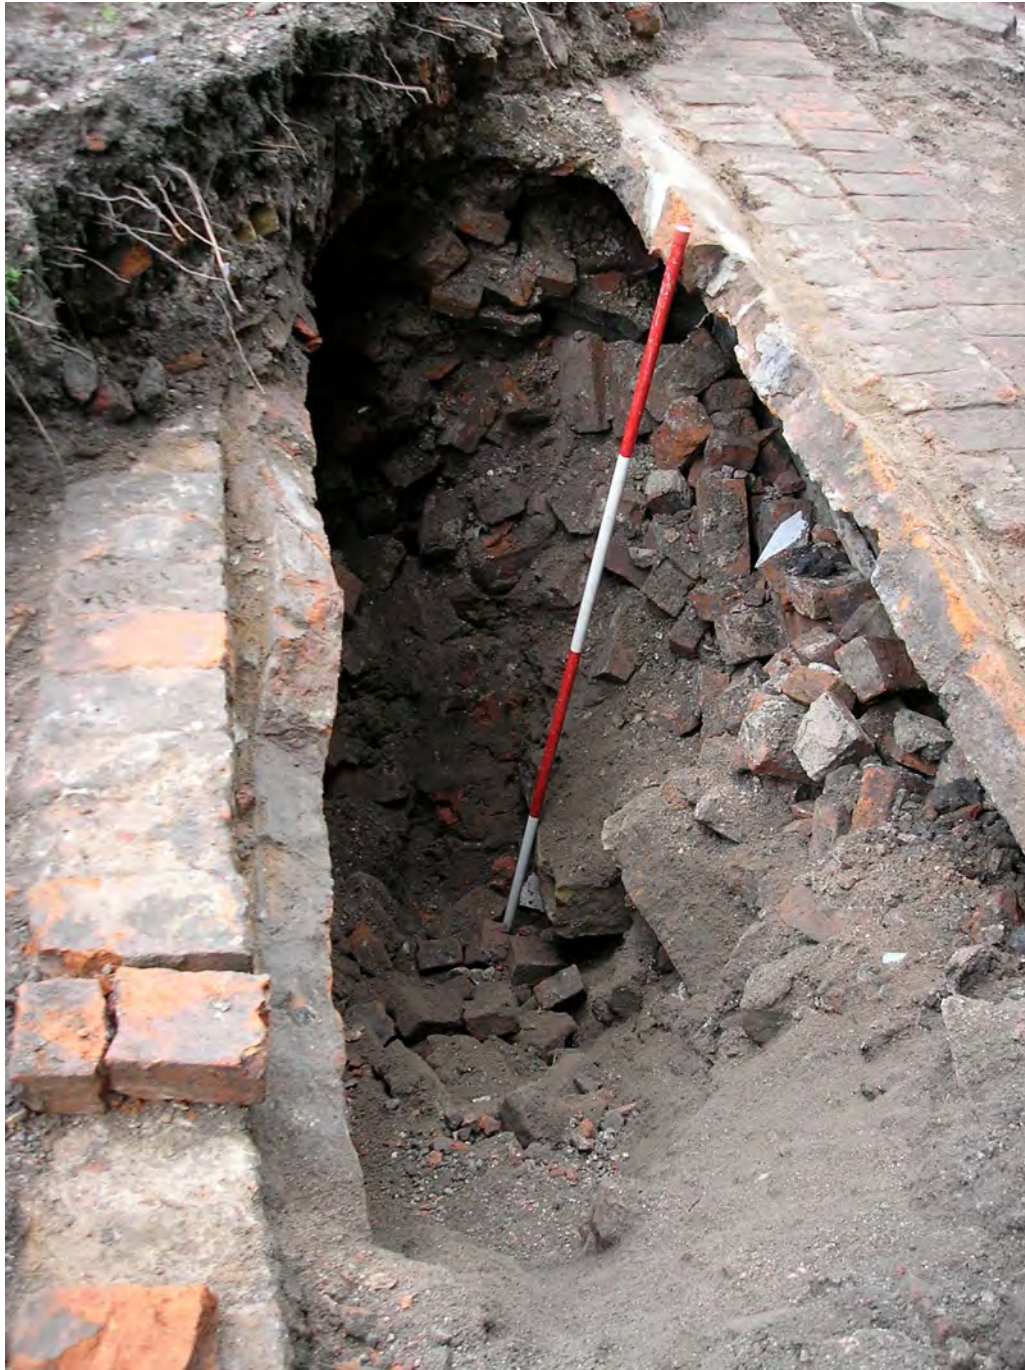
- 4.9.6 It is possible that the passage connected an entrance for servants and tradesmen along the eastern side of the wing to the cellars within the southern part of the house. The orientation of the passage suggested that it would lead to cellar 28 in Trench 7, passing beneath part of the east wing and, as such, may have been constructed prior to the alterations of the east wing undertaken some time after the mid-nineteenth century.

*Plate 29: Passage 08*

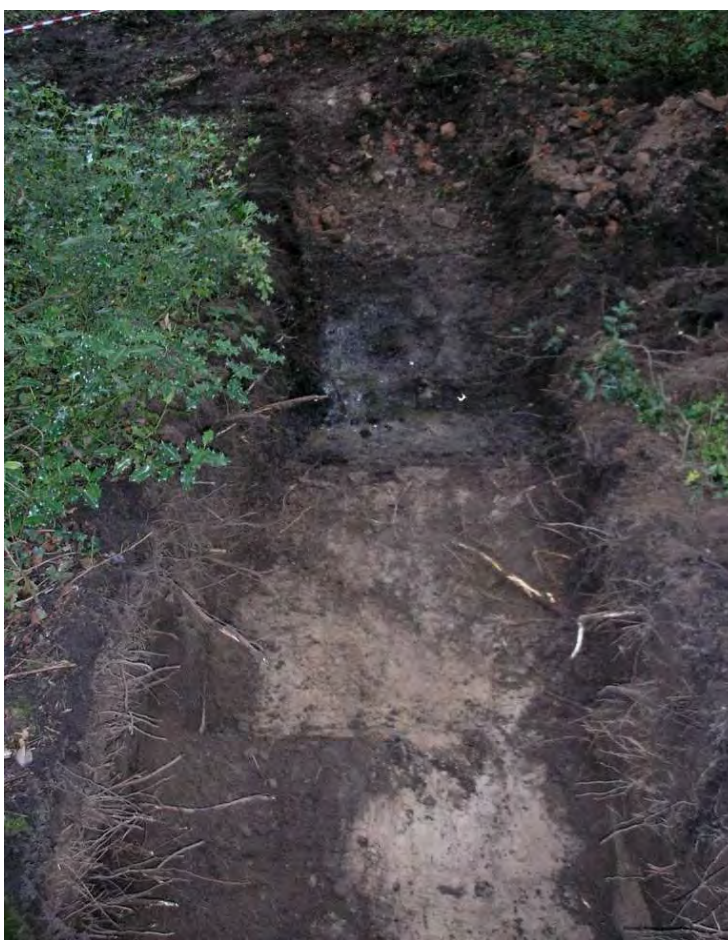
Plate 30: View of Trench 9, looking south-west

4.10.1 The trench was aligned east/west across a hollow located in a wooded area to west of the house (Fig 2). The hollow was thought to have been a possible location for an ice house, although firm evidence was lacking. The trench measured 10m long by 2m wide, and was excavated to a maximum depth of 1.2m (Plate 30). The earliest deposits encountered were a light grey sand (85), which was exposed at the northern end of the trench, and a mid-brown clay (89) that was present to the south; both deposits represented the natural geology. Structural remains of the putative ice house were not present within the excavated trench.

4.10.2 The natural geology was sealed by a deposit humic, dark grey silty-clay (86), which was exposed in the base of the hollow at the southern end of the trench. Deposit 86 had a maximum depth of 0.20m, and contained fragments of nineteenth- and twentieth-century pottery. Also within the southern part of the trench was a layer of dumped material (88), which contained fragments of dressed stone, brick, glass, plastic, and roofing slate. Deposit 88 extended for a distance of some 2m along the trench, and had a maximum depth of 0.8m. Deposits 86 and 88 were both likely to represent debris from the demolition of The Park, and were sealed by a layer (87) of topsoil.

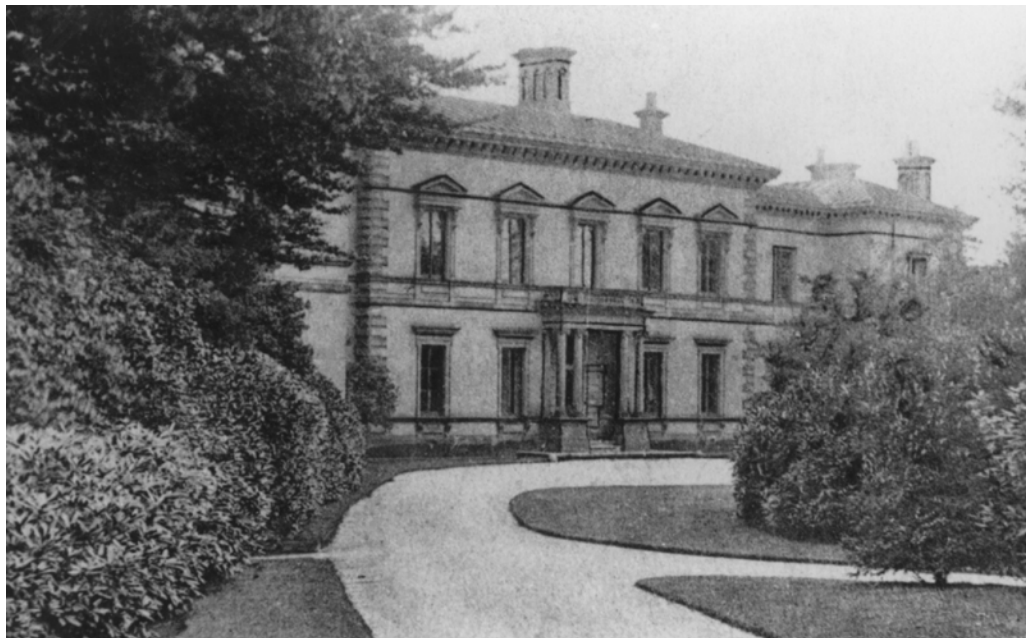
*Plate 31: The main entrance to The Park*

4.11.1 The trench was aligned north-east/south-west, extending from the northern end of Trench 4 (Fig 5). It was excavated to a length of 8.3m, and to a maximum depth of 0.30m, onto the surface of natural geology. The trench was intended to establish the precise location of the porch and main entrance to The Park, shown on historical photographs (Plate 31).

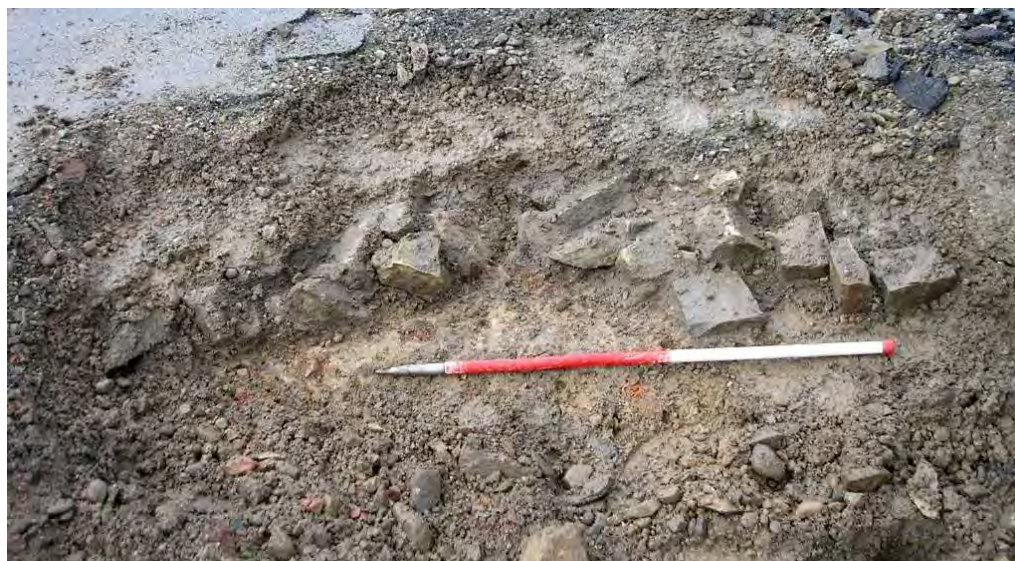
4.11.2 Potentially, the earliest remains encountered in the trench were fragmentary elements of a stone wall (97) exposed in the northern part of the trench (Plate 32). Wall 97 was aligned north-east/south-west, and comprised irregularly laid, roughly hewn stone blocks. These were laid above a layer of compacted clay (98), which contained numerous small stones, and overlay the natural sand geology. The intended function of the wall remains uncertain.

*Plate 32: Wall 97, looking north-west*

- 6.3.4 The origin and function of the crude east/west-aligned wall (**97**) to the north-west of the main entrance into the house remains uncertain. It seems possible, however, that it represented a foundation for an earlier porch, perhaps of timber-framed construction, although supporting evidence is lacking. Conversely, it may have represented a wall around a large flower bed, or similar garden feature; its position does not correspond with any structures shown on historical mapping, suggesting that the wall may be of an early date, as the first detailed map of the site was not produced until 1835-40.

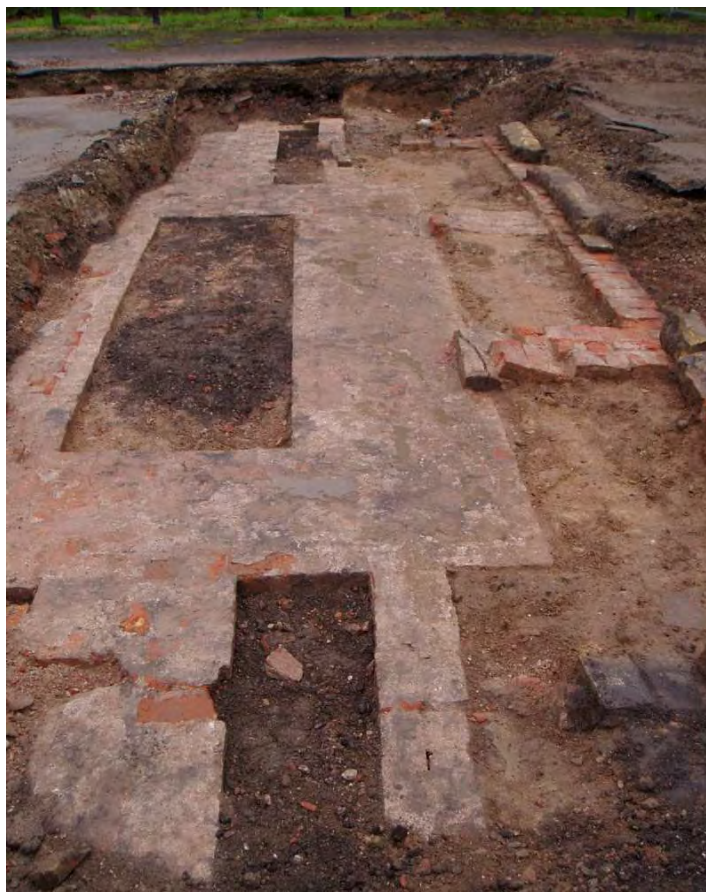
4.11.3 Remains of the northern wall (**41**) of The Park were exposed along the entire trench, together with the foundations for a porch (Plate 33). Wall **41** had a maximum width of 1.5m across the entrance of the house, although it incorporated a large cavity (**93**), measuring 3m by 0.7m, immediately beneath the entrance. Three other cavities were exposed in different parts of the northern wall. The western cavity (**92**), measuring 3.5m long and 0.36m wide, lay beneath the foundation for a window. The eastern cavity (**94**) was also located beneath a window foundation, and measured at least 1.2m long by 0.4m wide. The porch comprised a low stone wall (**90**) aligned north-east/south-west, with two north/south-aligned returns abutting wall **41** at each end. The stone wall (**90**) survived to a height of 0.23m, and incorporated chamfered sandstone blocks, each measuring up to 0.48m long by 0.12m wide and 0.12m deep. They overlay thin slabs of sandstone, which served as an interface with a brick foundation. Remains of iron strips on the upper surface of wall **90** were noted, representing masonry ties for the corner stones of the porch. The eastern face of wall **90** was butted by a brick surface, which had seemingly provided a foundation for a floor within the porch. The wall was also butted by two north-west/south-east aligned walls (**91**), set 1.7m apart, representing the foundations for low walls flanking the entrance steps. Each foundation survived to a height of 0.16m comprising two brick courses laid above a thin stone slab.

Plate 33: View of Trench 10, looking west

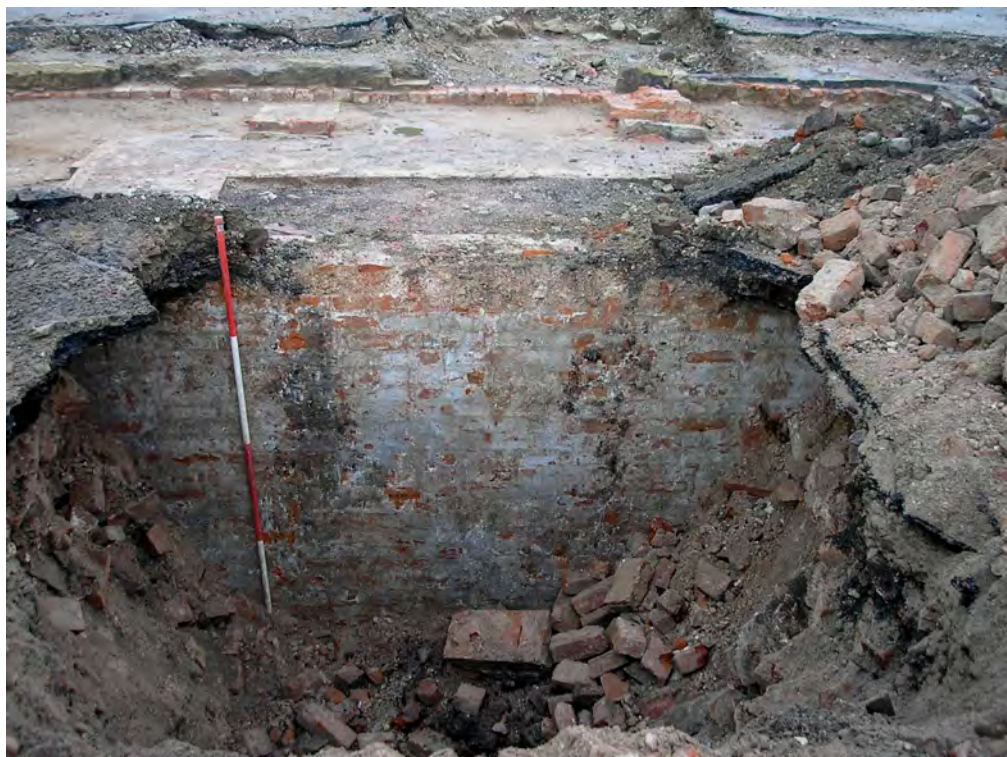
4.11.5 The northern edge of the cellar was formed by wall **41**. The southern elevation of wall **41** incorporated a narrow step (**95**), which supported a large stone block. This provided the foundation for a row of angled bricks, which formed the springing course for the brick-vault of the cellar ceiling.

*Plate 34: South-facing elevation of wall 41 to the rear of the main entrance into the house*

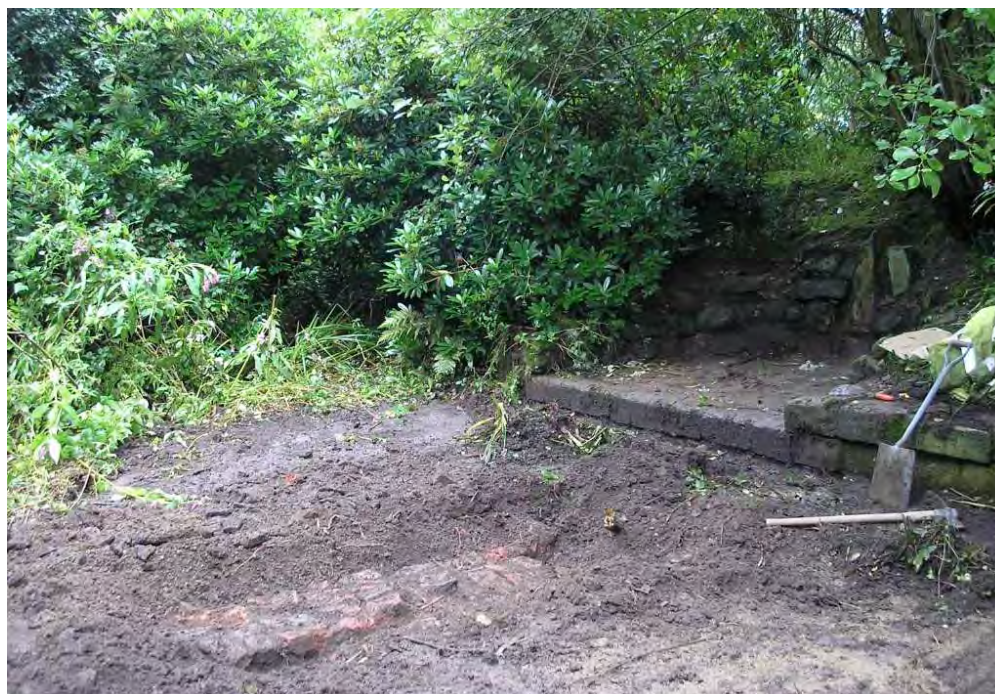
*Plate 35: Area of clearance surrounding the garden feature*

- 4.12.1 In addition to the targeted evaluation trenches, an area lying some 10m to the west of The Park was cleared of undergrowth (Plate 35) in order to establish the presence or absence of the square-shaped building shown on the parish plan of 1835-40, and to determine whether this represented the ice house.

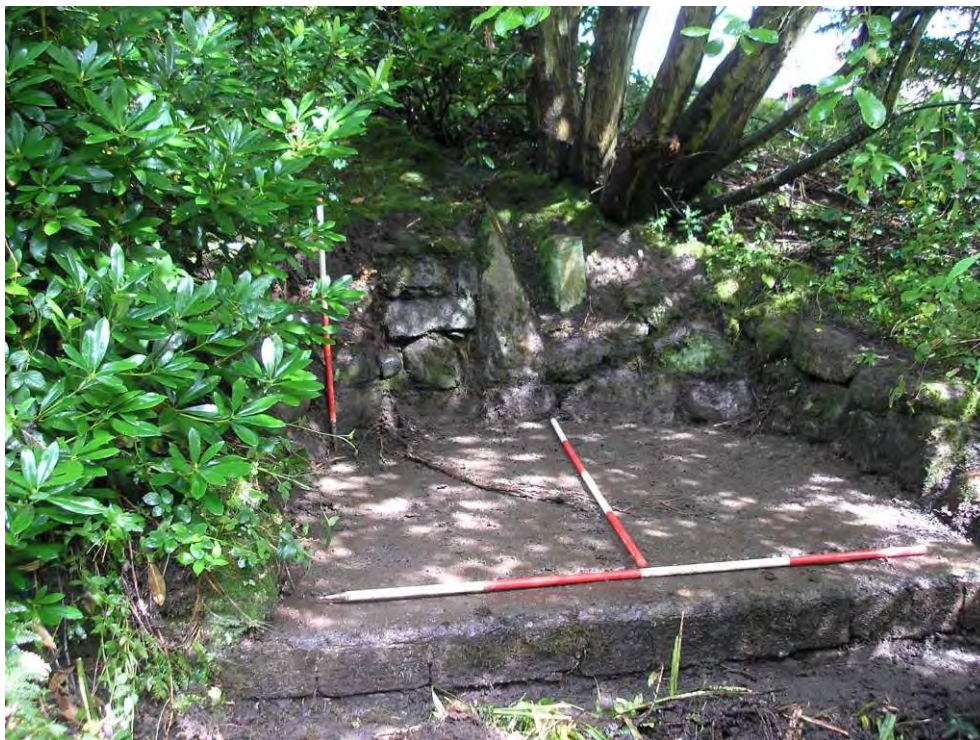
- 4.12.3 A semi-circular-shaped stone structure, built into a stone boundary wall that circumnavigated the western side of the house, formed the eastern edge of the cleared area (Fig 7). The rear of this stone structure was cut into an earthen bank, which separated the western wing of the house and the boundary wall. The structure had a diameter of 2.15m, and survived to a height of 1.2m (Plate 36). It was composed of roughly shaped sandstone blocks of varying sizes. The floor of the structure comprised a thick layer of concrete, although an indication of an earlier surface was represented by a single block of sandstone that abutted the internal elevation of the structure. This was not investigated further during the course of the evaluation, as the removal of the concrete floor would have wrought irreparable damage to the structure.

*Plate 36: View of the stone-built garden feature, looking north*

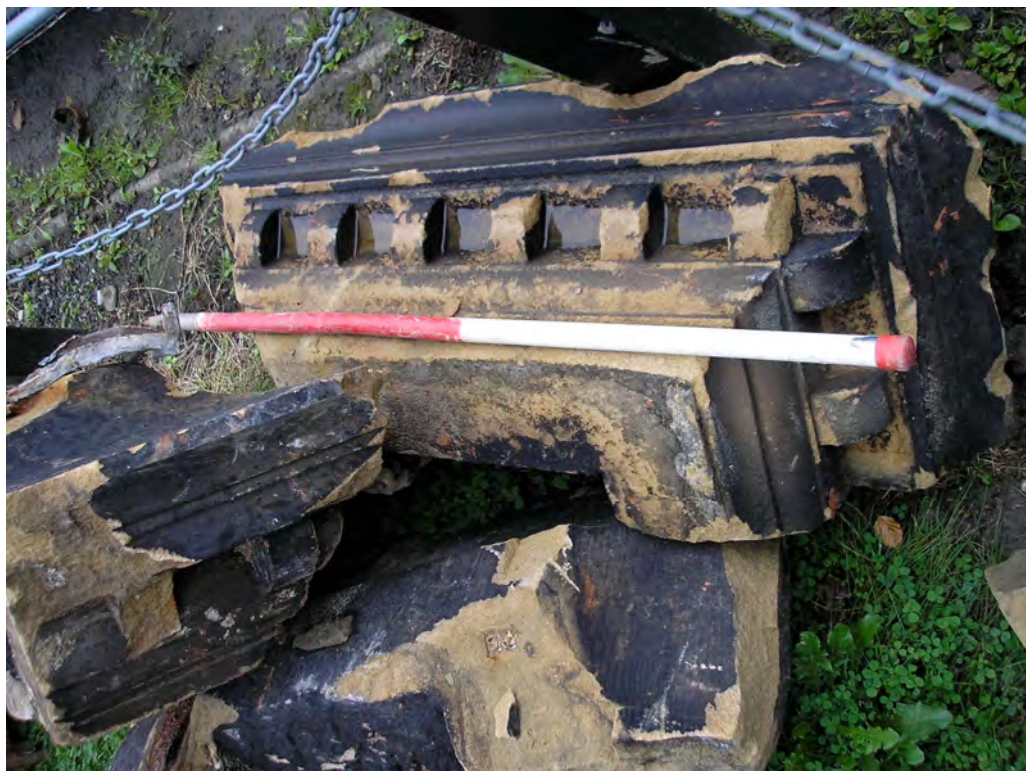
5.3.2 Several large fragments of ornamental stonework were also recovered from the evaluation trenches, particularly fragments of dentilled cornice (Plate 37); these were not retained, but recorded on site and backfilled in the northern end of Trench 7. These fragments of ornamental stonework were all sandstone, and were probably quarried from a local source. The fragments are likely to have derived from the north elevation of the house, and formed surrounds for the windows.

*Plate 37: Fragments of dentilled cornice ornamental stonework*

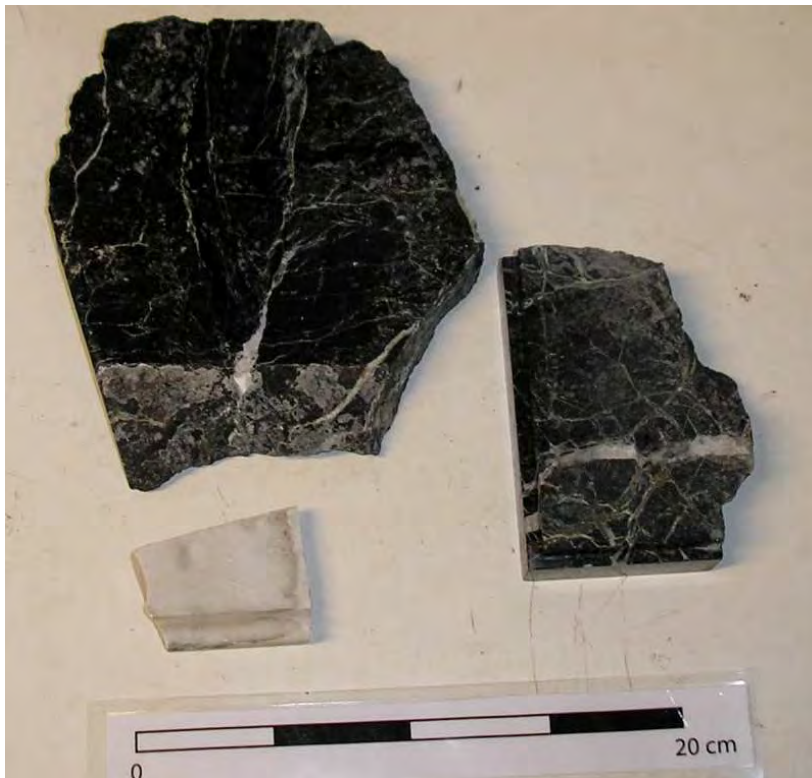
Plate 38: Fragments of marble from Trench 6 and 10

- 5.3.3 Two fragments of thin white floor tiles were recovered from Trench 4. These may have originated from an inlay on the drawing room floor, or perhaps formed part of the mantelpiece. Thicker fragments of black tiles were found overlying the stone sink in Trench 5.
- 5.3.4 The remainder of the stone artefacts comprised fragments of black marble, which may have derived from fire surrounds and mantelpieces (Plate 38). These were recovered from Trenches 1, 6, 10, and perhaps derived from the library, dining room, and the main entrance.

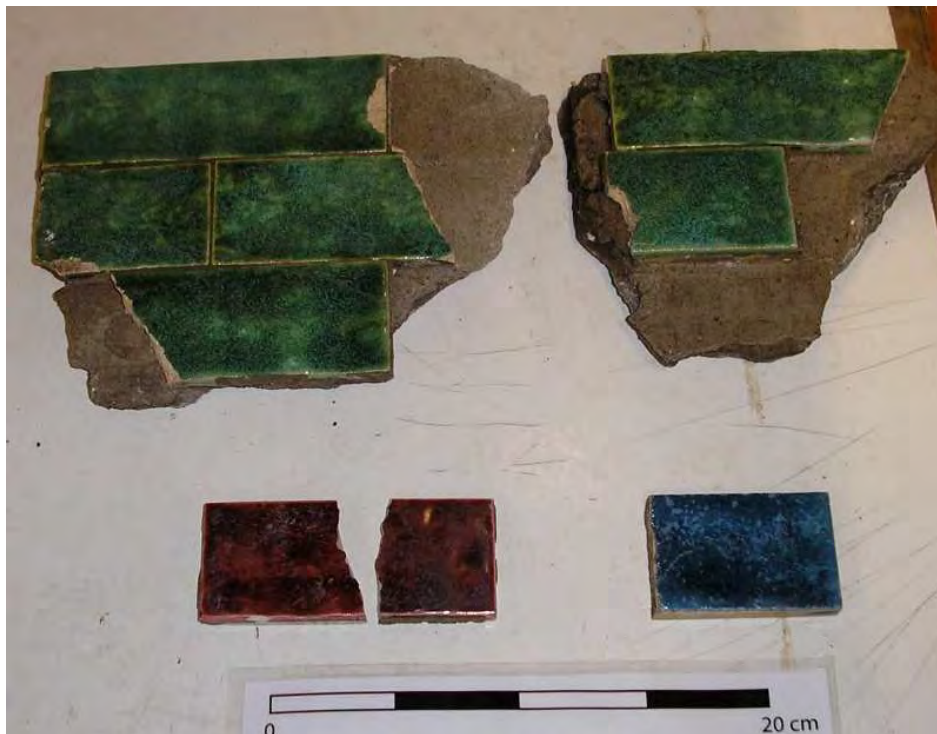
- 5.4.2 Fragments of wall tiles were recovered from Trenches 2, 4 and 10 (Plate 39). A well-preserved section of green-glazed tile attached to plaster was recovered from Trench 10. In total, 11 of these tiles were recovered, each measuring 100mm by 50mm. A variety of other coloured glazed tiles were found, including dark red and blue. All of the wall tiles were likely to have been manufactured by Pilkington, indicated by a manufacturers stamp noted on the rear of one tile (Plate 40). Pilkington's works was based at Clifton Junction, which produced tiles of this type from the late nineteenth century. The

*Plate 39: Selection of Pilkington wall tiles recovered from the evaluation*

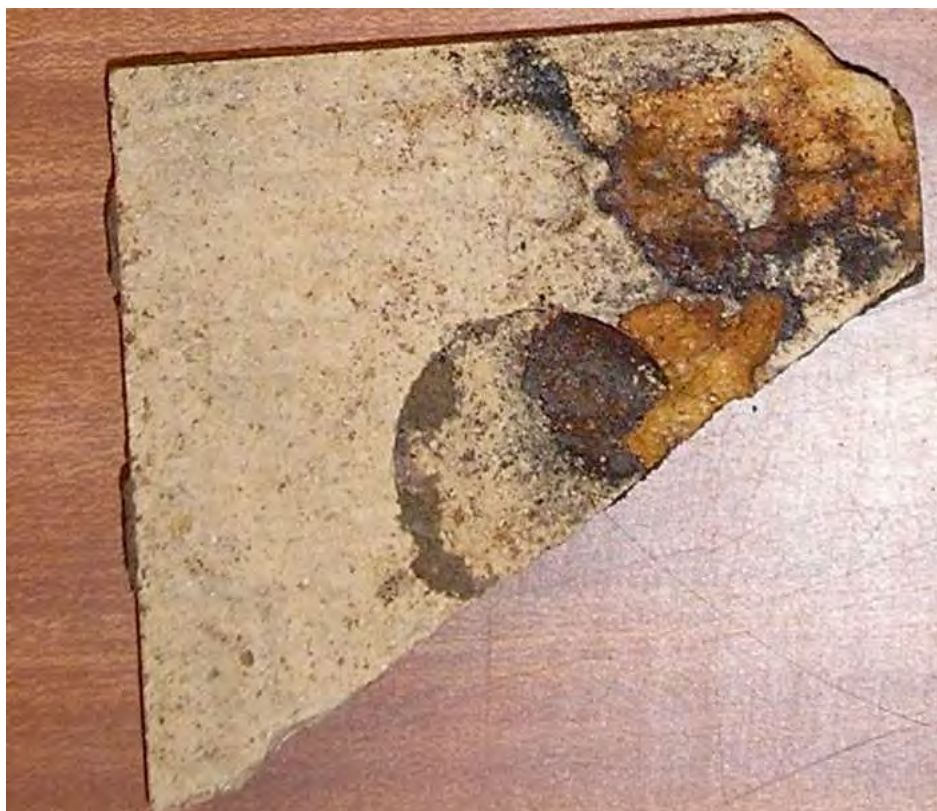
*Plate 40: Reverse view of a tile with a faintly legible P stamp and a firing scar*

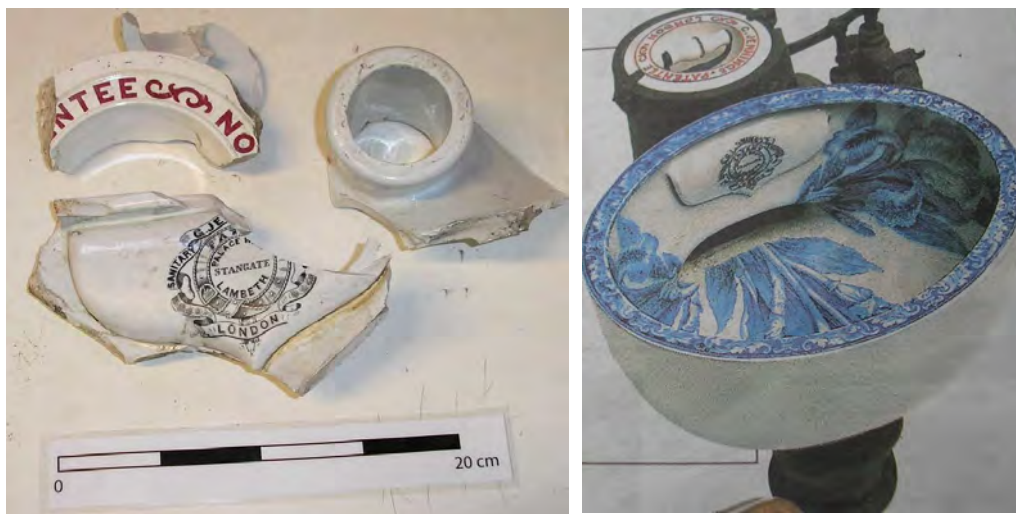
- 5.4.3 Other ceramic items included two white-glazed door and drawer knobs, and the fragmentary remains of a water closet, which was recovered from Trench 6. The fragments were reminiscent of the type of closet designed by George Jennings in the latter half of the nineteenth century (Palmer 1973; Plate 41).

Plate 41: Fragments of a water closet designed by George Jennings (left), and an example of the type of closet patented by Jennings in 1875 (right)

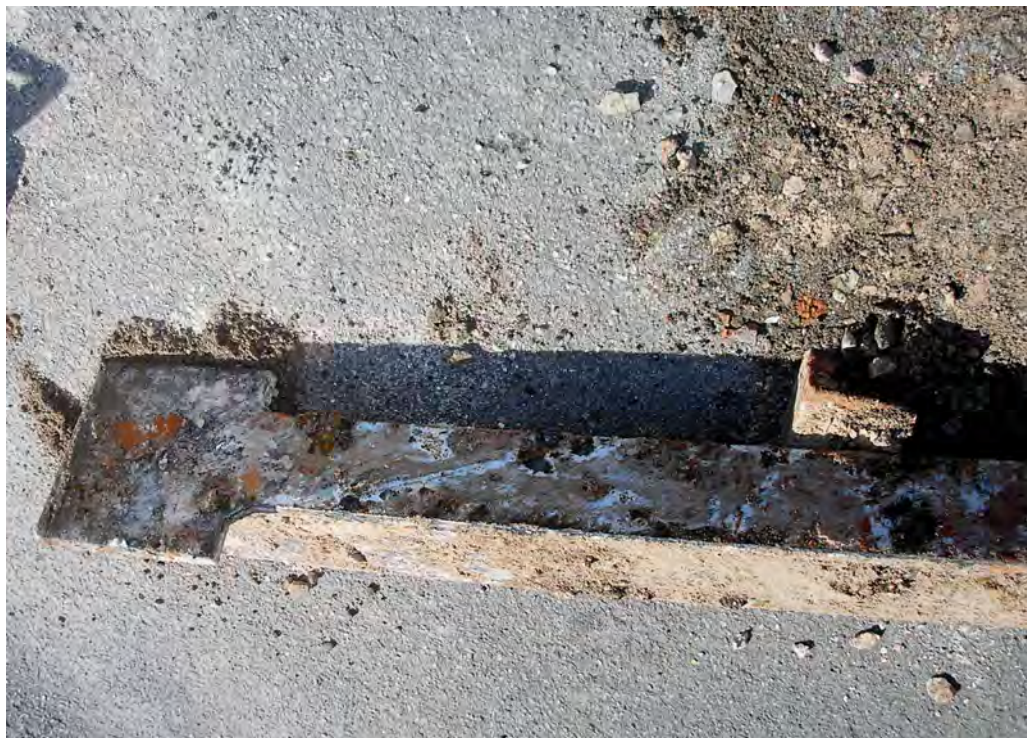
Plate 42: Fragment of a cast-iron beam recovered from demolition material

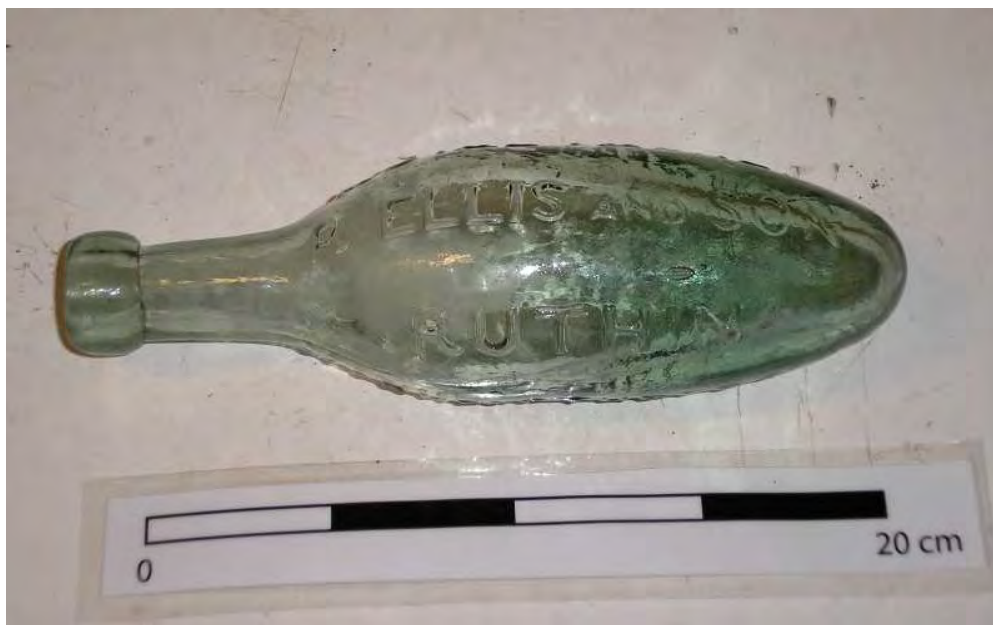
- 5.6.2 The mineral water vessel was torpedo, or Hamilton, bottle that was stamped with 'R Ellis & Son' of Ruthin, North Wales (Plate 43). This firm was established in 1825, and for several years supplied water to the Royal Family (*Daily Post* 2007); the firm had ceased trading by 1924. Another glass bottle had the manufacturer's mark of 'Slack & Cox Ltd', a firm based at Pott Street in the Ancoats area of Manchester, who was producing mineral water between 1895 and 1914 (Slater 1895; 1914).

Plate 43: Nineteenth-century mineral water bottle manufactured in Ruthin
