# 53 KING STREET, BLACKBURN, LANCASHIRE

## Archaeological Building Investigation

**Oxford Archaeology North**

March 2008

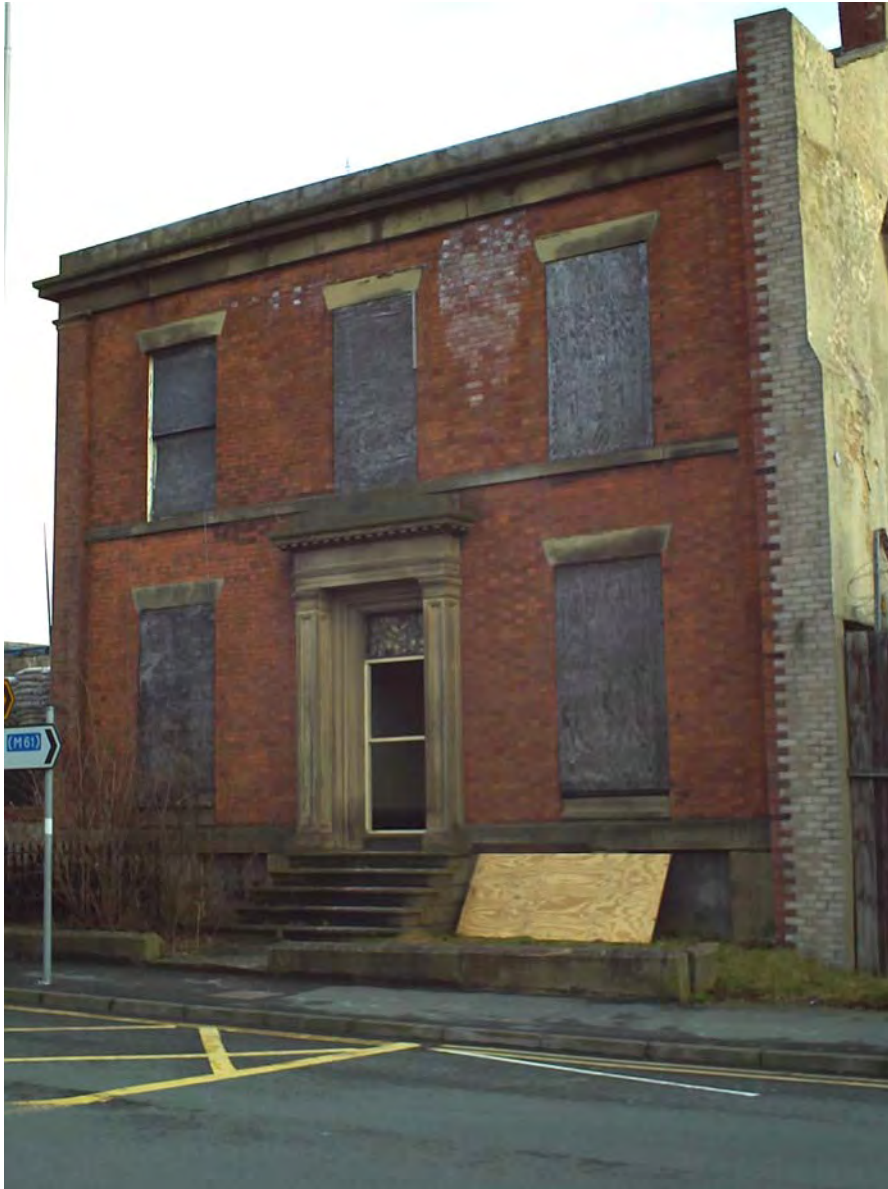
Plate 1: The front (north) elevation of 53 King Street

- 4.2.1 The understated, classically-inspired exterior is built in red brick laid in a Flemish bond on the main façade (north), which is trimmed with yellow sandstone dressings (Plates 1-3), whilst a mixture of Flemish bond and English Garden Wall (five to one) comprise the side and rear elevations. The corners of the front façade are trimmed with brick pilasters, which rise to the full height of the building and support the plain, stepped parapet, whilst a stone string-course divides the ground and first floors. Additionally, the west elevation has a thickly-applied cement render, in order to mask the scars left from the demolition of the adjacent building, whilst at the north-west corner, there is a modern grey brick build, which has been keyed in with the original red brick. This has been added to maintain the structural integrity of the projecting corner, following this demolition. The east elevation is remarkable in its non-descript appearance, but this may be attributed to the fact that an extra course of later brick appears to have been added to the elevation, which is suggested by the butt-joint on the south-east corner. Additionally, the south facade has an interesting projecting 'wing', which has a distinctive curved corner to the right that houses the stairwell providing access to the upper floors. The roof is laid with regularly-coursed Welsh slate finished with raking parapets and features flush gable stacks, and is of common rafter design (Plate 4).

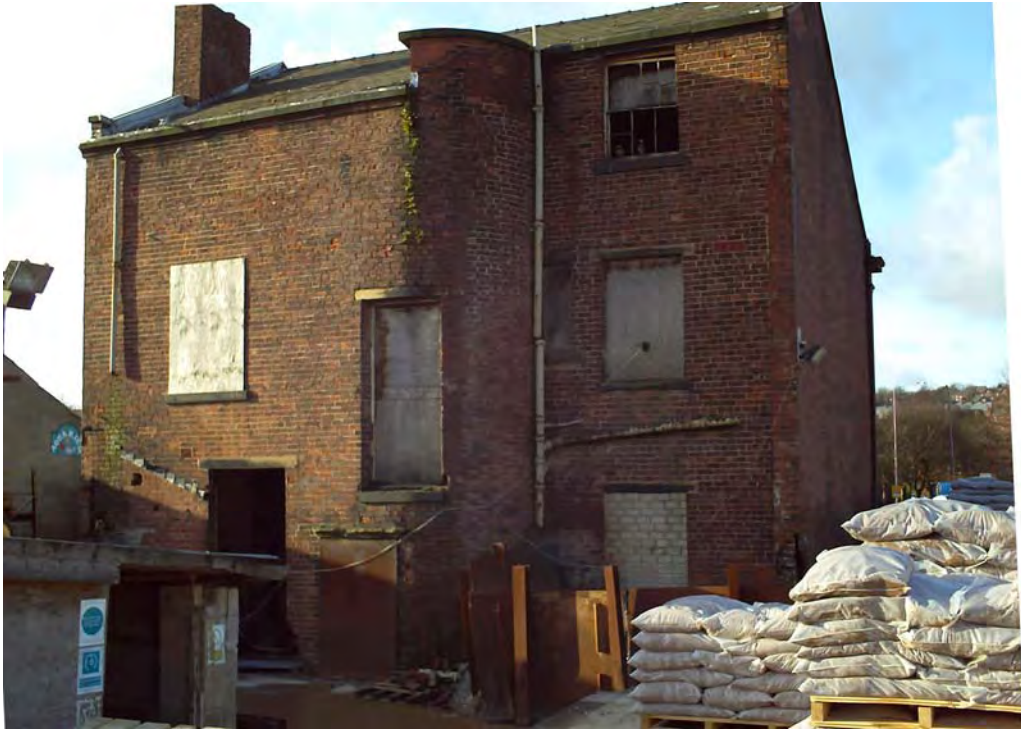
Plate 2: The rear (south) elevation of 53 King Street

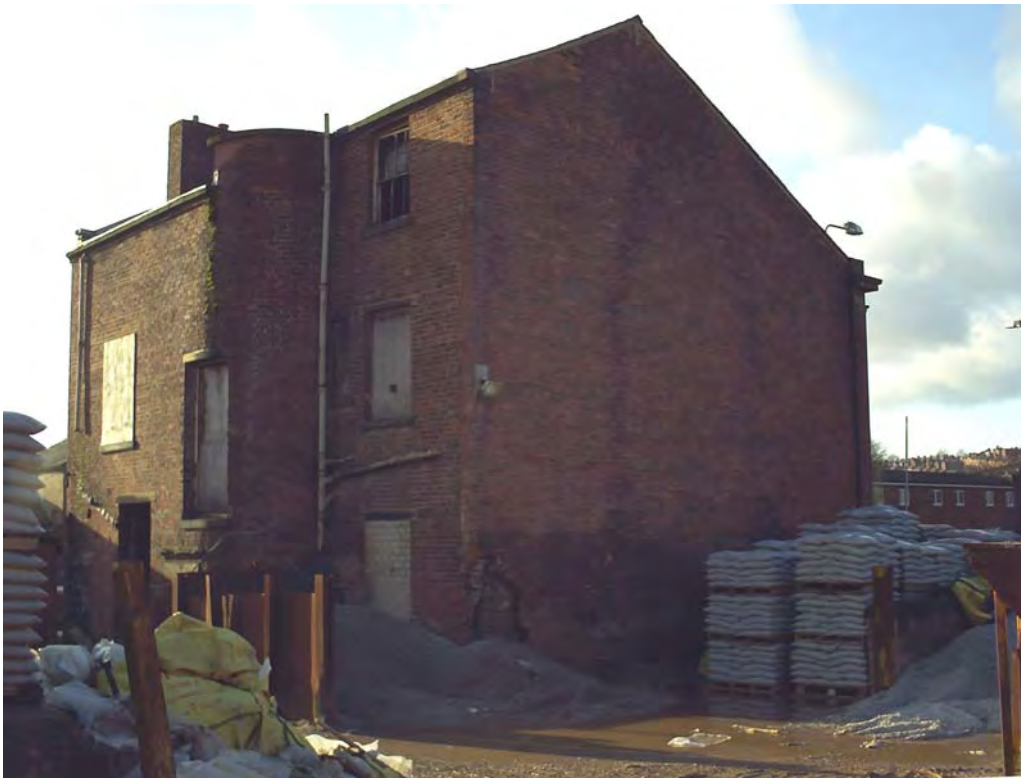
Plate 3: The east elevation

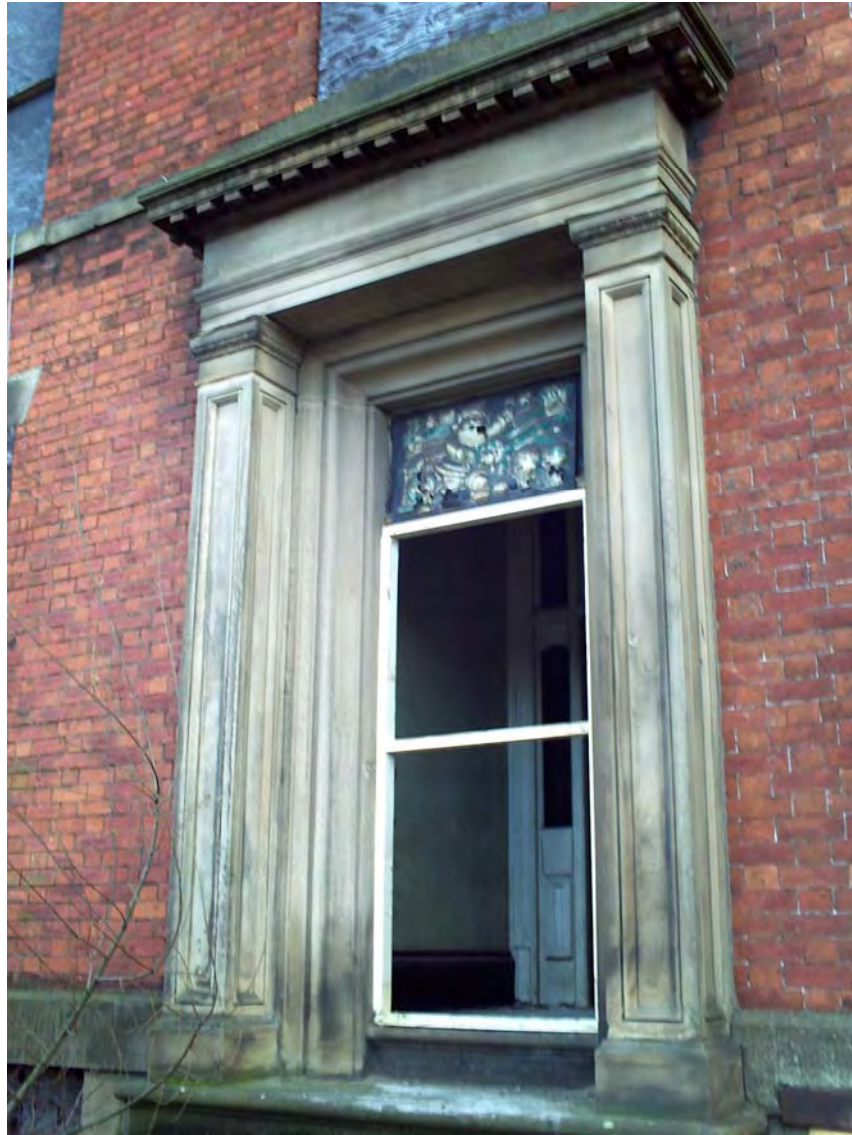
Plate 4: The aedicular doorway on the north elevation

- 4.2.2 Access to the building is provided by a restrained *aedicular* door on the front (north) elevation, that features an entablature consisting of a modillioned cornice, plain frieze and pediment (no raking cornice), which is supported by panelled pilasters decorated with egg-and-dart detail (Plate 5). To the left of

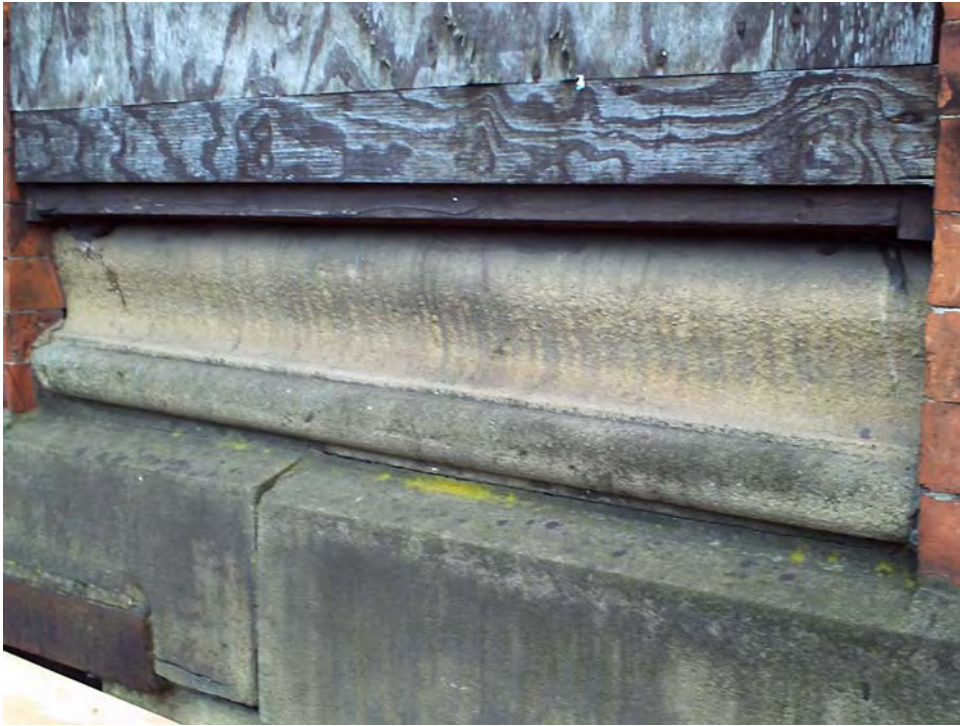
Plate 5: Detail of the moulded sills on the front elevation

- 4.2.3 The fenestration on the front elevation comprises tall elegant eight-over-eight sashes, which have been boarded over, but their plain, flush lintels and *lesbian cymatium* sills are still visible (Plate 6). At the rear of the building, there is a small projecting ‘wing’, which has a curved corner to the east (housing the staircase), featuring a tall, elegant stairlight sash. All of the other windows have been boarded-over as the front, but their plain flush lintels and projecting sills are evident (Plate 7), whilst the doors are either blocked or shuttered. Additionally, on the ground floor, the tall sash and sill have been removed to create a makeshift door, which may be attributable to the builder’s merchants that lies to the rear of the building. Certainly the ground level of its yard has been raised significantly and laid to concrete, which has obscured the windows and the doors of the basement at the rear of the townhouse.

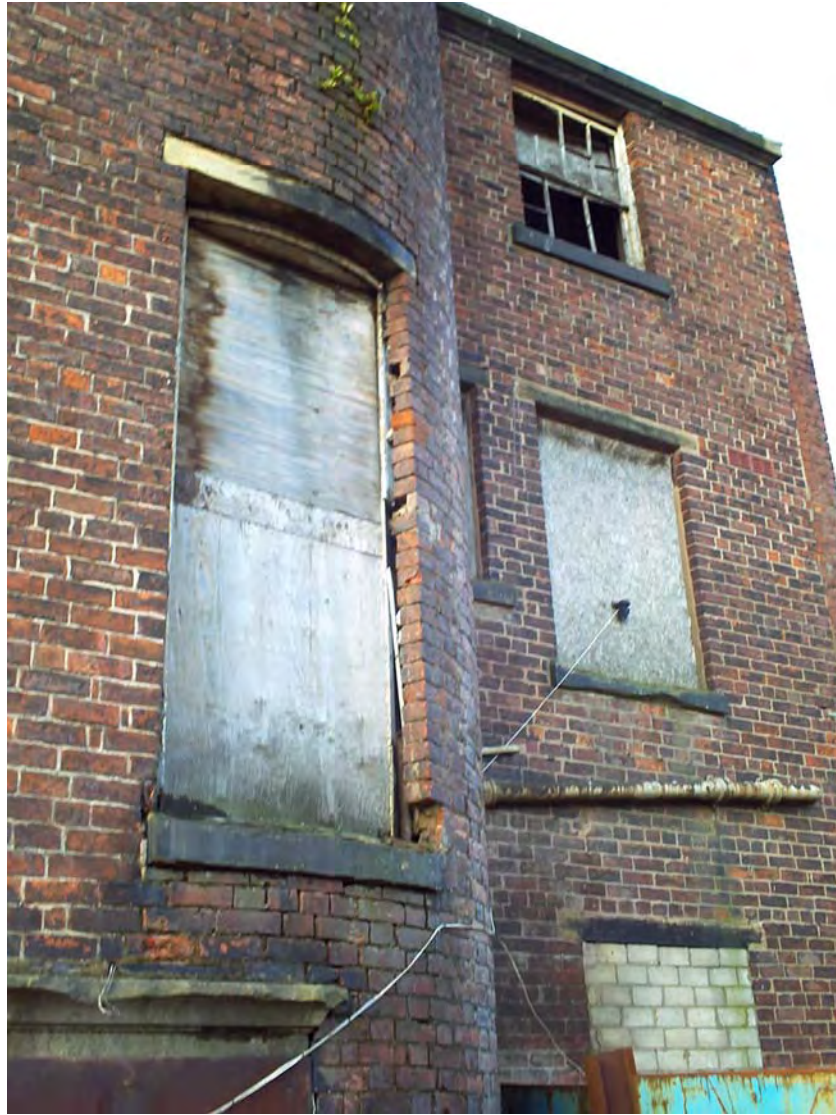
Plate 6: The blocked windows on the rear (south) of the building

5.2.4 **Phase 4:** during the second half of the twentieth century the majority of windows and doors have been blocked, but most of these appear to have been for security purposes following the demise of the building, rather than alterations during its occupancy. Additionally, the adjacent County Police Station was demolished and it is likely that the demolition of the extension at the rear of the property coincided with this. Certainly, both structures were still present during the first half of the twentieth century (Ordnance Survey 1938). Subsequently, the empty plot of the former Police Station, as well as the grounds to the south of 53 King Street, were acquired by a builder's merchants. The land to the rear of the building was concreted, in order to allow for additional space for the storage yard, and it appears that the removal of the ground floor sash and the demolition of the sill beneath are attributable to this period.

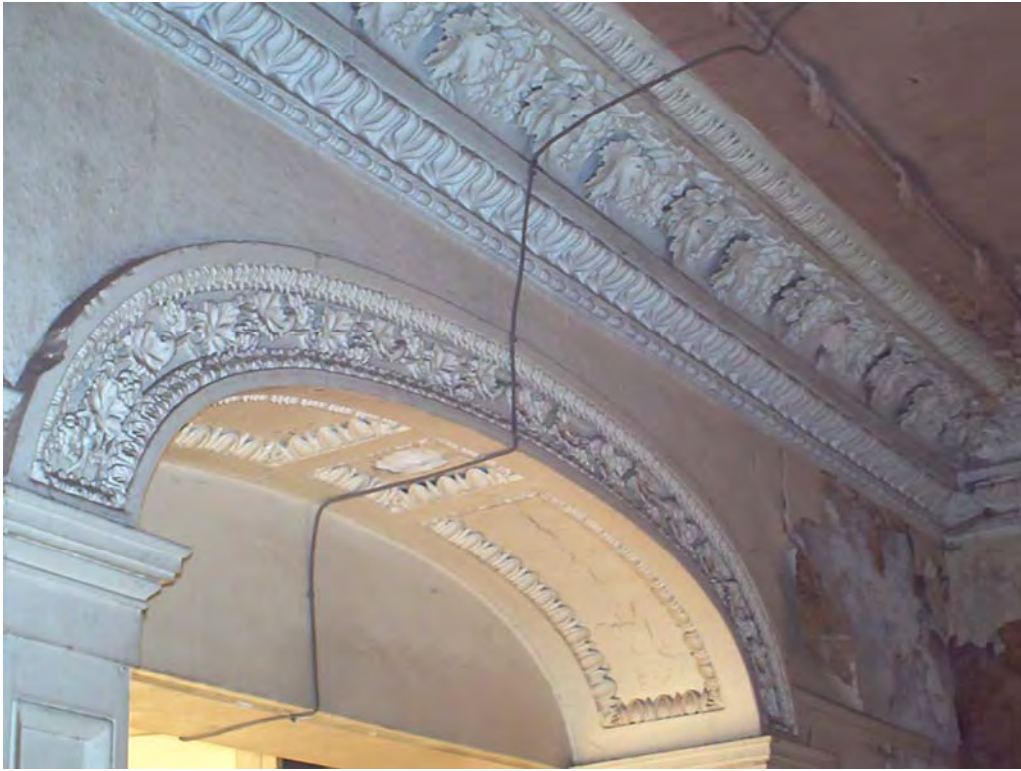
Plate 7: Detail of the segmental arch and cornice in room 5

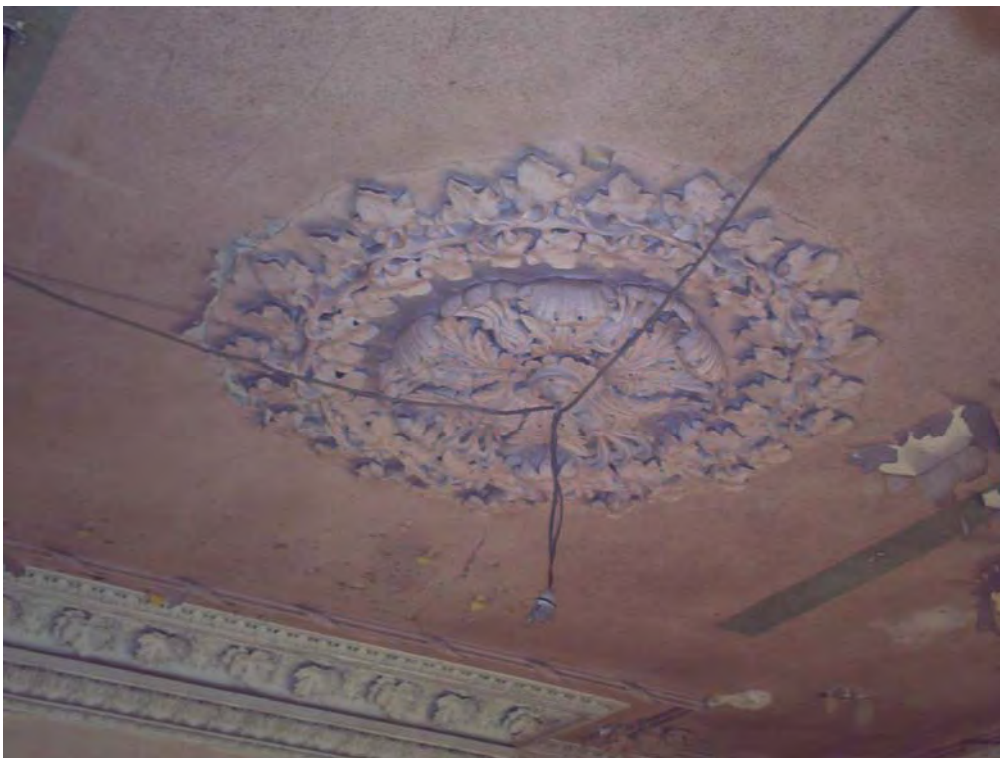
Plate 8: Detail of the ceiling rose in room 5

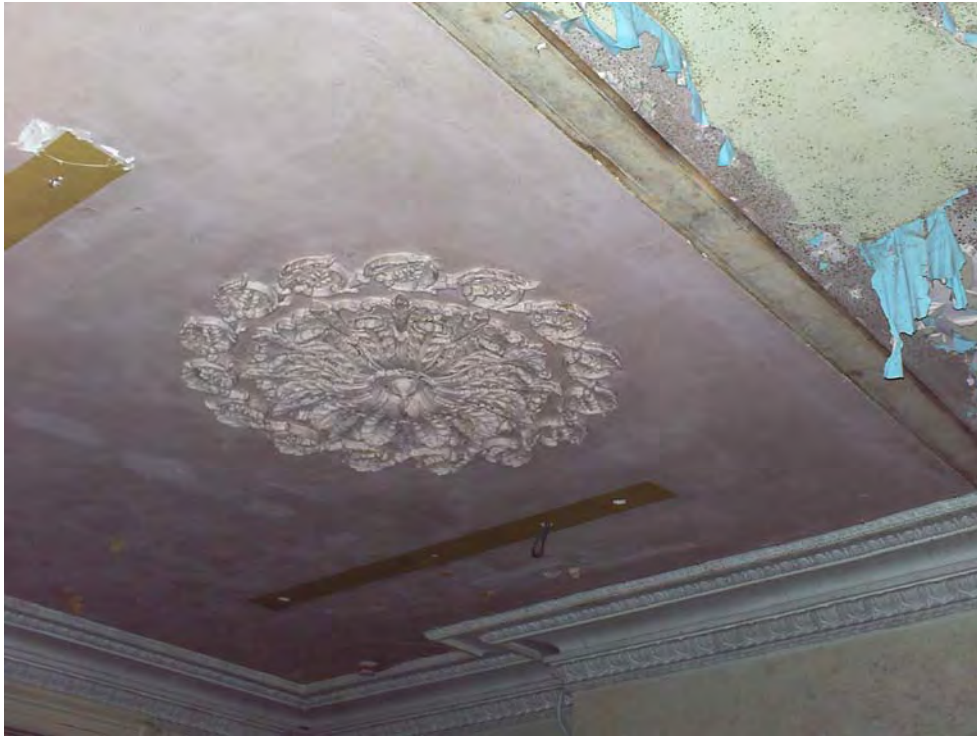
Plate 9: The ceiling rose in room 2, with the scar of the former partition to the right of the frame

4.4.2 Within room 2, the cornice has a plain *cavetto soffit*, enriched with egg-and-dart, leaf-and-dart and bead-and-reel. As in room 4, there is an acanthus rose in the centre of the ceiling, although in this instance it is bordered by oak leaves (Plate 10). Additionally, of particular interest is a scar that marks the floor, walls and ceiling of the room, and which visibly cuts through the picture rail whilst respecting the cornice itself. It is evident that the room was partitioned at some point and subsequently, this has been removed to create a single space again.

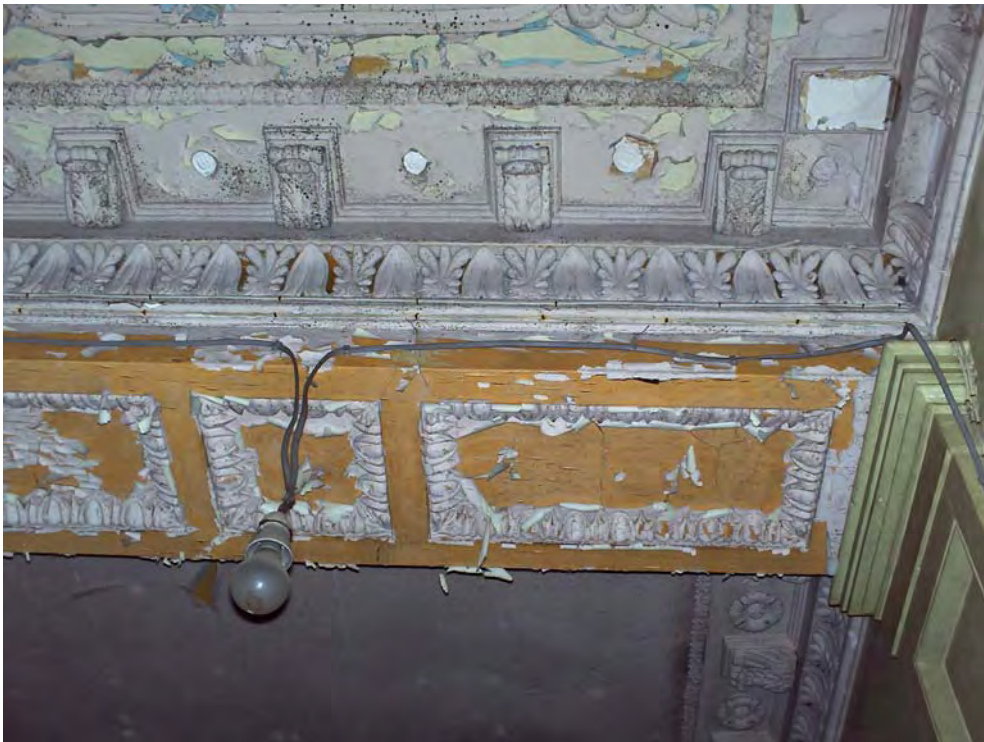
Plate 10: Detail of the various mouldings adorning the ceiling of the hallway (room *1*)

4.4.3 The entrance hall (1) likewise retains this decorative style, although the effect is somewhat marred by the insertion of an inner door, thus reducing the length of the room and, in turn, the impact of the decoration. A former ceiling rose, now no more than a circular hole in the plaster, lay to the centre of the room, but would appear to have become rather unnecessary following the insertion of this partition (Plate 13). The ceiling is bordered by a moulding featuring a palmette and tongue motif, whilst alternating rosettes and scrolled modillions with palmette motifs, adorn the margins of the ceiling (Plate 11). Additionally, the corners of the room are decorated with a combination of scallop shells and fleshy tendrils (Plate 12), and egg-and-dart decoration has been used to trim the panels of a squared 'arch' that bisects the corridor.

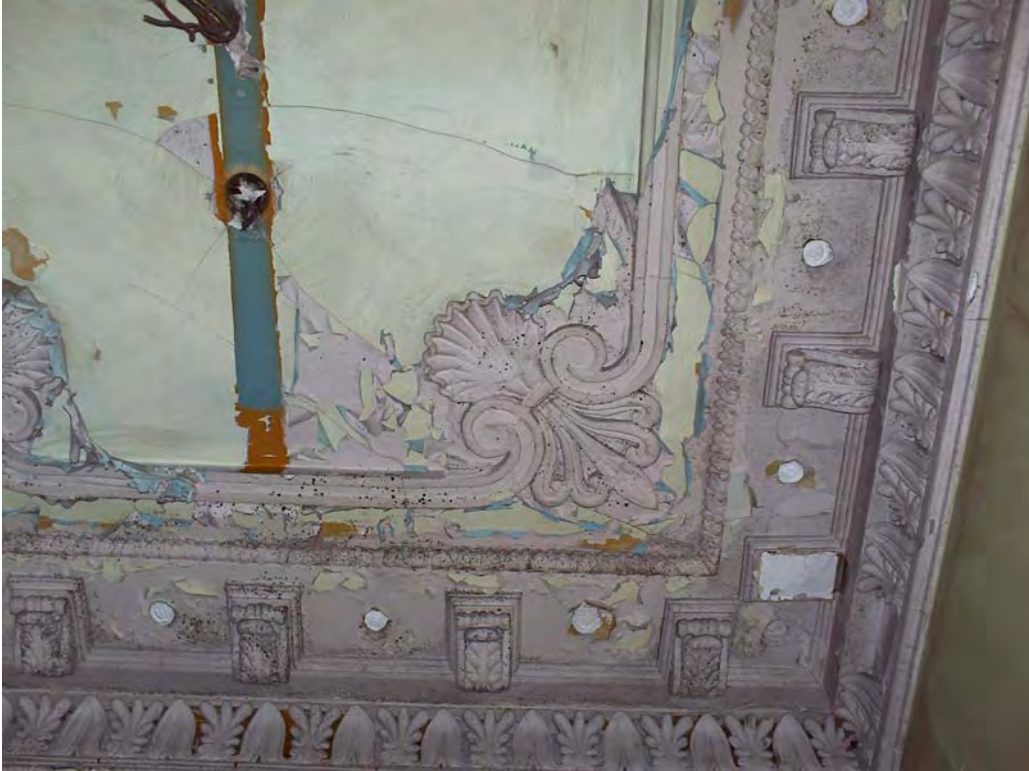
Plate 11: Further detail of the mouldings within the hallway (room *I*)

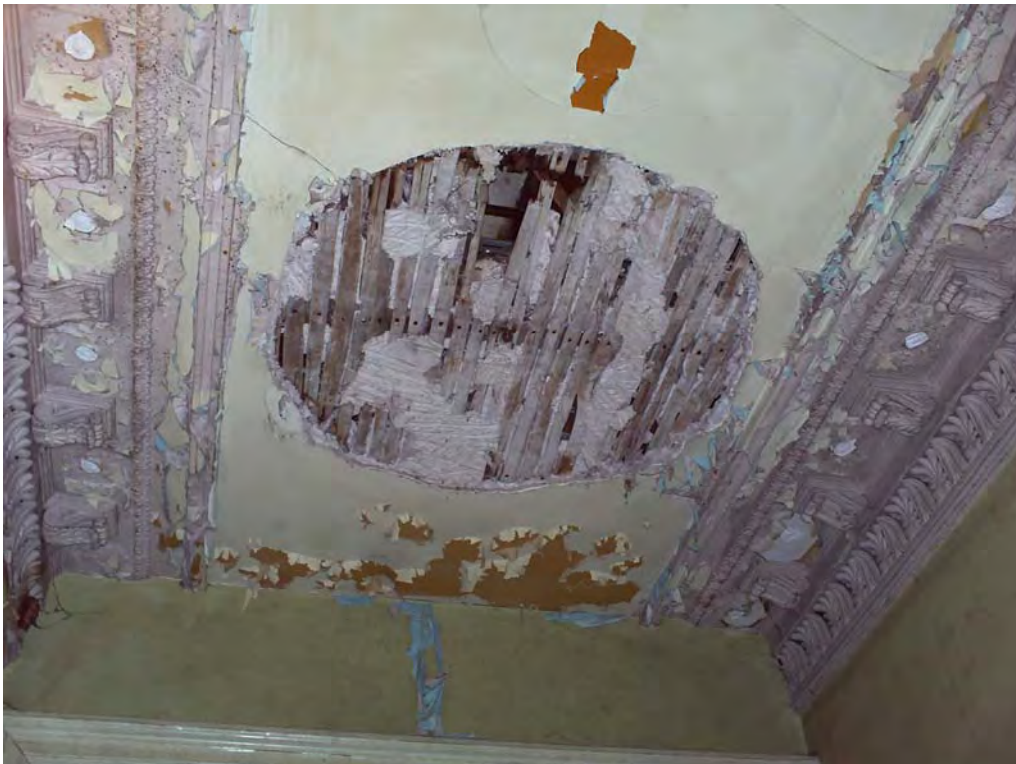
Plate 12: The scar of the former ceiling rose within room *I*

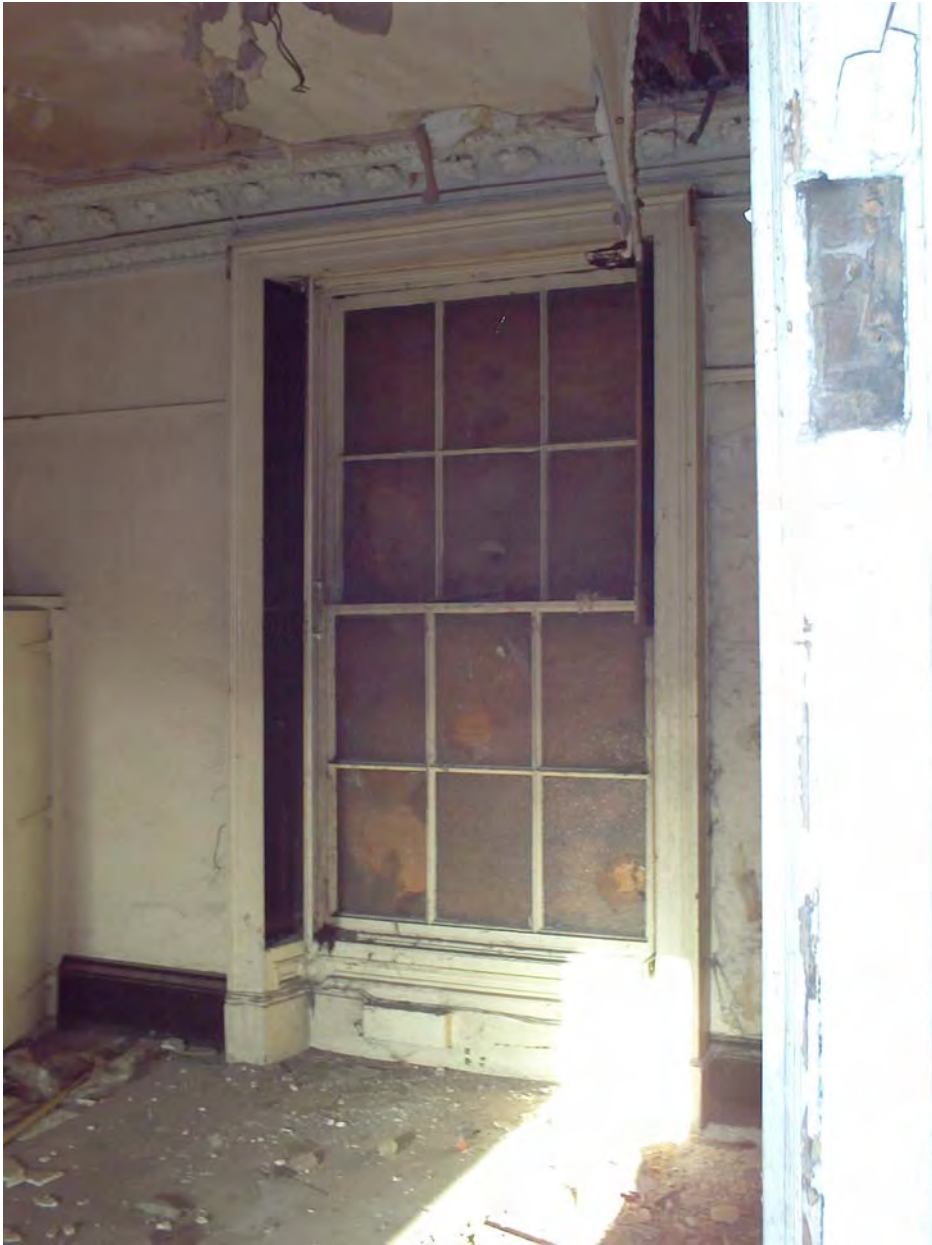
Plate 13: The sash window within room 5

- 4.4.6 The windows on the ground floor and the frontage of the first floor are elegant six-over-six sash windows that stand almost to the full height of the room, and have moulded panel surrounds with bossing, splayed reveals and shutters (rooms **2 – 5**) (Plate 15). To the rear of the house, the first floor and attic windows are a mixture of sash designs and sizes. The window within room **16** is a shorter version of those on the front of the building, whilst a tall, narrow sash illuminates the staircase (**7a**). On the right of the building, there are a further pair of shorter sashes (**15** and **21**) with splayed reveals and plain timber sills, whilst a small, narrow one-over-one sash lights the first floor bathroom (**14**). Within the basement, there are two brick-blocked windows at the rear of the building (rooms **6** and **7**), whilst to the front (rooms **10** and **11**), there are 10-over-five sash cellar lights featuring splayed reveals and plain timber sills (Plate 16).

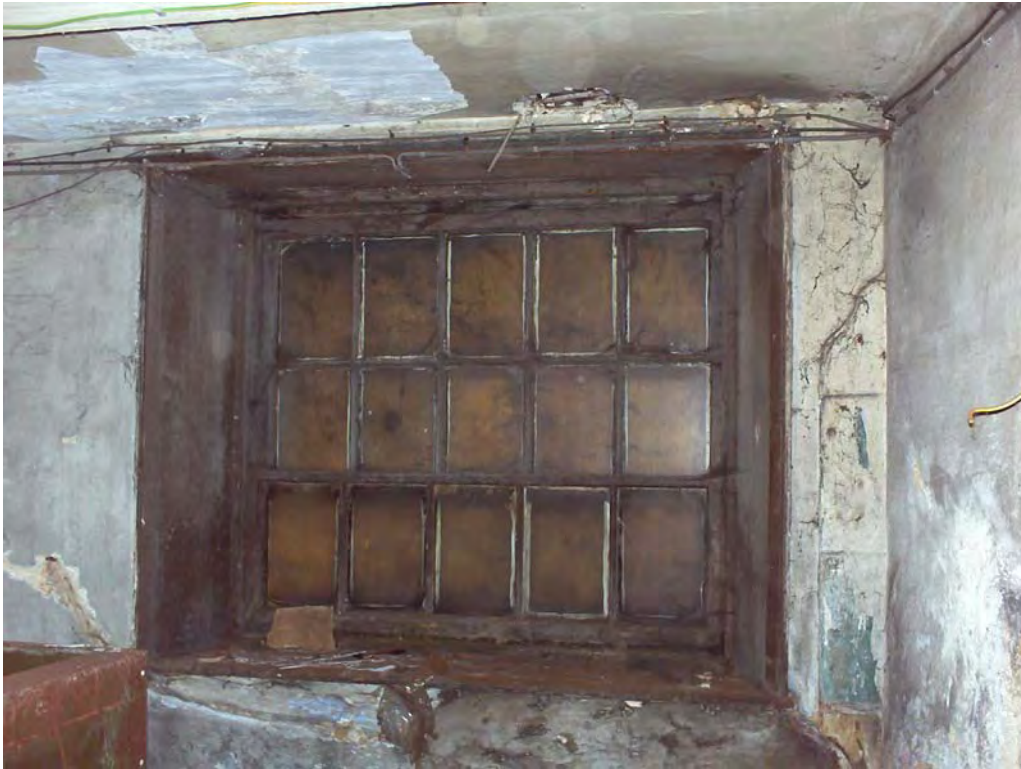
Plate 14: Detail of the cellar-lights in room *10*

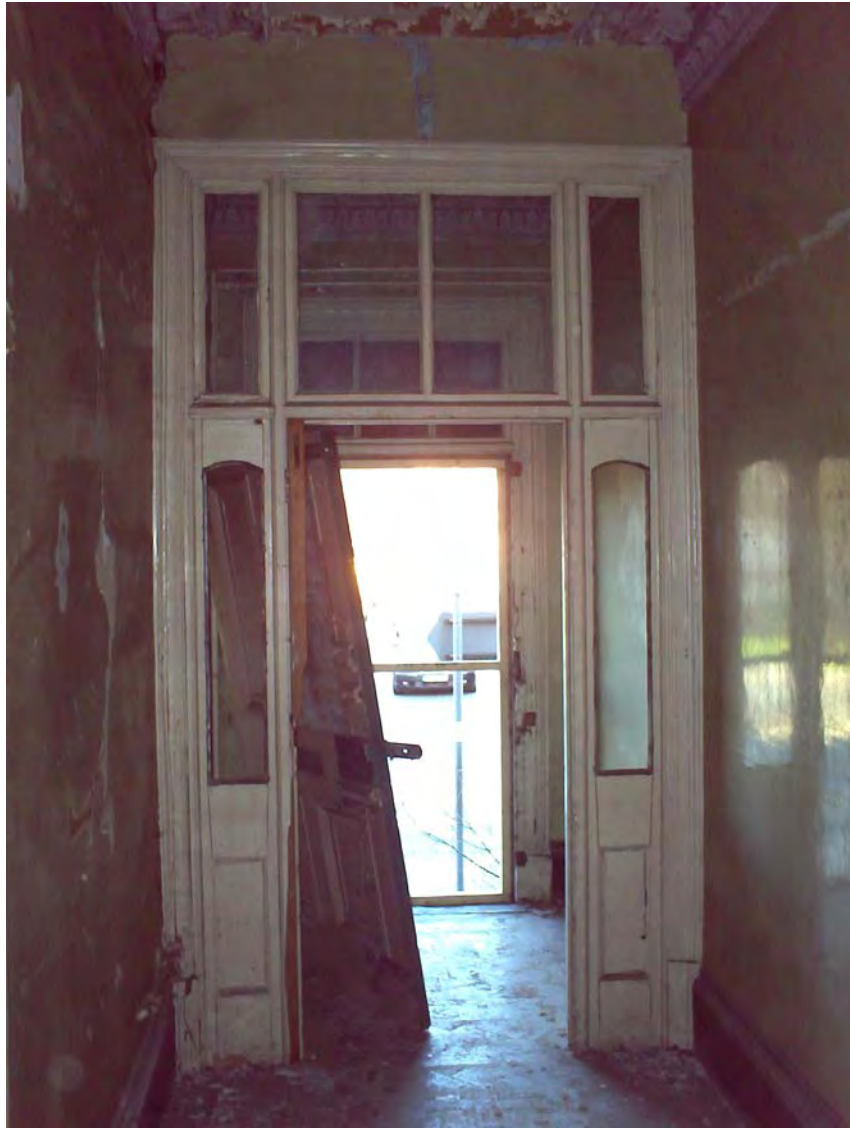
Plate 15: Detail of the partition within room *1*

- 4.4.7 The doorways are, for more the most part, empty embrasures with the doors having already been removed. Even the inserted timber partition of the hallway is now minus its door, but the overlying four lights have been retained, whilst the empty doorway is flanked by replacement windows with segmental heads (Plate 17). Further along the hallway corridor, there is an ephemeral blocked doorway, that originally led into room **5**, but which is now only discernible through a pair of joints in the plain skirting board. In addition, a brick-blocked door is also located in the south-west corner of the building, within the basement. One of the few doors that is not removed or blocked is the ledged and braced matchboard door that stands at the end of the hallway corridor. No doors have been retained in any of the doorways on the first and second floors.

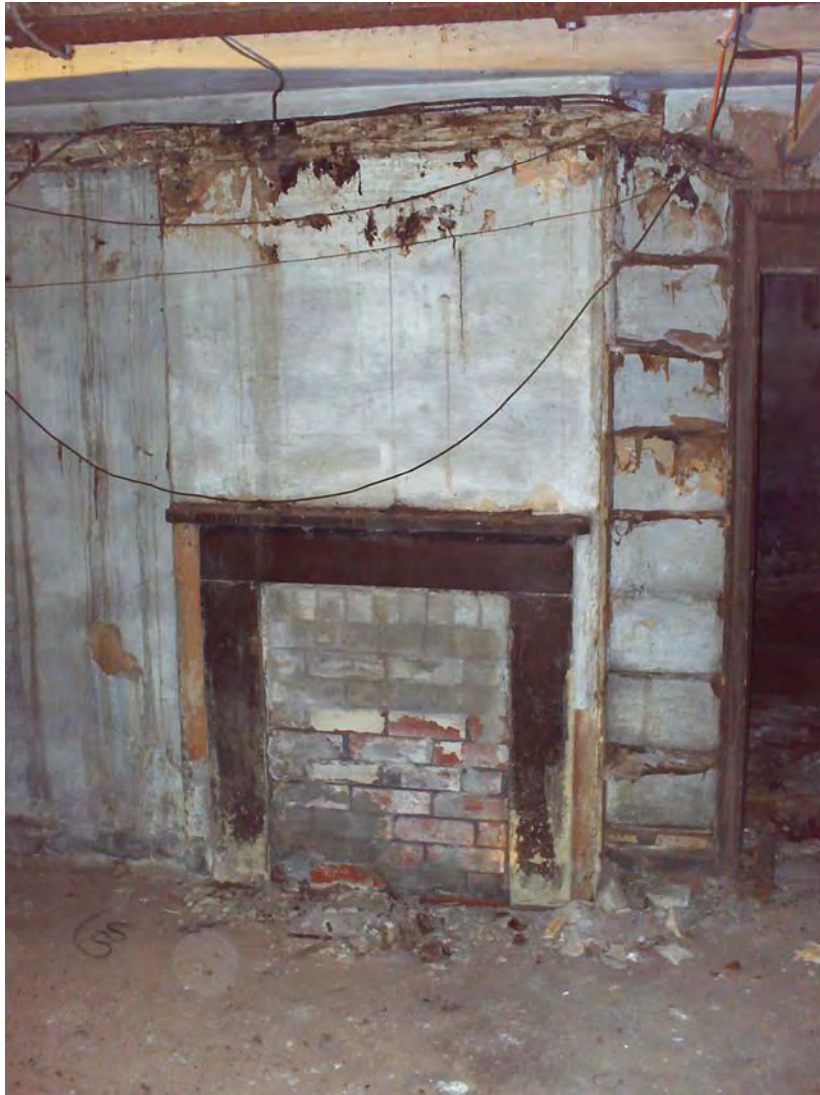
Plate 16: Detail of the fireplace within room *10*

- 4.4.8 In a similar fashion to the doors, many of the fireplaces have been removed and blocked, whilst the fireplace in room **2** is missing its mantelpiece, it has a tiled surround featuring a voussoir round arch over the firebox. Conversely, in room **10**, the mantelpiece has been retained, whilst the firebox has been infilled with brick (Plate 18). On the second floor, room **23** has the remains of a modest fireplace. Although the hearth and surround have been removed, the fireplace itself has not been blocked (Plate 19). The most substantial fireplace
