Deep Clough Farm, Littledale, Caton, Lancashire

Archaeological Building Investigation

Oxford Archaeology North

November 2008

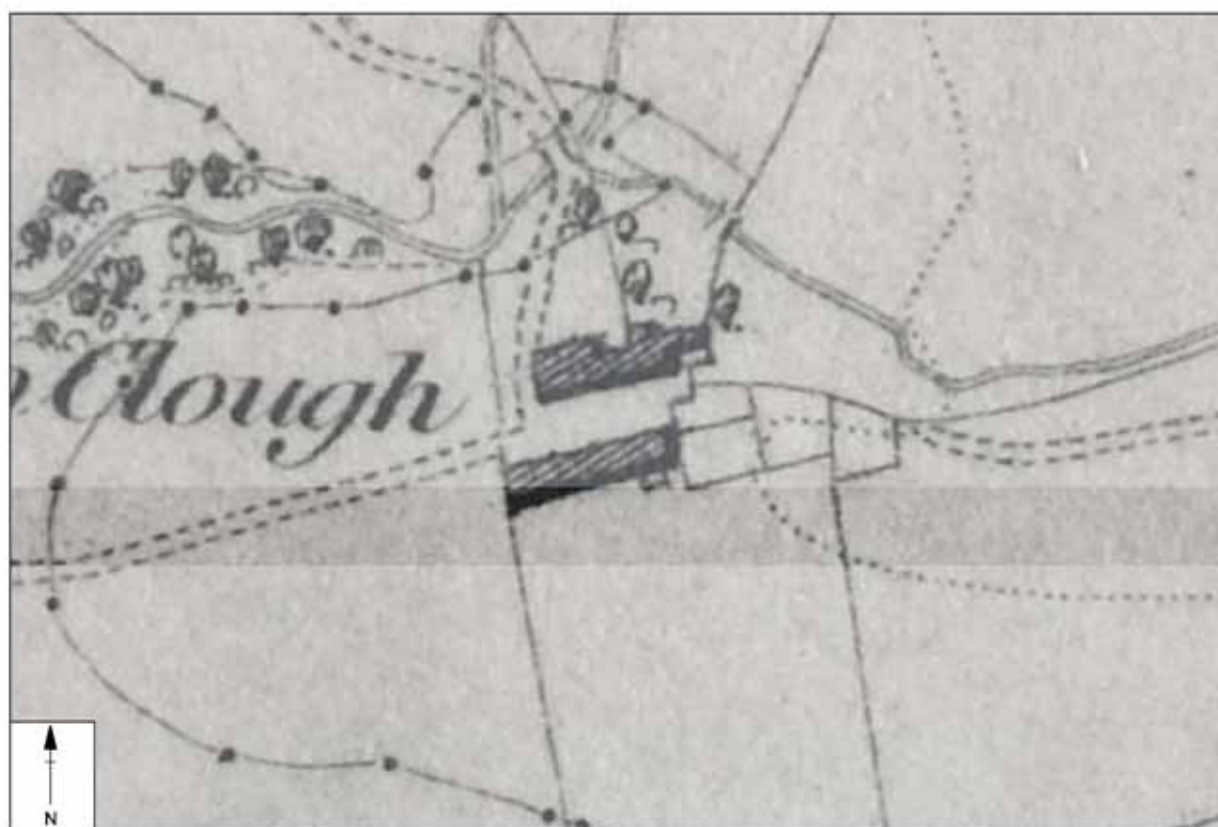
- 3.5.2 ***Ordnance Survey 1844 - 1919:*** (Figs 4-7) there is little change to the mapping over the next eighty years (Ordnance Survey 1844, 1891, 1913), and the Ordnance Survey offers little if any extra detail to that supplied in the mid nineteenth century. However, the series of enclosures at the east end of the barn (Barn B) have been converted into one larger pen, which is clearly annotated as a *sheep fold*.

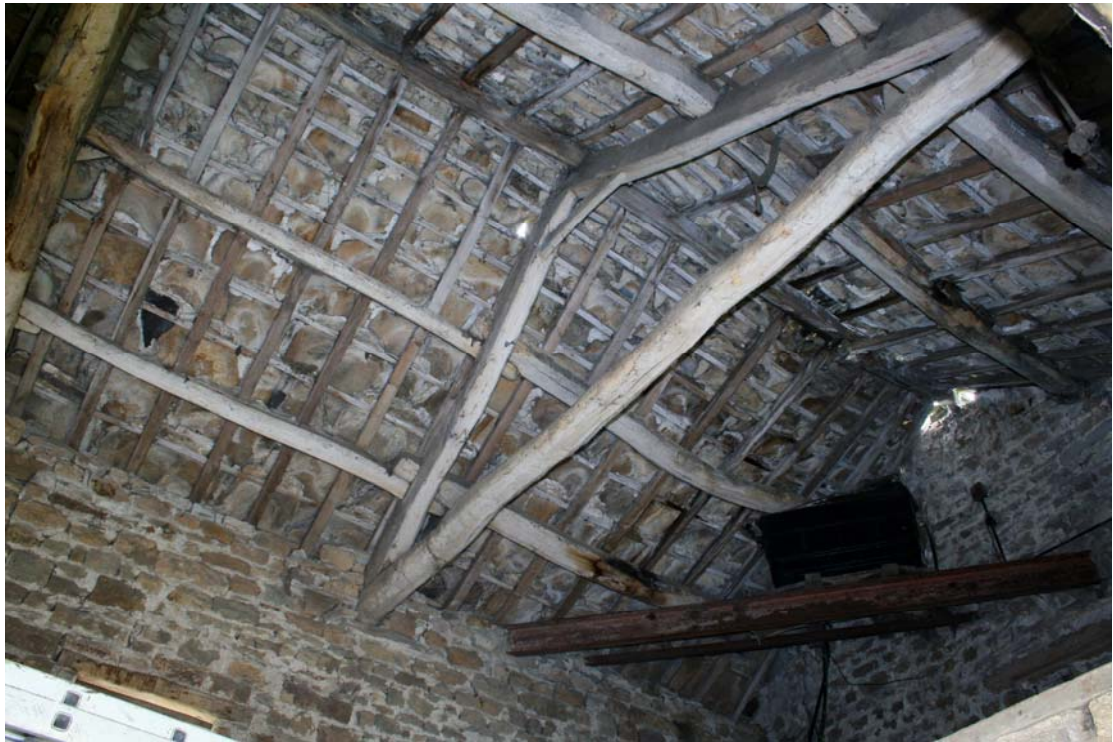
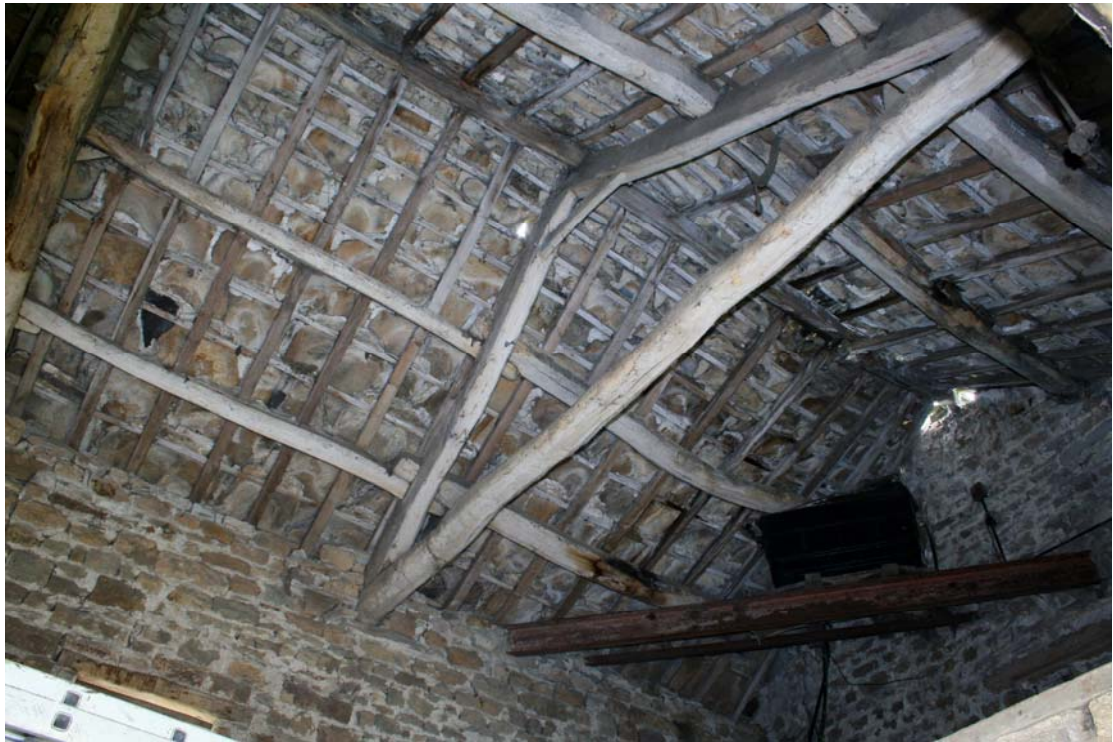
Plate 3: Roof truss in room *1* of Barn A

- 4.1.2 The building originally had a slated gabled roof, which was in very poor condition at the time of the investigation. In light of health and safety concerns, access to the barn was only attempted following the removal of this roof, although the main truss was recorded following its removal. This was observed to be of collar and tie beam construction (Plate 3), comprising waney-edged, hand-cut timbers with trenched purlins.

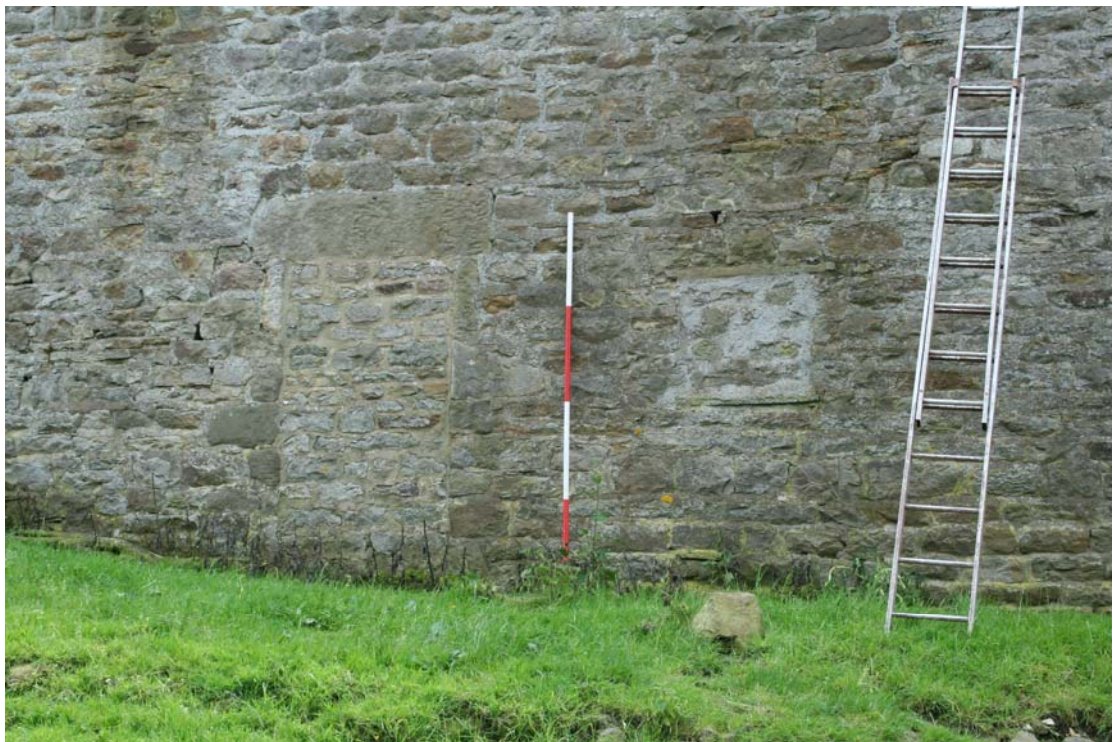
Plate 6: Blocked door and window on the north elevation of Barn A

- 4.1.3 A large wagon doorway on the front (south) elevation provides the main access to the barn. Additionally, at the east end of the front elevation, there is a small door leading into the stable area (room 2, Plate 4). The outshut to the north of the building, although now partially-ruinous, has a small door on the west elevation (Plate 5), as well as a former doorway, now blocked, on the north elevation (Plate 6).

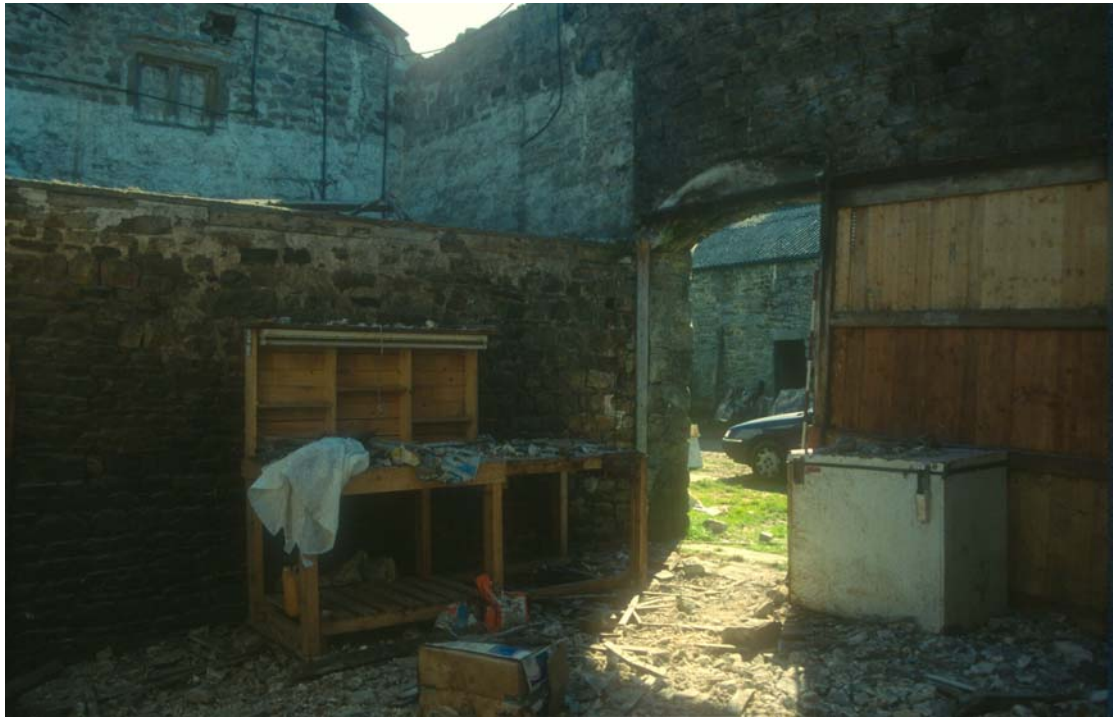
Plate 7: Room *1* of Barn A (following the removal of the roof)

- 4.3.1 **Room 1:** forms the main part of the barn and is accessed from the wagon doors on the south elevation. It is a large, square room with a hayloft to the east, which also forms the roof of room 2. The interior fabric of the walls are as described for the exterior of the building, whilst the floor is stone, with a thick covering of earth and hay. On the northern elevation, there is a door with timber lintel, through which, the outshut can be accessed internally. The lack of windows in this room is typical of a threshing barn.

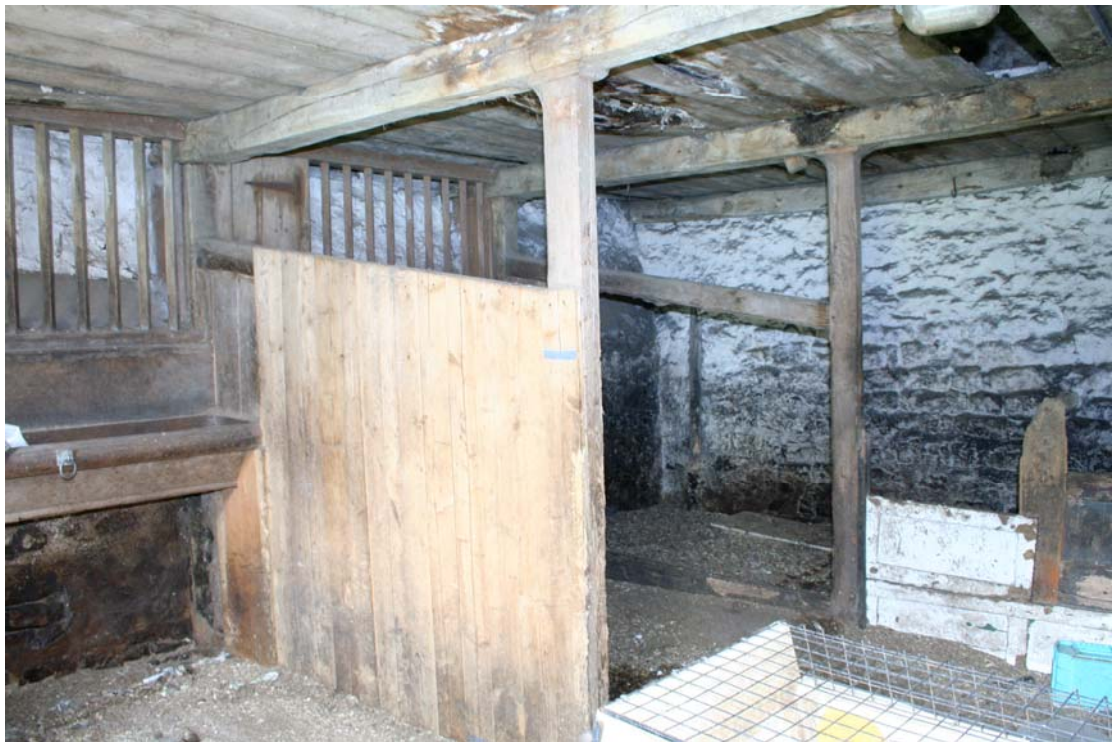
Plate 8: Room *2* of Barn A

- 4.3.2 **Room 2:** a small, rectangular room to the east of room 1, and was originally used as a shippon, or stables. The room has been divided up into three stalls, with wooden partitions between each one. Each of these contains a hayrack and manger also constructed in wood (Plate 8). The ceiling is half height and constructed of timber boards, although most of these are now missing. The hayloft originally overlay this room, though it was accessed from room 1.

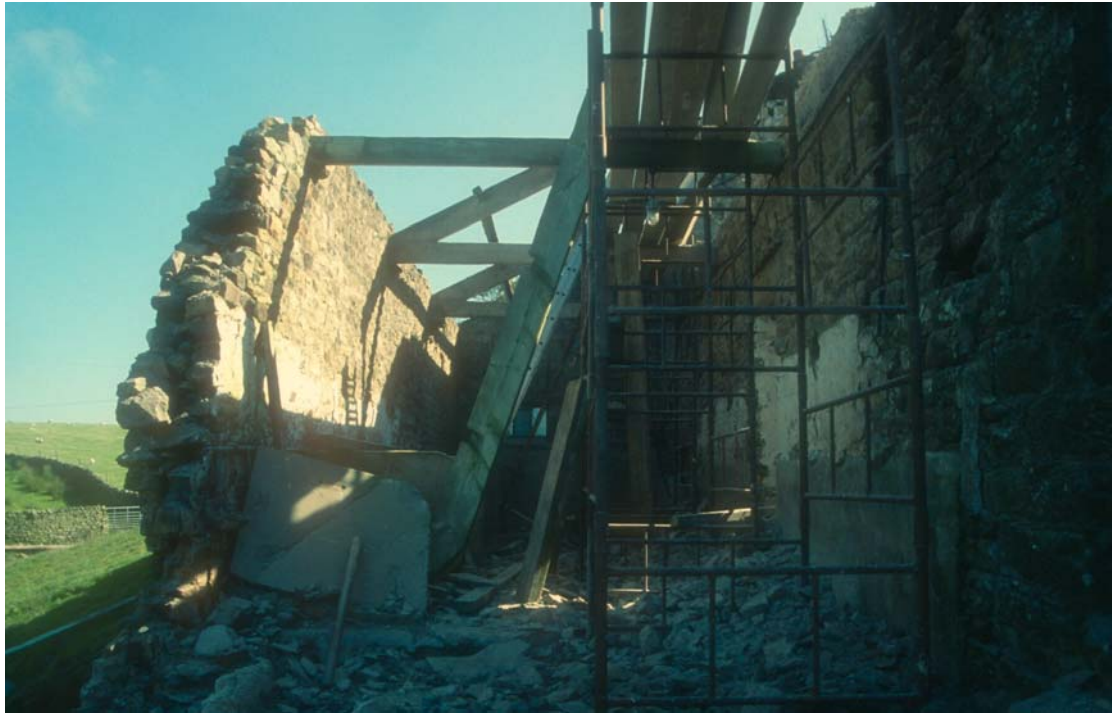
Plate 9: Room 3 of Barn A (following the removal of the roof)

- 4.3.4 **Room 3:** a long, rectangular room, used as a cow shed and probable milking shed. Along the remaining part of the northern wall there are concrete stalls with a modern metal drinking trough within each (Plate 9). The walls in this room are again as described above (*Section 4.2.1*), but due to the potential danger of falling wall and roof debris, full access to this room was not attempted.

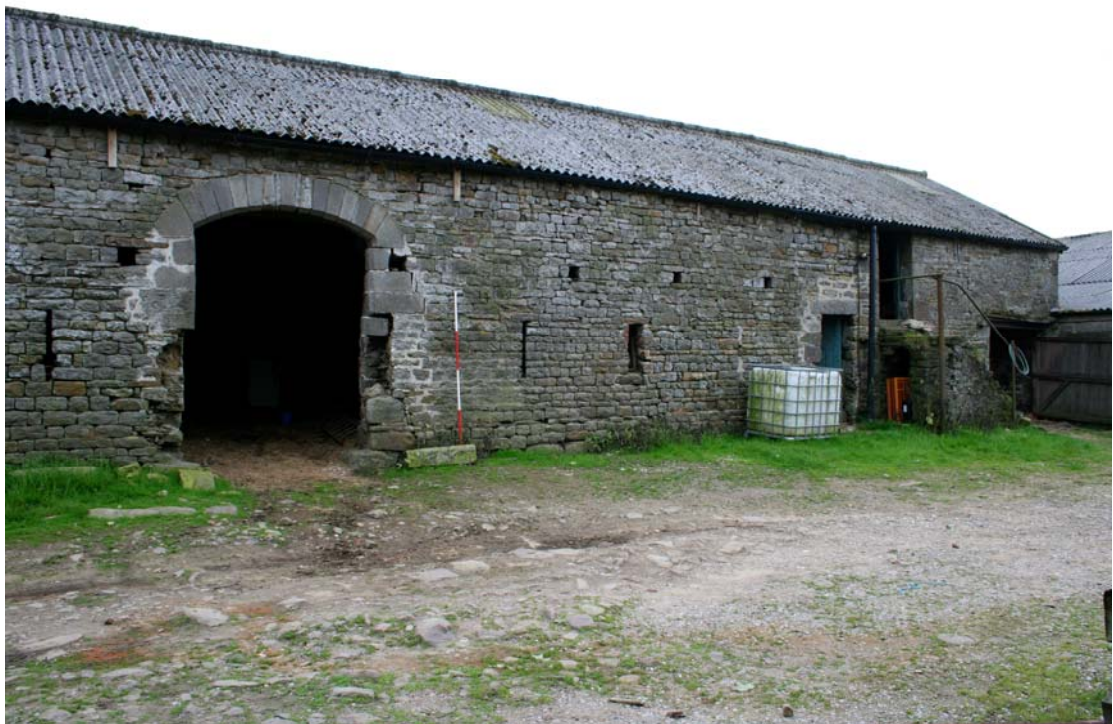
Plate 10: West end of the North elevation of Barn B

- 4.5.1 The north (front) elevation (Plates 10 and 11) includes the main access into the barn, which is through a large wagon door. This features a sandstone segmental voussoir, as well as a surround of dressed and chamfered quoins, which are now partially-collapsed towards their base.

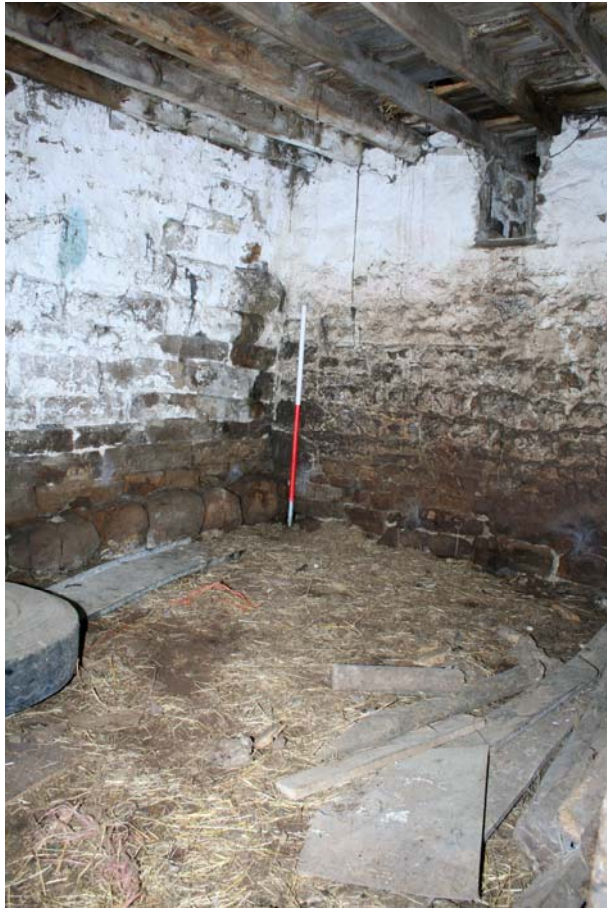
Plate 20: Room 5 of Barn B

- 4.6.11 **Room 5:** a small square room, which can only be accessed via room **4** and lies directly below room **7**. The floor is laid with cobbles, whilst the walls are consistent with the rest of the building. A butt joint in the south-east corner of the room, in conjunction with a projecting foundation course on the east wall, indicates that this east wall was originally an external elevation. Thus, room **5**, along with rooms **4**, **6** and **7**, comprises an extension that has been appended to the main barn (room **1**). Additionally, a plinth is visible at the base of the east wall (Plate 20).
