Lime Kiln Plantation, Burton-in-Kendal, Cumbria

Archaeological Landscape Survey

Oxford Archaeology North

November 2010

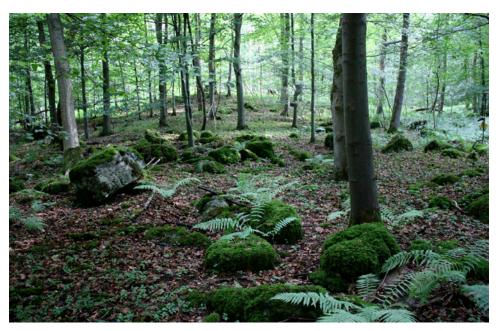
Plate 1: Site 02, stone-built structure

Site Number Site Name	02 Lime Kiln Plantation, Stone-built structure
NGR	354411 476076
Ref no	
Site Type	Possible structure
Period	Medieval / post-medieval ?
Source	Archaeological Survey
Description	A possible stone-built structure: 6m east to west, 6.5m north to south. The wall
lengths survive only as a single course, of generally large stones (0.3-0.1m).

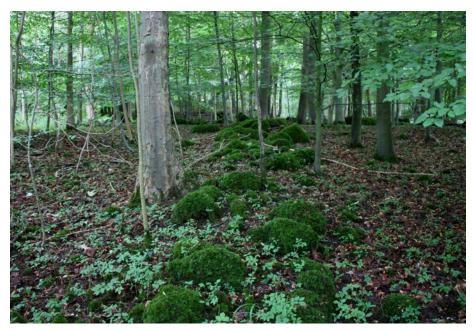
Plate 2: Site 03, field boundary wall

Site Number	03
Site Name	Lime Kiln Plantation, Field Boundary
NGR	354400 476096
Ref no	
Site Type	Boundary wall / bank
Period	Medieval / post-medieval ?
Source	Archaeological Survey
Description	The south-east corner of a well-defined field boundary of an enclosure or field,
32m west to east	then 87m south to north and 1.5m wide. In places it is a wall footing, and in others a
stone filled bank.

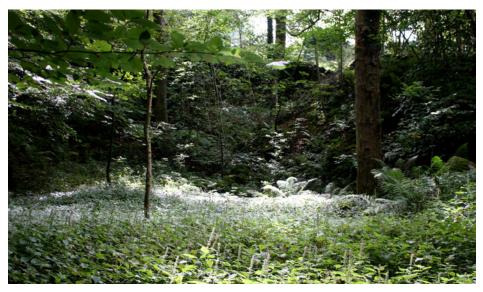
Plate 3: Site 04, Henridding Quarry

Description A large road-side quarry and lime kiln. The surviving evidence of the lime kiln is limited to a poorly preserved arc of cut stones, projecting slightly from the north-west part of the mound. which is heavily calcined reflecting the condensing of lime. The state of preservation prevents any other observations on the structure or size of this kiln. The quarry was extremely deep, in places, being up to 3.5m deep, and was 54m x 34m in size. It had large spoil heaps around the northern and western sides indicating that there was considerable discrimination being exercised in the quality or character of the stone being extracted.

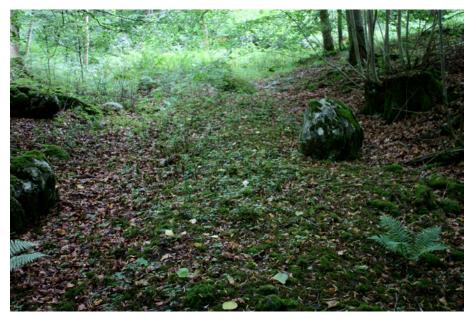
Plate 5: Site 05, Field boundary

Description A north-west to south-east aligned stone boundary wall or bank. It continues the line of the Site **03** boundary line and is probably a part of the same feature; however, this survives as a stone-filled bank rather than wall remains of Site **03**.

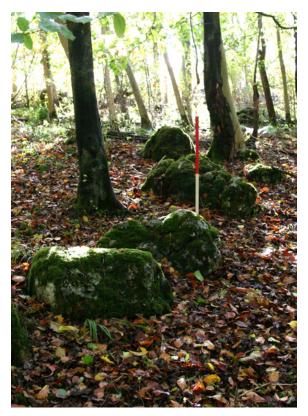
Plate 6: Site 07, orthostatic field boundary

Description The remnants of a stone-built boundary wall, 28m long and 2.2m wide, squarely conjoining the surrounding boundary wall of the wood (and edge of the study area). The wall was made of large, similar blocks of limestone with little evidence of a bank in between. The general character of this boundary wall is similar to the features of the village remains to the south of the woods.

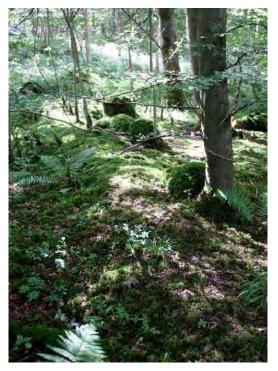
Plate 7: Site 09, Field Boundary

Description The debris of a stone-built wall / bank boundary (average 2.4m wide). The whole length of the wall is overgrown and is often obscured. The line of the boundary bank is walls marked on the First Edition 6" (1847) and First Edition 25" OS maps (1891). See also Sites **08**, **10-11**.

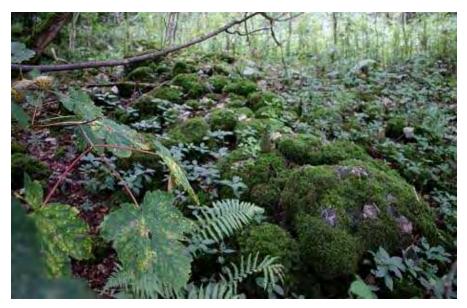
Plate 8: Site 11, Field boundary

Description The debris of a stone-built wall / bank boundary (average 2.4m wide). The whole length of the wall is overgrown and often obscured. The line of the boundary bank is walls marked on the First Edition 6" (1847) and First Edition 25" OS maps (1891). See also Sites **09-10**.

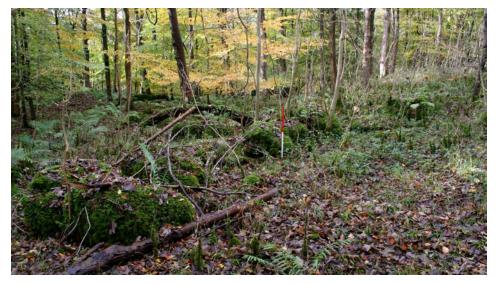
Plate 9: Site 27, orthostatic walled structure

Description The remains of a small, irregularly-shaped structure comprising large bouldertype boundaries, which are alignments of large stones with no obvious small stones or soil matrix. The structure is seemingly abutted by boundaries **11** and **25**.

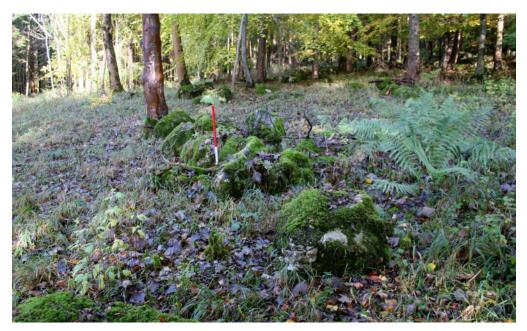
Plate 10: Site 28, orthostatic boundary

Site Number Site Name NGR	28 Lime Kiln Plantation, Plantation 354476 476339
Ref no	•
Site Type	Wall boundary
Period	Medieval / post-medieval ?
Source	Archaeological Survey
Description	An alignment of large boulder-type stones, converging towards the south-western
terminus of Bank 16. This is possibly an early boundary line.
