Dew Way, North Moor, Oldham

Archaeological Investigation

Oxford Archaeology North October 2010

Document Title:	DEW WAY, NORTH MOOR, OLDHAM,
	GREATER MANCHESTER

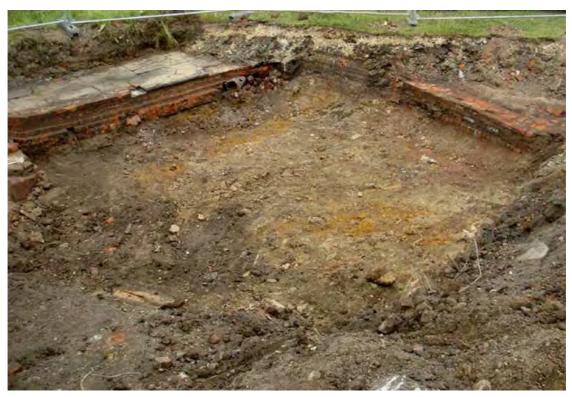
Plate 5: Looking north-east across Trench 2, showing walls 209, 207 and 206

- 4.3.4 The eastern side of wall **210** was abutted by another brick wall (**209**), which similarly comprised hand-made, mould-thrown bricks, bonded with a lime-based mortar (Plate 5). The wall was exposed for a length of 6m and measured 0.5m wide, incorporating two strings of bricks. The bottom two courses of the wall stepped out towards the south-east, representing an offset foundation. This incorporated the remains of an iron pipe, aligned broadly east/west, which had almost certainly been connected originally with the reservoir.

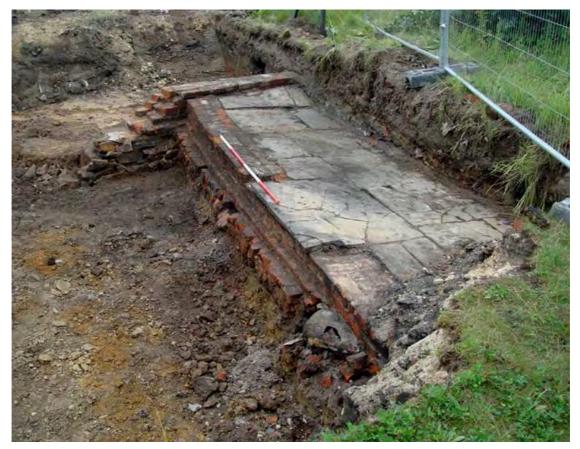
Plate 6: Walls 209, 210, 211, flagged surface 208, and cast-iron pipe exposed in Trench 2

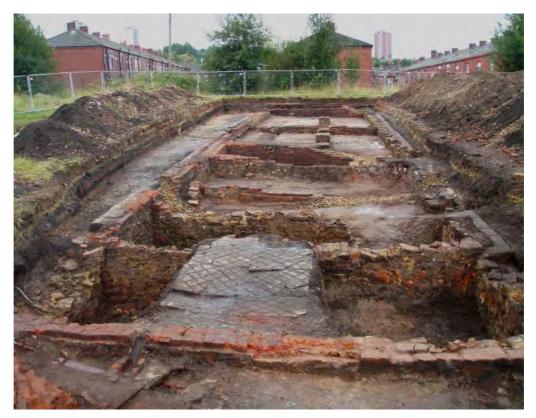
Plate 7: Looking south-west along Trench 3.

4.4.1 Trench 3 was aligned approximately north-east/south-west across the southeastern part of the study area (Figs 2 and 3). The trench measured 40 x 10.50m, and was excavated to a maximum depth of 2.72m (173.05m aOD). It was targeted on a range of buildings associated with West End Mill, as depicted on historical mapping (Plates 2 and 3). The well-preserved footprint of this building range was exposed, and was seen to incorporate six distinct rooms, with a combined length of 37.25m and a width of 7.50m (Plate 7). In addition, the remains of a chimney were revealed abutting the north-eastern corner of the building range; the location of the chimney corresponded with the position of a circular feature depicted on historical mapping (Plate 2).

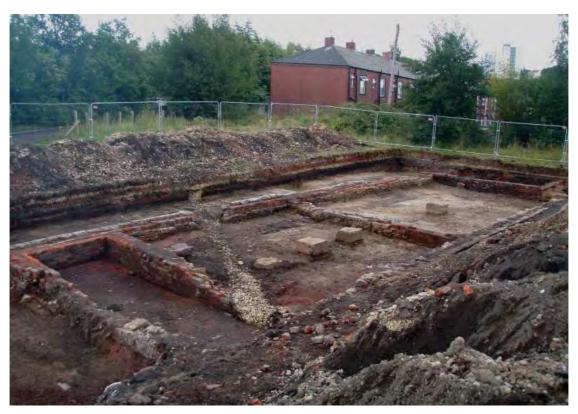
Plate 8: Looking south-east across Trench 3, showing Rooms 1-4

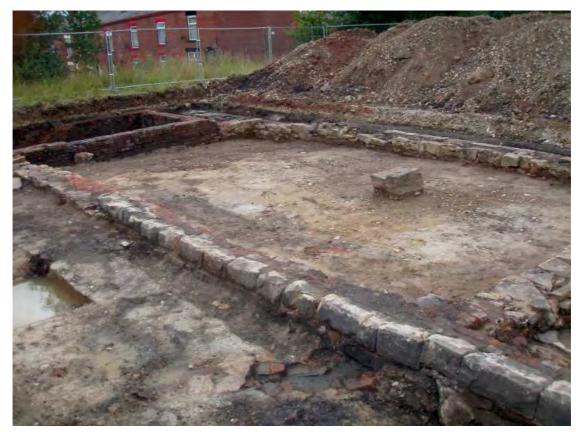
Plate 9: Looking south-west across the southern end of Trench 3, showing Rooms 1 and 2

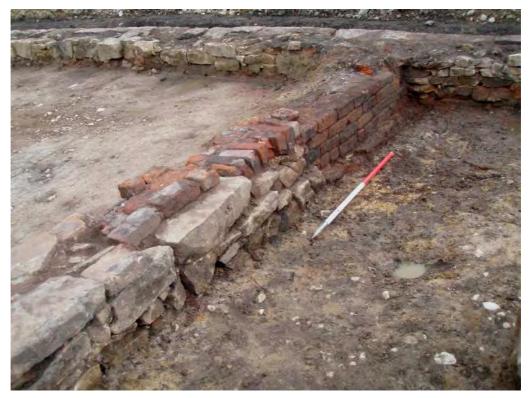
Plate 10: Wall 330 with blocked entrance exposed in Trench 3, looking east

- 4.4.3 In many places along wall **303**, hand-made bricks survived *in-situ* atop the stone foundation courses, suggesting that the demolished buildings had been largely of brick construction. In addition, a slightly wider string course of bricks survived along parts of the internal edge of the wall. These bricks carried the original flagstone floor, the remains of which were visible in parts.
- 4.4.4 Rooms 2 and 3: the central section of the building range was divided into two rooms (Rooms 2 and 3) by a partition (330) largely of stone construction (Plate 10). Room 2 measured 10.72 x 6.m, and Room 3 measured 6.85 x 5.50m (Fig 5). Access between these rooms was afforded via a 1.60m wide doorway situated at the north-western end of partition 330 (Fig 5). This doorway was blocked subsequently by a three-course wide wall (309) composed of hand-made bricks (Plate 10).

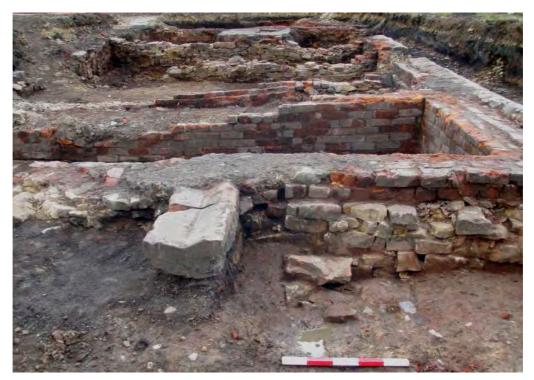
Plate 11: Wall 303, cladding 310, stone block 325 and drain 308, exposed in Trench 3

4.4.7 A fourth, linear-shaped stone block (325) with a wide V-shaped channel incised along its centre was exposed in the northern part of Room 3 (Plate 11). This may have acted as a drain, which would have originally run along the south-eastern side of the two machines located upon stone blocks 306 and 328.

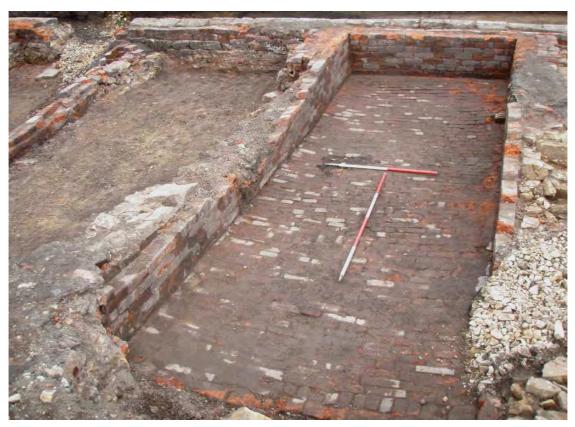
Plate 12: Looking east along Rooms 4 and 5 exposed in Trench 3

- 4.4.8 **Room 4:** this was the narrowest room in the building complex, measuring 5.60 x 2.20m (Plate 12). It incorporated a surface of hand-made bricks (**311**), which was set at a level slightly lower than the floors Rooms 2 and 3. The bricks were set on their side with no evidence for mortar bonding. The surface had a notable slope towards the reservoir to the west. The internal elevations of the external walls (**303**) were clad with hand-made bricks (**310**), which had been laid on top of surface **311**, suggesting that they were a later addition. A ceramic drain sat within the south-west wall of the room, which appeared to have been connected with stone **325** in Room 3.

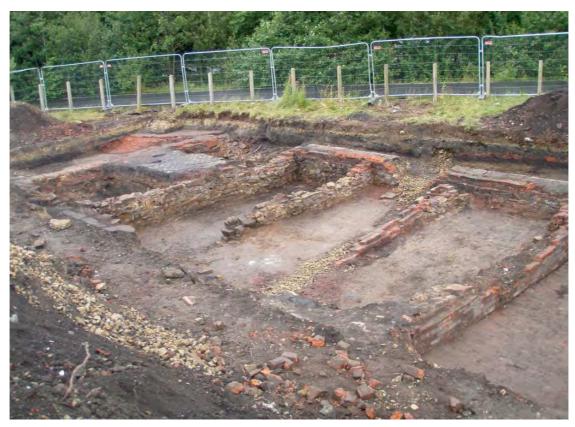
Plate 13: Looking north-east along Trench 3, showing Rooms 5 and 6

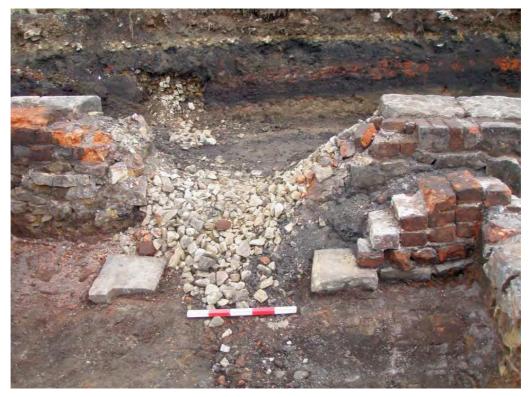
Plate 14: Possible doorway exposed along eastern wall 303 in Room 5

- 4.4.11 A stub of a wall (312) composed of hand-made bricks continued northeastwards from the south-eastern end of wall 313. Wall 312 ran parallel to external wall 303, but was separated from it by a gap of 180mm, which was filled with a loose deposit of ash and clinker. Adjacent to wall 312 were two stone pads, both measuring 0.3 x 0.3m. These appeared to respect a 0.80m wide entrance, which afforded access to Room 5 from the yard to the rear of the mill block (Plate 14), and may thus have represented the foundations for a wooden door frame. The doorway had been used subsequently as a route for a modern service pipe, which had presumably been laid following the demolition of the building (Plate 14).

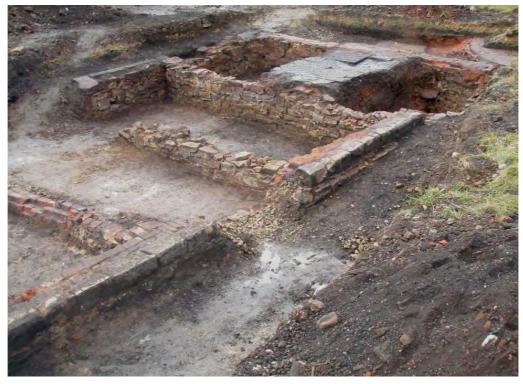
Plate 15: Looking north-west along Rooms 5 and 6, showing stone walls 329 and 316

4.4.13 *Room 6:* this room measured 6.30 x 3.30m, and comprised stone walls *316* and *334*, which formed the northern end of the building range (Plate 15). It was situated adjacent to a chimney (*319*), suggesting that Room 6 may have been intended as a boiler or engine room. However, walls *316* and *334* clearly represented a complete rebuilding of the room, suggesting a change in its original function. It seems likely that this may have been associated with the remodelling of the building between 1894 and 1909 noted on the historical mapping (*Section 3.2.5 above*). The build of these walls was considerably rougher than that in the other surviving stone walls of the building range. In the north-east corner of the room, wall *329* curved round to respect chimney *319*. Elements of this wall comprised hand-made bricks, each measuring 240 x 115 x 70mm.

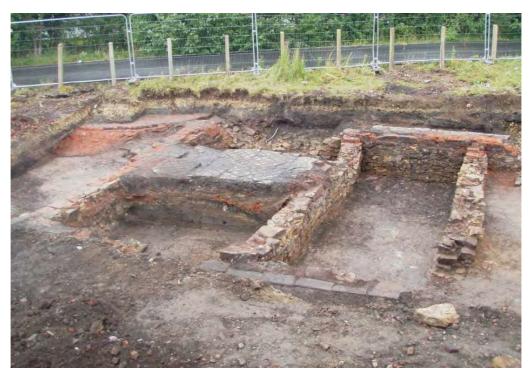
Plate 16: Looking east across Rooms 5 and 6, showing surface 315 and chimney 319

- 4.4.16 A brick-built structure (*319*) exposed partially in the north-eastern corner of the excavated area almost certainly represented the remains of a chimney; the position of this structure corresponded with the circular feature situated adjacent to the north-eastern corner of the building range depicted on historical mapping (Plate 2). The entire footprint of the chimney could not be exposed as it continued beneath a public footpath to the east of the excavation area. The exposed remains comprised a single course of hand-made bricks.

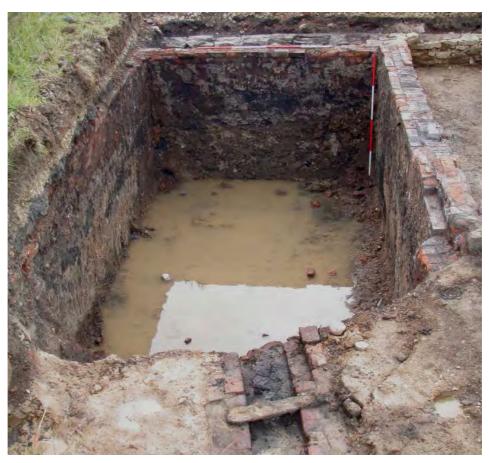
Plate 17: Looking east across Room 1, showing stone capped drain 304

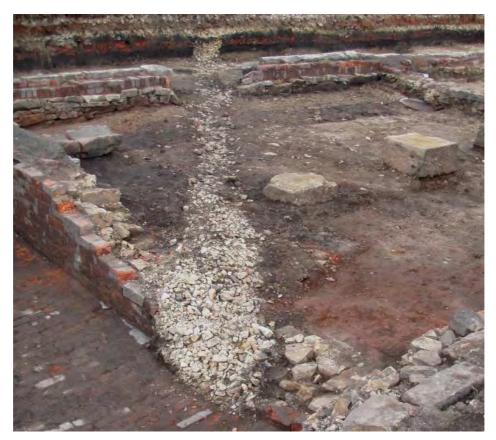
Plate 18: Modern intrusion running north-west/south-east across Room 3

- 4.4.19 Three modern intrusions were present in Trench 3. Two of these were drains, running approximately north-west/south-east (Plate 18) and east/west across the trench. The third was a possible trial pit, exposed in Room 5.

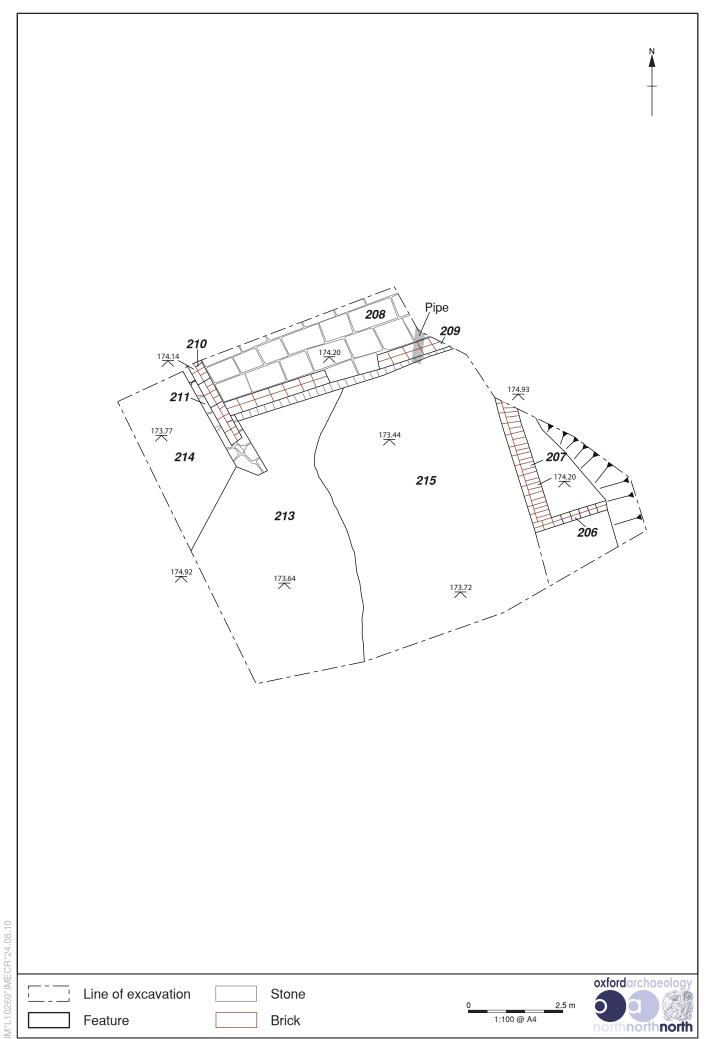
- Figure 2: Trench location
- Figure 3: Trench location superimposed on the Ordnance Survey first edition 25": 1 mile map of 1894
- Figure 4: Detail plan of Trench 2
- Figure 5: Detail plan of Trench 3

- 4.3.3 The western side of wall **211** was abutted by a thick deposit (**214**) of compacted clay, which contained frequent inclusions of stone and brick fragments (Fig 4). Deposit **214** is likely to have represented an impermeable layer, intended to prevent water seepage from the reservoir.
