# **GARDYNER HOUSE, QUERNMORE ROAD, LANCASTER**

## **Archaeological Building Investigation**

**Lancaster Royal Grammar School**

Issue No: 2007-08/668

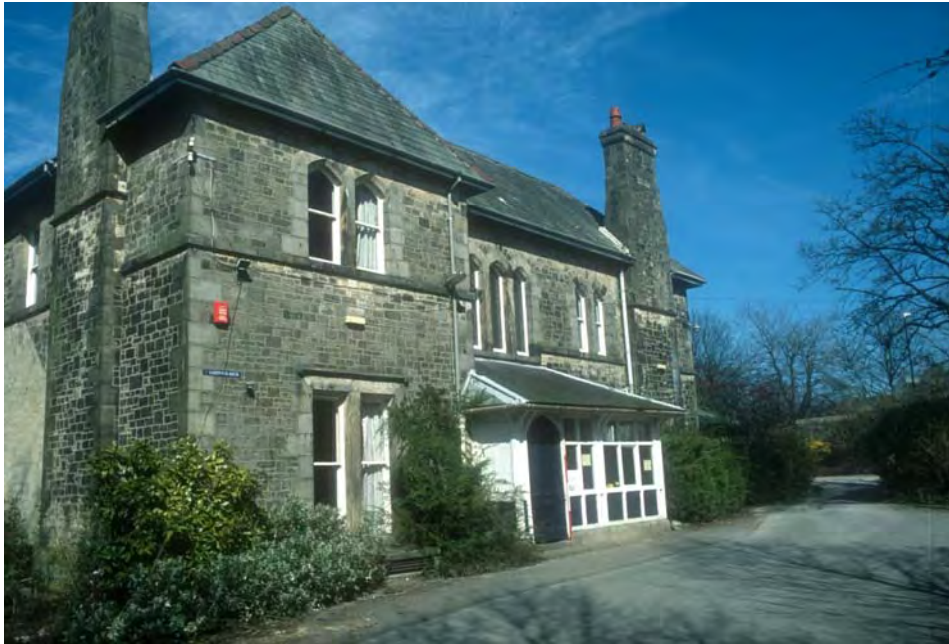
4.2.1 The house is constructed from coursed sandstone rubble with ashlar dressings, quoins and a string course beneath the first floor sash windows (Plates 1-5), whilst the original front and side entrances (now within rooms **1a** and **7** respectively) have chamfered corners. In addition, there are substantial projecting chimney breasts on both the south and west elevations, and a projecting plinth at the rear of the building. The porch on the front (south) of the building is constructed from timber and glass sat upon a sandstone base.

Plate 1: The front (south) elevation of the building from the driveway.

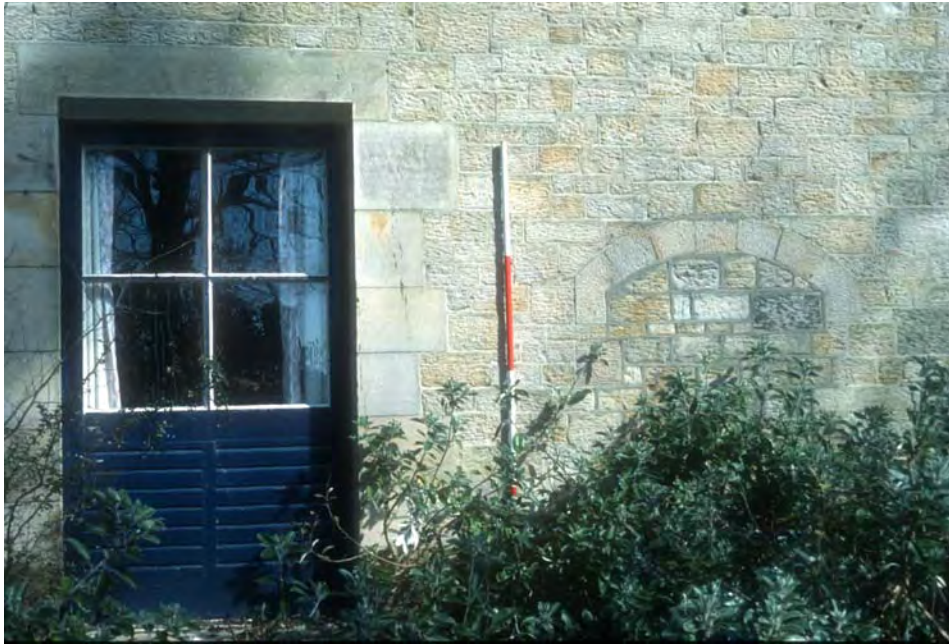
4.2.3 Of particular interest on this west elevation, is a small blocked aperture towards the centre of the wall. It differs significantly from the remainder of doors and windows (*Section 4.2.5*), in that it has a modest segmental voussoir of stone rubble rather than the dressed architraves observed elsewhere (Plate

6). This aperture may have been a cellar access, or a coal shute, or even a feature associated with heating pipes for the conservatory. Certainly, there is a coal shute to the left of the front porch, so it is unclear if this blocked aperture ever fulfilled this function.

Plate 6: Detail of the converted window and blocked aperture on the west elevation.

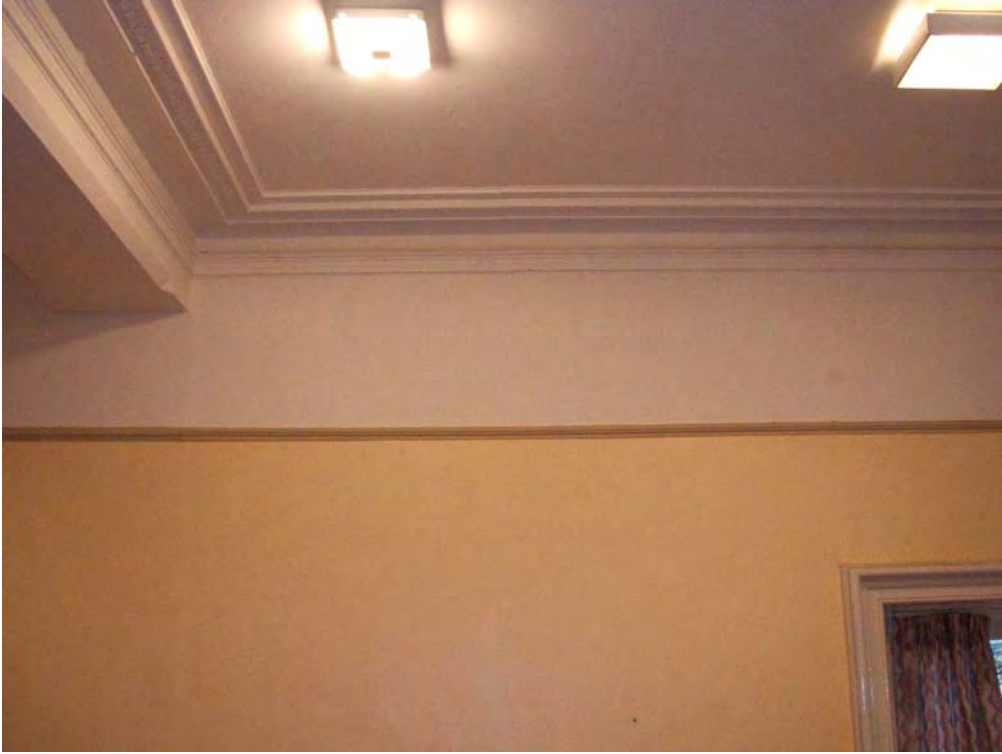
- 4.4.2 The ceilings in rooms **2**, **5** and **10** all attest to the fact these large single rooms were all originally sub-divided into two, and the substantial stop-chamfer beams featured in each case, mark the extent of the original stone dividing walls. Also within room **5**, there is a scooped recess on the south elevation, which is truncated by the plasterboard and timber partition of the modern kitchen (**6**). In addition, plasterboard has also been used to fashion the west wall of the kitchen (**14**), whilst the north wall of the same room, although an original stone wall, has been lined on its south side with the same material.

Plate 9: Detail of the chamfered beam and the cornice within Room 2.

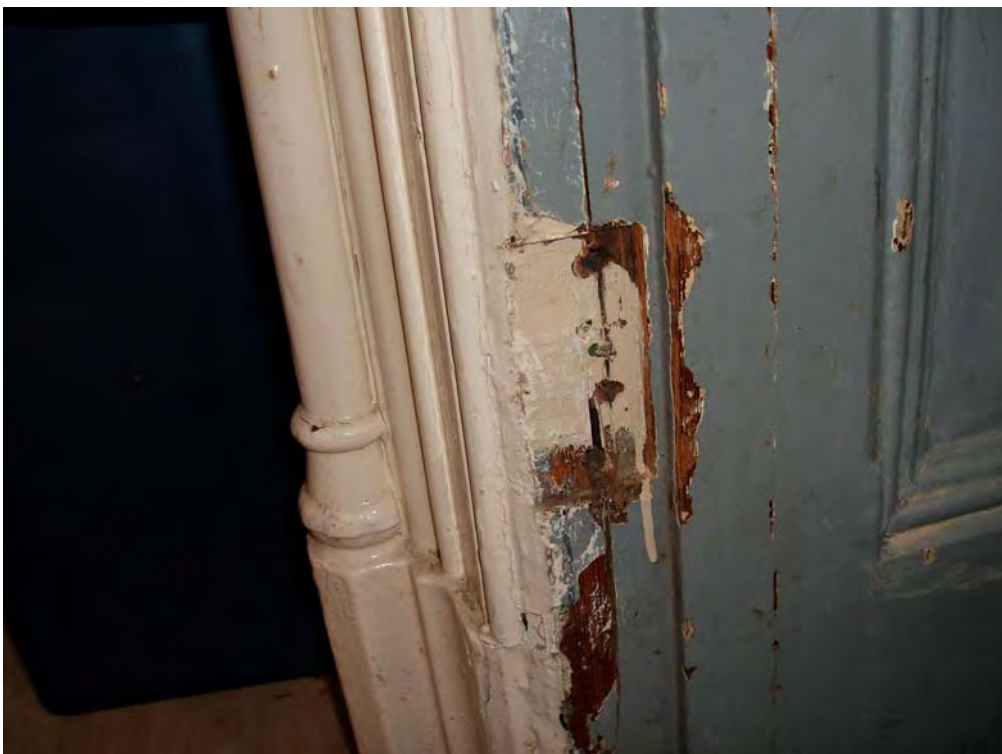
- 4.4.7 In keeping with the original layout of Gardiner House, the doors and architraves are more ornate at the west end of the building. The main entrance is a substantial eight panel doorway with pointed fanlight and deep recesses on its embrasure, whilst its architrave is a moulded timber surround with an astragal beading that descends to chamfered square bases (Plate 10). This panelled door with moulded architrave style is consistent throughout this end of the building, whilst the doors at the east end are all modern firedoors with modest surrounds. In addition, there are also several blocked doorways throughout the building, but these have been treated in different ways. Originally, room **2** was two separate rooms and the doorway leading into the former south room has subsequently been blocked with plasterboard. Similarly, the south door on the east wall of room **10** has become superfluous for the same reason, but this has been simply left locked. In addition, a doorway on the ground floor corridor (**4**) has been blocked with plasterboard and is now a recess to the left of the present doorway into room **5**, whilst the doorway into the kitchen of the flat (**18**) has been moved from its earlier position to the right.

Plate 10: Detail of the architrave adorning the principal doors of the building.

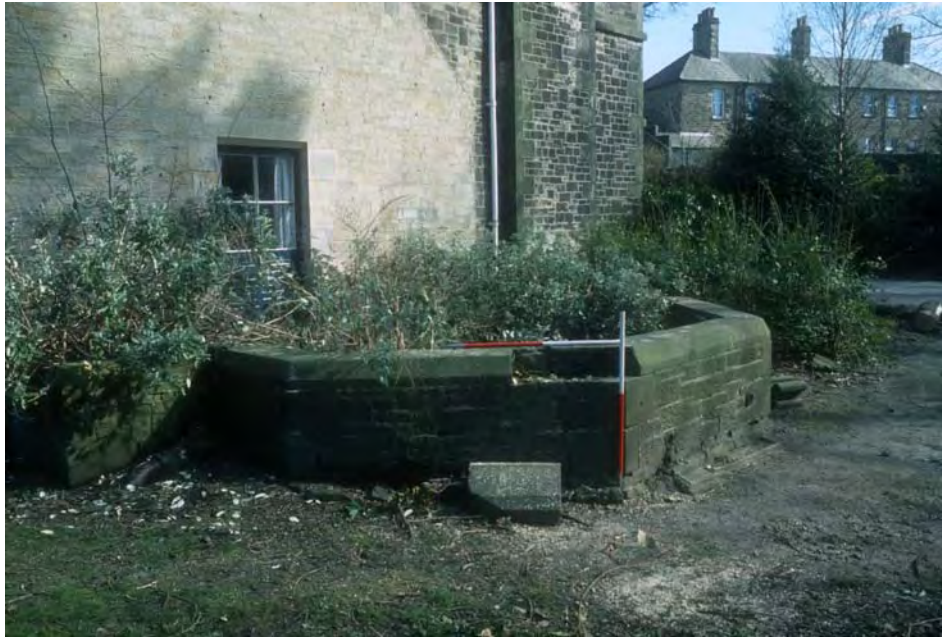
Plate 13: The remains of the Conservatory on the west end of the building

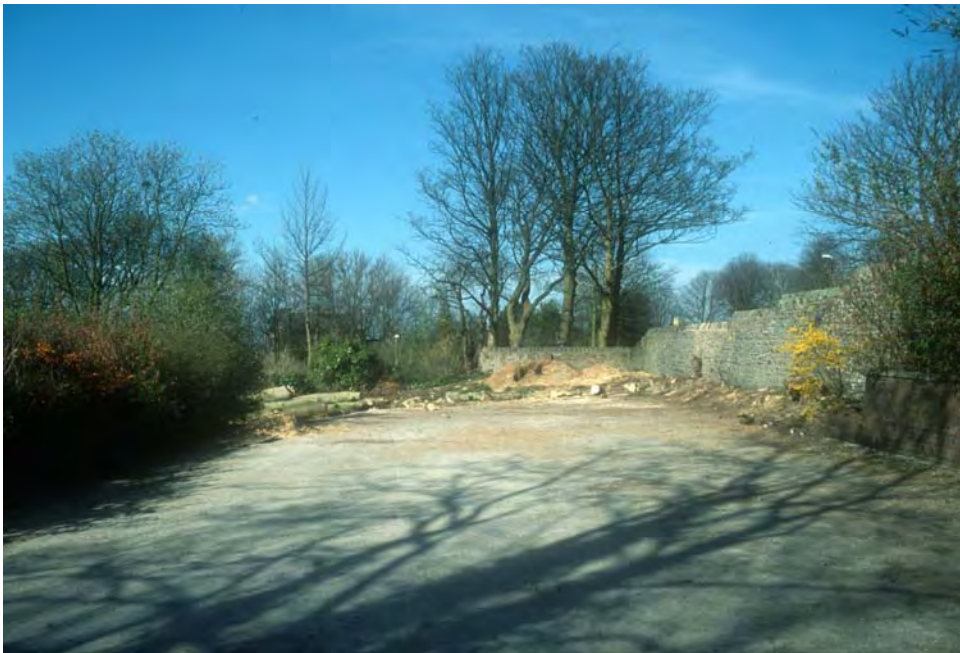
- 4.5.4 On the east side of the house, the ground surface has been significantly reduced to create a car park laid with asphalt (Plate 16). A shrubbery on the west side of this car park masks most of the east, north and south elevations of the single-storey extension.

Plate 16: The car park at the east end of the building

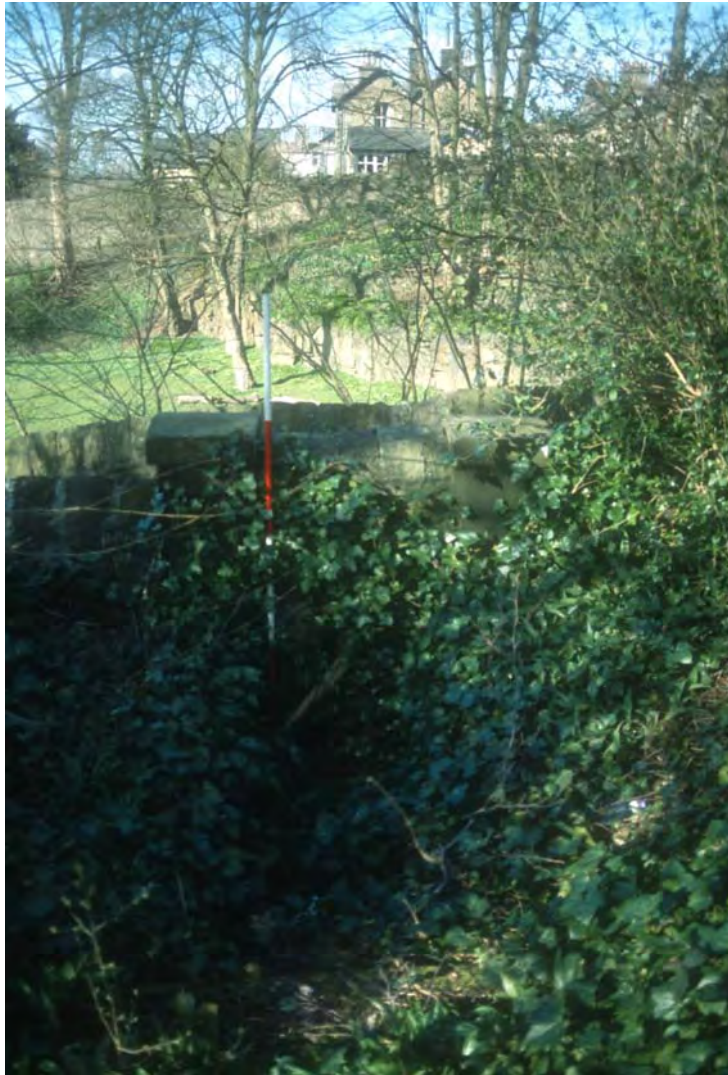
Plate 17: The blocked gate within the north extent of the perimeter wall.
