Outbuildings at the Rear of 112 High Street, March, Cambridgeshire

Historic Building Survey

September 2012

OA East Report No: 1403

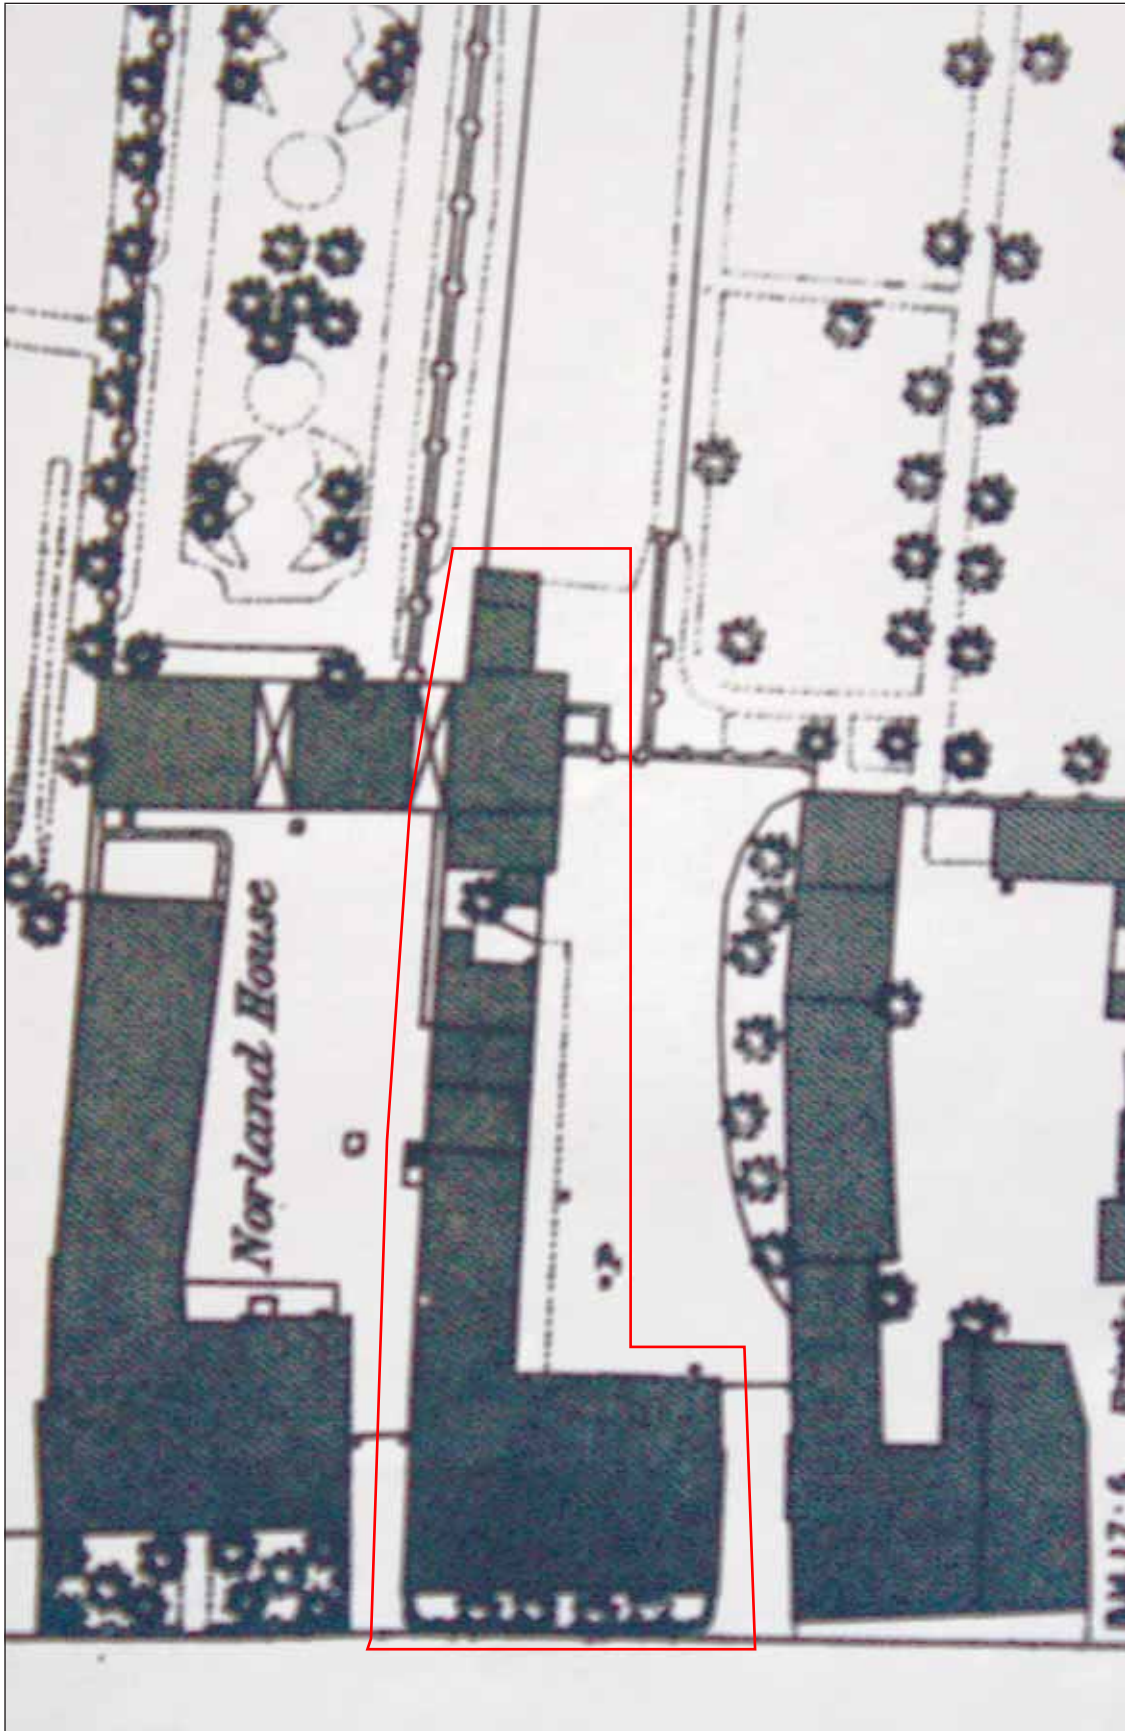
Figure 3: Extract from March Town Plan, 1887 (1:500) showing location of 112 High Street and out buildings (red)

- 3.2.5 The March Town Plan, drawn up in 1887 at a scale of 1:500, shows buildings in the town at the end of the nineteenth century in great detail. This map provides the earliest located representation of 112 High Street to include its outbuildings (Figure 3). Although it is known that the main house dates to the late 18th century, this is the earliest evidence for the existence of the associated outbuildings. There is no evidence on this map to suggest that the property was anything other than a residential house at this time.

- 3.2.6 The layout of the main house (112 High Street) is broadly the same as how it appears today, extending to the rear on the northern side. As today, this map shows a range of buildings at the rear of the main house, flanking the northern boundary on an east-west orientation. At the front of the house there is a small area denoted by a boundary wall which is still present today (Plate 1).

- 3.2.7 Although there are buildings depicted in the positions of the outbuildings surveyed, they extend further back than the current footprint (including the 20th century garages). There is a small break in the range of buildings with what appears to be a tree in this space.

- 3.2.8 Despite being a terraced row there are clearly separate outbuildings as denoted by what is most likely to be internal walls. A line running parallel to the outbuildings with a dot mid-way, just to the south, may denote a shelter, supported by a post.

- 3.2.9 This map shows an access route between 112 and the building to the south into a rectangular courtyard area with a small wooded/shrubbery area on the southern side as is still the layout today. Within the courtyard is a "P" which denotes the presence of a pump to provide fresh water.

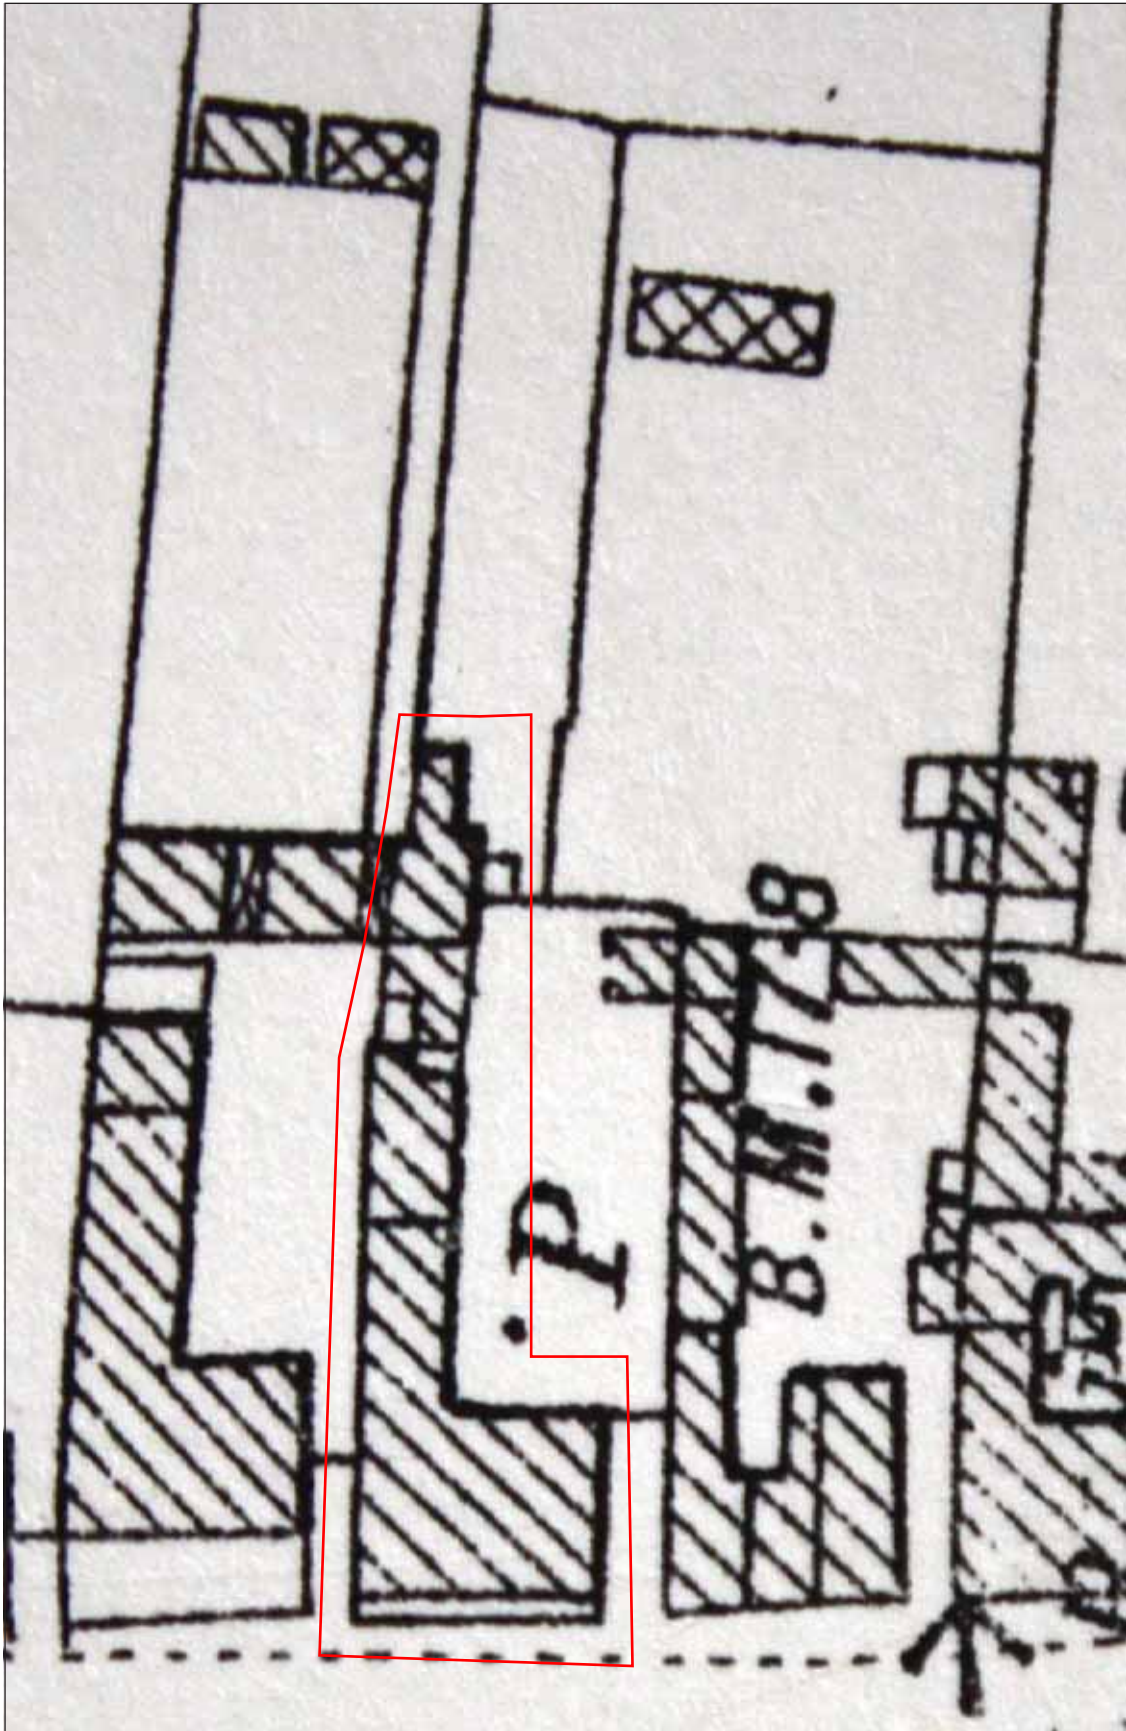
Figure 4: Extract from 1902 Ordnance Survey Map (1:2500) showing location of 112 High Street and out buildings (red)

- 3.2.11 The next available map is the 1902 Ordnance Survey map (Figure 4). This shows the same arrangement and number of outbuildings, unaltered since the previous map of 1887 other than by the addition of a small square outbuilding on the southern side of the courtyard.
- 3.2.12 The internal sub-dividing walls are not depicted, however this is possibly as it is a larger scale and less detailed plan.

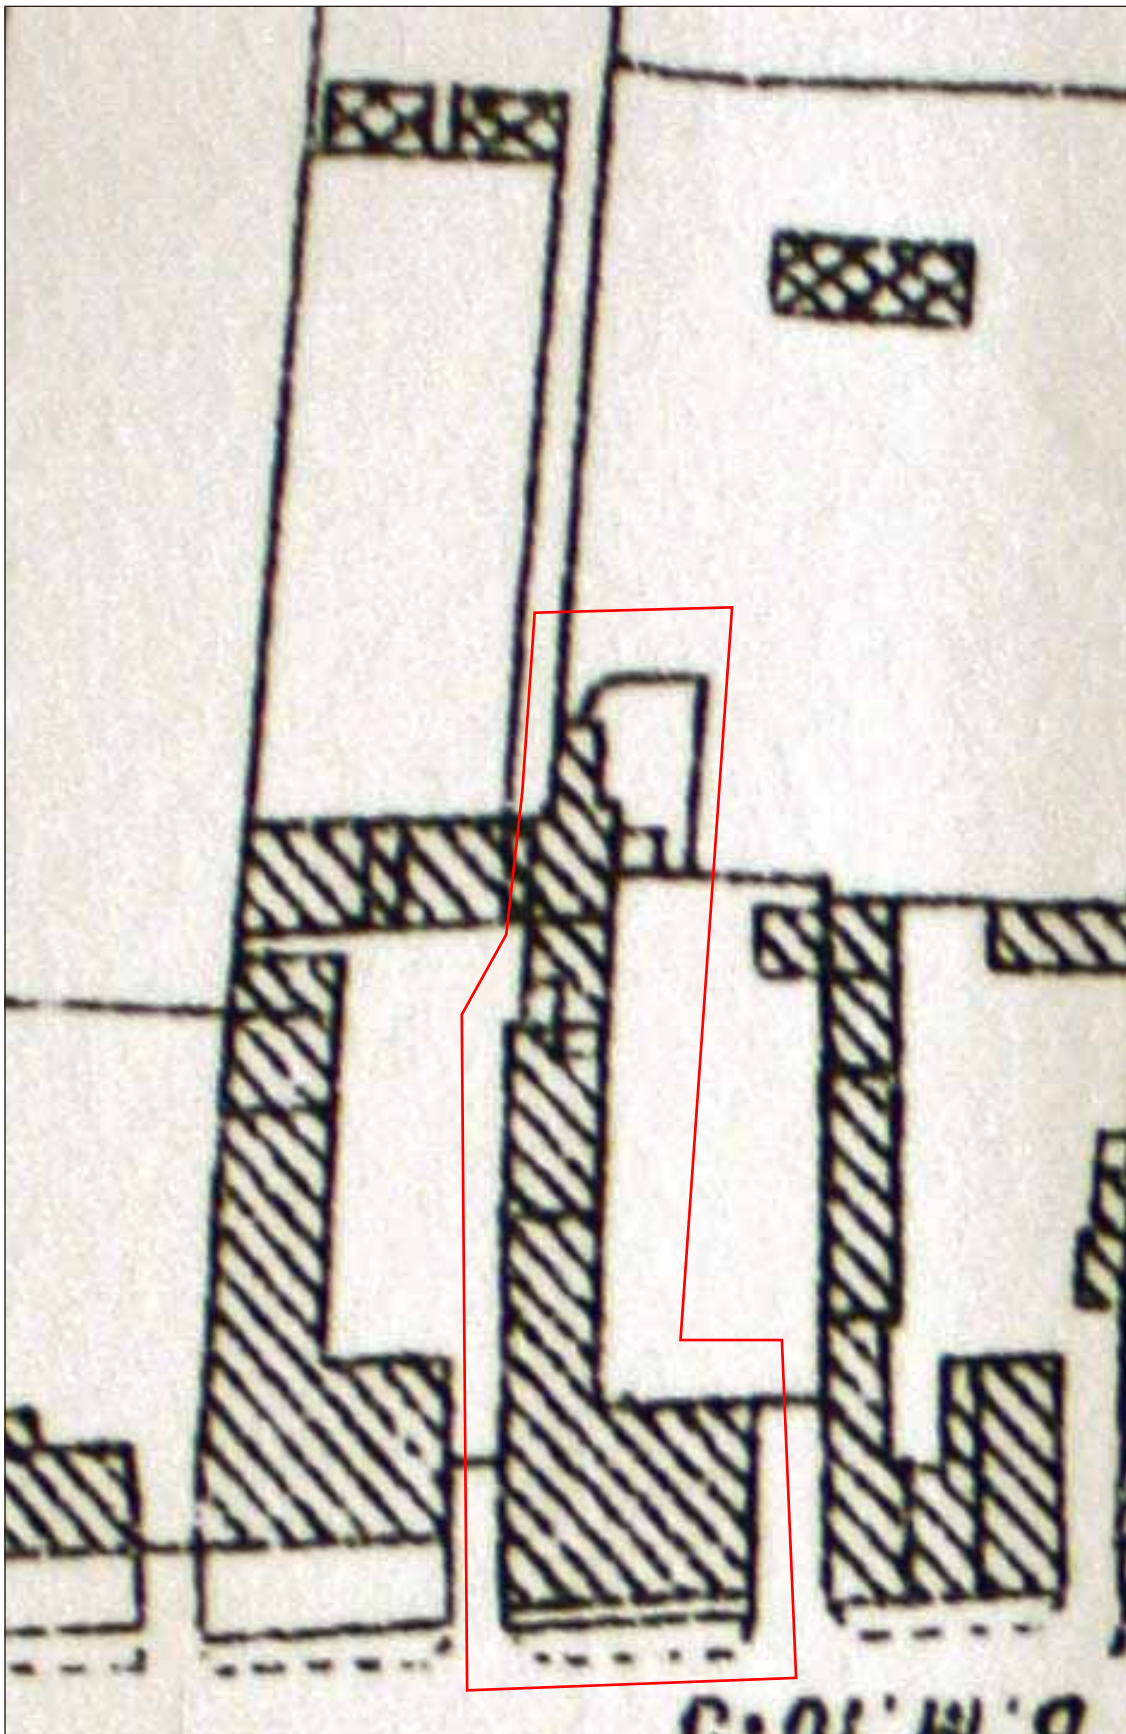
Figure 5: Extract from 1927 Ordnance Survey Map (1:2500) showing location of 112 High Street and out buildings (red)

- 3.2.13 No change is recorded to the outbuildings or the main house by the time of the next detailed Ordnance Survey map of 1927 (Figure 5).

- 3.2.14 The only obvious change by this point is the loss of the long narrow garden/land to the rear. A small curved wall has been introduced and the rest of the land has been merged with the gardens of the property to the immediate south.

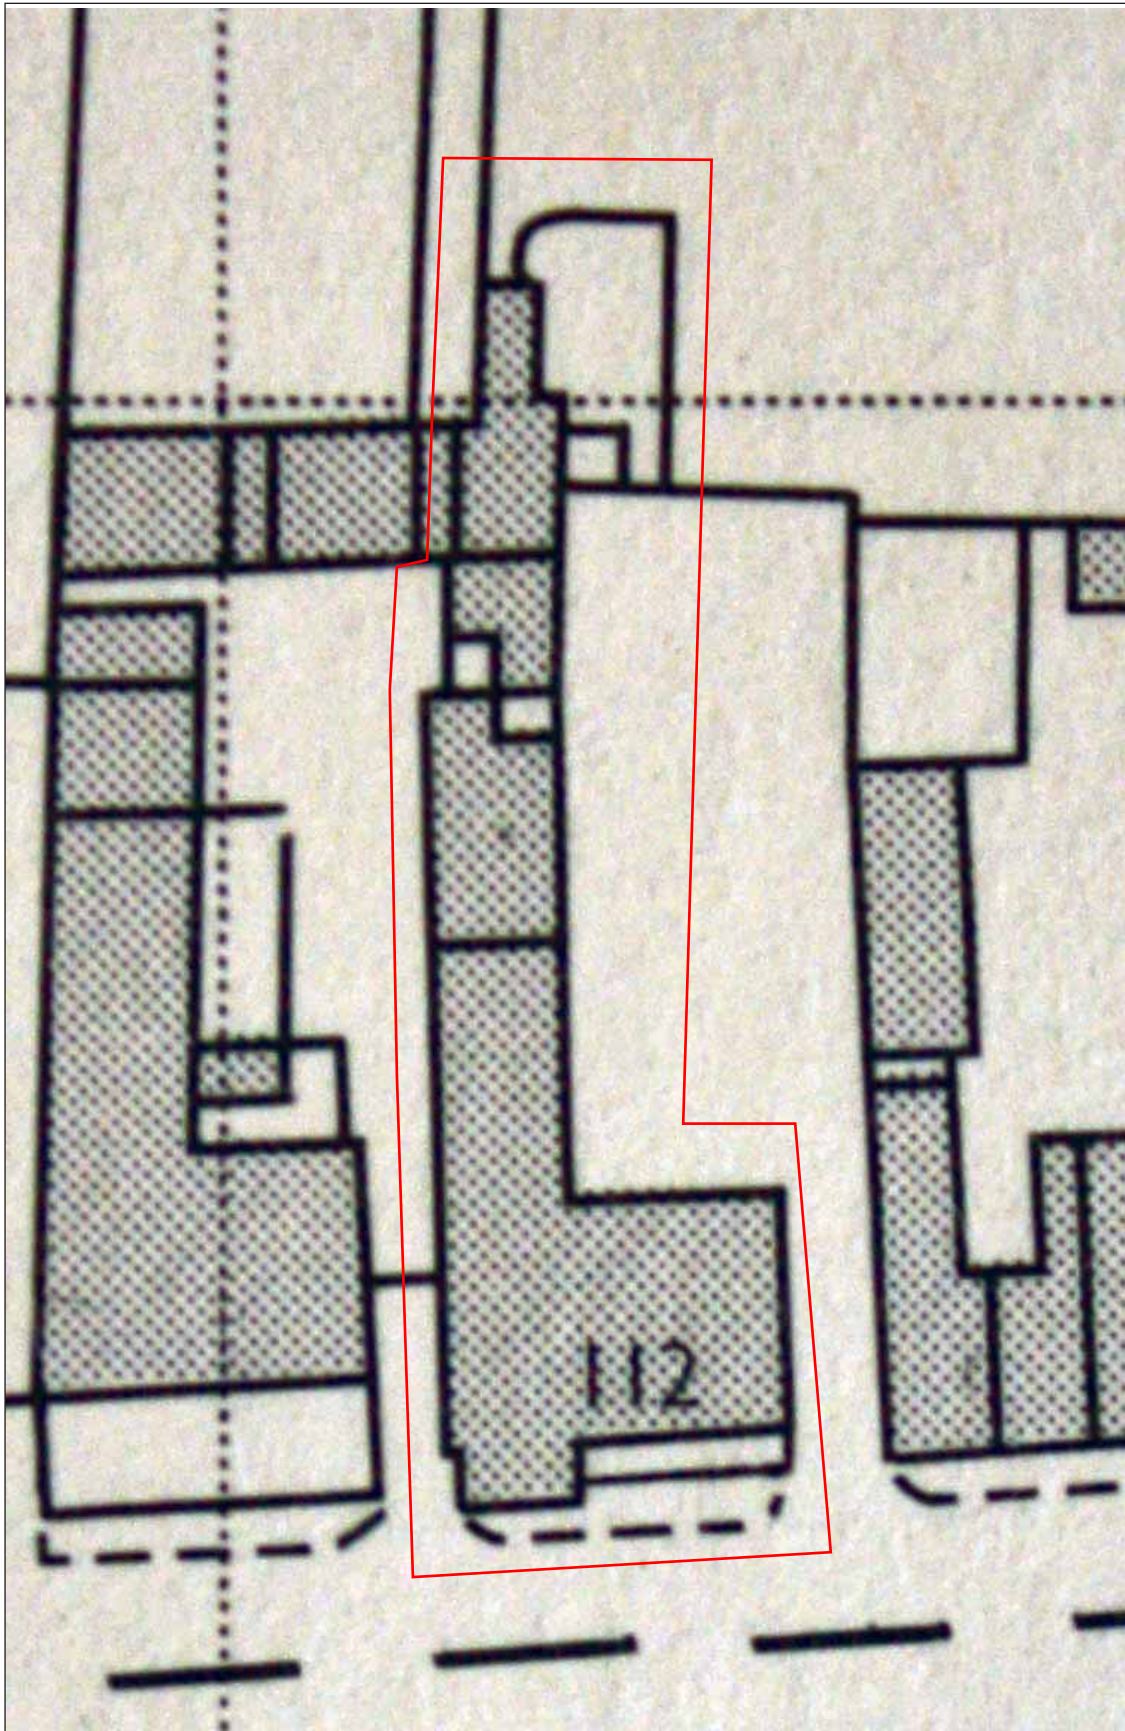
Figure 6: Extract from 1971 Survey Map (1:2500) showing location of 112 High Street and out buildings (red)

- 3.2.15 The next available map is the 1971 edition Ordnance Survey map (Figure 6). This shows no change to the outbuildings since the earlier 1927 map or in fact that of 1887.
- 3.2.16 There has been an alteration to the main house by this time, with a small addition to the façade, jutting out into the High Street. This is most likely the addition of the shop frontage which is still present and in use today (Plate 1). By this point, the building is also depicted with the house number 112.

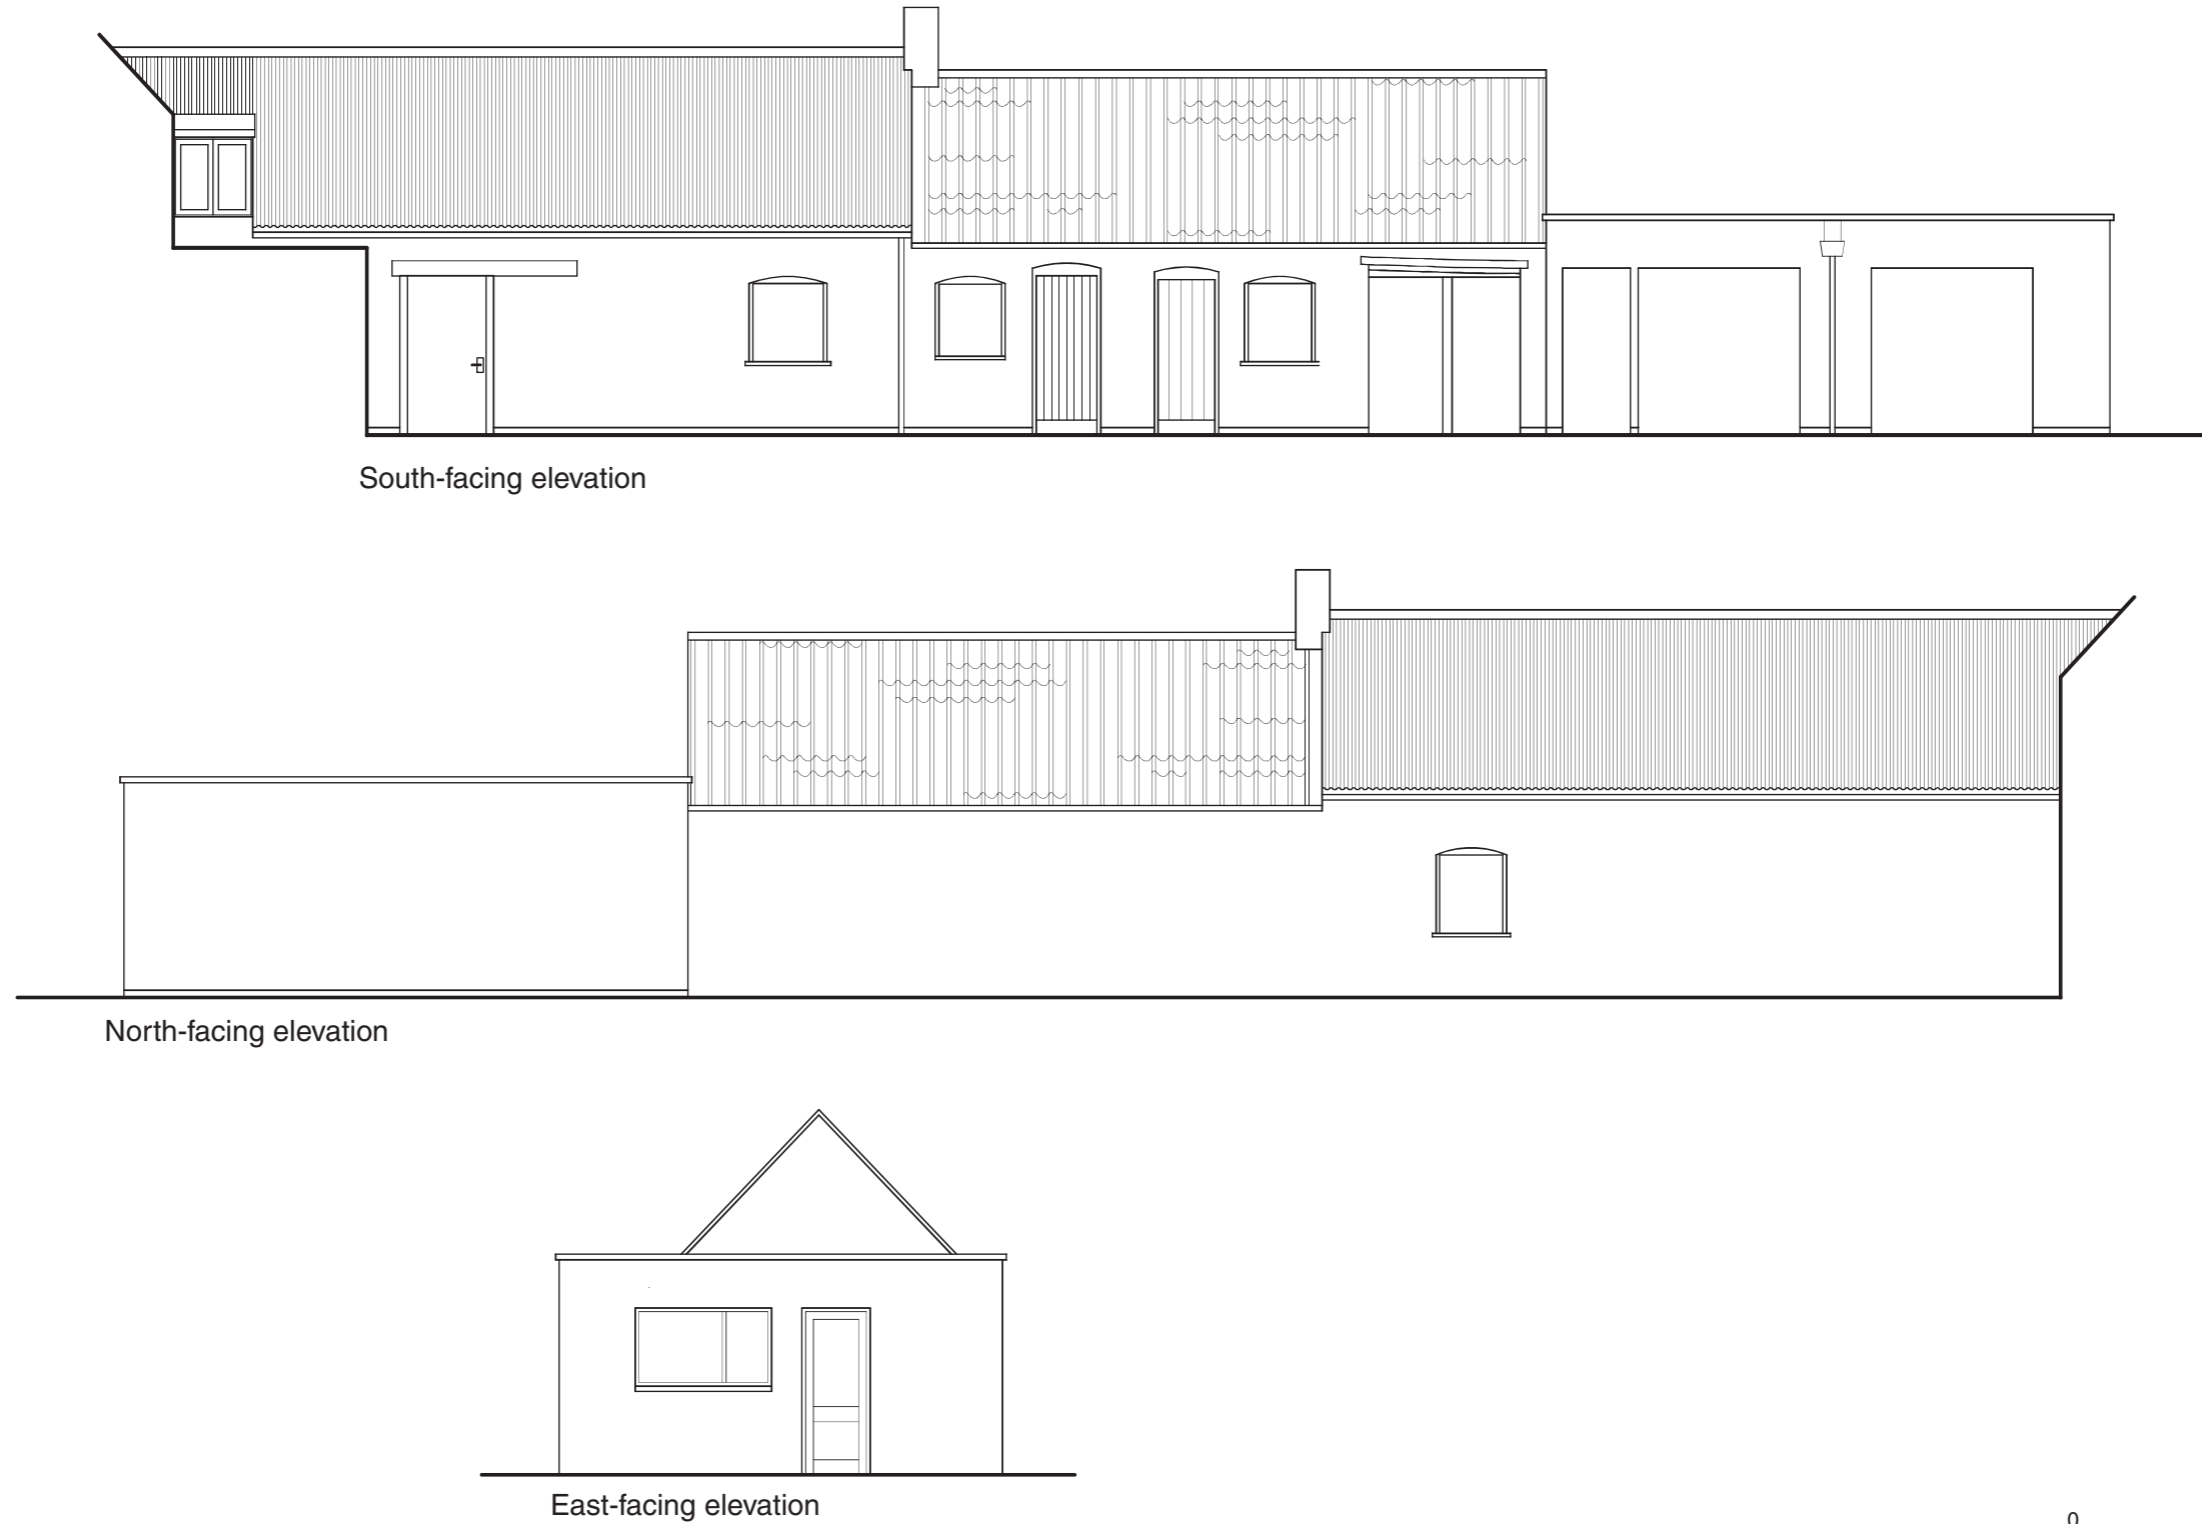
Figure 7: Elevations of buildings surveyed (from data supplied by client)

- 4.2.1 The south-facing elevation clearly represents the three distinct buildings which make up this survey. Although entirely rendered and painted white, different roof pitches, coverings and construction styles denote three phases of outbuildings (Figure 7 and Plate 2).

- 4.2.2 On the far left of this elevation is Outbuilding 1, a two storey building which has been incorporated and partially obscured by an extension added to the rear of the main house (Plate 3). This building has been completely covered with white painted render. It has a moderately steep sloping roof with corrugated asbestos sheeting and clay ridge tiles. There is a single dormer window located on the western end. The dormer window could not be closely inspected but appears to be a two-part, wooden framed casement window (Plate 4). The entrance on the ground floor comprises a modern, solid wooden door with brass fittings and a large lintel above. The ground floor window was boarded up at the time of the survey, but comprises a wooden frame with arch above and a wooden cill.

- 4.2.3 Adjoining Outbuilding 1 is a smaller, single storey building (Outbuilding 2), also covered with white painted render (Plate 5). This building has a similar pitched roof as Outbuilding 1, but covered with red clay pantiles with similar coloured clay ridge tiles and with a brick chimney at the western end constructed from buff and beige coloured bricks with horizontal pressure marks. The fenestration appears to be the same as Outbuilding 1 (also boarded up) and there are two plank and batten doors comprising seven vertically laid boards, under arches of similar proportions to the windows. The doors are opened using a simple latch, typically late 19th century in date (Plate 6). At the far eastern end is a double wooden door beneath a flat wooden lintel which provides access to the third “room” of this building

- 4.2.4 The third building (Outbuilding 3) comprises a double garage and external toilet (Plate 7). The toilet is on the left and accessed via a modern solid wooden door. There are two large openings with metal “up and over” doors. The building itself is rendered and painted white with a raised parapet of red bricks with a central void to allow for drainage via a hopper and downpipe.

- 4.2.5 The east-facing elevation comprises the end of the 20th century garage structure as viewed from the garden (Plate 8). This elevation is covered with a white painted render and has a single wooden-framed casement window and late 20th century wooden panelled door. This elevation confirms that the building has a flat roof and a raised brick parapet.

- 4.2.7 The south-facing elevation was not accessible for the survey as it is contained within the next door property. However, a photograph and elevation was provided by the client and notes can be made from these (Figure 7 and Plate 10).
- 4.2.8 This elevation is rendered and painted a sandy beige colour and the roof coverings of asbestos sheet and tiles continue on this side of the building. There is a window on this elevation which must be boarded up as it did not seem to correspond to any windows recorded from the internal survey.

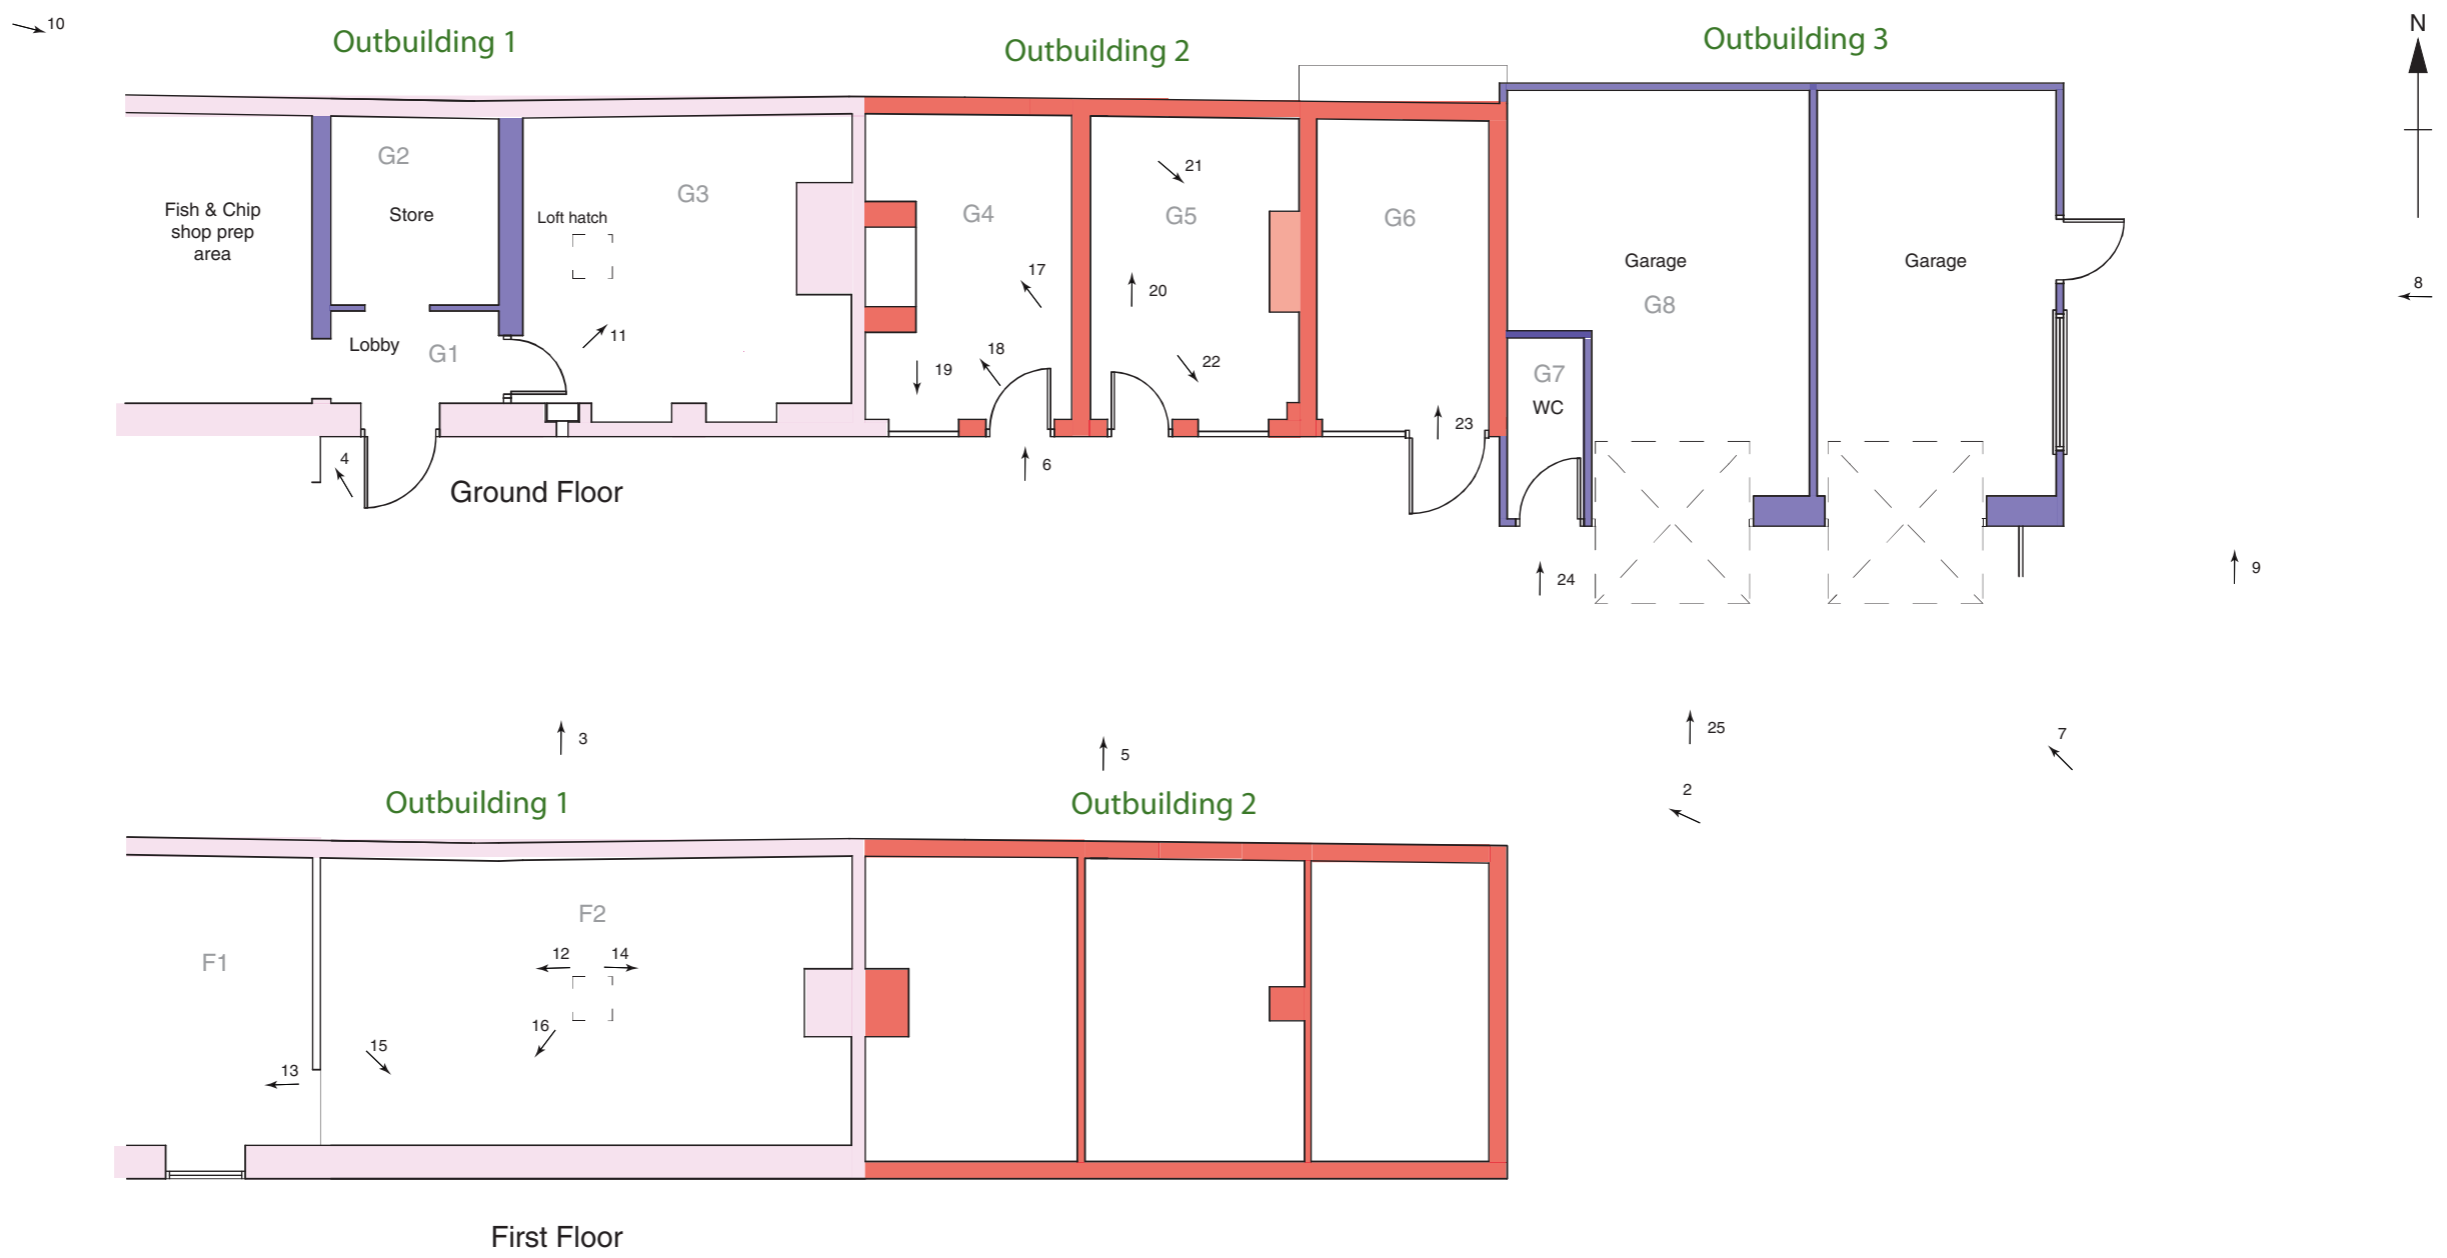
Figure 8: Plans of ground and first floor showing phasing and location of plates used in report (from data supplied by client)

- 4.1.1 For the purposes of this report, the buildings surveyed as part of the development have been labelled Outbuildings 1 to 3. Figure 7 shows building elevations and the layout of the buildings in relation to each other can be seen on Figure 8, which also shows the suggested phasing as well as locations of plates used.

- 5.1.1 The first phase of building on this site is Outbuilding 1, which comprises rooms G1-3 on the ground floor and F1 and 2 above. This building appears to link up with the main house, although further detailed investigation inside of 112 High Street would be required to confirm this, which was not possible at the time of the survey.

- 5.1.2 This building was most likely a service wing to the main house and probably had a red clay tiled roof. The listed building description describes the main house as late 18th century in date; its double pile, symmetrical façade and dormer windows are indeed typical of this era (Plate 1). However, the deliberate symmetrical appearance did not need to extend to the plan of the building or the unseen areas to the rear and it is here where Outbuilding 1 would be in the ideal position for a service wing where the preparation of food could take place. A house of this size would most likely have required at least two domestic staff. There may have been more staff accommodated in the attic rooms of the main house.

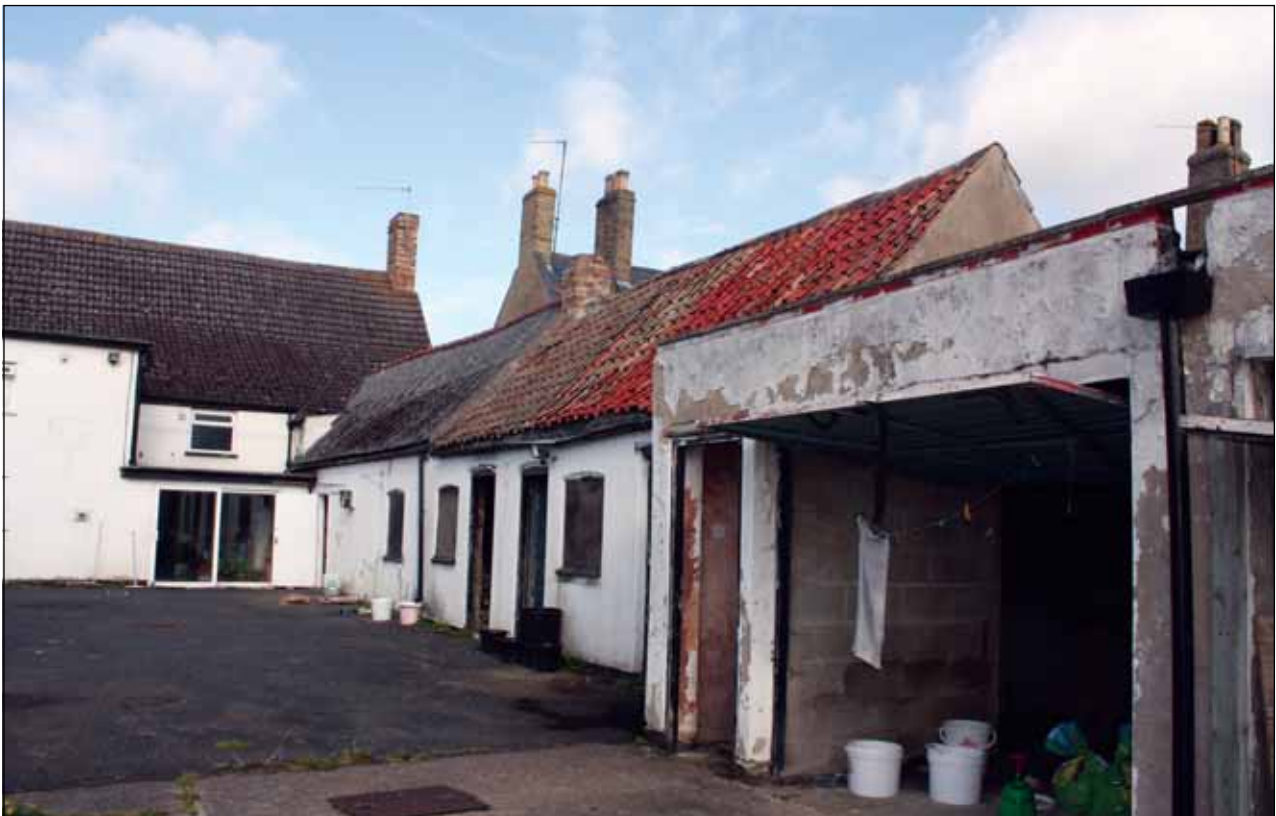
Plate 2: Range of outbuildings surveyed

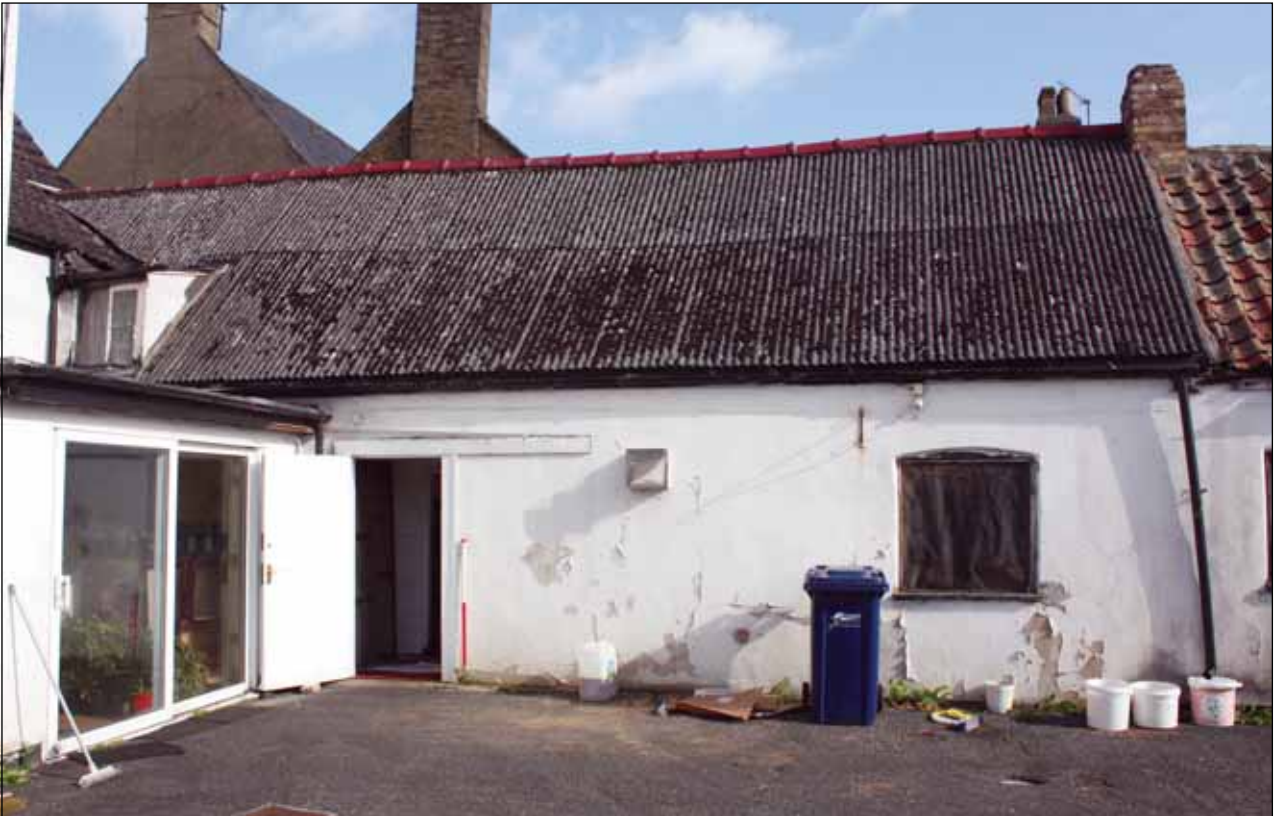
Plate 3: Outbuilding 1, south-facing elevation

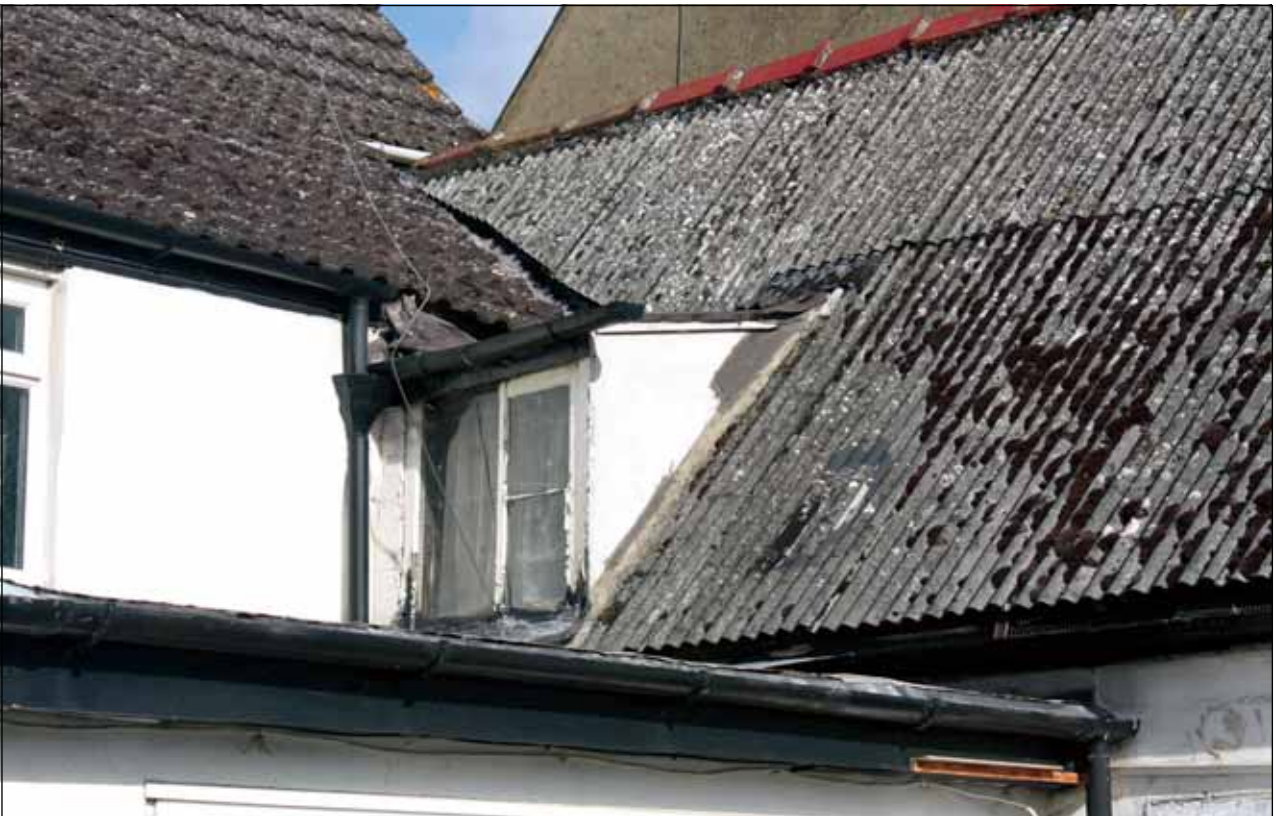
- 5.1.6 The close proximity of the existing dormer window to the main house (Plates 3 and 4) suggests the house has been extended slightly to the rear to incorporate this building, encompassing it slightly with an extension and change in slope to the existing roof-line.

Plate 4: Dormer window of Outbuilding 1

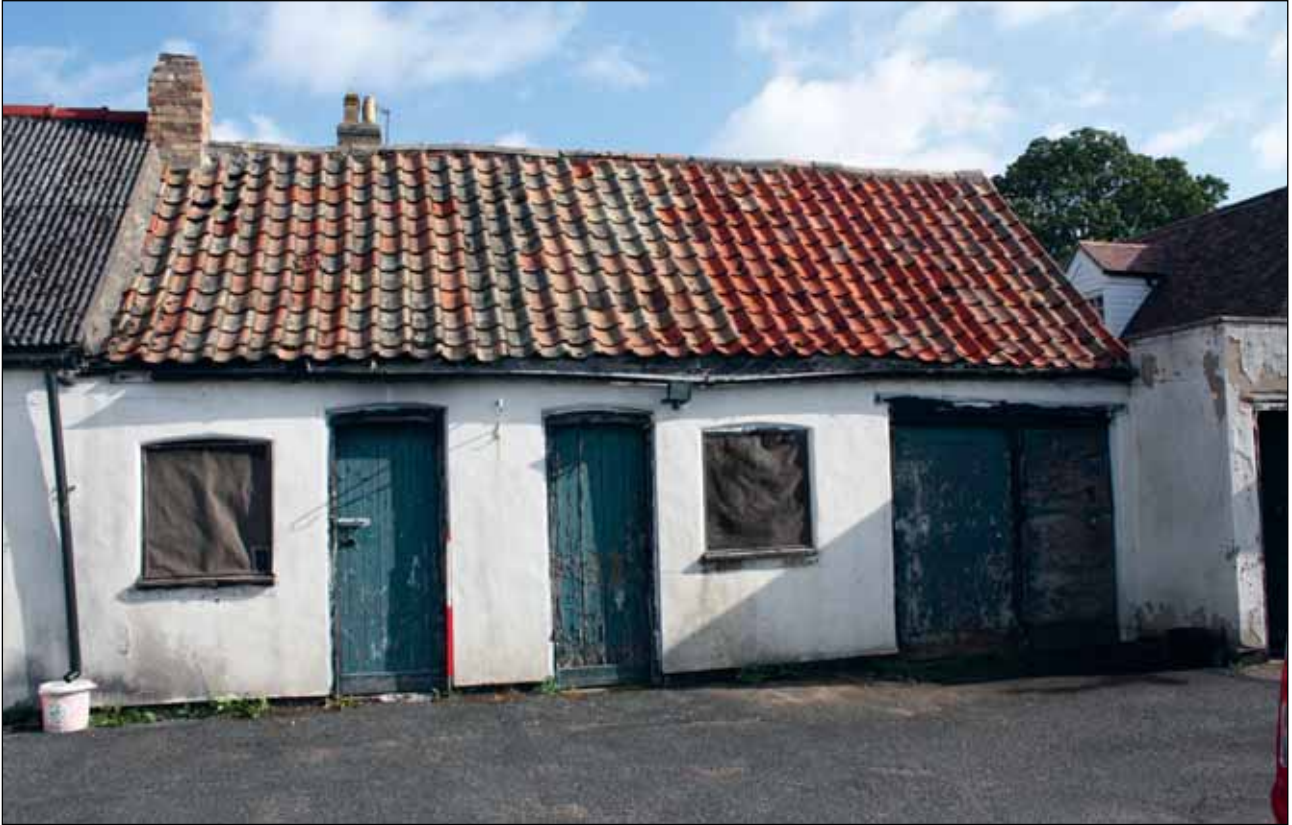
Plate 5: Outbuilding 2, south-facing elevation

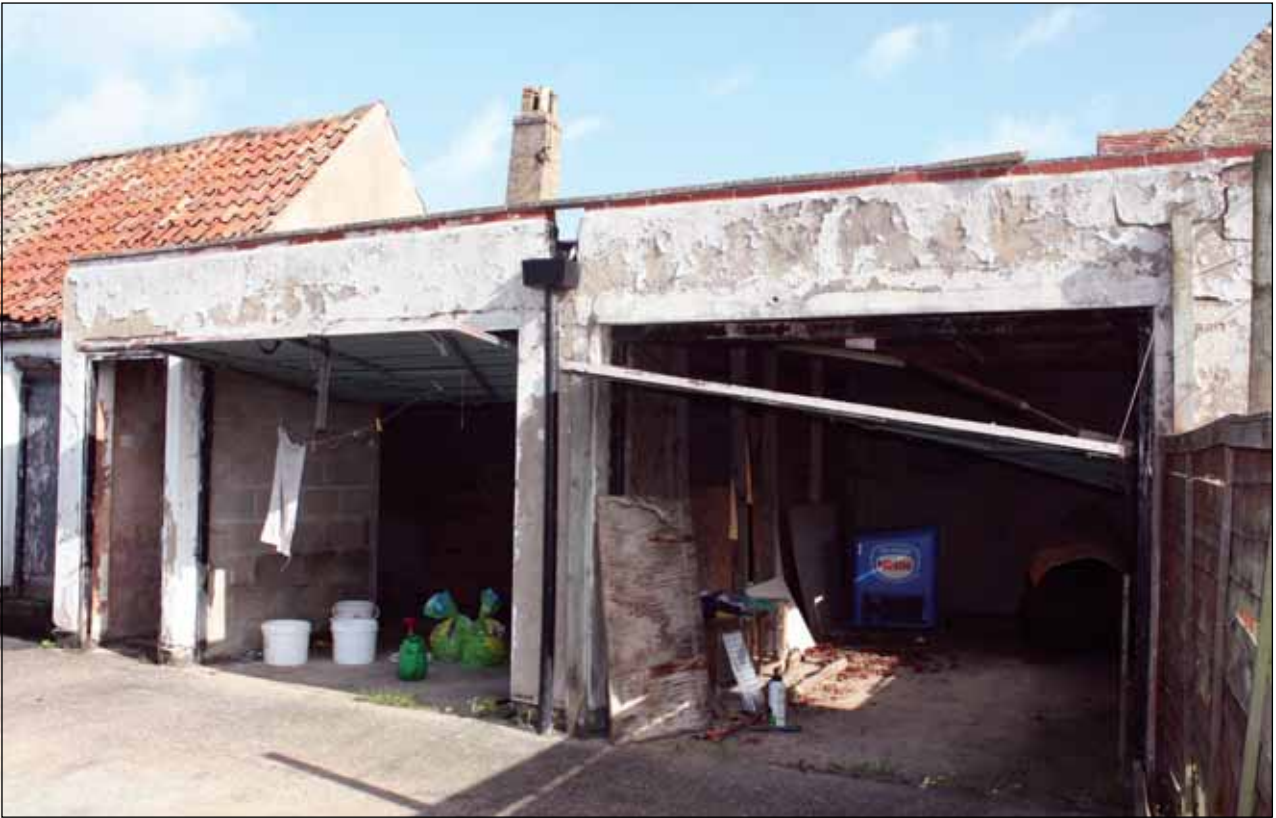
Plate 7: Outbuilding 3, south-facing elevation

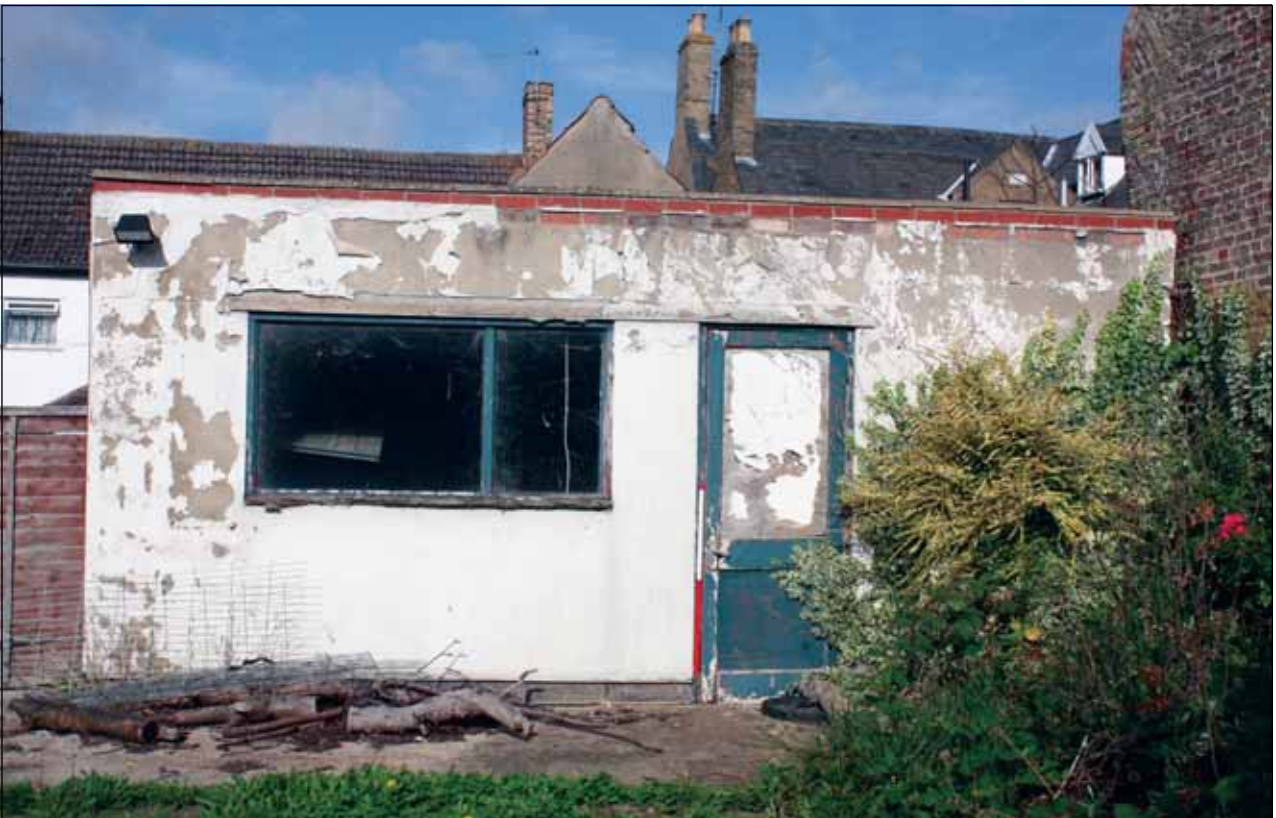
Plate 8: Outbuilding 2, east-facing elevation
