Outbuildings at the Rear of 112 High Street, March, Cambridgeshire

Historic Building Survey

September 2012

OA East Report No: 1403

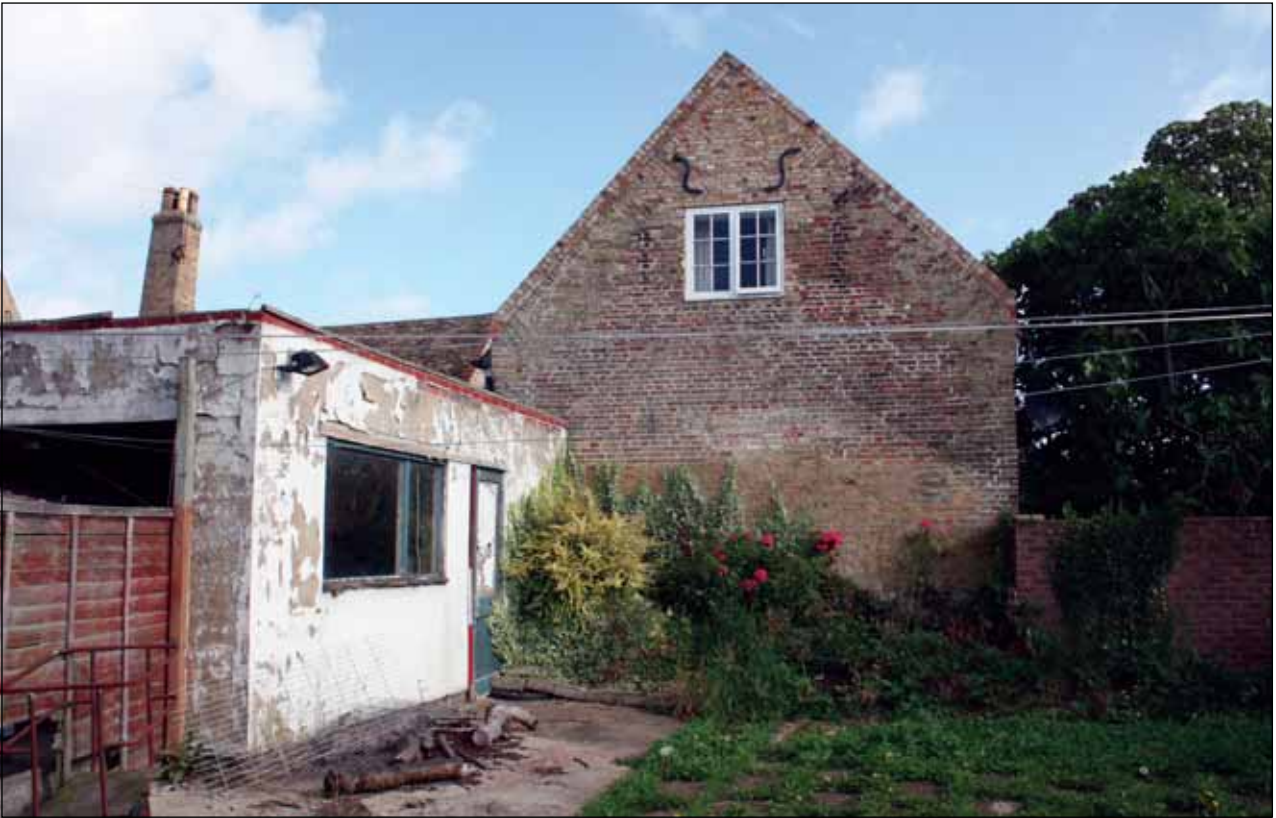
- 4.2.6 From this position within the garden, there is a ghost-line of a low-pitched roof on the gable end of the next-door property (Plate 9). This ghost-line may correspond with one of the earlier outbuildings depicted on the late 19th and early 20th century maps.

Plate 9: Detail of “ghostline” of former outbuilding on south-facing elevation of outbuilding at 110 High Street

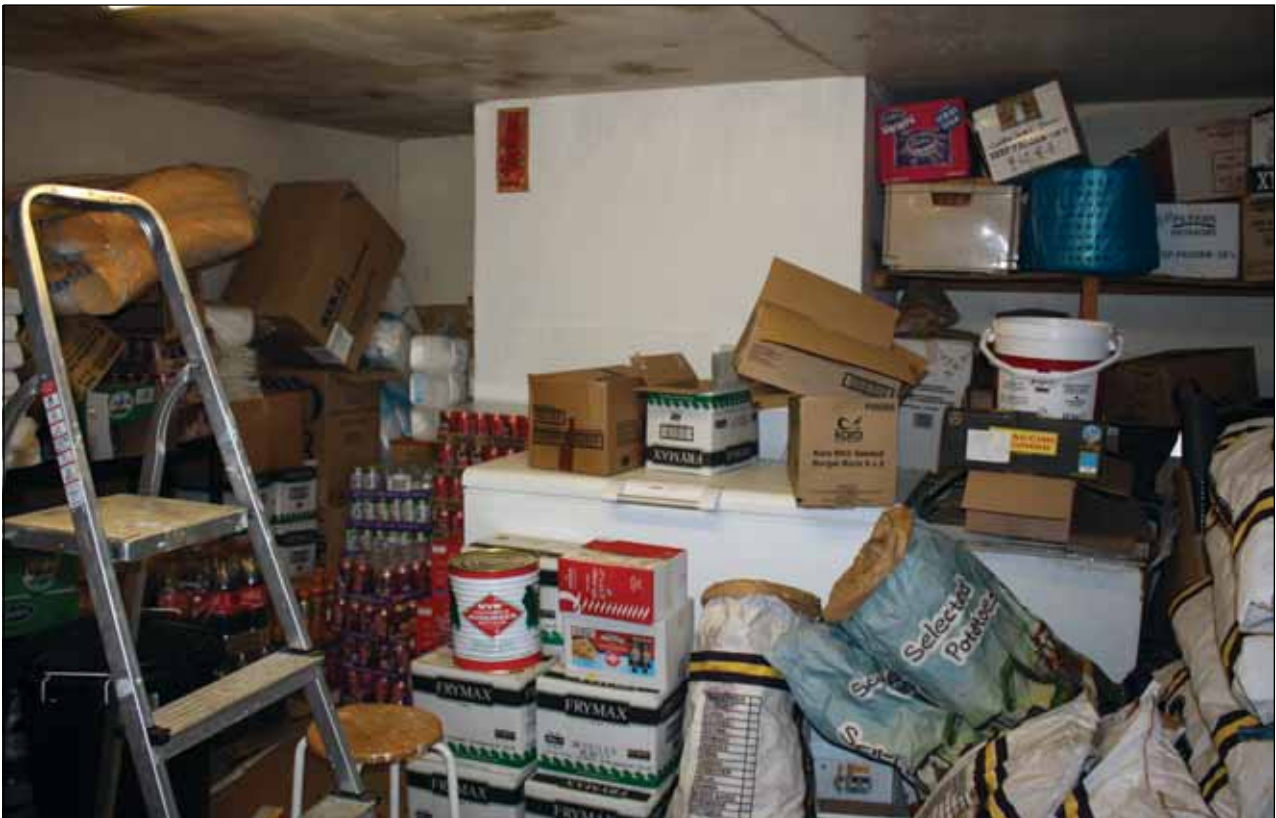
- 4.3.4 Turning right from the lobby entrance is a larger room (G3) which at the time of the survey was being used for storage. This room has a small access hatch which provides access to the first floor/attic space above. The floor is covered with concrete, the walls are all rendered and painted and the ceiling is covered with plasterboard (Plate 11). There is a blocked-up chimney present in the middle of the wall at the southern end and two recesses on the south wall. One of these recesses corresponds with the boarded up window recorded on the south-facing elevation (Figure 7, Plate 3), the other must have been in-filled and rendered over.

Plate 11: General room view, G3, Outbuilding 1

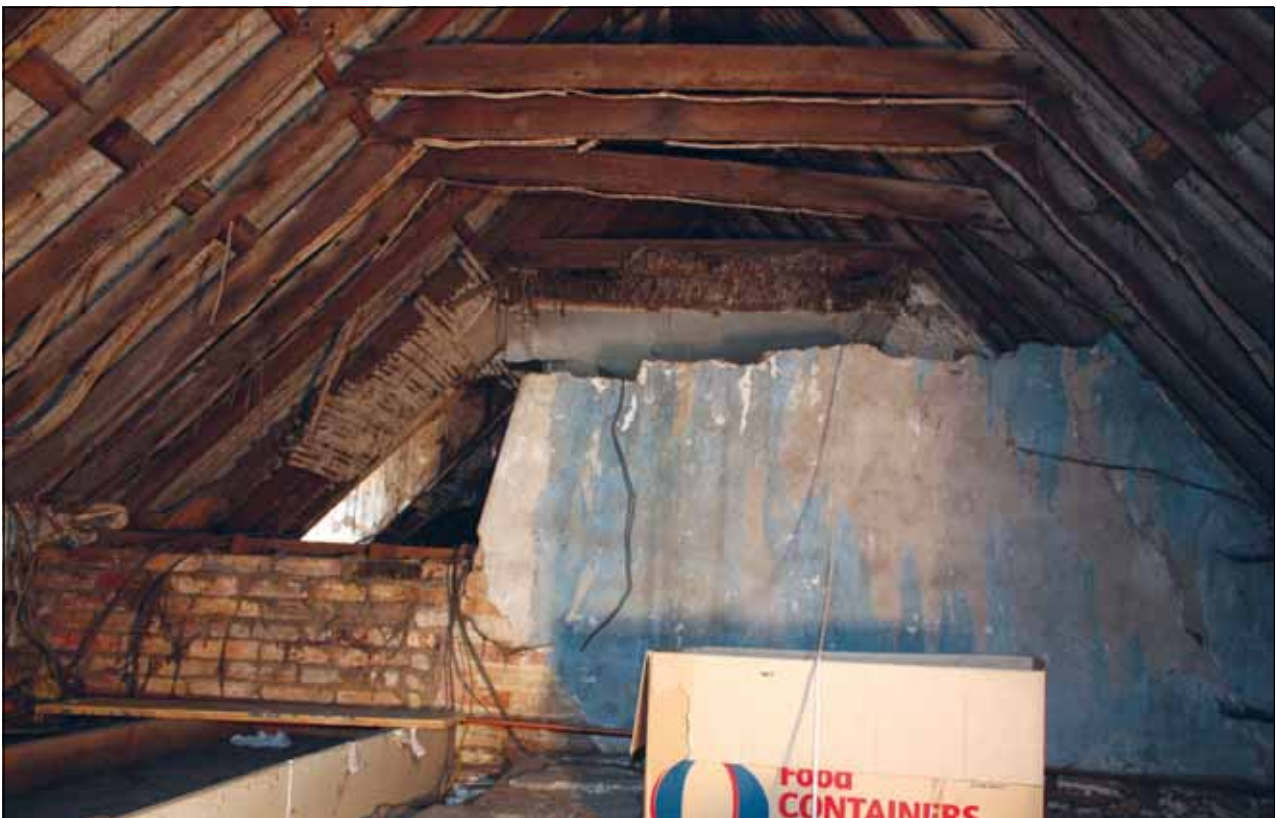
of brick which separates the two areas and there is a remnant of a plaster screen remaining (Plate 12). There are also remnants of lath and plaster on the walls and ceiling as well as what appears to be wallpaper on the northern side of the room. These features indicate that this may have been a domestic living space, although not in use for a significant amount of time. There is a single dormer window, flanked by wooden boards, which corresponds to that recorded on the south-facing elevation (Figure 7 and Plate 13).

Plate 12: Detail of internal partition within roof space

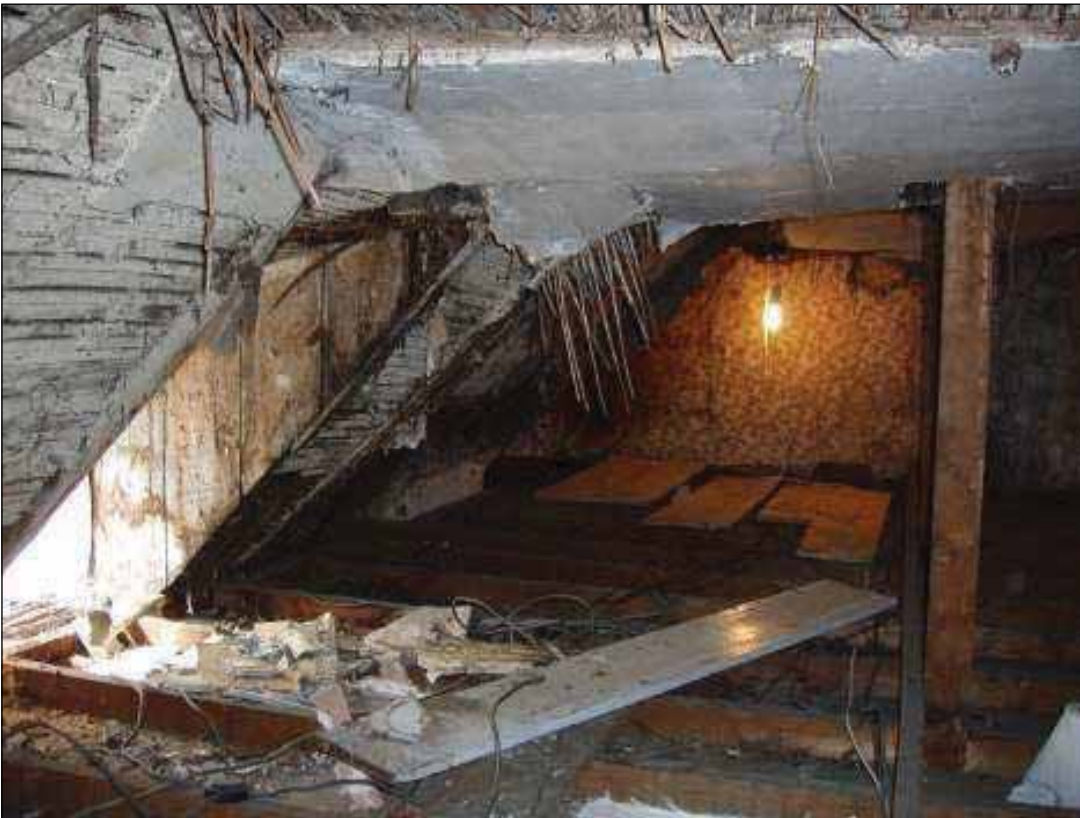
Plate 13: General view, F1, Outbuilding 1 (supplied by clients architect)

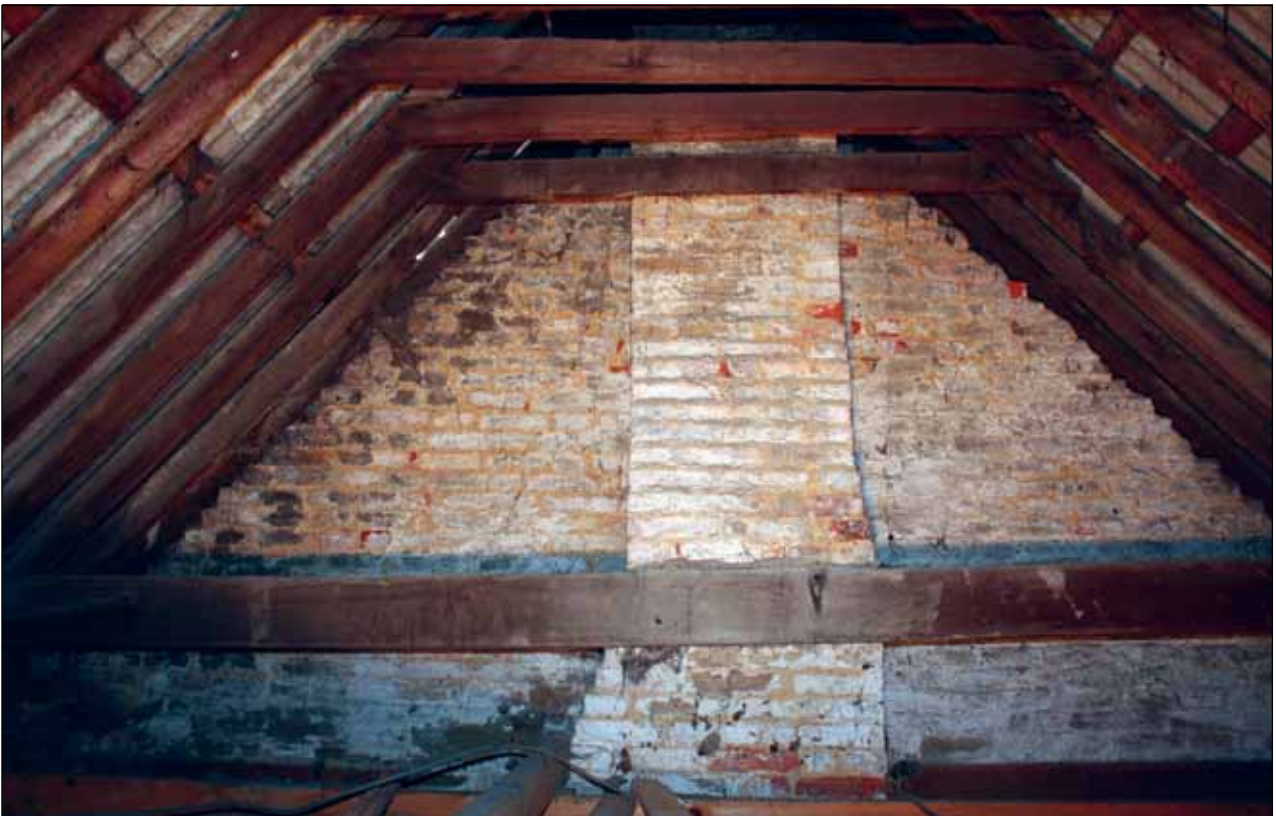
- 4.3.7 The main attic space (F2) is accessed via the loft hatch in G3. There is a brick-built sub-dividing/gable end wall at the eastern end of this area as well as a chimney-breast, all of which are painted white (Plate 14). There is a simple truss roof with pairs of machine-cut common rafters and collars between each (Plate 14). The roof is supported by three tie beams which sit on six courses of brick (Plate 15). This is most likely a replacement, perhaps added when the corrugated asbestos covering was introduced. There are however some areas on the southern side which do not appear to have been replaced and retain nails which would have held a lath and plaster ceiling covering (Plate 15 and 16). Within this part of the roof there is also evidence of the position of a dormer window – presumably contemporary and alike to that noted in F1.

Plate 14: Detail of roof structure, chimney-breast and wall, F2, Outbuilding 1

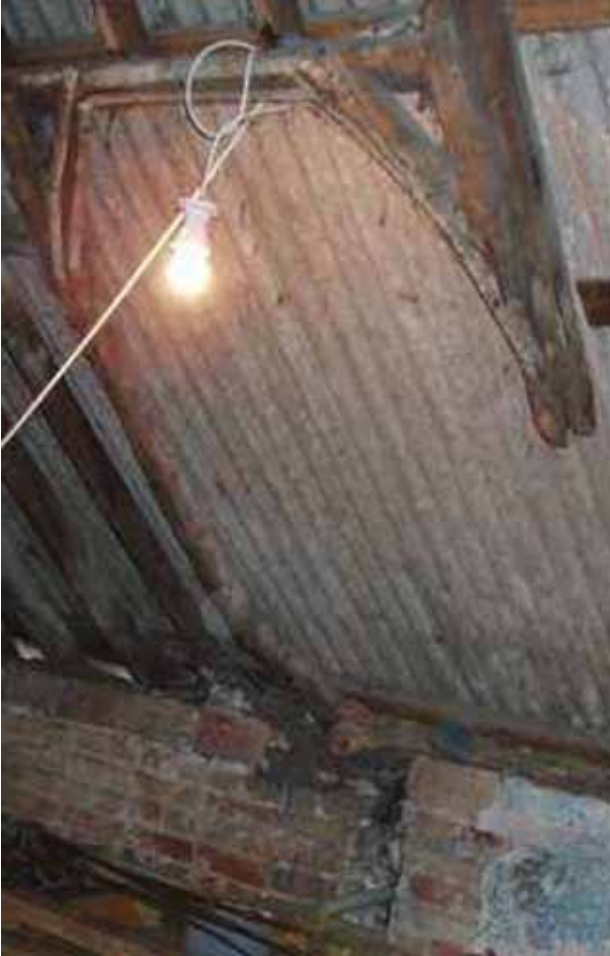
Plate 15: Detail of position of former dormer window, F2, Outbuilding 1 (supplied by clients architect)

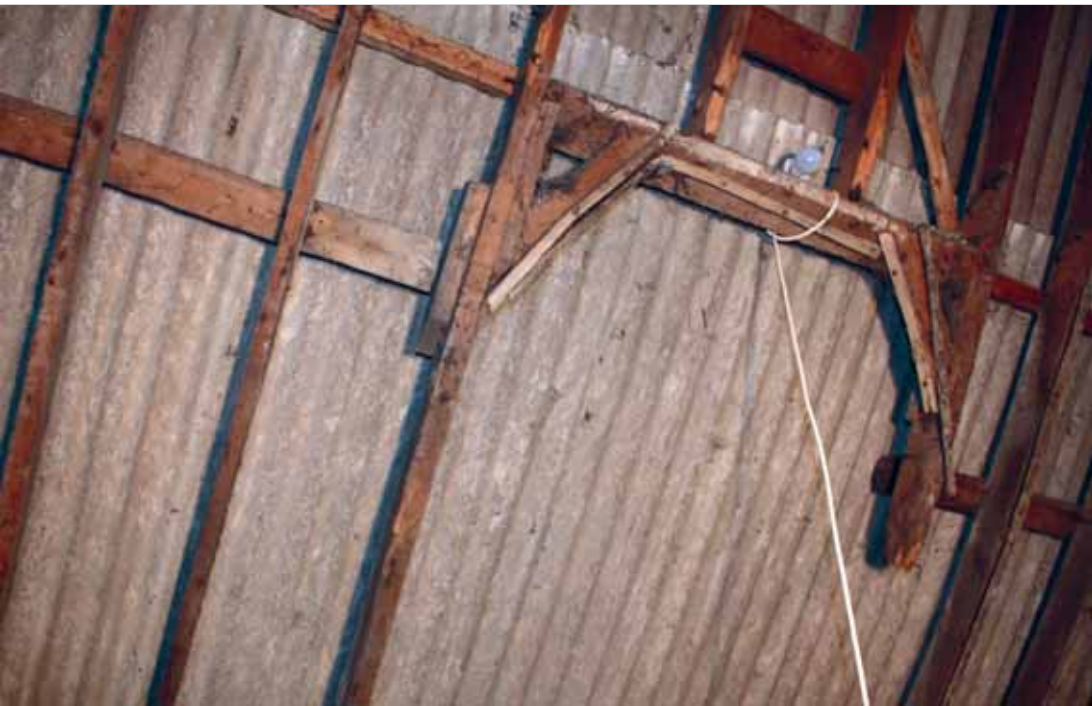
Plate 16: Detail of position of former dormer window, F2, Outbuilding 1

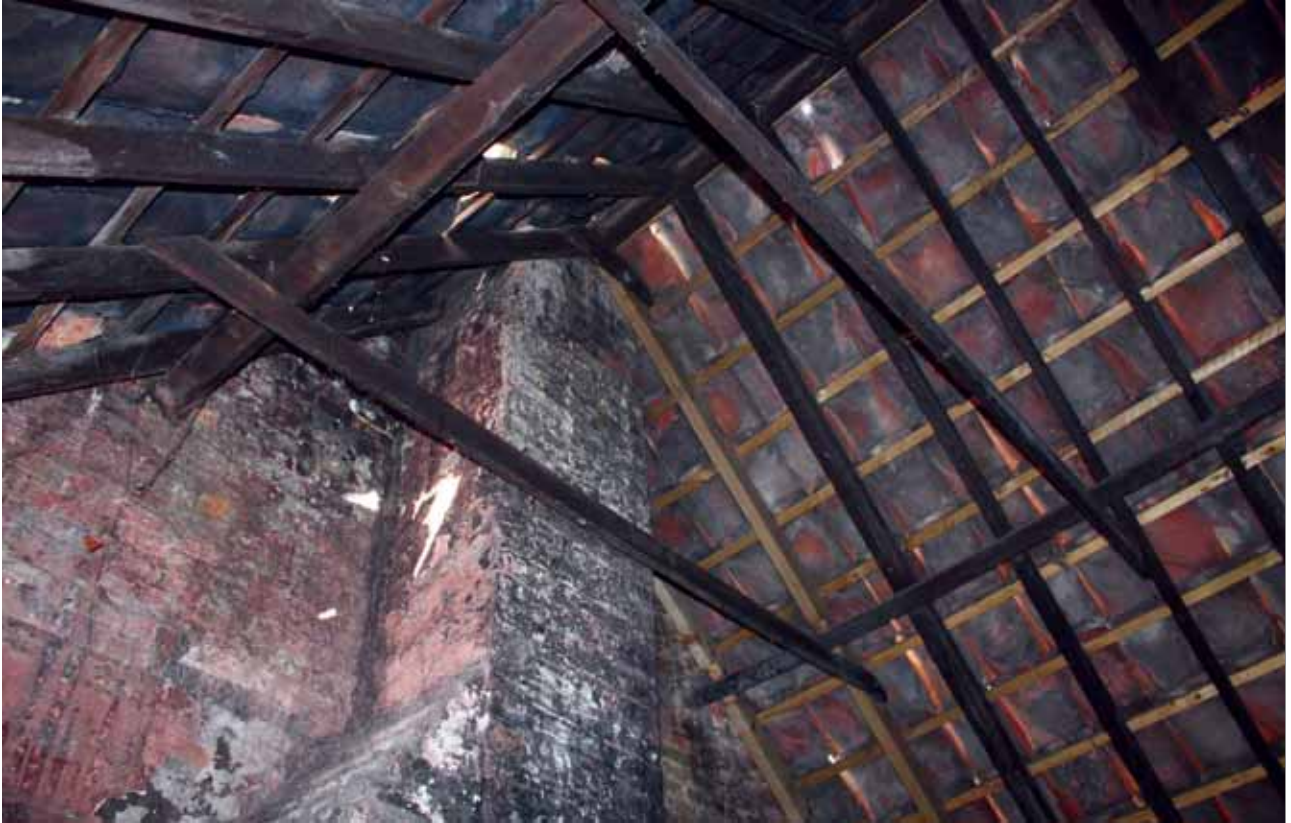
Plate 17: Detail of roof structure showing evidence of burning, G4, Outbuilding 2

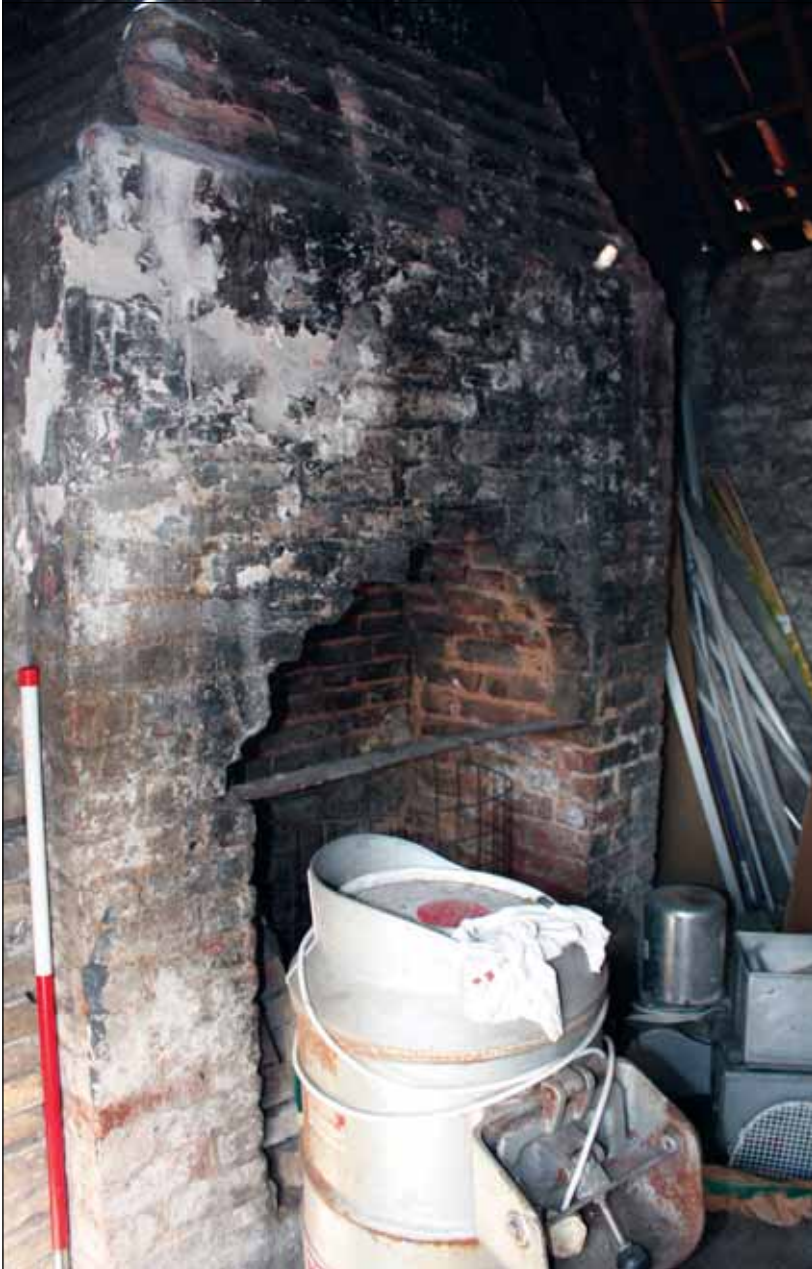
Plate 18: Brick-built hearth or oven, G4, Outbuilding 2

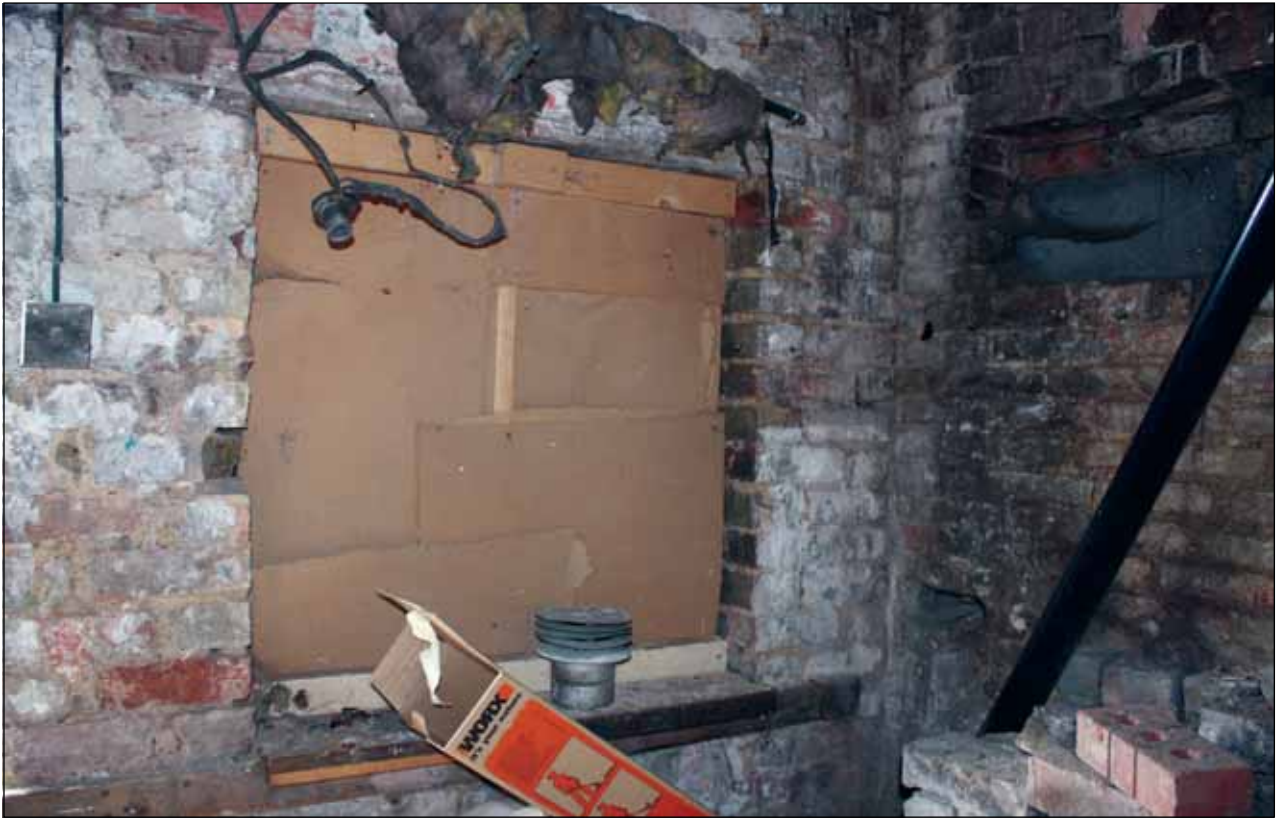
- 4.3.8 This building comprises three ground floor rooms (G4-G6), all of which are accessed from the courtyard area (Figure 8).
- 4.3.9 G4 is accessed via the left-hand plank and batten doors recorded on the south-facing elevation (Figure 7). This room was used for storage at the time of the survey and some of the equipment, including a large piece of cast iron catering equipment, could not be moved. The walls are all white painted exposed brick with horizontal pressure marks and an average dimension of 22cm x 5.5cm. The floor is covered with concrete and the roof fully exposed to reveal a simple truss roof of machine-cut timbers, most of which have evidence of charring, suggesting fire damage. This corresponds to sooting on the walls above room height (Plate 17). The main feature of this room is a large brick-built hearth or oven with a partially collapsed arch and an exposed steel support lintel (Plate 18). Figure 8 shows that this is a substantial feature for the size of the room and is unlikely to have been for heating/domestic purpose. There is a boarded up windows as noted on the external elevation within this room. The lintels and surrounding brickwork appear to indicate that these are original features, contemporary with the construction of the building (Plate 19).

Plate 19: Boarded-up window, G4, Outbuilding 2

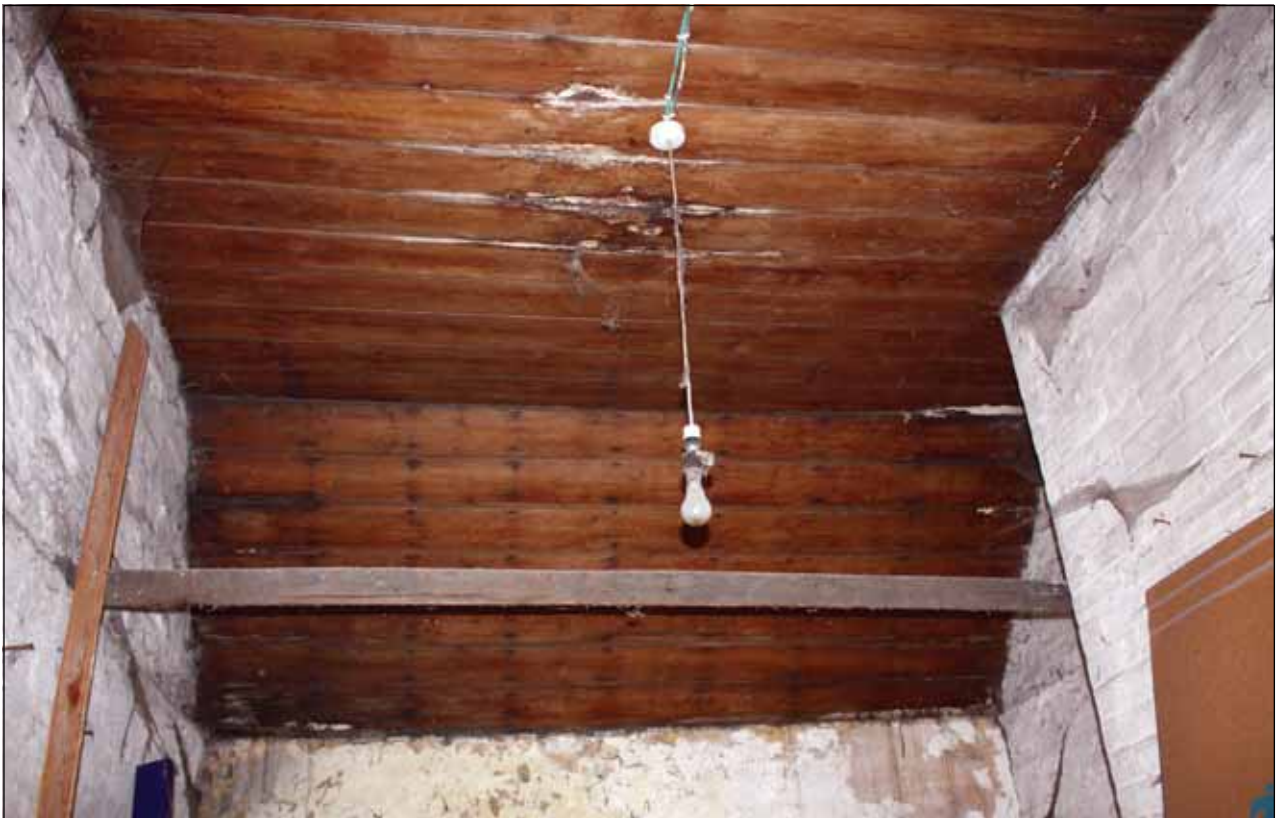
Plate 20: Detail of boarded ceiling, G5, Outbuilding 2

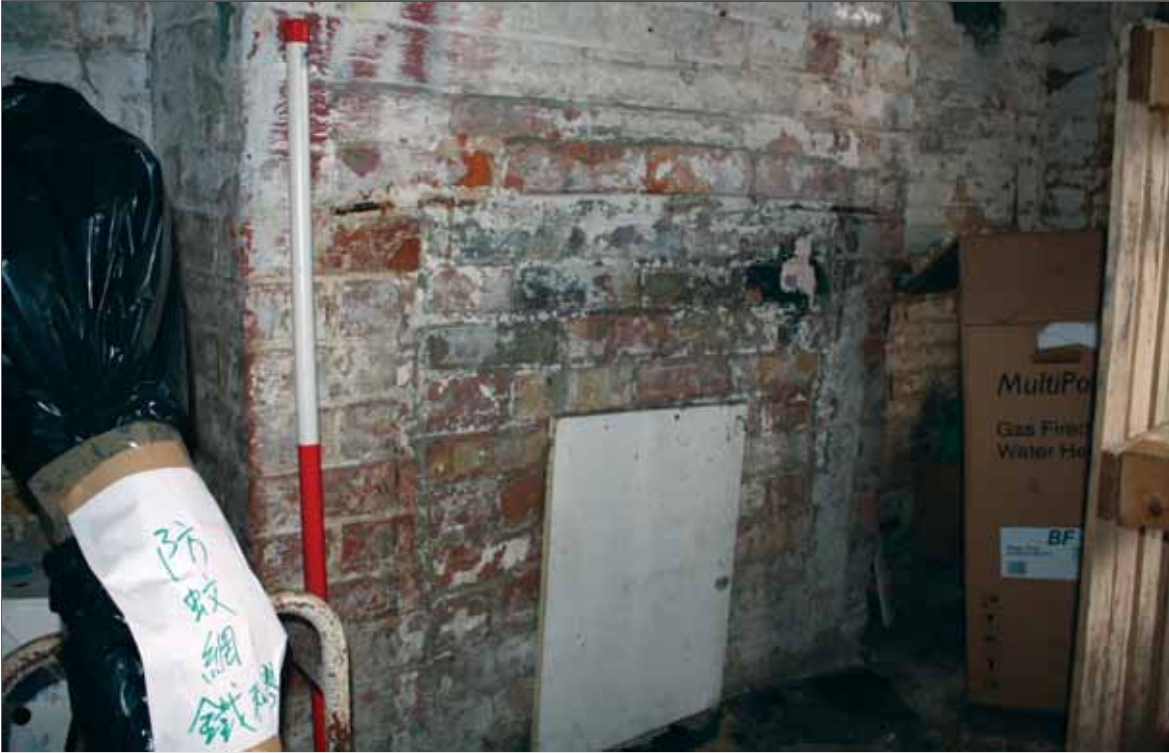
Plate 21: Detail of blocked-up fireplace, G5, Outbuilding 2

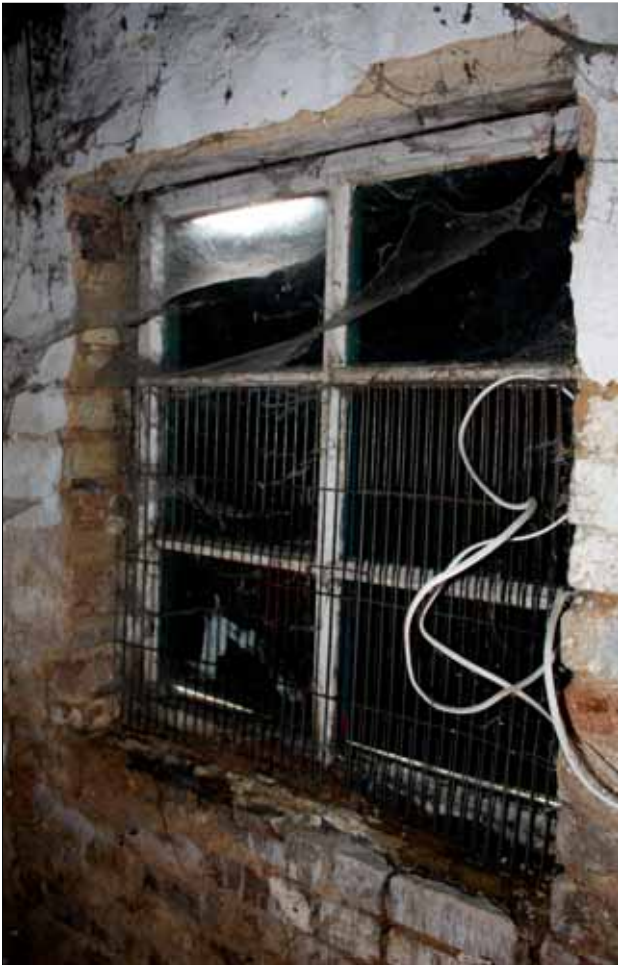
- 4.3.10 The next room/area is G5 and is accessed via the second plank and batten door as recorded on the south-facing elevation (Figures 7 and 8). This room has a concrete floor, tongue and groove boards covering the ceiling and all walls are exposed, whitewashed brick with average dimensions of 22.5cm x 5cm (Plate 20). The main feature of this room is a blocked-up fireplace which appears from the different brick used to be a later addition, perhaps late 19th or early 20th century in date (Plate 21). The average dimensions of the bricks used for the fireplace are 23.5cm x 7cm x 10cm, laid in a stretcher bond with diagonal pressure marks. The window in this room was not boarded up on the inside (Plate 22). It is a six-pane casement window with wooden frame and glazing bars.

Plate 22: Window, G5, Outbuilding 2
