SALFORD FLOOD IMPROVEMENTS, CASTLE IRWELL, SALFORD

**Archaeological Watching
Brief**

Oxford Archaeology North

June 2014

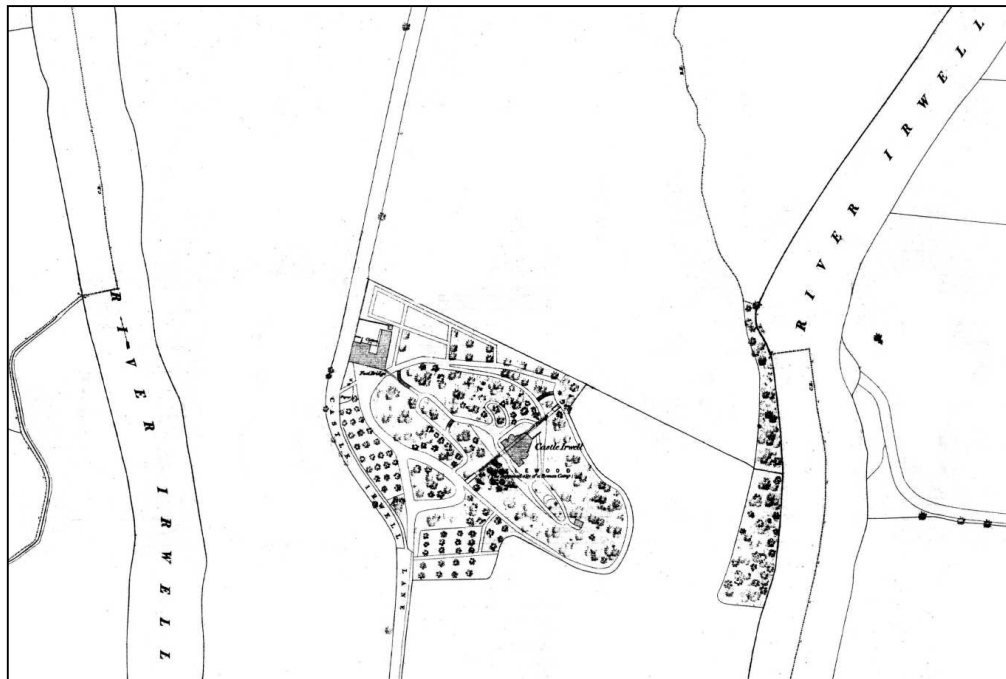
- 1.3.6 In the first decades of the nineteenth century, aside from the potential mill site on the northern bank of the Irwell (*Section 1.3.5*), the cartographic evidence indicates that the majority of the flood-defence area formed undeveloped land. However, in 1826 a mansion named ‘Castle Irwell’ was constructed on the knoll of Hylewood by John Purcell Fitzgerald, a wealthy landowner from Ireland (Nash 2014, 10). This mansion was a three-storey, brick-built, castellated structure, was accessed from Castel Irwell Lane, and was surrounded by enclosed gardens, which contained ancillary buildings. It was also associated with a subterranean passageway, which ran in a north-east/south-west direction below the western half of the house through the knoll (*ibid*). The building is depicted on the detailed Ordnance Survey map of 1852, which was surveyed in 1848 (Plate 1).

Plate 1: Extract from the Ordnance Survey map of 1852, showing Castle Irwell

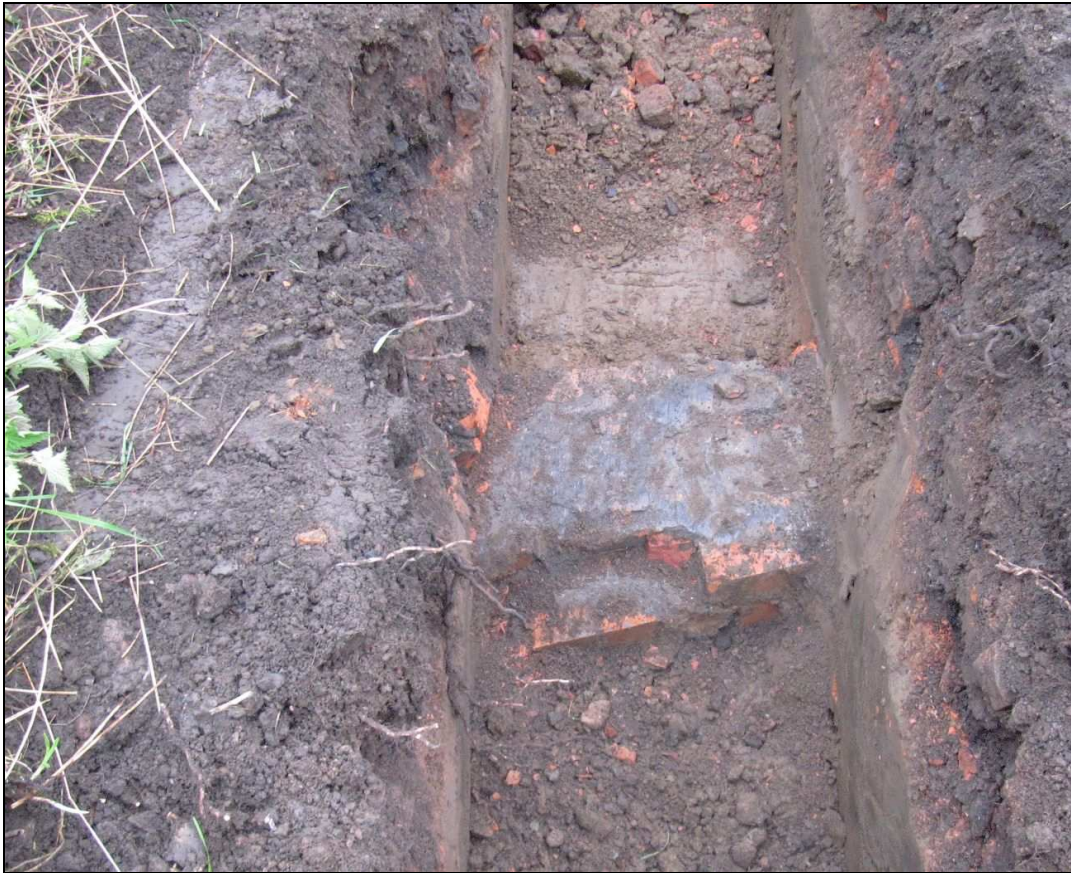
- 3.2.13 **TP-116:** this pit contained a demolition layer, which lay directly beneath the turf and topsoil. This layer was composed of a mix of sand, clinker, and crushed ceramic building material, ranged between 0.1m and 0.8m thick, and generally lay above natural sandy silt. However, beneath the demolition layer, in one part of the test pit, a brick wall was encountered, at a depth of 0.4m below present ground level. This wall was aligned north-west/south-east and was constructed from wire-cut bricks, four-courses deep, and four-courses wide. The bricks had dimensions of 0.23 x 0.11 x 0.07m (9" x 4³/₈" x 3") and were bonded with a black-bitumen mortar (Plate 2). The wall was laid upon a light-grey sandy bedding deposit, which had been mixed with lime mortar.

Plate 2: The brick wall in TP-116

- 4.2 In addition to the levelling layers, the watching brief also recorded structural remains in the form of two lengths of *in-situ* brick wall present in TP-116 and TP-117, which hold greater archaeological value (Fig 4). Both test pits lay in the same north-eastern part of the flood-defence area and this location suggests that they form elements of the stables associated with the Manchester Racecourse, which was in operation between 1902 and 1963 (Fig 3). This stable block formed a square enclosure, containing *c* 260 individual stables set within 13 stable blocks (ten double pile and three single pile), and probably had tack rooms on its south-western side (Nash 2014, 18). Significantly, the presence of brick walls in two separate test pits, set some 60m apart, may suggest that below-ground remains associated with these stables exist over a fairly extensive area.

- 5.1 The results obtained from the watching brief has concluded that there is little or no archaeological interest across most of the study area. However, buried remains of the former stable blocks associated with the former Manchester Racecourse evidently survive in the north-eastern corner of the study area. Any damage or disturbance of these buried remains during future stages of the flood improvement scheme may require archaeological mitigation, the scope of which should be devised in consultation with the Greater Manchester Archaeological Advisory Service in their capacity as archaeological advisor to Salford City Council.

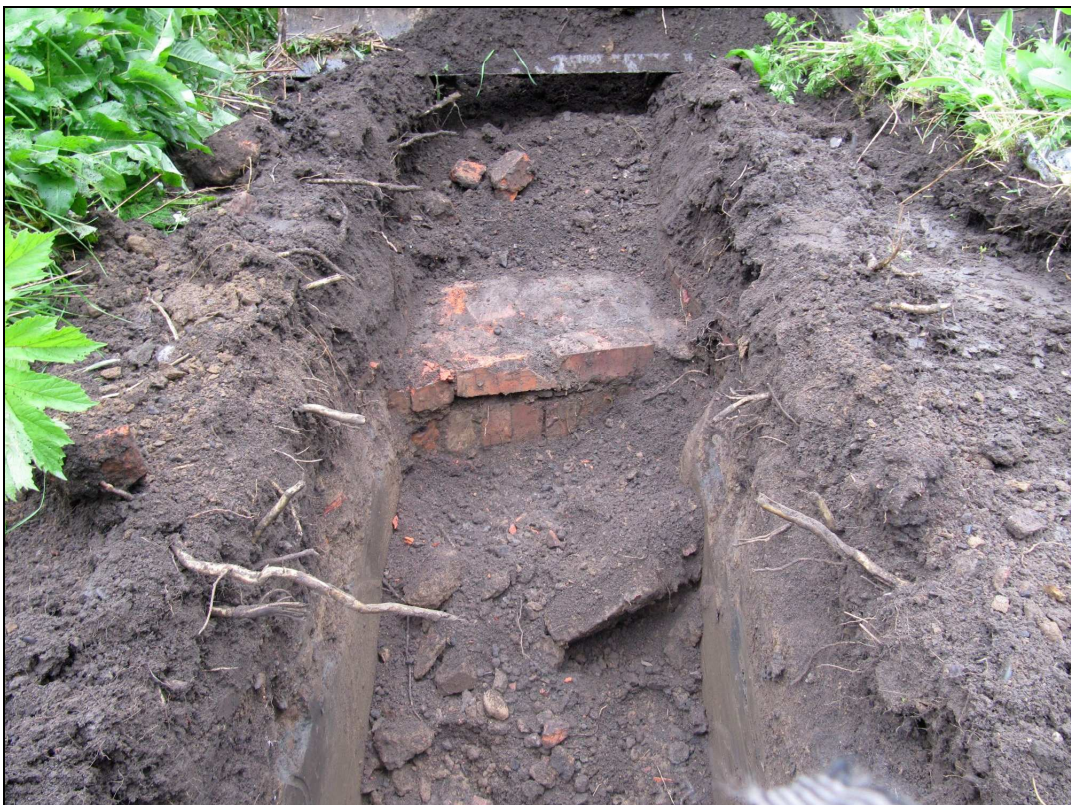
- 3.2.14 **TP-117:** in a similar manner to TP-116 (*Section 3.2.13*), a near-identical brick wall was present in this test pit, which lay at a similar depth. This wall was aligned north-east/south-west, was four-courses wide, and two-courses deep, and it was constructed from wire-cut bricks, measuring 0.23 x 0.11 x 0.07m (9" x 4³/₈" x 3"), that were bonded with black-bitumen mortar (Plate 3). It was also laid upon a light-grey sand and mortar bedding deposit.

Plate 3: The brick wall in TP-117
