Ivy House Mills, Commercial Road, Hanley, Stoke-on-Trent

Archaeological Watching Brief Final Report

Seddon Construction Ltd

Planning Application SOT/54550

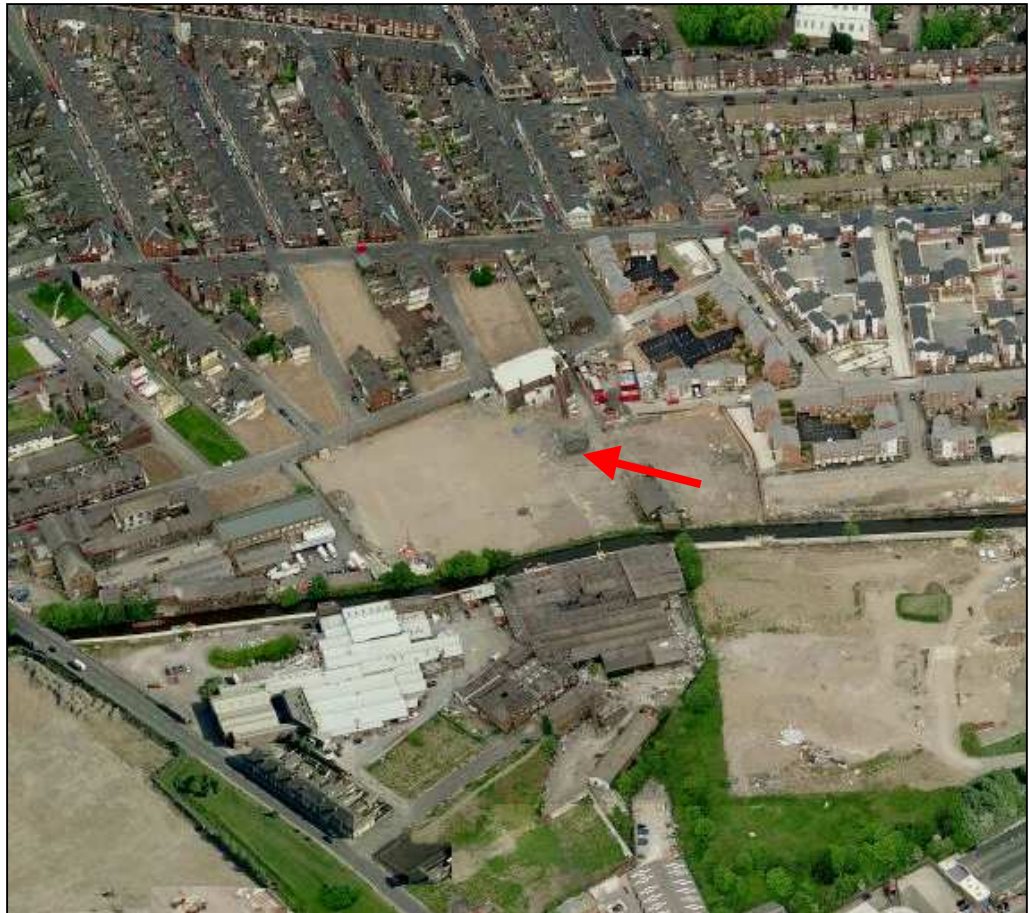
Plate 1: Recent aerial view of the study area, prior to the commencement of the present development programme, with arrow marking the location of the former workers' housing that formed the focus of the archaeological watching brief

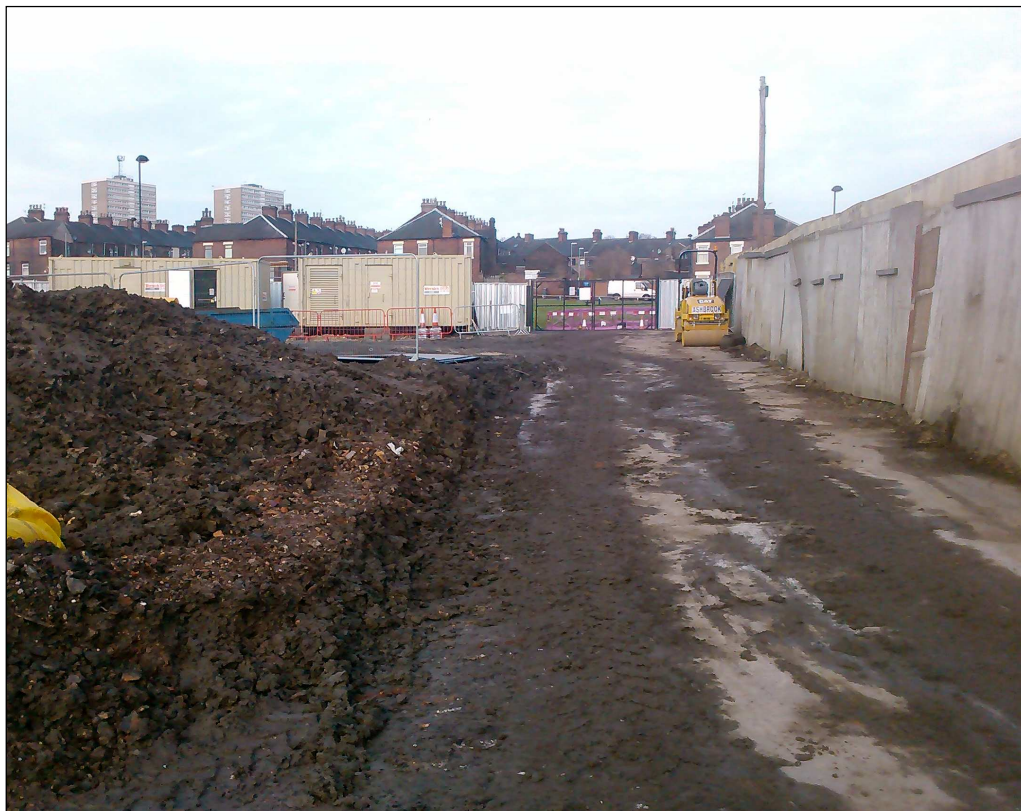
Plate 4: The site of the workers' housing prior to the commencement of any earth-moving works required by the construction programme

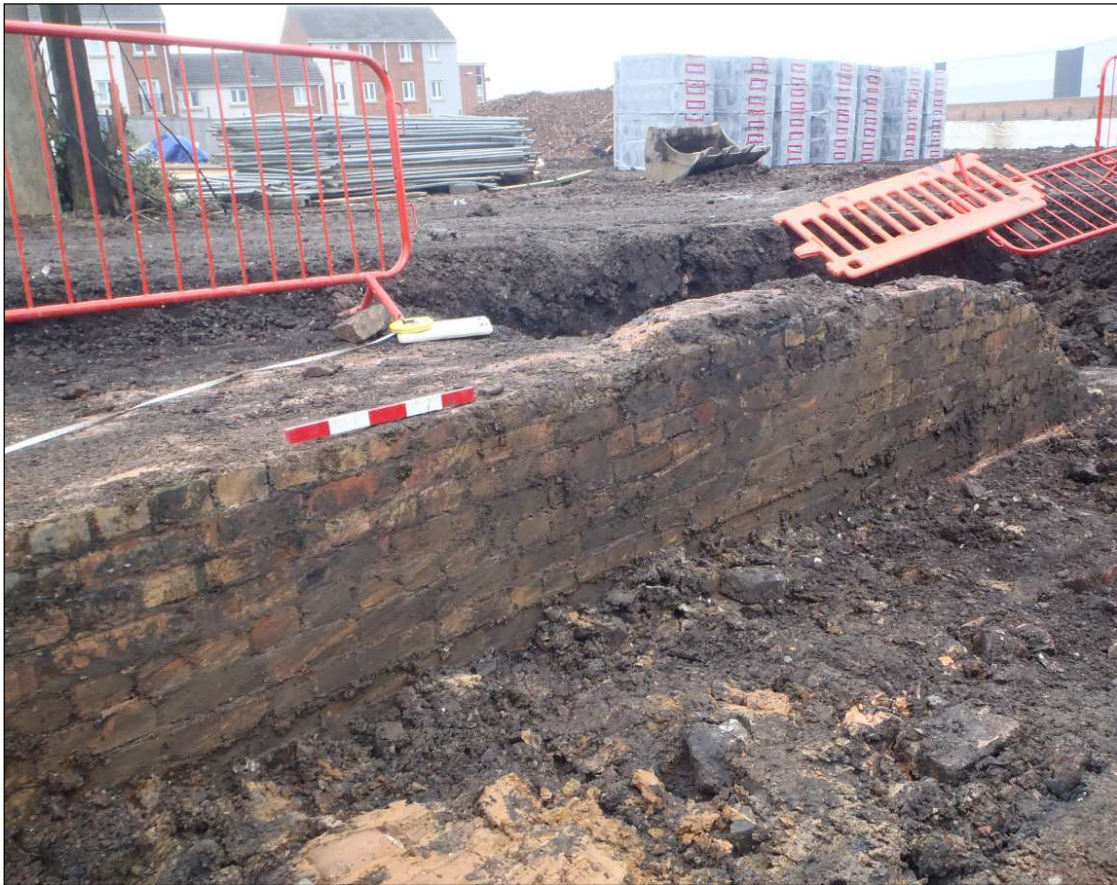
- 4.2.2 The westernmost wall was 0.34m thick, and survived to a maximum height of 0.82m (Plate 5). The fabric of the wall comprised machine-pressed bricks that were bonded in a cement-based mortar, indicative of a twentieth-century construction date. This late construction date was corroborated by a thin raft of concrete, which provided a foundation for the wall.

Plate 5: The westernmost wall exposed during the watching brief

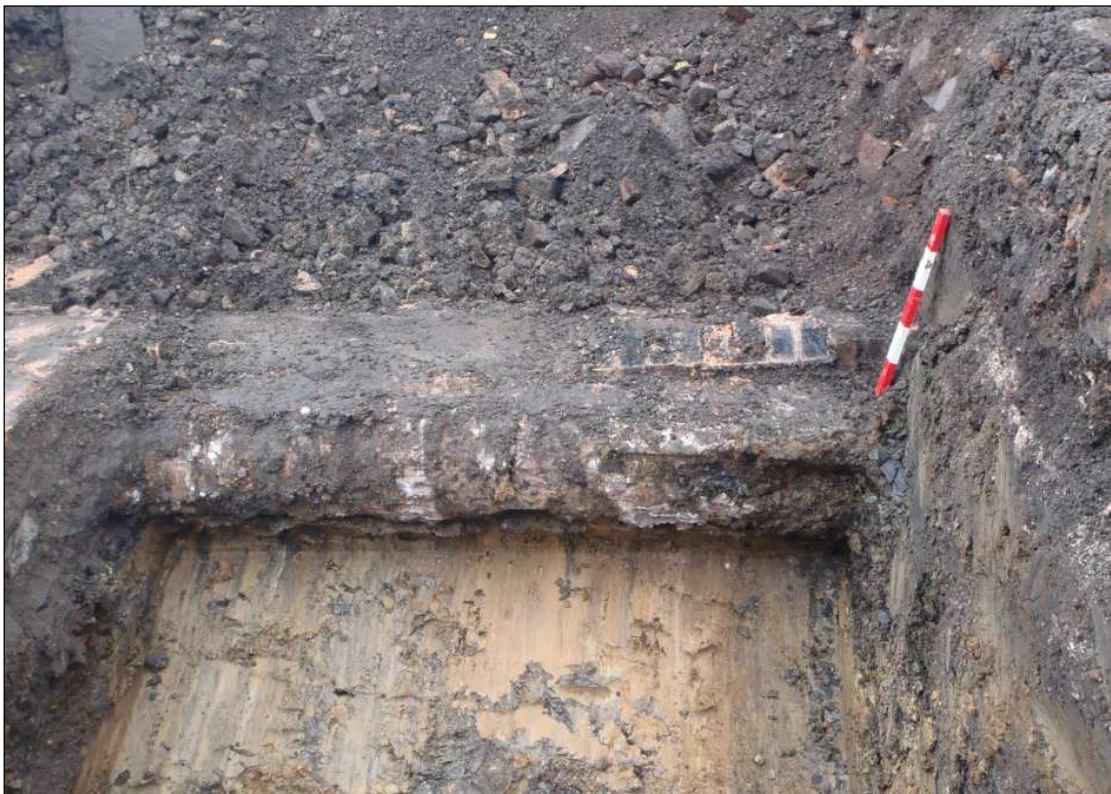
- 4.2.3 The western wall was keyed into the fragmentary remains of an east/west-aligned wall, the position of which corresponded broadly with the southern end wall of the nineteenth-century houses (Fig 2). However, the exposed wall was 0.82m thick, and was similarly laid upon a concrete foundation, indicating that it was almost certainly of a twentieth-century date (Plate 6).

Plate 6: The remains of an east/west-aligned wall set on a concrete foundation

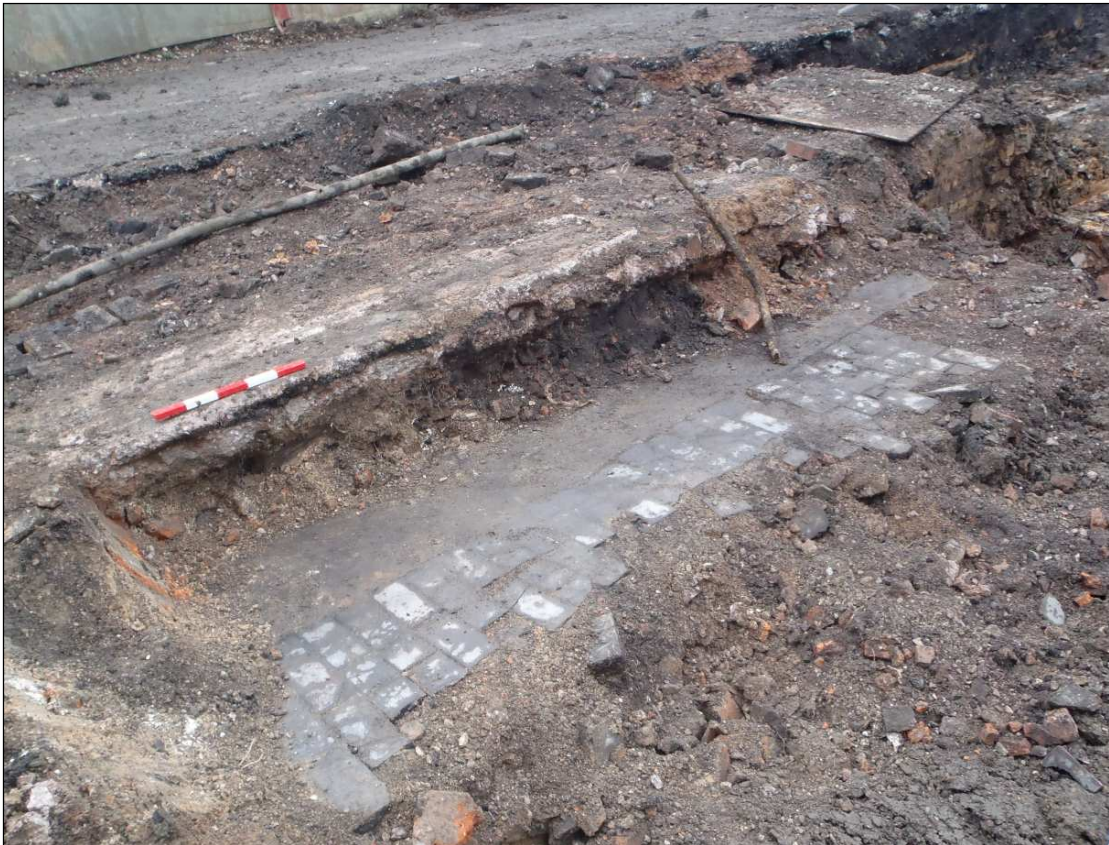
- 4.2.5 The fragmentary remains of an internal floor, covering an area of maximum dimensions of 3.5 x 1.3m, was exposed immediately to the west of the walls (Plate 7). The fabric of this floor comprised 'Victorian Blue' bricks. The eastern edge of the surface was abutted by a concrete surface, whilst the western edge had been destroyed during modern demolition works.

Plate 7: The remains of the internal floor

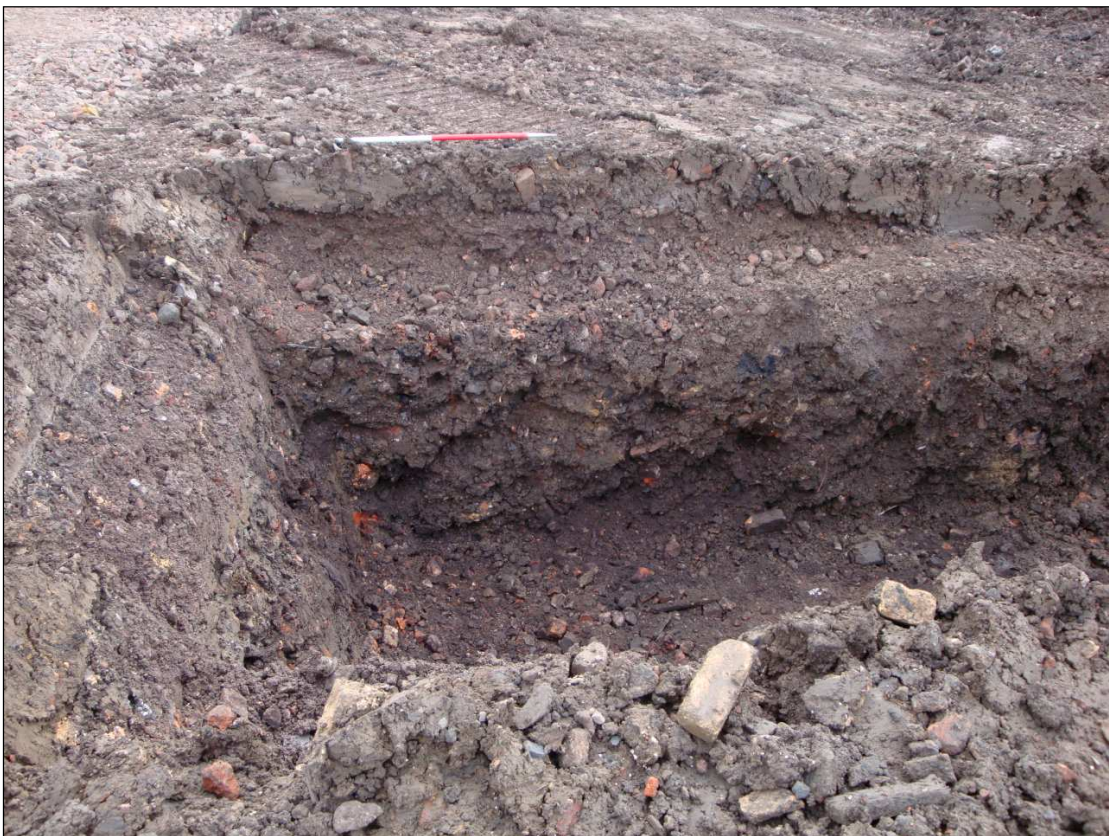
- 4.2.6 The footprint of the front portion of the former houses was investigated during a second-stage of works, which monitored the removal of a spoil heap and subsequent earth-moving works. This revealed a thick deposit of modern made ground to a depth of at least 3m (Plate 8). No physical remains of the nineteenth-century houses survived *in-situ*.

Plate 8: Made ground revealed across the footprint of the front portion of the former houses
