Croasdale (Old) Bridge, Slaidburn, Lancashire

Fabric Survey Report

Oxford Archaeology North

August 2011

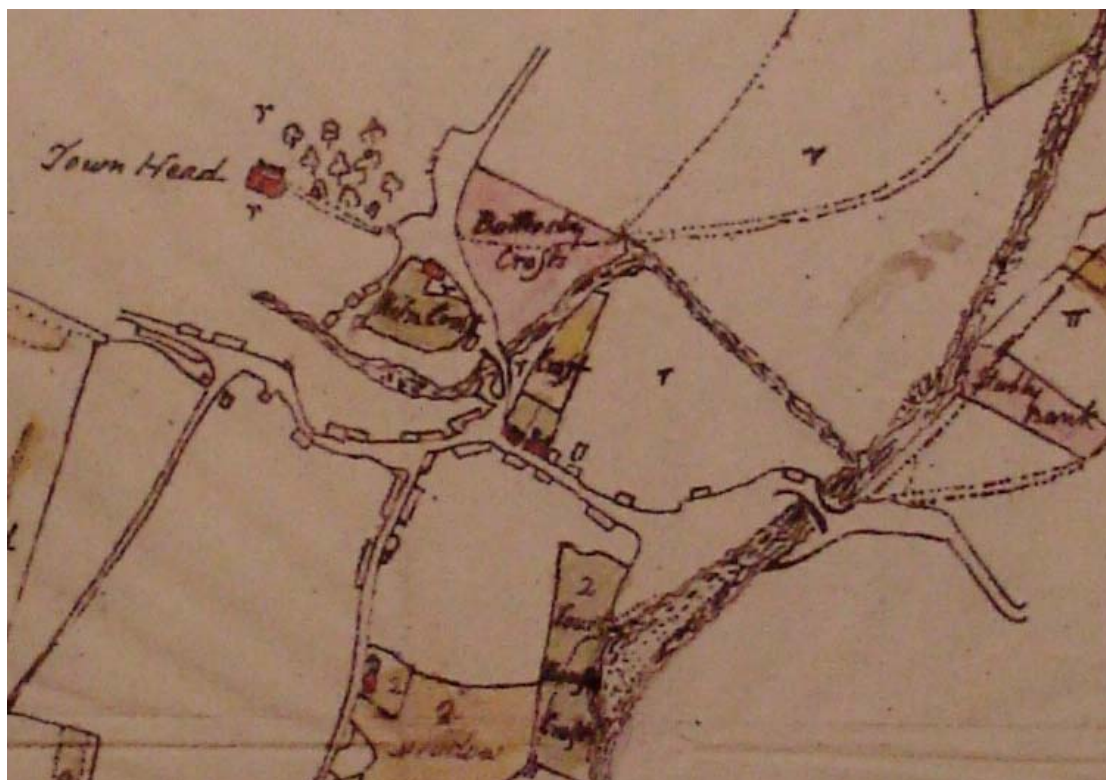
Plate 1: Lang's map of Slaidburn, 1765 (Slaidburn Archive)

- 3.1.6 LCC has a folder of information concerning the bridge, collated from the late 1920s onwards, including correspondence, damage reports and details of surveys etc. A letter dated 10/02/1928 from a Thomas J Backhouse at Wakefield County Council, makes reference to some discussion regarding the date of the bridge. The letter refers to the 1765 plan of the land in Newton and Slaidburn by JB Lang belonging to Edward Parker, which shows that the bridge was in existence (Plate 1). The plan had been shown to Mr Backhouse by a Mr William King-Wilkinson, a relation of Edward Parker. A note with the copy of the map held by Slaidburn Archive states that it was produced to record the land holdings of James Wigglesworth esq, Mr Robert Parker of Dunna (Dunnow) and Mr William King. The map clearly shows both the Old Bridge and the New Bridge.

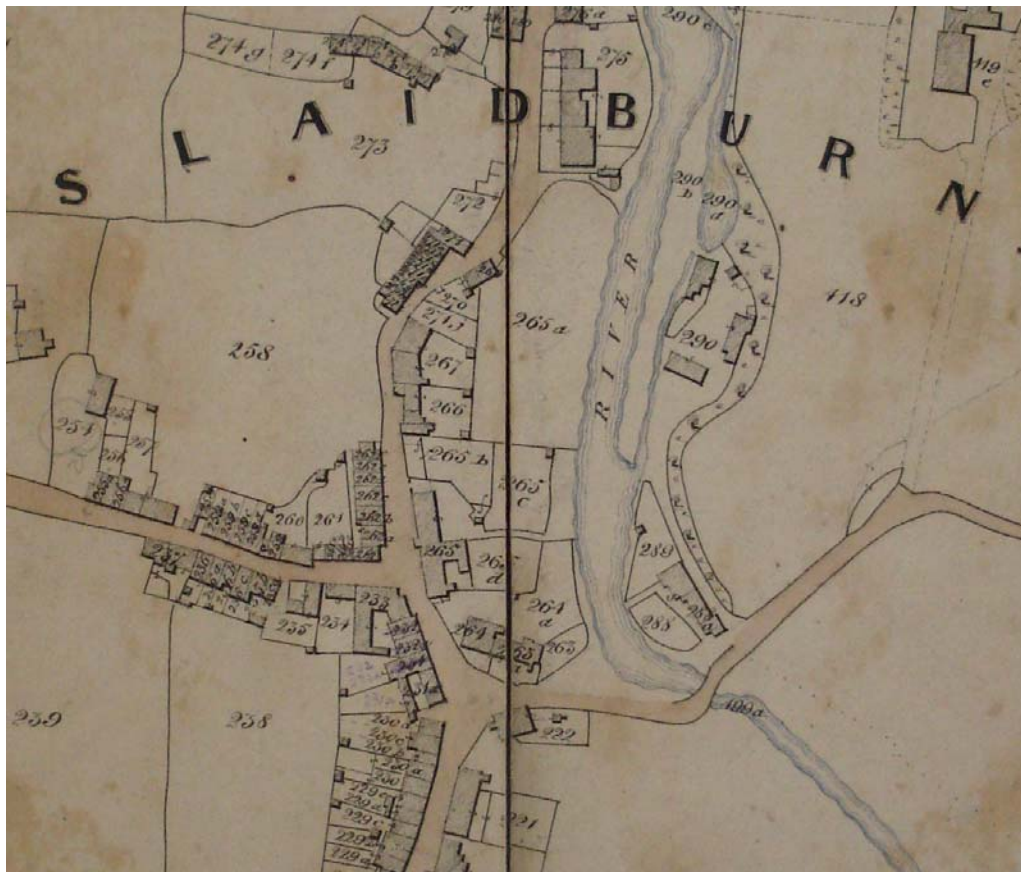
Plate 3: Slaidburn Tithe, 1843 (LRO PR 3035/4/1)

- 3.1.8 The bridge is clearly shown on the tithe map of 1843 (LRO PR 3035/4/1; Plate 3), over the 'river Croasdale'. In this area the river is labelled '199a', which in the tithe apportionment is listed as being owned by Sir Thomas Wigglesworth. No specific mention of the bridge is made. Plates 4 and 5 are the extracts from the nineteenth century OS maps (1850 and 1893), on which the bridge is clearly shown, and labelled 'Old Bridge'.

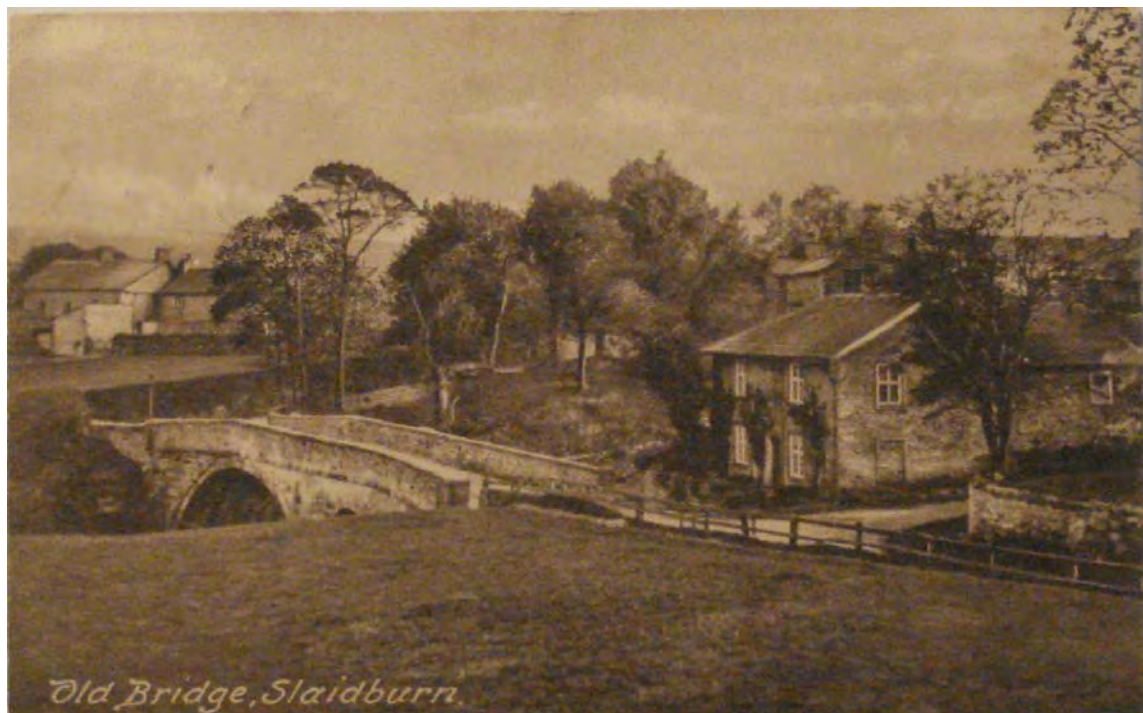
- Plate 6 is the earliest of the post cards, being dated to 1900 and shows the eastern side of the bridge, which has been widened, and shows what appear to be the arch ribs.

Plate 6: Postcard held by Slaidburn Archive, c 1900

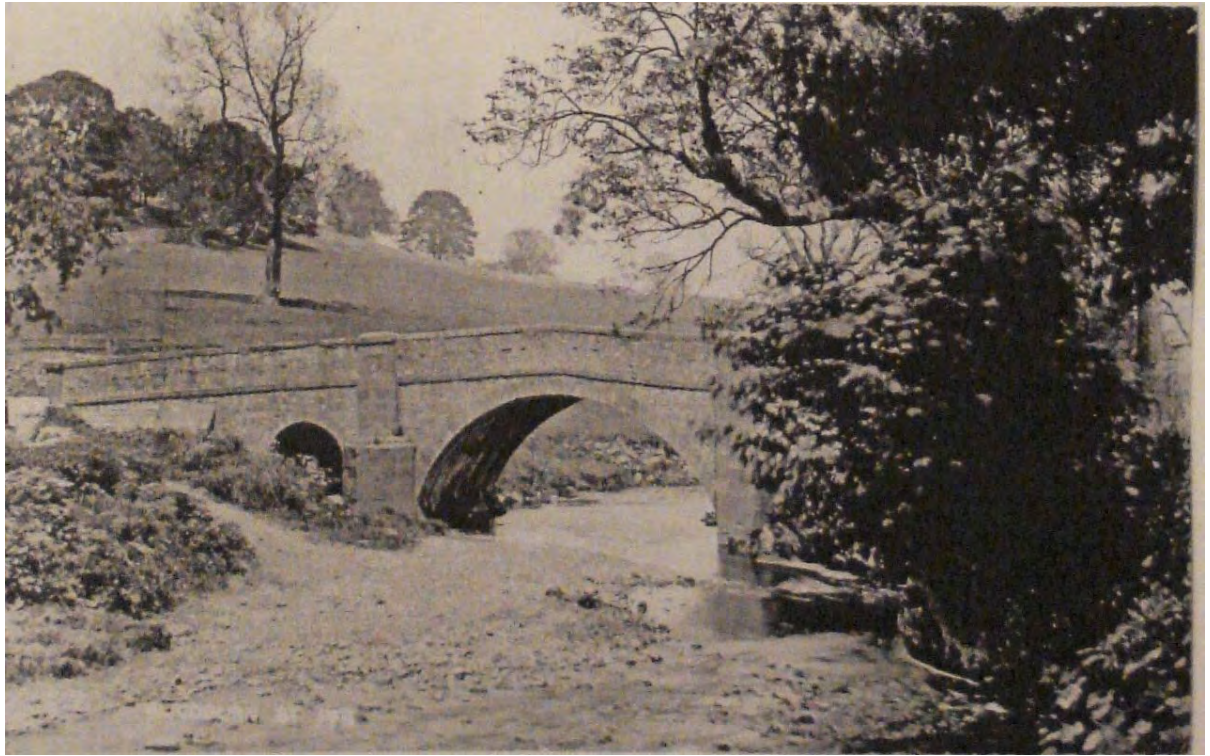
- Plate 7 shows the western side of the bridge, largely in its present state, including the cutwater. It is purportedly of 1905 date, but there are no visible arch ribs, or they are obscured by the shadows.

Plate 7: Postcard held by Slaidburn Archive, c 1905

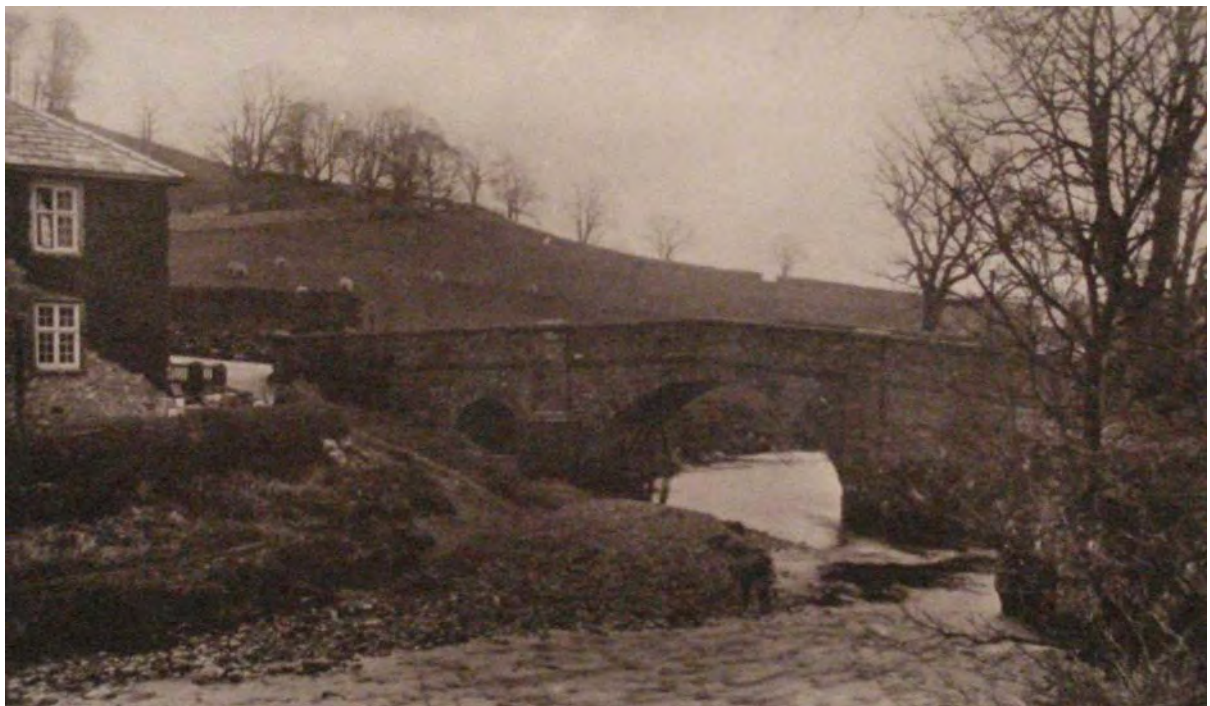
- Plate 8 is recorded as 1920s, but there are indications of shoring support on the eastern side, and this would suggest that it was of 1928 date. There are no visible arch ribs.

Plate 8: Postcard held by Slaidburn Archive, c 1920

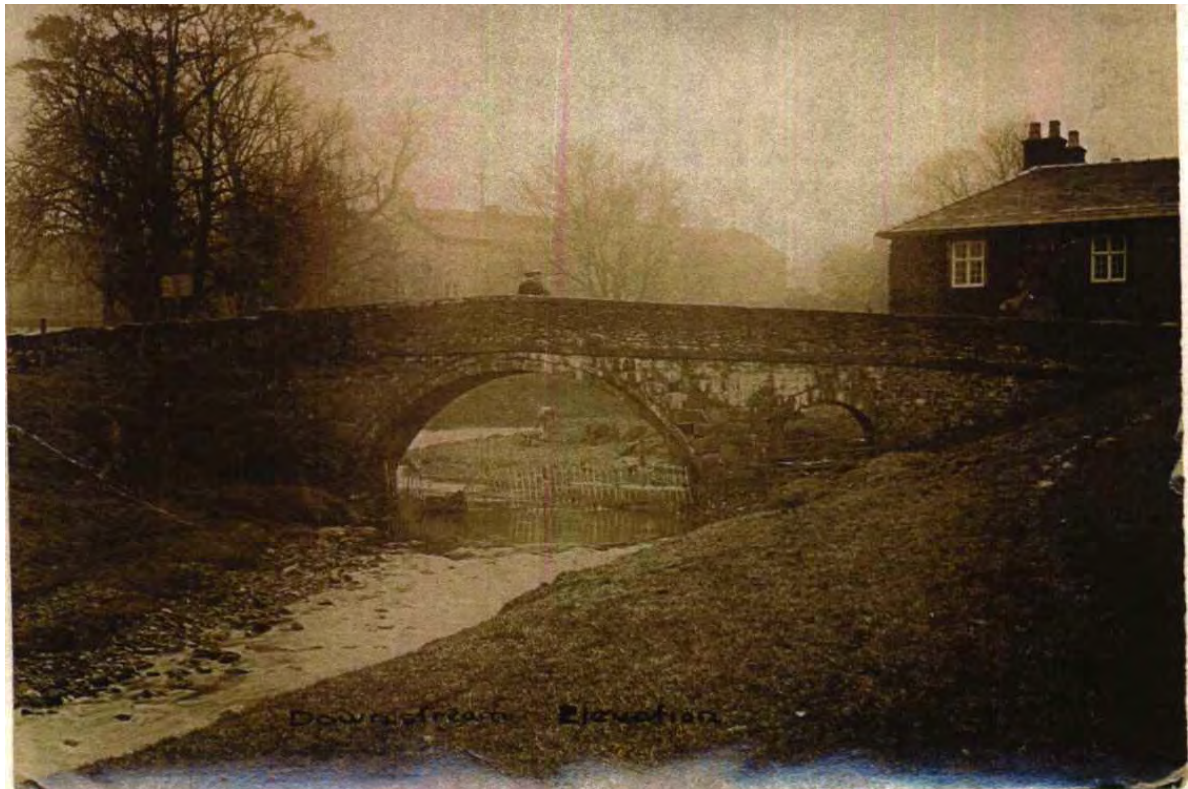
- Plate 9 is a photograph taken to accompany the engineers report (1928) and seemingly shows the arch ribs, of which the first was slightly recessed from the face of the spandrel.

Plate 9: Slaidburn Old Bridge, eastern elevation, taken in 1928 (from Lancashire County Council)

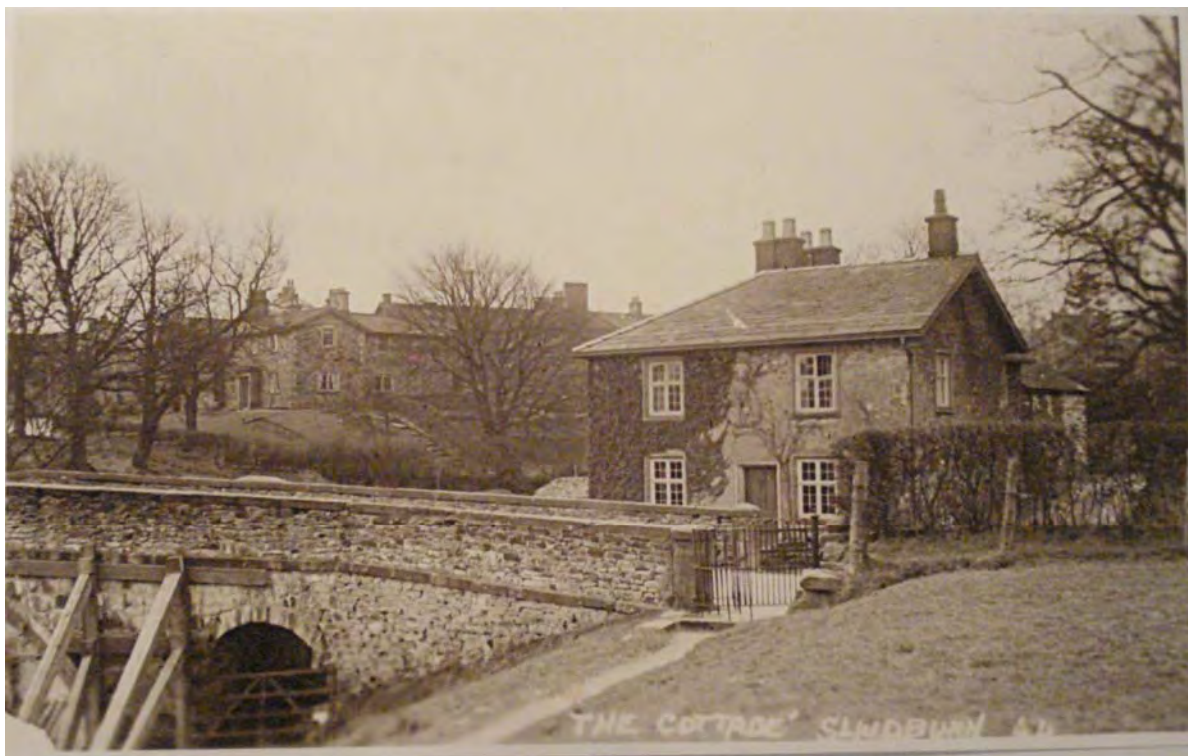
- Plate 10 shows the bridge being supported by wooden shoring, and was a response to the strain put on it by the traffic resulting from the construction of the Stocks Reservoir in the late 1920s.

Plate 10: Copy of postcard held by Slaidburn Archive, c 1928/29, showing the bridge being supported by shoring due to the strain put on it by heavy traffic during the construction of Stocks Reservoir

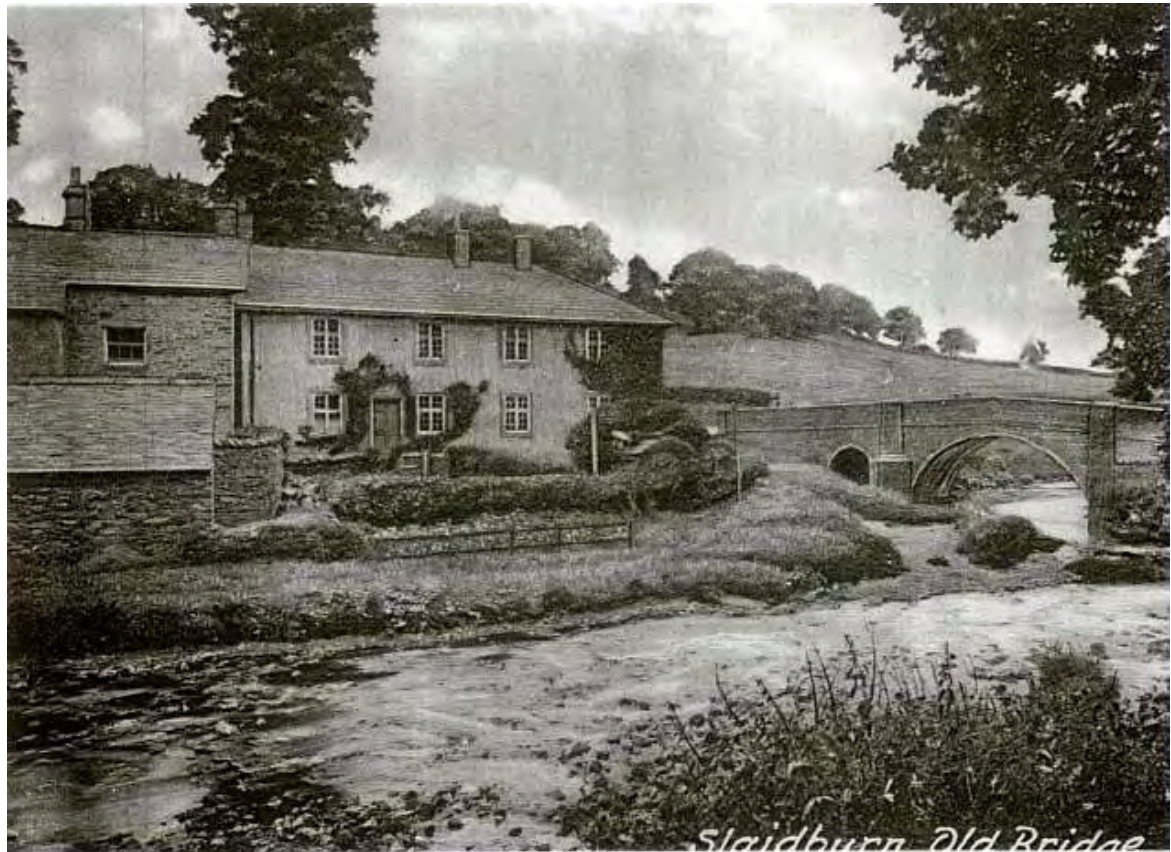
- Plate 11 is purported to be of 1930s date, but it shows the arch ribs, which were removed and replaced with a concrete arch in 1929, and would suggest that the photograph was slightly earlier.

Plate 11: Copy of postcard held by Slaidburn Archive, c 1930s

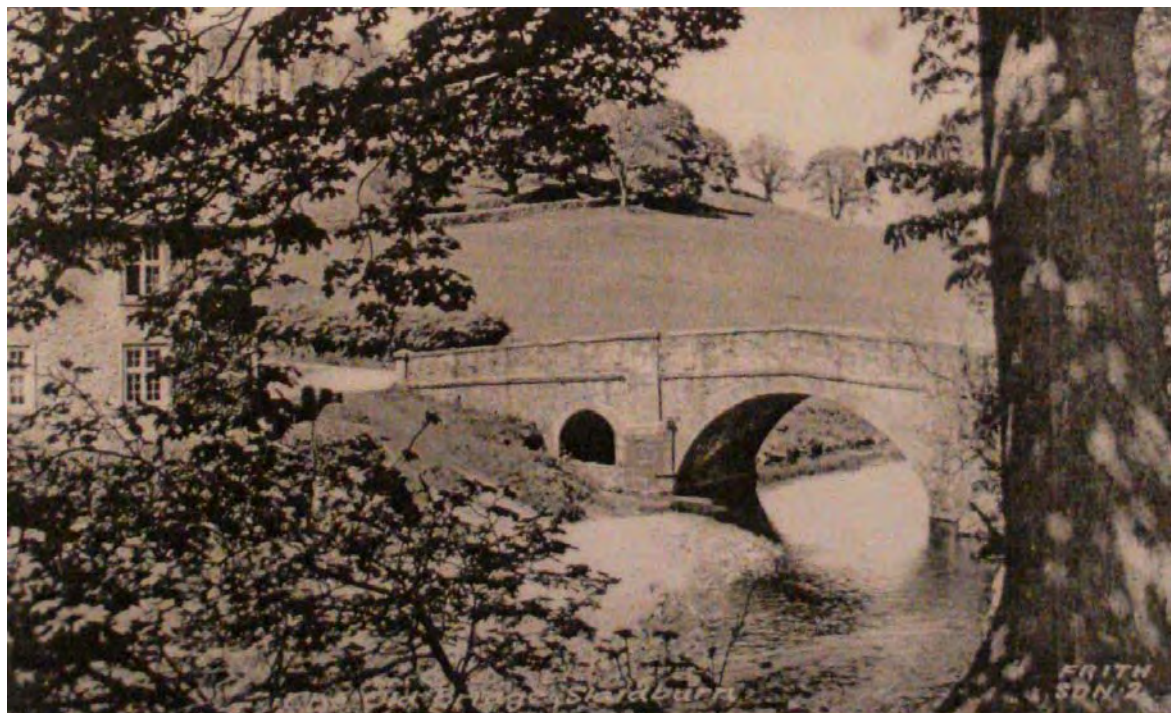
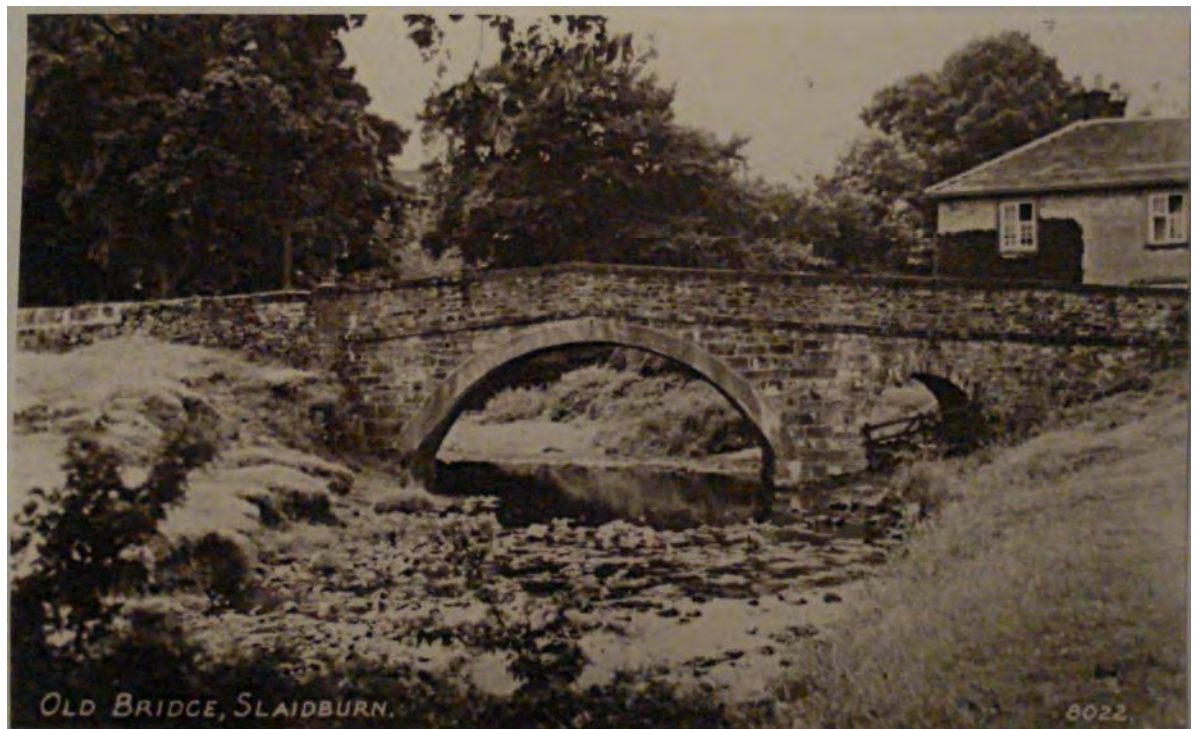
- Plates 12 and 13 show the bridge following the 1929 renovation and includes the concrete, eastern arch.

Plate 12: Postcard held by Slaidburn Archive, c 1930s

Plate 13: Postcard held by Slaidburn Archive, c 1930s/40s

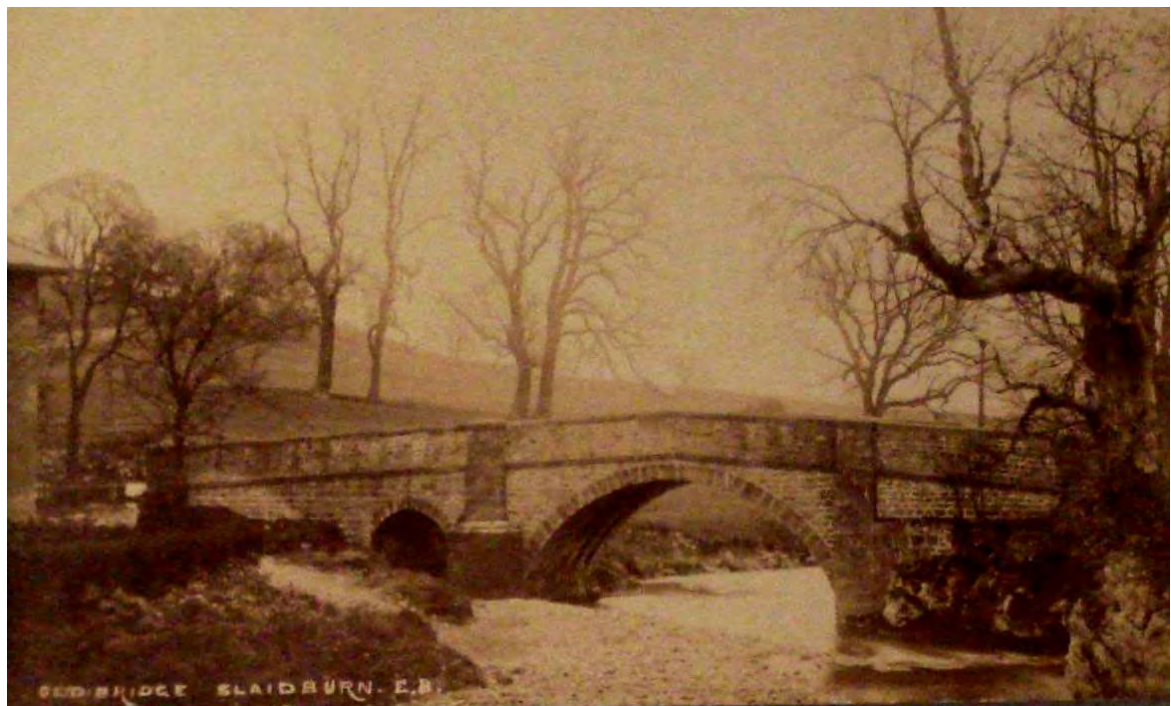
- Plate 14 is undated, and was taken of the western face of the bridge, but it shows the arch ribs on the eastern arch, and would indicate that the date is prior to the 1929 renovation.
- Plate 15 is similarly undated, but shows the eastern recessed arch rib, and is therefore also earlier than the 1929 renovation.

Plate 14: Postcard held by Slaidburn Archive, undated

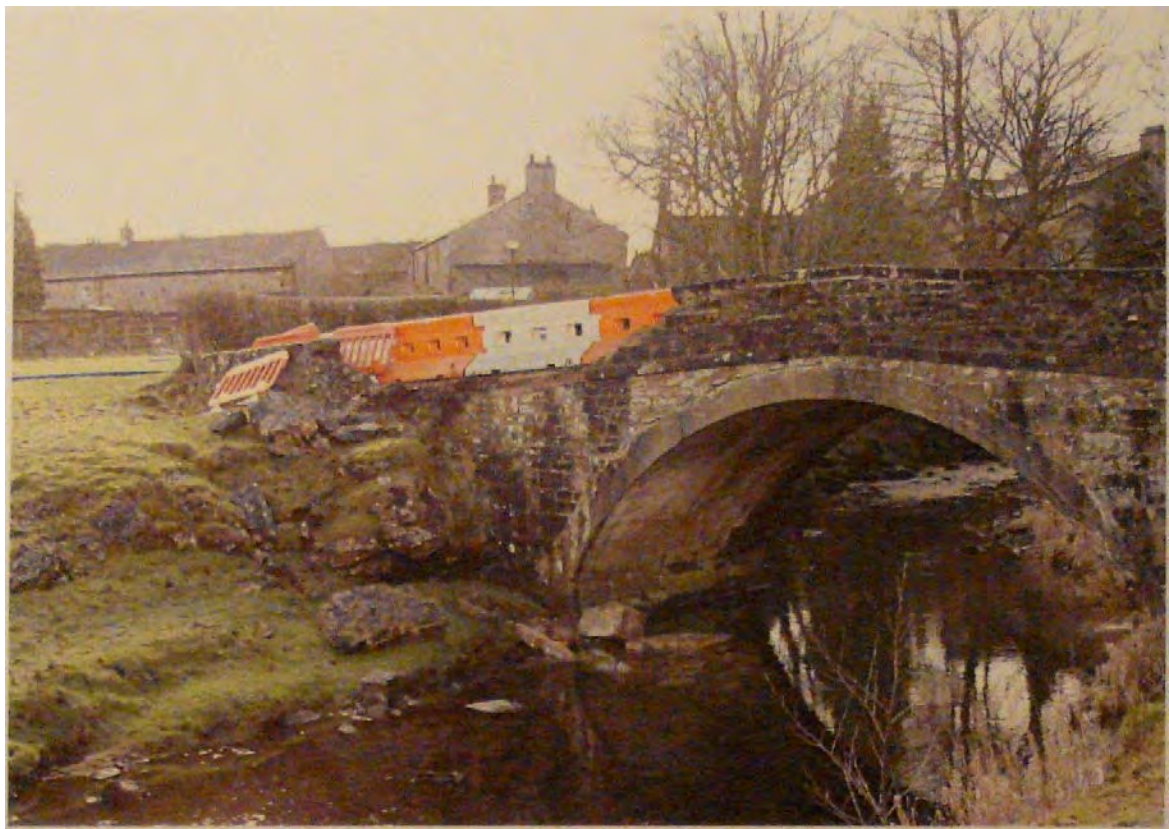
3.1.12 Much of the information in the folder provided by LCC contained details of damage done to the bridge in traffic accidents. The latest of these, in December 2010, was photographed by Slaidburn Archive, and is included here as Plate 16.

Plate 16: Damage to the bridge on 14/12/10 by a car in icy conditions (photo Slaidburn Archive)

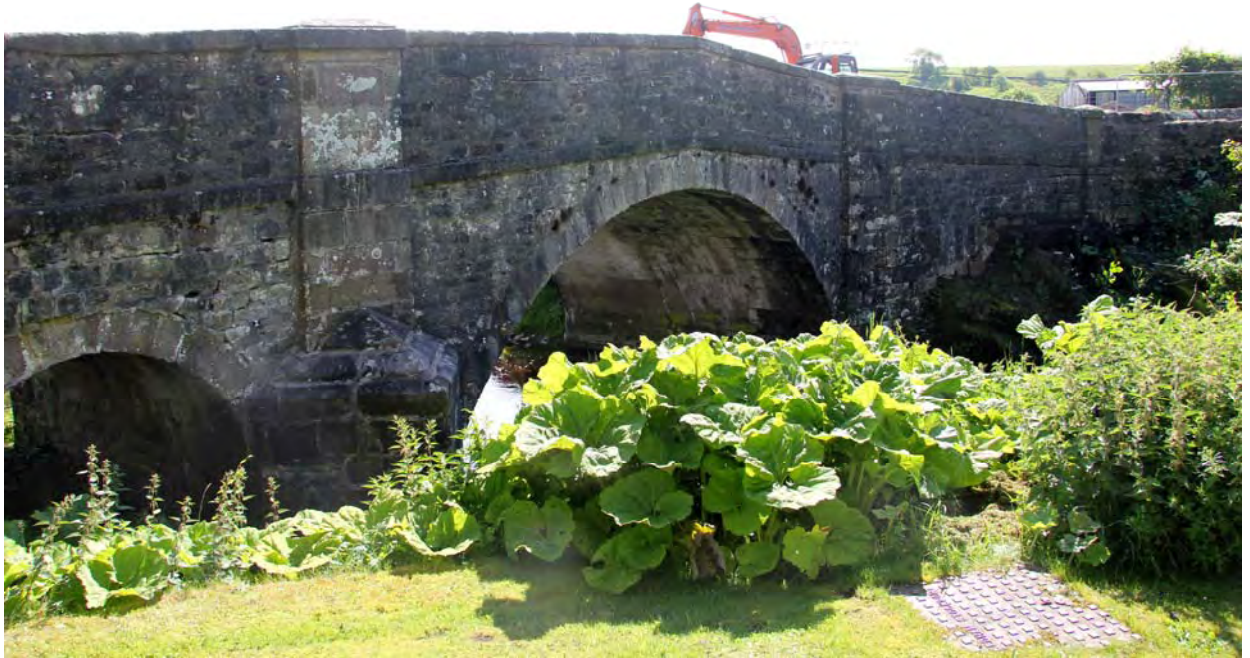
- 4.1.2 **Western Bridge Face (Figs 3-6; Plate 17):** the western-facing spandrels are built of regular-sized, coarsely-dressed blocks of limestone, with ashlar sandstone dressings and voussoirs. An ashlar string course divides the bridge superstructure from the parapet, which is constructed of squared rubble, and is partly obscured by overlapping cement pointing; the parapet has a sandstone coping. The masonry of the parapet is distinct from that of the spandrels below the string course and is of generally varied and patchy construction, suggesting that it has been subject to many episodes of repair and construction (Plate 18). The depth of the road deck, from the crown of the primary arch to the top of the string course and the road surface, is 0.68m.

Plate 17: General view of western face of bridge

- 5.2.1 The western face of the bridge, including the spandrels, has suffered as a result of increasing vehicle loads, and the masonry is cracked and much of the pointing has been dislodged. It is proposed to take down and reconstruct the western face of the bridge, up to the cutwater, and to replace the existing fill with a lightweight concrete. It is also proposed to repoint the masonry of the east and west parapets, as appropriate, although in some areas the pointing is in good condition.
- 5.2.2 This will result in the loss of much of the extant visible historic structure of the bridge, as much of the eastern façade was lost when the arch was rebuilt. Following these works the northern section of the bridge (north of the principal arch), on both sides, will, along with the western arch, represent the best surviving sections of the bridge.

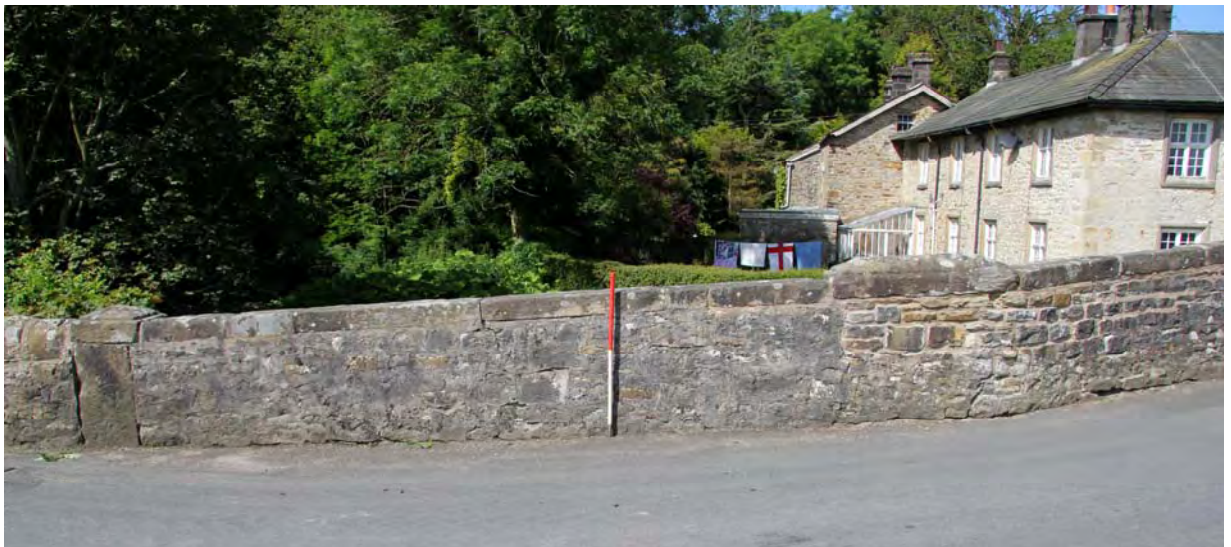
Plate 18: Western parapet showing patchy repairs as a result of vehicle damage

- 4.2.8 **Phase 3:** subsequent to the construction of the northern pilaster the cutwater (starling) was added. The parapet and string course on the western side of the bridge are seemingly contemporary with the pilaster, but there is evidence of patches of different build within the parapet, indicating that substantial parts of it have been rebuilt over the years, probably in response to damage as a result of road traffic accidents.

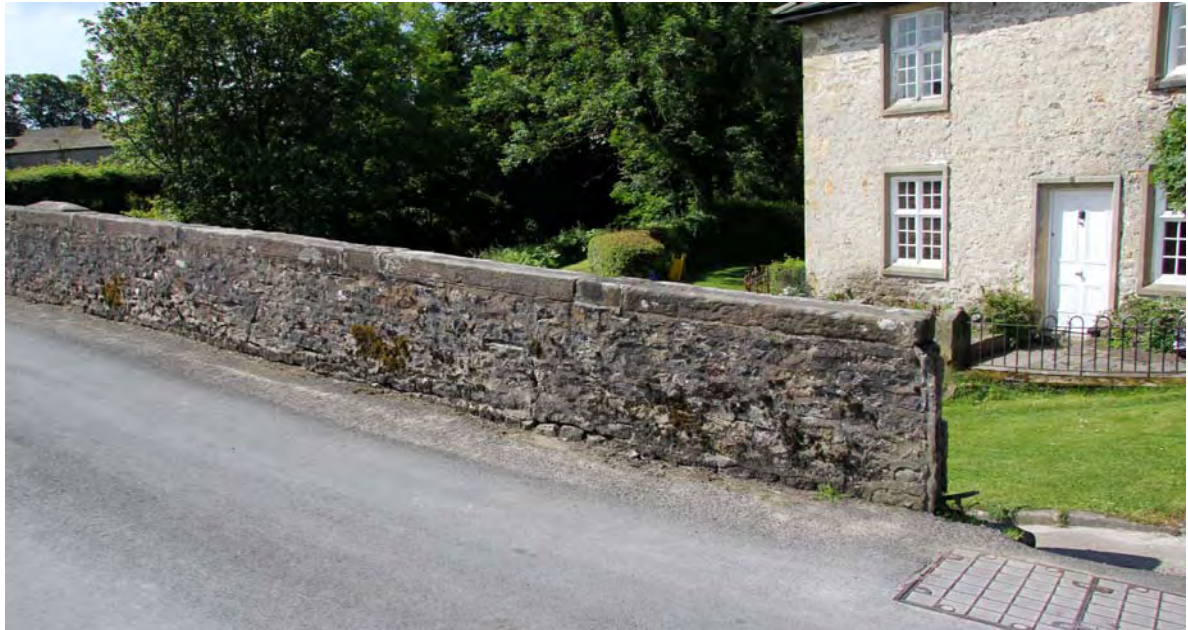
Plate 19: Northern section of western parapet showing the loss of the northern terminal parapet pillar

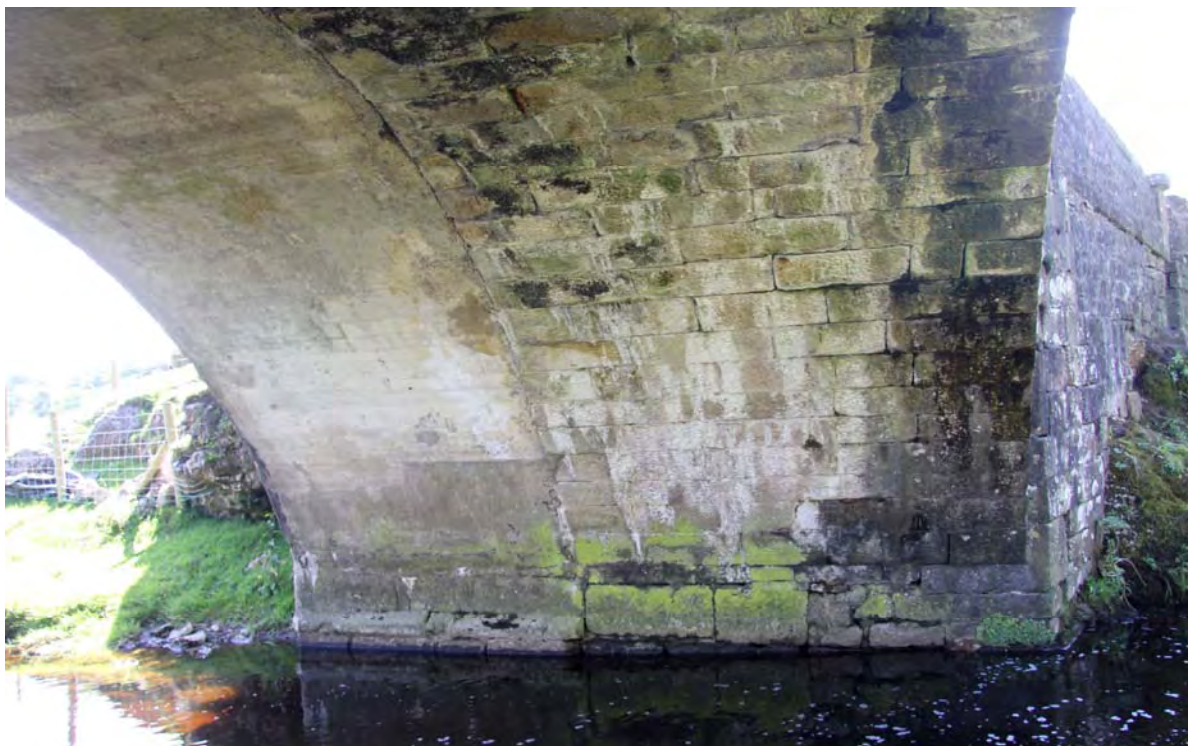
- 4.1.6 **Primary Arch:** the western part of the primary arch is constructed of ashlar sandstone voussoirs, but the eastern section is a 2.26m wide concrete arch (Plate 20). The interface between the two arch sections is a straight-lined butt-join and there is no indication of the concrete arch having been keyed into the masonry arch. The quoin voussoirs on the western side of the masonry arch, match, in length and form, those on the eastern side of the masonry arch, suggesting that both sides were

Plate 20: Underside of the primary arch showing the 1930 concrete arch and western masonry arch

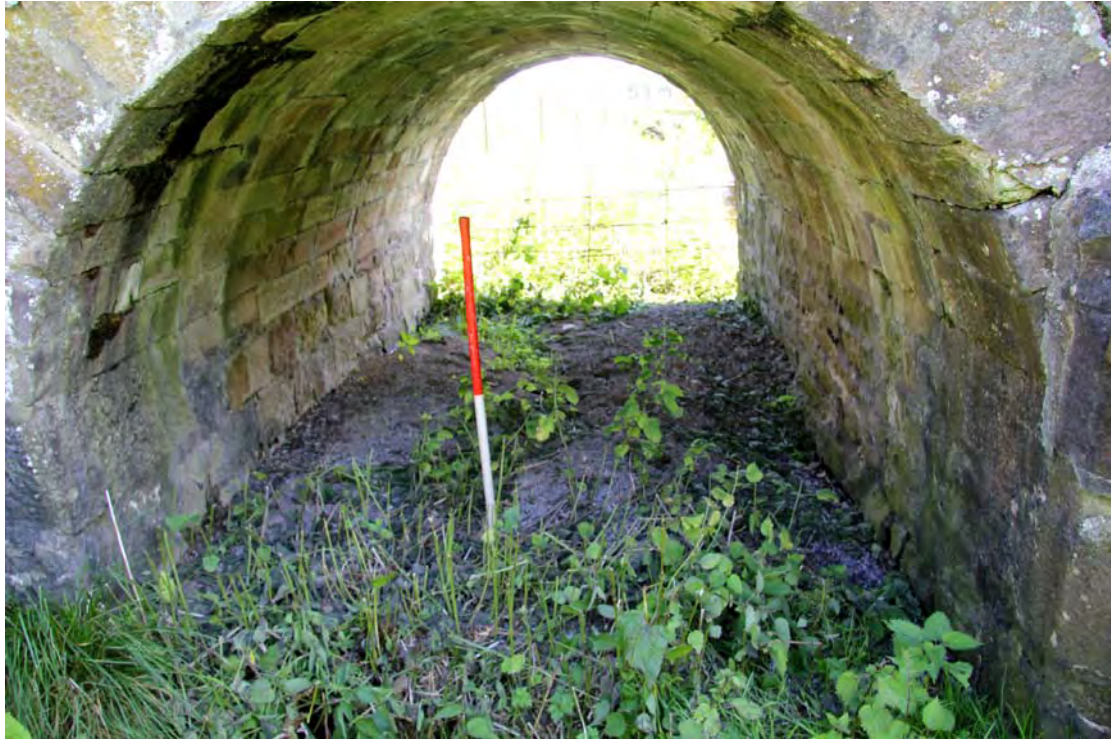
- 4.1.7 **Secondary Arch:** the intrados of the smaller, northern, arch is a mixture of dressed masonry, with a variety of sandstone types, including some red sandstone mixed with yellow sandstone, and also a variety of dressing techniques, and some stones are dressed better than others (Plate 21). Although all the voussoirs are dressed the lack of consistency argues against it being from a single quarry source, or from a single mason. It more likely reflects a reuse of mixed masonry from multiple sources, and is in contrast to the spandrels and pilasters on the western face which are of consistent masonry. It is therefore probable that this arch is a product of rebuilding and repair.

Plate 21: Underside of secondary arch, showing its patchy construction

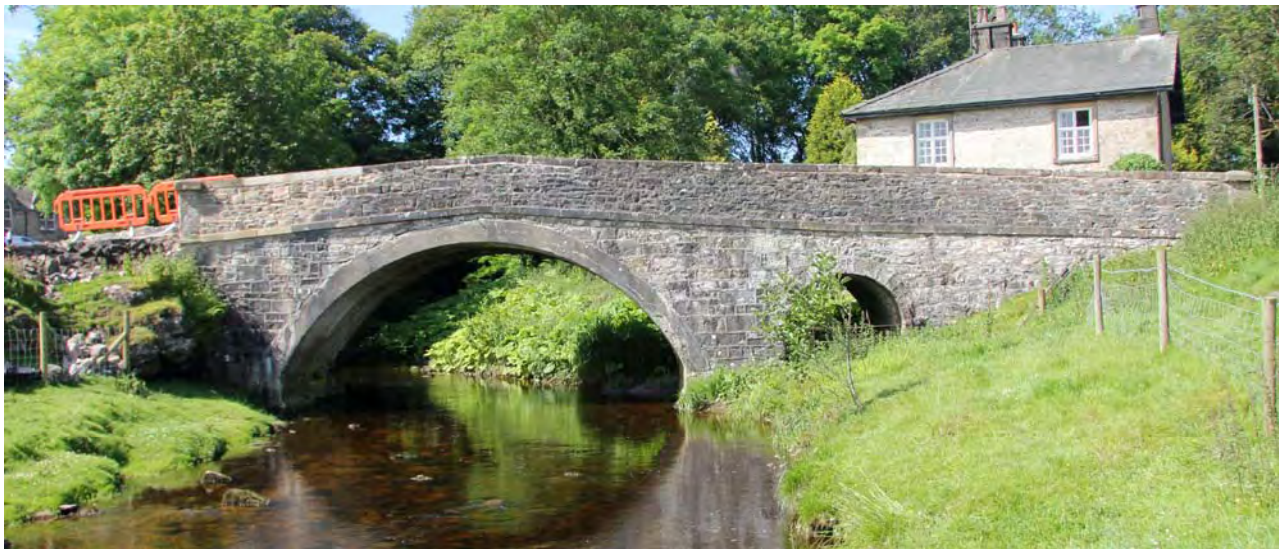
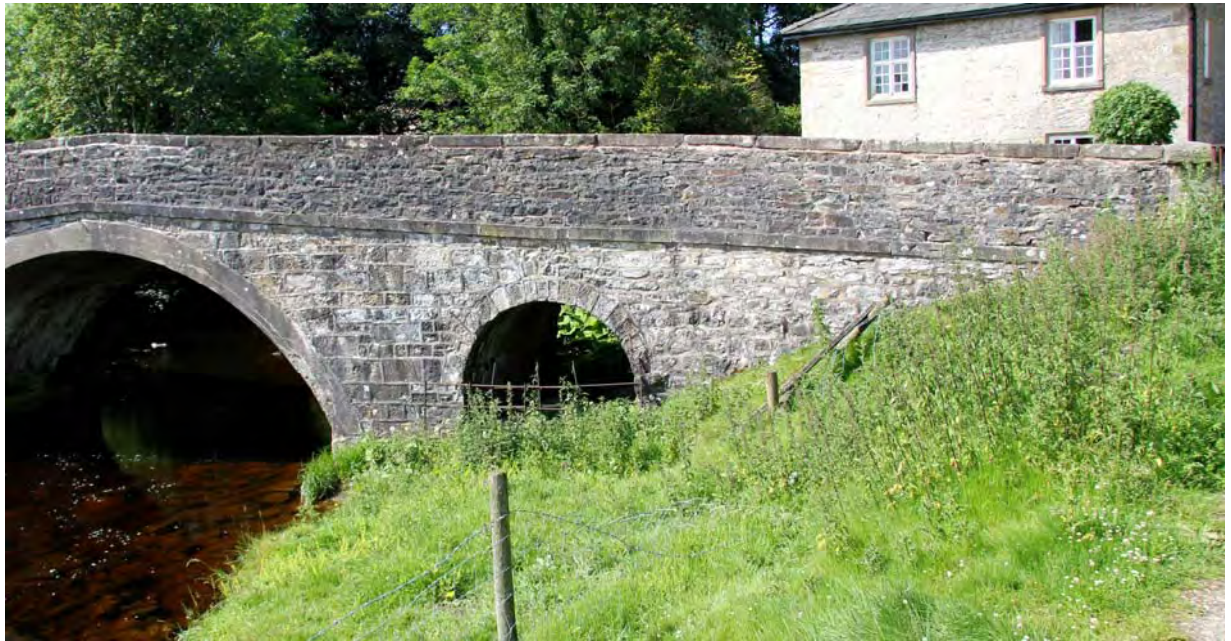
- 4.1.8 **Eastern Bridge Face (Plates 22 and 23):** the eastern face of the bridge has a very obvious concrete primary arch, and the spandrels on either side of it are of squared rubble with strap pointing. This contrasts with the coarsed rubble construction on the bridge elevation to the north of the small secondary arch, which has dressed sandstone voussoirs on its eastern face. The northern section of the bridge face, and the secondary arch, appear to be largely original, but the eastern section of the primary arch is evidently of relatively recent build, and includes the concrete arch, as well as the strap-pointed spandrels. The pilasters on the western face of the bridge are not evident on the eastern side and it is evident from the photograph of 1928, prior to the rebuild of the arch (Plate 9), that none were ever in existence on this eastern face. From the documentary and physical evidence it is apparent that this relatively recent concrete arch reflects a repair / partial rebuild, rather than an easterly extension. The southern string course stones are machine-cut, unworn ashlar and are evidently relatively recent. A small ashlar terminal column for the parapet has been set on top of the recent string course stones, but the column is worn and has greater antiquity than the string course indicating that it has been replaced in this location following relatively recent repairs to the parapet (Plate 24).

Plate 22: Eastern elevation of bridge

Plate 23: Northern section of the eastern face

- 5.3.1 The earliest fabric is an area of spandrel on the eastern side of the bridge, which was not the subject of the present study. If any alterations to the spandrel or adjacent parapet are required it is recommended that a similar building record is made of that elevation in advance of such works.

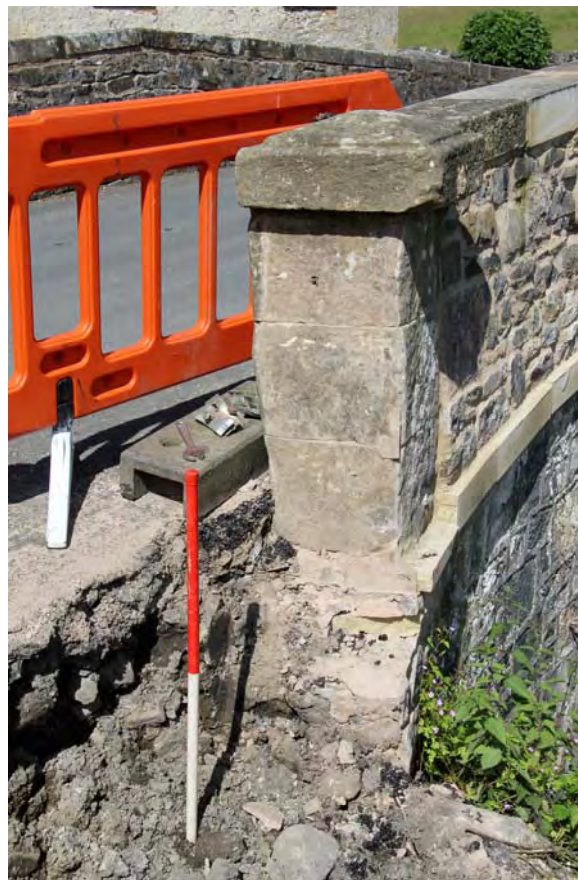
Plate 24: Southern terminal pillar of the eastern parapet, showing its placement on a modern section of string coursing following recent vehicle damage
