VICTORY WORKS, HEYWOOD, Greater Manchester

Archaeological Watching Brief and Building Investigation

Oxford Archaeology North

December 2009

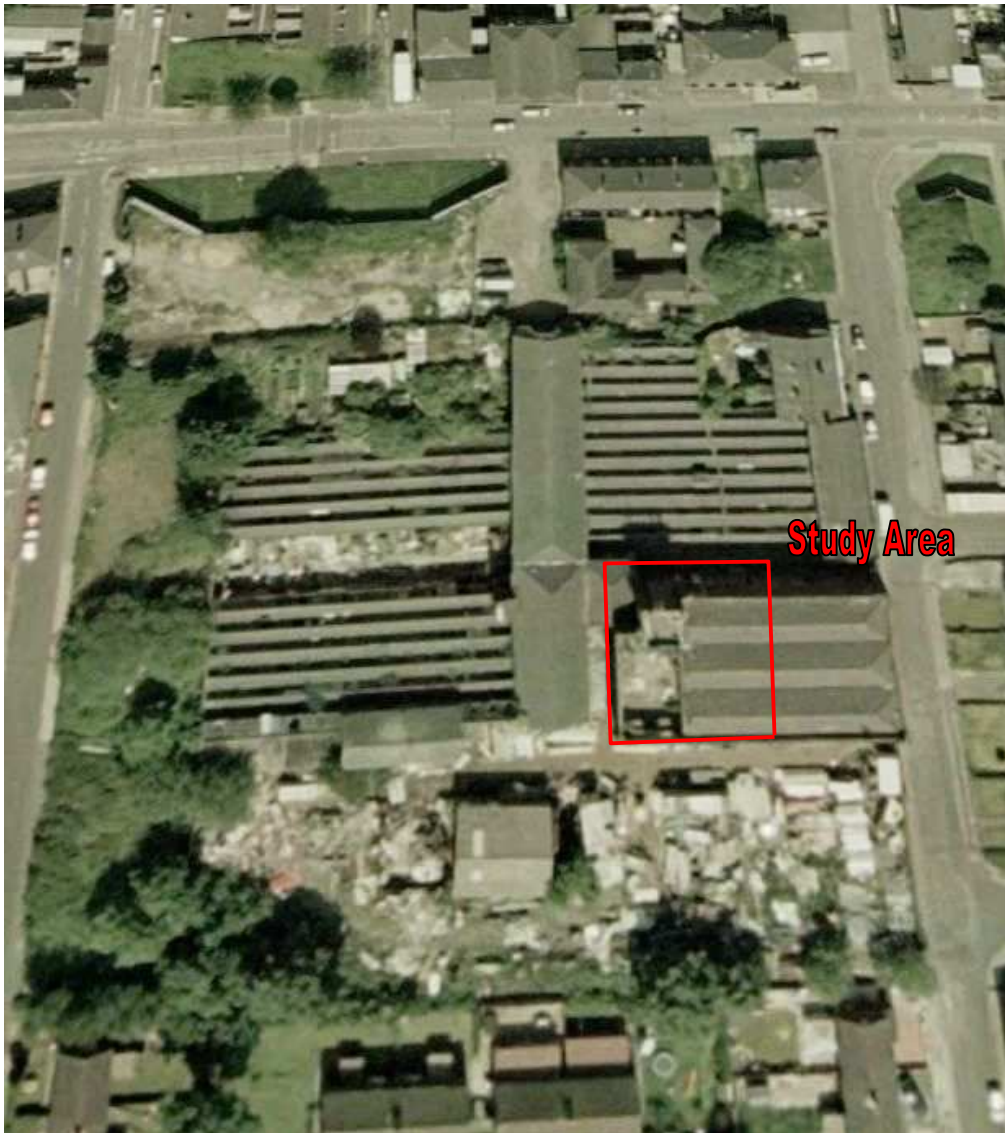
Plate 1: Aerial view of Victory Works prior to demolition, showing the area of archaeological interest

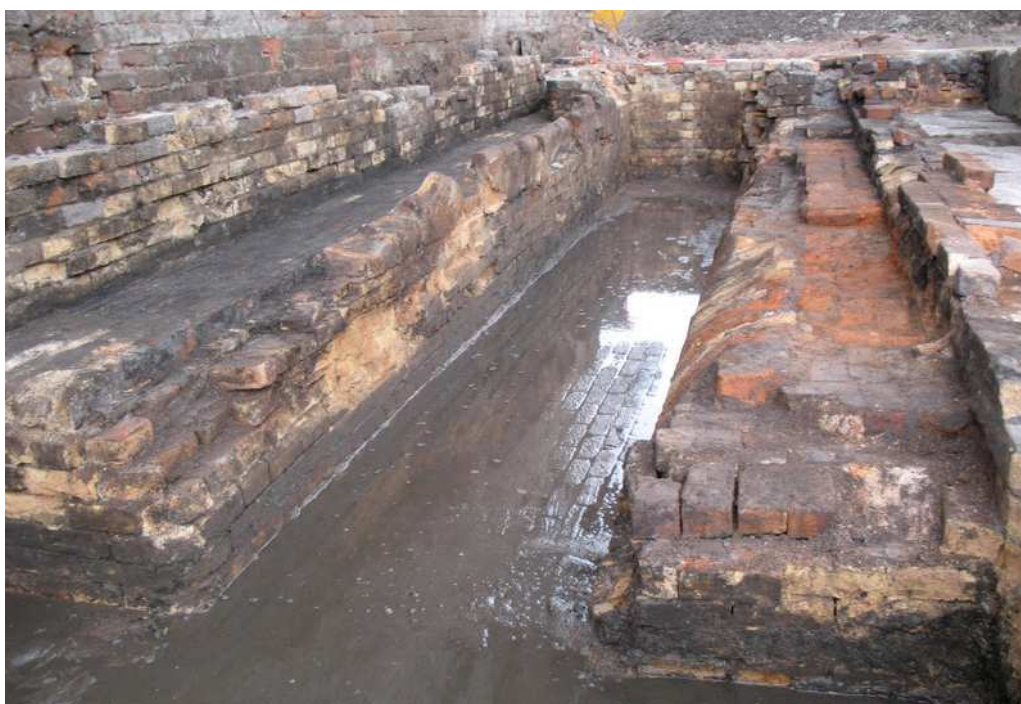
- 4.2.1 **Phase 1 (c 1858):** the earliest fabric within the boiler house pertained to the bed of a Cornish-type boiler (Plate 3). The remains were well-preserved, possibly as a result of its apparent continued maintenance into Phase 3, and comprised a floor of hand-made red brick, aligned broadly north/south, and measuring 31ft (9.44m) long by 10ft (3.04m) wide (Fig 3).

Plate 3: Bed of Phase 1 Cornish boiler

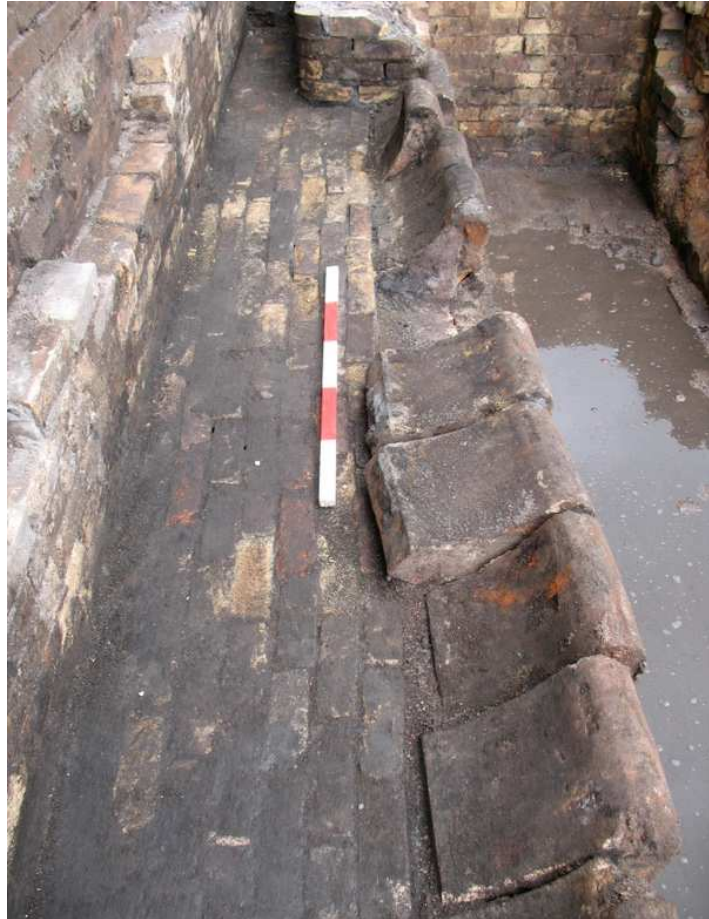
- 4.2.2 The bricks forming the floor of the boiler bed appeared to have been bonded with clay, rather than lime-based mortar, possibly to prevent moisture rising. The boiler benches survived to their full original height of 2ft (0.61m), and were constructed of hand-made red brick, faced with a single skin of yellow refractory brick (Plate 3), all bonded with a mid-brown lime-based mortar. The upper surface of the benches formed the base of the flues, which routed exhaust gases along the side of the boiler to link into the main flue to the chimney at the rear of the boiler. Numerous boiler-mounting blocks, moulded from refractory clay (Plate 4), survived *in-situ*, with further examples recovered from the demolition material that had been backfilled.

Plate 4: Detail of boiler mounting blocks and the side flue

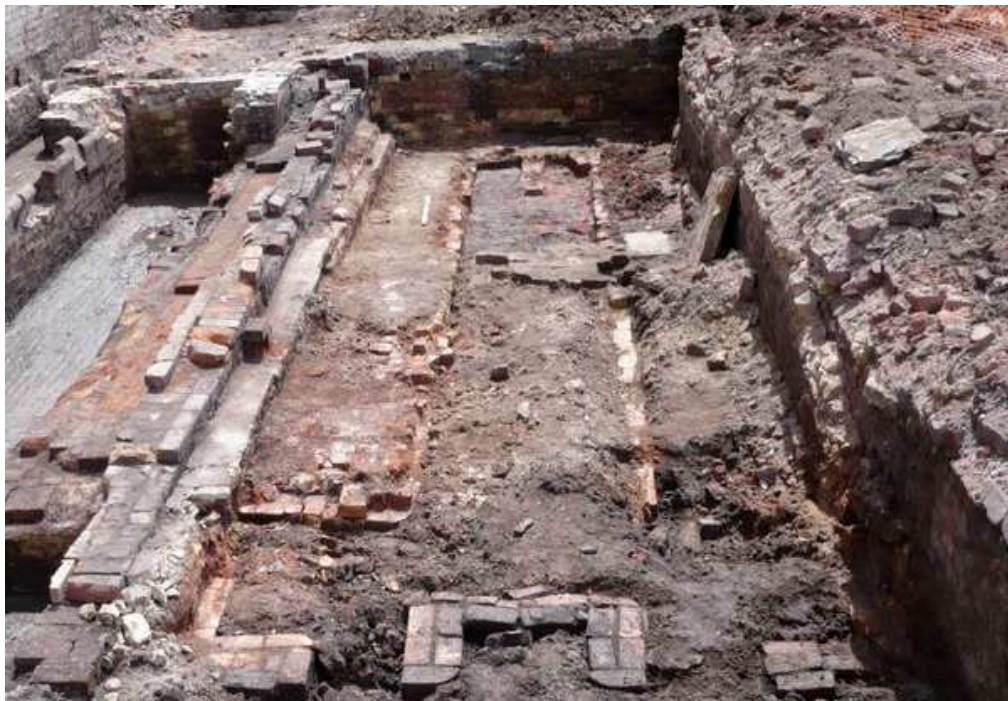
- 4.2.4 **Phase 2 (late nineteenth century):** the mill complex was expanded considerably in the late nineteenth century, creating an increased demand for motive power. This led to the construction of at least one additional boiler, placed immediately to the west of the existing Cornish boiler (Fig 3). The base for this new structure measured 30 by 8ft (9.10 x 2.44m) and survived below a flagstone floor (Phase 3; *Section 4.2.7 below*), but in a much poorer state of preservation than the remains of the Phase 1 boiler to the east (Plate 6).

Plate 6: Foundation bed for the Lancashire boiler (Phase 2)

- 4.2.5 The benches supporting the boiler survived to a maximum height of two courses, and were faced with refractory brick and bonded with a mid-brown lime-based mortar. The partial survival of a full-brick thickness central dividing wall at the rear of the boiler (Plate 6) indicates that it was of a Lancashire type. It seems likely, from the above-ground structures recorded during the building recording (Scott Wilson Ltd 2008), that another Lancashire boiler lay to the west of the watching brief area, serving a new engine house (Building C; Fig 2), constructed to supply power to a new Phase 2 weaving shed (Building B; Fig 2).

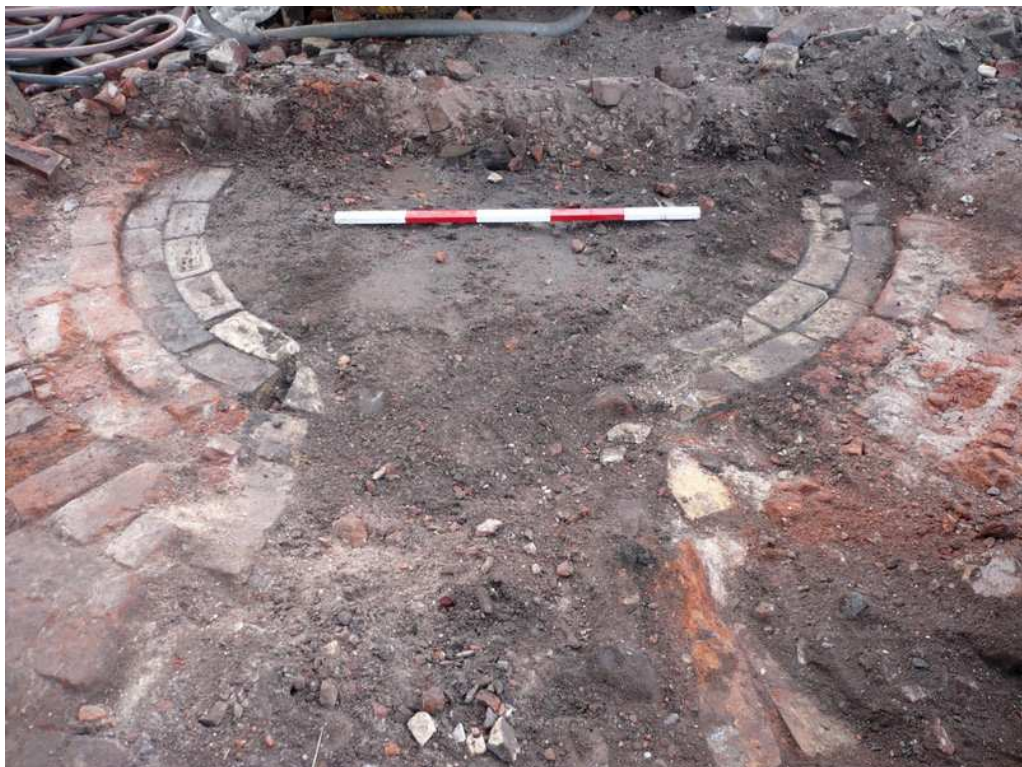
- 4.2.6 The new boilers utilised a new cylindrical chimney (Plate 7), placed immediately to the south of the Phase 1 Cornish boiler (Fig 3), adjacent to the existing chimney, but projecting beyond the south wall of the mill, as shown on the Ordnance Survey edition of 1893 (Plate 2). It had an internal diameter of 5 ft (1.52m), constructed of red brick, and faced internally with a single skin of yellow refractory brick. Evidence for valves within the remodelled flue to the Phase 1 boiler was observed (Plate 7), but was only fragmentary in nature, and it was thus not possible to confirm its design.

Plate 7: Exposed remains of the Phase 2 chimney

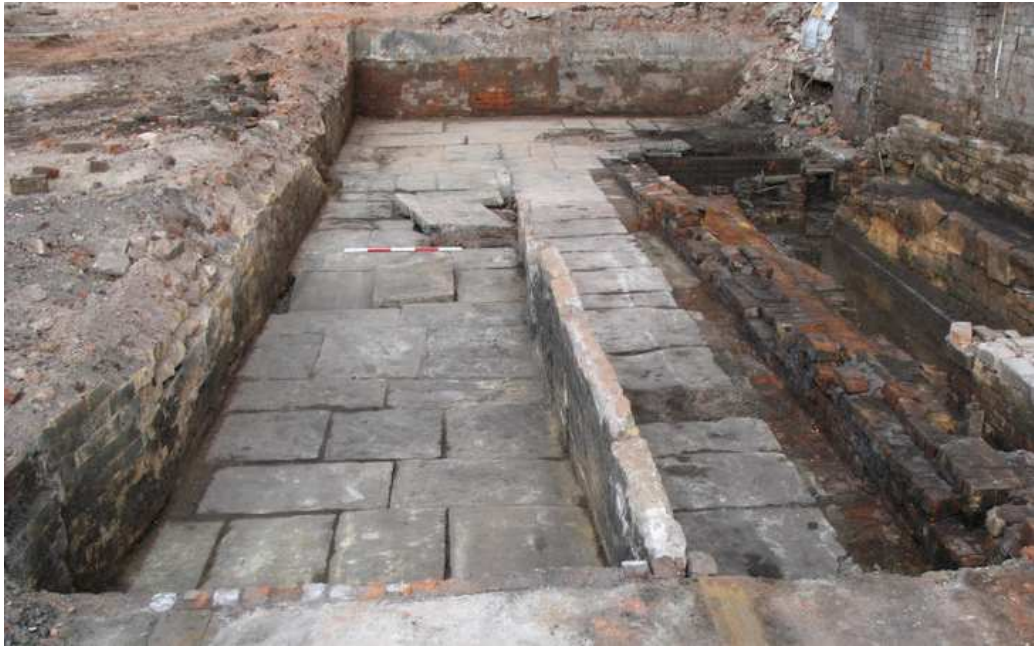
- 4.2.7 **Phase 3 (early twentieth century):** Building D (the boiler house) was remodelled significantly during the early twentieth century, an episode which almost certainly related to the introduction of an electrical power supply to the majority of the mill complex. The Lancashire boiler in the western part of the building was removed and its flue decommissioned, with the base of the bed sealed with sandstone flags subsequently (Plate 8). A central wall of vertically set flagstones was incorporated within the re-floored boiler bed (Fig 4), suggesting that the area was converted to sub-floor storage tanks for powders or other solid materials.

Plate 8: Dividing wall within the Phase 3 floor over the site of the Lancashire boiler

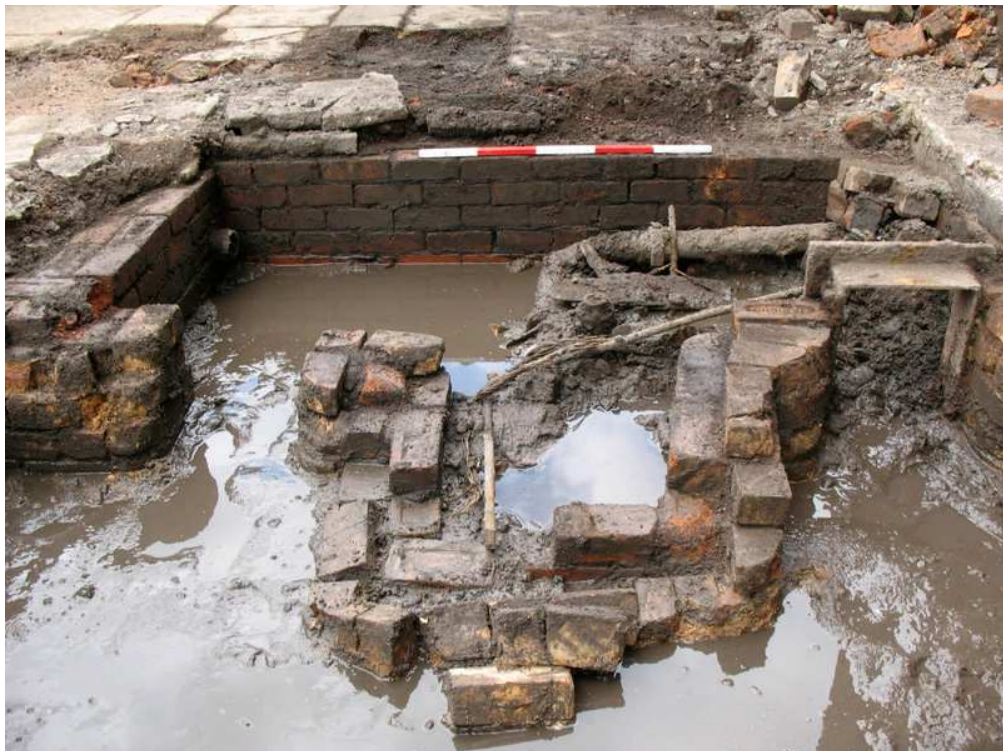
- 4.2.8 The original Cornish boiler appears to have been retained in service, presumably to provide heat for the mill complex. The charging platform at the front of this boiler (Plate 9), and the associated 'blow down', were constructed using a dark ash-based mortar, indicating that they almost certainly dated from this period, replacing earlier examples.

Plate 9: Remodelled 'blow down' and charging platform of Cornish boiler

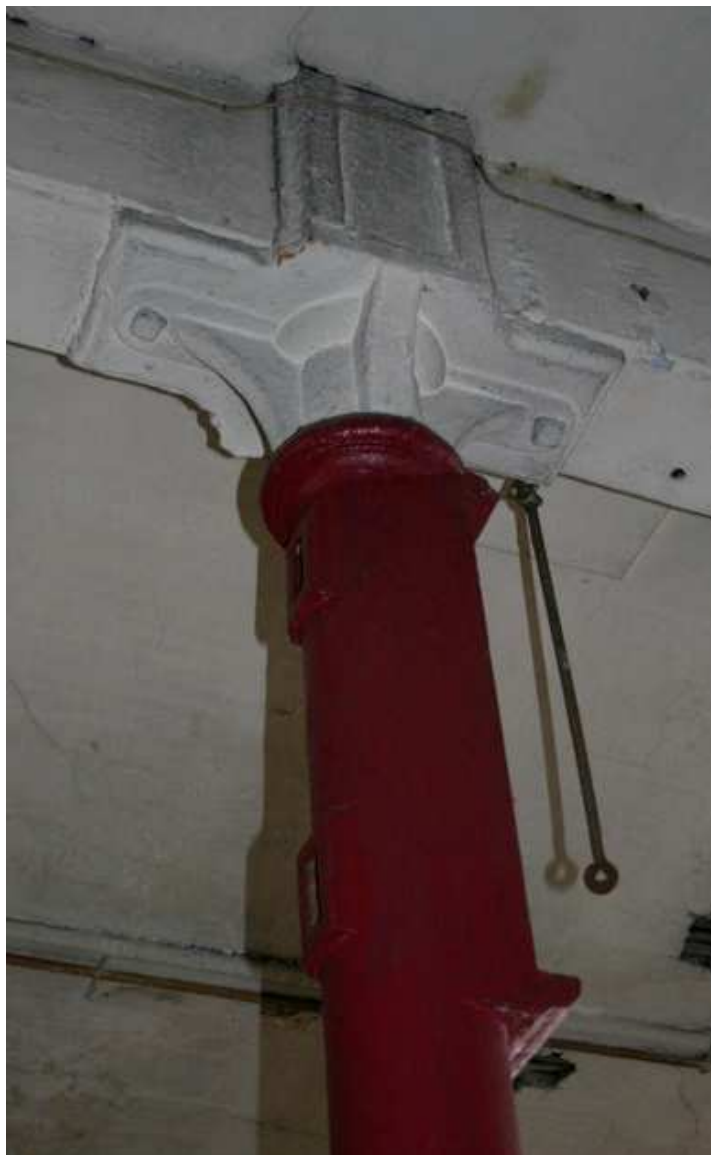
Plate 10: Cast-iron column head detail, second floor, Building A

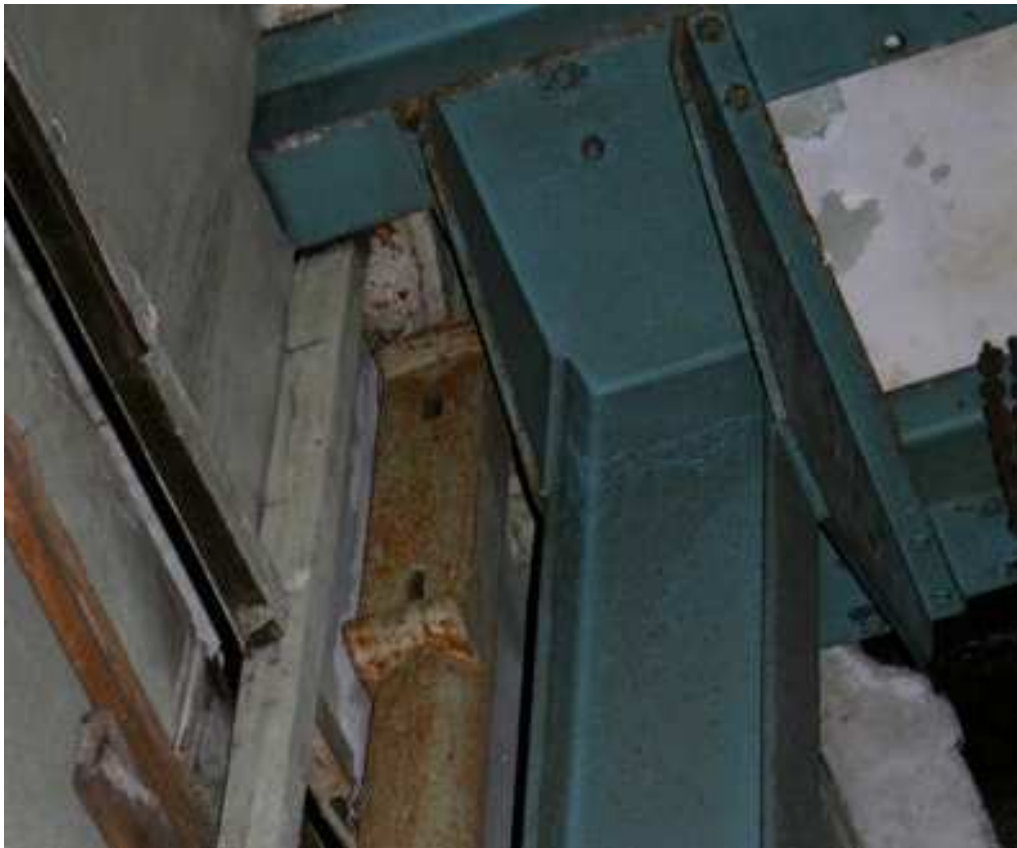
4.3.2 **Ground Floor:** the eastern eight bays of the ground floor comprised an open-plan preparation area, with the plastered ceiling supported by timber beams and cylindrical section cast-iron columns at each bay division. The beams were strengthened within each bay with channel-section cast-iron flitch plates, and deflection within their span suggests that they may have been jointed above the columns, with each bay division comprising three members. The columns were of typical mid-nineteenth century style, but also included integral load-transfer boxes for the timber beams within the column head (Plate 10), possibly to protect any such joint. At ground floor level, the columns did not incorporate castings for carrying the line shaft, which was positioned further to the south (see below). However, within the eastern part of the building, where the first floor had been removed, for the late insertion of a travelling hoist, line shaft hanger castings could be observed clearly on the southern faces of the southern of the two rows of columns at first-floor level (Plate 11).

Plate 11: Line shaft hanger casting in column head, first floor, Building A

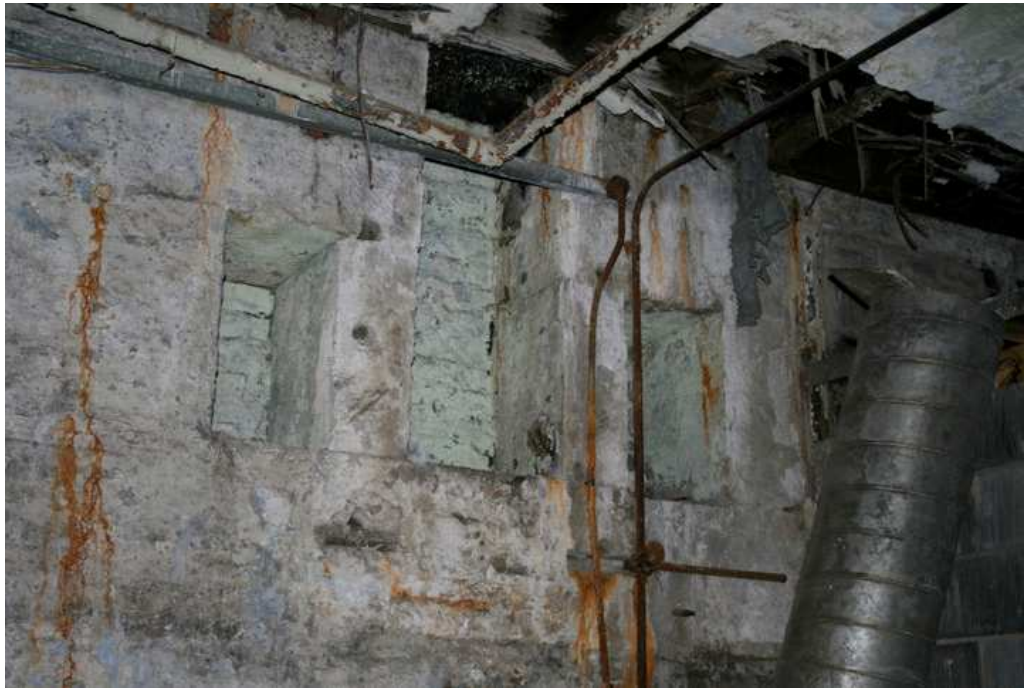
- 4.3.9 The northern apertures, relating to the engine, were framed with substantial dressed sandstone blocks (Plate 12), and housed the framing and aperture for a pinion wheel located against the northern wall of the engine house. A large bearing box to the immediate north was partially obscured behind/above a late clinker block structure in the north-western corner of the main ground floor area of the building. To the south, immediately adjacent to the southern row of columns, a very large bearing box was placed at ceiling level. This bearing box was 5'4" wide (1.62m), and had iron sheeting behind a redundant bracket housing on its eastern face (Plate 13). Brick blocking was visible behind this sheeting and, unlike that blocking the apertures to the north, this utilised a lime-based mortar, indicative of a mid-nineteenth-century date, and was possibly contemporary with the original construction of the bearing box. Examination of the western face of the wall (*Section 4.3.5, below*) revealed that the box housed the footstep bearing of the upright driveshaft on its western side. It would have been impractical to include a shaft into the ground floor in this position, given the nature of the bevel gear involved to translate the driveshaft vertically through 90°, thus explaining the rationale of enclosing the rear of the bearing box.

Plate 12: Pinion wheel framing, and bearing box, ground floor, Building A

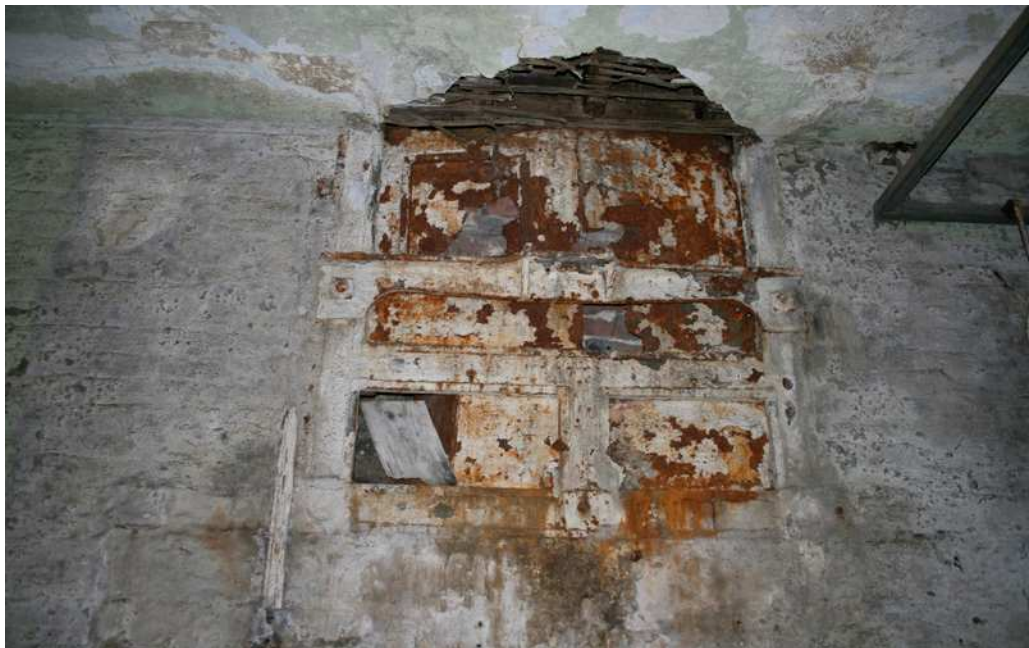
Plate 13: Rear of footstep bearing, ground floor, Building A

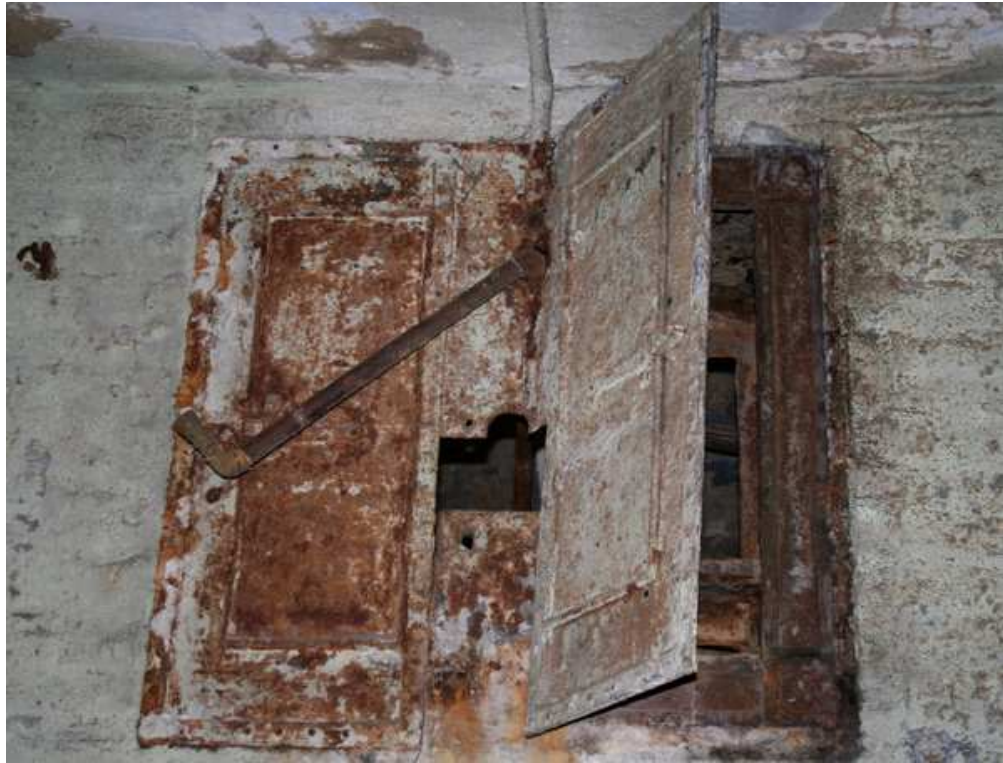
4.3.10 The smaller, 3'6" (1.07m) bearing box to the south, again placed at ceiling level, represents the position of the line shafting within the ground floor of the main mill. It is unusual for such a bearing box to incorporate shuttering on its eastern face, and whilst this does retain a central aperture which a small line shaft may have passed, it more probably represents a later addition to the box, as it includes apertures for both electrical cable ducting and water piping relating to the sprinkler system (Plate 14), both of which would probably have been introduced in the first two decades of the twentieth century.

Plate 14: Shuttering on bearing box

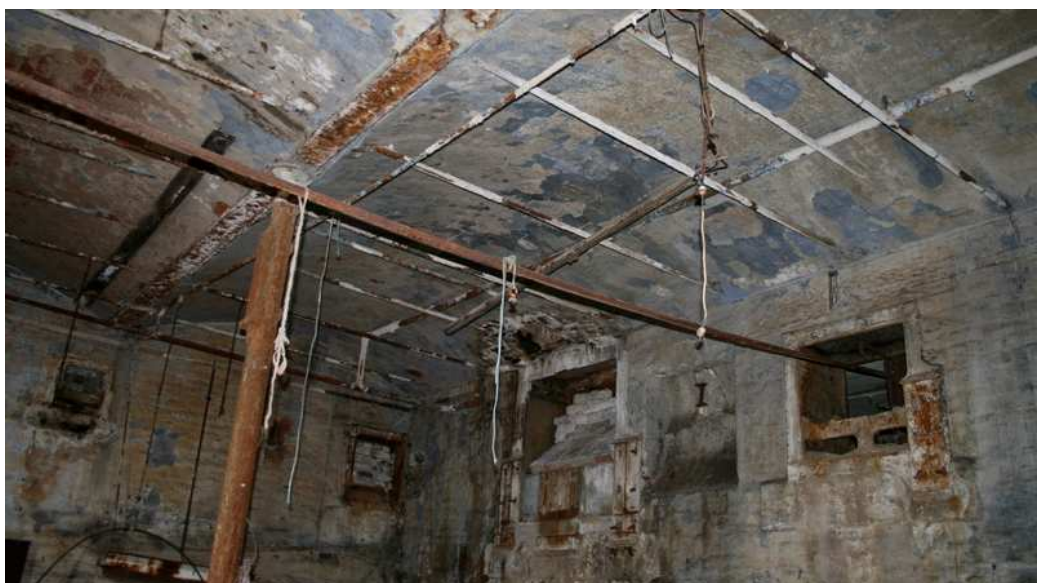
4.3.11 The southern half of the western two bays were of fireproof construction, with a north/south-aligned brick-vaulted ceiling (Figs 6 and 7; Plate 15). This was strengthened at regular intervals with iron tie-rods through the vaulting (Fig 5). The internal vaulting was carried on a cast-iron beam, probably T-section in profile, which was supported by a single cylindrical section column, similar to those within the main mill building, but placed centrally within the room and offset from those to the east. This had a line shaft carrier bracket on its western face (Plate 15), aligned with bearing boxes in the north and south elevations (Figs 5, 6, and 7), which would have housed the end bearings of a short line shaft, installed specifically for this room.

Plate 15: Brick-vaulted ceiling and line shaft carrier bracket, Building A

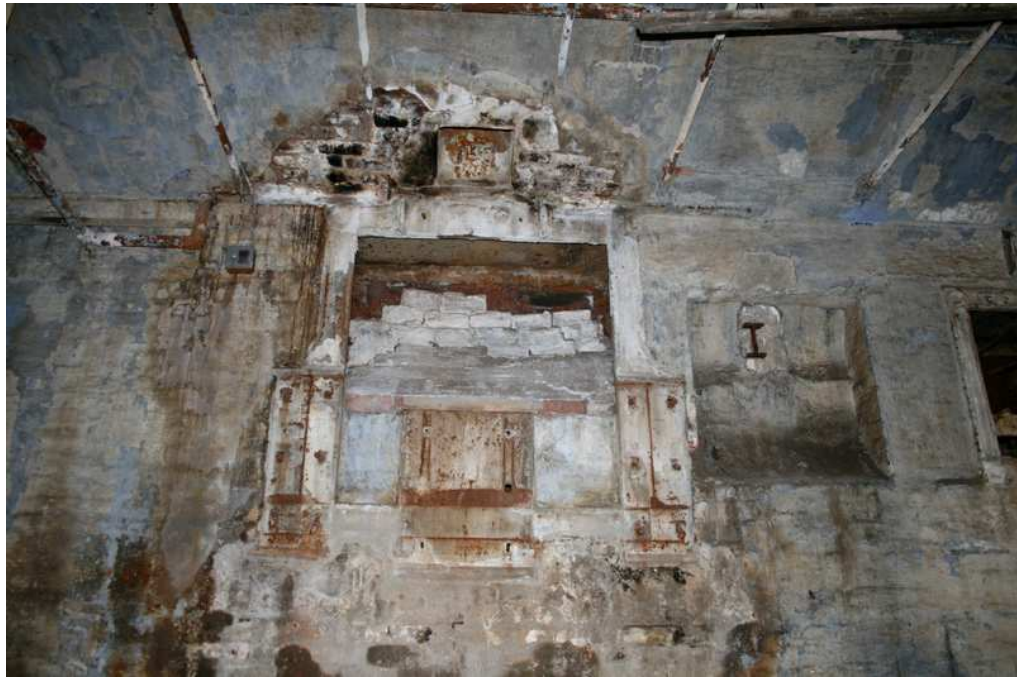
Plate 16: Main footstep bearing, blocked upright shaft aperture and drum cutaway

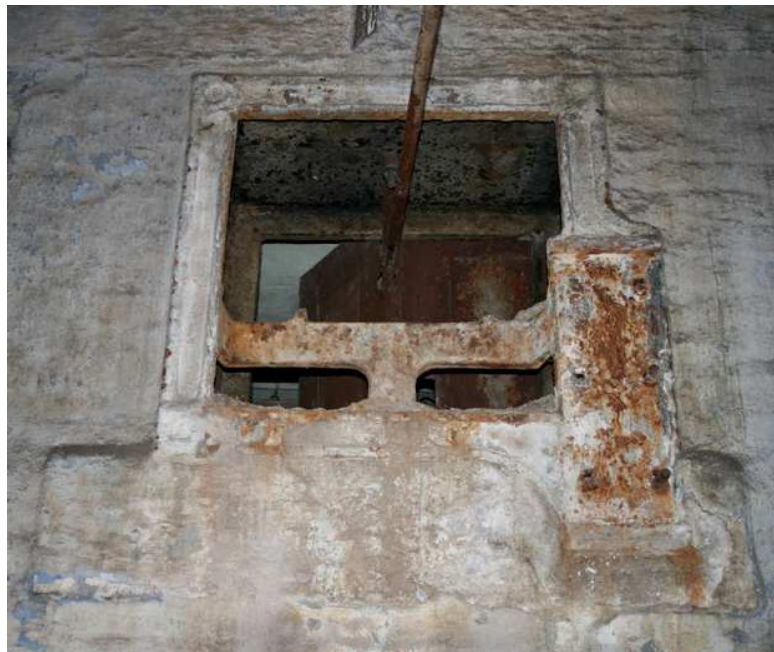
4.3.7 The north elevation contained two further apertures: a housing with a sandstone sill and lintel (Fig 6) for an engine mounting, located in the room to the north; and a larger, 3'6" (1.07m) bearing box, flush with the east elevation (Fig 8; Plate 15), which carried the primary shaft from the engine to the footstep bearing, positioned centrally in the east elevation (Fig 5). Both of these bearing boxes had cutaways within the wall face, for drums on the driveshaft, allowing it to be positioned as close to the wall as possible. Above the footstep bearing mount (Plate 16), a blocked aperture in the ceiling previously housed the upright shaft, distributing rotative power to the upper floors. A further bearing box in the east wall, to the south of the main bearing (Plate 17), would have housed a bevel gear, allowing the rotative power to be transferred

through 90° into the main mill block at ground floor level, whilst also allowing the main driveshaft to continue to the south, through the external south wall (Fig 7), where it was carried into a small structure to the south (Section 4.4.3, below).

Plate 17: Bearing box for bevel gear

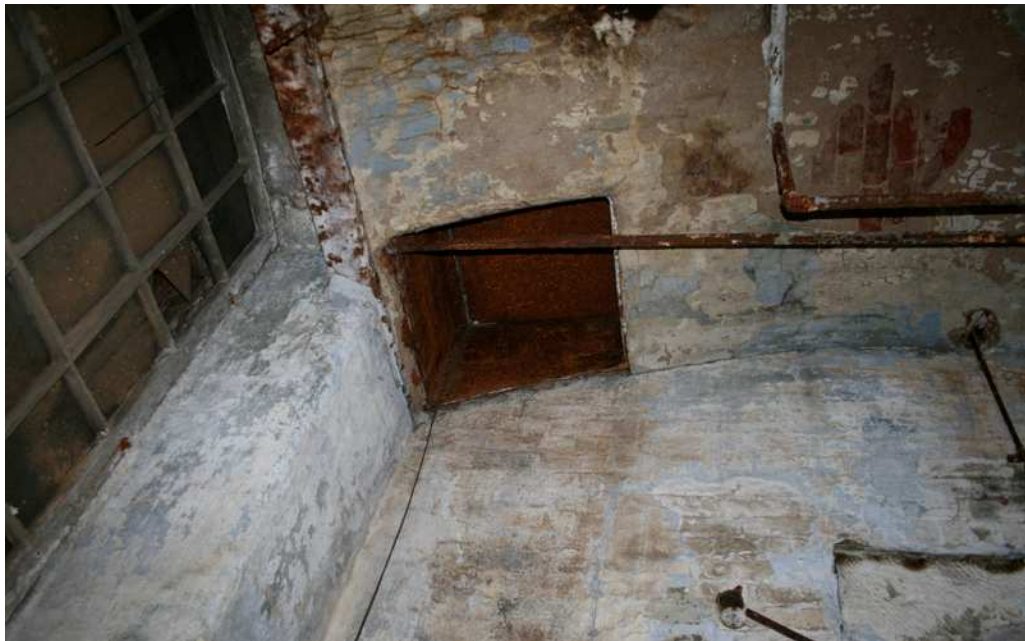
- 4.3.8 Access into this room was originally at the southern end of the east wall, through a doorway from the main area of the ground floor (Fig 8). This had a segmental brick arch and a timber plank door, presumably replacing an earlier fireproof example. A doorway inserted at the western end of the southern elevation more recently provided external access into the room, with the original window above presumably being blocked at this time (Fig 7). To the west of this doorway, the wall had a boxed return to the west elevation. This housed the original chimney, the tapering cylindrical stack of which survived into the 1980s (Plate 5). No evidence for apertures into the flue were observed, although a void in the wall face (Fig 8) revealed that the chimney stack was of a single-brick thickness (Fig 9), and was infilled with rubble. In the north-west corner of the room, an aperture within the brick-vaulted ceiling originally led to the first floor. It had an iron-sheet lining (Plate 18) and was covered/sealed at first-floor level with a similar sheet, presumably serving originally as a ventilation shaft/flue.

Plate 18: Blocked aperture in vaulted ceiling

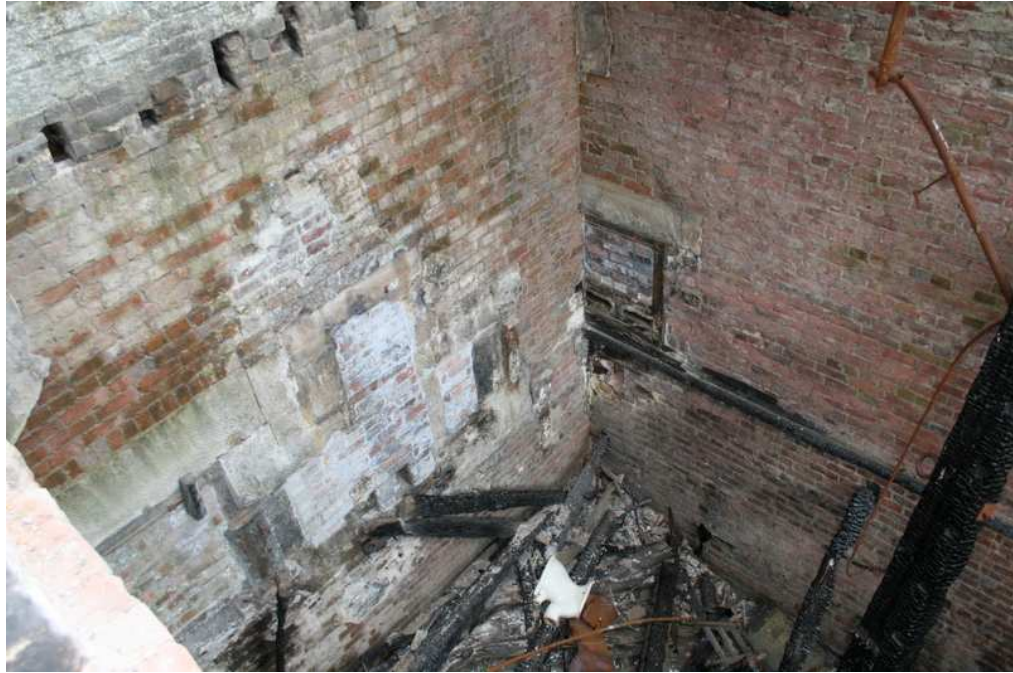
- 4.3.9 To the north of this room lay the engine house. It was arranged in a somewhat unusual style, with the engine aligned longitudinally within the mill, rather than the more common transverse position of an internal engine. No safe access was possible into the 2 x 1 bay structure, but details of the wall fixtures for the vertical engine it housed could clearly be identified from the stair tower, positioned in the north-west corner of the mill (Plate 19). A doorway in the south elevation at second floor level provided access to the room above the engine, whilst access to the engine house itself was afforded from the stairwell in the north-west corner, at ground floor level. Hoist rings survived within a badly burned ceiling beam, which had fallen into the debris of the engine house. These demonstrate how integral the structure of the engine house was to its support, rather than the almost free-standing, later engines. Various sandstone-lined apertures, mainly described above, were also observed within the walls of the engine house, demonstrating how it was largely supported by the structural fabric of the building.

Plate 19: View into damaged engine house from stair tower

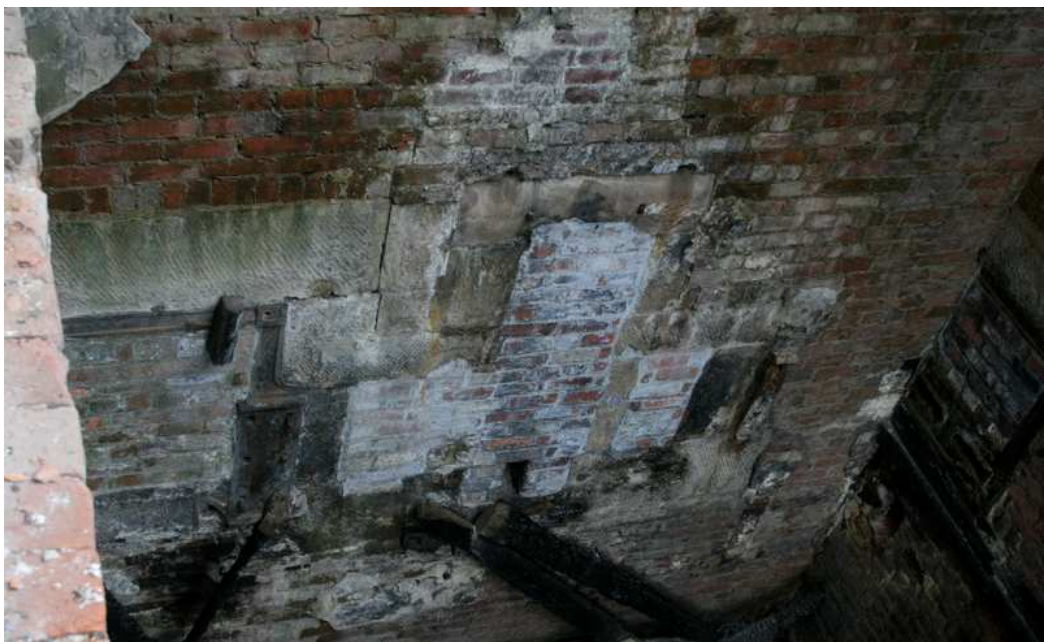
4.3.10 The large central aperture in the east wall represented the housing for the framing for a pinion wheel (Plate 20). The two outer apertures would have supported the axle mount, whilst the central, much taller aperture, formed a partial cutaway into the wall, allowing the wheel to be positioned as closely as possible to the wall. The large bearing box observed to the immediate north of the pinion wheel housing (Plates 12 and 20) was of very similar style to that in the room to the south of the engine, suggesting that a bevel gear was also housed in this position, taking power from the primary shaft and translating it through 90° into the ground floor of the spinning block, providing a second line shaft, to power machinery in the northern part of the ground floor.

Plate 20: Pinion wheel housing within engine house

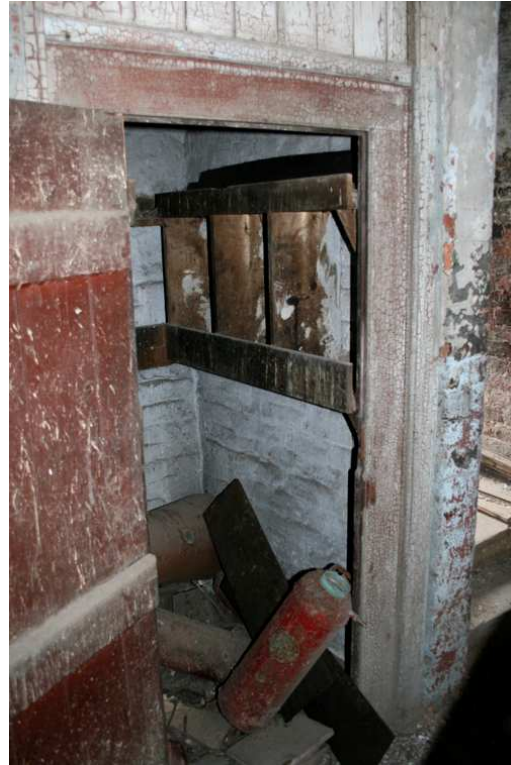
- 4.3.11 **First Floor:** access to the first floor was via a fireproof stair tower, placed in the north-west corner of the mill. It comprised sandstone flag floors and steps, and had a central rectangular-section brick newel, which housed a hoist (Plate 21). The first floor was partitioned by a brick dividing wall, where the engine house continued at this level. No safe access was afforded to the room on its southern side, which had a loading door in the southern elevation, suggesting materials were hoisted into this room. This room also housed the vertical driveshaft, and a large bearing box transferred power into the main floor area. The line shaft was carried on hangers attached to castings on the southern face on the southern row of columns, and presumably drove spinning mules placed transversely across the room. The room had a timber-plank floor and a whitewashed lath and plaster ceiling, and was partitioned from the extension to the ground floor at the eastern end of the building by a stud and chipboard partition.

Plate 21: Hoist within the stair newel

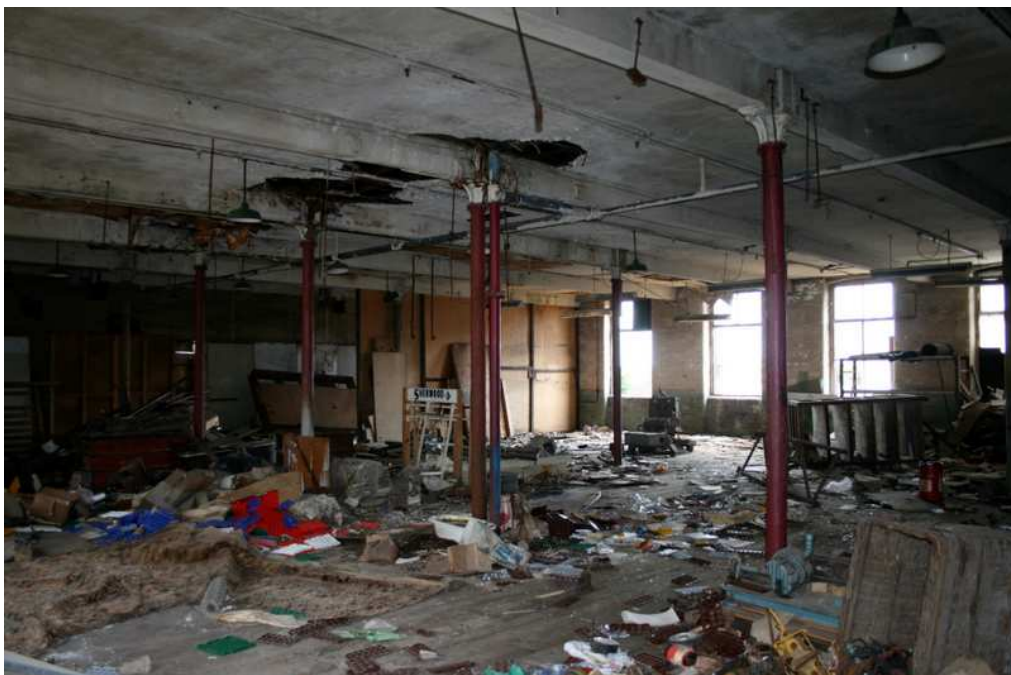
- 4.3.12 The water supply for the sprinkler system did not utilise the newel of the stair tower, but instead rose between the floors adjacent to the second column in the northern row of columns (Plate 22). Smaller-section pipes directed the supply around the floor at ceiling level, hung from hangers attached to the beams.

Plate 22: First floor, Building A, with sprinkler pipe arrangement

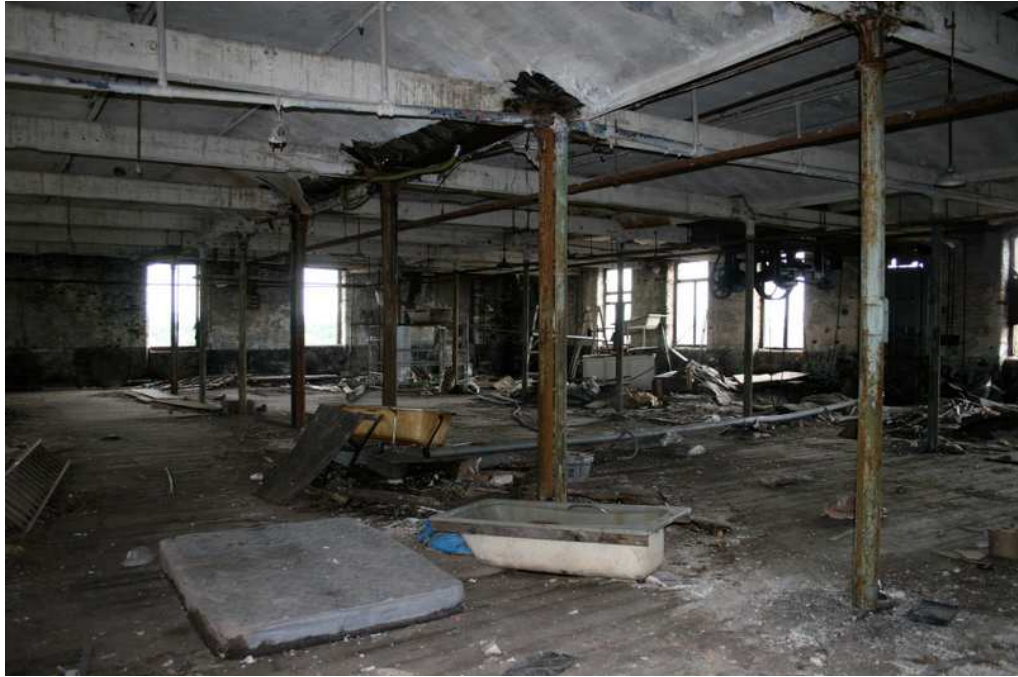
- 4.3.13 **Second Floor:** the upper floor of the mill was of a similar open plan to the first floor, although it remained intact at the eastern end, above the ground- and first-floor alterations below. The three-span, east/west-aligned roof had its valleys positioned above the two rows of columns. However, the entire ceiling was sealed with lath and plaster, covering the detail of the trusses, which were presumably simple collared trusses, as there were neither queen or king posts in the open raised sections above the beams (Plate 23).

Plate 23: Second floor, Building A,

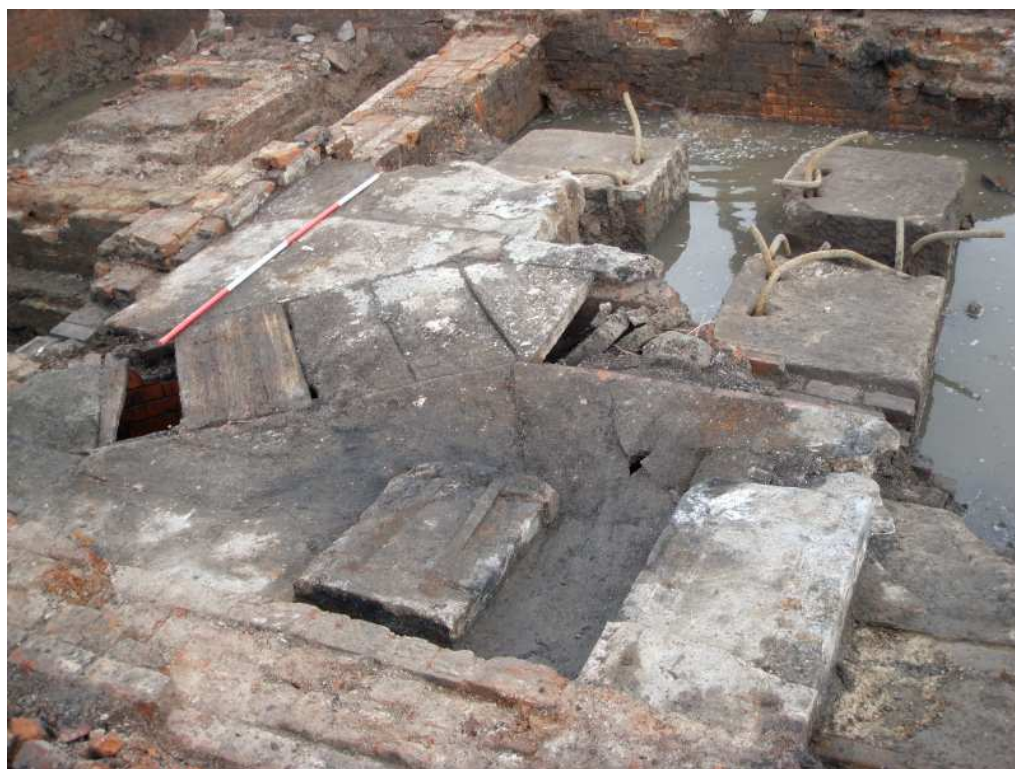
- 4.4.2 **Engine House:** the sub-floor remains of the engine house comprised two distinct areas. The western area had been significantly remodelled, housing a timber plank-capped machine-made brick culvert (Plate 24), whilst the eastern end retained large sandstone blocks pertaining to the original engine (Fig 10). Four such blocks survived, comprising dressed sandstone piers, each measuring approximately 4' (1.21m) square and 18" (0.46m) thick. The north-western of the four blocks survived to an additional block's height, level with the remodelled flagstone/concrete floors to the west. Bolts for tying down the engine to the bed, were cut flush with its upper surface, suggesting that it formed part of this later floor, whilst the lower remaining piers had twisted and bent bolts projecting significantly from their upper surfaces (Plate 25). The western two almost certainly supported the cylinders of the engine, whilst those to the east would have housed columns supporting the entablature beam of the engine. The western end of the engine house would have contained a void below floor level, providing an ideal space through which to place a later culvert.

Plate 24: Remodelled western part of engine house

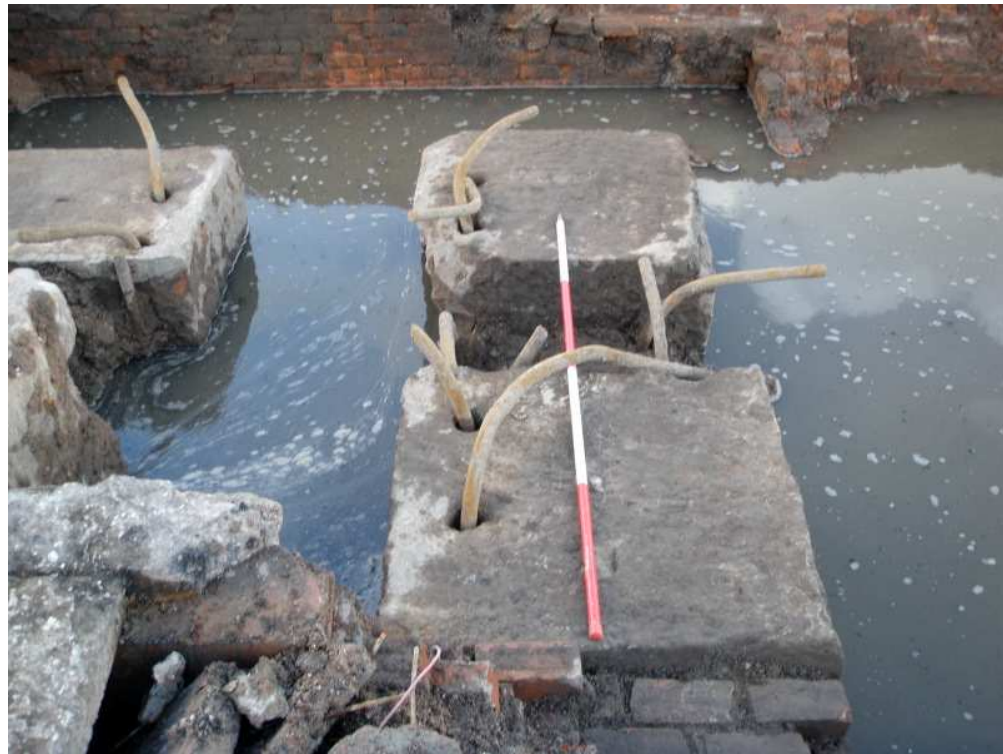
Plate 25: Engine bed, showing fixing bolts

- 5.3.1 The layout of the engine bed revealed during the final strip and record phase of the fieldwork, suggests that the engine was of 'compound' design, with the two western sandstone piers each supporting a cylinder; one utilising high-pressure, and the other utilising low-pressure steam, to increase the power of the engine. This type of engine, patented by McNaught in 1845 (Giles and Goodall 1992, 134), re-used exhaust steam, and provided much more powerful engines without the need for much larger structures to house them. The cutaway for the pinion wheel, observed during the additional building investigation was placed central in the eastern elevation of the engine house, demonstrating that the flywheel of the engine must also have been placed centrally, between the two rows of extant sandstone blocks. It is, therefore, inevitable that the two visible blocks within each such pair were joined by a much larger and more substantial blocks, presumably not far below the depth excavated, which housed the flywheel axle.

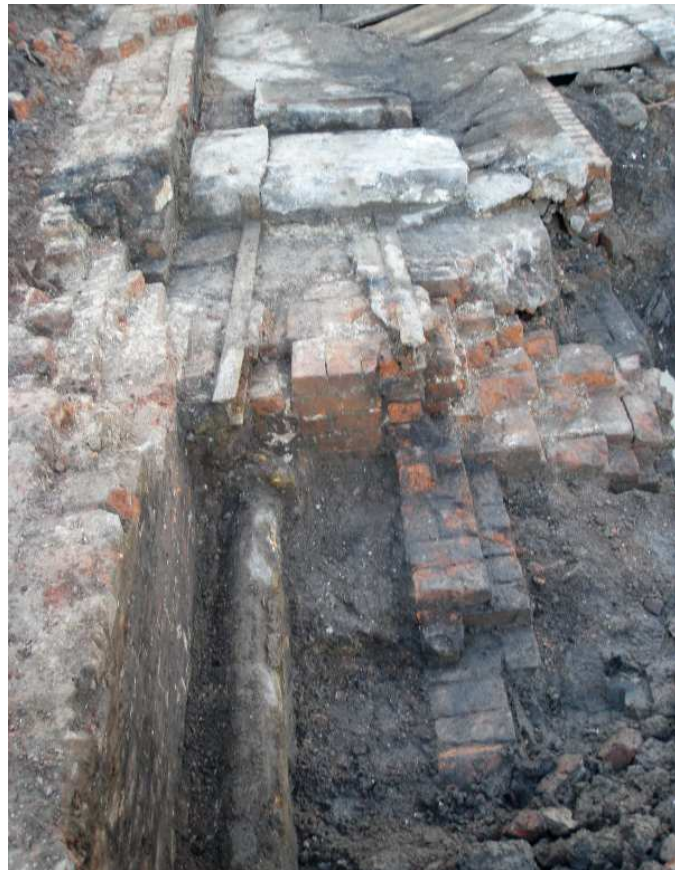
- 4.4.3 **Preparation Room:** very few archaeological remains were observed beneath the floor of the preparation room to the south of the engine house (Fig 10). Fragmentary wire-cut brick walls, bonded to a small expanse of concrete floor, were observed in the north-west corner of the room, and appear to relate to relatively late remodelling of the engine house. This overlay a north/south-aligned wall, of 1½ brick thickness, bonded with a black sooty mortar, indicative of a late nineteenth-century date. This formed the eastern wall of a conduit housing a 9" (0.23m) diameter cast-iron water pipe (Plate 26).

Plate 26: Cast-iron water pipe adjacent to the western wall

- 4.4.4 The pipe was probably associated with the water return from the engine to the reservoirs, which were located to the south of Buildings A and D, and perhaps replaced a culvert revealed in the south-eastern corner of the trench (Fig 10). This comprised an 18" (0.46m) wide curving channel, with walls turning towards the north-west at its northern end. Both walls were of hand-made brick, bonded in a pale lime-based mortar, but were of differing thickness; the western wall was of only a single skin, whilst the eastern wall was of a full-brick thickness (Plate 27).
