VICTORY WORKS, HEYWOOD, Greater Manchester

Archaeological Watching Brief and Building Investigation

Oxford Archaeology North

December 2009

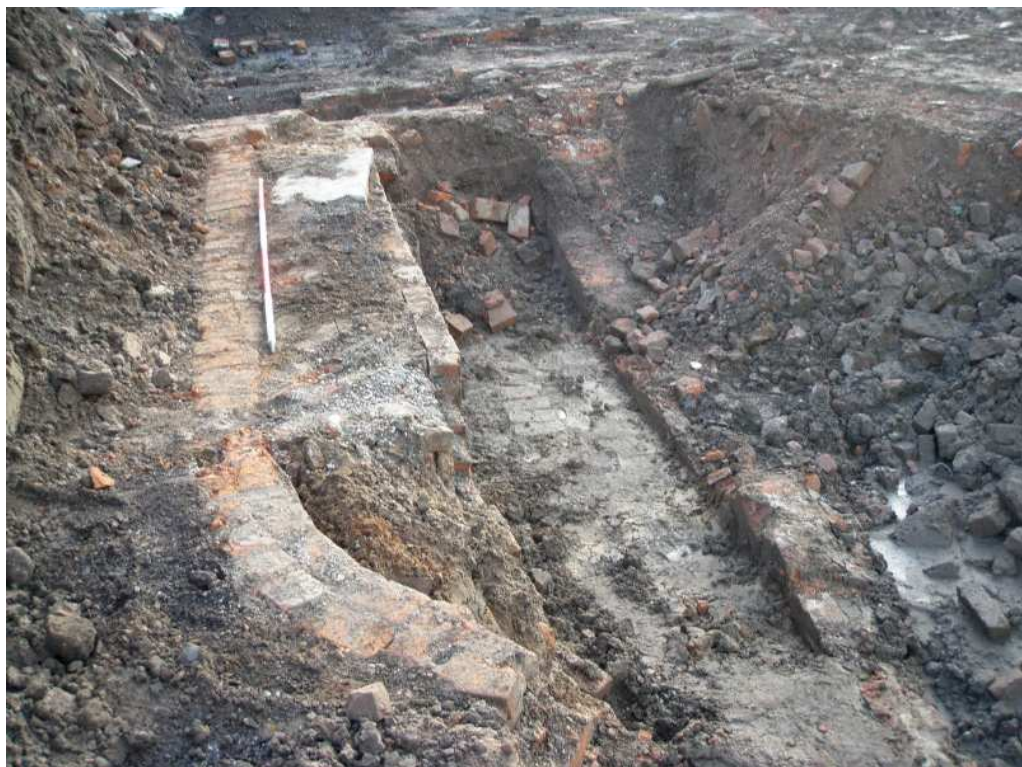
- 4.4.5 The culvert was truncated at its northern end, possibly for the insertion of a lower, much narrower culvert, which appeared to have been constructed for drainage rather than relating to the water supply for the power plant. At its southern end, its passage through the external wall of the building was blocked with brick, bonded in a black sooty mortar, again suggesting that this related to a change in the water management of the engine, almost certainly relating to changes in use of the boilers. The culvert original led into an east/west-aligned chamber, immediately to the south of the spinning block, and this feature is possibly that shown on the Ordnance Survey plan of 1893 (Plate 2). The results of the building investigation suggest that this structure had a power supply, which probably drove a pump between the culvert and the reservoirs.

Plate 27: Truncated curving culvert below spinning block

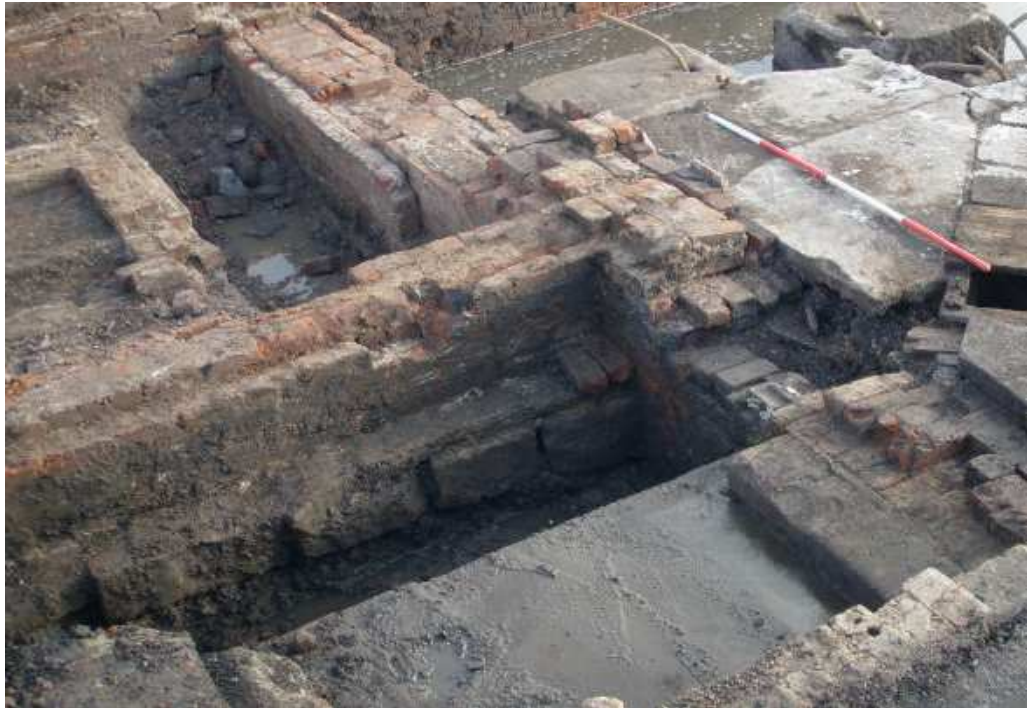
- 4.4.6 **Stair Tower:** the foundation of a stair tower extended below floor level, and appeared to have had a flagstone base to the central newel (Fig 10). Whilst the north, east and south walls of the stair tower were of significant structural integrity to the main mill building, the west wall formed part of the stair tower only. This was reflected at foundation level, where a row of roughly dressed sandstone pads were observed below the basal course of the wall (Plate 28), whereas the bases of the other walls were not observed within the depth of the trench. The use of such sandstone pads reflects the height of the tower, as they appeared to have been intended to provide additional stability to its base.

Plate 28: Sandstone footings for stair tower

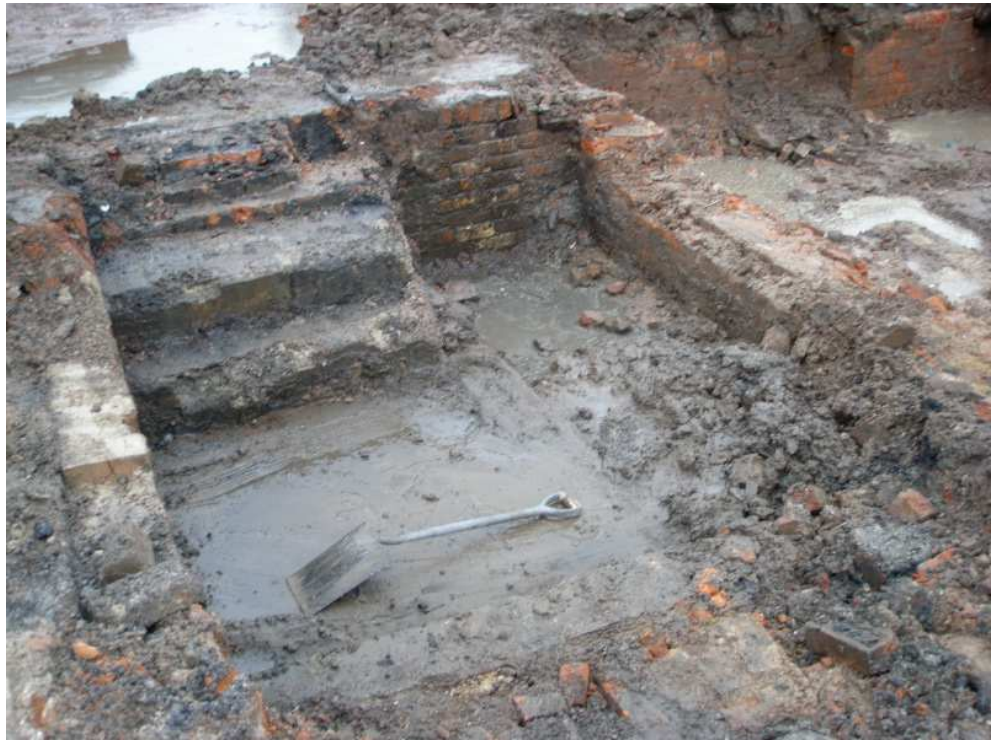
- 4.4.7 To the west of the stair tower, in the re-entrant angle beyond the engine house, a set of three brick and concrete steps were revealed (Plate 29). These afforded access into a small sub-basement, measuring 11½' x 8½' (3.51 x 2.59m). This appears to be of Phase 3 date, and was almost certainly used as a store, probably relating to the surviving boiler.

Plate 29: Steps into sub-basement adjacent to stair tower

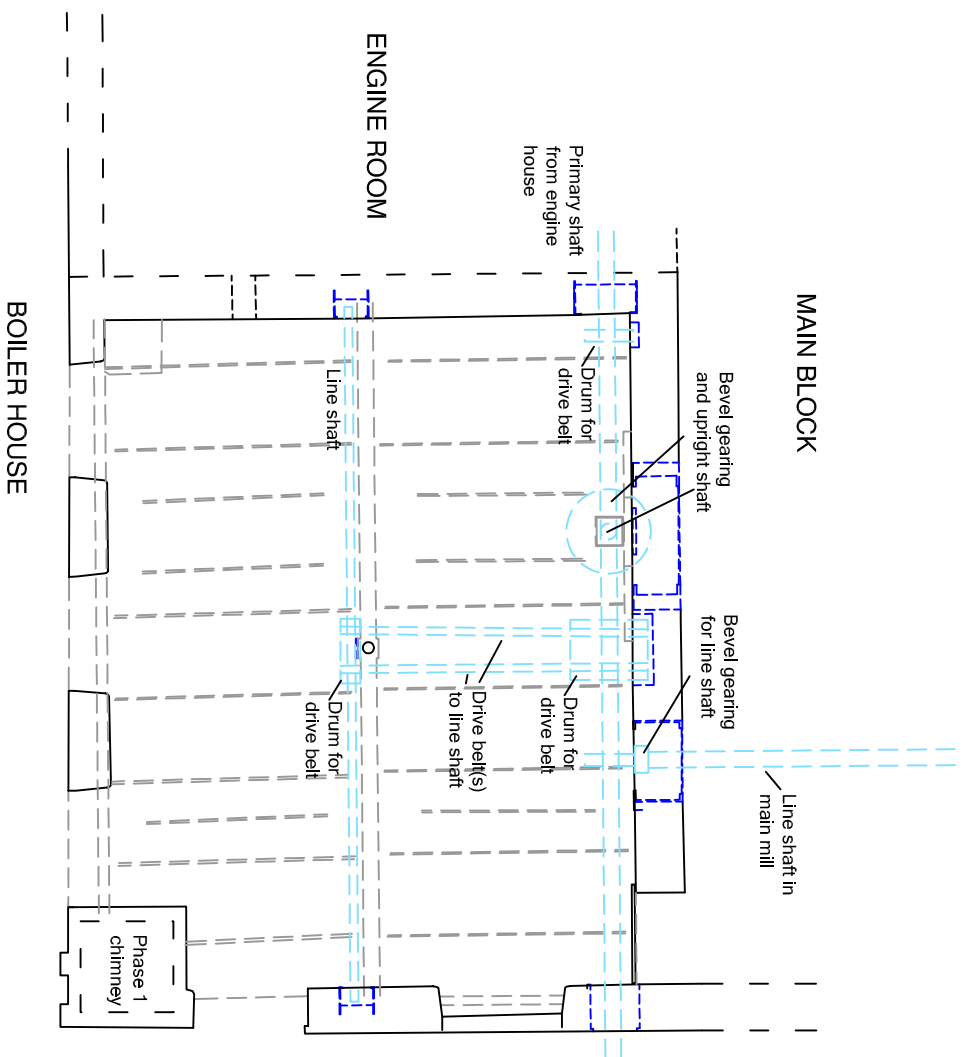
Figure 5: Plan of the power train in the preparation room, on ground floor in the south-west corner of the spinning block

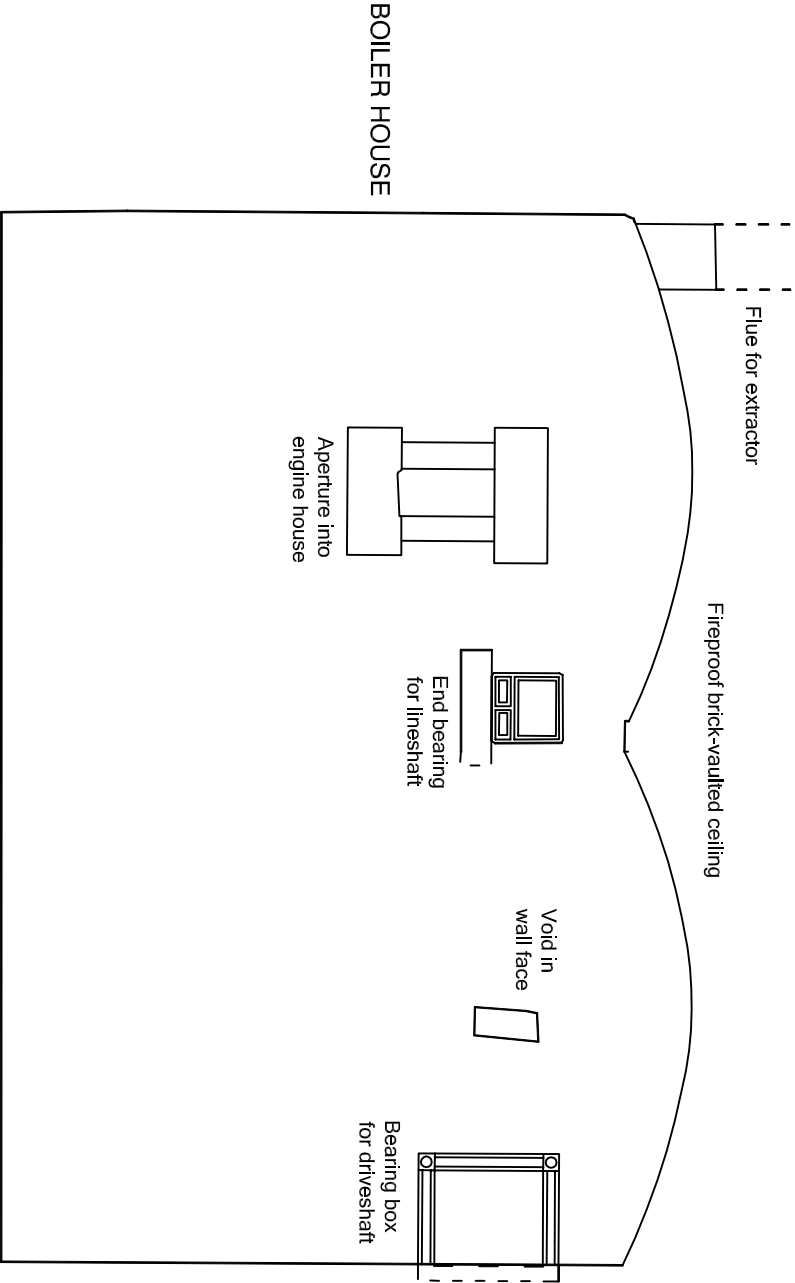
4.3.7 The north elevation contained two further apertures: a housing with a sandstone sill and lintel (Fig 6) for an engine mounting, located in the room to the north; and a larger, 3'6" (1.07m) bearing box, flush with the east elevation (Fig 8; Plate 15), which carried the primary shaft from the engine to the footstep bearing, positioned centrally in the east elevation (Fig 5). Both of these bearing boxes had cutaways within the wall face, for drums on the driveshaft, allowing it to be positioned as close to the wall as possible. Above the footstep bearing mount (Plate 16), a blocked aperture in the ceiling previously housed the upright shaft, distributing rotative power to the upper floors. A further bearing box in the east wall, to the south of the main bearing (Plate 17), would have housed a bevel gear, allowing the rotative power to be transferred

Figure 6: North internal elevation of the preparation room on the ground floor in the south-west corner of the spinning block

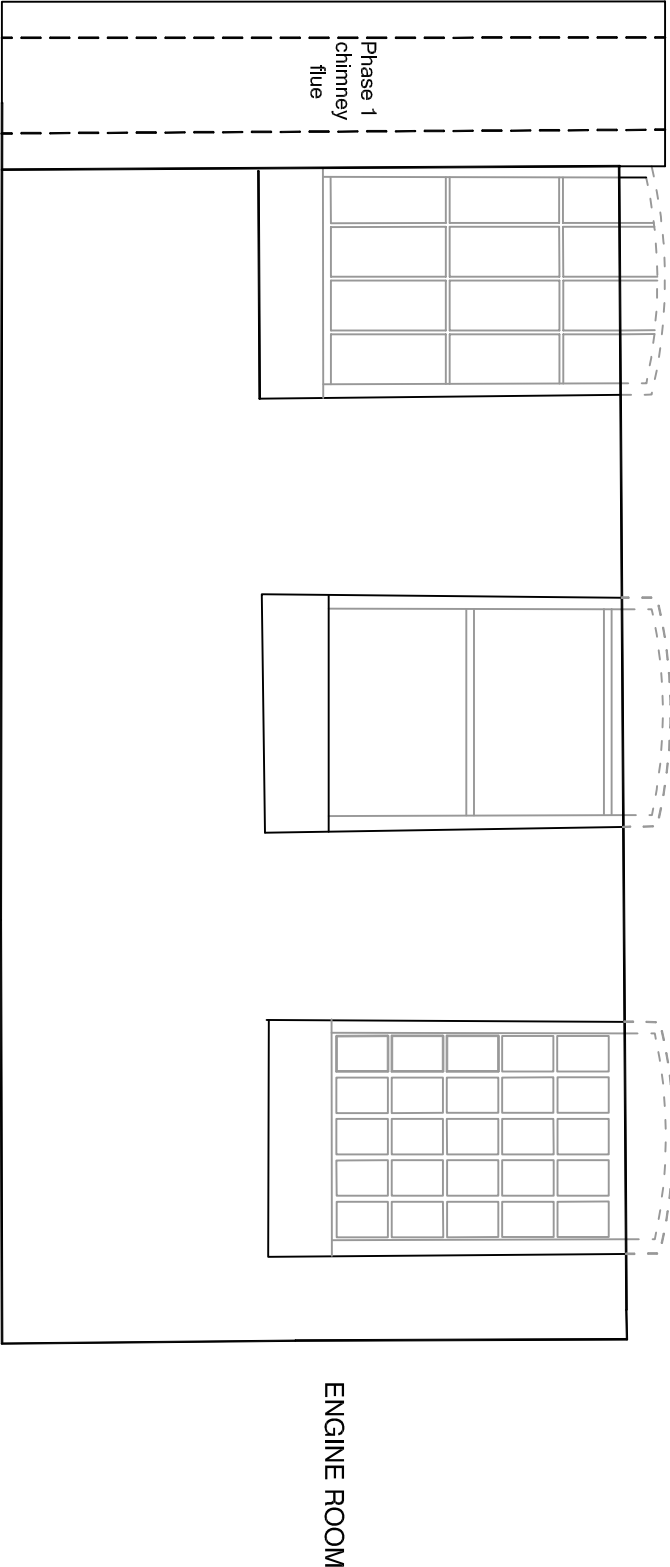
Figure 9: West internal elevation of the preparation room on the ground floor in the south-east corner of the spinning block
