# **Maryport Promenade, Maryport, Cumbria**

## **Archaeological Topographical Survey and Watching Brief**

**Oxford Archaeology North**

November 2008

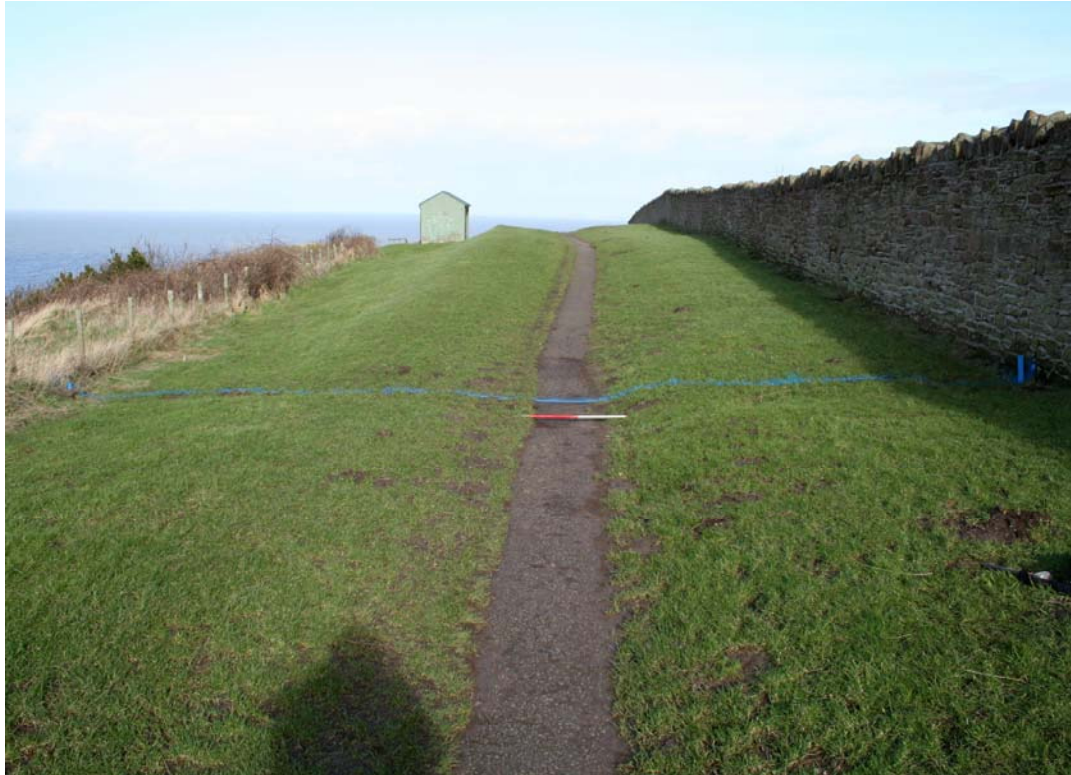
- 3.2.3 The southern limit of the earthworks coincides with a field drain running from the field to the east, over the area of the groundworks and draining down to the west (Plate 1). From discussions with the on-site contractor, Stobbarts Ltd, it was envisaged that remedial sub-surface work was required on the drain but that this would not adversely affect the surface archaeological resource on the alignment of the drain. The northern limit of the earthworks is easily defined by extending the line of a south-east/north-west aligned modern field wall in a north-westerly direction (Plate 2) from the eastern side of the site (Fig 3).

Plate 1: The demarcated southern limit of the earthworks , looking north-east, at the time of the topographical survey

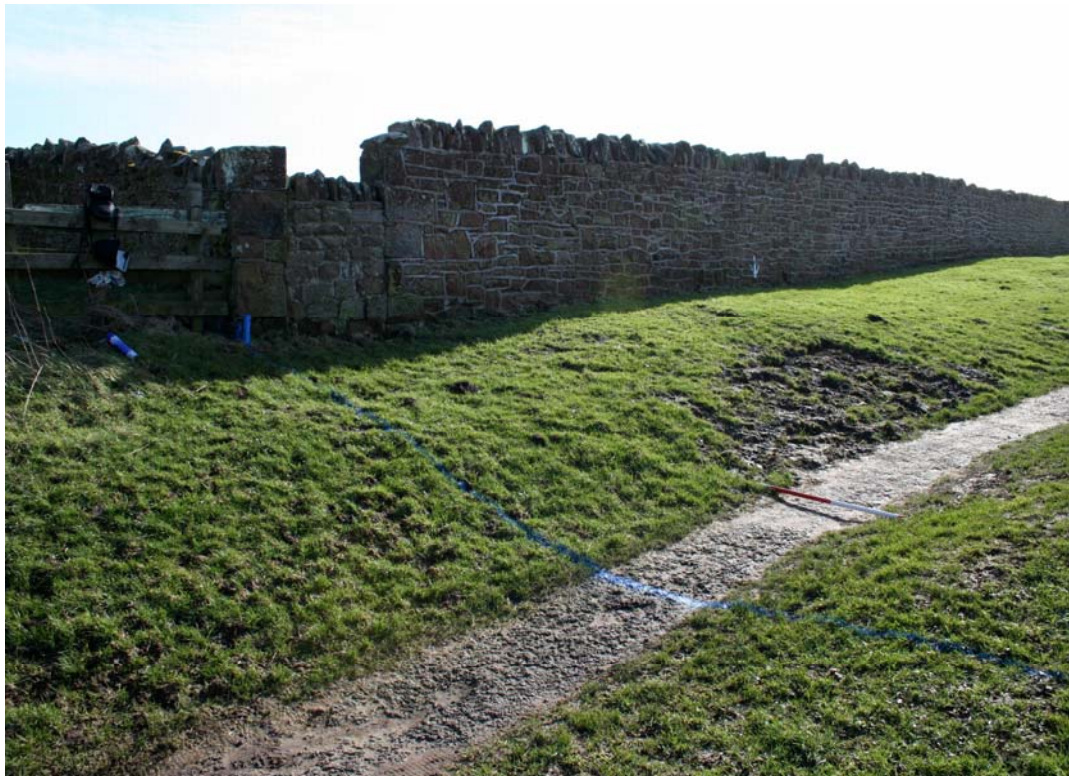
Plate 2: The demarcated northern limit of the earthworks, looking south-east, at the time of the topographical survey

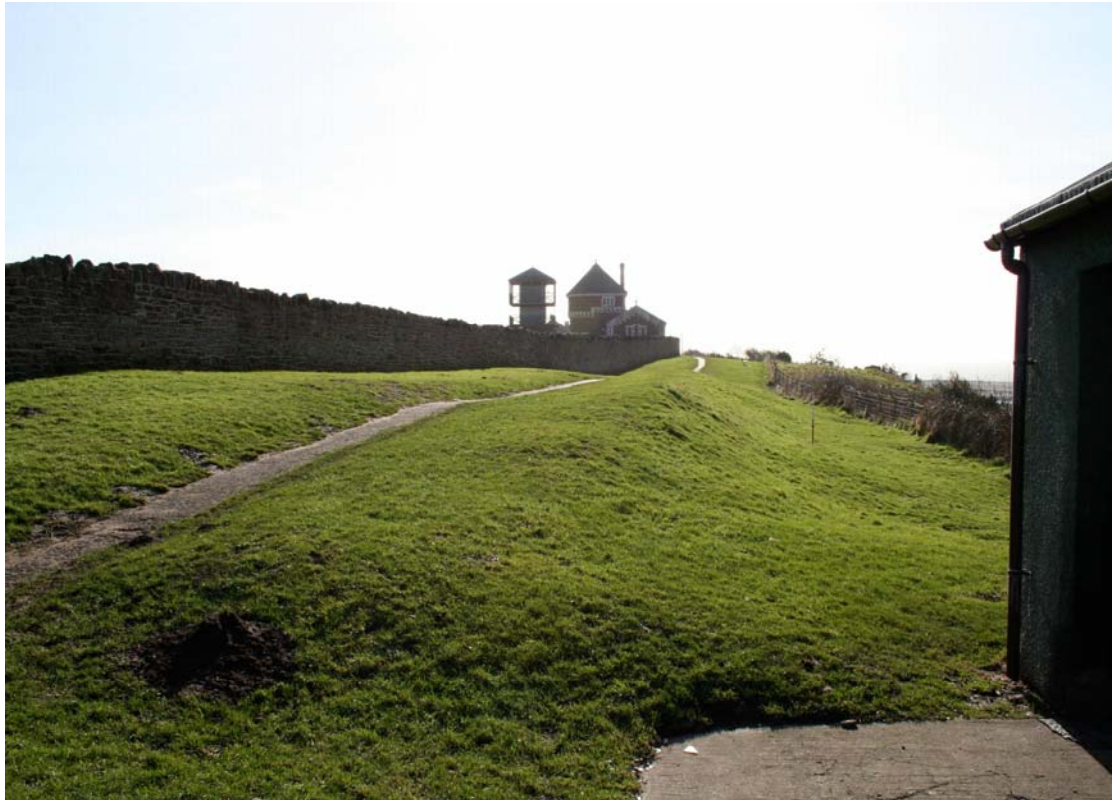
- 3.2.4 The current metalled footpath requiring upgrading crossed the alignment of a large terraced earthwork on the eastern side of the development area (Plate 3). Historically, prior to its surfacing, this well-used footpath had worn a course into the earthworks (Plate 3).

Plate 3: Footpath crossing the terraced earthwork, looking south-west, at the time of the topographical survey

- 4.2.2 The planning condition prohibited any groundwork excavation into the earthworks as demarcated during the topographical survey (*Section 3*, Fig 3), which necessitated a change in the footpath design in this area, to build up the level of the footpath instead within the hollow way that already existed (Plate 3). However, some stripping of turf from the edge of the existing footpath was necessary, and carried out under archaeological supervision. A 2m wide layer of geotextile membrane was laid along the centreline of the existing footpath to protect the archaeological features, and the hollow way built up with the new footpath material to the required dimensions.

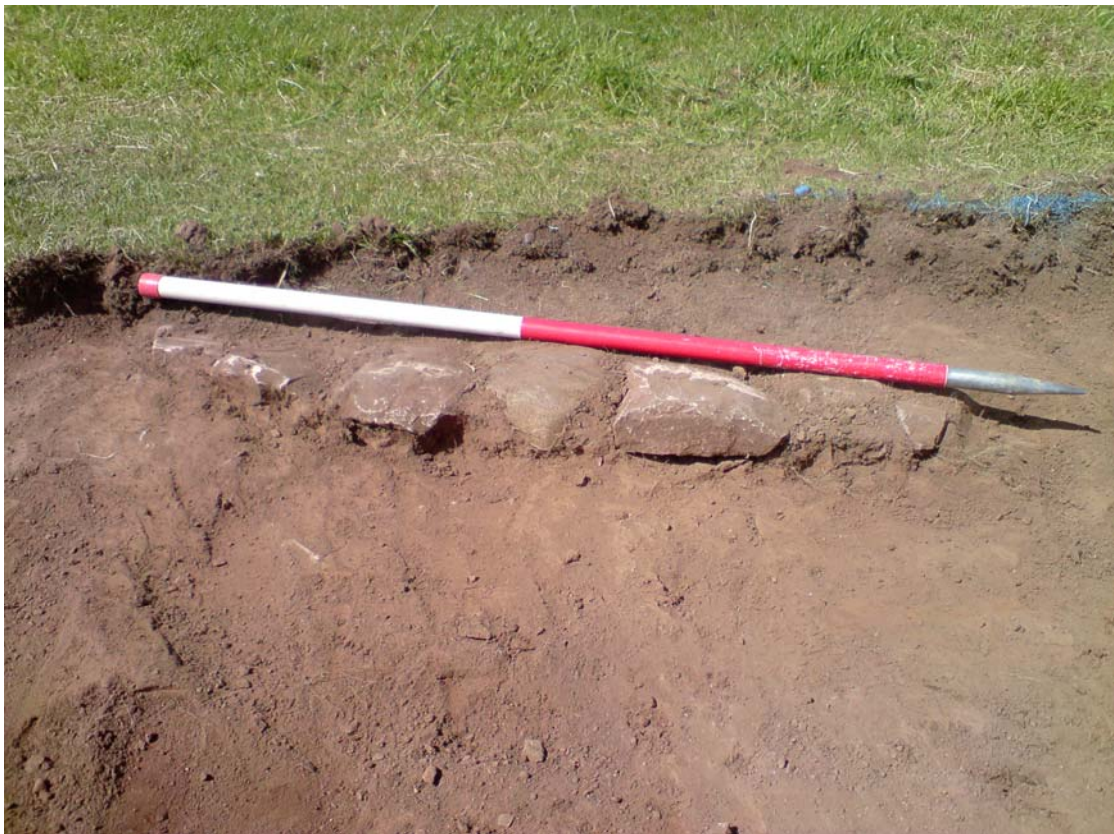
- 4.2.3 The watching brief only noted one archaeological feature, which was a small stone linear running north/south directly beneath the surface of the stripped turf (**1002**). It ran into the area of excavation from the west for approximately 1m. It was only one course high but appeared to be the foundation remains of a boundary wall of probable post-medieval date given its apparent association with the abutment of the ridge and furrow (Plate 4).

Plate 4: Stone linear feature, facing west

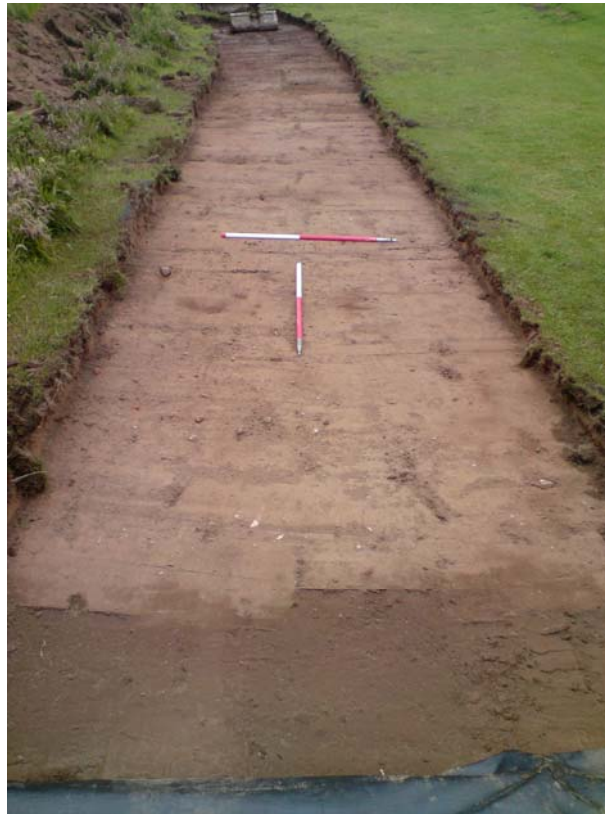
- 4.2.1 The mini-excavator proceeded to remove the topsoil to a maximum depth of 150mm-200mm. The removal of the turf revealed a light reddish-brown sandy-silt (Plates 5 and 6). Lengths of approximately 35m-40m were removed each day in stints of 10m-15m, with a width of up to 2m (see *Appendix 2* for progress schedule).

Plate 5: Section 6, facing south-west

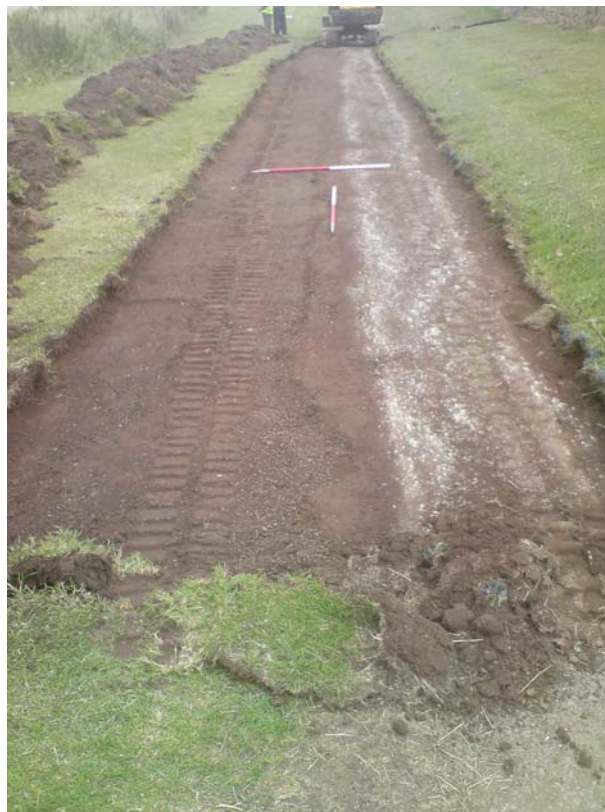
Plate 6: Section 12, facing north-east
