**32-38 Oldham Road,  
Ancoats,  
Manchester,**

**Archaeological  
Building Investigation  
Final Report**

**Oxford Archaeology North**

November 2007

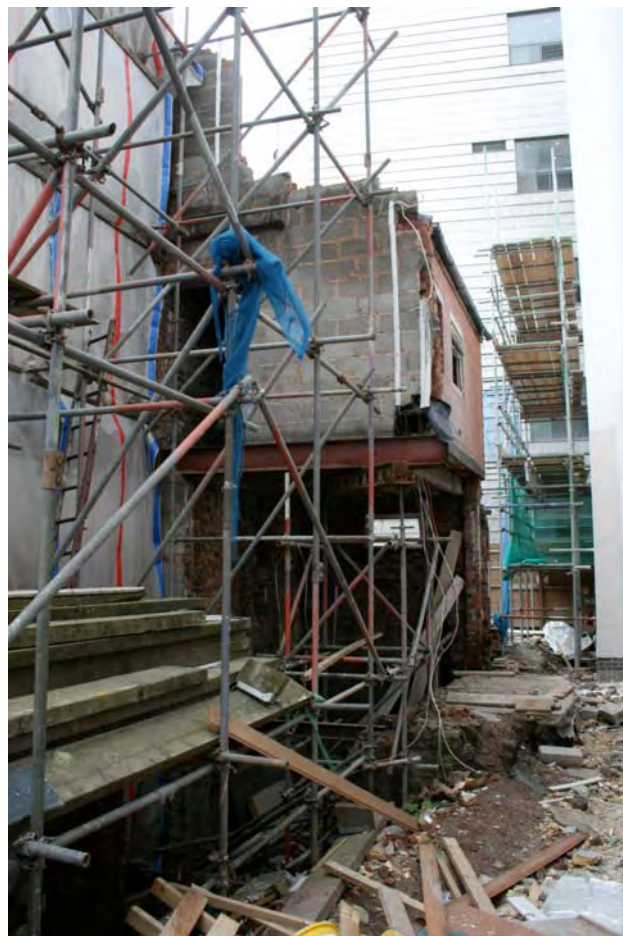
4.1.1 The study area comprised three extant buildings (Nos 34-38), fronting onto Oldham Road (Plate 1) and situated approximately 100m to the east of its junction with Great Ancoats Street (Fig 1). The site of a fourth building (No 32) was also examined, although it had been largely demolished prior to the building survey, and its footprint was obscured by materials associated with the adjacent development; only elements of the rear wall and the party wall to No 34 survived demolition (Plate 2).

Plate 2: No 32 Oldham Road

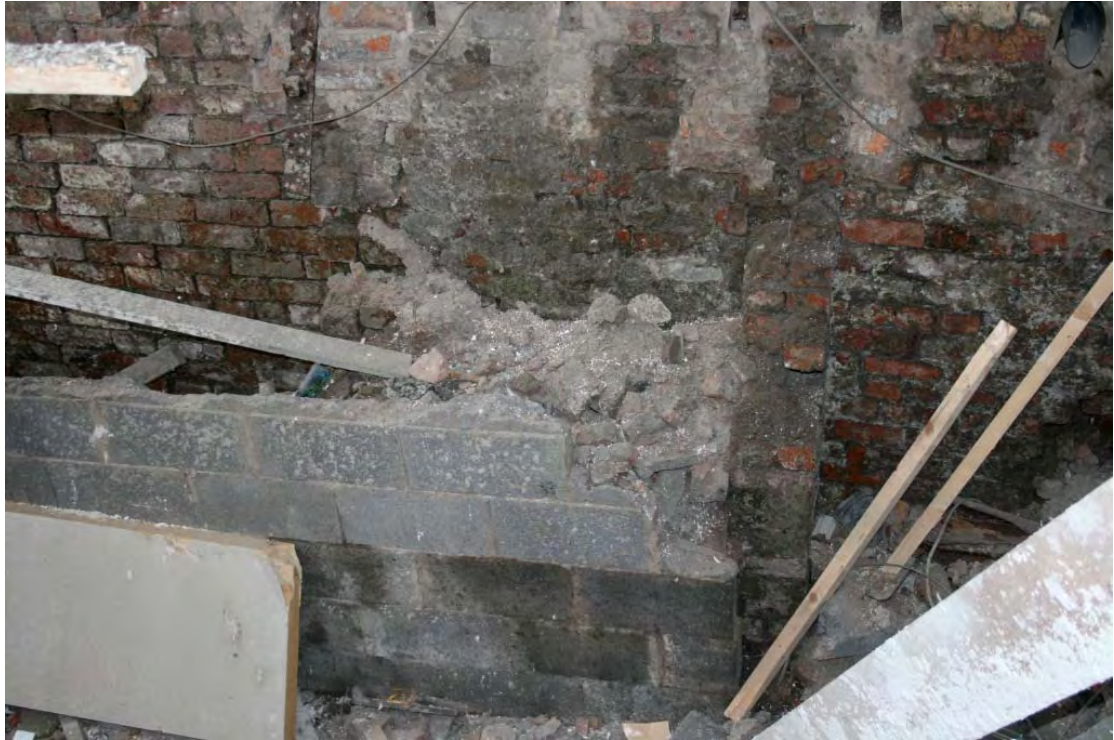
- 4.2.2 **Cellar:** a cellar survived to an observed depth of 1.9m, although rubble infill obscured the floor, which probably lay some 0.2m lower. The remnant of a fireplace chimney breast survived within the cellar (Plate 3), 1.07m (42") from the south-eastern end of the wall. The breast walls were a single-brick thick, projecting 15" (0.38m) from the wall face, which was obscured by a low clinker-block wall. It measured 4'9" (1.45m) wide, housing an aperture 3'3" (0.99m) wide. Whilst the fireplaces above had been removed, wall scars of broken and mortared bricks in corresponding positions at ground and first floor level were clearly visible (Plate 4), providing evidence for hearths on each floor; these fireplaces were seemingly original features. The level of the ground floor was represented by 11 sockets for floor joists, each typically 8" x 3" and a single-skin deep (Plate 4).

Plate 3: Fireplace within cellar, 32 Oldham Road

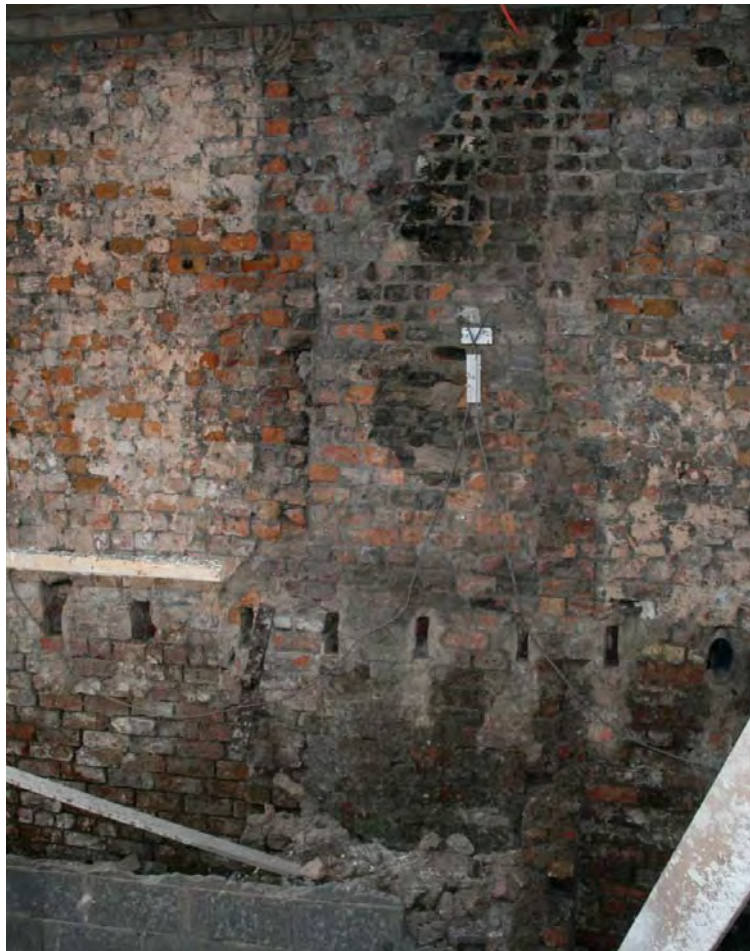
Plate 4: Floor joist sockets and fireplace scars, 32 Oldham Road

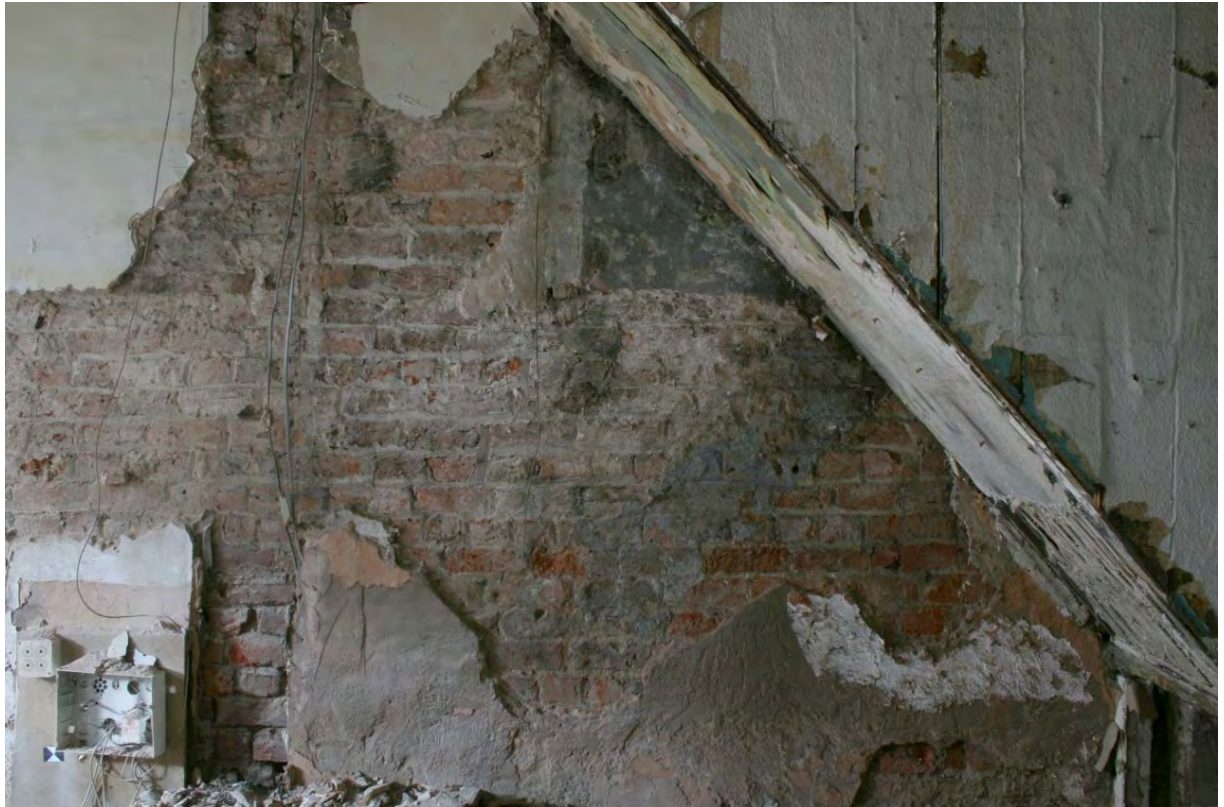
- 4.3.10 The north-east wall retained evidence of the original cross-wall, 4.2m from the front wall (Fig 10). This only survived from 7' (2.13m) above the floor, in the form of broken brick within the wall face, above a sawn-through timber. These represent the return of the wall, where it was keyed into the long elevation, with the timber being the stub of a lintel of a doorway in this position, also explaining why no evidence for the wall survived lower down the wall. A blue paint scar, 0.28m wide, surviving beneath the wall plaster, representing the position of the original staircase, on the opposite alignment to those now present (Plate 7). The angle appeared similar (43°), but the stairs were orientated to the front of the building, accessed through the doorway at the eastern end of the cross-wall, identified immediately to the north. The present stairs are presumably contemporary with the plastering of the wall, which required the removal of the earlier stair, the direction reversed, with a quarter-turn of winders near the base affording access, whilst conserving room size. The staircase is of timber construction, with the stair wall comprising vertically set planks on a timber stud partition, which may originally have been infilled with lath and plaster, in a similar fashion to that *in-situ* on the underside of the stair. The scar of a partition was revealed on the plaster wall, marking the extent of a former under-stairs cupboard (Plate 7).

Plate 7: Wall scar of original stairs and later partition, 34 Oldham Road

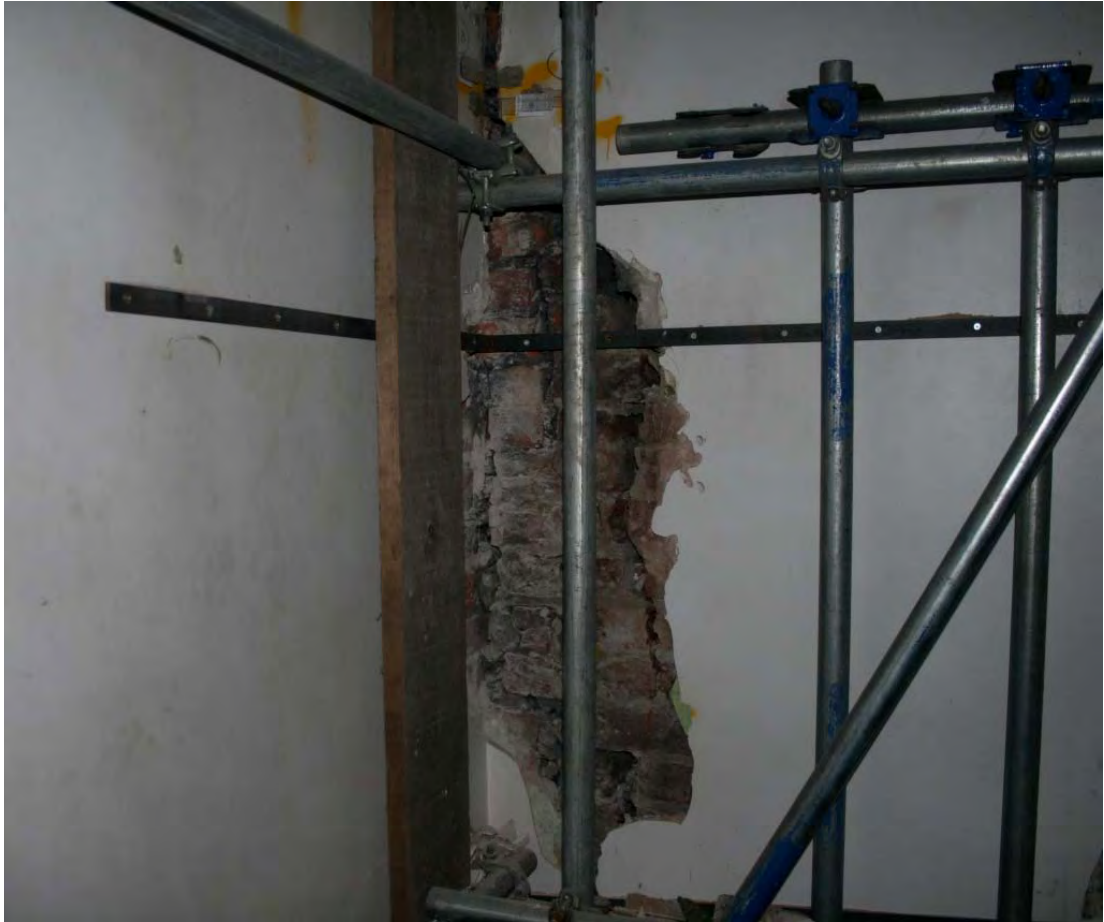
- 4.3.12 **First floor:** the first floor was in poor condition at the time of the survey, with significant deterioration of the floors and ceiling, particularly in the northern of the two rooms. The walls are plastered, as below, with ½" (13mm) of horse-hair-rich lime plaster, covered with a skim of finishing plaster in the late 20th century. Little access was possible into the northern room, although it was easily identifiable that the front elevation was not keyed into the side walls, with large cracks visible (Plate 9).

Plate 9: Rebuilt facade (left) butting broken end of original wall, 34 Oldham Road

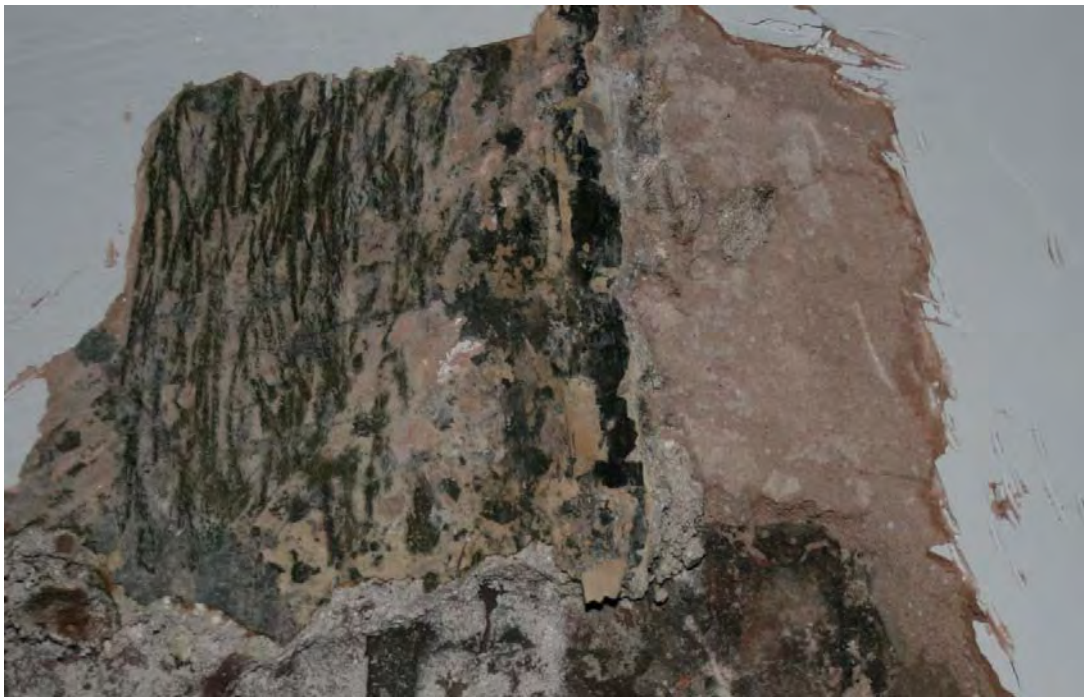
Plate 10: Straight joint between early plaster around chimney breast and late mid-brown plaster, 34 Oldham Road

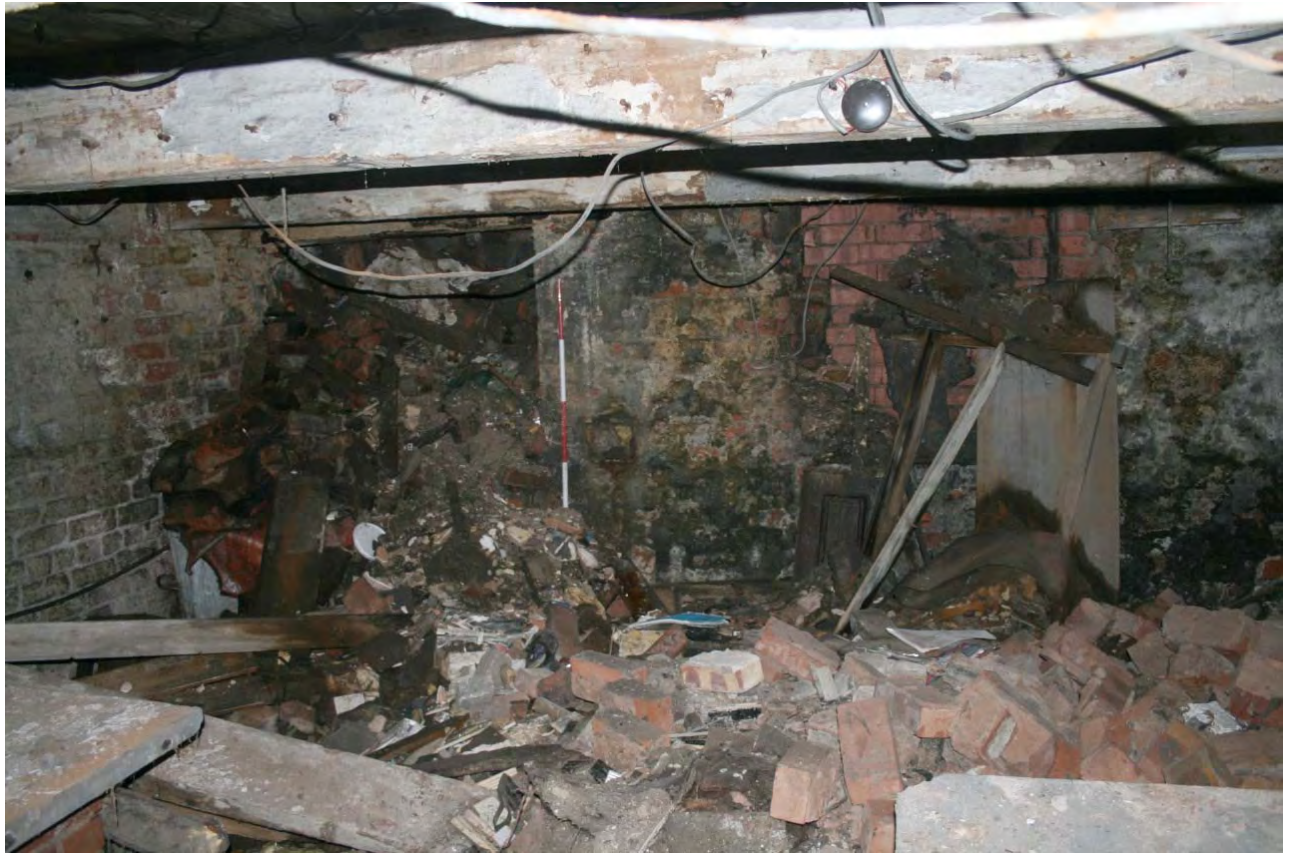
- 4.3.6 A 4'5" (1.35m) wide doorway, which was heavily white-washed, afforded access into the rear cellar of No 34 Oldham Road, but this was also completely filled with rubble (Plate 13). A remodelled and subsequently blocked window to the west provided the original light source for the cellar, although it remains unclear as to whether the cellar was partitioned in a similar manner to the rooms above. Only putative evidence of such a partition was observed in the north-east wall, 0.8m to the south of the blocked doorway (Fig 9), comprising several broken headers and voids in the wall face. However, the wall was also heavily whitewashed, disguising any clear relationships.

Plate 13: Rear of cellar, 34 Oldham Road

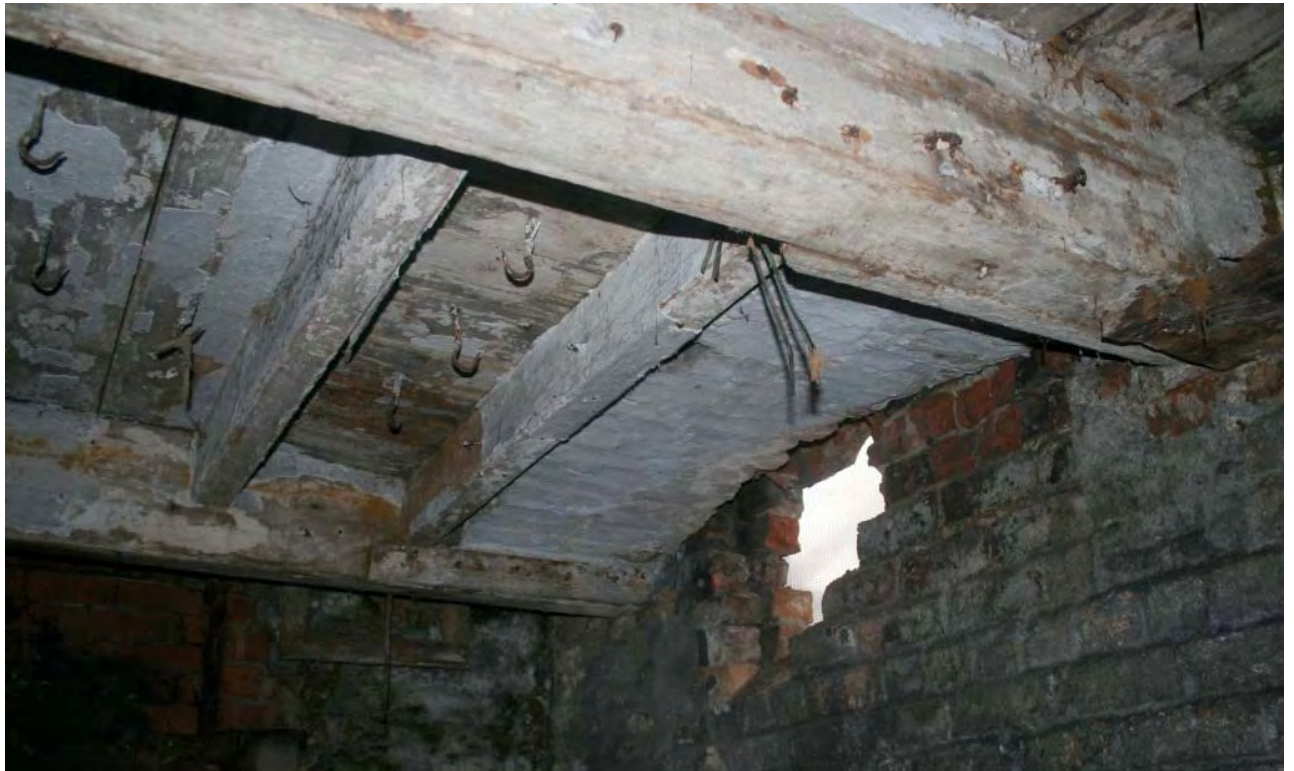
Plate 14: Brick vault within cellar, 34 Oldham Road

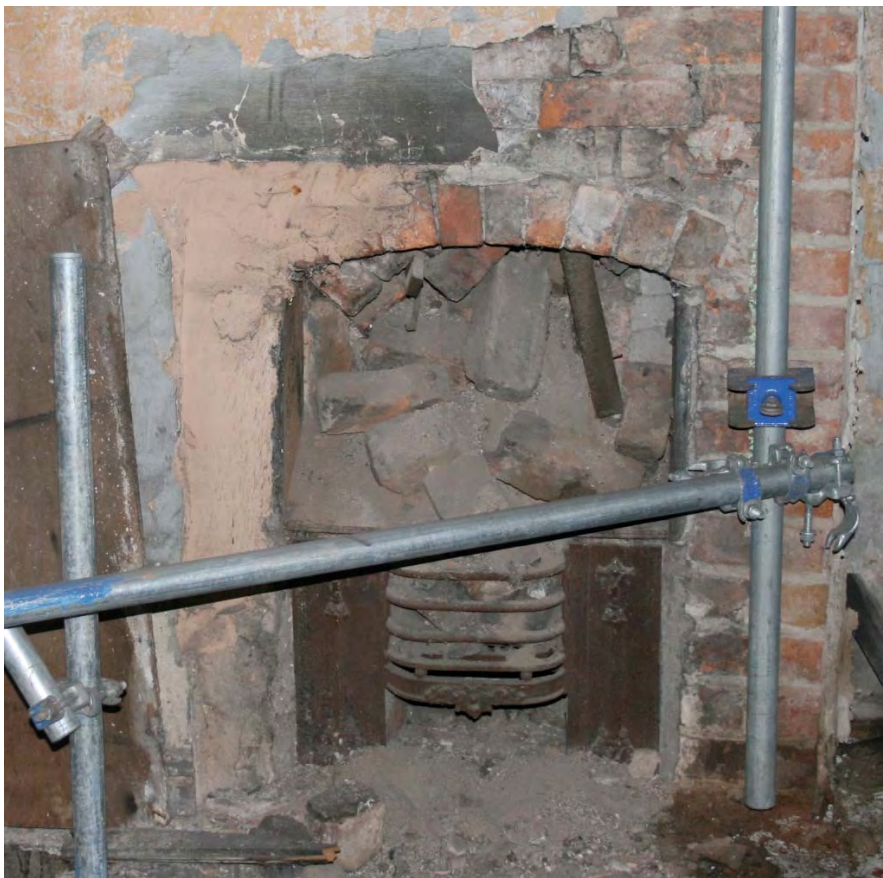
Plate 22: *In-situ* decorated fireplace, second floor, 36 Oldham Road

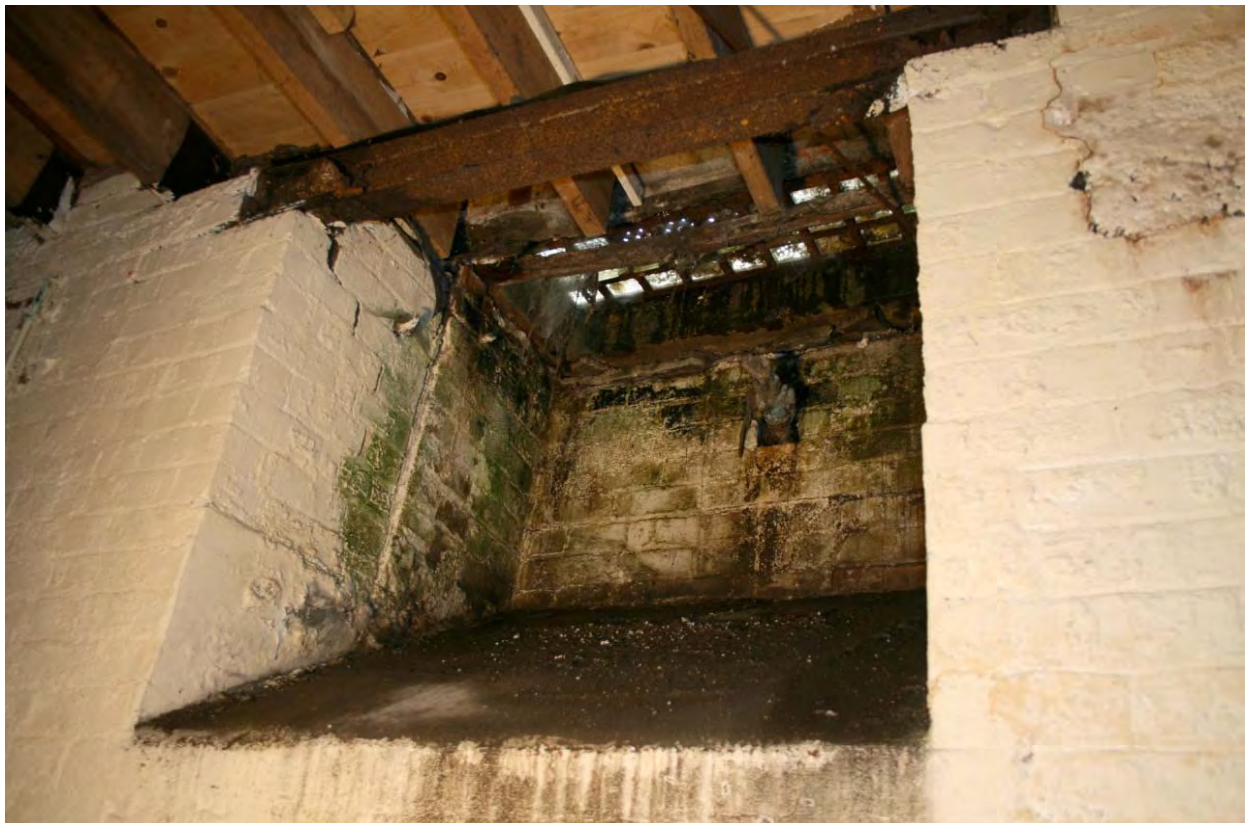
- 4.5.2 **Cellar:** the basement is open plan, with two cellar lights, each with rebuilt surrounds to the pavement (Plate 30), and with glass tile infilling of the pavement grates. The stair walls are continuous into the cellar, and are bullnosed (Plate 31). The floor above is carried on longitudinal joists supported on I-section steel beams of 7 x 4" (0.18 x 0.10m) section, supported on 5" (0.13m) diameter hollow cylindrical-section columns (Plate 31), each with an astragal below the cap, which clasps the beam (Plate 32). These are positioned at the mid-span of each beam, with the northern example being offset to the west, as the beam is supported at its eastern end by the stair wall.

Plate 30: Remodelled pavement light, basement, 38 Oldham Road

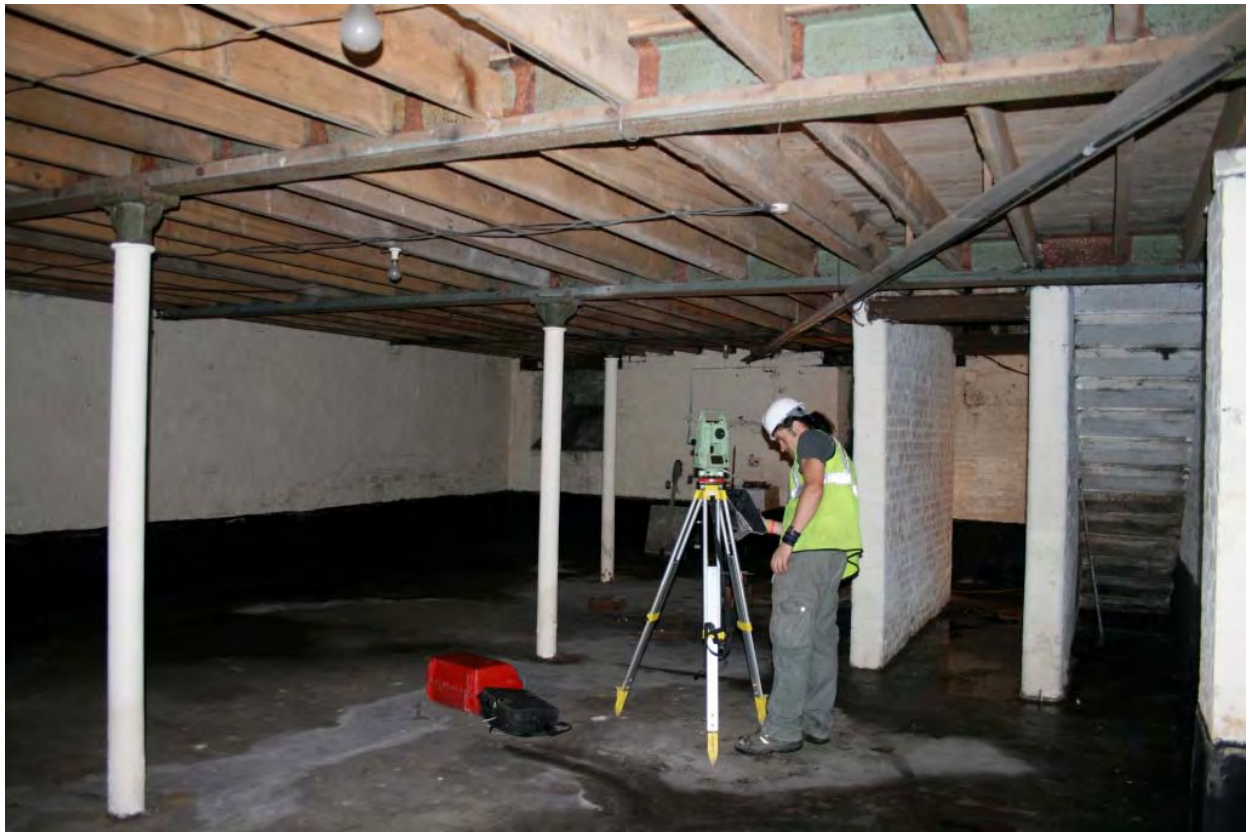
Plate 31: Stair walls and columns, basement, 38 Oldham Road

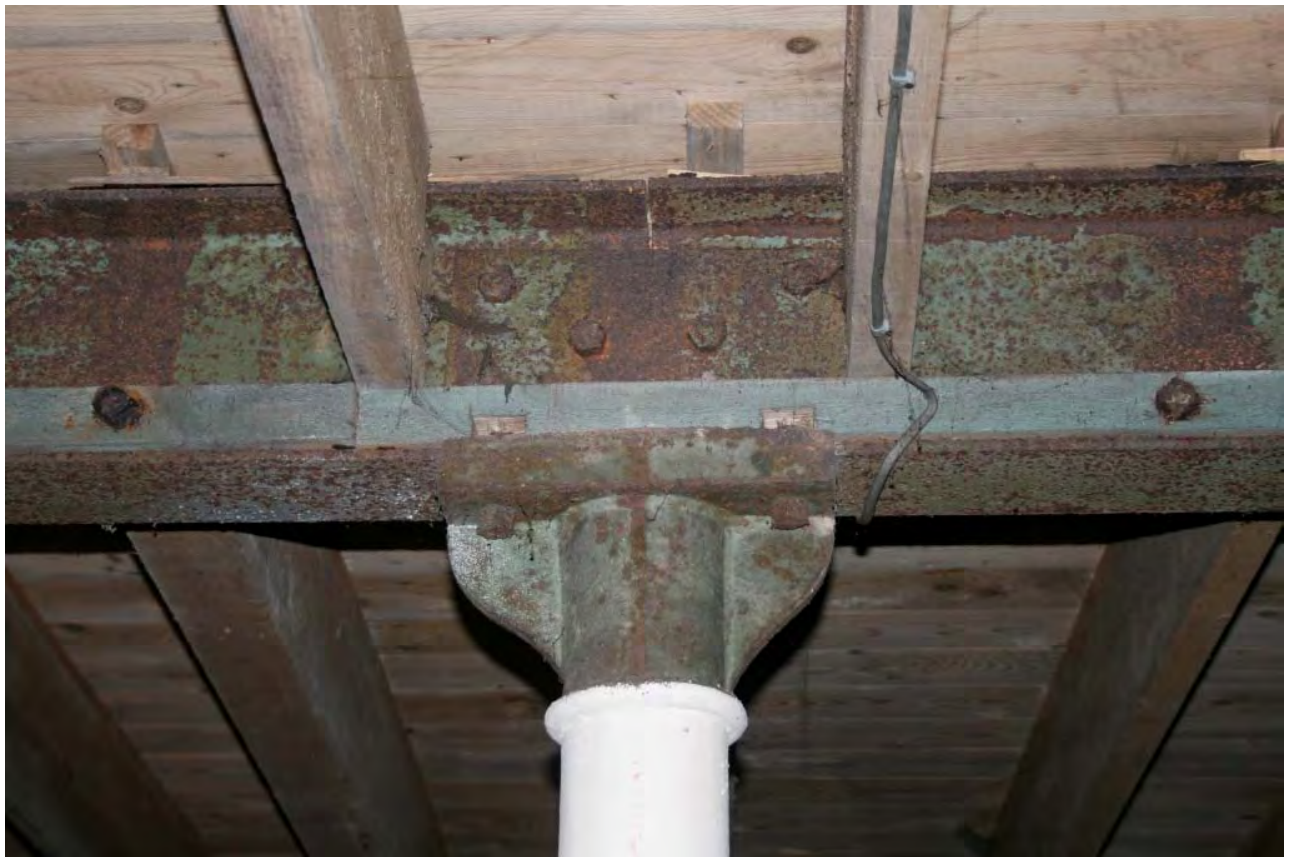
Plate 32: Column cap detail, basement, 38 Oldham Road
