# SOLWAY COAST CLUSTER, CUMBRIA

## Archaeological Evaluation

**Oxford Archaeology North**

**United Utilities**

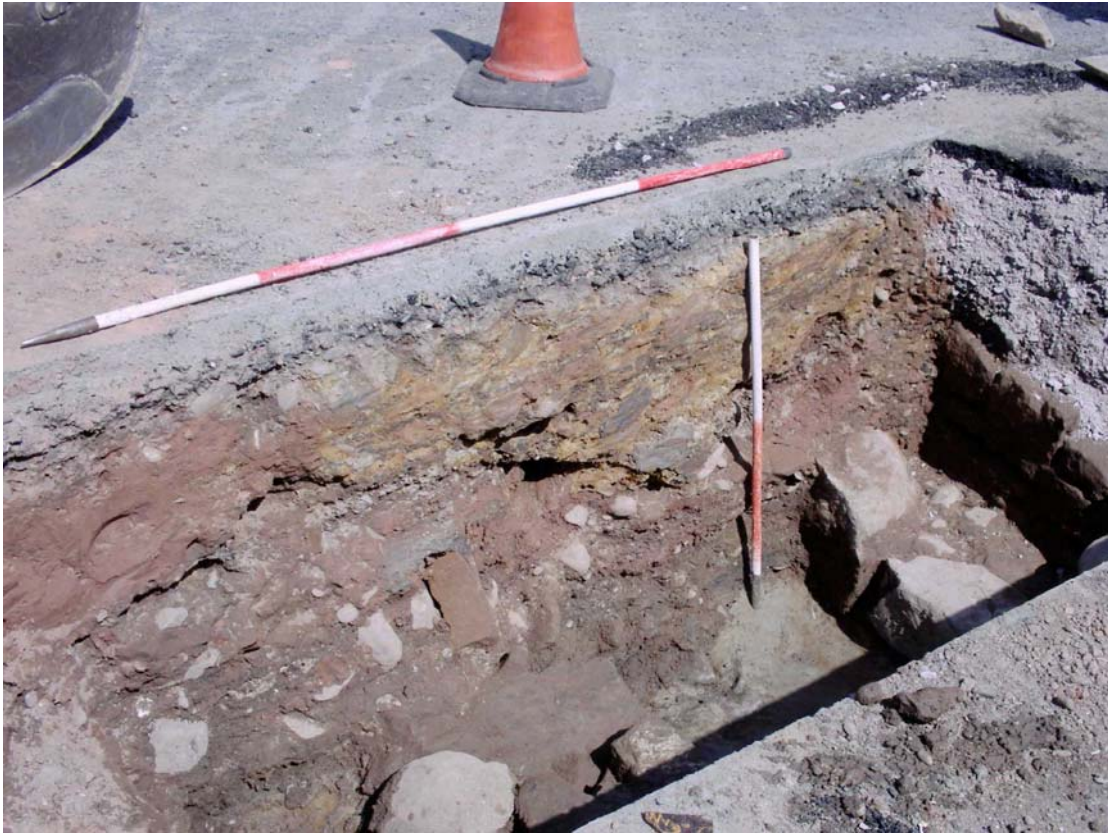
Plate 7: South-facing section of Site A, Trench 2 (east), showing remains of stone-lined culvert *738/739*

- 4.1.6 **Copper-Alloy:** a single heavily worn and patinated copper-alloy coin was recovered during the course of the evaluation, from the area adjacent to culvert **738/739** in Trench 2 at Site A. The coin has been identified as a radiate copy of Claudius II (AD 268-70), probably minted in the AD 270s/280s, although its worn condition suggests that it remained in circulation for some time. Coins of Claudius II seem to have had a relatively enduring circulation, probably because the great fourth century emperor Constantine I (d. AD 337) claimed Claudius (falsely) as an ancestor (D Shotter *pers comm*).

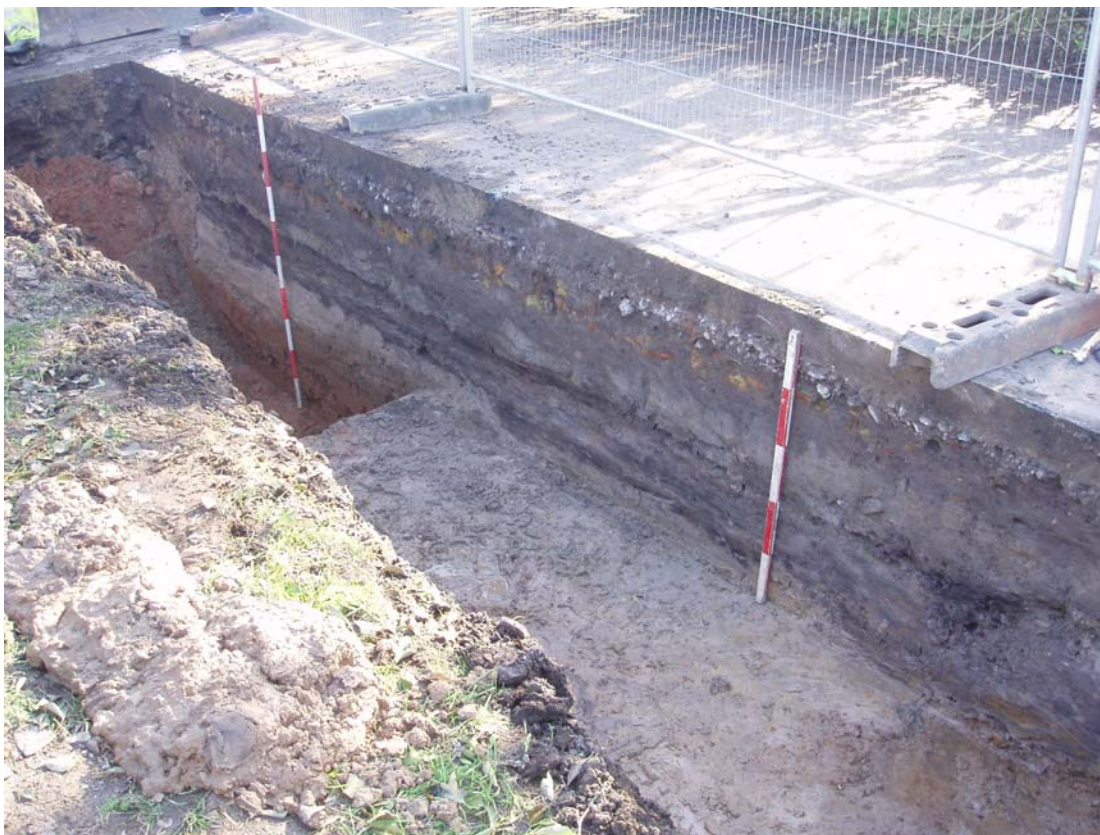
Plate 12: North-east-facing section within trench extension, Site D, showing possible spread material derived from the Turf Wall

character of these deposits, however (Plate 12), and their location, precisely on the projected line of Hadrian's Wall as shown on modern mapping, it is possible that they represented the remains of the Turf Wall, surviving to a height of *c* 0.25m. As built, the Turf Wall was *c* 6m wide at the base (Breeze 2006, 58), but the remains at Site D extended north-west to south-east for at least 8m. This discrepancy may have been due to subsequent levelling and spreading of the Wall material, either in antiquity (perhaps when the Turf Wall was replaced in stone), or as a result of more recent agricultural activity, and to the fact that the trench cut obliquely across the projected line of the Wall.

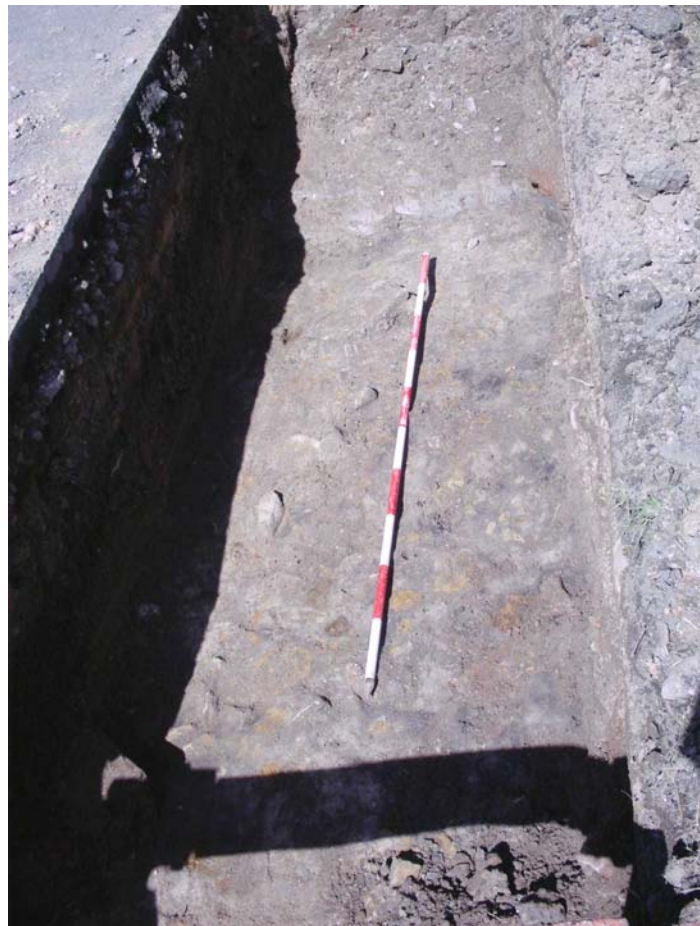
Plate 14: Site E, Trench 1, showing crushed sandstone layer *501*, looking north-west

- 5.1.9 **Site E:** a layer of crushed sandstone, **501**, was found at the base of the trench at this site, directly overlying the natural subsoil. It appeared to form a low bank just under 8m wide and 0.24m thick, and has been interpreted as the probable

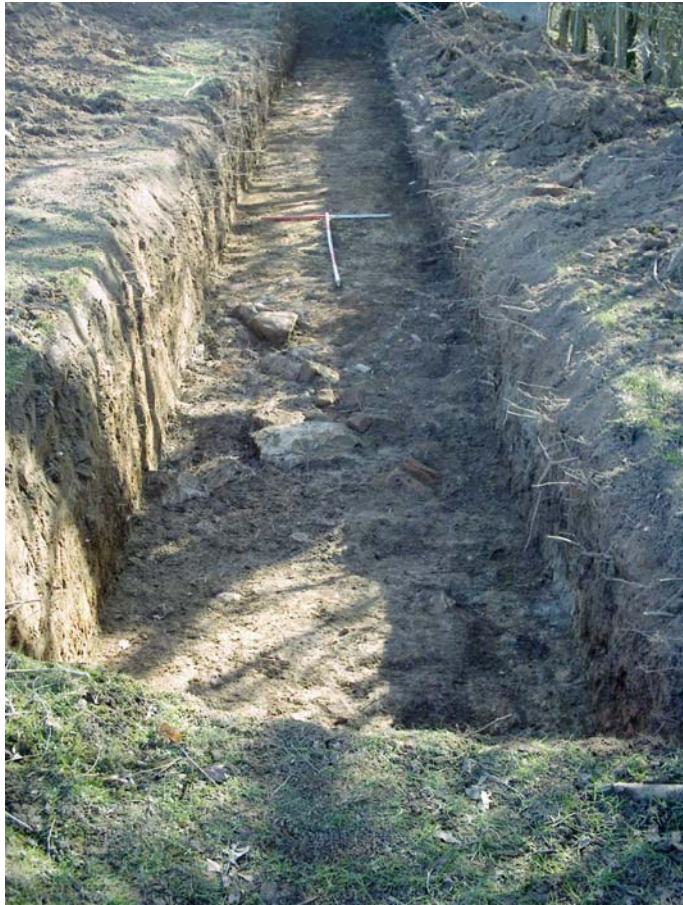
Plate 16: Site G, Trench 1 showing stone feature *302*

- 5.1.10 **Site G:** a roughly linear spread of sandstone boulders, **302**, was observed at Site G. This deposit was aligned roughly east to west and lay only a few metres north of the projected line of Hadrian's Wall as shown on modern mapping. It is therefore tentatively interpreted as the remains of the Stone Wall foundation. However, Site G also incorporated the edge of the embankment of the disused railway, represented by context **303**, which directly overlay **302**, so it is conceivable that the boulders also formed part of the embankment make-up, which is known to date from the early 1850s. A linear feature, **316**, running along the western edge of Site G is thought to have been associated with the construction of the canal, which was opened in 1823.

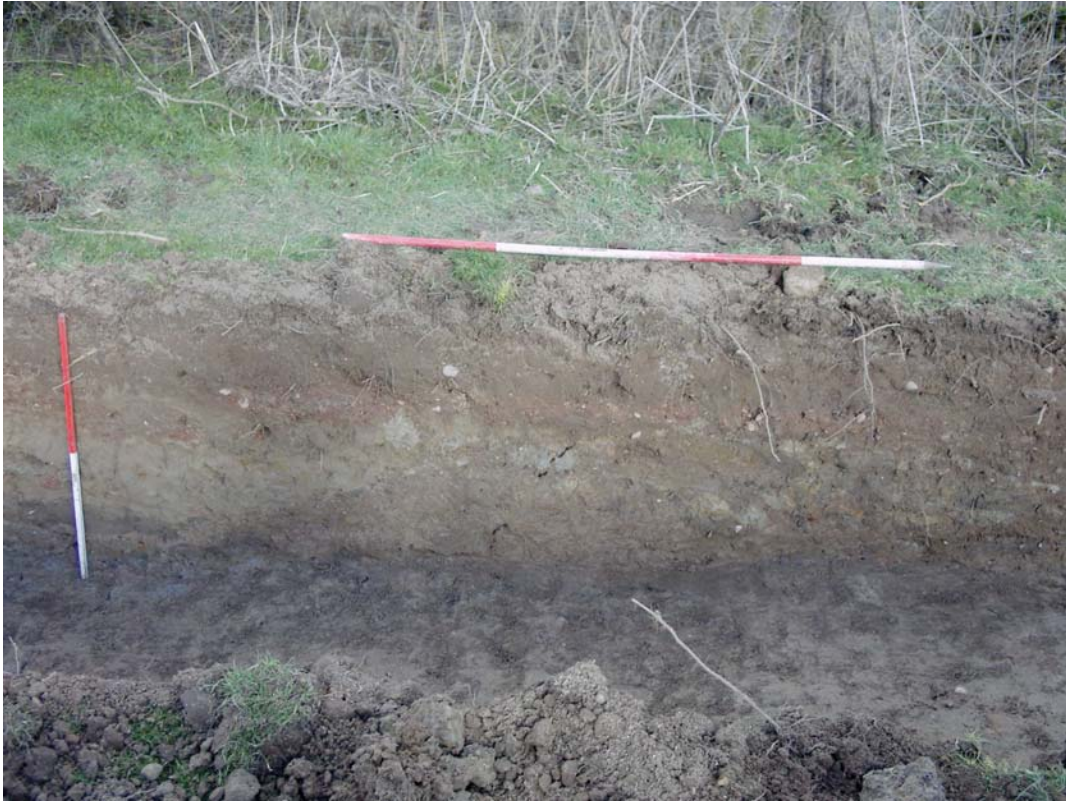
Plate 19: South-west-facing section of Site I, Trench 1 showing embankment make-up layers *401-407*

- 5.1.11 **Site I:** Site I was located partly on top of the disused railway embankment between Glasson and Drumburgh and partly within the highway. Trench 1 revealed dumped deposits associated with the construction of the embankment, but few other deposits of note were recorded. Although the site traversed the projected line of Hadrian's Wall, no trace of the Wall was found.

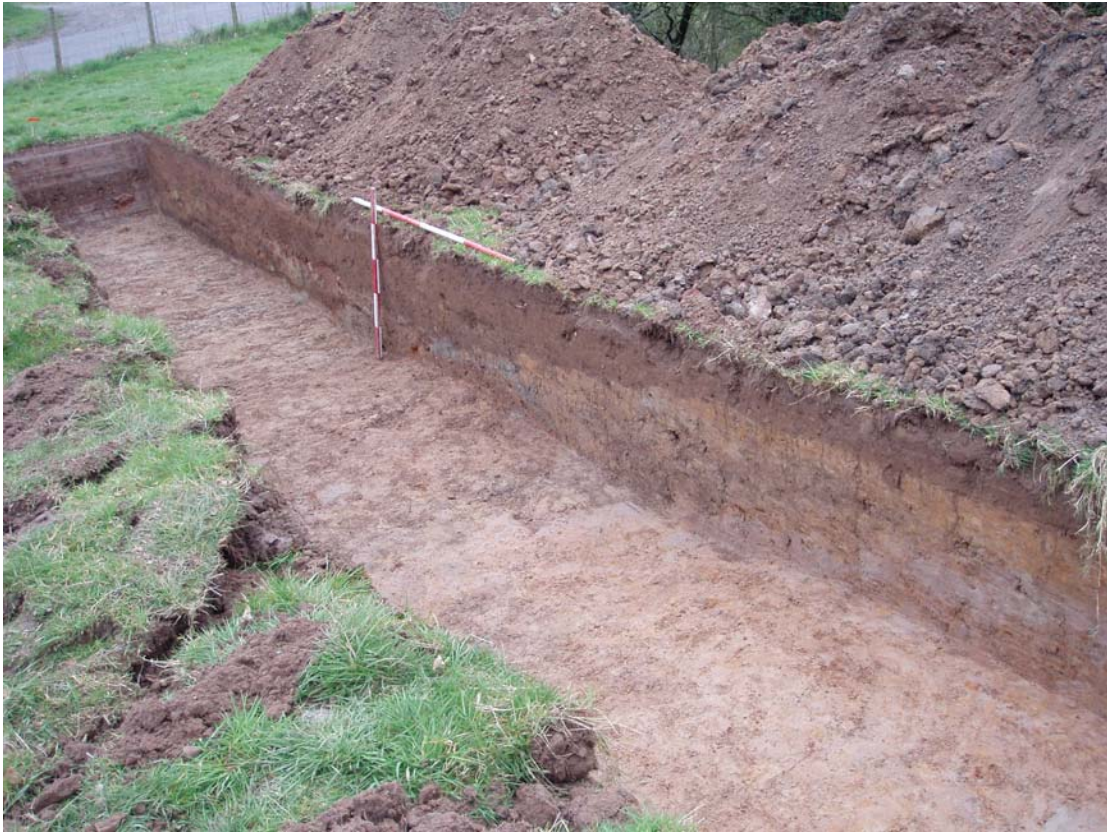
Plate 21: North-east-facing section within trench extension (Site I), showing possible road deposits *413*, *414* and *415* beneath later levels *411* and *412*

- 3.5.5 Sealed below deposit **413**, was a layer of pale yellowish-grey, mottled - possible gleying - clay, **415**. This deposit sloped downwards to the south-east and, together with layers **413** and **414**, might possibly have filled the edge of a pond (Plate 21). Natural drift geology, in the form of a pale yellowish grey clay, **416**, was glimpsed at the north-western end of the trench. No evidence for Hadrian's Wall was observed within the trench.
