FORMER PYE'S WAREHOUSE Lancaster

Building Survey Report

**Persimmon Homes
(Lancashire) Ltd**

Document Type: Building Survey Report

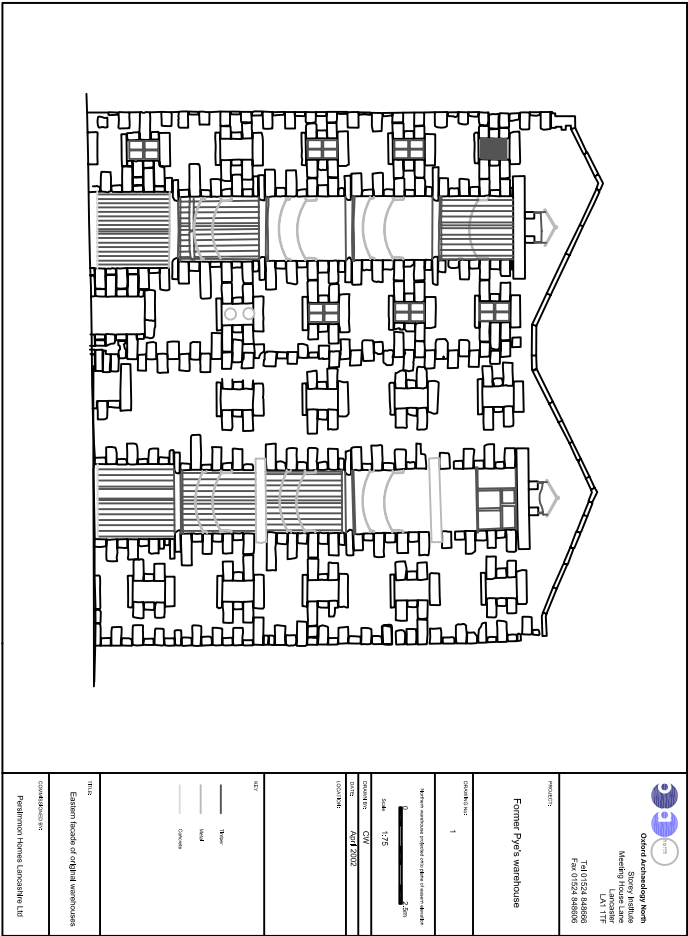
Figure 2: Eastern facade of original warehouses

- 4.1.2 **Eastern elevation:** the eastern elevation fronted onto the quayside and comprised two contemporary five-storey warehouses, most probably of early / mid nineteenth century date. Both were constructed of roughly-dressed and squared coursed yellow and pale pinkish local sandstone. The northern warehouse is significantly wider (8.8m compared to 6.6m) and was canted slightly to the west, following the bend in the road. The junction between the two warehouses was dressed with quoins moulded to span the angle. Each of the five storeys originally had a central doorway with apertures either side, all dressed with quoins. Both gables are capped with projecting flagstone copings, the southern being higher, and with the apex offset slightly to the south.

- 4.1.3 Above ground floor level, the two warehouses were of similar style. Each had full height central doorways to each storey, with only the boarded floor projecting to the wall-face, supported by simple convex stone corbels. The original loading doors were flush with the internal wall-face and survived in all but the upper northern doorway (where it had been infilled with a metal frame and partly glazed in the twentieth century). Each comprised double batten doors, inward opening, with a double safety chain externally across the doorway. The doorways of the upper floor had large sandstone lintels below central projecting hoists, each supported by a pair of projecting convex corbels, and with moulded timber cover above. The hoist of the northern warehouse appeared to be *in-situ* at the time of the survey. Each floor had a four-light window either side of the central doorway, with projecting sandstone sills, and flush sandstone lintels, the tops of which were aligned with the base of the doorway corbels supporting the floor above. The upper southern window of the southern warehouse had been replaced with timber slat vents, probably in the early twentieth century, and the first floor northern window of the same warehouse was blocked with concrete and housed two mid-twentieth century fire alarm bells.

- 4.1.4 The ground floor of each warehouse had a slightly wider central doorway, with similar windows to those above on the southern side of the south doorway and the northern side of the north doorway. To the north of the southern doorway was a man door, lower than window height, probably giving access to a stair down to the cellar. This was later blocked with similar stones to those used in the construction of the main wall. A lintel was observed at present ground level, directly below the southern window, and of similar style. It most

probably represents the visible remains of a similar window to those above, providing natural light to the cellar of the warehouse. It became blocked as the road was widened up to the external wall of the warehouse. A similar lintel was also observed to the north of the northern doorway. To the south of the northern doorway, immediately north of the angle between the two warehouses, was an aperture at ground level, 1.5m high. It was of similar construction to the windows, with flush sandstone lintel, but was slightly wider. It was unclear whether it continued below ground level into the cellar, as the area was obscured by a modern kerb, and the aperture blocked with cinder block; it is probable that the aperture represents a small loading door into the cellar from the quayside.

- 4.1.5 The valley between the two warehouses was drained down the eastern side via a cast iron downpipe. Much of its length had been replaced during the twentieth century, but the basal 0.75m survived in the original cast iron, recessed flush with the wall-face for the lowest 0.65m, and probably continuing below present ground level. At the valley top the drain projects through an aperture within the extended façade, which continues to the same height as the north elevation.
