# Flood Alleviation Scheme Ascott-underWychwood Oxfordshire

Archaeological
Watching Brief Report

# Flood Alleviation Scheme Rear of 36 Shipton Road, Ascott-under-Wychwood, Oxfordshire

# ARCHAEOLOGICAL WATCHING BRIEF REPORT

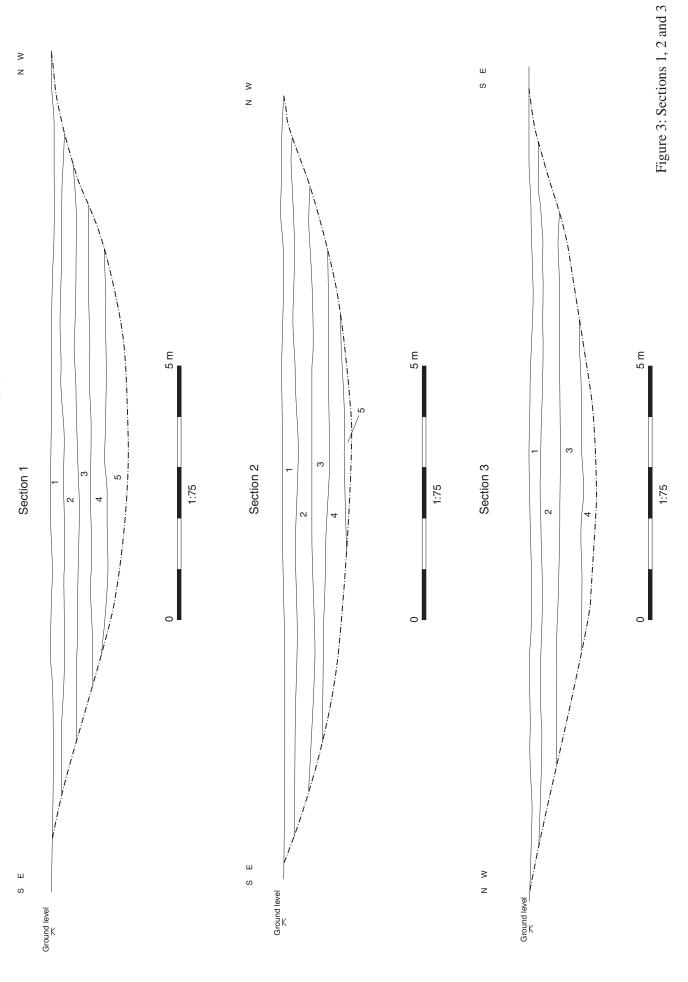
- 3.1.1 This work involved the stripping of the topsoil over a 16 m wide strip for a length of approximately 100 m (Fig. 2) and the excavation of a gently sloping ditch, measuring up to 1.3 m in depth and spanning the full width of the stripped area.

- 3.1.2 The topsoil strip exposed a sequence of layers of modern made ground directly overlying the natural clay.
- 3.1.3 The underlying lias clay (5) was encountered at a depth of between 1 m and 1.1 m below the current ground level (Fig. 3, Sections 1 and 2). This was overlain by a layer of light grey-brown silt clay up to 0.3 m in depth (4). This deposit produced fragments of brick, concrete, tarmac and various modern iron objects including the flattened remains of an Austin A30 car. Overlying this was a 0.25 m - 0.3 m deep layer of grey-brown silt clay (3). This deposit contained quantities of concrete, angular brick fragments and lengths of iron piping suggesting that it also was of recent origin.

- 3.1.5 At the southern end of the swale excavation the depth of made ground increased and the underlying natural clay was not exposed within the base of the cut (Fig. 3, Section 3).

This was sited between the north-eastern edge of the swale and the railway 3.1.6 embankment (Fig. 2). The area measured approximately 25 m by 10 m and was stripped to a maximum depth of 0. 25 m.

- 3.1.8 This was sited abutting the garden of The Barn House, adjacent to Gypsy Lane and measured approximately 30 m x 20 m (Fig. 2). The area was stripped to a maximum depth of 0.3 m.

- 3.1.10 A 3.8 m wide parallel sided band of small to medium sized angular oolitic limestone fragments (7) was observed running north-west to south-east parallel to Gypsy Lane (Fig. 2). Fragments of glazed earthenware and transfer printed pottery were recovered from within the make up of this feature suggesting a 19th- or early 20thcentury date. Two large fragments of glazed bricks whose dimensions suggest an 18th-century date were also recovered but it is probable that these were residual bricks reused as hardcore. Overlying the track and the colluvium was a 0.25 m deep layer of dark brown clay loam (6), the present day topsoil and turf.
