# **BUTTERMERE PIPELINE**

### **Watching Brief**

**Document Type:** Watching Brief Report

**Client Name:** Ryan Utility Services

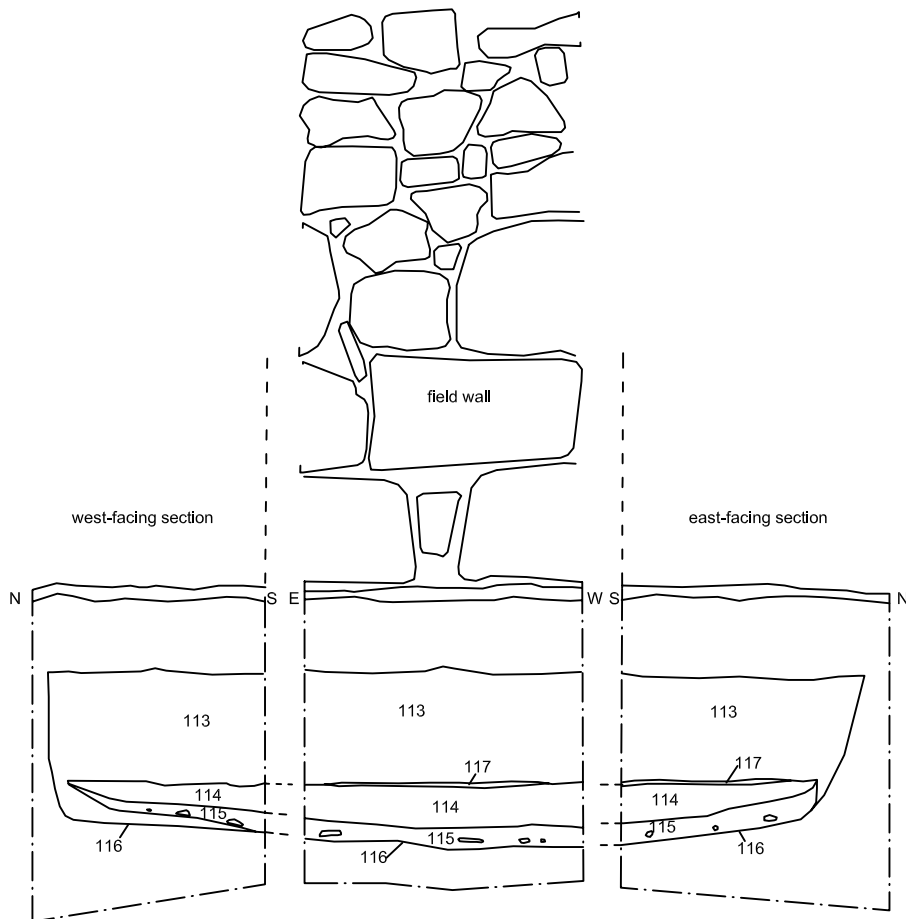
Figure 6 : Section through Feature 116

TITLE: Section through Feature 116  
 CLIENT: Ryan Utility Services  
 DRAWN BY: ELC  
 DATE: November 2001

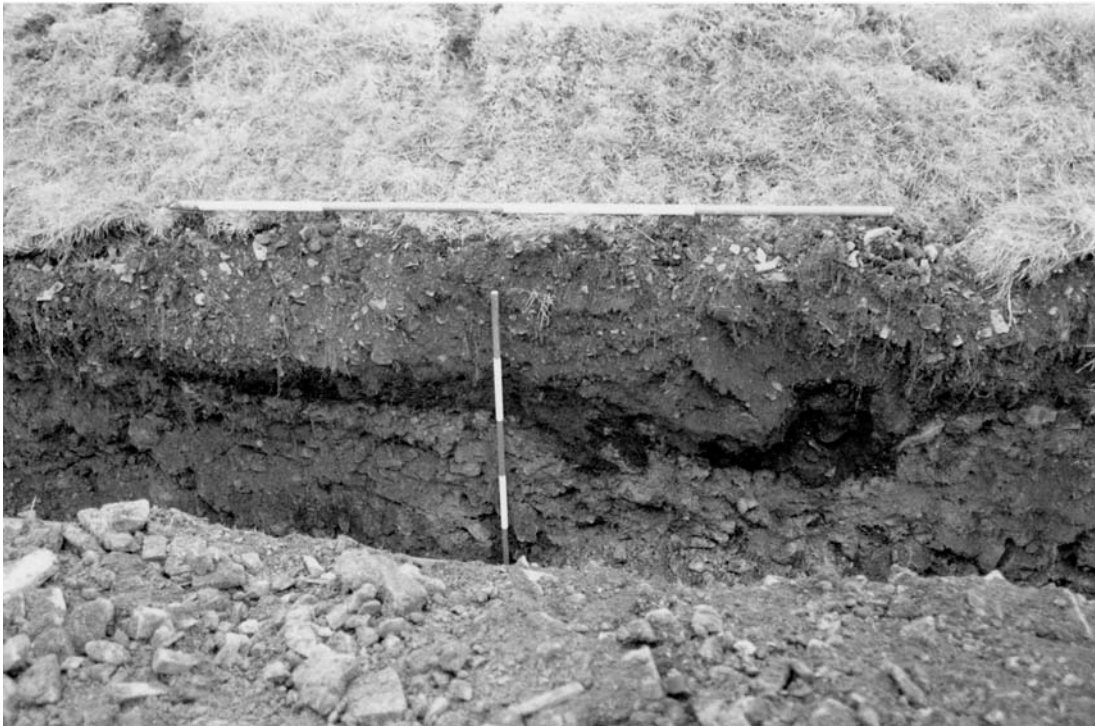
Plate 1: Industrial Feature *103*

- 3.5.4 In comparison, the second feature, 2m to the south of **101**, had a very obvious cut, **103**, truncating the subsoil below (Fig 2; Plate 1); it had a symmetrical profile as seen in the section, with a sharper break of slope and steeper sides to the north and a more gentle slope to the south, with a flat base. The orientation of the feature was unknown but it was deeper and clearer to the west and appeared to peter out to the east, implying that the remainder lay to the west. It was filled with a black sandy silt, **102**, containing 5-10% charcoal flecks throughout, but with a greater concentration along the base of the fill and 2-5% of probable metal processing residues. The feature had maximum visible dimensions of 2.4m in length by over 0.9m width and a depth of 0.3m.

- 4.1.6 However, in Field 4 a slag-rich pit, **103**, was found; this feature was not detected during the geophysical survey, nor was it evident on the ground surface or during the topsoil stripping. There was little evidence of the clay dome element of a typical bloomery but since the entire feature was not seen the exact nature of the site remains unclear. Metal processing residues were found both within the associated fill, **102**, and spread several metres to the north, **104**. The metal residues seemed to be iron and were slag-like, their interpretation suggesting that the site was a possible bloomery. Located approximately 0.4m below the ground surface, there is little sign of the pit and deposits having been disturbed to any great degree. It should be noted that there was a distinct difference between feature **103** and the other charcoal-rich features seen (see 4.1.7), in that the former contained metal processing residues and only smears of charcoal, resulting from its use as a fuel source for the processing. The other deposits had no obvious metal residues and appear to be related to the production of charcoal.

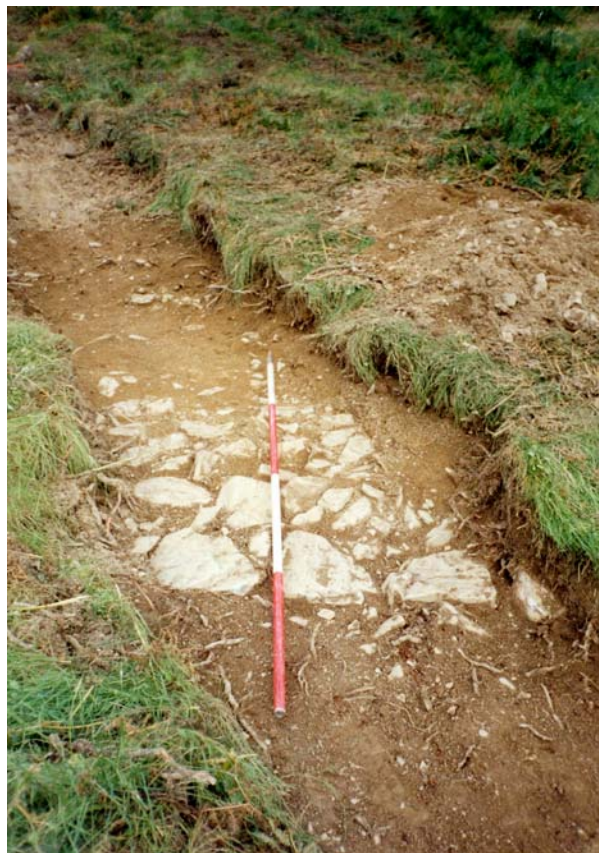
Plate 2: Wall *110*

- 3.9.3 In contrast, feature **110**, located 9.5m further south, was definitely a wall (Fig 2; Plate 2). There were two rows of parallel stones aligned east/west and the feature measured over 1.1m in length, 0.6m wide and about 0.25m in depth. Only one course of stones survived, the form of which was indicative of a dry stone wall, with two parallel roughly-worked faces forming a foundation and smaller stones acting as a core between; there was no evidence of a cut for **110**. There were also numerous small stones to the north of the wall, which seem consistent with tumbled material. The feature was identifiable in the field as a curvilinear earthwork, less than 0.15m in height, which seemed to partition the extreme north-eastern corner of the field, and, as only two stones were partially visible along its length at the ground surface, it had obviously been out of use for some time. There were no obvious indications of the wall having been keyed into the existing field wall to the east although to the north where the earthwork met the field wall it coincided with a gateway through the existing wall. The wall may have served as some form of shelter or small stockade, no longer needed and therefore allowed to decay.

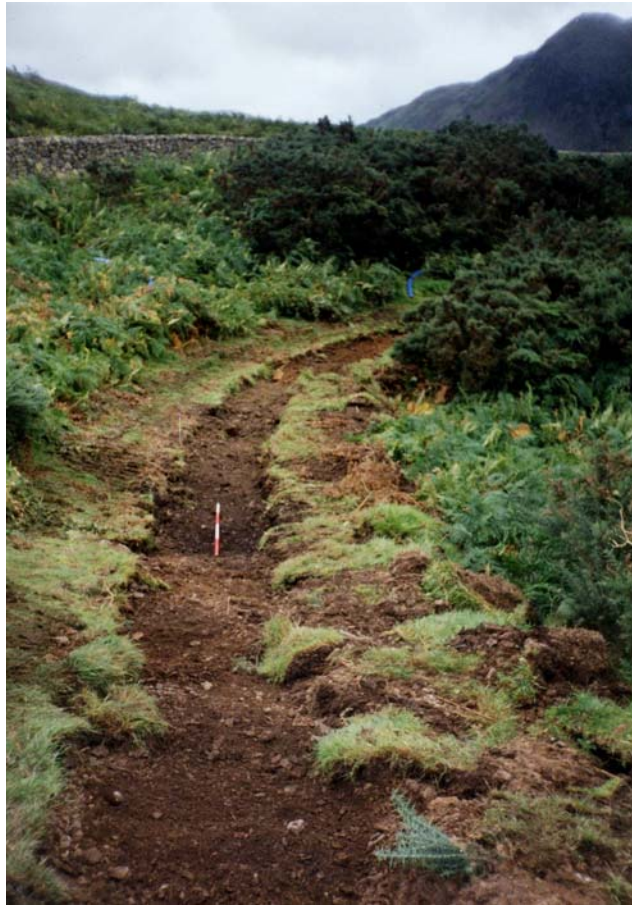
Plate 3: Feature *125*

3.14.1 Centred on NY 3161 5197, the field was covered in bracken and gorse and very undulating in nature. The topsoil stripping revealed an area of darker soil, **III**, approximately 3m in length, located 115.5m from the boundary wall with Field 14 to the south and 12.5m from the east wall of Field 13 (Fig 2; Plate 3). Deposit **III** was a dark greyish black, humic silt, contained burnt charcoal flecks, and occurred 0.2m below the ground surface. Upon excavation, the deposit was also noted to have about 40% small–medium stones and was

thicker to the west, reaching a maximum thickness of 0.3m, implying that the remainder of the feature exists in that direction. The deposit contained sufficient burnt material to suggest *in situ* burning rather than a dump of material cleared from another location. Below this deposit was a mid brownish pink, soft, silty clay, **112**, again containing about 40% small stones. The deposit was only 0.1m deep and appeared to represent a basal layer, possibly providing a surface on which the burning could be carried out, or providing a support for an upstanding structure around which material was burnt. Deposits **111** and **112** appeared to be contained within a very shallow cut, **125**, which had gradual breaks of slope and gently sloping sides. It was not possible to tell to what extent the feature may have been truncated and whether the upper part had been disturbed by later activity such as ploughing.
