# Minster of St Mary-the-Virgin Reading Berkshire

Archaeological
Watching Brief Report

December 2006

**Document Type:** Watching Brief

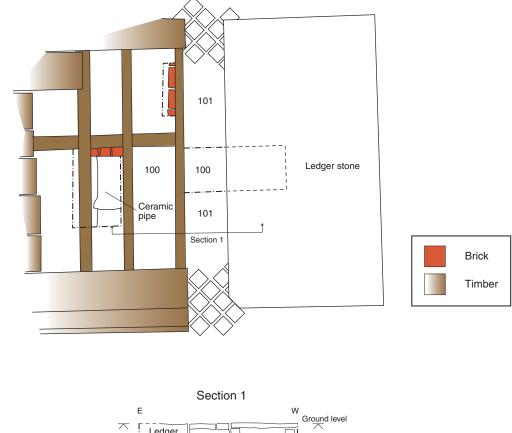
Figure 3: Plan of area monitored and sample section

- 3.1.1 The floor timbers to the west of the ledger stone were supported on wooden beams, some of which were supported on stepped brick footings (see Fig. 3). This created a *c* 0.3 m deep void beneath the timber floor. A 0.32 m x 0.52 m sondage was excavated through the deposits exposed beneath the timber floor, which appeared to comprise a mixed, very loose sandy silt deposit with chalk, flint, charnal, ceramic building material and coffin furniture throughout (100). This was interpreted as made ground, possibly associated with the 1872 phase of renovation. A north-south aligned ceramic pipe, approximately 0.2 m in diameter, was encountered within the sondage, although no obvious trench was observed within deposit 100, and it is likely that this was installed prior to the deposition of the made ground and is therefore contemporary with the same phase of renovation. The brick supports for the timber beams also appeared to pre-date the deposition of the made ground as no construction cuts were observed and the deposit appeared to overlie the lower stepped courses of the brick footings.

- 3.1.2 To the east of the timber floor, the made ground was overlain by a bedding deposit for the tiled floor which comprised compacted chalk and flint (101) and was approximately 0.16 m thick. The ledger stone appeared to truncate this deposit and was laid directly over the made ground. A 0.30 m x 0.65 m sondage was excavated underneath the stone to a maximum of 0.43 m below ground level, and the base of the made ground deposit was not encountered.

- 4.1.1 It seems likely that the ceramic pipe and the brick footings for the timber beams had been laid prior to the deposition of the made ground. The bedding deposit for the tiled floor had then been laid over the made ground to the east of the timber floor. The relationship between the ledger stone and the bedding deposit was unclear, although it seems likely that the laying of the stone had truncated the bedding deposit, almost certainly as it is considerably thicker than the tiles to the east and west of it.

- 4.1.2 The initial monitoring visit established that it was highly unlikely that significant archaeological deposits would be compromised during consolidation of the cracked ledger stone. It seems likely that the reason the stone had cracked was that it had been placed directly over the rubble rich made ground deposit (100), as opposed to the tiled floor which was laid over the compacted chalk (101), or the timber floor which was supported on the wooden beams.

- 4.1.3 As the lifting and repair of the stone was impractical given the fragmentary nature of the cracking, it was decided to excavate further sondages under the stone and fill the resulting voids with sandbags to provide a stable base. As this would not impact below the projected extent of the made ground deposit, no further archaeological monitoring visits were considered necessary.
