RHYDDINGS PARK, OSWALDTWISTLE, LANCASHIRE

Archaeological Evaluation Report

Oxford Archaeology North

March 2015

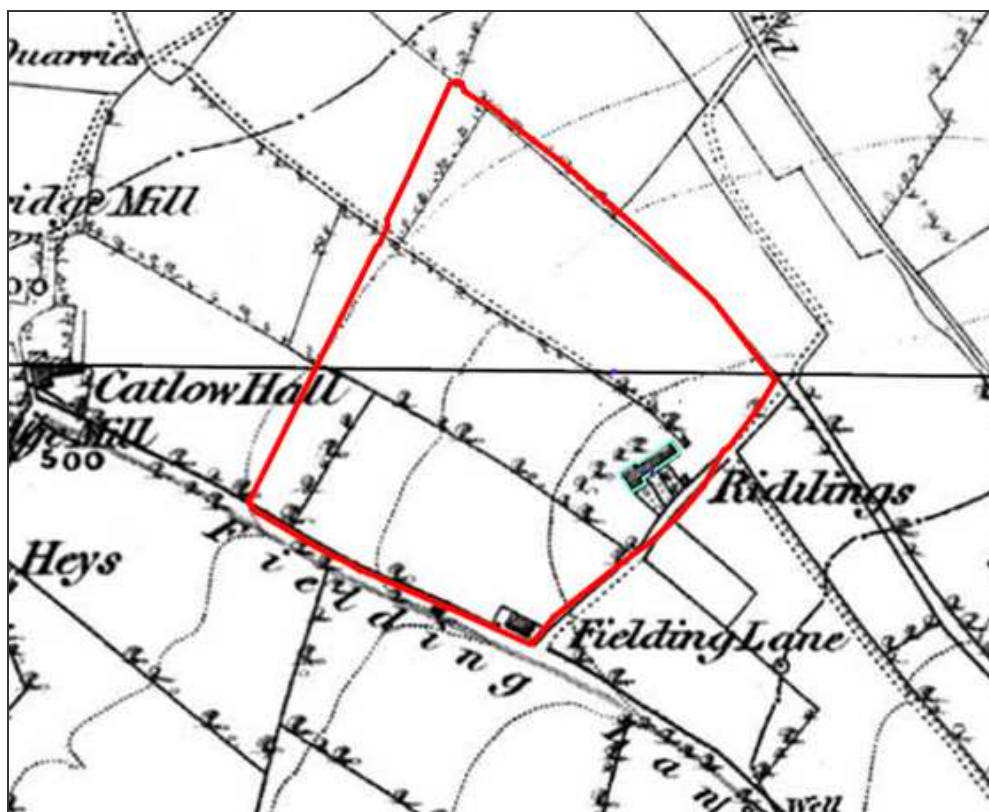
Plate 2: Extract from the Ordnance Survey map of 1848, showing the modern boundary of Rhyddings Park

- 1.1.3 The earliest buildings within the area of the park are shown on the Ordnance Survey map of 1848. One of these is annotated as 'Riddings' (Plate 2), and whilst little is known about the building and its date of construction is presently uncertain, its layout on the map is consistent with a large yeoman farmhouse or minor hall of seventeenth-/eighteenth-century date. The second building shown on the 1848 Ordnance Survey map fronts onto Fielding Lane, and survives extant as the Stop and Rest public house.

- 3.2.3 The Riddings Estate was originally part of the Catlow Estate, owned by the de Catlow family. The estate was divided in the 1500s, and part of it was taken by the Ridding family, who owned it until 1631; it is possible that a property known as 'Riddings' was occupied by the Ridding family. The footprint of this building lies within the boundary of the modern Rhyddings Park, and it is shown on the first edition Ordnance Survey map of 1848 (Fig 3; Plate 2).

4.2.1 Test Pit 1 was placed across the projected course of the south-western wall of Riddings farmhouse, as depicted on the Ordnance Survey map of 1848 (Plate 2). The test pit measured 1 x 1m, and was excavated to a maximum depth of 0.67m below the modern ground surface (Plate 5).

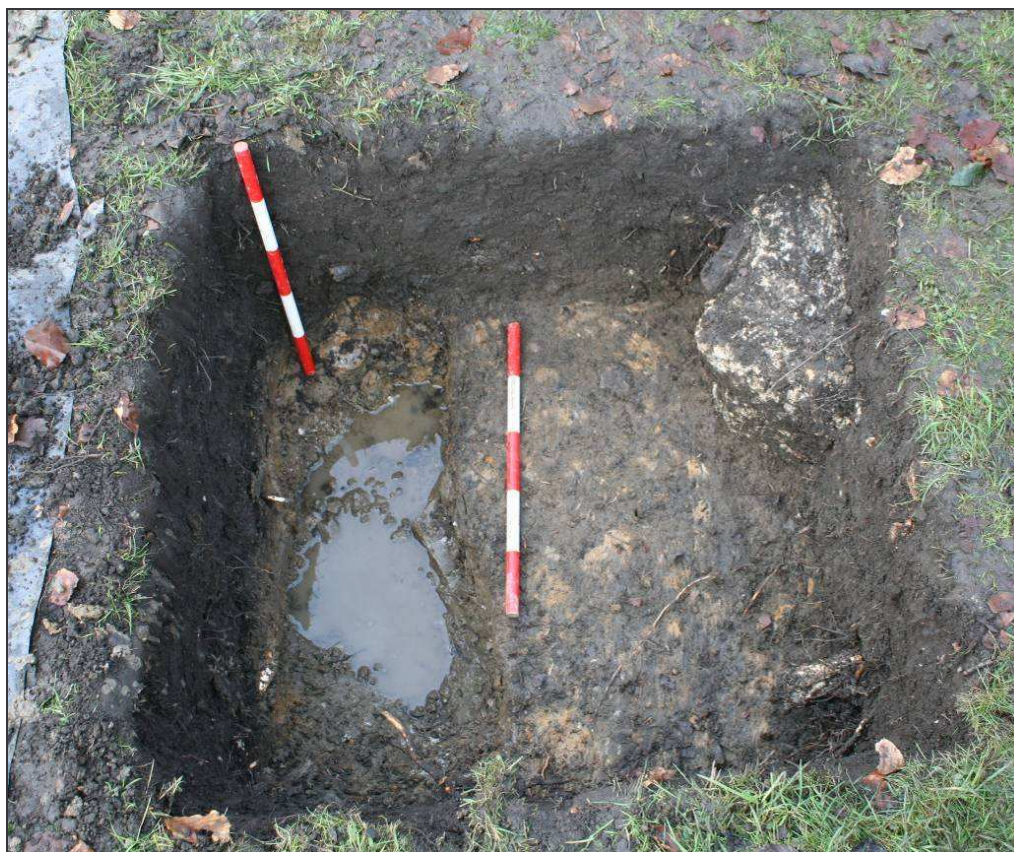
Plate 5: Test Pit 1 fully excavated

- 4.2.2 A thick layer of mixed clay (**103**) was exposed at a depth of 0.45m. This contained fragments of sandstone and degraded mortar, together with occasional rounded cobbles and flecks of charcoal. Excavation for a further 0.2m demonstrated that the layer was fairly homogeneous in both its texture and constituents. Whilst the clay component is likely to represent the natural geology, it had clearly been disturbed and mixed with materials that probably derived from the demolition of the building in the mid-nineteenth century.

- 4.2.3 Mixed clay **103** was overlain by a 0.05-0.10m thick layer of light brown silty clay subsoil (**102**), which contained occasional fragments of coal, sandstone and pottery. This appeared to have been cut by a block of concrete, which was only partially exposed within the confines of the excavated test pit (Plate 5). It is possible that this had formed the base pad for a fence posts, although this could not be established with any degree of certainty.

- 4.2.4 Subsoil **102** was sealed by the modern topsoil (**101**). This contained occasional stones and fragments of glass and pottery.

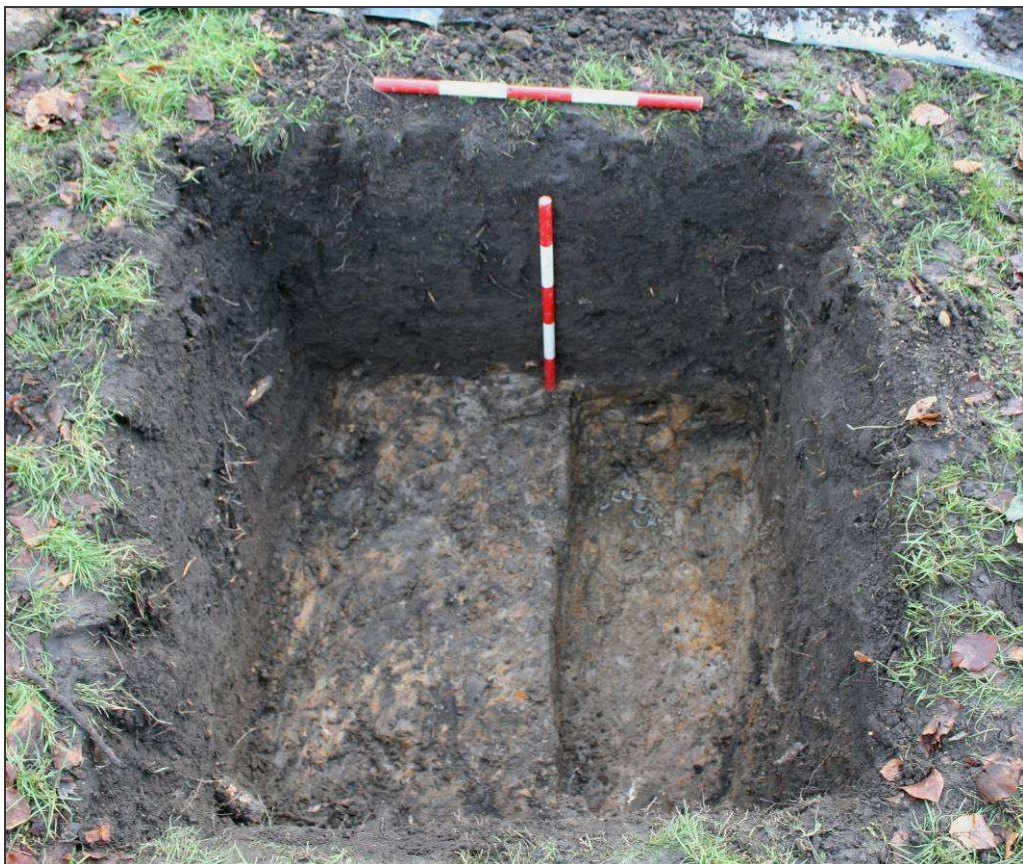
- 4.3.1 Test Pit 2 lay a short distance to the north-east of Test Pit 1, and was similarly intended to investigate the site of Riddings. The test pit measured 1 x 1m, and was excavated to a maximum depth of 0.8m (Plate 6).

Plate 6: Test Pit 2 fully excavated

- 4.3.2 The stratigraphic sequence exposed in the test pit was very similar to that in Test Pit 1, although a layer of clean clay revealed at the base of the excavation, at a depth of 0.8m, almost certainly represented the natural geology. This was overlain by a 0.2m thick layer of mixed demolition material in a clay matrix (**203**). This contained occasional rounded stones, together with fragments of sandstone and pottery, and represented a continuation of layer **103** that was recorded in Test Pit 1.
- 4.3.3 Layer **203** was overlain by a deposit of light brown silty clay subsoil (**202**), which contained occasional fragments of coal, sandstone and pottery. Whilst similar to layer **102** in Test Pit 1, **202** had a maximum thickness of 0.3m. It was sealed by the modern topsoil (**201**), which contained occasional stones and fragments of brick.

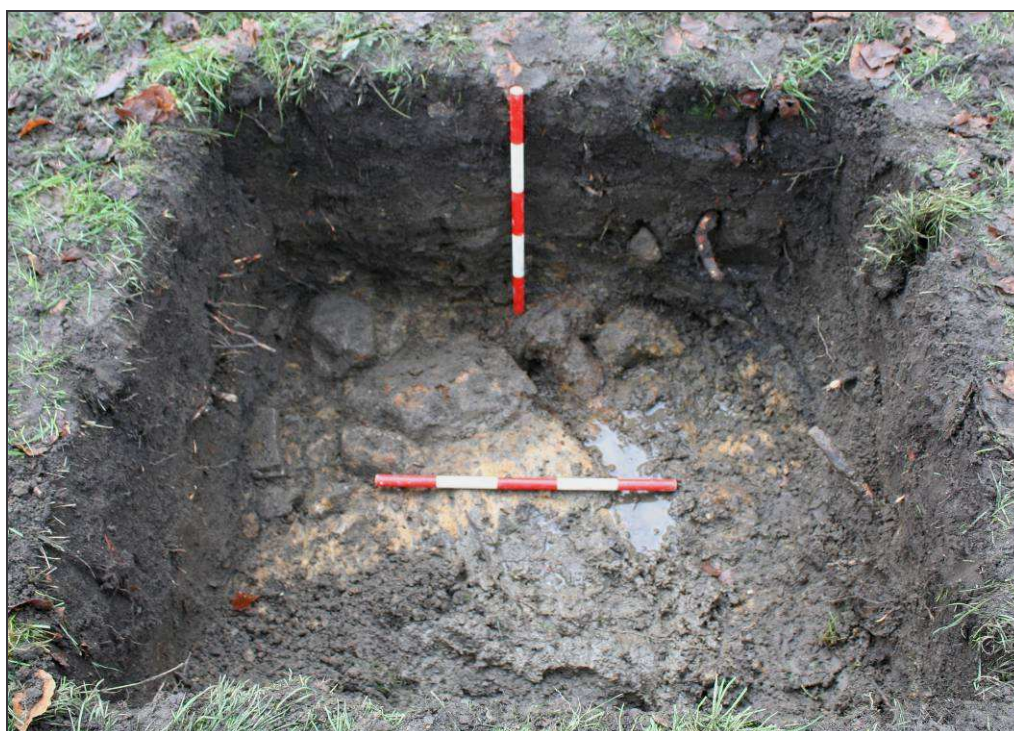
- 4.4.1 Test Pit 3 was placed a short distance to the east of Test Pit 2, and was targeted on the projected south wall of Riddings. The test pit measured 1 x 1m, and was excavated to a maximum depth of 0.5m (Plate 7).

Plate 7: Test Pit 3 fully excavated

- 4.4.2 A thick layer of orange-brown clay exposed at the base of the excavated test pit clearly represented the natural geology. A series of irregular-sized stones was set into the clay in the western part of the test pit. These appeared to have been deliberately laid, and potentially represented part of the foundations for a north-west/south-east-aligned wall. As such, this putative structure lay at a right angle to the exterior walls of the building, and may thus have been an internal partition. However, there was no indication for any interior surfacing.

- 4.4.3 The natural clay in the eastern part of the trench had been cut by a modern land drain. The construction trench for this drain will have removed any archaeological remains in the eastern part of the trench.
- 4.4.4 The natural clay geology and putative wall foundation were overlain by a layer of light brown silty clay subsoil (302), similar to that exposed in the other test pits. This layer had a maximum depth of 0.3m, and was sealed by the modern topsoil (301).

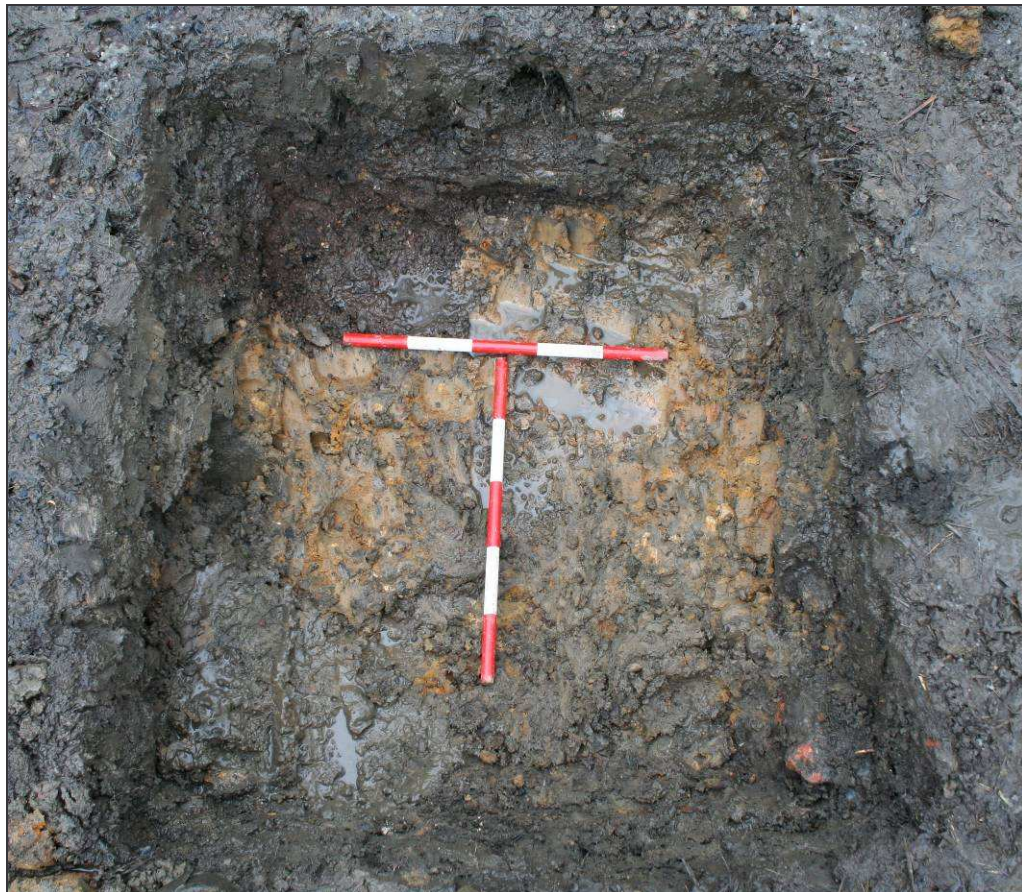
- 4.5.1 Test Pit 4 was targeted on the footprint of a former glass house depicted on the Ordnance Survey map of 1893 (Plate 4), within the area occupied most recently by 'Pets Corner'. The test pit measured 1 x 1m, and was excavated to a maximum depth of 0.5m (Plate 8).

Plate 8: Test Pit 4 fully excavated

- 4.5.2 A layer of stiff orange-brown clay was revealed at the base of the excavated test pit (403). This contained occasional rounded stones and fragments of pottery, implying that it was not the natural geology. It was overlain by a layer of dark brown silt clay (402), which contained demolition material, including fragments of bricks, pottery and mortar. It also incorporated a distinct lens of ash with abundant flecks of mortar and ash.

- 4.5.3 Layer **402** had a maximum depth of 0.34m, and was sealed by a layer of modern detritus (**401**) that reflected the recent use of the area by animals. This contained organic matter, including decomposed straw and animal faeces.
- 4.5.4 No structural remains of the glass house were present in the trench. It seems probable that the building had been completely demolished and the area subject to earth-moving works during the construction of 'Pets Corner'.

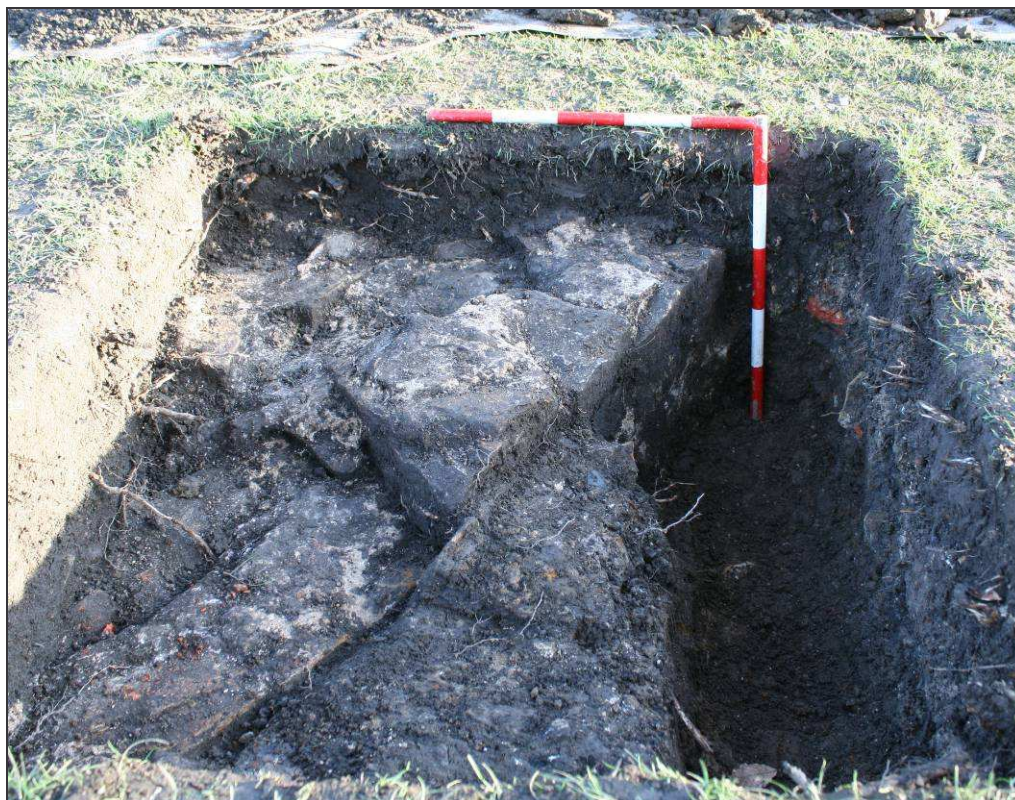
- 4.7.1 Test Pit 6 targeted the site of the mid-nineteenth-century Rhyddings Hall, and was placed across the footprint of the bay window in the centre of the south-west-facing elevation of the building, as shown on the Ordnance Survey map of 1893 (Plate 4). The test pit measured 1.1 x 1.1m, and was excavated to a maximum depth of 0.48m (Plate 9).

Plate 9: Test Pit 6 fully excavated

- 4.7.2 A layer of quite compact, dark brown clay (**604**) was exposed at the base of the excavated test pit, at a depth of 0.32m. Whilst this may have represented the natural geology, it appeared to have been redeposited, perhaps to create a raised platform during the construction of Rhyddings Hall, as it contained small fragments of hand-made bricks. Layer **604** had been cut by the foundation trench for a substantial curved wall (**603**), which almost certainly represented the foundations of the bay window of Rhyddings Hall. The wall survived to a height of at least two courses, and comprised large sandstone blocks, with a sandstone rubble core (Plate 9). Traces of lime-based mortar, consistent with a mid-nineteenth-century construction date, were clearly visible on the component stone blocks. Layer **604** was also cut by a salt-glazed drain pipe, 4" in diameter, which was revealed in the south-eastern corner of the excavated test pit.

- 4.7.3 Wall **603** was overlain by a 0.32m thick later of mixed demolition rubble (**602**), comprising fragments of sandstone, bricks, ash and mortar, deriving from the demolition of Rhyddings Hall in the twentieth century. This was sealed by the modern topsoil (**601**), which had a maximum depth of 0.17m.

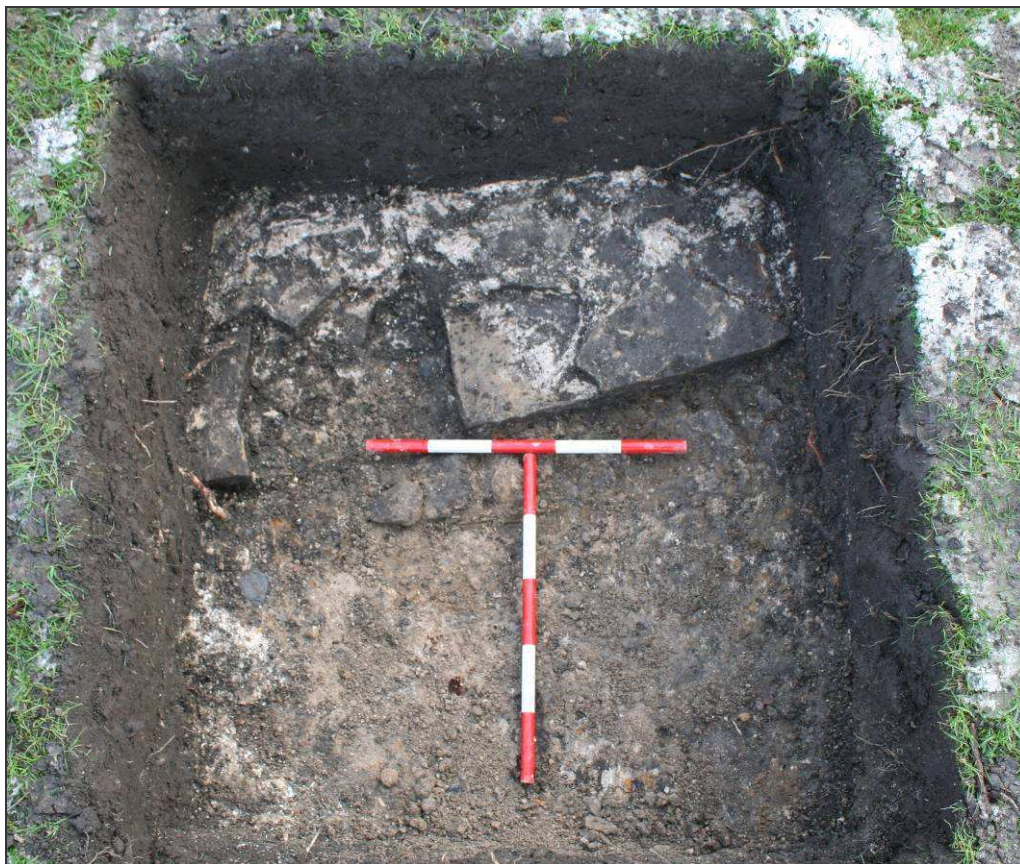
- 4.8.1 Test Pit 7 was placed within the footprint of Rhyddings Hall, and aimed to establish the presence or absence of any structural remains in the central part of the building. The test pit measured 1 x 1m, and was excavated to a depth of 0.61m (Plate 10).

Plate 10: Test Pit 7 fully excavated

- 4.8.2 A layer of dark brown clay (**704**), very similar to layer **604** in Test Pit 6, was exposed at the base of the excavated test pit, at a depth of 0.46m. This similarly appeared to represent made ground, creating a raised level platform upon which to erect Rhyddings Hall.

- 4.8.3 Layer **704** was cut by the foundation trench for a sandstone wall (**703**), which was 0.4m wide and was aligned north-east/south-west across the test pit (Plate 10). The wall comprised large, worked sandstone blocks bonded with lime-based mortar. This probably represented the foundation course of a substantial partition wall within Rhyddings Hall.

- 4.8.4 Wall **703** was overlain by a 0.2m thick later of mixed demolition rubble (**702**), comprising fragments of sandstone, bricks, ash and mortar, deriving from the demolition of Rhyddings Hall in the twentieth century. This was sealed by the modern topsoil (**701**), which had a maximum depth of 0.28m.

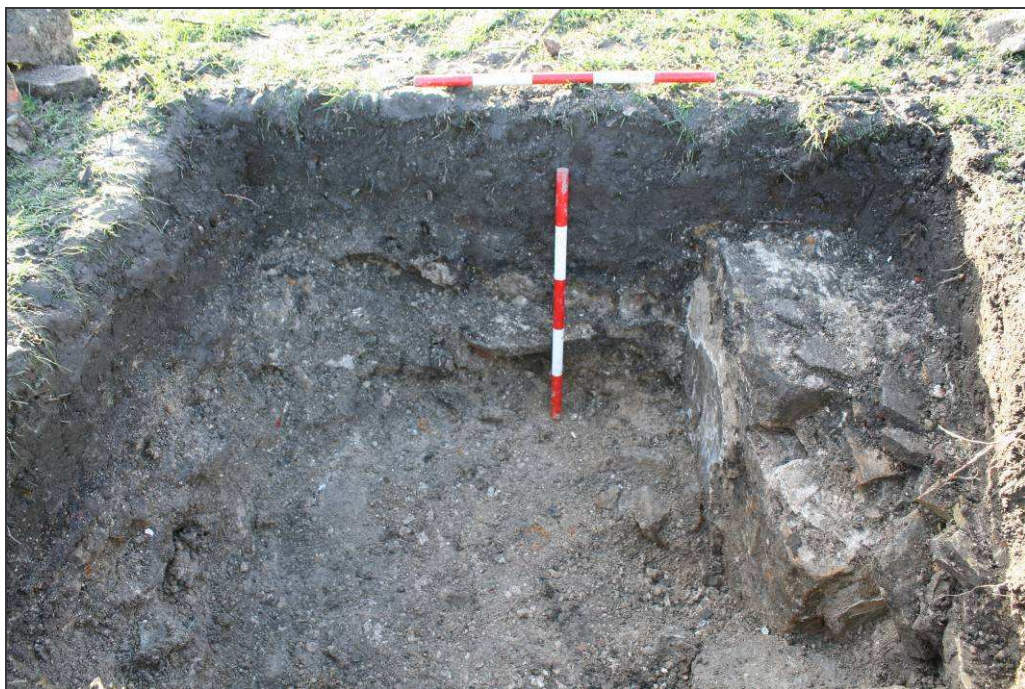
- 4.9.1 Test Pit 8 was placed to the north of Test Pit 7, and was again within the footprint of Rhyddings Hall. The test pit measured 1.2 x 1m, and was excavated to a maximum depth of 0.6m (Plate 11).

Plate 11: Test Pit 8 fully excavated

- 4.9.2 The earliest feature exposed in the test pit was another substantial stone-built wall (**803**), which was aligned north-east/south-west across the south-eastern corner of the trench. The wall was covered with demolition rubble (**802**), which formed the lowest deposit excavated in the test pit. Rubble **802** was exposed to a depth of 0.6m, but continued below this level, suggesting that this may have been an infilled cellar. The rubble contained numerous fragments of broken bricks, stones, and floor tiles (Plates 12 and 13). It was sealed beneath a 0.2m thick layer of topsoil (**801**).

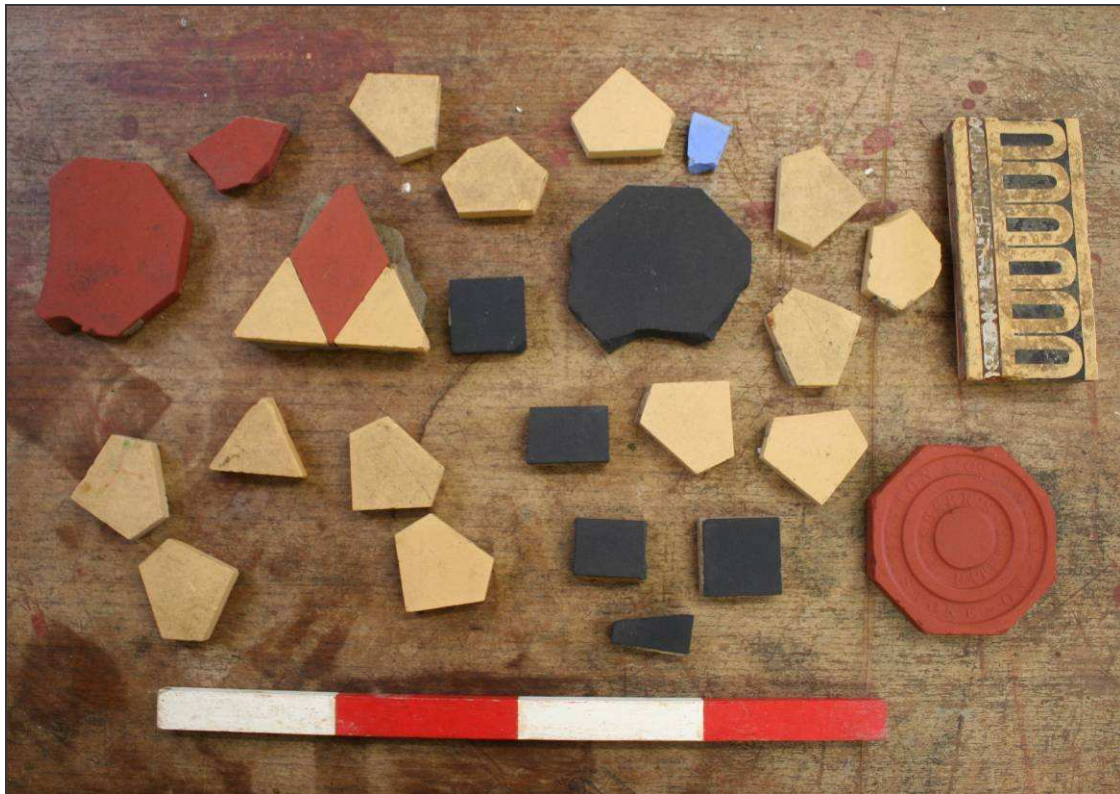
Plate 12: Fragments of floor tiles recovered from Test Pit 8

4.10.2 **Ceramic tiles:** numerically, fragments of tiles dominated the finds assemblage, nearly all of (229 fragments) which was recovered from the demolition rubble (802) in Test Pit 8. Several of the fragments had been stamped with the manufacture's mark of the Minton tile companies of Stoke-on-Trent, and it is probable that all of the tiles had been supplied by Minton (Plates 13 and 14). There were several different tile companies with Minton in the name that were active in the nineteenth and early twentieth centuries, although some of the tiles recovered from the test pits were stamped 'Minton & Co' and 'Prosser's Patent' (Plate 13). This relates to a dust-pressing method of producing floor tiles that was patented by Richard Prosser in 1842, and was in widespread use by 1860, enabling the tiles to be dated with confidence to the second half of the nineteenth century. The vast majority of the tiles were of a single colour, either black, terracotta or cream. They occurred in a variety of shapes, including diamonds, triangles, hexagonals and small squares, presumably to enable a geometric pattern to be laid, typical of high-status Victorian buildings. Examples of decorated rectangular tiles were also discovered (Plates 14 and 15), and had probably formed the borders to the tiled floor.

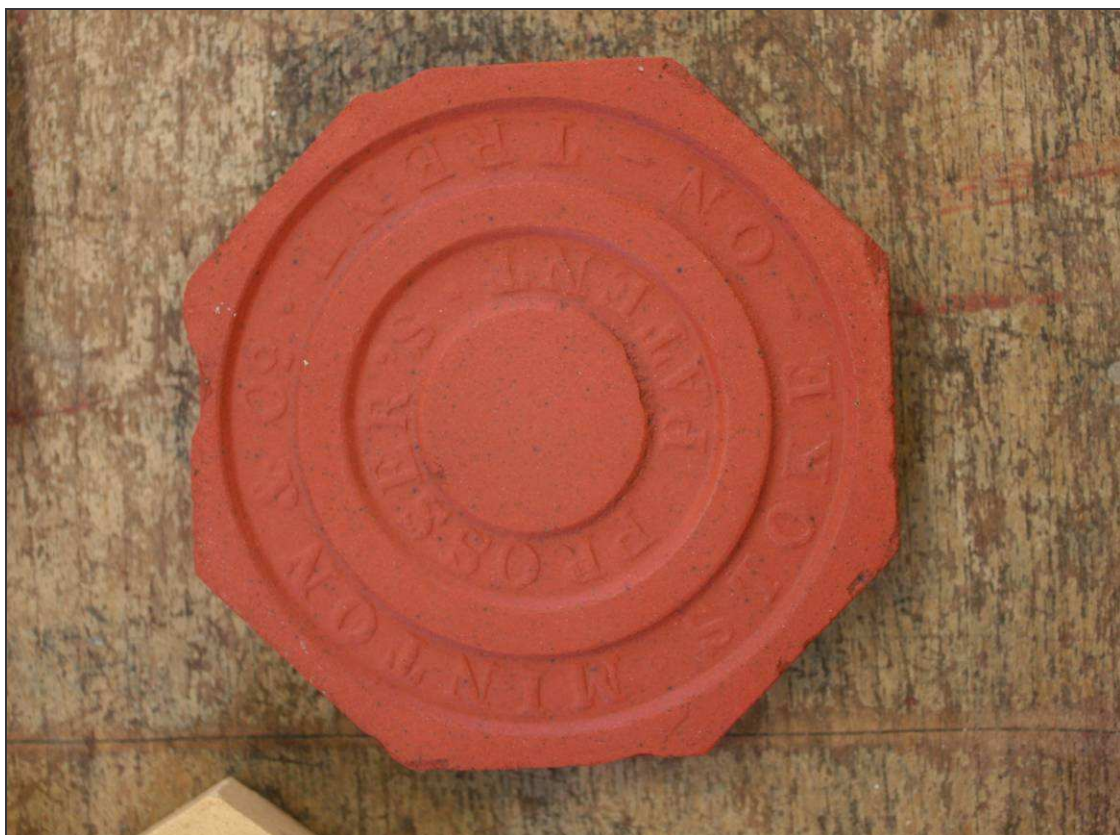
Plate 13: Fragment of a Minton floor tile recovered from Test Pit 8

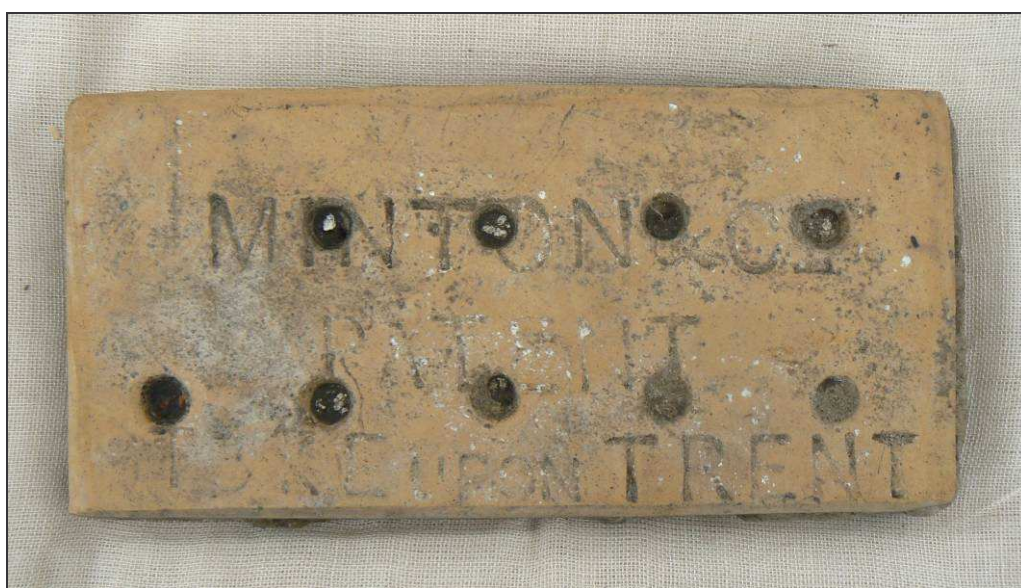
Plate 14: The underside of a complete Minton & Co floor tile recovered from Test Pit 8

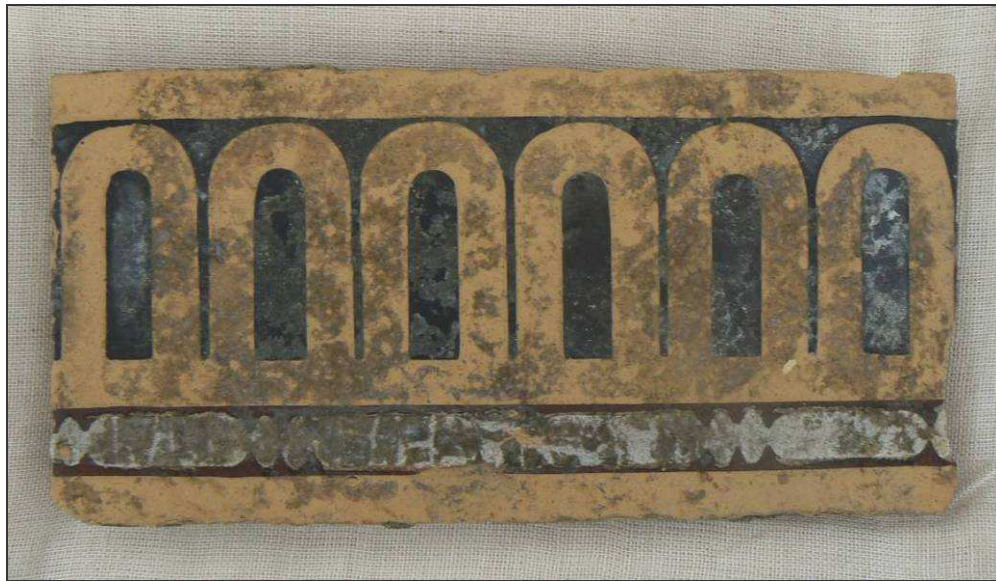
Plate 15: A complete Minton floor tile recovered from Test Pit 8

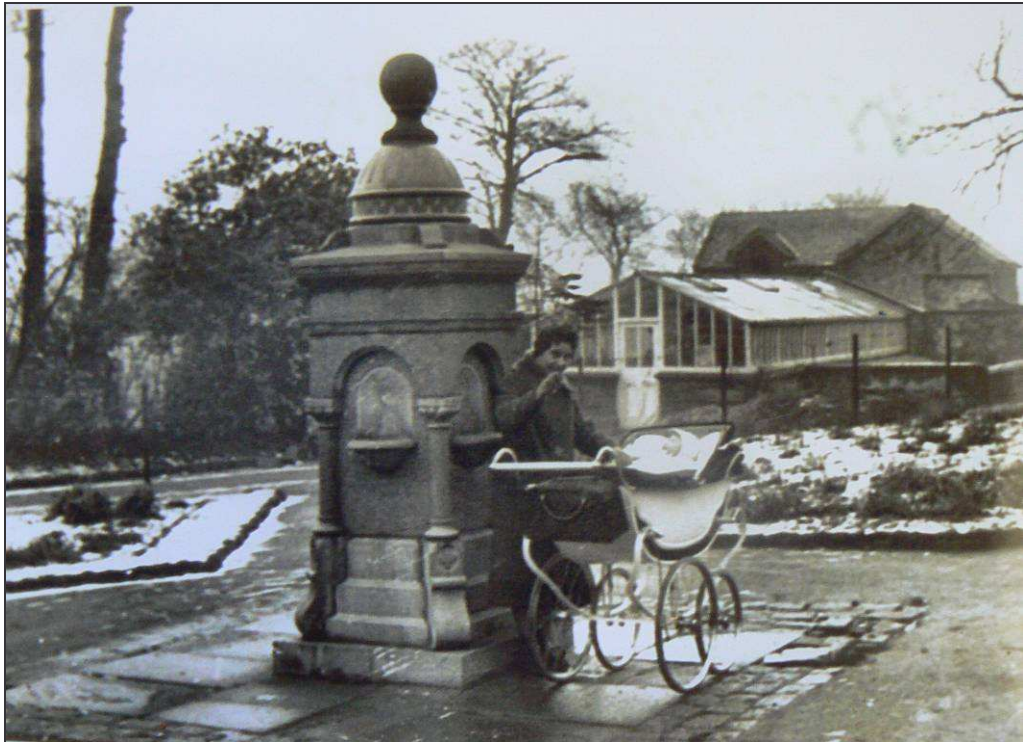
- 5.1.4 The second glasshouse was targeted by Test Pit 4, although this concluded that all buried remains of the structure had been removed, presumably when the site was converted for use as 'Pet's Corner'. However, the glasshouse is shown in an historic photograph dating to the early 1950s (Plate 16), which was kindly supplied by a local resident who expressed an interest in the archaeological evaluation. This shows the hothouse with its original glass superstructure atop the dwarf walls, with a doorway providing access

Plate 16: An historic photograph dating to the early 1950s kindly shared by a local resident, showing the hothouse adjacent to the coach house in the background prior to its demolition
