3-5 DAMSIDE STREET, LANCASTER

Archaeological Building Investigation

Oxford Archaeology North

October 2003

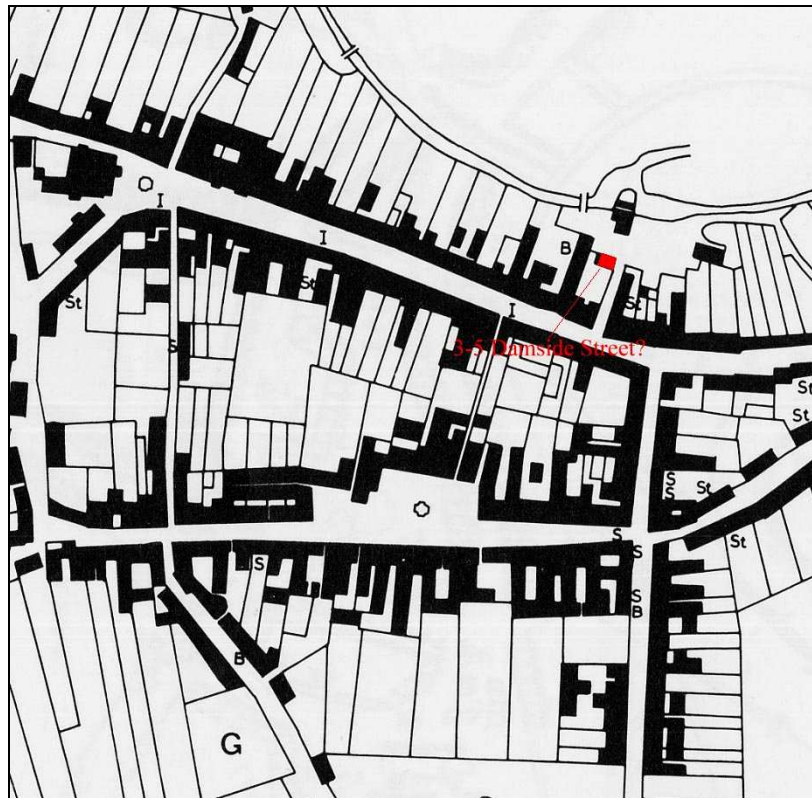
Plate 1: Speed's map of 1610 showing the approximate location of 3-5 Damside Street

3.1.4 ***History of 3-5 Damside Street:*** as no desk-based assessment was undertaken as part of this project it is not possible to provide a detailed history of the building. A few general details can be identified by reference to maps however. The earliest map of Lancaster (Speed 1610; Plate 1) shows Calkeld Lane and houses along Church Street. The mill (labelled 9) is also shown, with a building opposite to the south in the approximate area of the site. The plan of Lancaster in 1684 (Docton 1957; Plate 2) is even more revealing, as it appears to show a building in the exact position of the site. It is, of course, not certain that this is the same building, however, but it does show that there were structures in the immediate vicinity from an early date. There is a substantial gap in the map evidence from this point, although other early buildings were present on Damside Street, one dated 1687 (Penney 1981, 25). Buildings of such a date rarely survive in Lancaster, in part because of recent demolition and rebuilding, and in part because of a move during the seventeenth century towards building with stone and slate to reduce the risk of fire (Penney 1981, 22-25). The next map, of 1778 (Mackreth; Plate 3), shows no building on the site, and the plot is shown as empty. This may have followed the demolition of earlier buildings as the east part of town was redeveloped during this time. There appears to have been a building on the site again soon after as both Clarke's map of 1807 and Binns's of 1821 (reproduced in White 2000b) show buildings in this position, although they lack detail. By the time the detailed maps of the Ordnance Survey 25": 1 mile are produced (1893; Plate 4), 3-5 Damside Street had taken its present form.

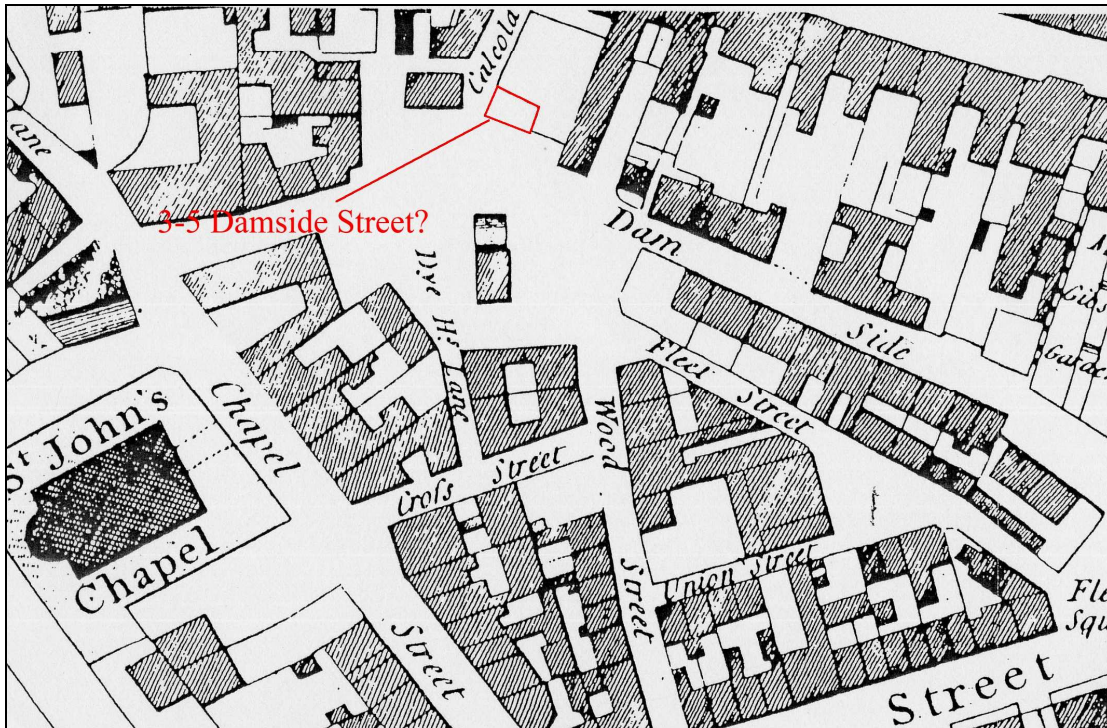
Plate 2: Plan of 1684 showing building in approximate position of 3-5 Damside Street (after Docton 1957)

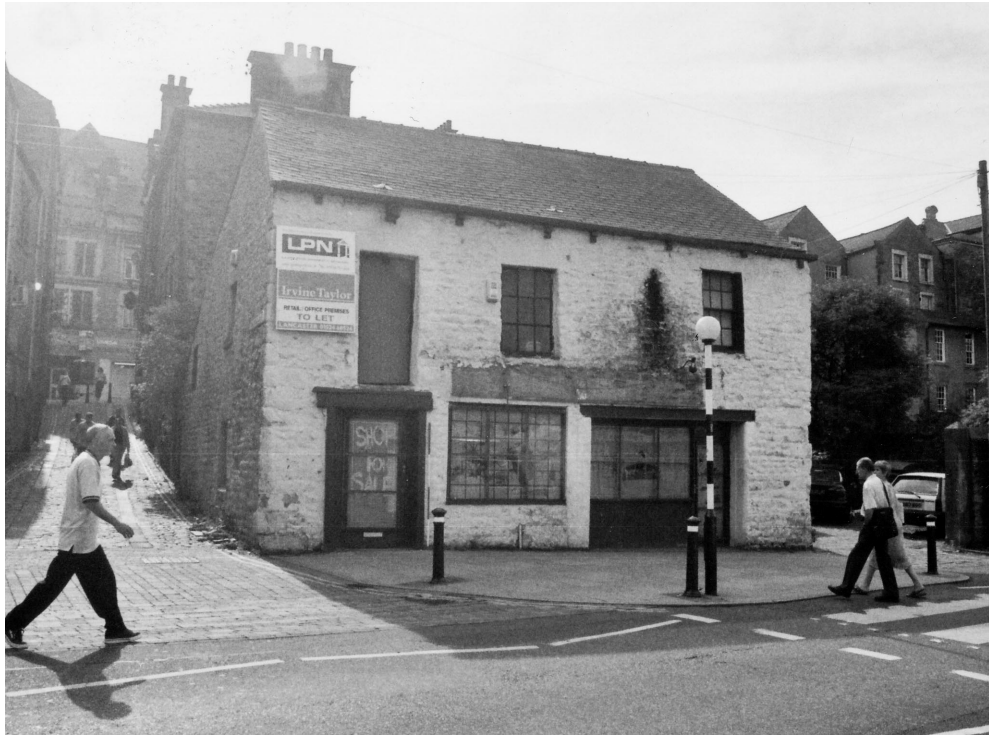
Plate 5: The front (north) external elevation

- 4.1.3 **External Elevation, North:** this forms the front of the building (Plate 5). It comprises courses of roughly dressed gritstone blocks, which have been painted, with quoins at the corners. On the ground floor, a large aperture forming both a large window and a doorway dominates the right side. The window is formed by a large single pane, with tongue and groove boards below, and is evidently modern, as is the door. The entire opening is evidently a later insertion and has an iron I-beam lintel. There is a second large window towards the centre of the ground floor, which appears original, with what is probably a large stone lintel, up to 0.5m wide. To the left of this is a doorway with splayed timber jambs and surrounds forming simple pilasters, with a timber fascia board across the top. On the first floor there is a tall doorway on the left side with a plank door and plain surround. To the right of this there are two windows, the central one (which is at a slightly lower level) consisting of a single 9-light opening, and that to the right comprising a 12-light sliding sash with a deep casement. Along the roofline, rows of projecting brick corbels support a square timber gutter. Above the doorway in the left side a beam also projects, onto which is attached an iron hoisting hook. There are additionally some modern fittings such as lights across the whole elevation. The roof is slate with, possibly ceramic, ridge tiles.

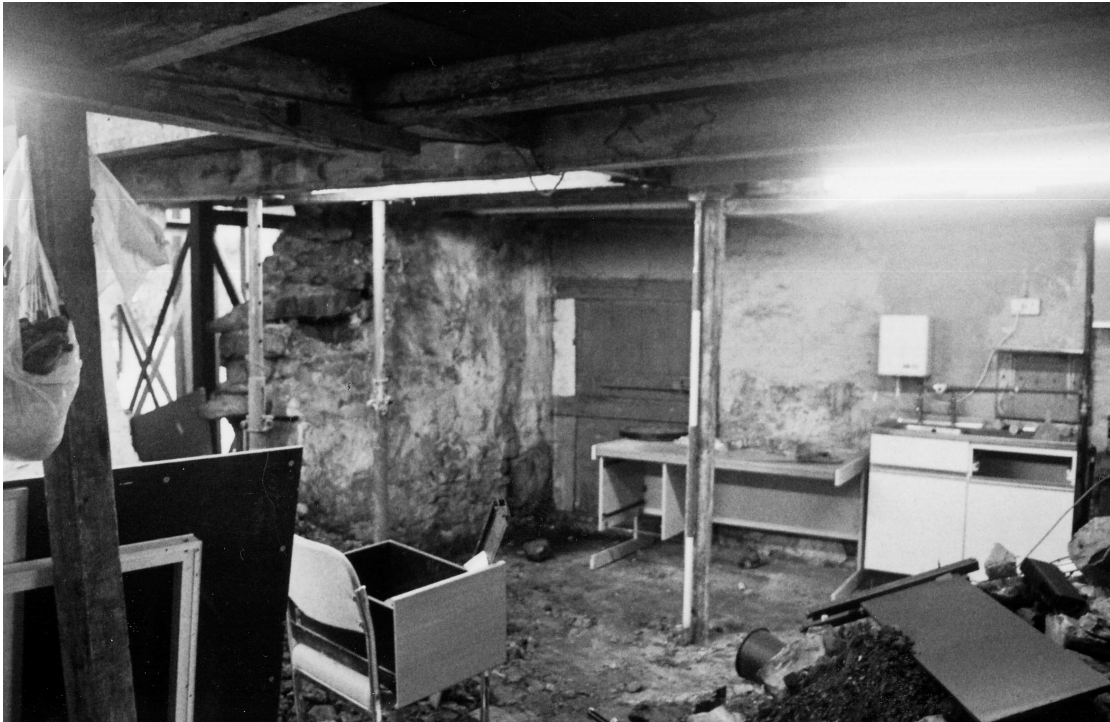
Plate 7: Room 3, looking southwest

- 4.1.9 ***Internal Details, Ground Floor, Room 3:*** this comprises the majority of the ground floor of the outshut. It is essentially square, with a small section extending to the southeast filled with a large walk-in fridge. The floor is modern concrete and raised above that of the main block, and the ceiling consists of timber boards supported on a complex structure of beams, the two main ones orientated north/south. These are in turn supported on two upright timber posts. The north elevation consists of stone finished with plaster and paint, with a doorway in the centre into Room 2, with a timber lintel (Plate 7). There are modern fittings attached. The east wall butts onto the north, and consists of modern plywood panels attached to a beam. This returns to the west at the right side, but is obscured by a cupboard and the large fridge. The east end of the south elevation is entirely lost behind the fridge and is otherwise plain. The main joists supporting the ceiling are built into it. Towards the centre there is a modern hole knocked through the wall, and immediately to the right of this the back of the small aperture is just visible. It is filled with concrete blocks and its exact extent cannot be made out from the inside. The west elevation has a doorway in the south side and modern kitchen fittings attached to the north.

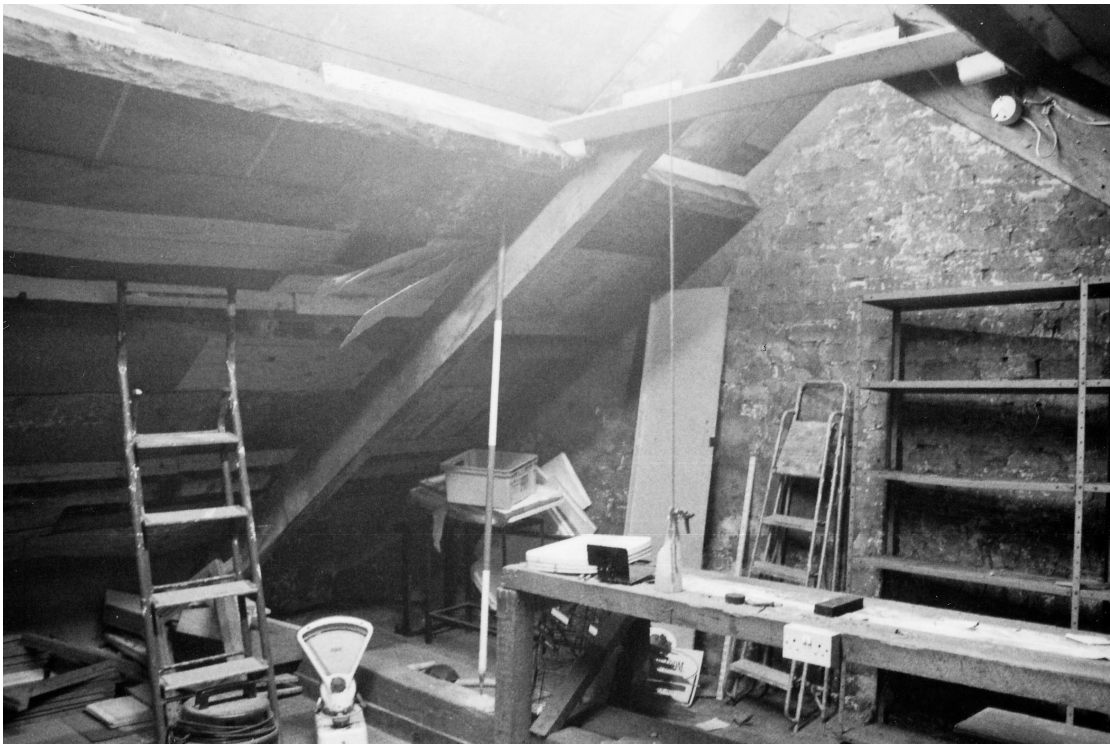
Plate 8: Truss in Room 10, looking southwest

4.1.16 **Internal Details, Second Floor, Room 10:** this essentially forms an attic space above Room 6, on the east side of the main block. The ceiling is open to the roof and is boarded, with three purlins visible in each pitch as well as a ridge purlin, some of which are evidently adze finished. A single truss consisting of a tie beam and overlapping principal rafters runs across the west side of the room, the tie beam being at floor level (Plate 8). The floor is covered by vinyl sheeting but presumably consists of timber boards. The north and south elevations consist of very little, as they are essentially just the wall tops. Timber wall plates are visible in places and both sides have been recently re-rendered. The east elevation consists of courses of gritstone with several patches of render and some noticeable subsidence cracks. The purlins are inserted into this wall and there is evidence for further rendering around these. The west elevation consists of painted brick, with an extensive render repair along the north side, and along the roofline.
