**Haslam Street Mill,  
Haslam Street,  
Bolton**

**Archaeological  
Assessment**

**Oxford Archaeology North**

March 2015

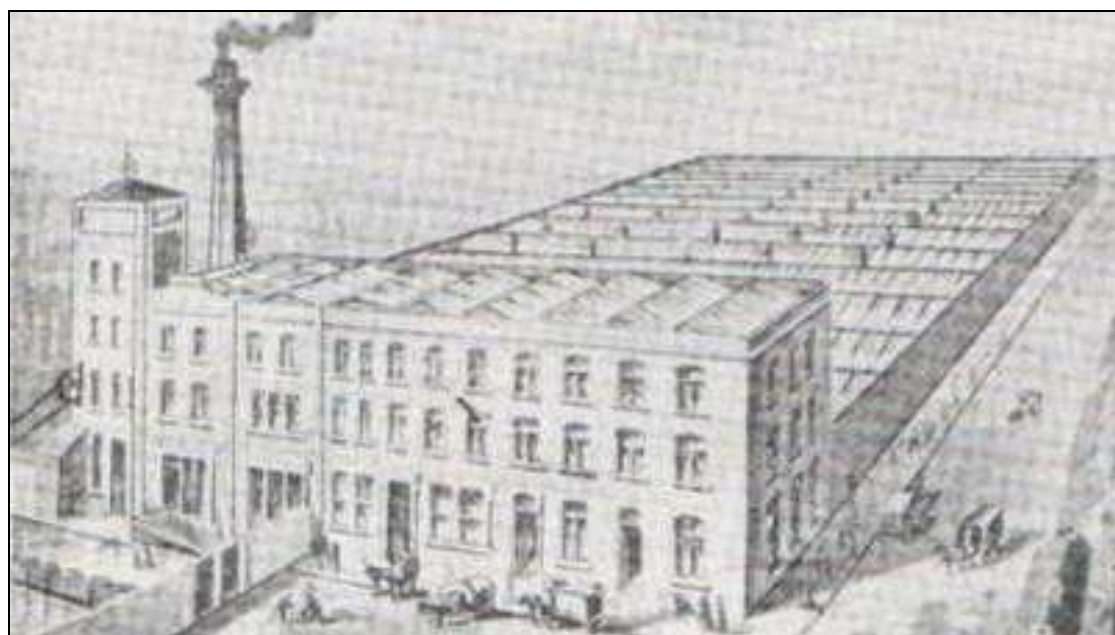
- 3.1.6 Further details of the mill complex may be gleaned from a contemporary illustration (Plate 5). Whilst the provenance, date and accuracy of this illustration is uncertain, it appears to depict the mill in its late nineteenth-century format, as the footprint of the buildings shown corresponds broadly to those mapped by the Ordnance Survey. The engine and boiler houses are shown as three-storey structures, with the unusual arrangement of the fenestration matching that in the preparation/warehouse block, and all with multi-pitch roofs. A four-storey water tower is shown adjacent to the engine house, but set back slightly; the position of this structure does not correspond precisely to the outline shown by the Ordnance Survey (Plate 4). The tapering, octagonal chimney is also shown to the rear of the water tower.

Plate 5: Illustration of Haslam Street Mill, probably dating to the late nineteenth century, reproduced in Longworth 1986

- 3.1.7 A detail of particular interest on the illustration is what seems to be a belt drum protruding from the first floor of the water tower (Plate 5). This appears to house a drive belt, which continues towards the ground level in the direction of the reservoir, suggesting that it may have powered at item of machinery in the mill yard. The rationale for such an arrangement cannot be explained easily, and it is unfortunate that there is no other evidence available to confirm the accuracy of the illustration, and that this unusual power arrangement actually existed. There is certainly no indication for any powered machinery in this area on the 1891 Ordnance Survey map, or any pumping mechanism associated with the reservoir that may have required power.

- 5.1.2 The most intriguing element of the documentary material is the illustration presumed to date to the late nineteenth century, which depicts a belt drum protruding from the first floor of the water tower (Plate 5). Whilst the inclusion of this unusual feature implies that there was a requirement to supply power to machinery in or beyond the mill yard, there is nothing on the Ordnance Survey mapping to indicate what this may have been. The accuracy of the illustration should also perhaps be considered, as some ‘artistic licence’ has clearly been incorporated. Most obvious in this respect is the width of the preparation/warehouse block, depicted on the illustration as a three-bay structure, whilst the photograph from 1921 clearly shows it to have been four-bays wide. The multi-pitch roof structure shown on the illustration is similarly incorrect, as later photographs depict a twin-span roof with hipped gables.

- 5.1.3 The most enigmatic feature on the illustration, however, is the four-storey water tower that is shown to have housed the belt drum. The footprint of this building does not correspond easily to the detailed Ordnance Survey map of 1891, and whilst a similar tower is partially visible on an illustration produced by the Amalgamated Mills Trust Ltd in 1921, it is absent from a photograph of the same date. The footprint of the mill shown on the Ordnance Survey map of 1908, moreover, corresponds closely with the buildings that survived immediately prior to demolition, with the tall rectangular water tower occupying the site of the tower shown on the late nineteenth-century illustration.

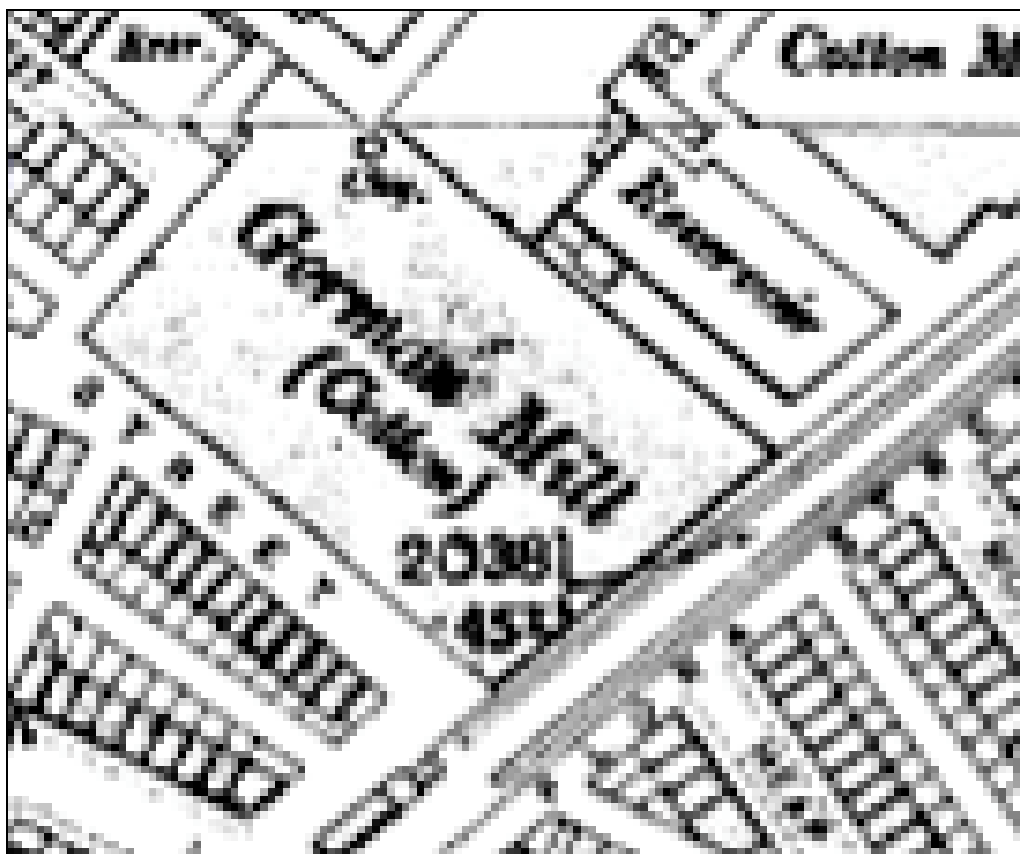
- 3.1.8 The next available plan of the mill complex is provided by the Ordnance Survey 25": 1 mile map of 1908 (Plate 6). The detail of this map suggests that the northern corner of the mill complex, and specifically the four-storey tower, had been remodelled or replaced. The new structure extended further to the north-west, bringing its front elevation in line with the adjacent engine house. This map similarly provides no indication of any features that might have been powered by the drive belt shown in the late nineteenth-century illustration.

Plate 6: The Ordnance Survey 25": 1 mile map of 1908

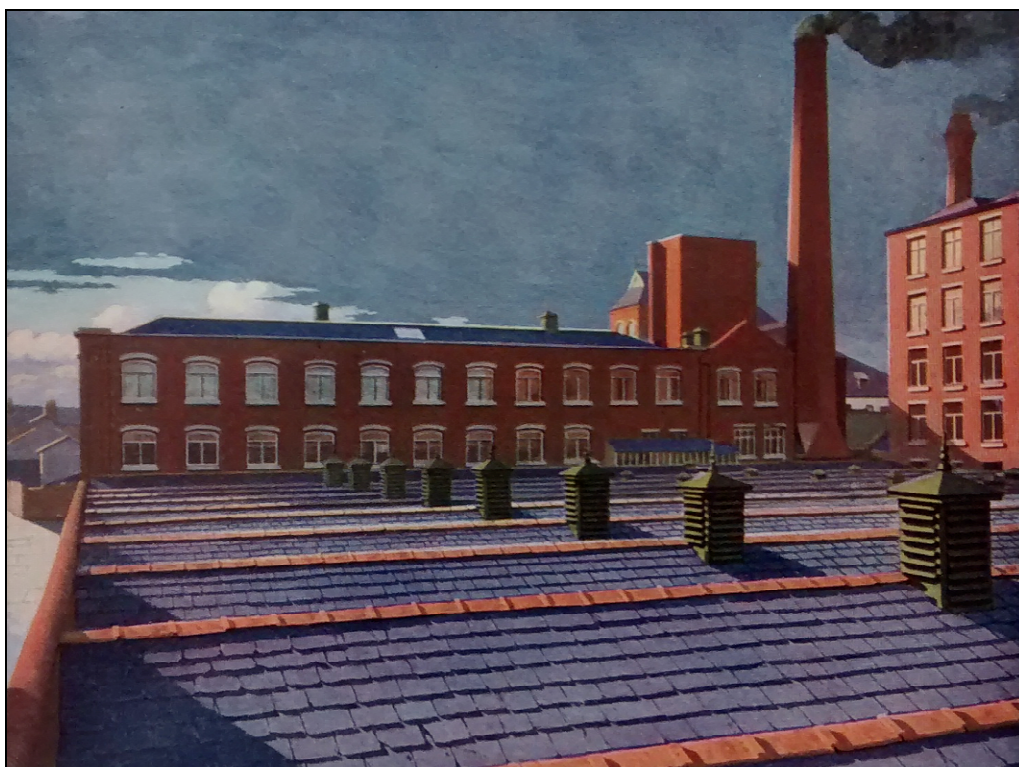
- 3.1.11 The brochure also includes several photographs and an illustration of the mill that provides a view across the north-light weaving shed roof to the rear elevation of the three-storey preparation/warehouse block and steam-power plant (Plate 7). The boiler house appears to have formed the northern two bays of the preparation/warehouse block, with the distinctive pitched gabled of the engine house being visible. A tower similar to that shown in the late nineteenth-century illustration is partial visible, behind a large rectangular water tower that may have been added to the mill complex.

*Plate 7: The view looking west across Haslam Street Mill (reproduced from the Amalgamated Cotton Mills Trust Ltd, 1921)*

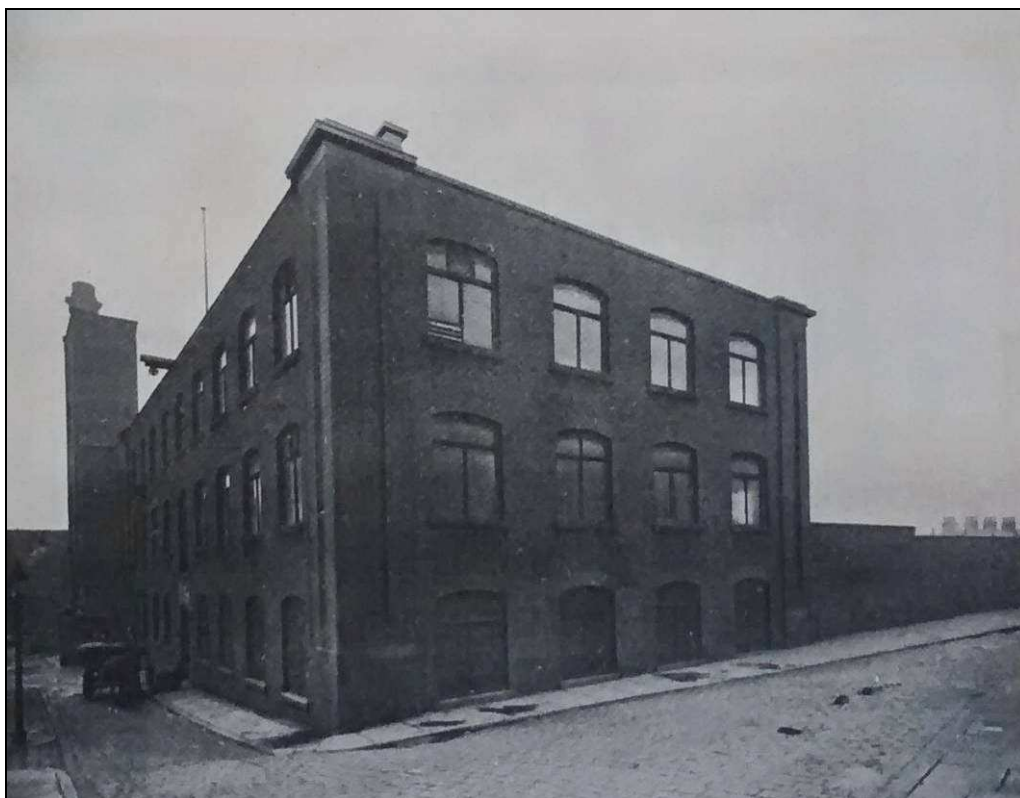
- 3.1.12 Amongst the photographs in the brochure is a view of the three-storey preparation/warehouse block from Haslam Street. Whilst this block is shown as a three-bay structure on the late nineteenth-century illustration, it is depicted clearly as four bays in the photograph (Plate 8). The pitched roof of the engine house can just be seen projecting beyond the preparation/warehouse block into the mill yard, and the large rectangular water tank lies beyond. The tower in the illustration, however, is absent.

*Plate 8: View of Haslam Street Mill from Haslam Street (reproduced from the Amalgamated Cotton Mills Trust Ltd, 1921)*

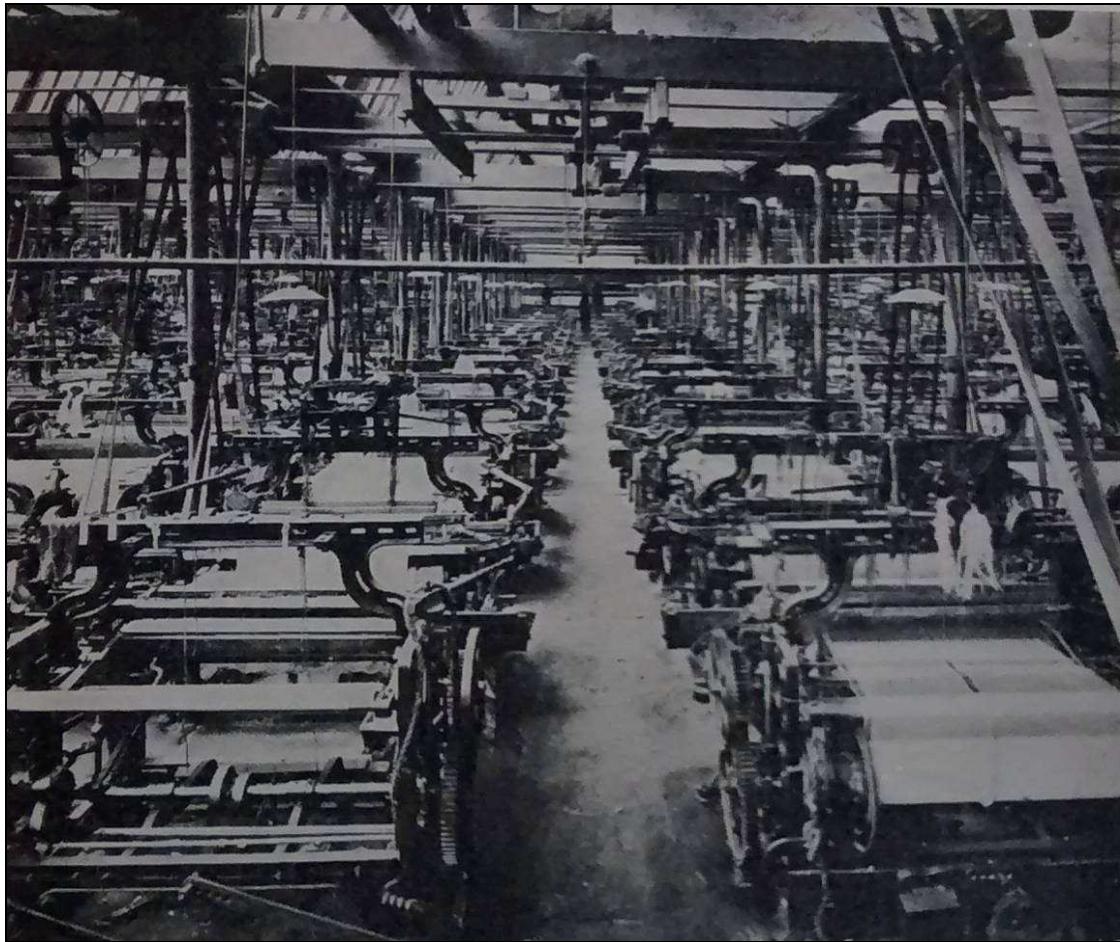
- 3.1.13 Other photographs feature the interior of the weaving shed (Plate 9) and the cloth warehouse (Plate 10). The weaving shed appears to be typical for the period, with power to the looms provided via drive belts from overhead line-shafts. The roof trusses appear to be of timber, consistent with a mid-nineteenth-century construction date, together with relatively narrow spacing between the columns that was necessary before the introduction of steel joists in the late nineteenth century.

*Plate 9: View of the weaving shed (from the Amalgamated Cotton Mills Trust Ltd, 1921)*

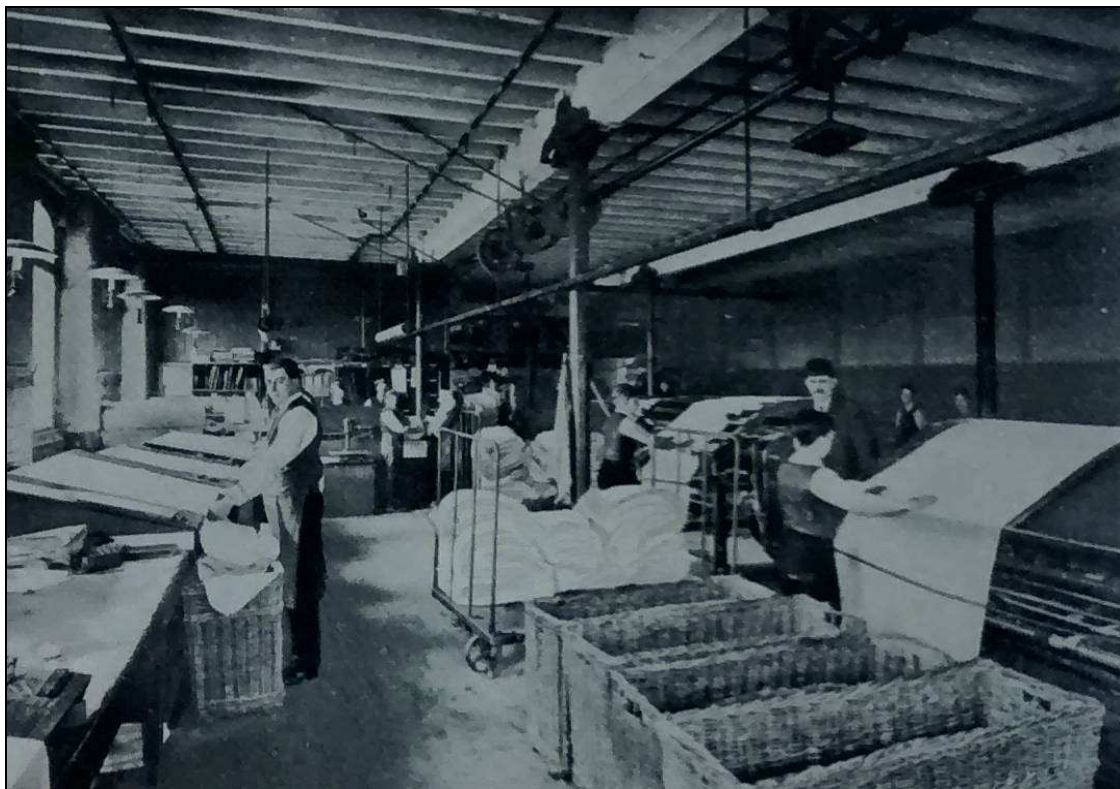
*Plate 10: View of the cloth warehouse (from the Amalgamated Cotton Mills Trust Ltd, 1921)*

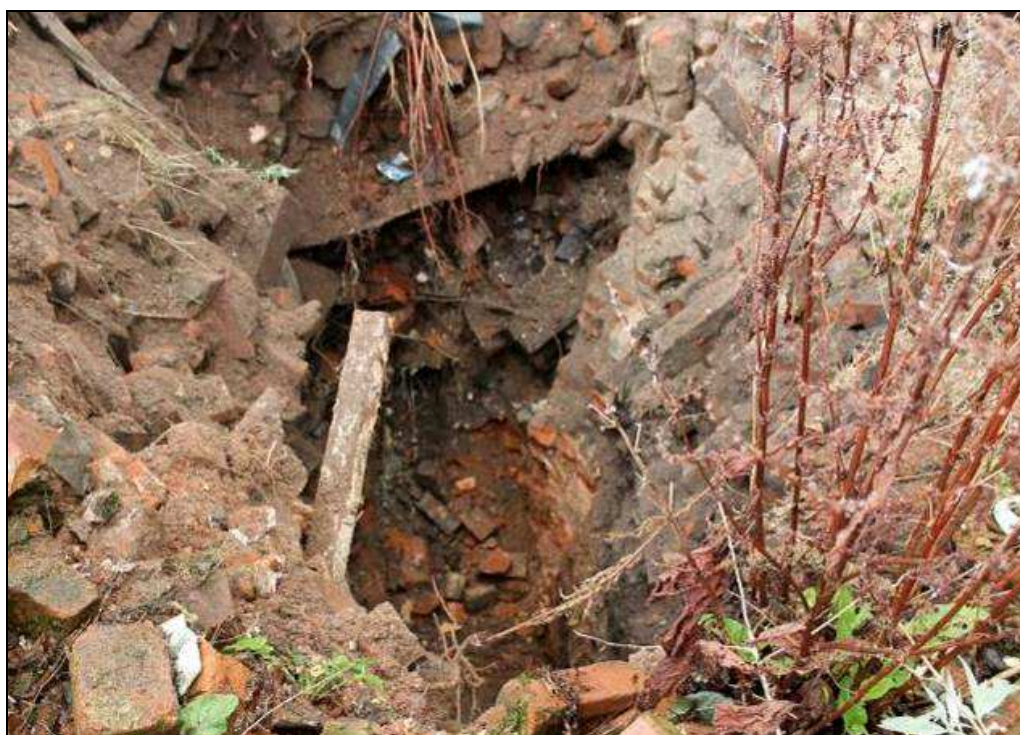
4.2.1 **Trench 1:** in the first instance, this trench measured 5 x 1.7m, and straddled the footprint of the engine house and water tank in the northern part of the study area (Fig 2). The trench contained loose brick and masonry rubble, and was excavated to a maximum depth of 2.7m. The fragmentary remains of the brick-built wall between the engine house and the adjacent building were observed on the north-western side of the trench (Plate 12). However, only the north-western end of this wall survived *in-situ* within the confines of the small trench, with no evidence for any interior fixtures, fittings or floor. The loose demolition rubble contained numerous metal pipes, which probably derived from the mill's sprinkler system and steam pipes.

Plate 12: Trench 1 looking west, remains of dividing wall centre right

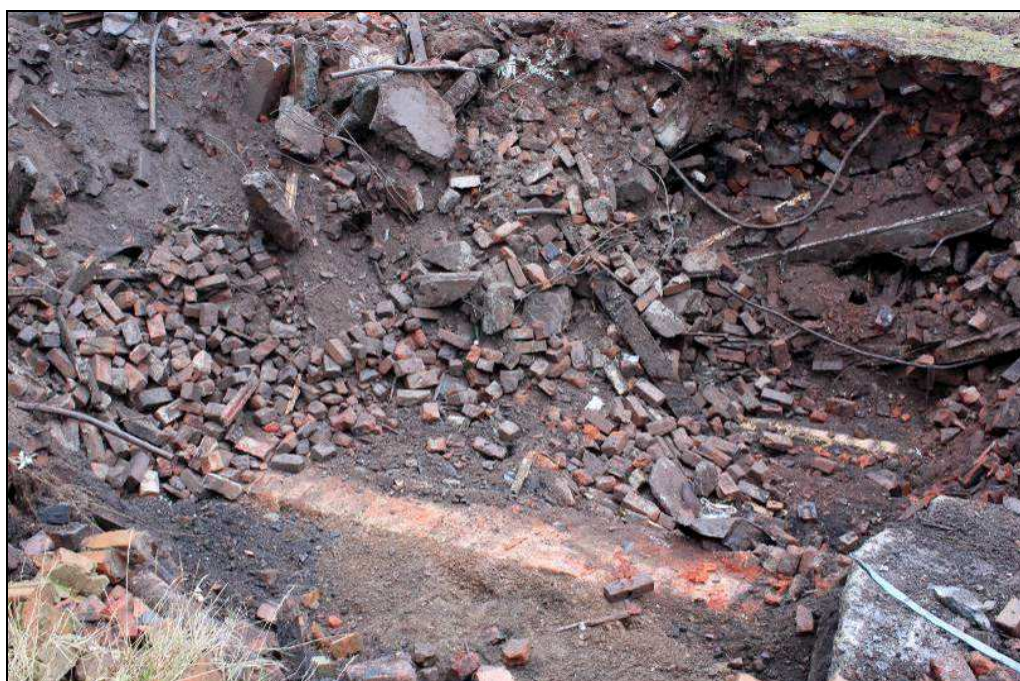
- 4.2.2 In order to further understand the nature of the buried remains in this part of the site, the trench was extended to dimensions 15 x 5m along the footprint of the engine house and the adjacent water tower, incorporating the south-western edge of the chimney. The north-eastern wall of the engine house was exposed along the length of the trench as a depth of *c* 1.4m (Plate 13). The wall was three brick-courses thick, and the fabric comprised a combination of hand-made and machine-pressed bricks, suggesting that the building was constructed after 1850, and was thus added to the original mill complex in the later nineteenth century. The demolition rubble around the intact element of the wall contained numerous examples of bricks stamped 'J Higson Daubhill'; this local brickworks did not open until the mid-1870s.

*Plate 13: The extended excavation of Trench 1, looking east across the north-eastern wall of the engine house and the side of the refractory-brick lined flue to the rear*

- 4.2.3 Lying parallel to the engine house wall was a second wall that was lined with refractory bricks, almost certainly representing the remains of the flue to the chimney. The top of this wall was exposed beneath demolition rubble at a depth of *c* 1.9m below the modern ground surface. The base of the flue was not exposed, although the side wall survived to a height of at least six courses. The flue continued to the south-eastern end of the excavated trench, where it joined to the chimney.

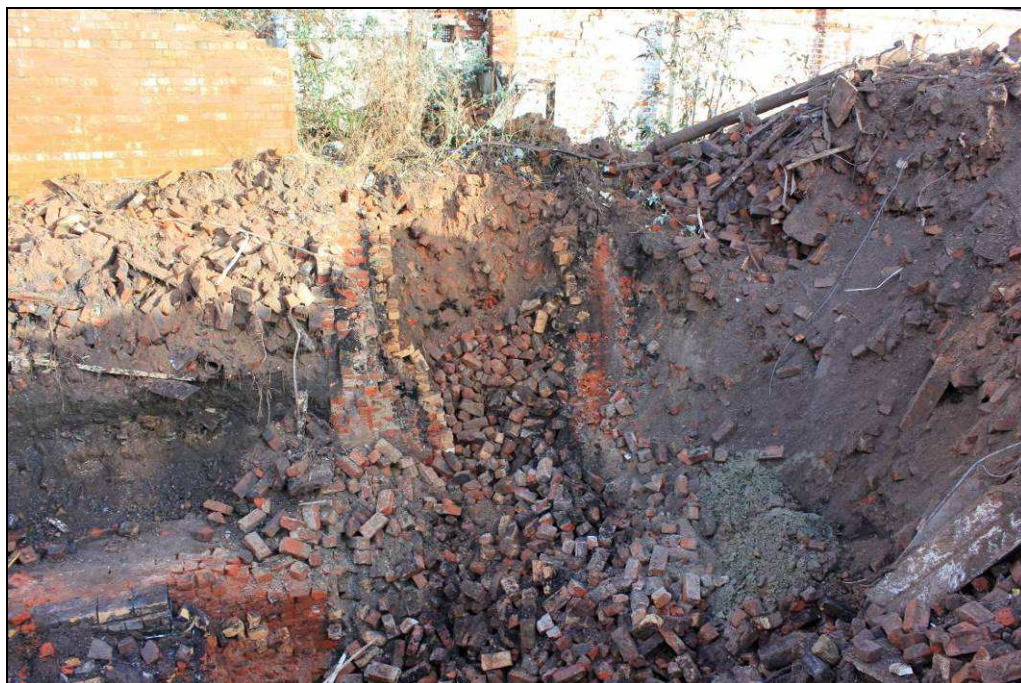
- 4.2.4 The remains of the chimney stack and its foundations were exposed in the south-eastern section of the trench. The foundations were built entirely of brick, and the chimney throat was lined with refractory bricks. The arched aperture that connected with the flue at the base of the stack was largely collapsed (Plate 14).

*Plate 14: The remains of the demolished chimney stack, and the side wall of the flue*

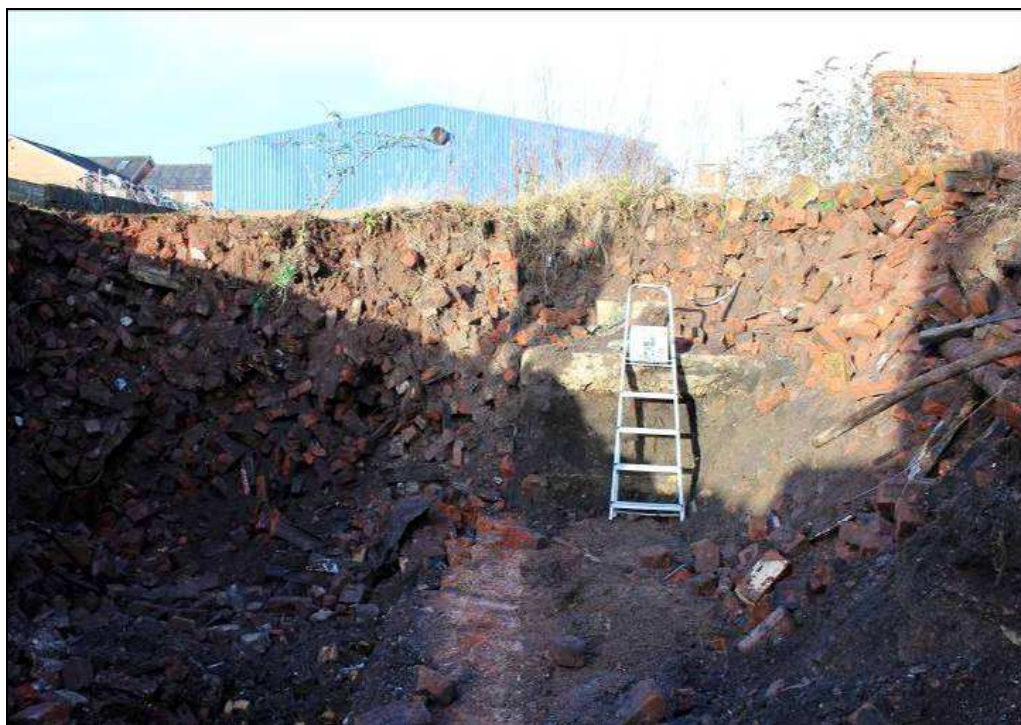
- 4.2.5 Structural remains of the water tower were revealed at the north-western end of the trench (Plate 15). This comprised a large stone slab, which was exposed at a depth of *c* 0.9m.

- 4.2.6 Limited excavation against the exterior of the engine house wall revealed what appeared to be the foundation course at a depth of *c* 3.5m. However, a floor to the engine house was not exposed in the trench, and no remains of the engine beds were revealed, suggesting that they had either been removed, or lay beyond the edge of the excavated trench.

*Plate 15: The north-eastern wall of the engine house and stone foundation at the base of the water tower at the north-western end of Trench 1*

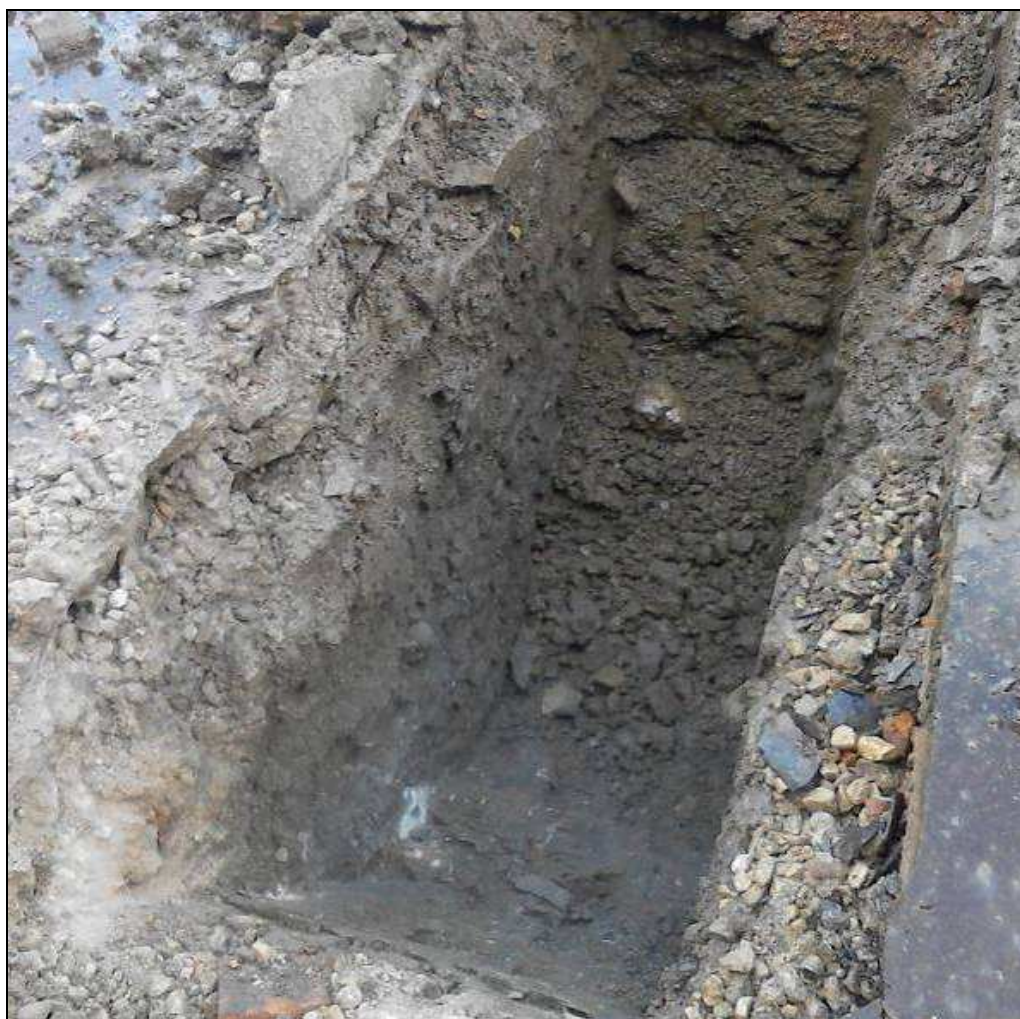
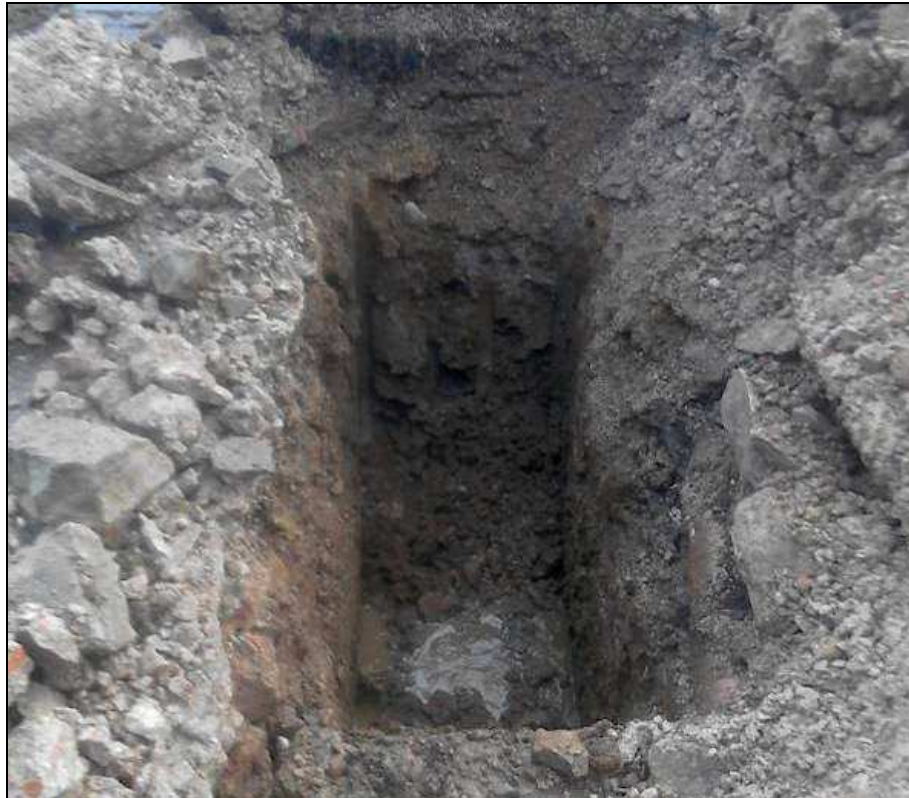
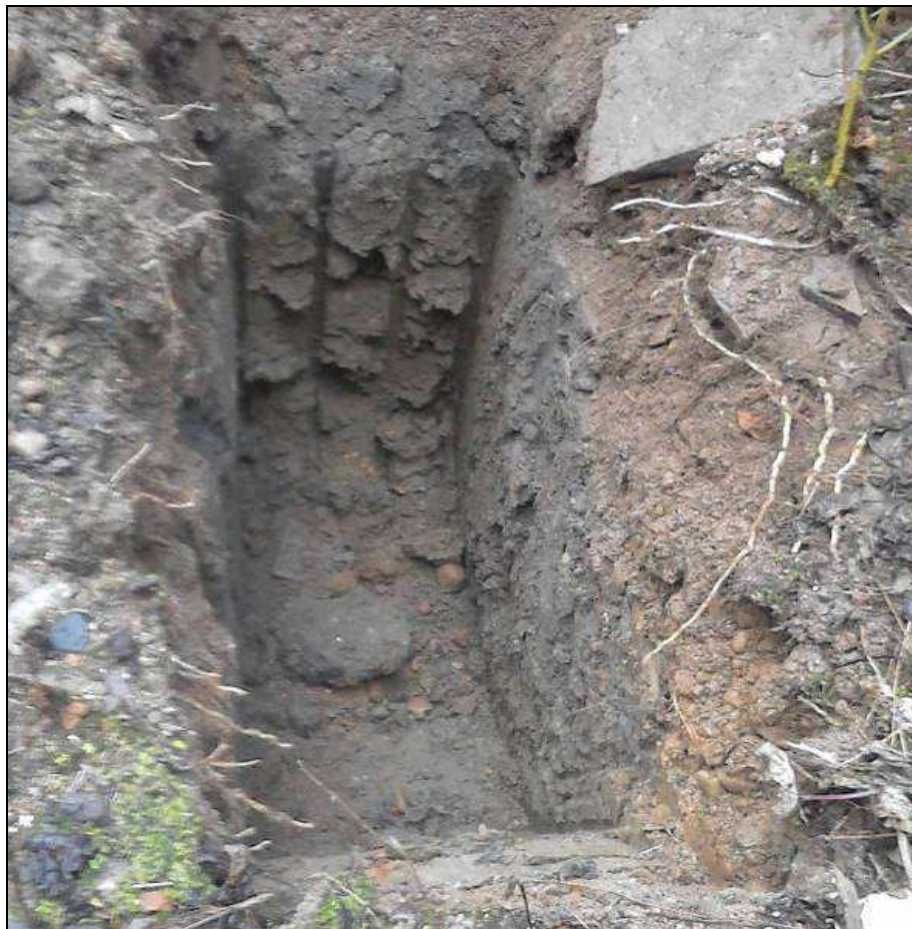
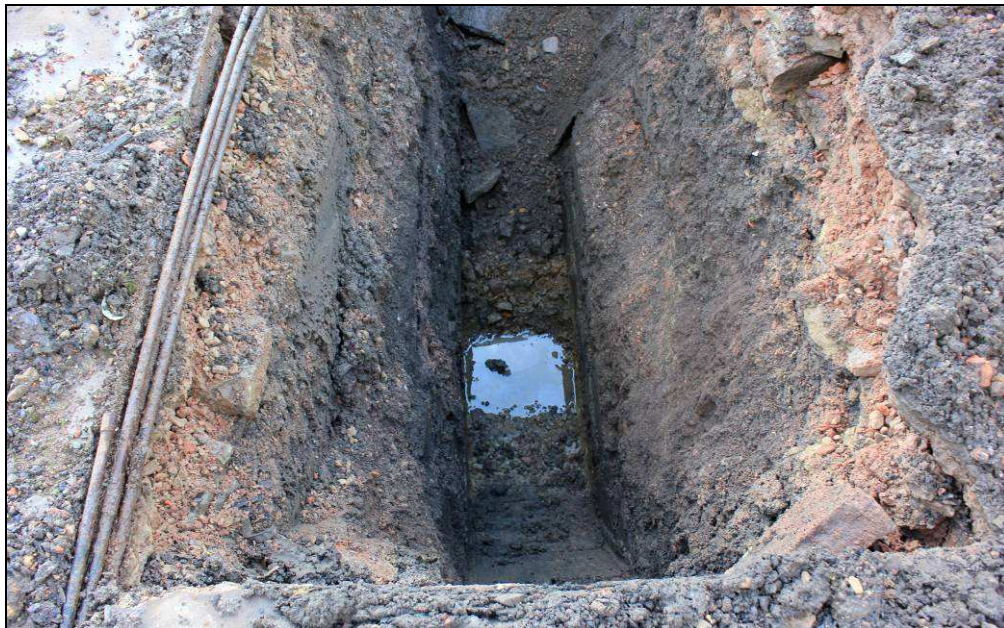
- 4.2.7 **Trenches 2 – 9 and 11:** these trial trenches were placed across the footprint of the weaving shed and the three-storey block, as shown on the Ordnance Survey plan of 1891 (Fig 2), and were excavated primarily for geo-technical purposes. The trenches all measured 3m long, with the exception of Trench 11, which was excavated to a length of 7m.
- 4.2.8 The concrete floors throughout these buildings were revealed beneath the existing ground surface and demolition rubble. Excavation through the concrete and into the natural clay geology revealed no remains of any archaeological interest. The natural clay geology was exposed at a depth of 0.3m to 0.4m at the south-western side of the site, sloping gradually downwards to the north-east where it was observed at between 0.7m and 1.1m below the existing ground surface (Plates 16-19).

*Plate 16: Trench 2, looking south-west*

*Plate 17: Trench 6, looking south-east*

*Plate 18: Trench 8, looking south-west*

*Plate 19: Trench 11, looking north-west*

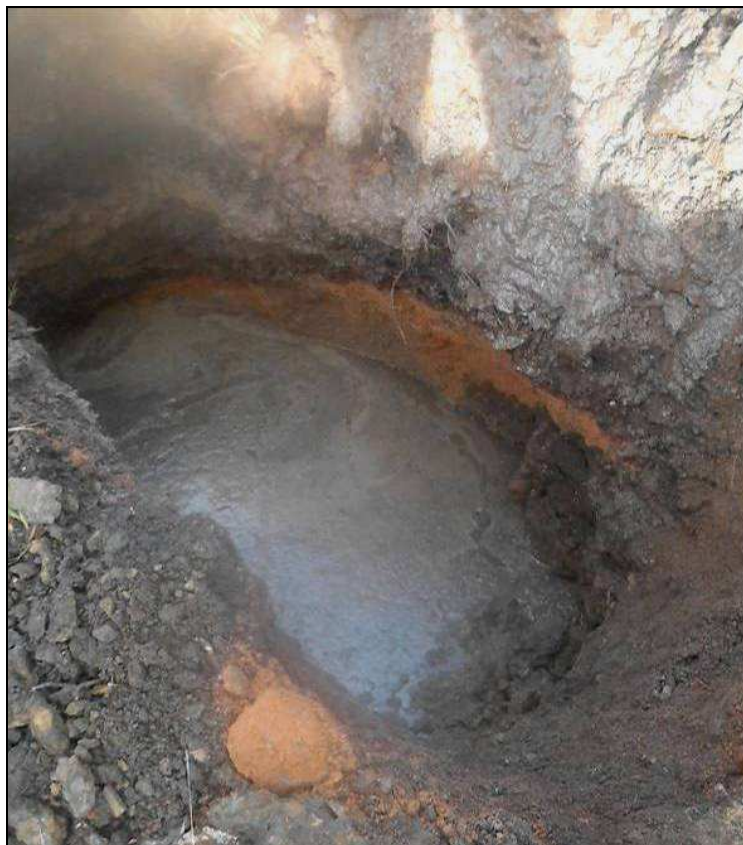
4.2.9 **Trench 10:** this trench was placed across the site of the former reservoir to the north-west of the main mill complex (Fig 2). Excavation revealed that the reservoir had been backfilled with layers of cinder, ash and sand. The trench was subject to rapid flooding at a depth of *c* 1.2m (Plate 20), undermining the loose material in the vertical sections, and precluding any further excavation. No remains of archaeological interest were identified in the trench

*Plate 20: Flooded Trench 10, looking south*
