Fulbourn Primary School, Cambridgeshire

Archaeological Monitoring & Recording Report

OA East Report No: 1689

Site Code: FULPRS14

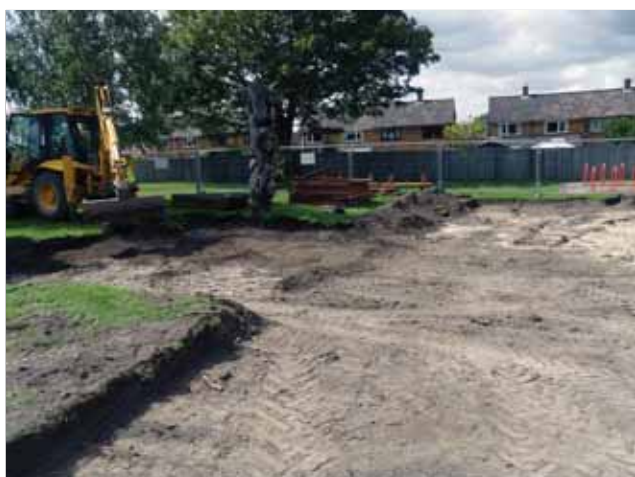
- 4.1.1 No archaeological features were seen during the monitoring of the works.
- 4.1.2 During construction of the new car park (Fig. 2; Plate 1), 0.25m of topsoil was stripped with a ditching bucket. In parts of the area, modern made ground was uncovered. In other areas, topsoil was deeper than the excavated level for the car park. No finds were recovered from the topsoil.

←
Plate 1: Stripping of topsoil in car park area

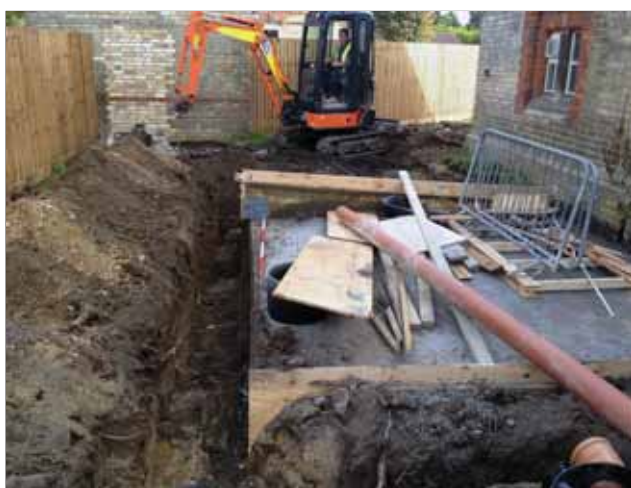
- 4.1.3 The pipe trenching excavated around the school (Fig. 2; Plate 2) was excavated to a depth of 0.7m. Natural sand geology was located at a depth of 0.6m below ground level, overlain by 0.3m of sandy subsoil, in turn overlain by 0.3m of topsoil.

←
Plate 2: Excavation of pipe trenches, looking east
(Victorian well located underneath concrete slab)

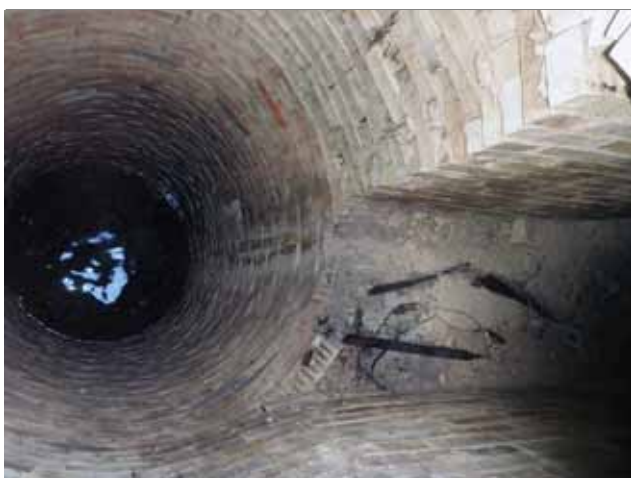
- 4.1.4 A Victorian well was uncovered during the works next to the Victorian school house. This well was lined with Cambridge White perforated bricks, dating to the mid 19th Century. The well measured 3.5m in diameter, with a depth of at least 5m. The well was beehive shaped at the top, and was sealed by a 0.5m by 0.5m sandstone slab. A brick lined channel lead from the well into the back of the school house, presumably to draw water into the building (Fig. 2; Plate 3).

←
Plate 3: View down Victorian well, note the channel
leading in to school building.

- 5.1.1 The works at Fulbourn Primary School have shown that no known or unknown heritage assets have been impacted upon during the works. The known Saxon remains found in excavations directly to the north were not seen to be within the areas excavated during the works.
- 5.1.2 The Victorian well uncovered during the building works was constructed of the same Cambridge White brick as the school building, dating the well to the same period as the construction of the school, the mid 19th century. The well was re-capped with a concrete slab during the works.
