# Alma Tavern and Winstanley Metal Works Wandsworth

**Historic Building Recording  
and Investigation**

**Client: Young's and Co. Brewery**

*Historic Buildings Recording and investigation*

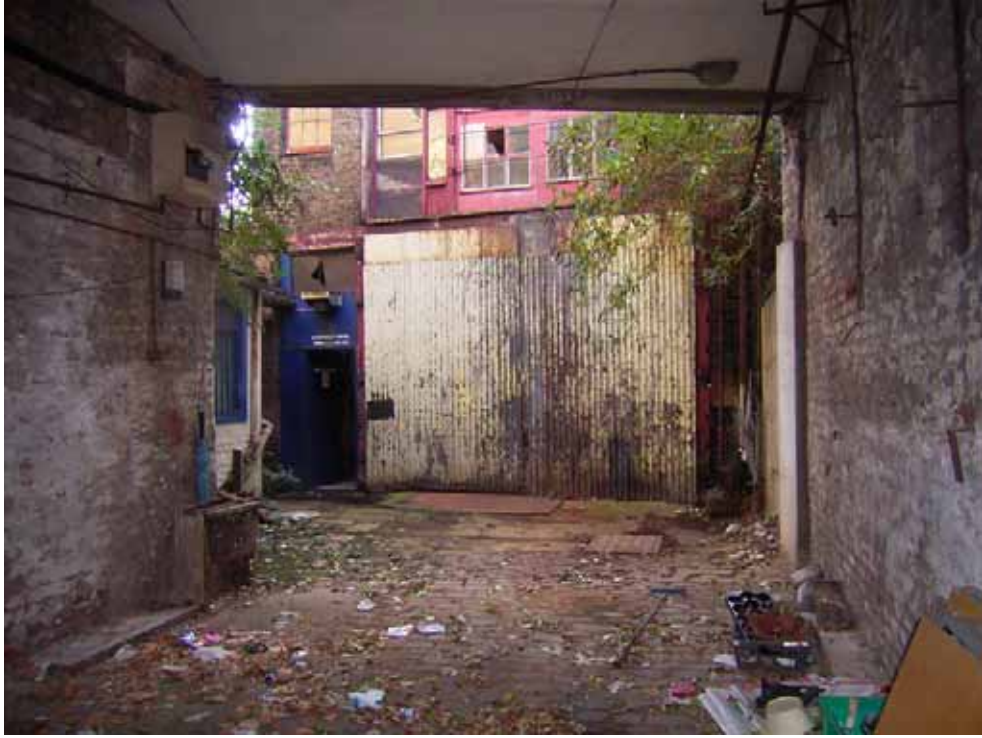
- 3.2.1 *North Elevation:* The north elevation is a 2-storied gable end with walling of smoke darkened, yellow stock brick. Ground floor level is mostly made up of large corrugated metal double doors on a simple iron frame (Plate 1). These are modern replacement doors. Next to these, on the left hand side, is a smaller modern doorway for pedestrian access. At the east side of this elevation, there is an outdoor concrete stairway which is the only mean of access to the first floor (Plate 2). It has a very shallow incline north to south and runs the whole length of the northern half of the building on the east side where it meets a door at the point where the wall dog-legs towards the east. The stairway is enclosed on the east side with a high wall of yellow stock brick. There are the remains of a modern timber roof over the stairs but this would probably have replaced an original roof. The shallow nature of the incline may have been to allow small barrows to access the upper floor. The staircase abuts three primary first floor windows in the east elevation suggesting it may have been a secondary addition. The windows beneath the line of the stairs have now been blocked.

Entrance in north elevation

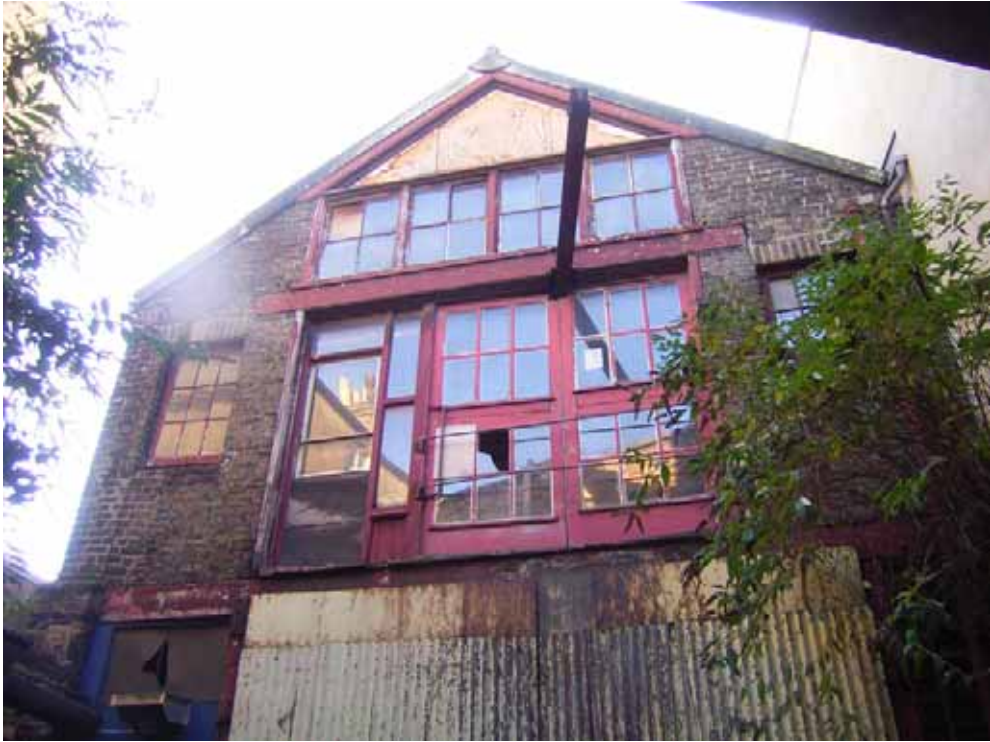
- 3.2.2 In the first floor level of the north elevation is a glazed loading bay with two almost entirely glazed doors beneath a projecting RSJ from a former hoist (Plate 3). This projects approximately 2m out of the building. Above the doors are four 4-light windows and at either side of the loading bay are fixed 9-light windows. There are two safety bars fitted across the doorway of the loading bay on the exterior. The arrangement of the doors and the surrounding windows of the loading bay appears to be an original 19<sup>th</sup> century feature.

Glazed loading bay in north elevation

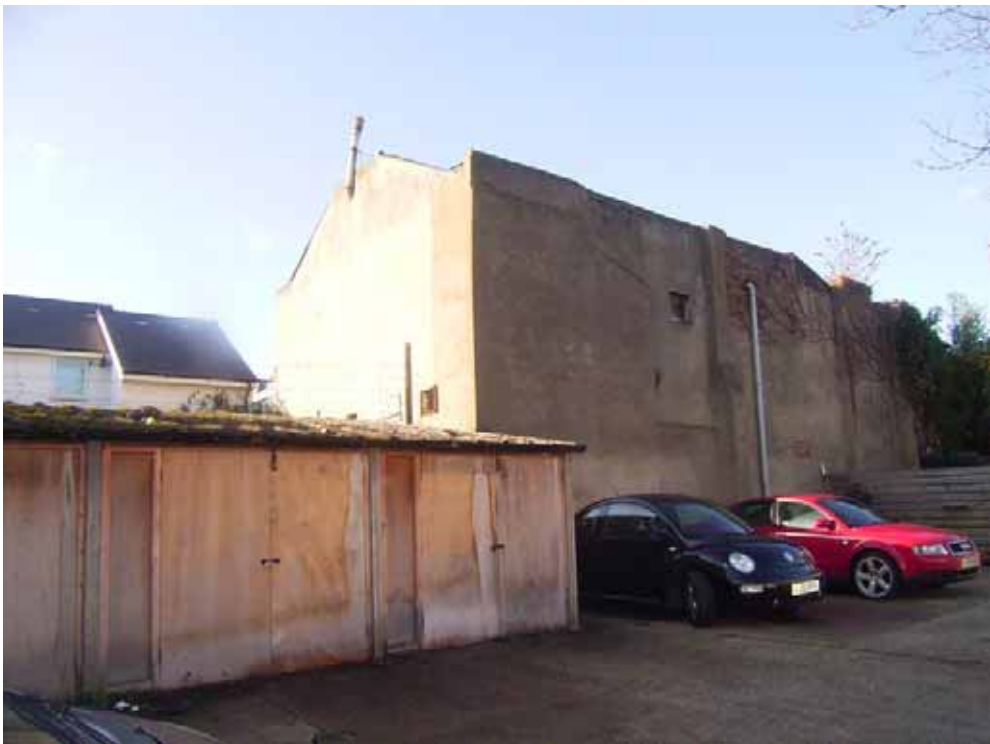
3.2.4 *East Elevation:* The southern half of the east elevation is entirely rendered with cement and is unpainted (Plate 4). There is one small window in the wall at first floor level towards the south side and to the right of this is a buttress. The line of the roof is irregular as the building seems to have been built in two halves with the northern half approximately 1m lower than the southern half where the east face dog-legs (discussed in more detail below). The northern half of this elevation is the wall enclosing the outdoor shallow staircase which provides access to the first floor of the building.

South and east elevations

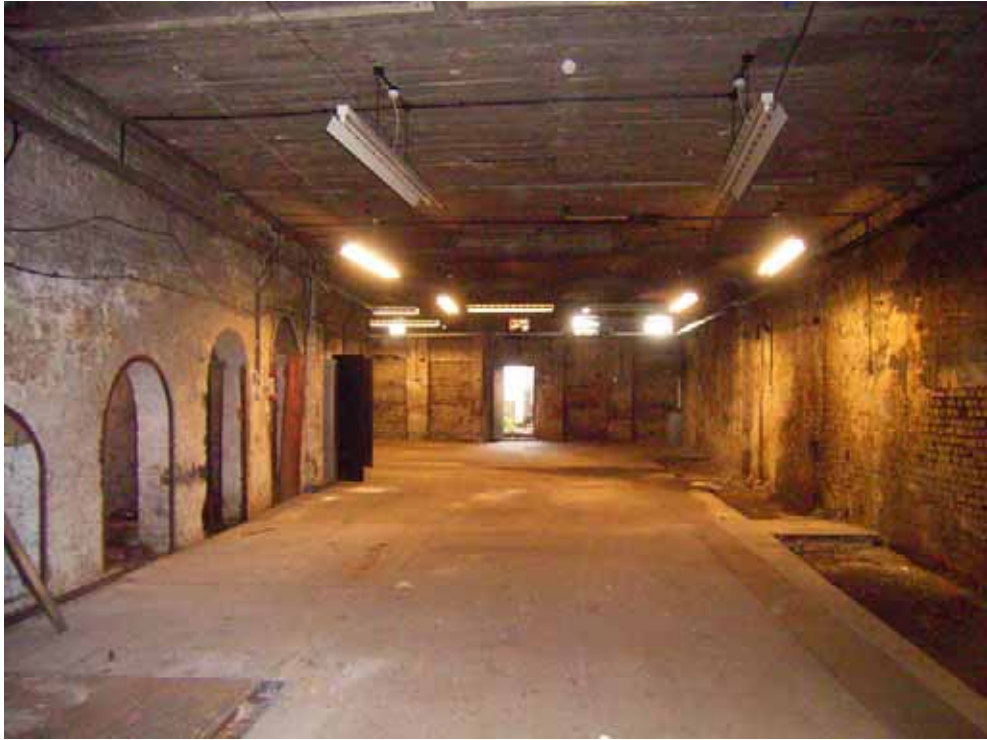
3.3.1 *Ground Floor:* (Fig. 4) The ground floor of the metal works is an open hall which has been stripped of machinery and equipment (Plate 5). The walls are of un-plastered brick with many paint layers, much of which has come away. The bricks are of a rough quality, typical of late 19<sup>th</sup> century industrial London. The west elevation is relatively featureless and has no clear imprints of former machinery or fixtures. It does however feature two shallow piers supporting large steel joists above. The North wall, as on the exterior, is mostly made up of large corrugated doors with a smaller modern door to the right (Plate 6).

General view of ground floor facing south

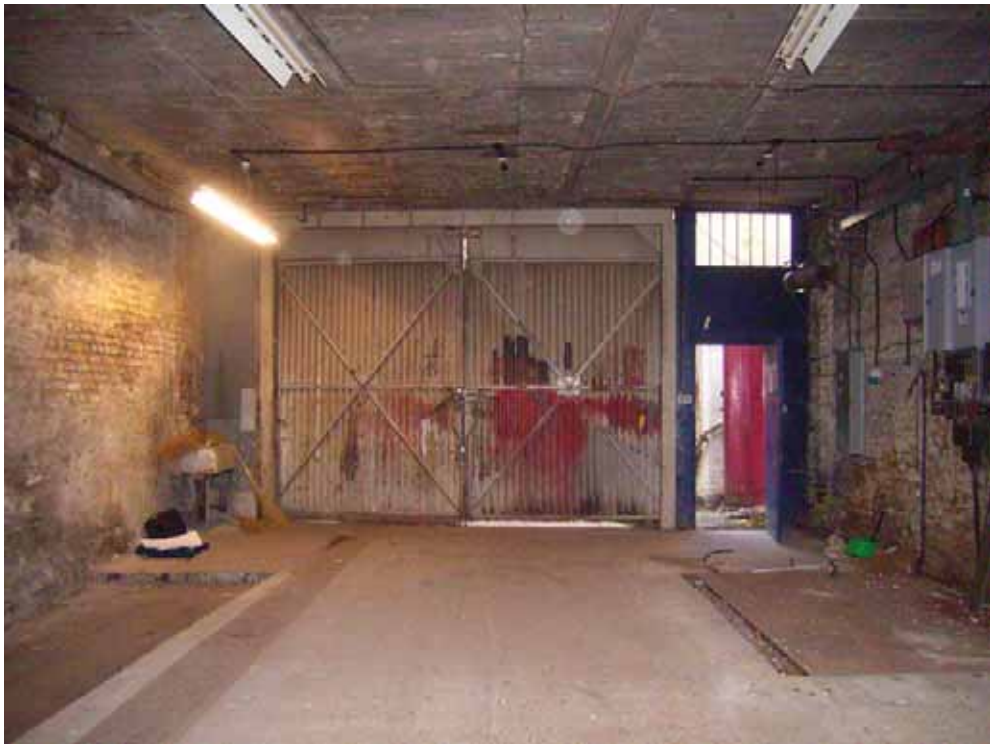
North interior elevation

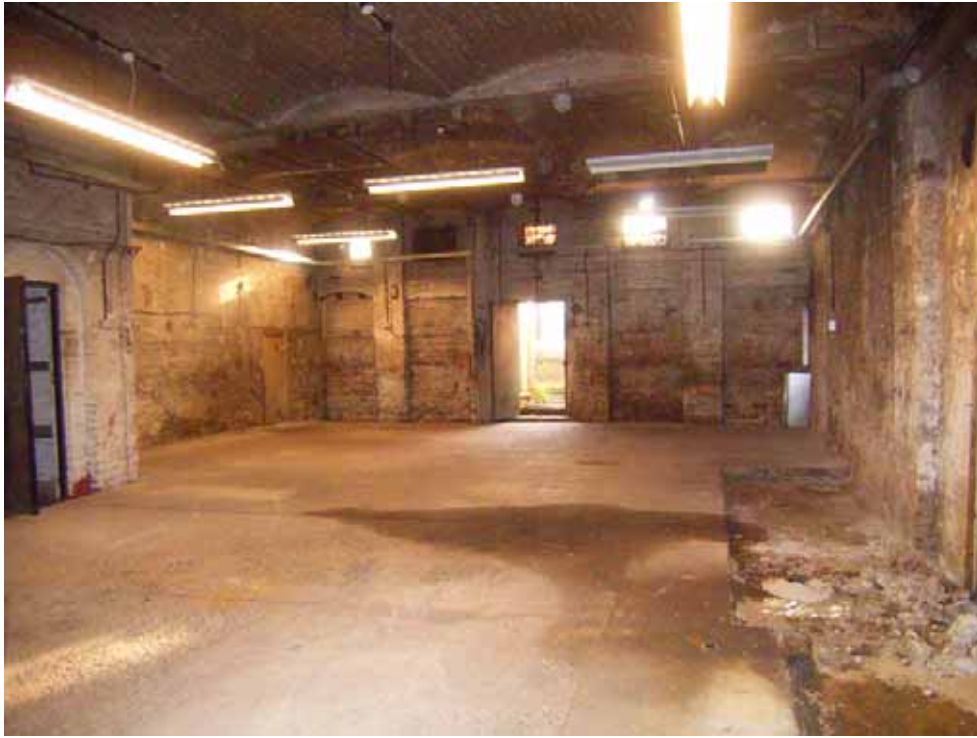
3.3.2 The south wall is a little more interesting with five narrow flat arched bays divided by shallow piers (Plate 7). At the top of each bay, there is a small rectangular window filled with perspex glazing, with the exception of the second from the left, which is filled with a modern extractor fan. The middle bay features a doorway and the four flanking bays feature relieving arches under the windows. In the two left hand bays, the blind arches appear to have what could be a large blocked window or two blocked doorways in them (Plate 8).

South interior elevation

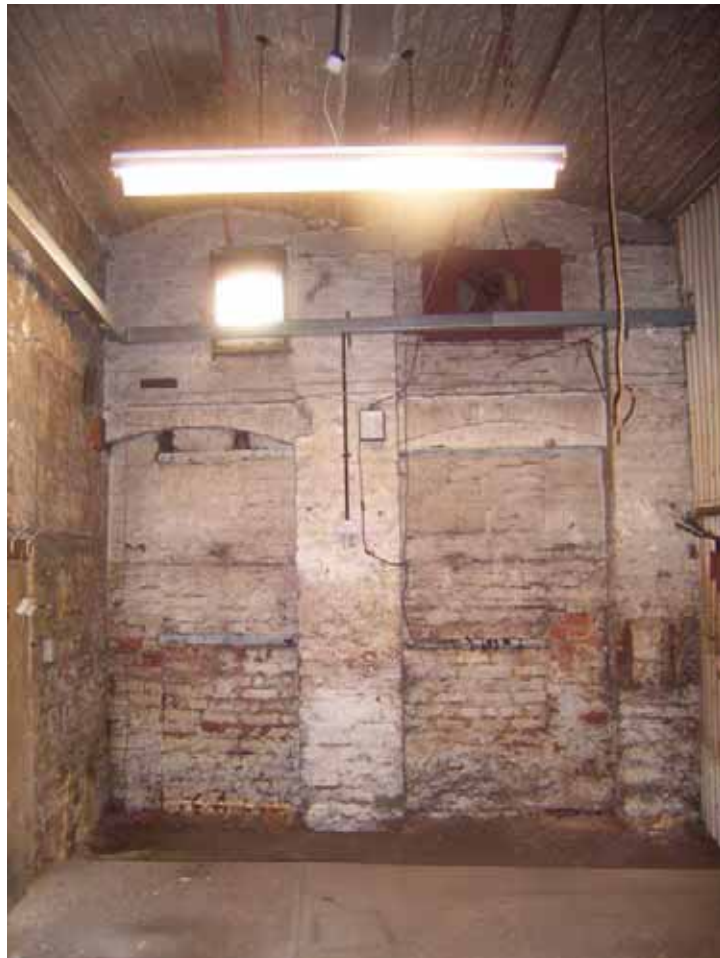
Detail of south interior elevation

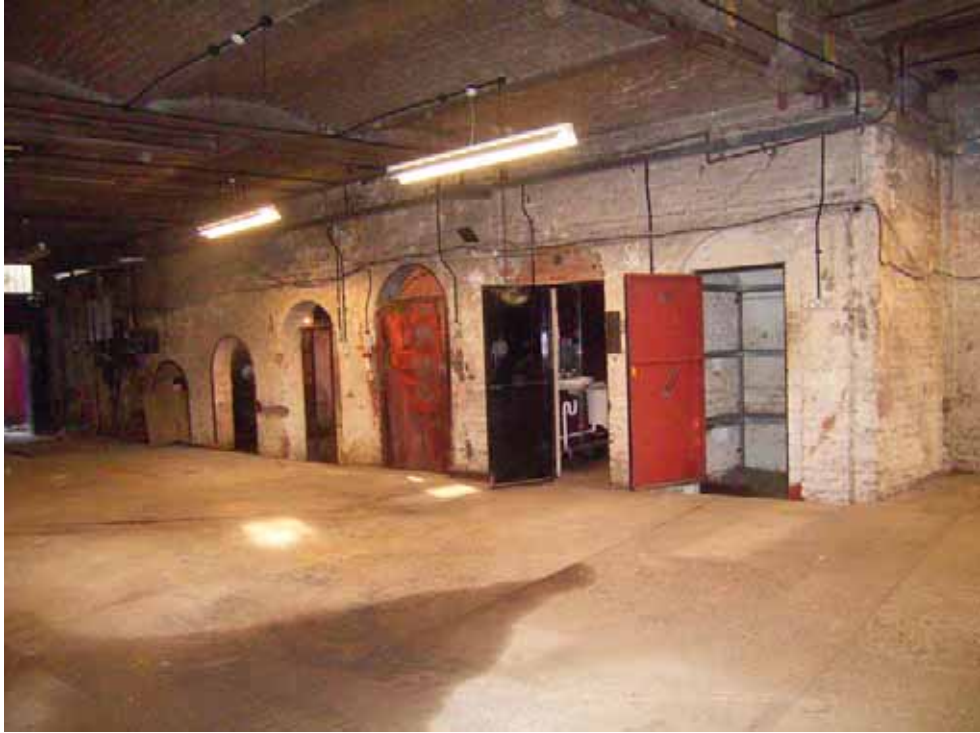
Arches in east interior elevation

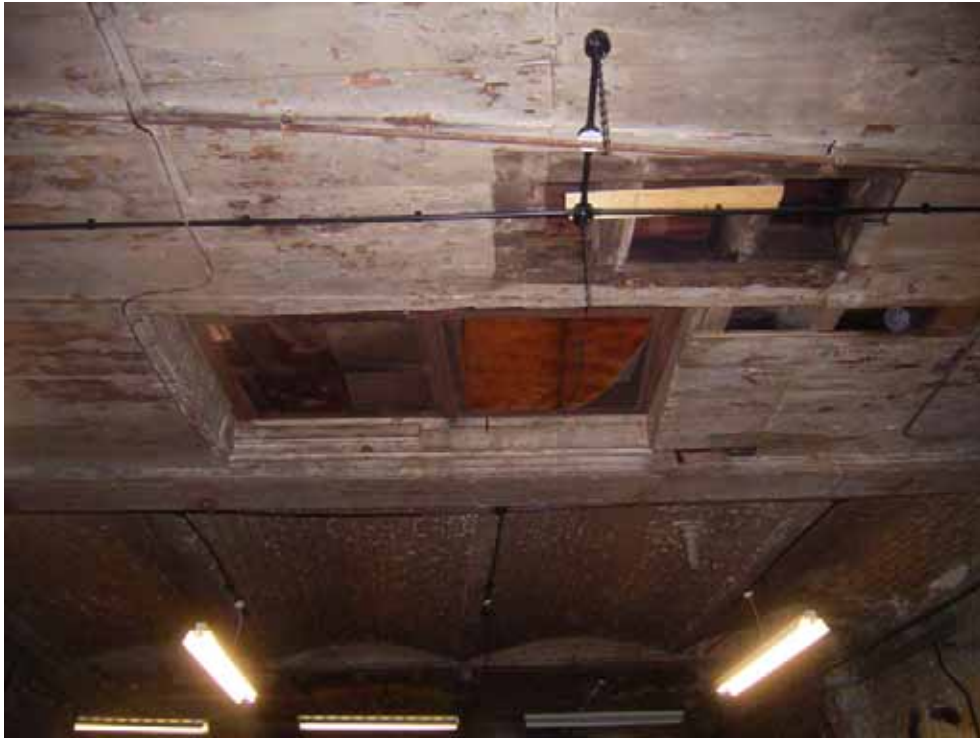
- 3.3.5 The underside of the first floor is of structural interest as the northern half is made up of timber boards with a large hatch and the southern end is built with brick jack arches, forming the flat arched bays of the southern elevation (Plate 10). There are two composite steel beams riveted to the jack arch ceiling running east to west.

Ceiling detail, facing south

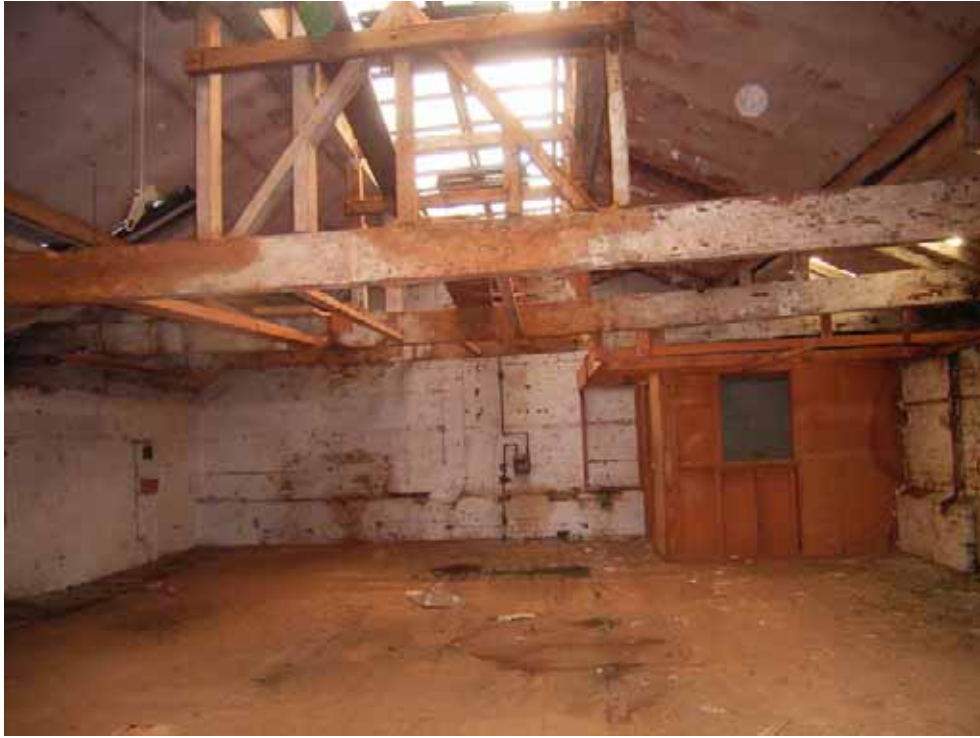
- 3.3.6 *First Floor, South:* The first floor, even more so than the ground floor below, features two distinct areas north and south and the form strongly suggest that at least for a period the two halves were occupied by different companies. The south side has walls of painted rough stock brick, consistent with the ground floor, and is largely featureless except for a small, modern wooden office unit in the south west corner (Plate 11) and a small, square shuttered window in the east wall.

South room on first floor, facing south

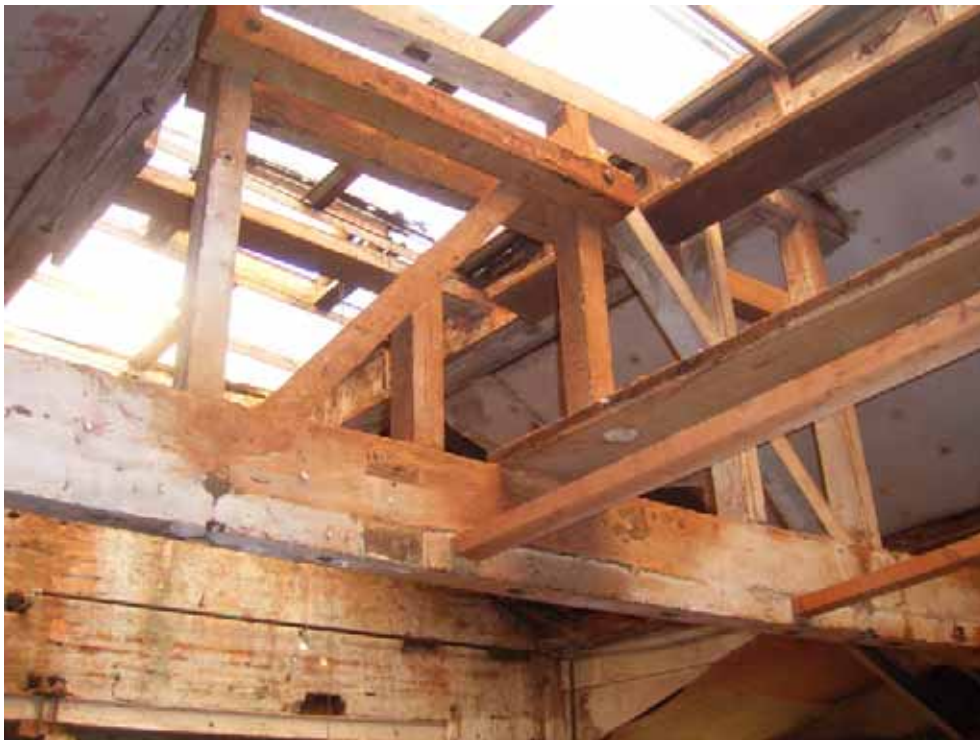
- 3.3.7 The roof however, has a very unusual form. It has three trusses and long spans but the main structure all appears to be concentrated at the centre with queen posts which are braced from the centre rather than the sides (Plate 12). The trusses have a cobbled-together appearance and in several areas, there are secondary bearers strapped and bolted to primary members. Presumably, there would have been a previous louvre or window prior to the curved perspex skylight that currently occupies the length of the roof.

Roof structure of south room on first floor, facing north-east

- 3.3.8 In the centre of the room, there is a depression in the floor with two bolts and some minor oil stains suggesting that there was machinery there. In the northernmost truss above this, there are mortices, some extra bearers and some oil stains suggesting that it may have formed part of a frame for the machinery.

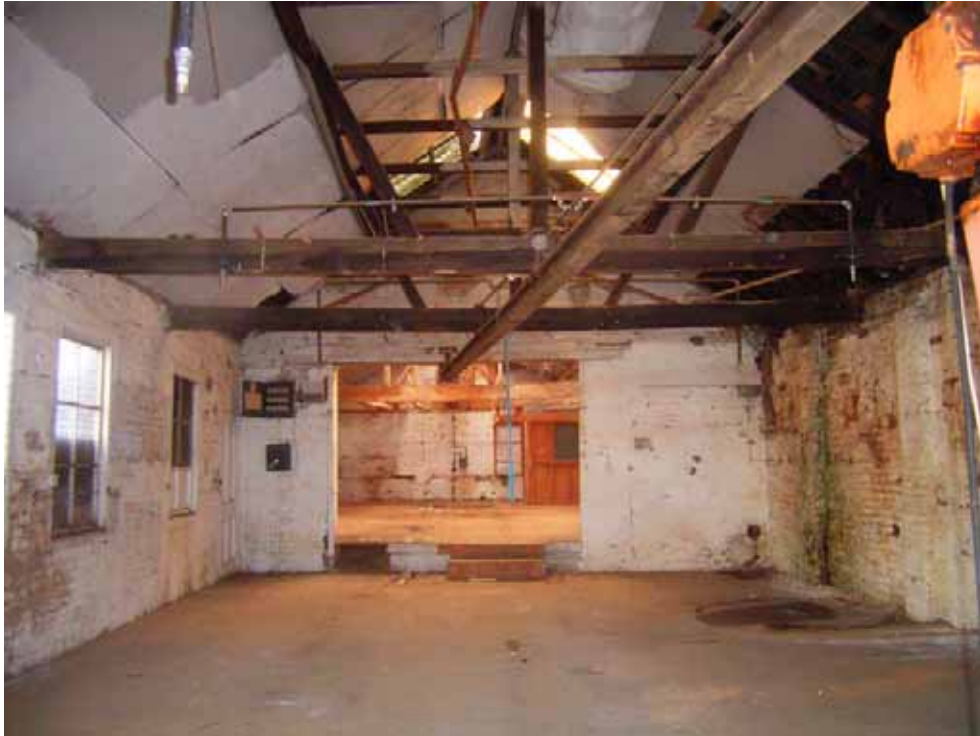
- 3.3.9 *First Floor, North:* There is a large squared opening in the centre of the first floor and wooden steps descend from the south side to the north side where the floor is approximately 40cm lower (Plate 13). The walls are of painted yellow stock brick and there are four 6-light windows on the east wall (above the exterior stairway), some of which are partially blocked on the outer face by the staircase (Plate 14). To the north of these windows, in the corner, there is a wooden frame fixed to the wall where the painted brick is duller (Plate 15). Above this there is a wooden platform fixed to the roof structure. Perhaps there was more machinery or a storage area situated here. The north gable end features the glazed loading bay, discussed earlier in the exterior description, and in the north west corner is a small modern unit built with tongue and groove walls and a simple timber roof (Plate 16). Inside is a WC and a tiny sink area. The west wall is almost entirely featureless except for three shallow buttresses and a large piece of plywood nailed to the wall in the centre (Plate 17). This wall appears to have been subject to much weathering and dampness, perhaps where the roof has failed above.

North room on first floor, facing south

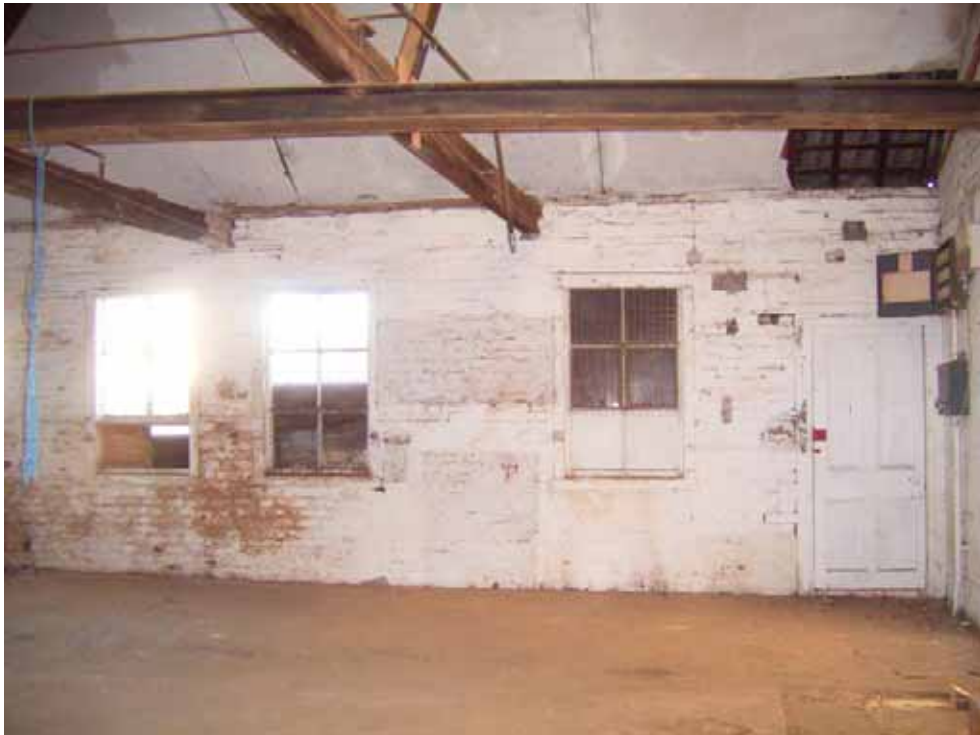
East elevation of north room on first floor

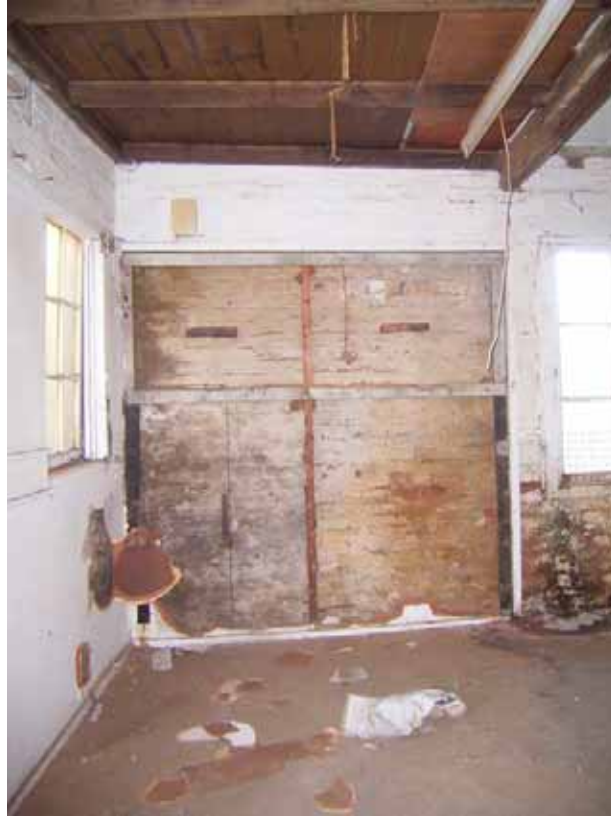
Detail in east elevation of north room on first floor

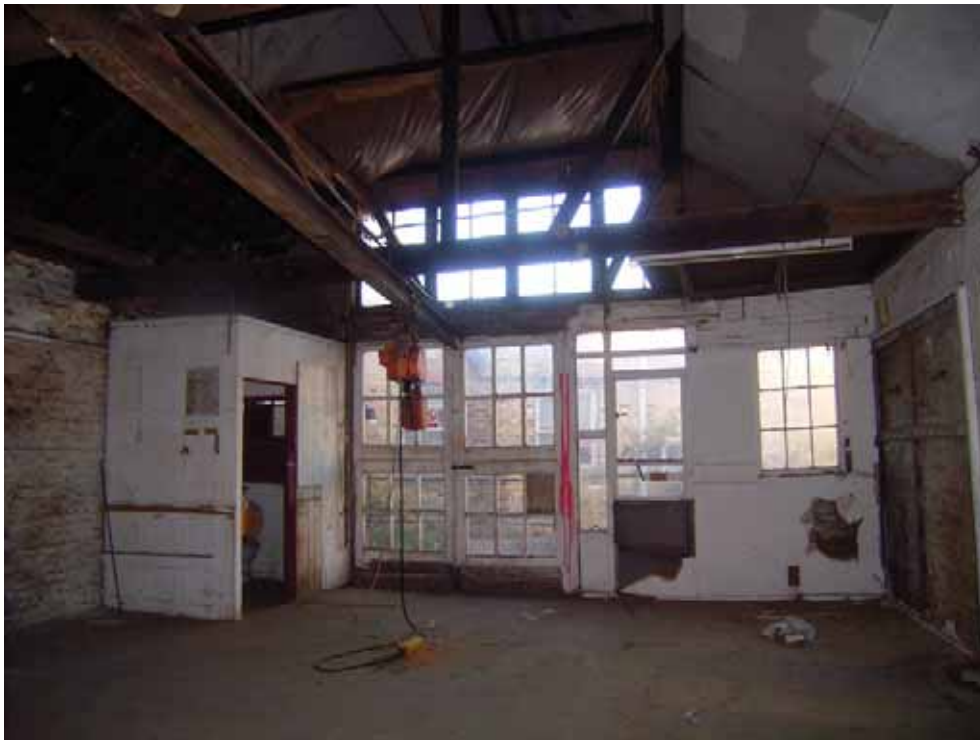
North elevation of north room on first floor

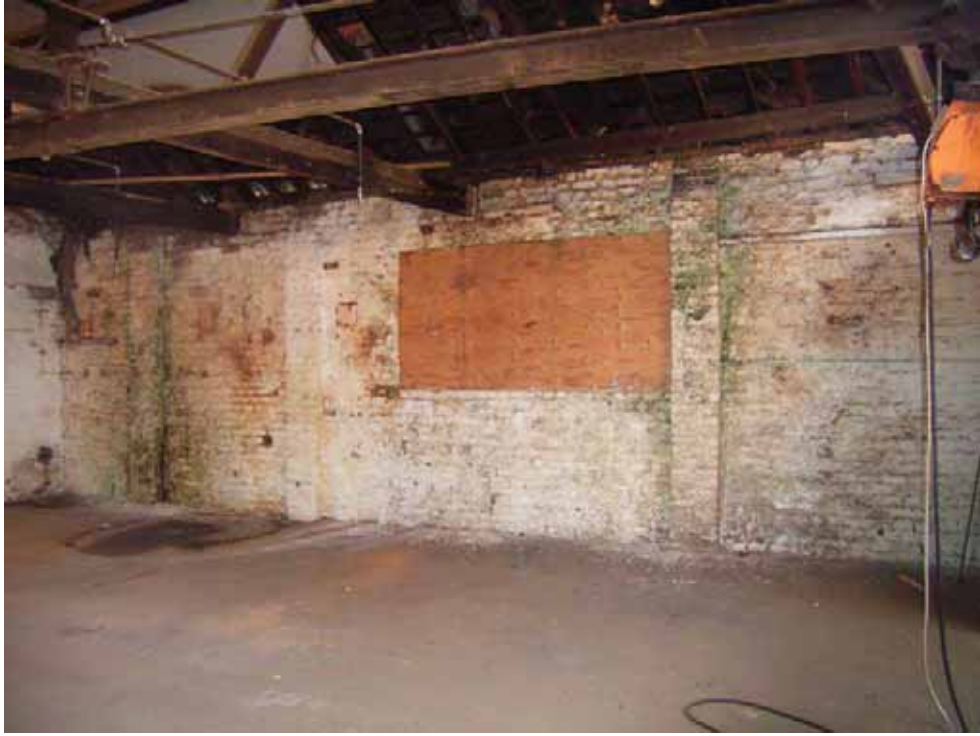
West elevation of north room on first floor

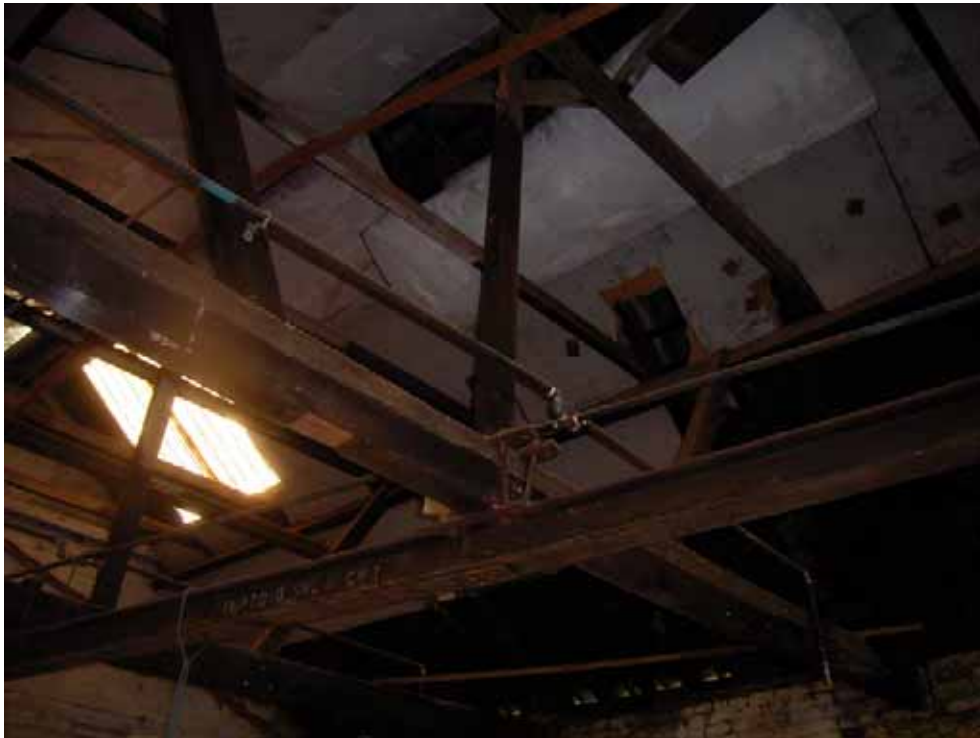
- 3.3.10 The roof in the northern half has a simple timber king post structure with three trusses with a series of joists laid over the purlins (Plate 18). There are windows on the slopes of the roof at the south end but these are largely hidden by the later ceiling. Bolted to the underside of this the large RSJ hoist which protrudes from the glazed loading bay on the exterior of the north elevation. It extends south as far as an opening between the north and south sides and is bolted to the underside of the lintel. The small motorised winch which is still attached to it, would have run along the RSJ (Plate 19).

Roof structure in north room on first floor, facing south-west

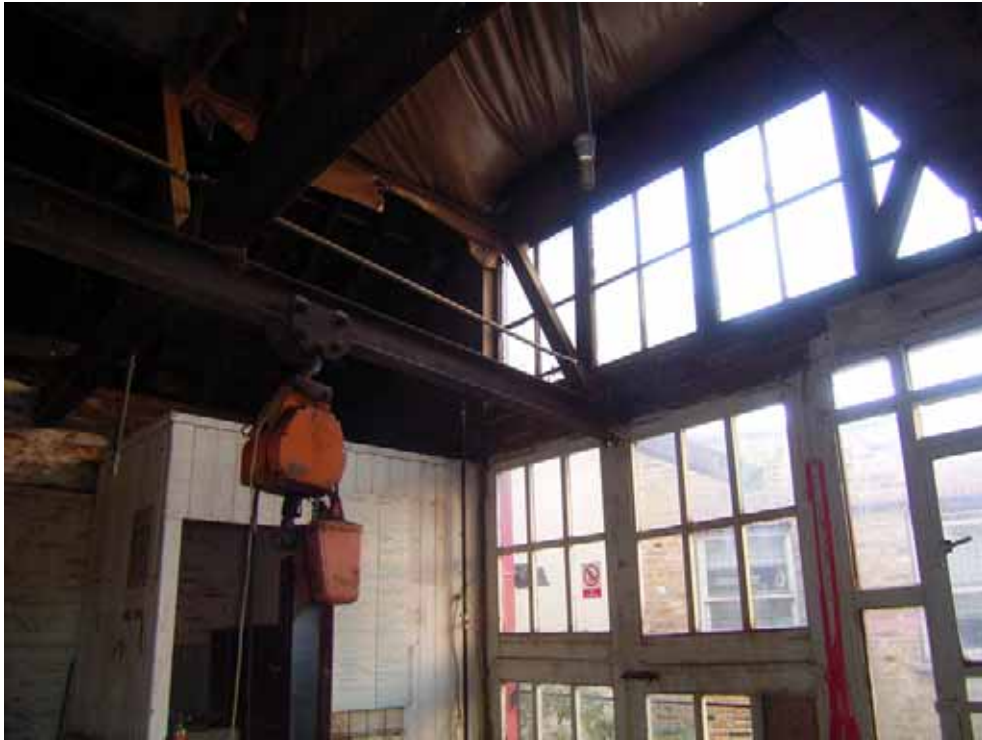
RSJ and winch attached to roof structure in north room on first floor

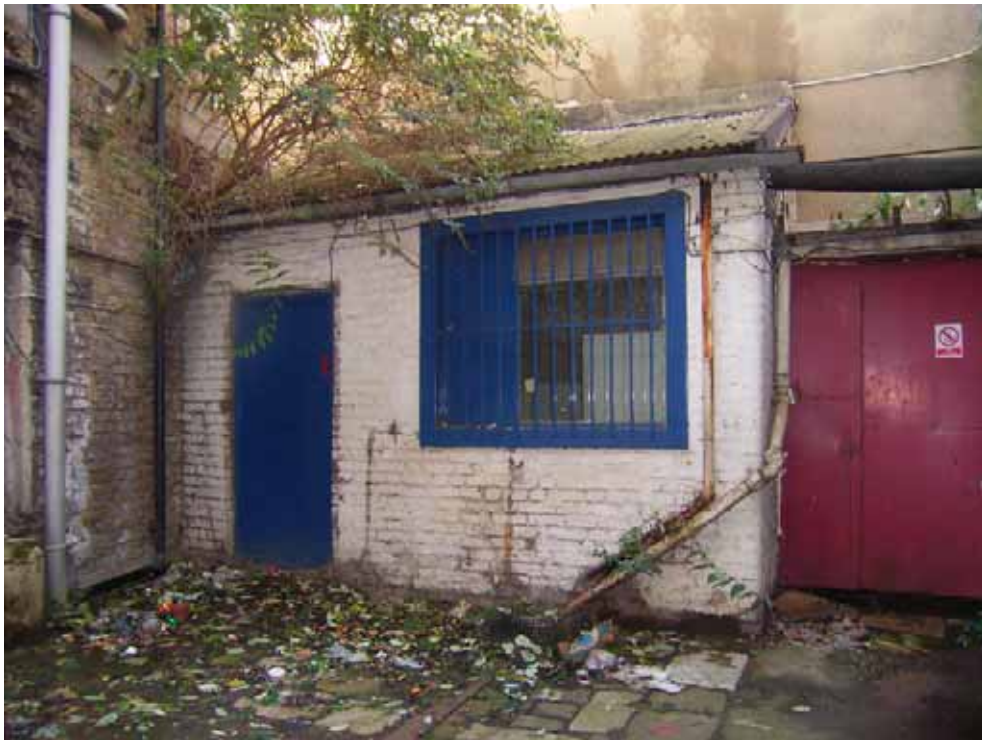
window with bars and a door to the left. Both are painted blue. The roof is of corrugated zinc (Plate 20).

Lean-to outside north end of metal works, facing east

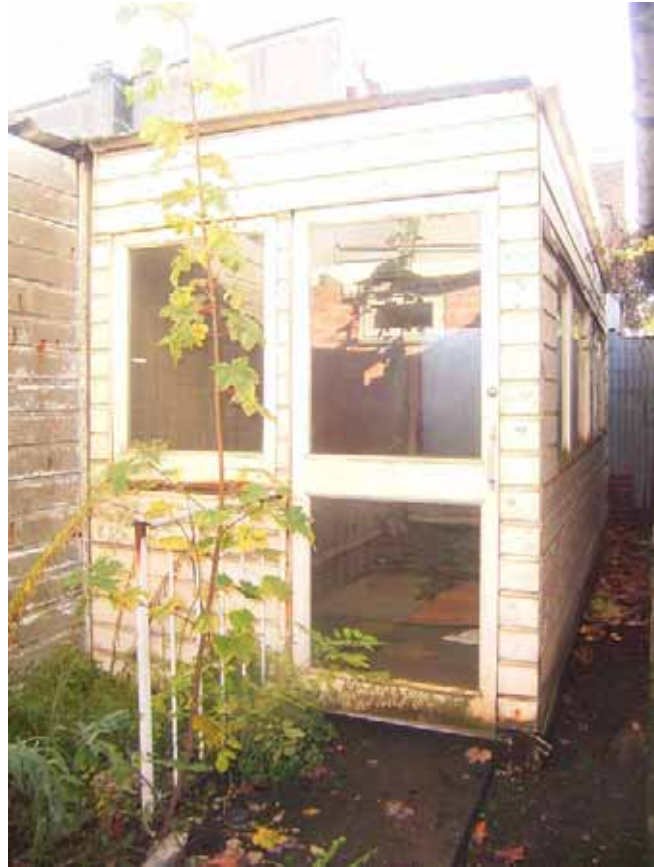
Prefabricated office outside south end of metal works, facing south

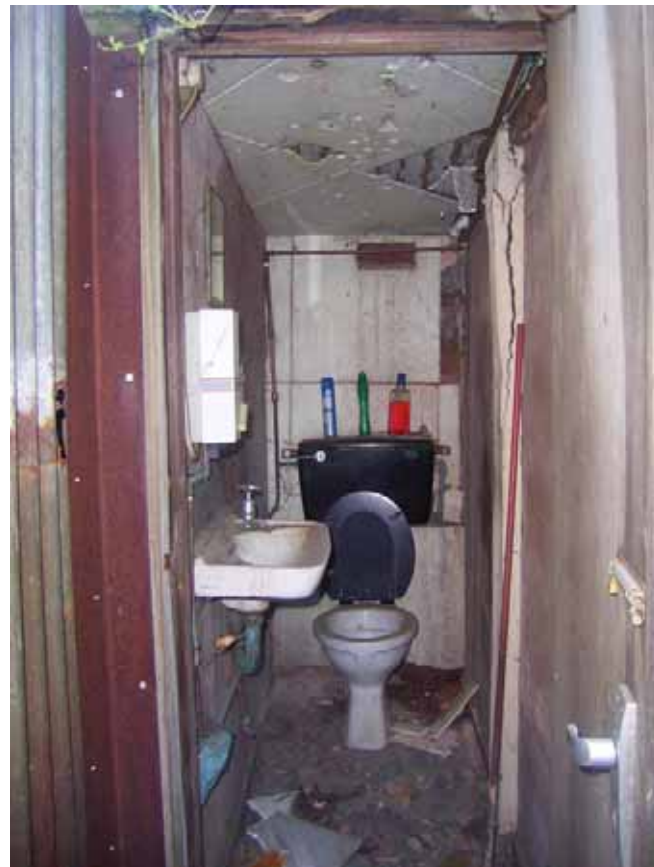
- 3.4.2 At the south side of the metal works, in a small compound, are some more small out buildings, built very close together. Just to the right of the entrance, built against the exterior, is a small modern red bricked shed. It is approximately 1.5m x 1.5m and has an entrance on the west side. The ground is of cement and it has a make-shift plywood roof which is falling inwards. To the south of this are two prefabricated office buildings. The eastern structure is a single room with a door at the north side and windows on the west and south sides (Plate 21). It has no fixtures and fittings. The structure on the west side is larger and has a small corridor entered from the north side which leads to two rooms. All of the windows are on the east side. There is a brick built WC immediately to the south of this pre-fab (Plate 22).

WC behind prefabricated building outside south end of metal works
