Archaeological
Watching Brief Report

January 2010

**Daniel Department Store,
Peascod Street,
Windsor, Berkshire**

ARCHAEOLOGICAL WATCHING BRIEF REPORT

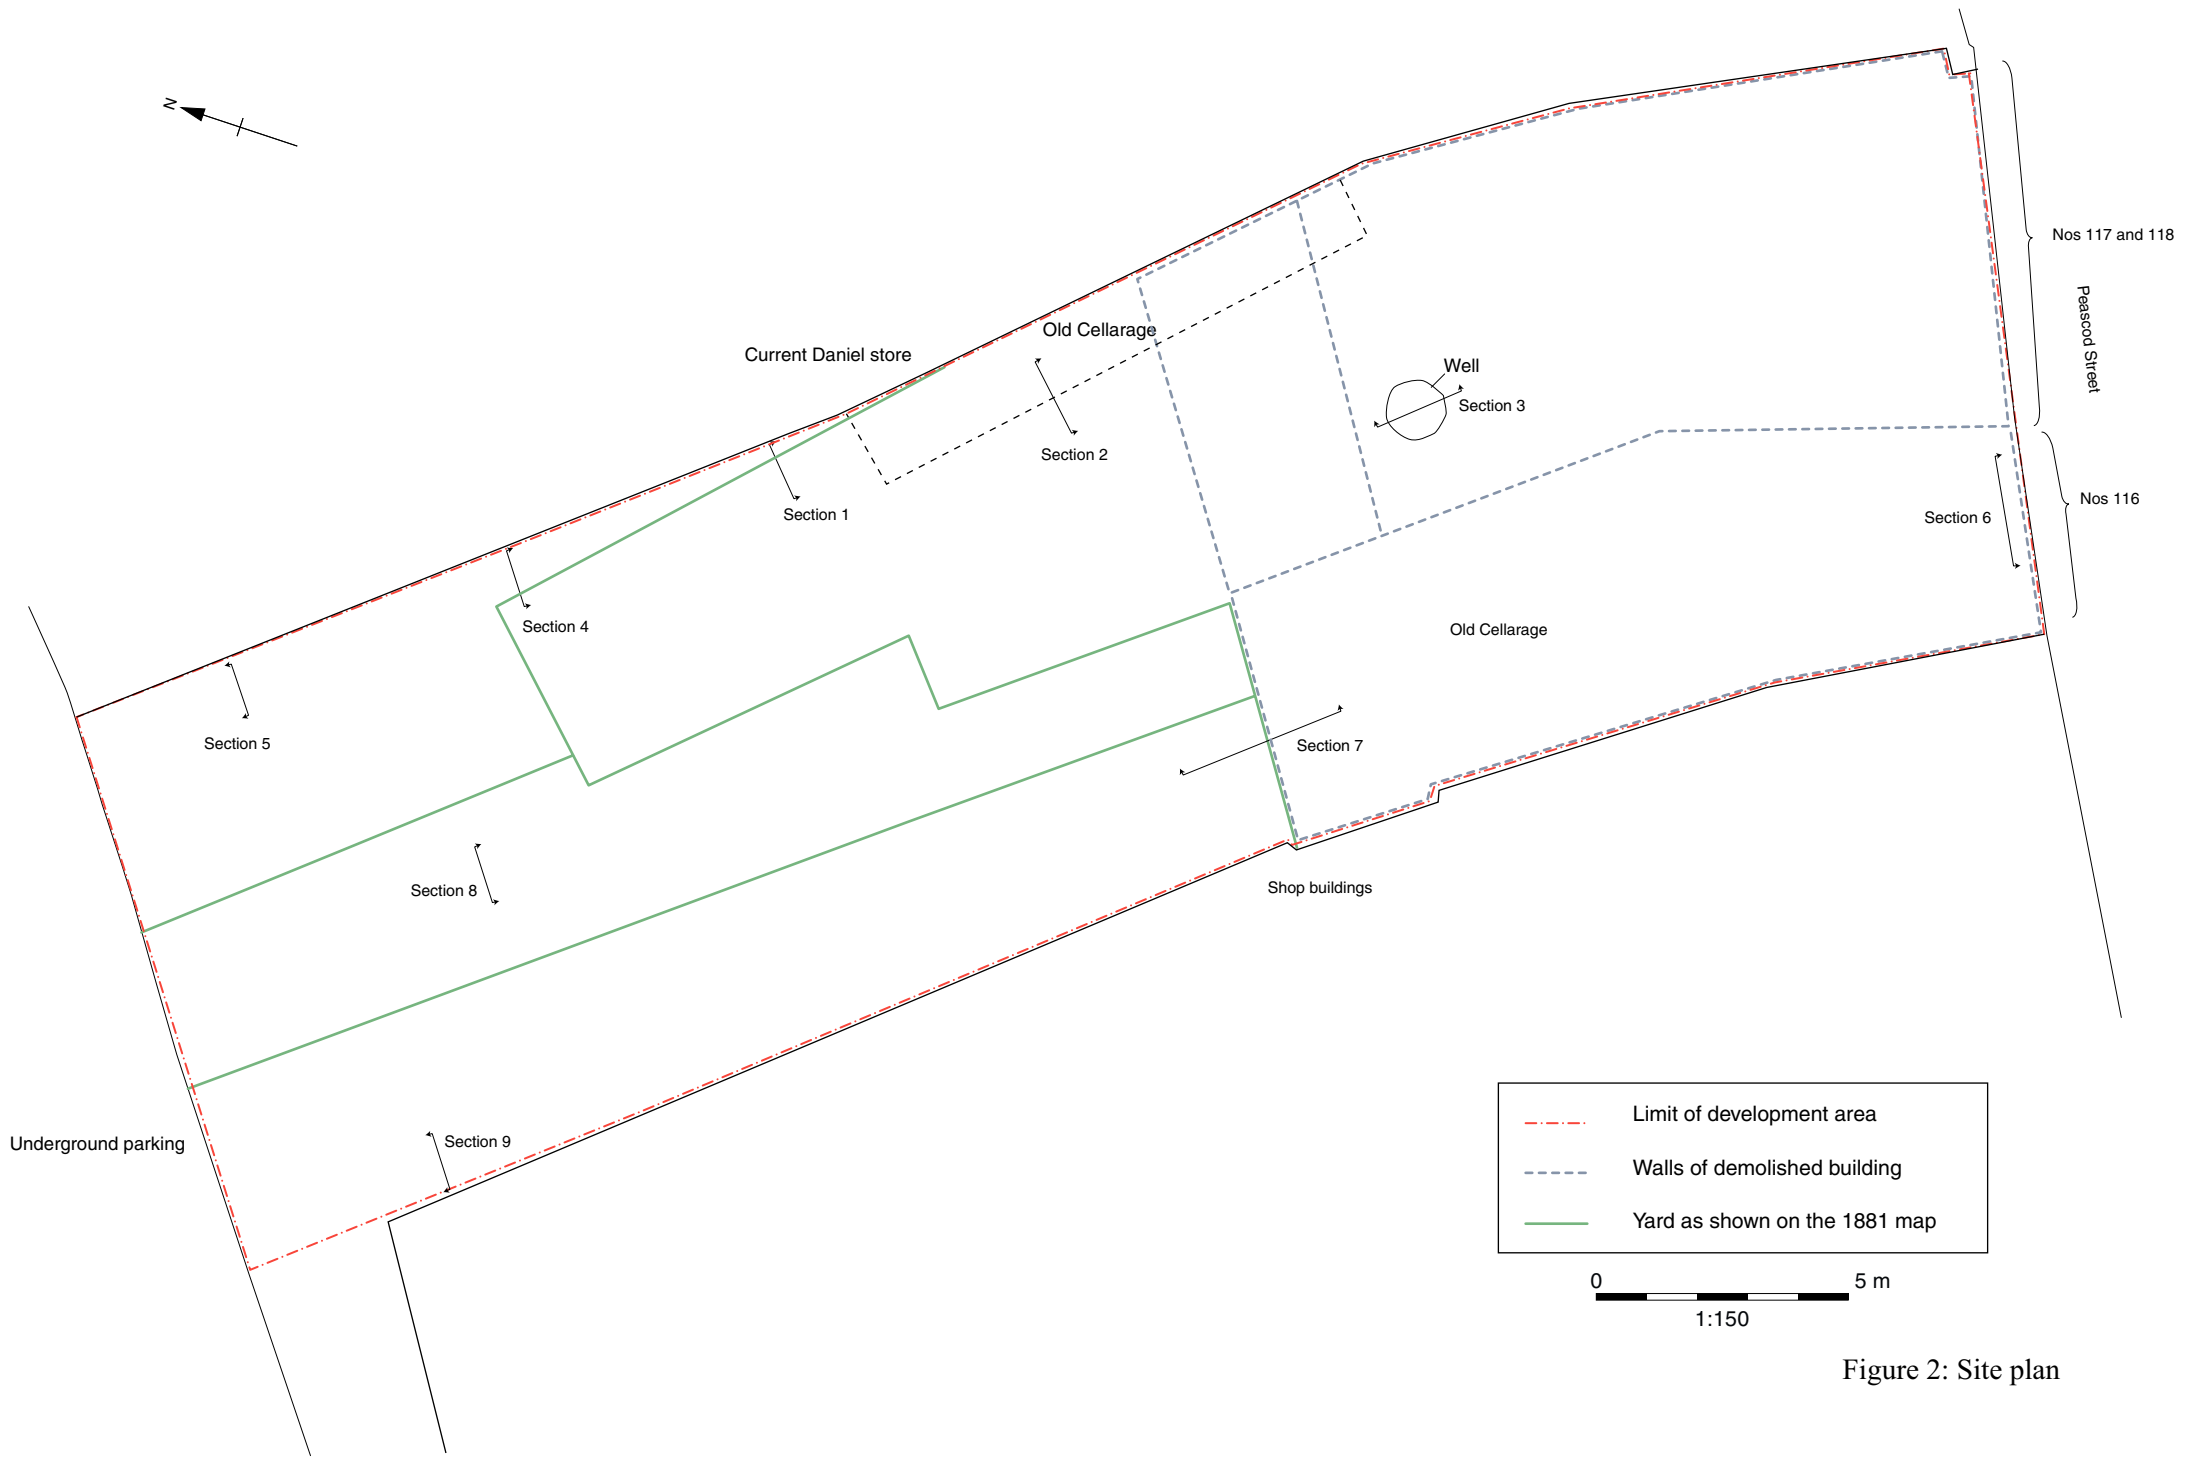
Figure 2: Site plan

- 2.2.1 The watching brief was conducted as a series of site visits during the demolition of the old building and the preparation of the site prior to piling.
- 2.2.2 A plan of the excavations (Fig. 2) was maintained at a scale of 1:100 and any recorded sections were drawn at a scale of 1:20. The site and the recorded sections were photographed using digital photography, colour slide and black and white print film. A general photographic record of the work was also made. Recording followed procedures detailed in the *OA field manual* (Wilkinson 1992).
