Daniel Department Store  
Phase 2 Redevelopment  
Peascod Street  
**Windsor**

**Archaeological  
Watching Brief Report**

OA Job No: 3442

## *Archaeological Watching Brief Report*

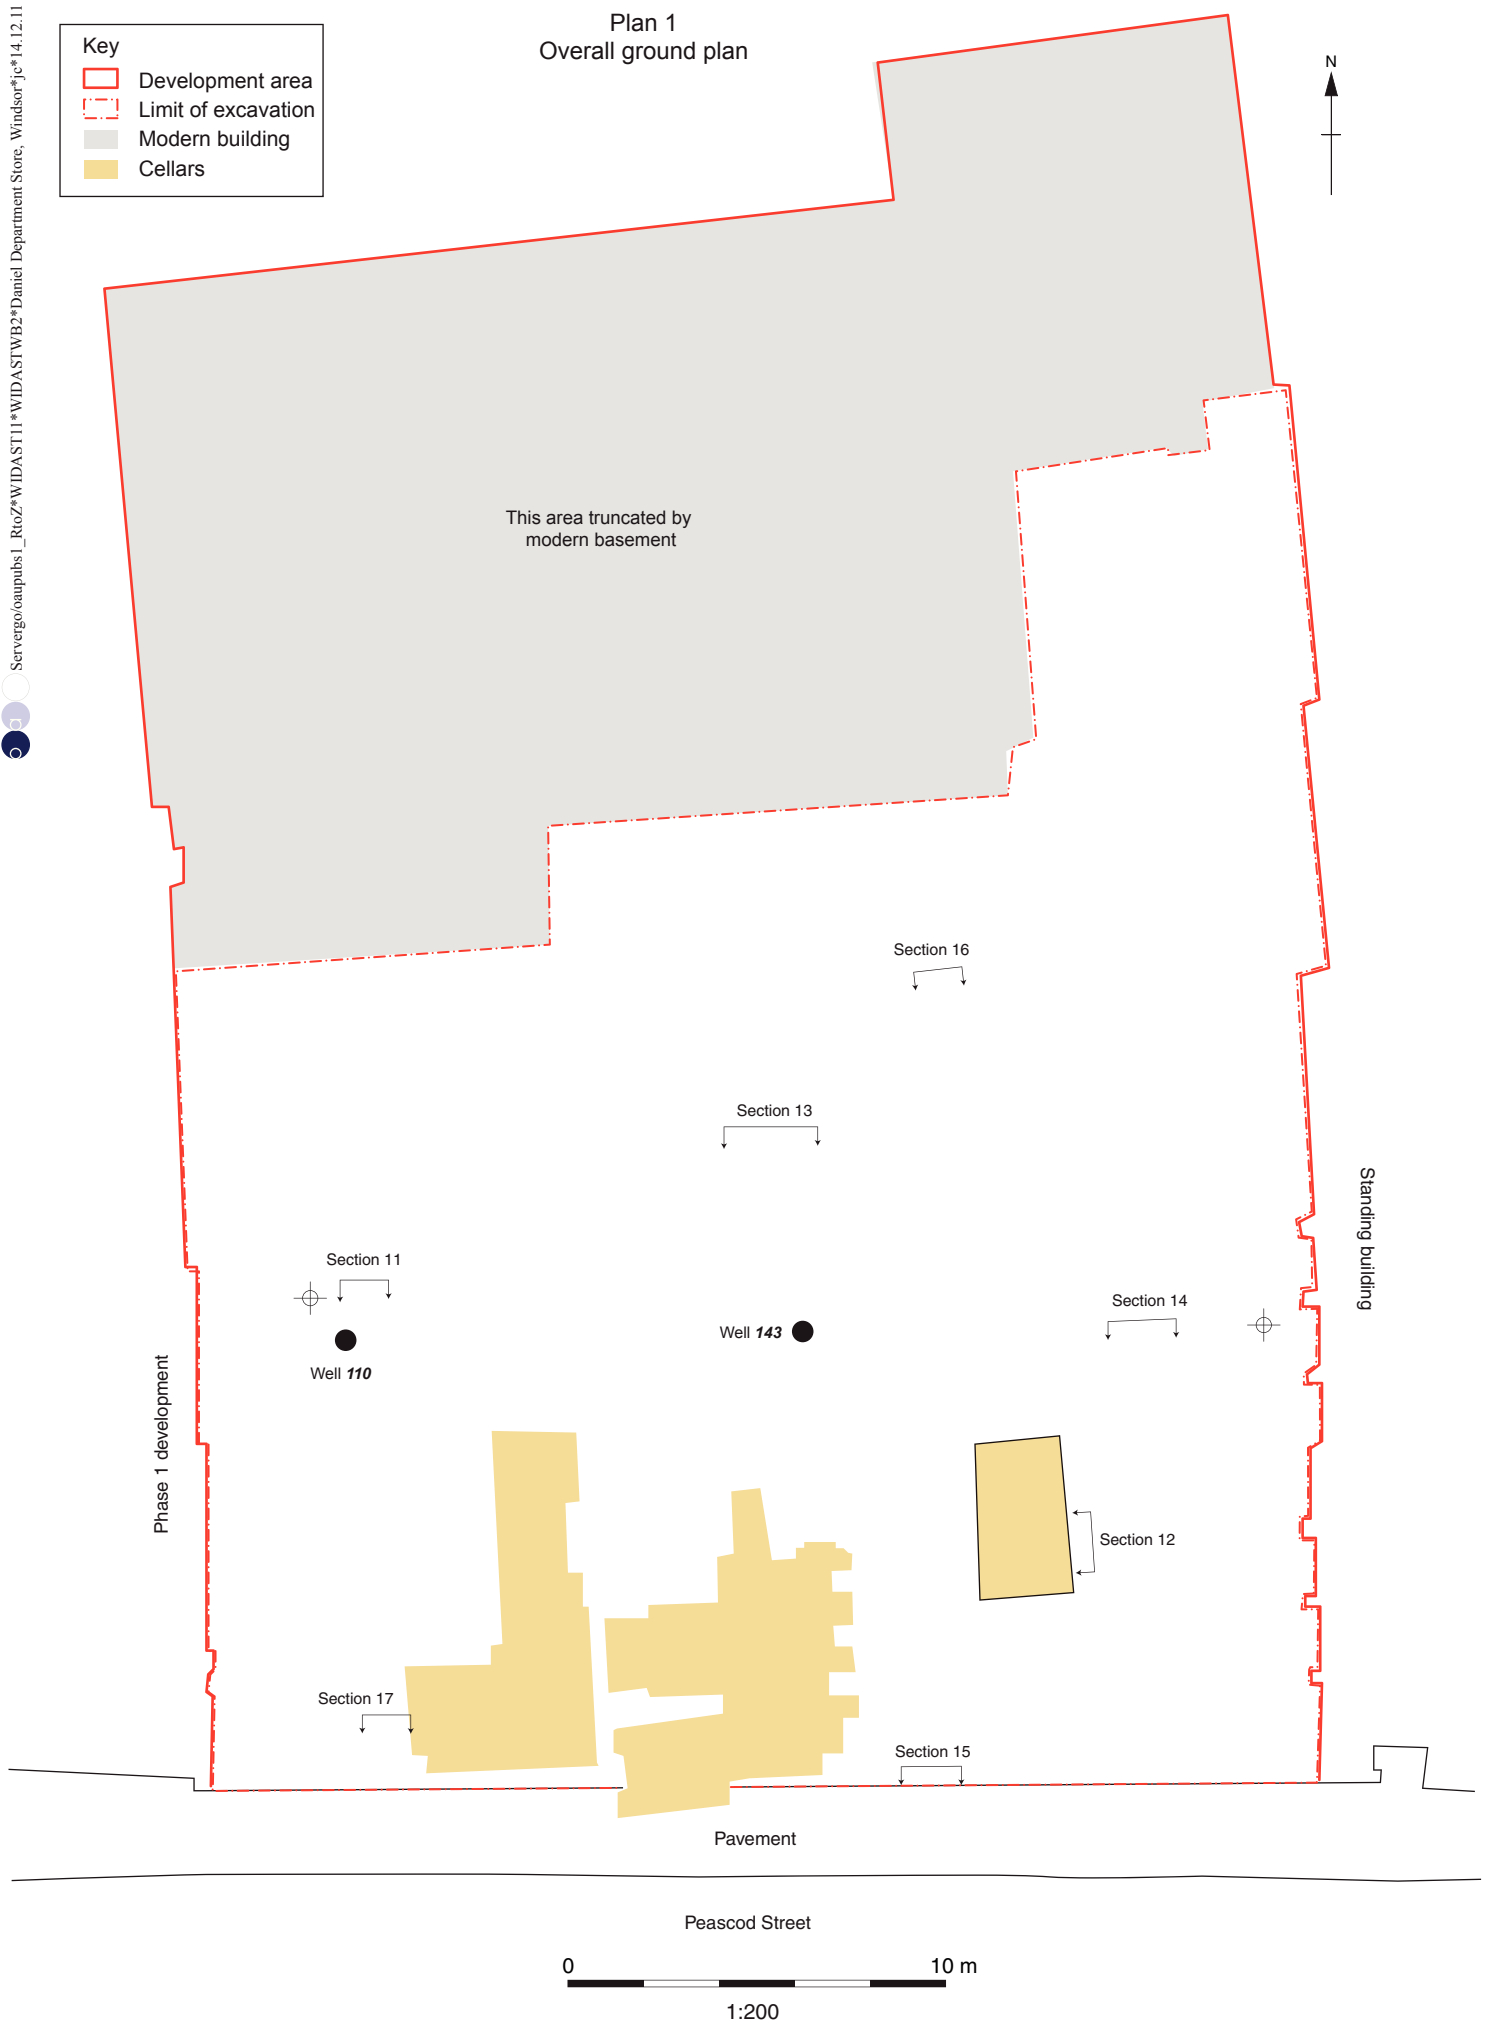
Figure 2: Site plan

- 2.2.3 A plan showing the extent of the excavations and the location of the recorded sections was maintained at a scale of 1:50 (Fig. 2). The excavations and any recorded sections were photographed using colour digital photography and black and white print film. A general photographic record of the work was also made.

- 3.1.33 Other features encountered during the course of the watching brief were a second brick lined well, (143), located towards the rear of Numbers 121 and 122 (Fig. 2). This was very similar in construction to Well 110 and was cut from a similar level.

- 4.1.4 The majority of the stratigraphy observed directly relates to buildings shown on the Ordnance Survey maps (Figs 4 and 5). The position of cellarage shown on Fig. 2 corresponds closely to the plot divisions shown on both the 1881 1<sup>st</sup> ed OS map (Fig. 4) and the 1932 ed OS map (Fig 5).

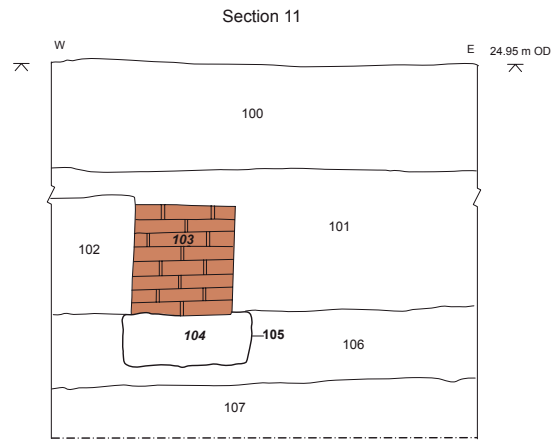
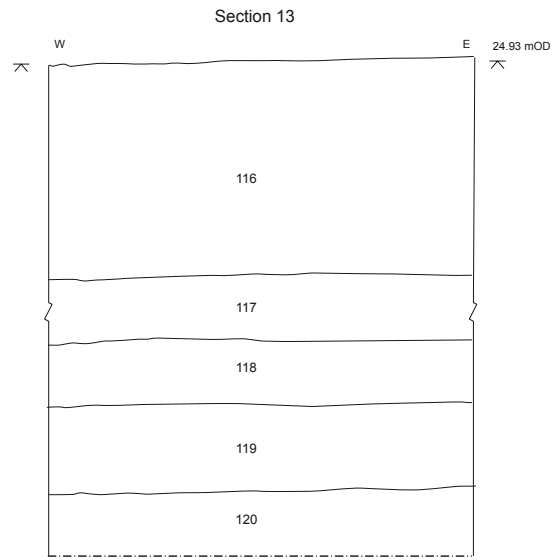
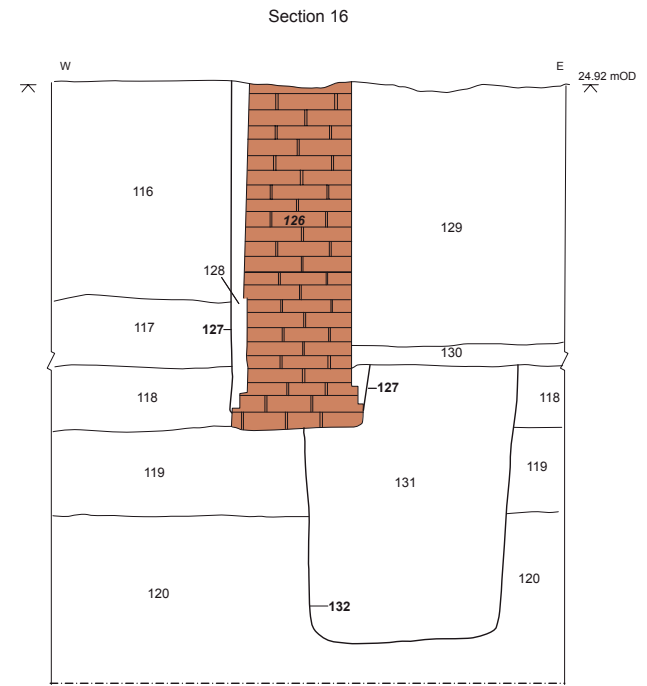
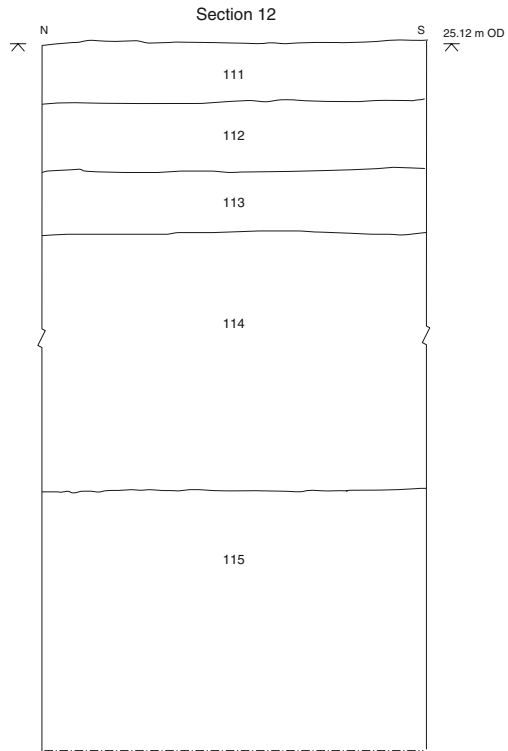
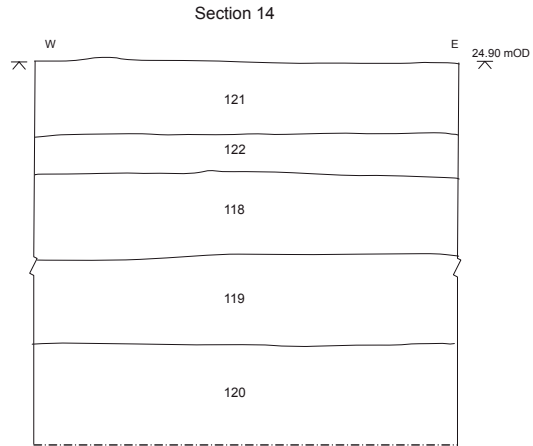
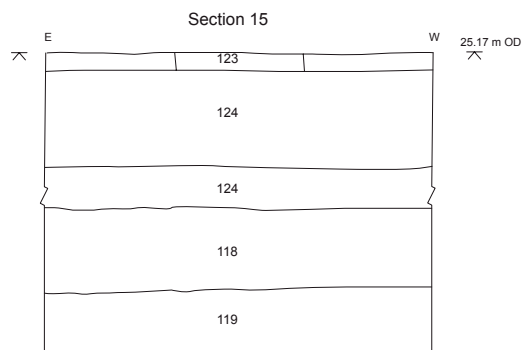
Figure 3: Sections

*Section 11 (Rear of Number 119)(Figs 2 and 3)*

- 3.1.4 This was located approximately 15m south of Peascod Street, roughly on the line of the rear of the 19<sup>th</sup> century street frontage.
- 3.1.5 A layer of grey-brown clay silt was exposed in the base of the section (107). This deposit contained charcoal flecking and fragments of 19<sup>th</sup> century ceramics together with numerous fragments of clay roof tile and ceramics dating to the 17<sup>th</sup> century.

- 3.1.6 Overlying 107 was a 0.35 m deep layer of yellowish grey-brown clay silt (106), which also contained many fragments of tile and charcoal flecking. Cut into this layer was a circular well shaft (109) (Fig. 2). This measured approximately 1.1 m in diameter. It had been lined using unfroged bricks measuring 0.225 m x 0.105 m x 0.072 m laid tangentially around the circumference without mortar (110).

- 3.1.7 Overlying 106 and Well 110 was a 0.55 m deep layer of light grey-brown clay silt (102), which contained fragments of brick and tile together with lenses of mortar. Layer 102 was cut by a north-south aligned construction cut (105), 0.6 m wide by 0.75 m deep. This contained a concrete footing (104) which supported wall (103). The wall was constructed using plain red bricks and lime mortar laid using English stretcher bond. The top of the wall had been truncated, presumably by a later phase of building.

- 3.1.8 Butting up to the eastern side and also running over the top of Wall 103 was a loose mixture of dark grey brown clay silt and demolition debris (101), up to 0.7 m in depth. This deposit formed a base for the 0.5 m deep concrete floor slab (100), the ground floor of the demolished building.

*Section 12 (Located behind the eastern cellar wall of Number 125)(Figs 2 and 3)*

- 3.1.10 A layer of orange-brown sandy silt (115) was encountered at a depth of 1.5 m below the original ground floor level. This was very clean and represents a layer of undisturbed natural ground. It could be seen to be in excess of 1.2 m deep within the section. Overlying this was a 1.2 m deep layer of clean yellow brown sandy silt (114), also a probable layer of undisturbed ground.

- 3.1.11 Layer 114 was overlain by a 0.3 m deep layer of reddish brown clay silt (113), containing many small sub-angular flints. Above 113 was a 0.3 m deep layer of mid brown clay silt (112) containing flecks of lime mortar and fragments of roof tile. Overlying this was a layer of grey-brown clay silt (111), 0.28 m in depth. This deposit produced many fragments of brick and tile, together with flecks of lime mortar. The concrete floor for the demolished building rested upon this layer.

*Section 14 (Rear of Number 126)(Figs 2 and 3)*

- 3.1.15 This was located towards the rear of number 126 approximately 12 m north of Peascod Street.
- 3.1.16 A probable continuation of the layer of the pale reddish brown silt clay brickearth (120) was exposed at a depth of 1.35 m below ground level. This was overlaid by probable continuations of layers 119 (0.4 m deep) and layer 118 (0.4 m deep).
- 3.1.17 Above 118 was a 0.15 m deep layer of a grey-brown clay silt (122), which produced fragments of plain tile, pantile and brick together with much charcoal flecking. It is possible that this layer may represent a continuation of layer 117.
- 3.1.18 Overlying 122 was a 0.36 m deep layer of light grey-brown clay loam (121). This deposit produced fragments of tile and contained flecks of lime mortar.

*Section 15 (Adjacent to Peascod Street)(Figs 2 and 3)*

- 3.1.19 This was located immediately south of the pavement alongside Peascod Street, roughly in the centre of Number 124.
- 3.1.20 A layer of light orange-brown clay silt, a probable continuation of (119), was observed at a depth of 1.15 m below the pavement level. Overlying this was a 0.4 m deep layer of yellow-brown clay silt, similar to, and a probable continuation of, (118).
- 3.1.21 Covering 118 was a 0.15 m deep layer of grey-brown clay silt (125). This was overlaid by a 0.4 m deep layer of light grey-brown clay silt (124). This deposit contained charcoal and mortar flecking together with pottery and brick fragments. The paving slabs (123) together with their associated cement bed had been laid directly upon 124.

*Section 16 (rear of Number 124)(Figs 2 and 3)*

- 3.1.22 This was located approximately 22 m south of Peascod Street towards of rear of Number 124.
- 3.1.23 A continuation of the pale reddish brown brickearth 120 was exposed within the base of the section. This was overlaid by probable continuations of layers 119 (0.4 m deep) and layer 118 (0.3 m deep).

- 3.1.24 On the western side of the section, layer 118 was overlaid by a layer of dark grey-brown clay silt. This contained much charcoal flecking together with fragments of tile and is a probable continuation of layer 117.

- 3.1.25 On the eastern side of the section layer 118 was cut by a vertically sided circular pit (132) measuring 0.9 m in diameter and 1.4 m in depth. This was filled entirely by a coarse black gritty sand or possibly fine clinker (131). No artefacts were recovered from the fill. It is unclear if the pit was cut from a higher level as the top has been truncated.

- 3.1.27 Cutting layer 116 and the top of pit 132 was a north-south aligned foundation trench (127), measuring 0.6 m deep and 0.6 m wide (127). Constructed within this trench was a vertical brick wall (126), 0.5 m wide with a surviving height of 1.55 m. The wall was built using a plain unfrosted red brick, 0.225 m x 0.11 m x 0.072 m in size. These were laid using lime mortar in English stretcher bond. The location and alignment of the wall suggests that it originally formed the boundary wall between Numbers 124 and 125.
- 3.1.28 On the eastern side of the wall a floor composed of a weak cement mix (130) had been laid butting up to the wall and sealing pit 132. This probably formed a sub-basement to the rear of Number 125. A loose mix of demolition debris (129) had been used to backfill the cellar during a later phase of building work.

*Section 17 (Centre of Number 119)(Fig. 2 and fig. 3)*

- 3.1.30 At the base of the section a layer of light yellowish grey silt clay (142) was encountered. This deposit contained flecks of chalk and lime mortar. Overlying this was a 0.6 m deep layer of grey-brown clay loam (141) containing numerous fragments of flat roof tile and pantile, together with chalk blocks and flecks of lime mortar.

- 3.1.31 Above 142 was a 0.45 m deep layer of dark grey-brown clay silt (139) which produced charcoal flecking and fragments of roof tile. This was overlaid by a similar layer of light grey-brown clay silt (138), 0.5 m deep. Cutting this layer was a vertical straight edged feature (136), 1 m deep. Built up against the western edge of the cut was a brick wall (134), forming the western side of the U-shaped cellar beneath Number 119. The wall had been constructed using an unfrosted plain red brick and lime mortar, laid using English stretcher bond. On the western side of the wall the gap between the construction cut and the wall had been backfilled with a loose grey-brown silt (137).

- 3.1.32 Butting up to the western side of wall 134 was a 0.7 m deep layer of mixed dark and light grey-brown clay silts, brick and tile fragments and mortar flecking (135). Butting up to the eastern side of wall 134 was a floor composed of a single layer of bricks laid in a weak mortar bed (140). The cellar had been backfilled with a mixture of demolition debris and grey-brown silts (133).

- 4.1.5 Wall 103 observed within section 11 corresponds with one of the north-south walls subdividing Number 119 shown on the 1932 map. Wall 126 recorded in Section 16 similarly corresponds with the north-south wall forming the eastern side of the yard to the rear of Number 123. Pit 132 also recorded in the same section may predate the walls construction, but its fill suggests that it may have been originally excavated as a soak-a-way pit to the property. Floor 130 is also associated with Number 123.

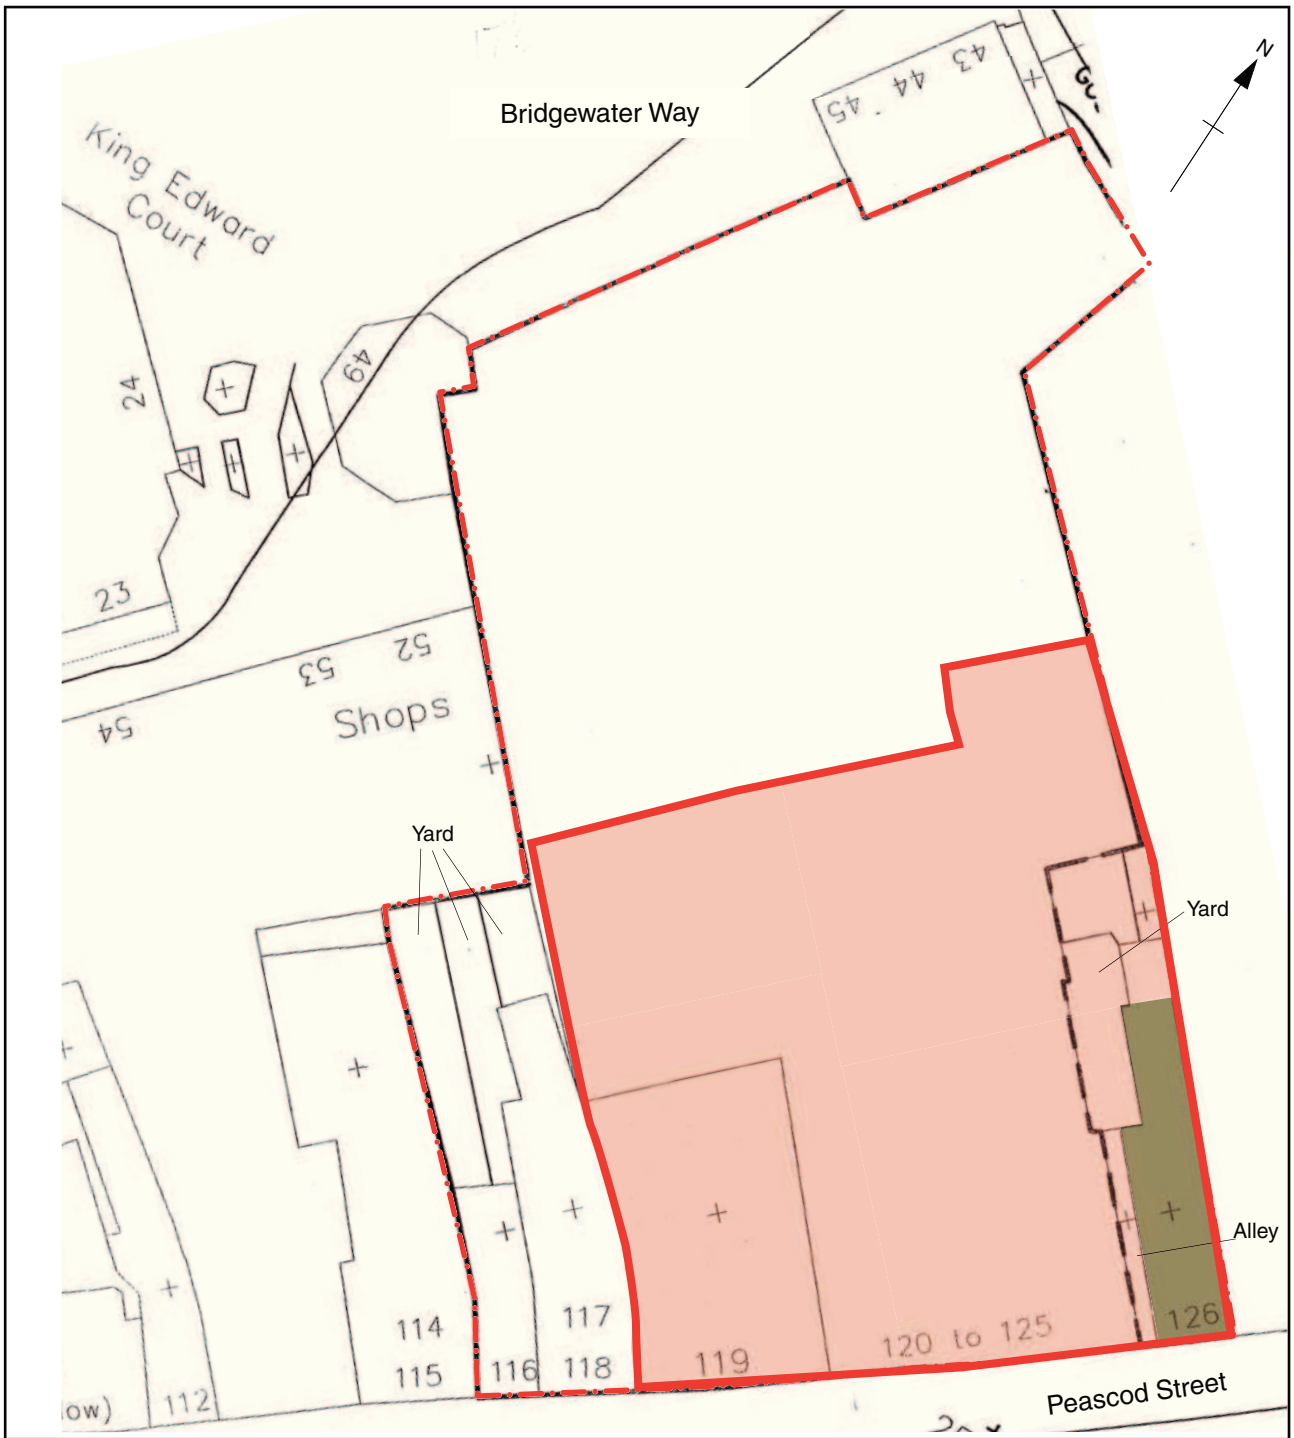
Figure 4: 1881 Ordnance Survey plan of area

- - - Approximate area of development
- Buildings present on c. 1881 copy of 1st Edition OS Map
- Phase II development

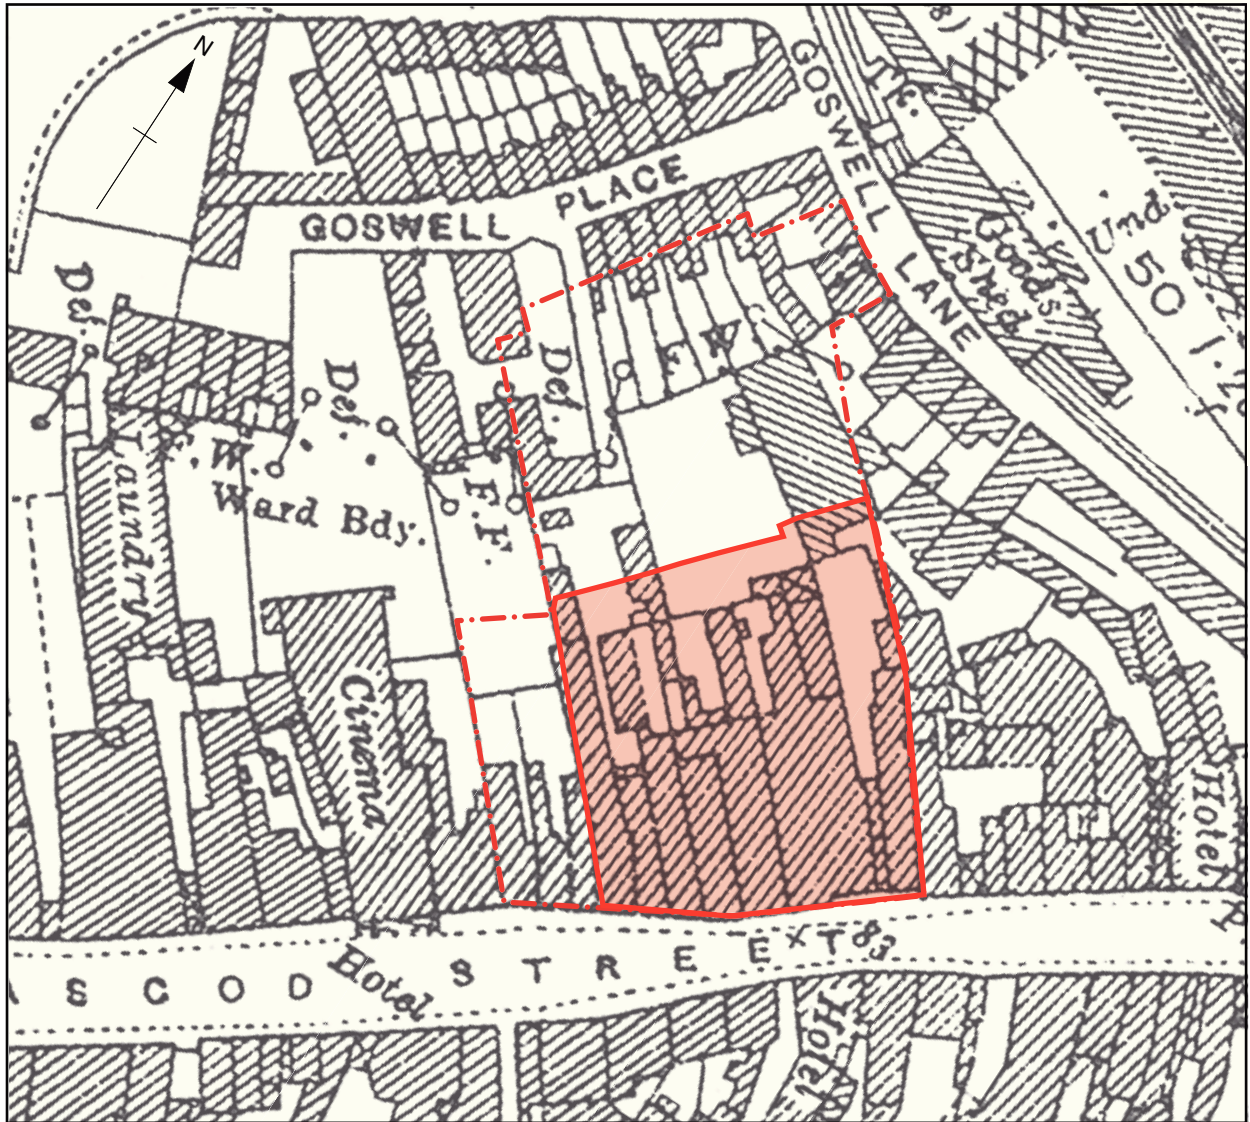
Figure 5: 1932 Ordnance Survey plan of area

- - - - - Approximate area of development
- Phase II development

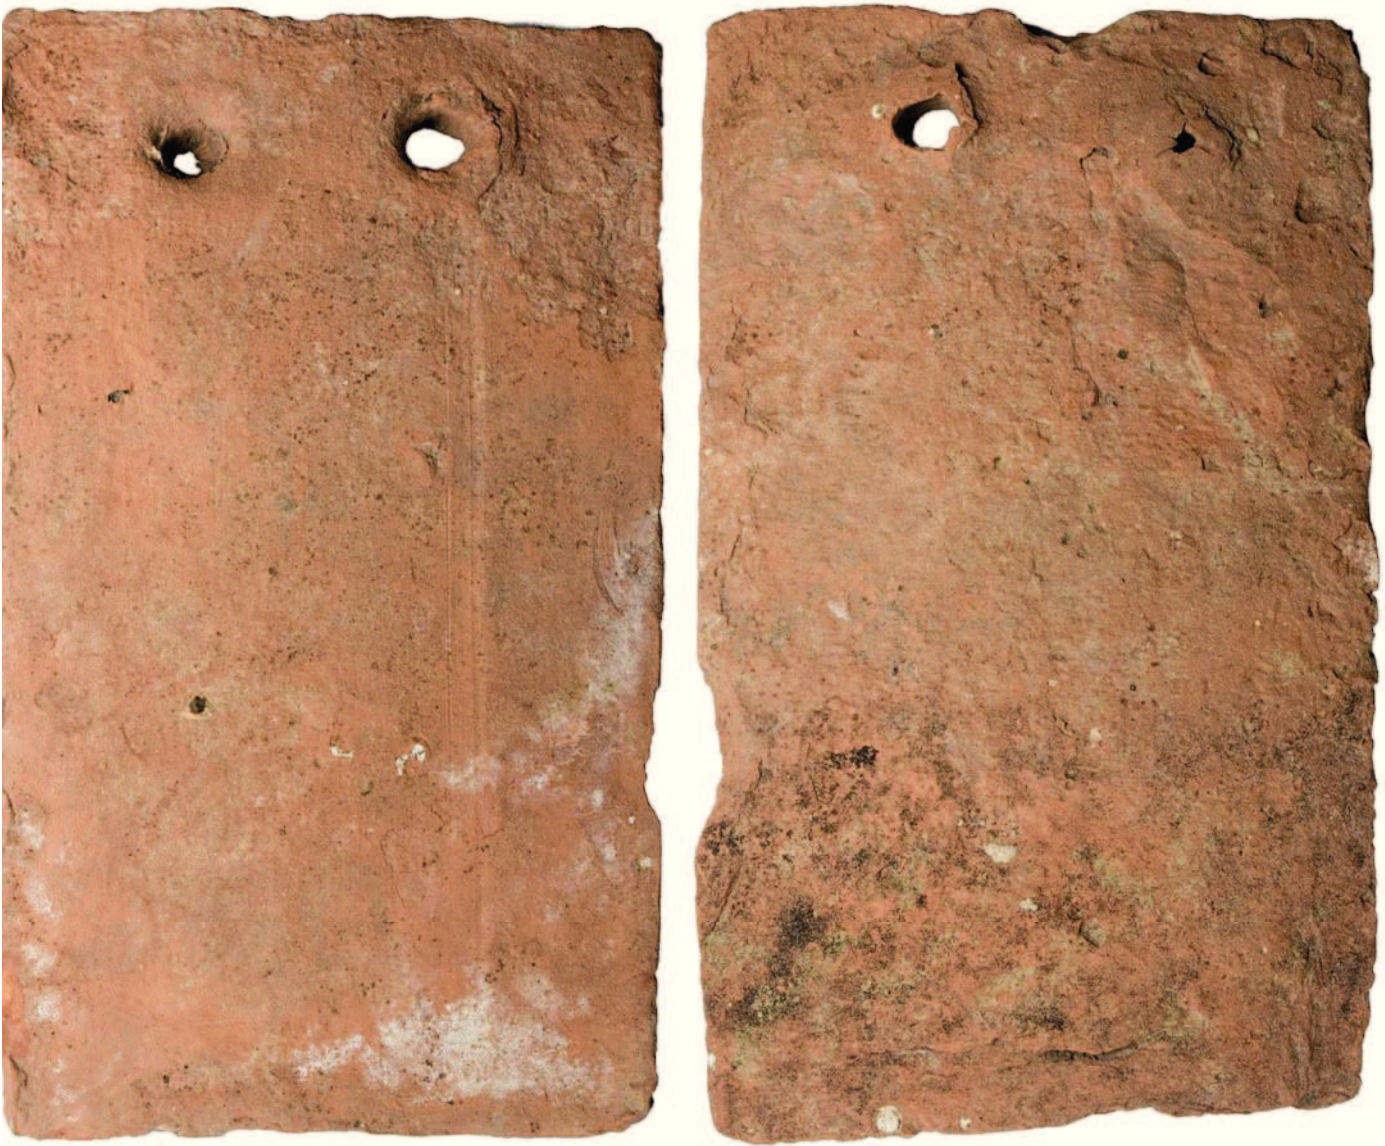
Plate 1: Peg tile from context 117

B.1.12 A complete late medieval or early Tudor peg tile from Context (117) is notable as complete tiles of this date - with associated pottery dating - are fairly rare. The tile has a length of 280mm., a width of 167mm. and a thickness of 14-18mm. (average c 15mm.). This has a pair of circular nailholes, crudely punched-through the upper end. One of the nailholes appears to have been imperfectly perforated during manufacture but the small c 5mm. hole subsequently punched-through after firing was probably sufficient to take a narrow iron nail (but not a wooden peg). These 'blind' nailholes have been observed on other medieval tiles in the Thames Valley. The complete tile is associated with a large

- 3.1.14 Layer 118 was covered by a 0.3 m deep layer of dark grey-brown clay silt (117). This context contained numerous fragments of plain red clay peg tiles together with charcoal flecking, oyster shell and a fragment of a possible late medieval/ early post medieval pot (Plates 1 and 2). Layer 117 was sealed by a 1 m deep deposits of grey-brown clay silt (116) containing numerous fragments of brick and tile, lenses of reddish brown brickearth, partially burnt coal and fragments of glazed earthenware all dating between the 16<sup>th</sup> and 17<sup>th</sup> centuries.

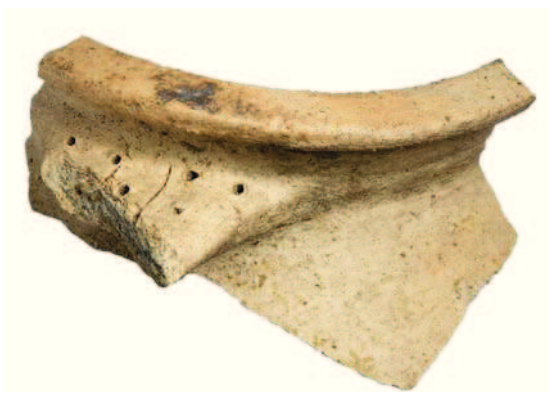
Plate 2: Rim sherd from Coarse Border ware cistern/jug 15th - Early 16th century

- B.1.4 The assemblage is in a fresh though fragmentary condition. Apart from one late medieval sherd all the pottery is of post-medieval date. The earliest piece (ctx 117) is a large fresh jar rim in white-firing Coarse Border ware from the Surrey/Hampshire border. This has a diameter of 190mm. and a short piece of attached strap-handle with characteristic stabbed and incised decoration which, together with its globular form, identify the vessel as a probable cistern for brewing and storing ale or beer. These have a full date range of c 1350-1525 but are most typical of the 15th and early 16th centuries (Pearce and Vince 1988).
