St John's College,
Oxford
Senior Common
Room Extension

Archaeological Evaluation Report

Document Title: St John's College, Oxford. Senior Common Room Extension

Document Type: Evaluation

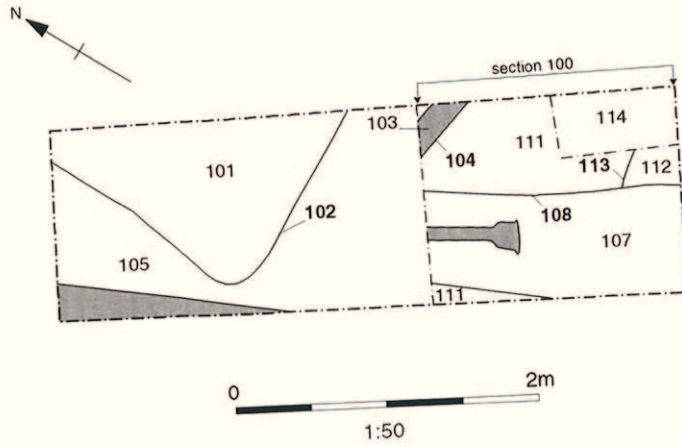
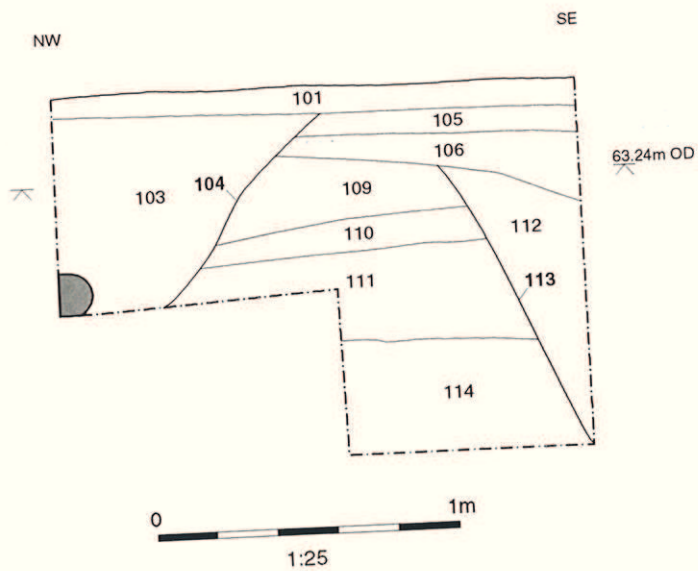
Figure 3: Trench 1, plan and section

- 5.1.1 Trench 1 (Fig. 3) was excavated through the current driveway to the President's House, to the south-east of the existing car port. The trench was 4 m long, aligned north-west to south-east and located between a buried power line detected by Catscan to its west side and an Ash tree to its east. On excavation, the north-west end of the trench was found to be clipping the edge of the cable trench and so only the south-east half of the trench could be excavated to full depth. Machine excavation of this part of the trench also had to be abandoned on encountering a cast iron drain pipe at a depth of 0.68 m below the current ground level (62.84 m OD). It was however possible to hand-excavate a sondage in the eastern corner of the trench to a depth of 1.2 m (62.32 m OD).

- 5.1.2 Natural geology was not exposed in this trench. The earliest deposits encountered were a sequence of layers at least 1 m deep of levelling/ground raising material and seen in the hand-dug sondage. The earliest of these was a layer of compact brown silty clay (114). This deposit was not bottomed, but was at least 0.36 m thick and was overlain by layer 111, which was grey and more friable with a thickness of 0.33 m. Overlying this was a layer of limestone rubble, 0.12 m thick (110) sealed by a further layer of silty grey clay (109). The only datable material retrieved from these layers was a single sherd of medieval pottery, which is likely to be residual. These layers were cut by a number of modern service trenches, and consequently survived only in an area 1.5 m north-west/south-east by 0.7 m north-east/south-west.

- 5.1.3 Service trench 113 was at least 0.45 m wide and 0.92 m deep and was filled by reddish sand (112) The trench extended east-west across the south-east end of the trench. It was overlain by yellowish brown sand make-up layer (106) for a former gravel surface (105). Surface 105, presumably a former driveway surface here was cut by two pipe trenches. Pipe trench 108 was oriented north-west/south-east, and connected to two man-holes near the entrance to the President's House. It contained

a cast iron pipe, was back-filled with gravel (107), and was 0.7 m wide. Excavation of this feature was terminated on exposing the pipe, at a depth of 0.6 m. Service trench 104 cut across the trench on an east-west alignment. Like 108 it was not fully excavated, but it was more than 0.5 m wide and at least 0.64 m deep. These services were sealed by the current gravel surface (100) of the driveway to the President's House. Toward the north corner of the trench was a large square pit (102) dug for an existing ash tree. This feature was not excavated.
