**MILL HILL  
RESOURCE  
CENTRE,  
WATSON STREET,  
BLACKBURN**

**Archaeological  
Investigation Report**

**Oxford Archaeology North**

May 2015

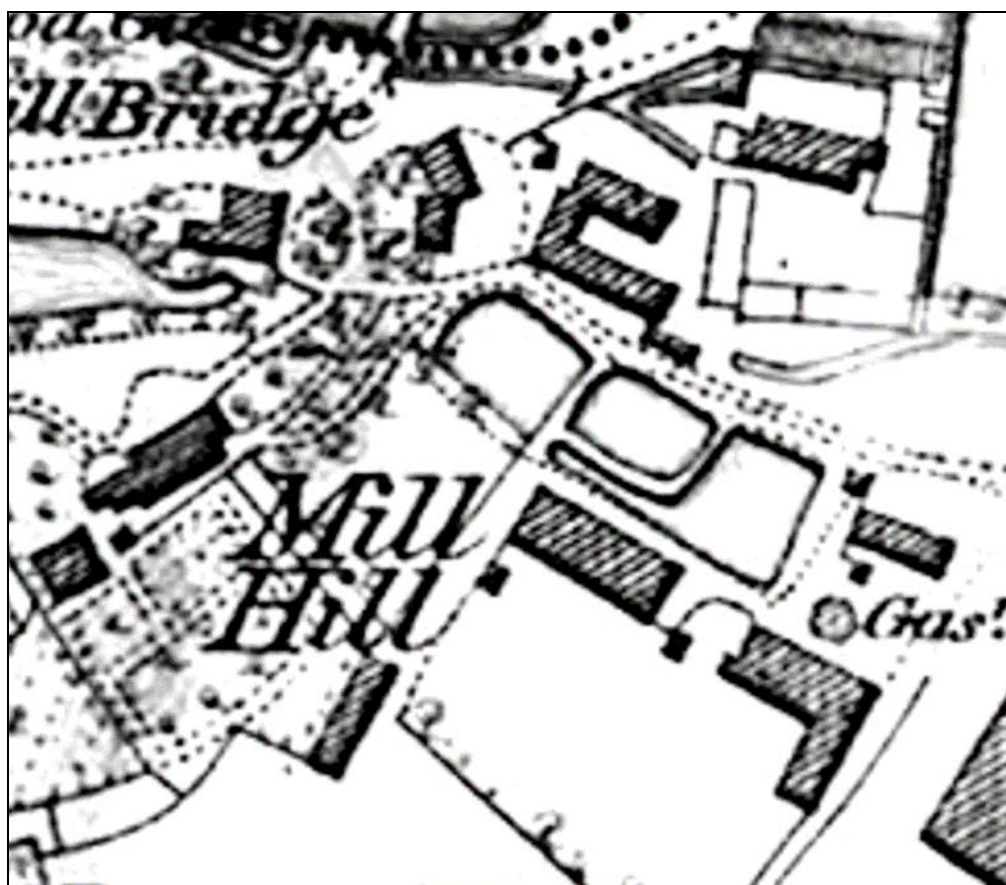
Plate 2: Extract from the Ordnance Survey first edition map of 1848

- 3.2.3 In December 1842, on the instructions of the executors of the late W Turner esq, 'a general assortment of choice drugs, dry-salteries, etc of a superior quality' was offered for sale by auction at Mill Hill and Ewood printing works. This included some 16 chests of indigo, 108cwt gum Senigal, 50cwt Dutch madder, 32cwt French madder, 26cwt dark and pale British gum, 13cwt sulphate of zinc, 12cwt farina starch, 13cwt of ground alum, 2cwt gum dragon, 3cwt gum substitute, and other materials (*Preston Chronicle*, 31 December 1842). The works closed in 1843, and many of the buildings were demolished subsequently. Other parts of the works were converted to the Mill Hill Cotton Works and Woodfield Cotton Mill by Joseph Eccles in 1844-45. The form of the mid-1840s cotton mills can be seen on the Ordnance Survey first edition mapping of 1848, which appears to show the disused printworks (Plate 2).

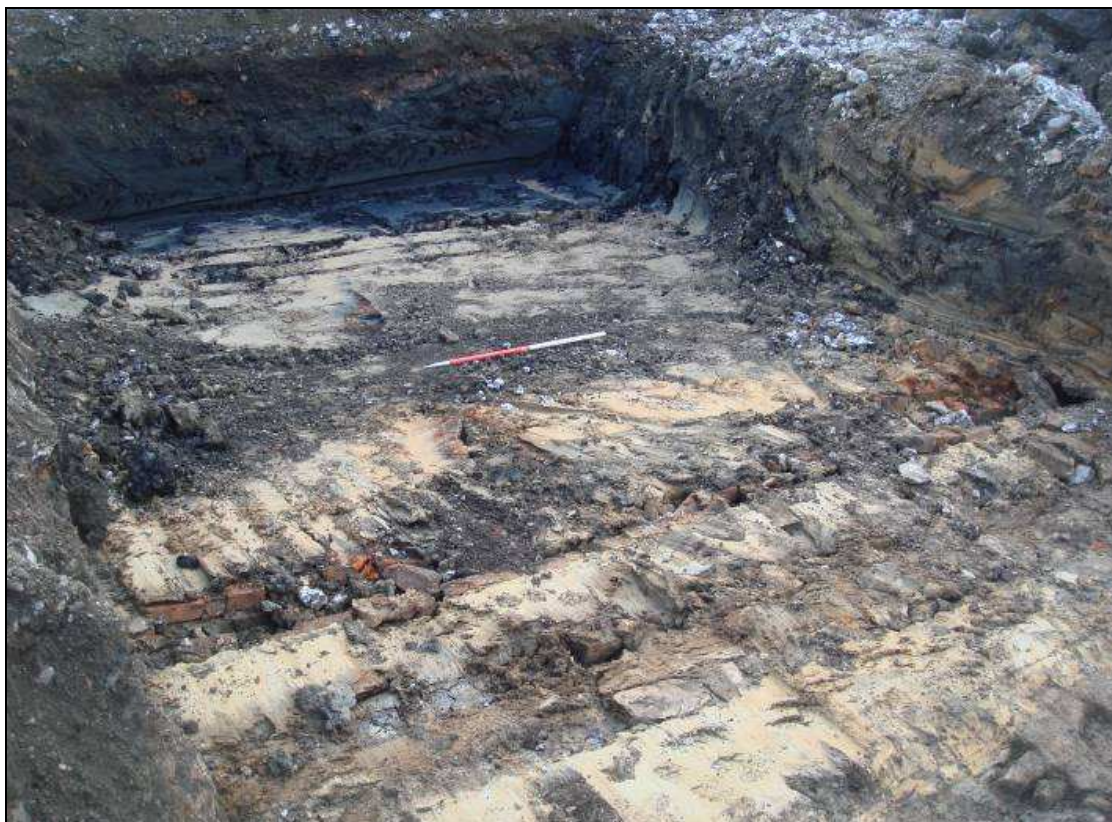
*Plate 5: Natural clay in Trench 1, with drains 102 and 103, looking west*

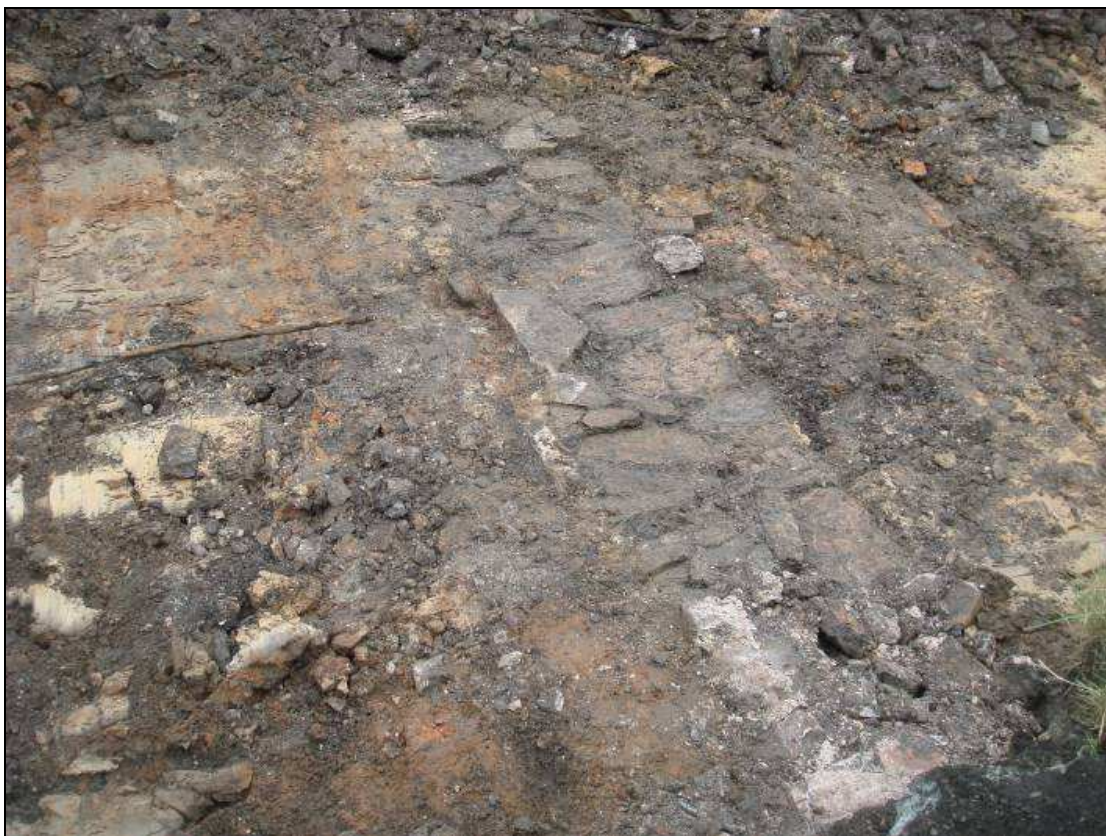
*Plate 6: Wall 101, looking south-east*

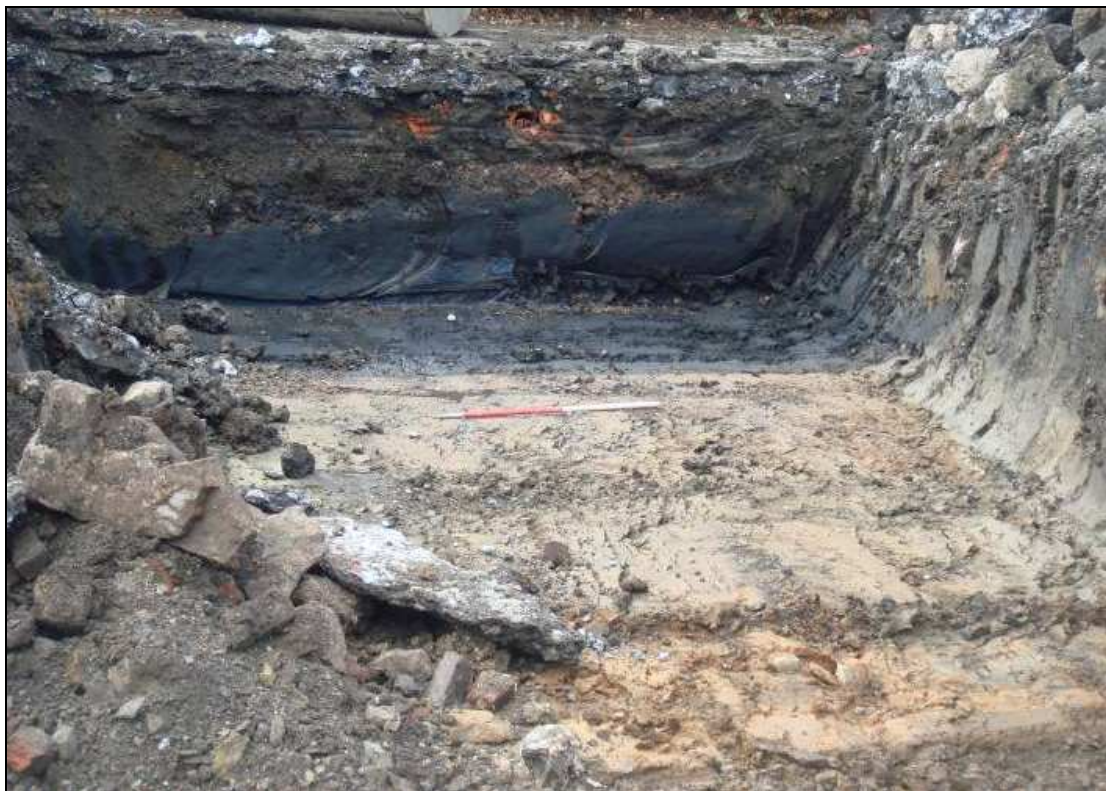
4.2.4 The edge of a large feature (**105**), cut into the natural clay, was observed along the central south-eastern side of the trench (Plate 7). This was 17.3m long, with 1.75m of its width within the excavated trench. It was filled with sticky black sandy silt, and may have been part of an infilled reservoir to the south-west of the eighteenth-century printing works. The feature was not bottomed, as the sides of the trench were unstable. No artefacts were recovered from the feature.

*Plate 7: Cut feature 105, looking south-west*

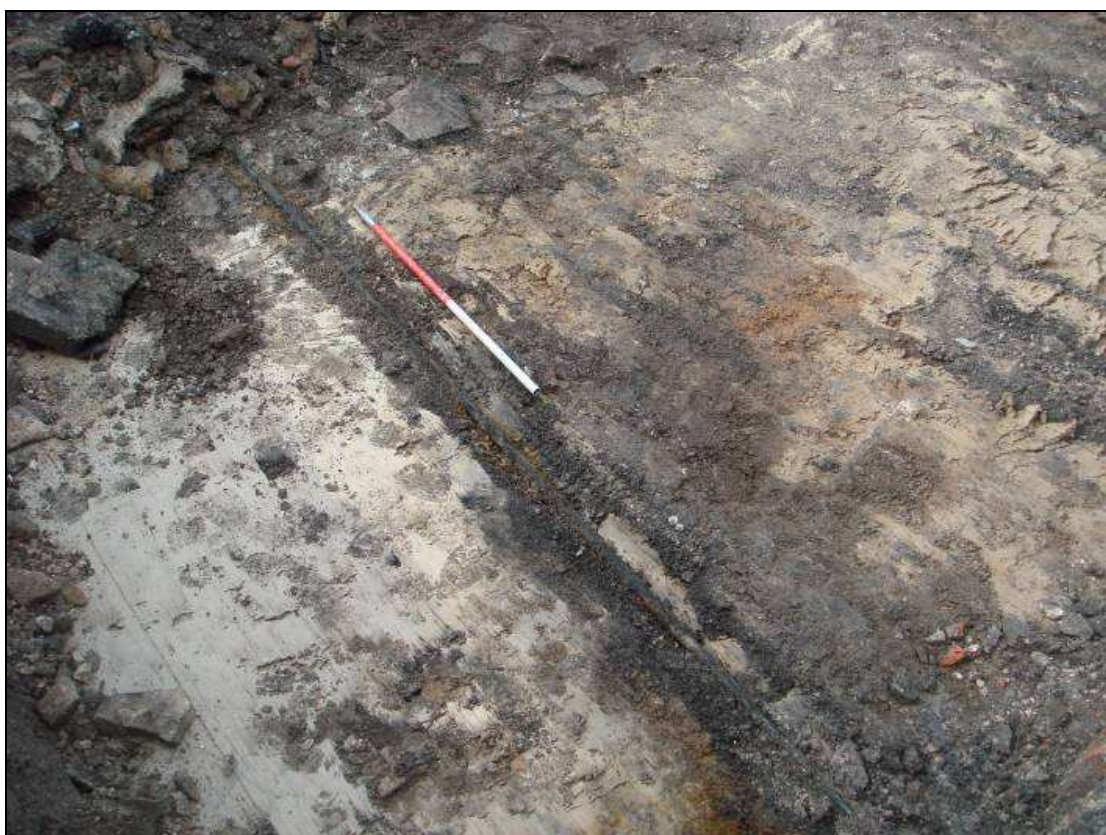
4.2.5 Wall **101** was cut by a 60mm-diameter metal pipe (**106**), aligned north-east/south-west across the trench. The pipe gave off a live signal when scanned, and so a 2.5m wide bund was left unexcavated over it across the south-western half of its length.

*Plate 8: Live service connection 106, looking east*

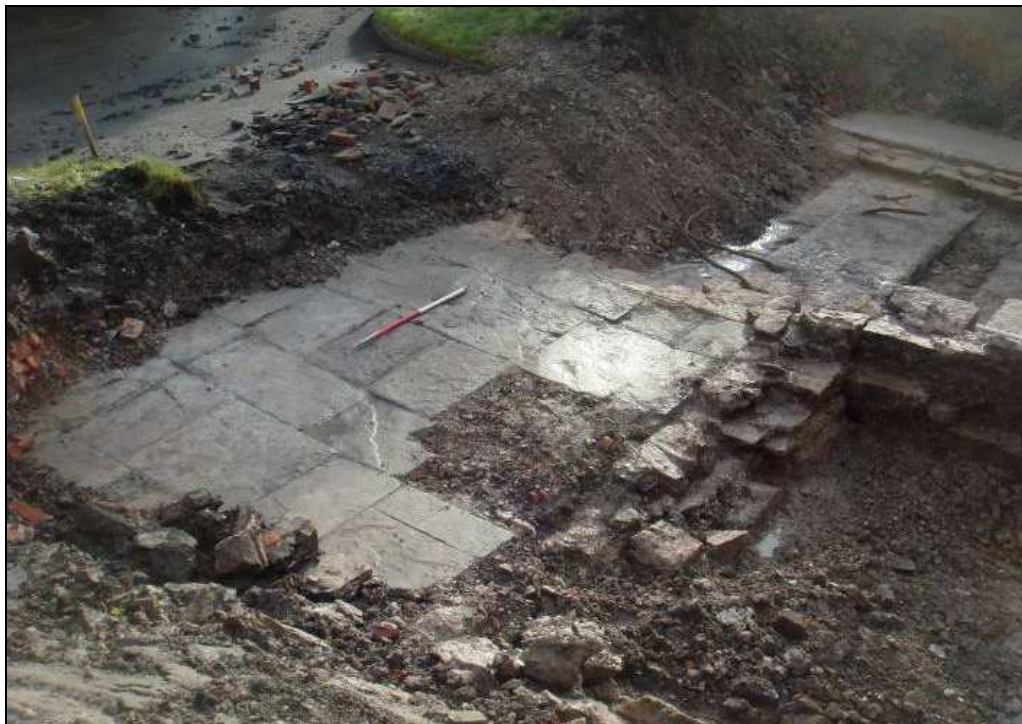
- 4.2.6 The south-eastern end of stone wall **101** abutted another stone wall (**108**), which was aligned north-east/south-west. The foundation course for another stone wall (**107**) continued north-eastwards from wall **101**, at a distance of 7.6m to the north-west of its south-eastern end (Fig 6). This formed a 7.6m wide room, the north-eastern side of which extended beyond the edge of the excavated trench. The room was floored with flagstones **108** (Plate 9).

*Plate 9: Flagged floor surface 108 with wall 109, looking east*

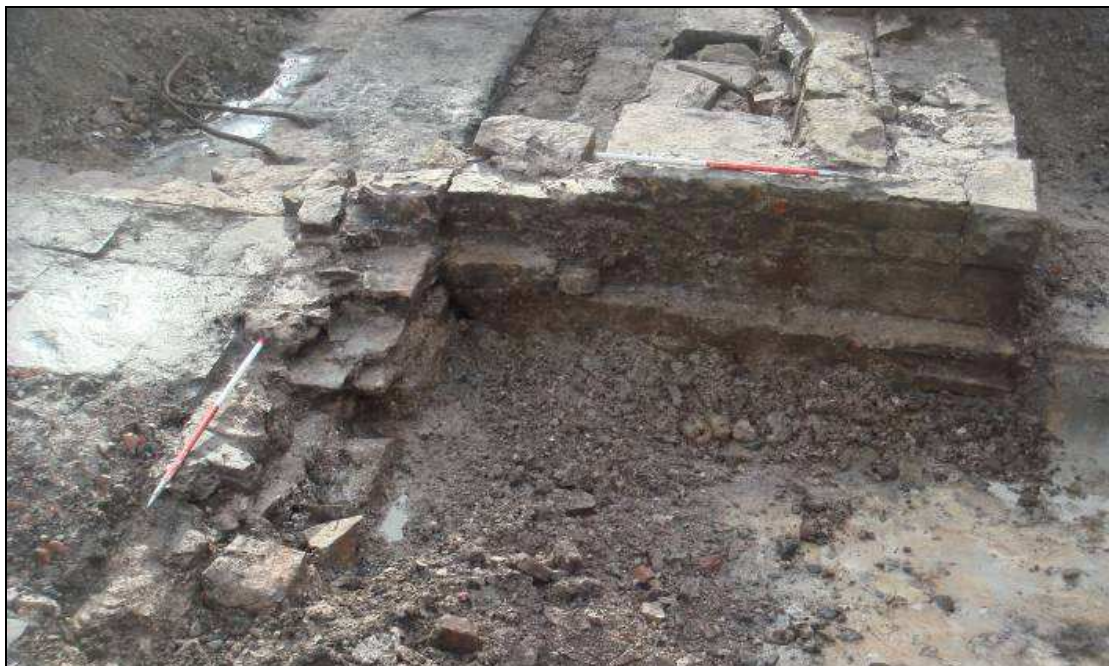
- 4.2.7 Buried structural remains exposed at the south-eastern end of the trench, below the landscaped banking, were better preserved than those elsewhere in the excavated trench. A series of walls formed three rooms, two of which represented part of an engine house. Stone wall **109** continued south-westwards from the trench edge for a distance of 6.3m before turning south-east for 3.7m where it terminated at engine bed **113** (Fig 6). The wall was 0.75m wide, and comprised substantial stone blocks with a stone rubble core bonded with lime-based mortar (Plate 10). The footings for the engine bed stepped out a further 0.2m along its north-western edge.

*Plate 10: Wall 109 and engine bed 113, looking south-east*

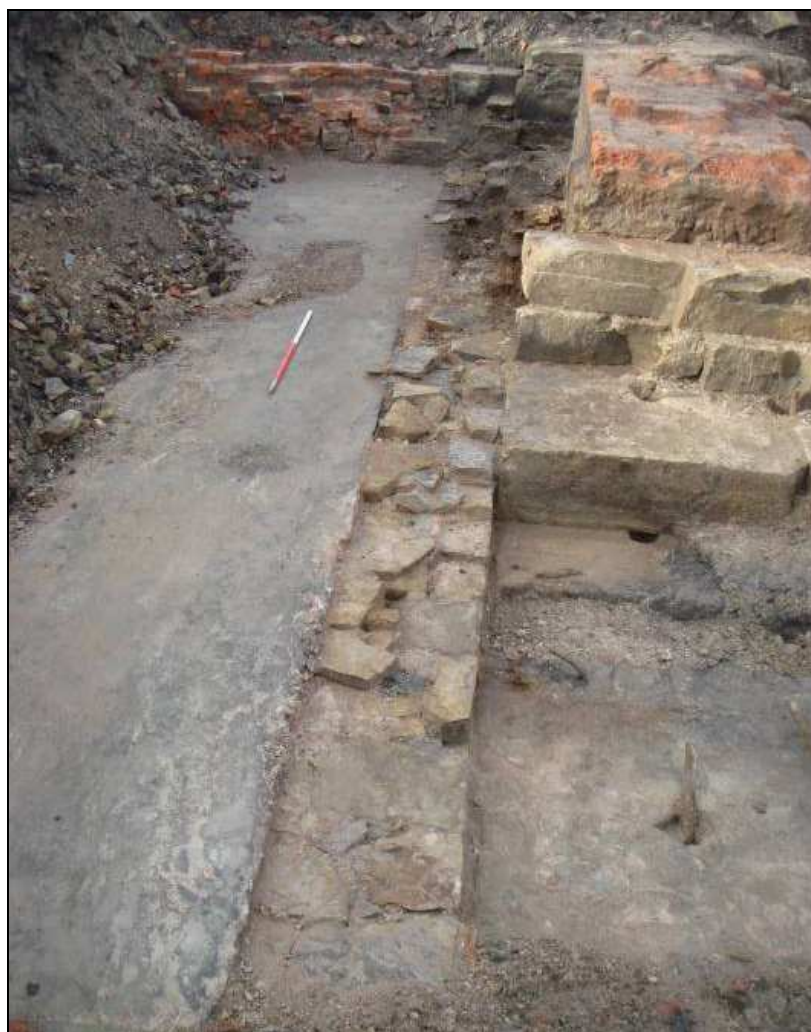
- 4.2.8 The foundations for another substantial stone wall (**110**) were exposed parallel and some 5.1m to the south-east of wall **109** (Plate 11). This incorporated a right-angle return at its south-western end, with a further return back to the north-east at the western end (Fig 6). A 1.29m gap in the wall was revealed at the north-eastern end of the second return section, which was likely to represent the position of an entrance. The corner of wall **109** on the opposite side of this gap survived to a greater height, and had incorporated a rusticated corner block (Plate 12), further suggesting that this had been an entrance. These walls formed a room that measured some 4.8 x 3.1m in the south-western corner (Plate 13), and a second room that measured 4.8m wide to the north-east (Fig 6).

*Plate 11: Wall 110, looking south-west*

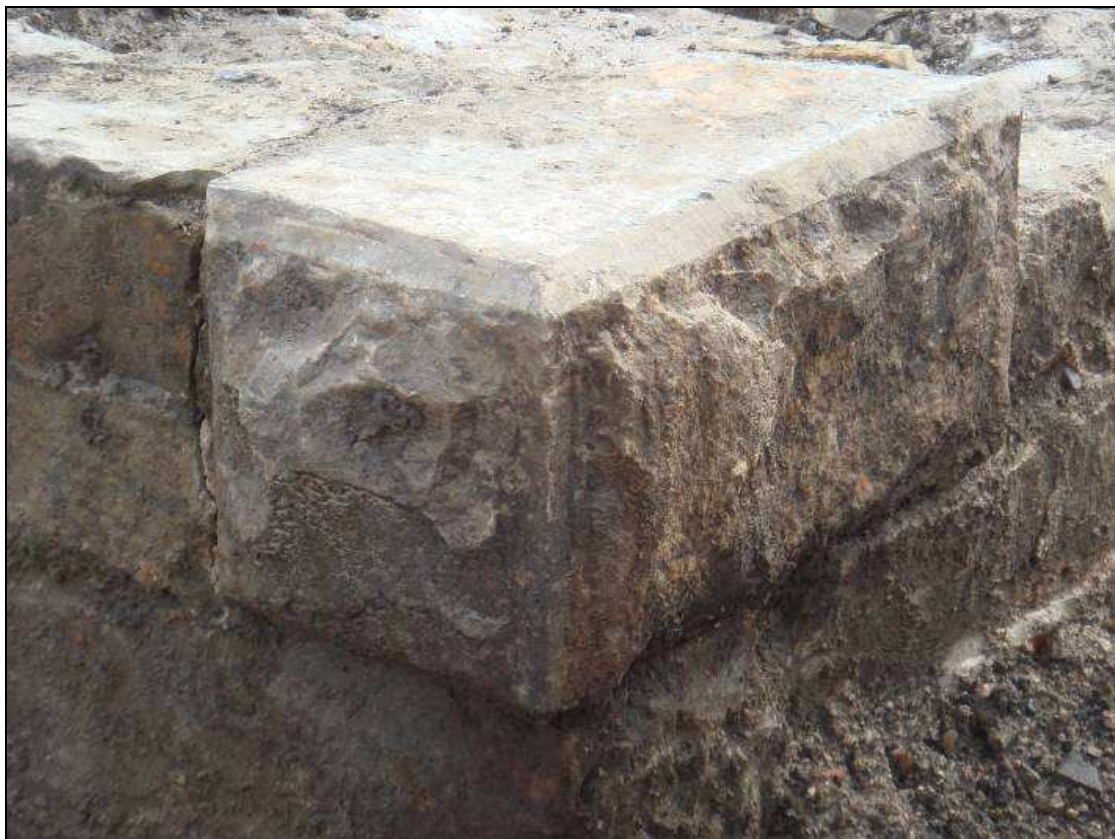
*Plate 12: Rusticated block at entrance corner of wall 109, looking east*

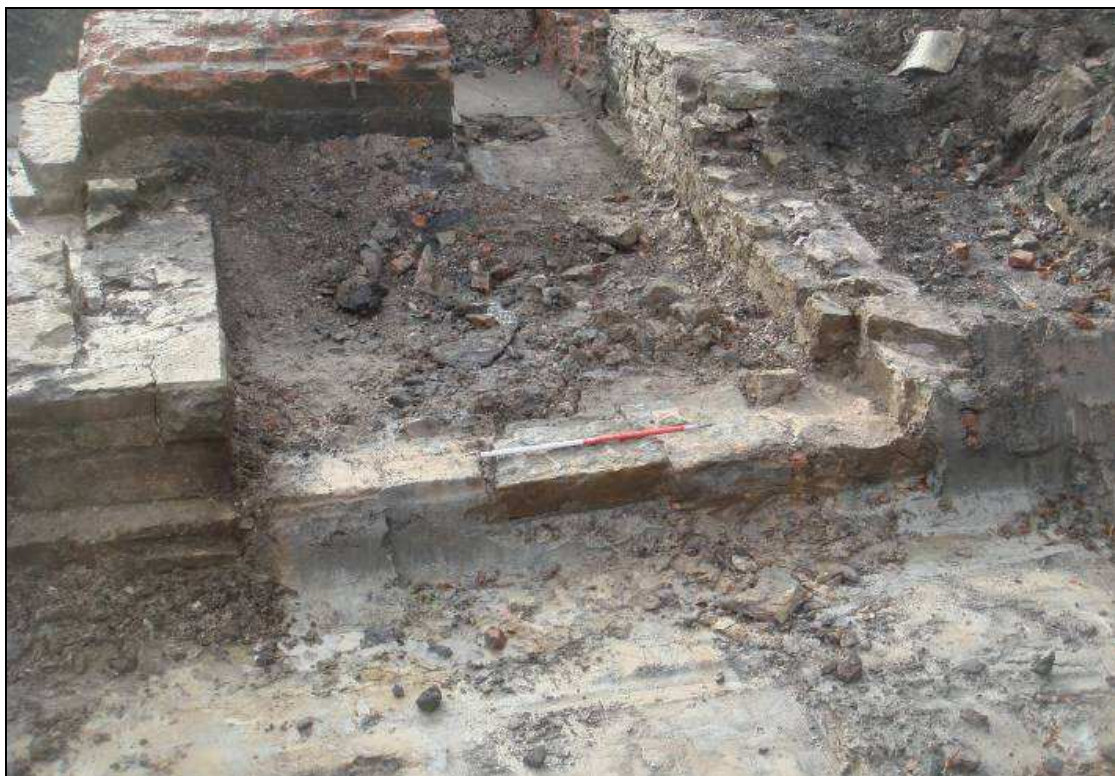
*Plate 13: South-western part of the engine room, showing the entrance through walls 109 and 110, looking south-east*

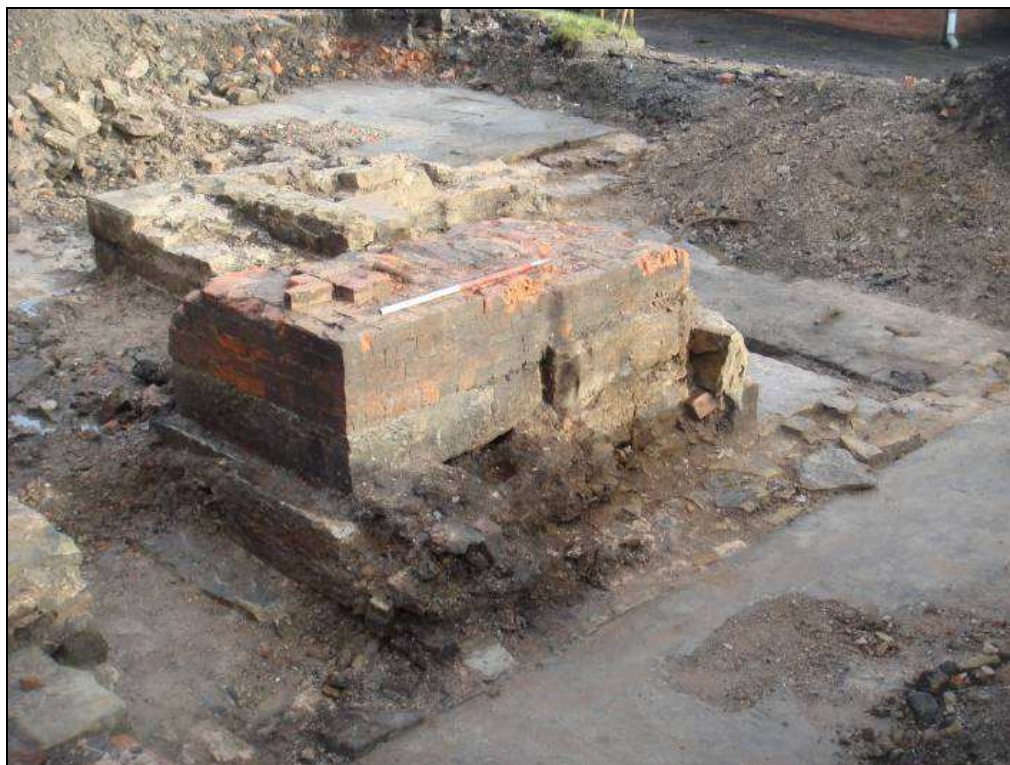
- 4.2.9 Within the south-western room of the engine house was a 2.36 x 1.38m engine bed (**II3**), comprising a block composed of hand-made bricks set onto a foundation of large stone blocks (Plate 14). The engine bed survived to a height of 1.25m, and had two 36mm diameter cast-iron bolts set into its upper surface, situated to the south-west of the centre. These had almost certainly contained iron rods for restraining the steam engine.

*Plate 14: Engine bed II3, looking north-east*

- 4.2.10 Engine bed **II3** was set into the natural clay geology, with no evidence for an associated floor surface, suggesting that this had been removed during demolition. The natural clay was also observed within the entranceway, but it was not fully exposed in the north-western half of the room as a cast-iron pipe exiting from the base of the engine bed was wrapped in what appeared to be tarred fibrous material, possibly asbestos cloth.

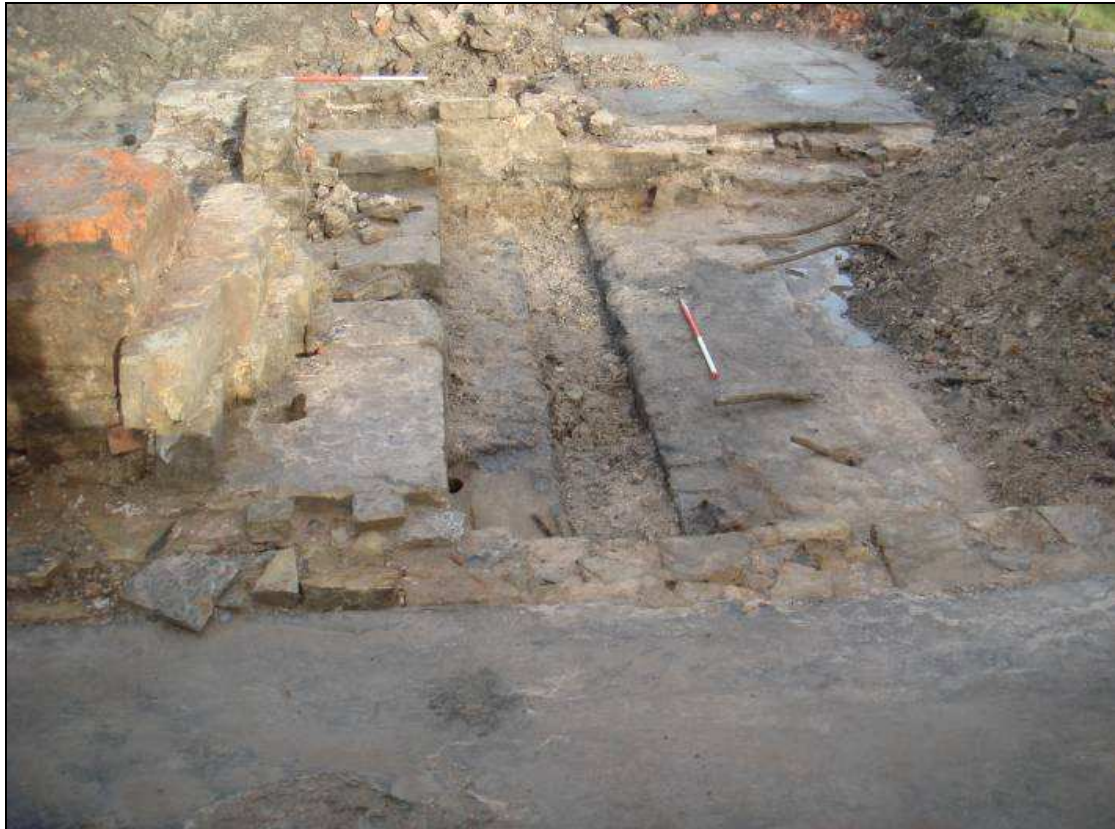
- 4.2.11 The north-eastern room of the engine house appeared to contain two phases of engine beds (Plates 15 and 16). The later bed (**II2**) only survived partially, and consisted of a series of stone blocks on the south-western side of the room. In the centre of the lower blocks was a 0.55m-wide channel aligned north-east/south-west, which would have run below the blocks above it (Plate 15). The channel contained stone rubble, and what appeared to be possible tarred asbestos cloth and was thus not fully excavated. The large stone blocks at either side of this channel each had two 165mm holes drilled into them, each containing a 38mm round cast-iron bolt with lead sealing. The north-western block also had round grooves in its north-eastern face, probably one half of round bolt holes shared with the block that formerly sat next to it.

*Plate 15: North-eastern room of the engine house, showing later engine bed 112 to the left, and earlier bed 111 to the right, looking north-west*

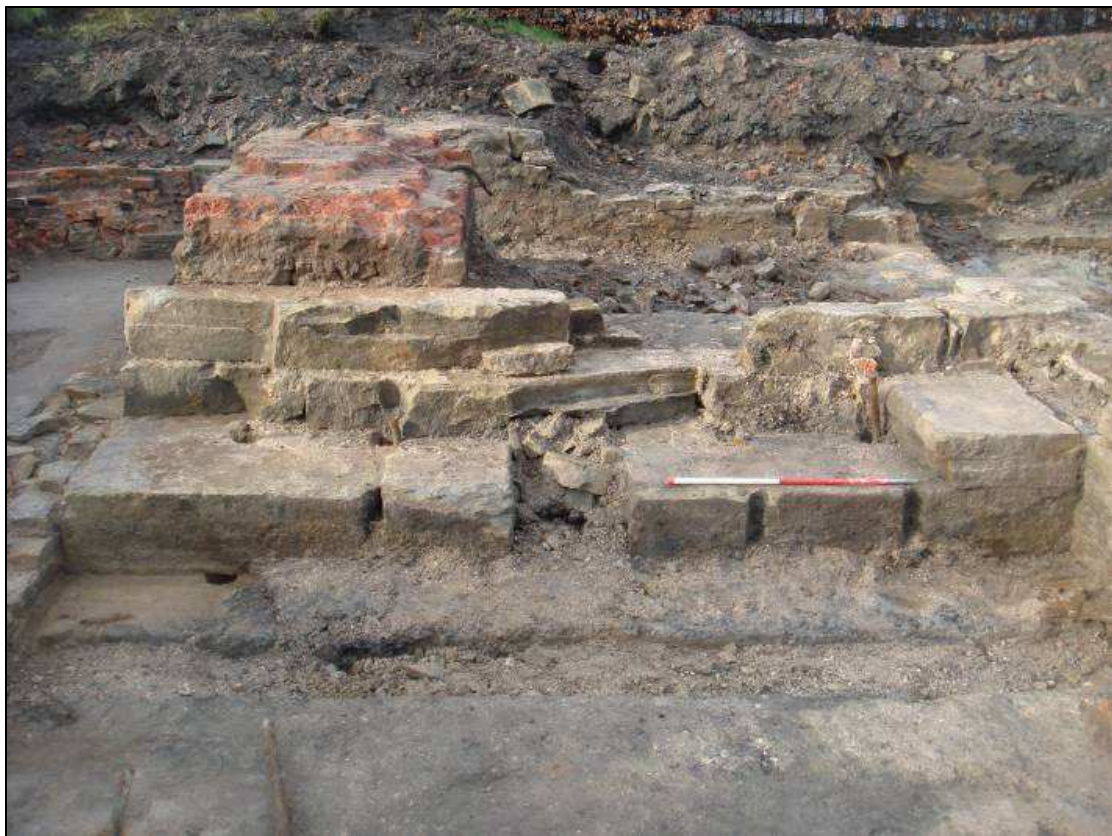
*Plate 16: Engine bed 112, with bed 113 to rear, looking south-west*

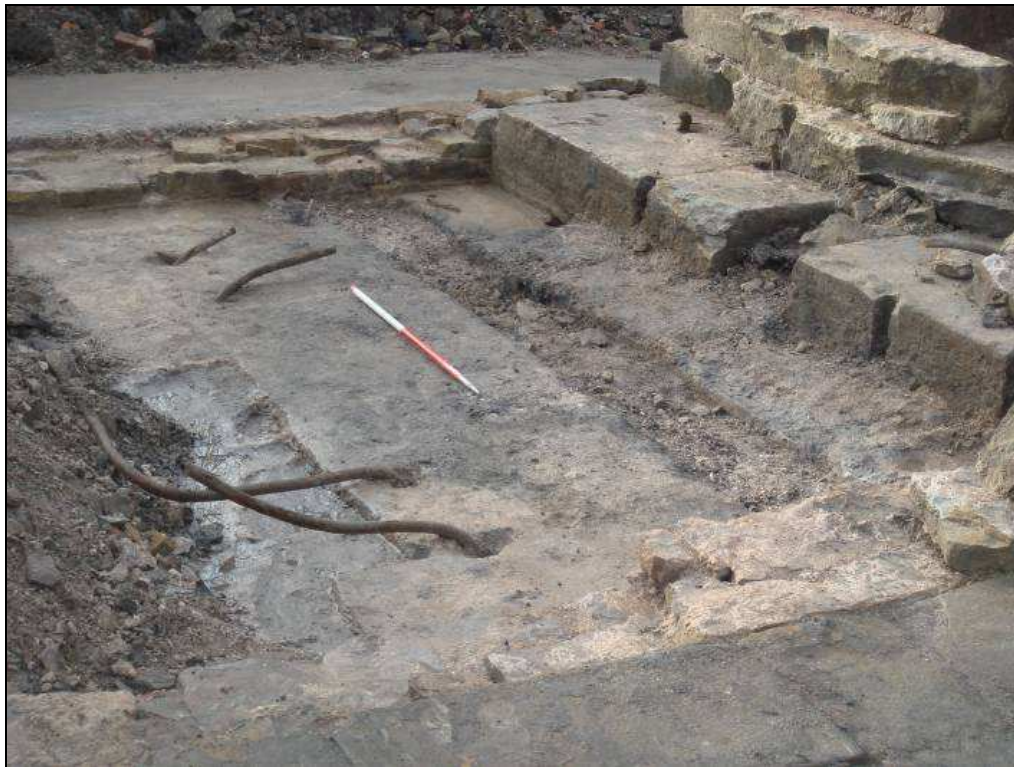
- 4.2.12 Below the later engine bed **112** was an earlier phase of stone bed (**111**). This comprised two large flat stone blocks spanning the width of the room with a 0.55m channel aligned north-west/south-east between them (Plate 17). The south-western block had a drilled 140mm diameter hole in its upper surface, which was partially overlain by later engine bed **112** (Plate 18).

*Plate 17: Earlier engine bed 111, looking south*

- 4.2.13 The north-eastern block of stone engine bed **111** had two pairs of two 180mm holes drilled into its upper surface, each containing a 40mm round cast-iron bolt, and a shallow chamfer for a component of the engine mechanism. The channel between the two blocks was rounded at its north-western end, where it abutted wall **109**, and had cast-iron plates at its sides at either end, attached to the stone blocks (Plate 19). The plates at the north-western end each had two 28mm round threaded cast-iron bolts with square nuts, and the south-eastern plates each had two 22mm threaded cast-iron bolts.

5.2.2 The two phases of engine bed suggest that an earlier, smaller, engine with a flywheel of up to 5m in diameter was built onto engine bed **111**. This is likely to have been a vertical beam engine, which may have become obsolete and underpowered when the old mill building was demolished and the new Woodfield Mill built, and been replaced with engine beds **112** and **113** accommodating a larger more powerful engine. The surviving blocks for engine bed **112** clearly overlie the drill hole within bed **111**, and may have overlain the flywheel pit as well. The concrete floor surface at the south-eastern end of the trench with the southern brick wall appeared to be a later modification, possibly replacing a boiler room when the mill was converted to electrical power during the 1920s. On the 1892 Ordnance Survey map, the older building is shown as being replaced with a raised reservoir. This may be represented by feature **105** as the remains of part of the reservoir and the large amount of stone rubble in the area, with demolition material from the earlier building being used to make up the banks of the reservoir.

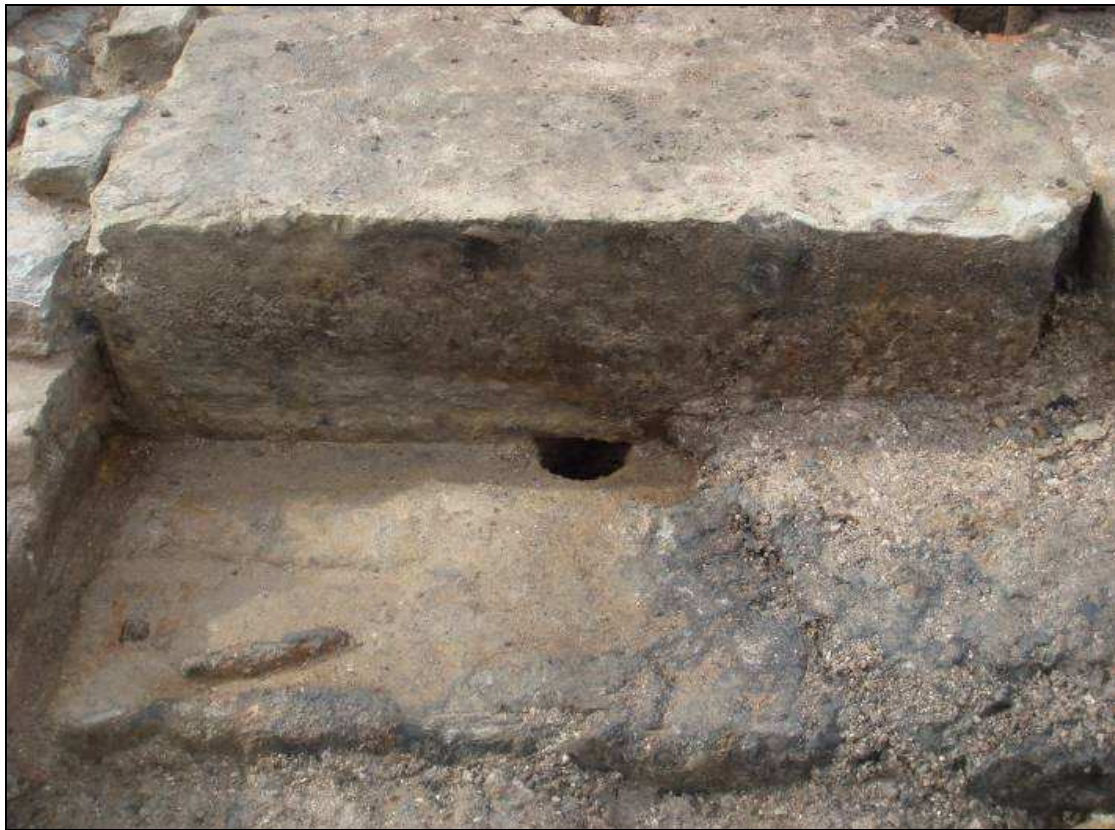
*Plate 18: Drill hole in early engine bed 111, overlain by blocks of later engine bed 112, looking south-west*

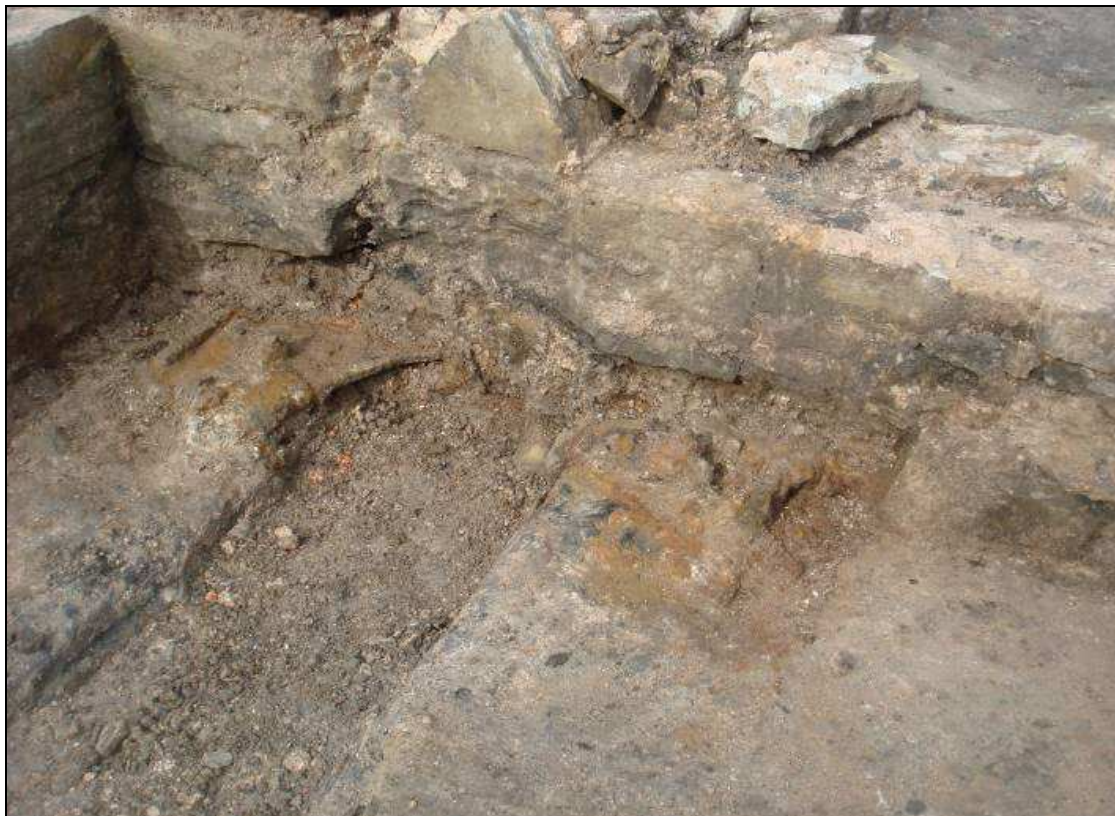
*Plate 19: Cast-iron plates and rounded north-western end of possible flywheel pit, looking north-west*

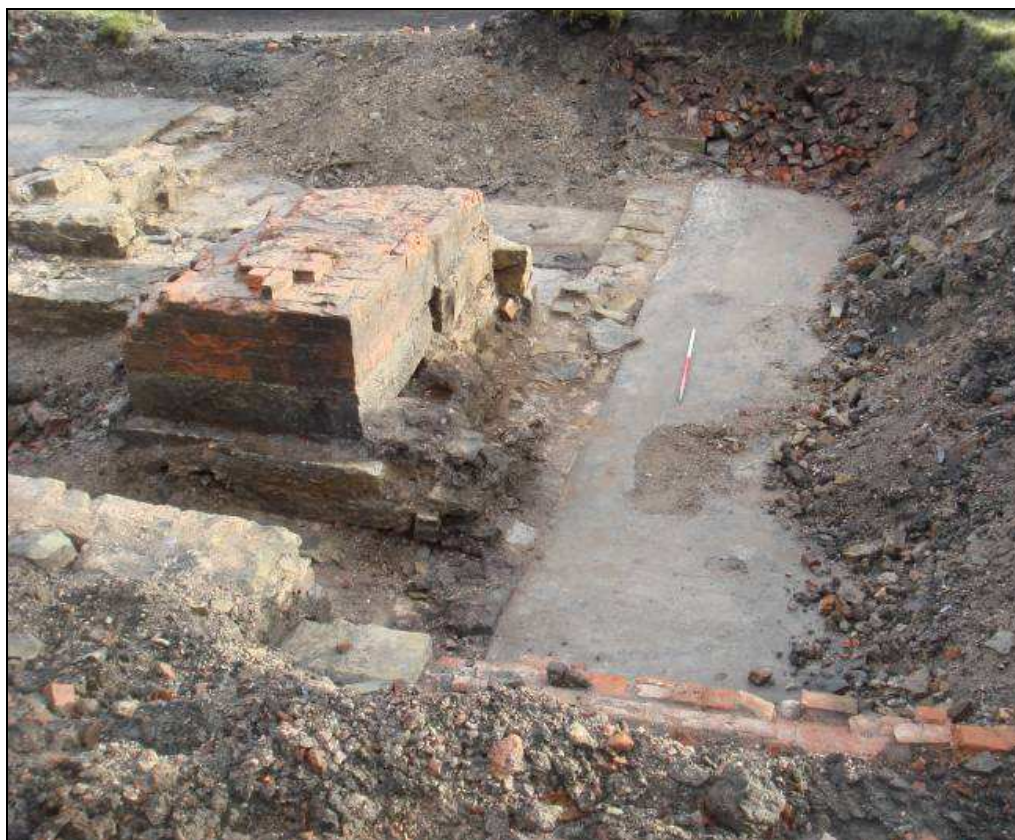
- 4.2.15 A concrete floor surface (**115**) was revealed along the south-eastern side of wall **110** (Plate 20). A wall of machine-made bricks (**114**) continued to the south-east from the southern corner of wall **110**. Both the brick wall and the concrete floor appeared to represent a later extension to the engine house.

Plate 20: Brick wall 114 and concrete floor surface 115, looking north-east

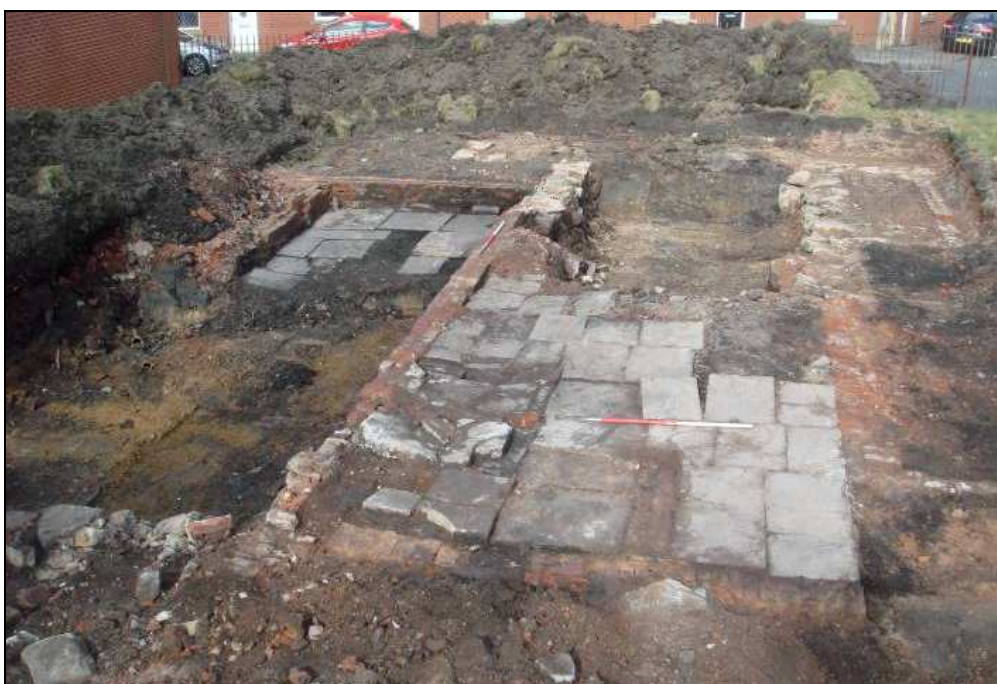
*Plate 21: General view across Trench 2, looking north, showing depth of the natural clay*

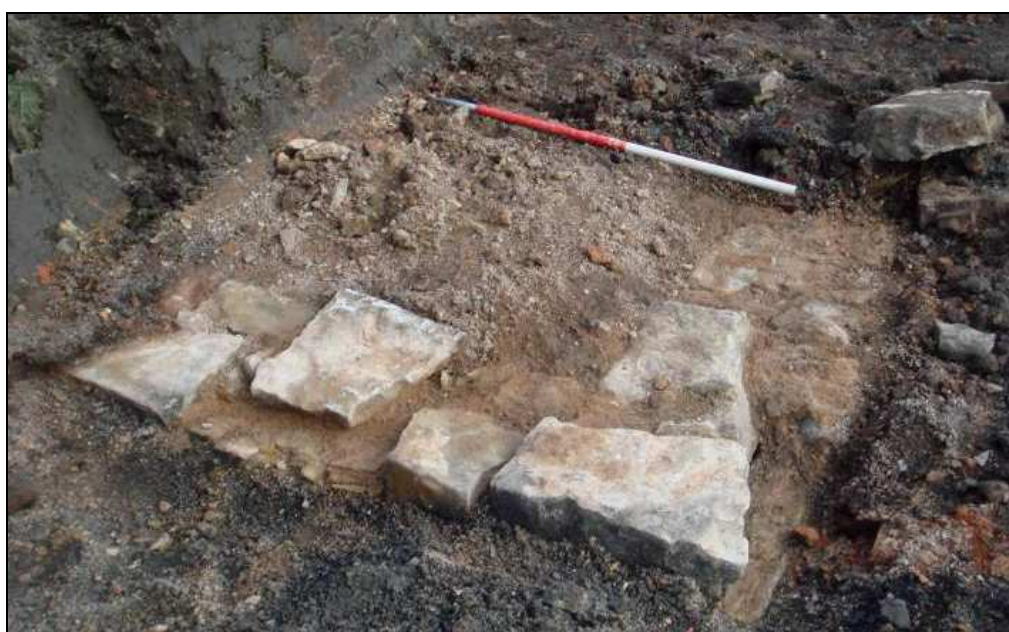
- 4.3.4 A length of stone wall (**201**) was observed at the north-eastern end of the trench (Plate 22). This was aligned south-westwards from the edge of the excavated trench edge for a distance of 1.6m before turning south-east for 1.4m, beyond which it had been removed by demolition or modern disturbance. A modern pit around this wall had removed most archaeological remains in the north-eastern part of the trench (Plate 21).
- 4.3.5 A north-east/south-west-aligned wall (**204**) was revealed along the trench, comprising a 1.1m deep footing of irregularly sized stone blocks, with machine-made brick surviving on top in places (Plates 23 and 24). The north-western side of the wall had smoothed concrete chamfer.

*Plate 22: Section of stone wall 201, looking east*

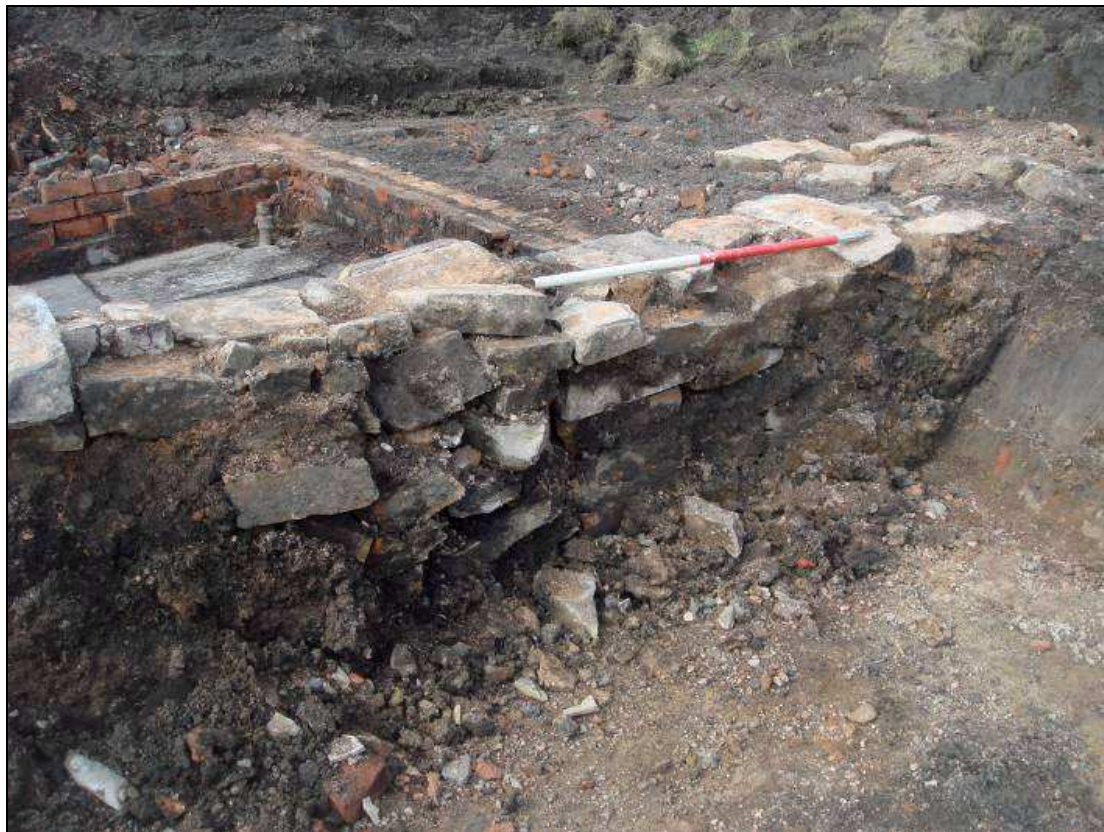
*Plate 23: Stone wall 204, looking north-west*

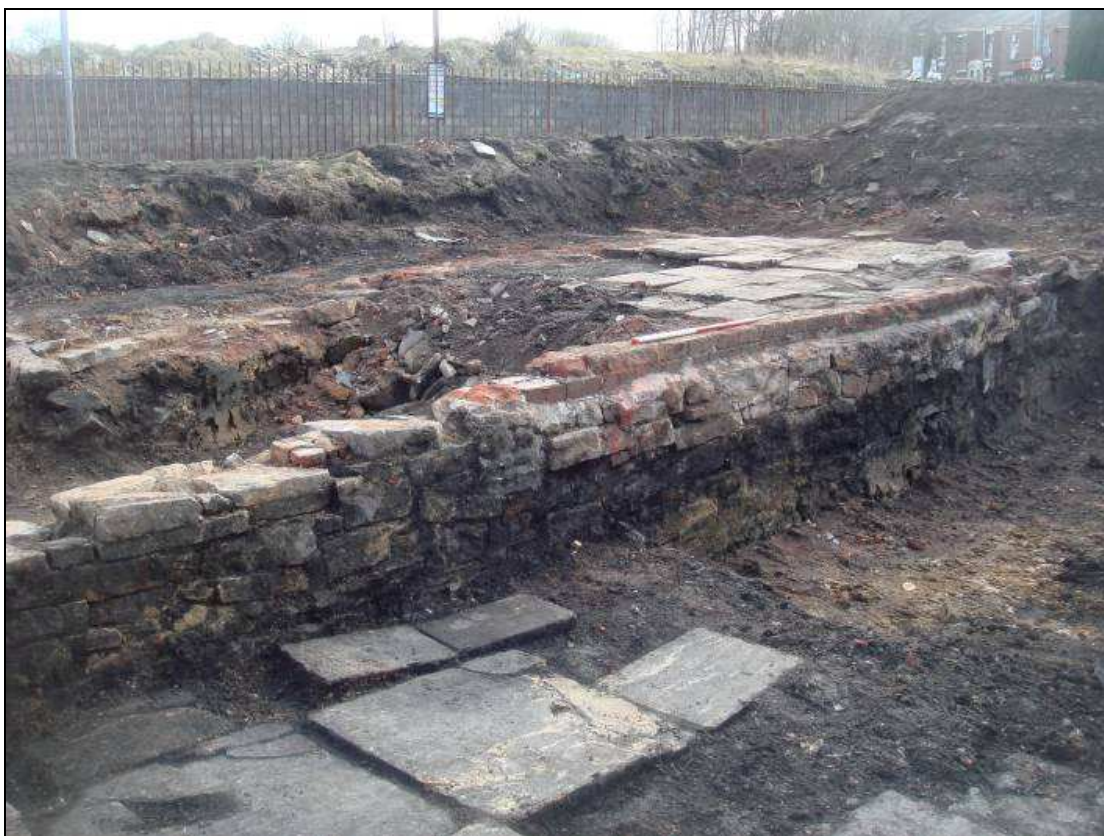
*Plate 24: Stone wall 204, with bricks on top and concrete chamfer, looking south*

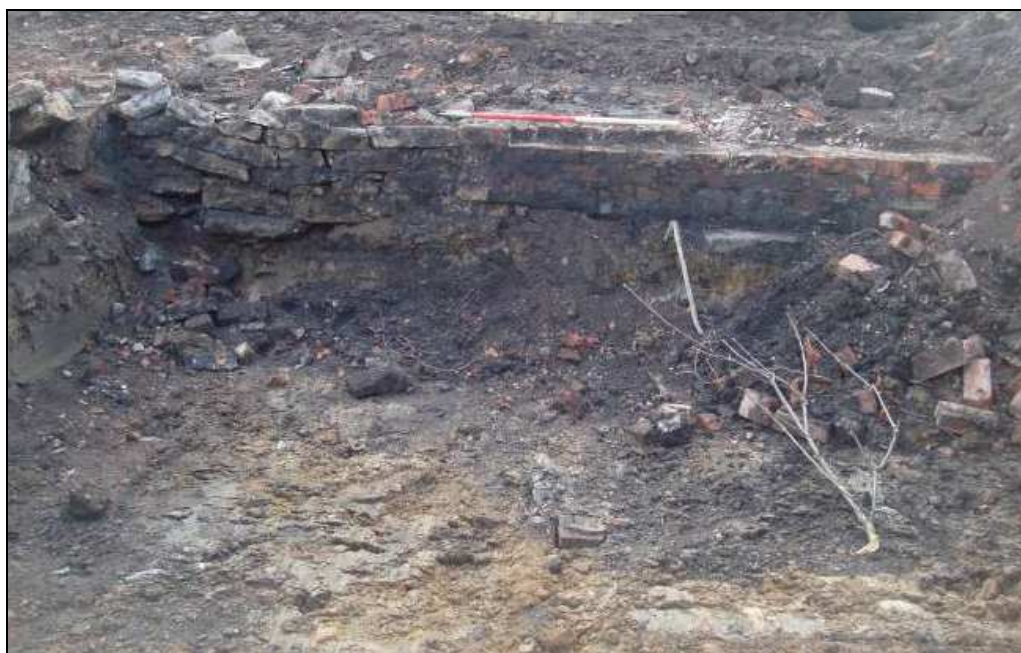
- 4.3.6 The trench was divided into two halves by a wall **215**, which was aligned north-west/south-east across the centre of the excavated area. This wall similarly comprised a 1.1m-deep stone footing, with some stretches of surviving machine-made brick above.

Plate 25: Stone wall **215**, looking south

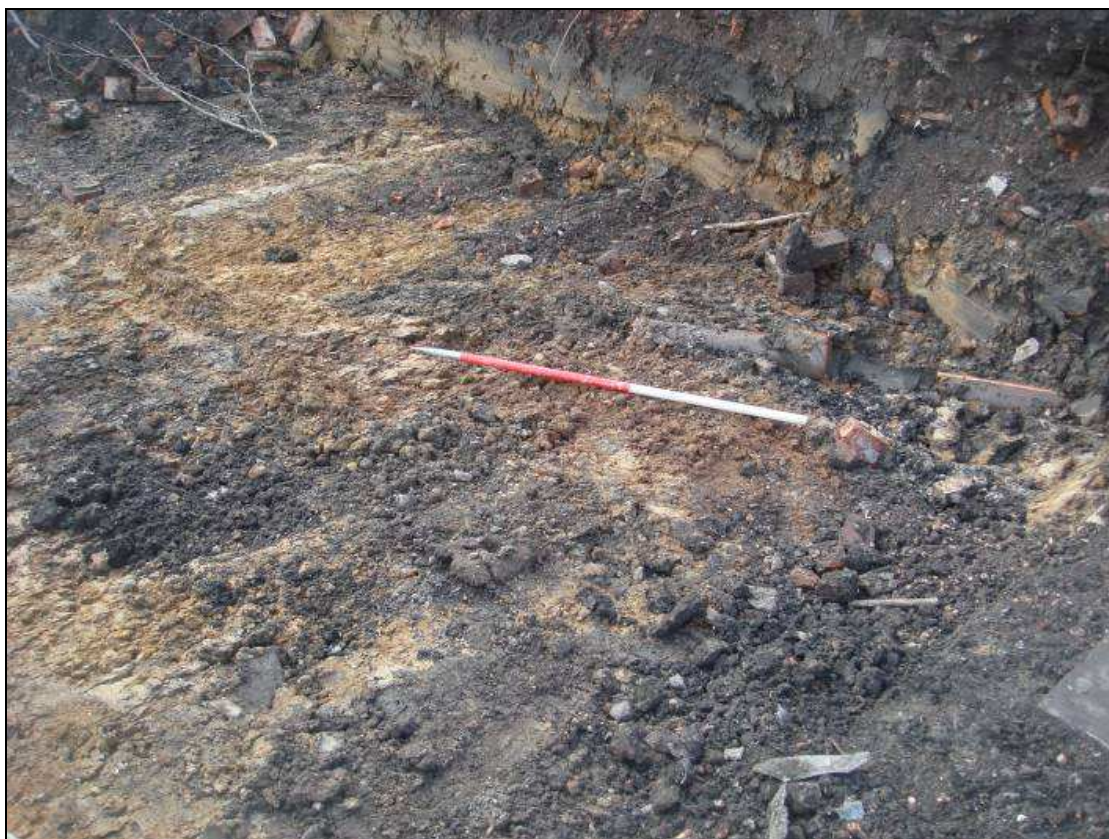
Plate 26: Natural clay 203 at the north-western side of the trench with drain 212, looking west
