**MILL HILL  
RESOURCE  
CENTRE,  
WATSON STREET,  
BLACKBURN**

**Archaeological  
Investigation Report**

**Oxford Archaeology North**

May 2015

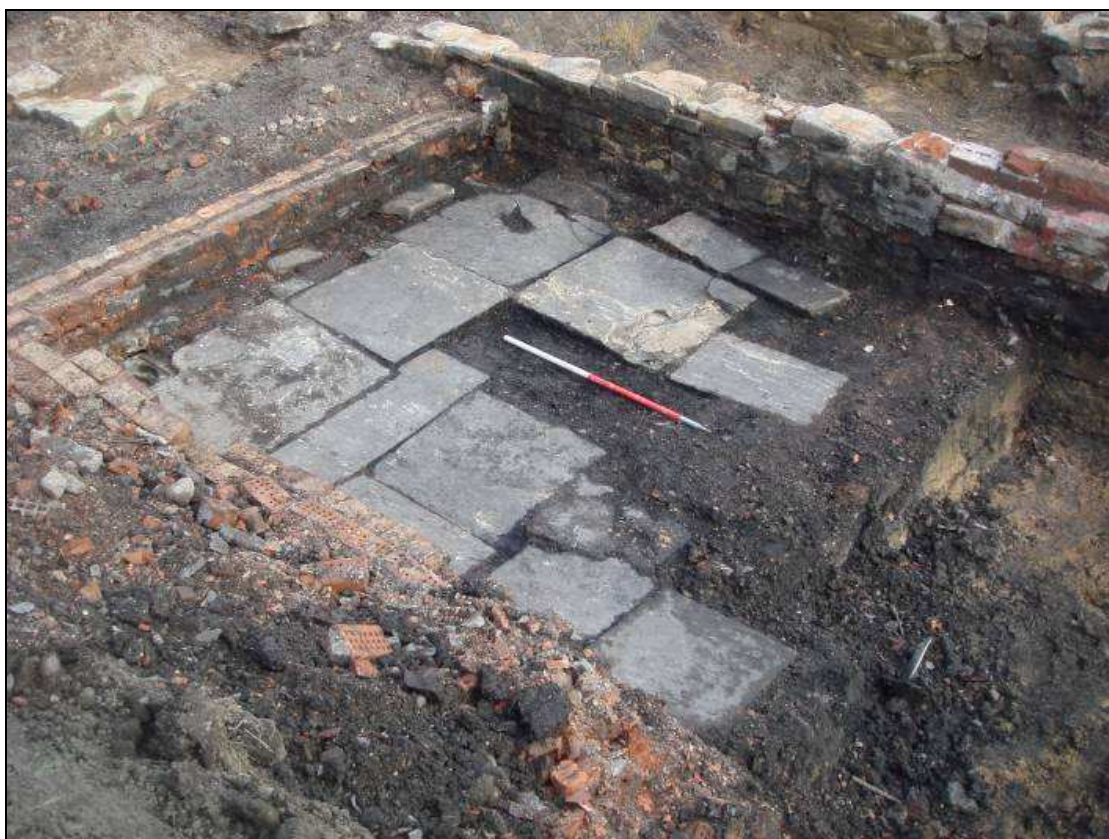
Plate 27: Flagstone floor 208 with brick walls 206 and 207 and stone and brick wall 204, looking east

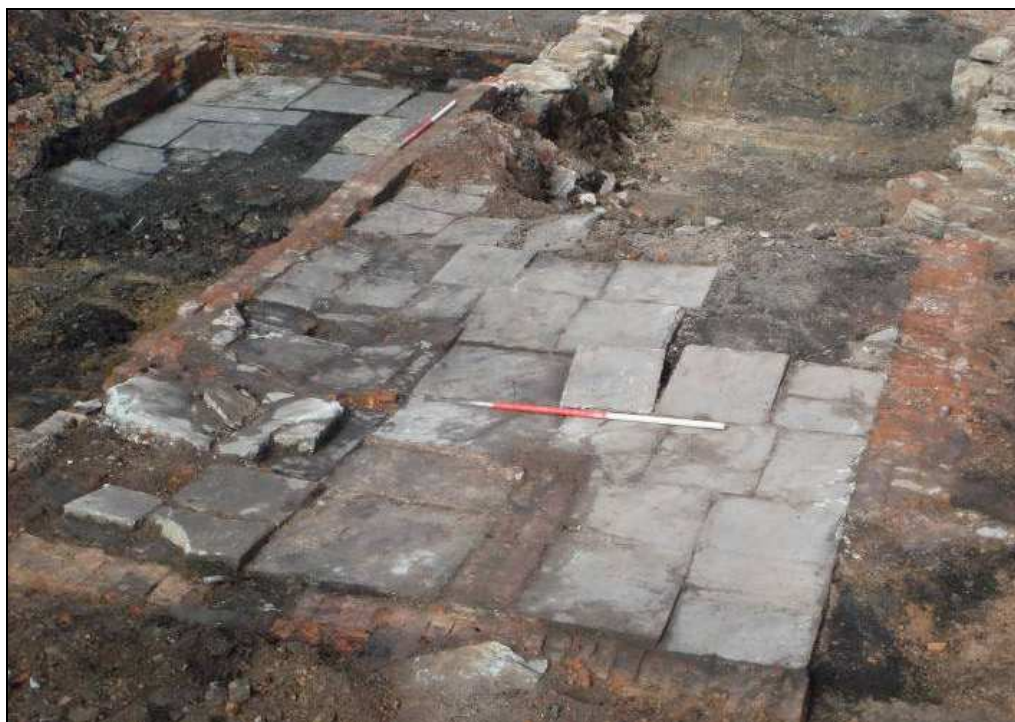
4.3.10 The south-western half of this area was surfaced with flagstones **213** (Plate 28). Two wall stubs of machine-made brick continued south-eastwards from wall **204**, creating a small 1.13 x 0.62m chamber. This was also flagged, but a ceramic drain set into concrete beside it suggests it may have been a privy. A third brick wall stub ran north-eastwards from wall **215**, creating what appeared to be a small entranceway from a 0.9m-wide ginnel formed by wall **215** and a parallel stone wall (**214**), running south-east. As the later intrusions had removed all the structures in the north-eastern half of this area, it was not possible to tell whether this was an interior room or an exterior yard.

Plate 28: Flagged area **213**, with walls **204**, **205** and **215**. Entranceway bottom right and possible privy centre left, looking north

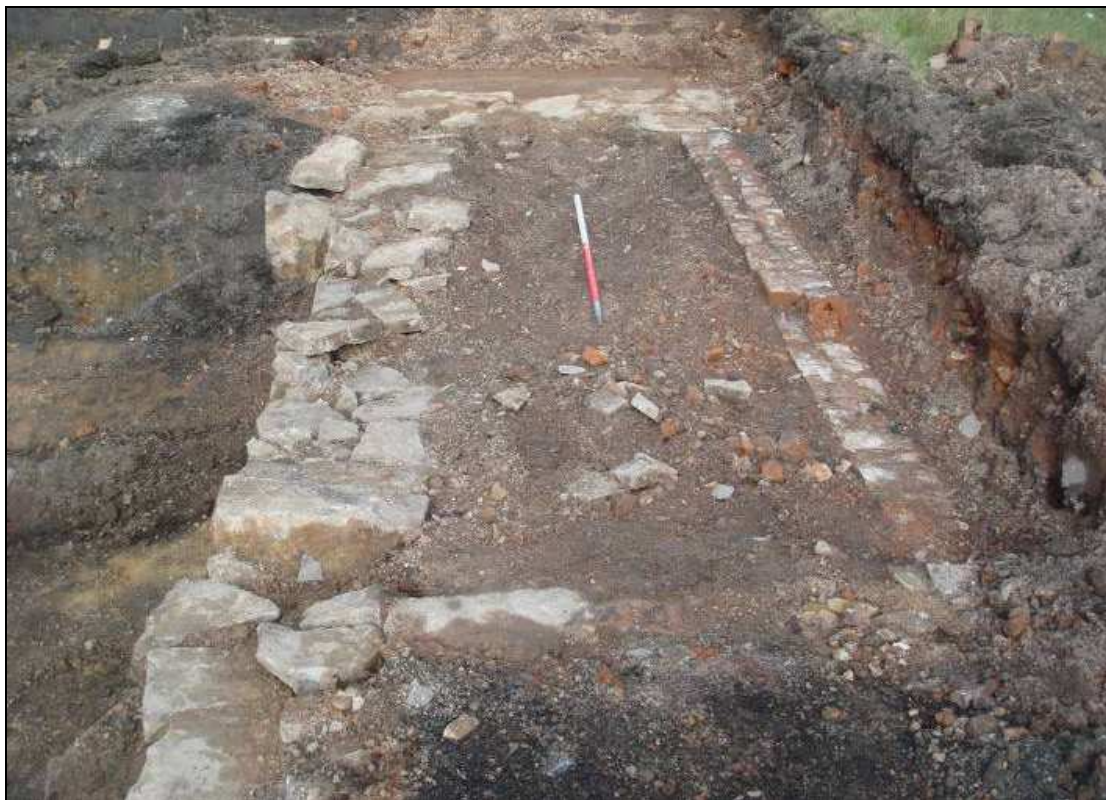
4.3.11 A small stone wall (**210**) continued south-eastwards from wall **205**, parallel to wall **214**, forming a 5.9m wide room, the south-eastern wall of which was beyond the edge of the excavated area. Beyond this, wall **205** continued north-eastwards for 4.4m, turning south-east for 1.86m and then south-west for 0.68m (Fig 7). From this point, a later brick wall (**209**) had been added to the end of the return of wall **205** and continuing back to the south-west, where it abutted stone wall **210**. This created a 4 x 1.1m rectangular room, possibly a storeroom (Plate 29).

*Plate 29: Possible storeroom in eastern corner of Trench 2, with walls 205, 209 and 210, looking north-east*

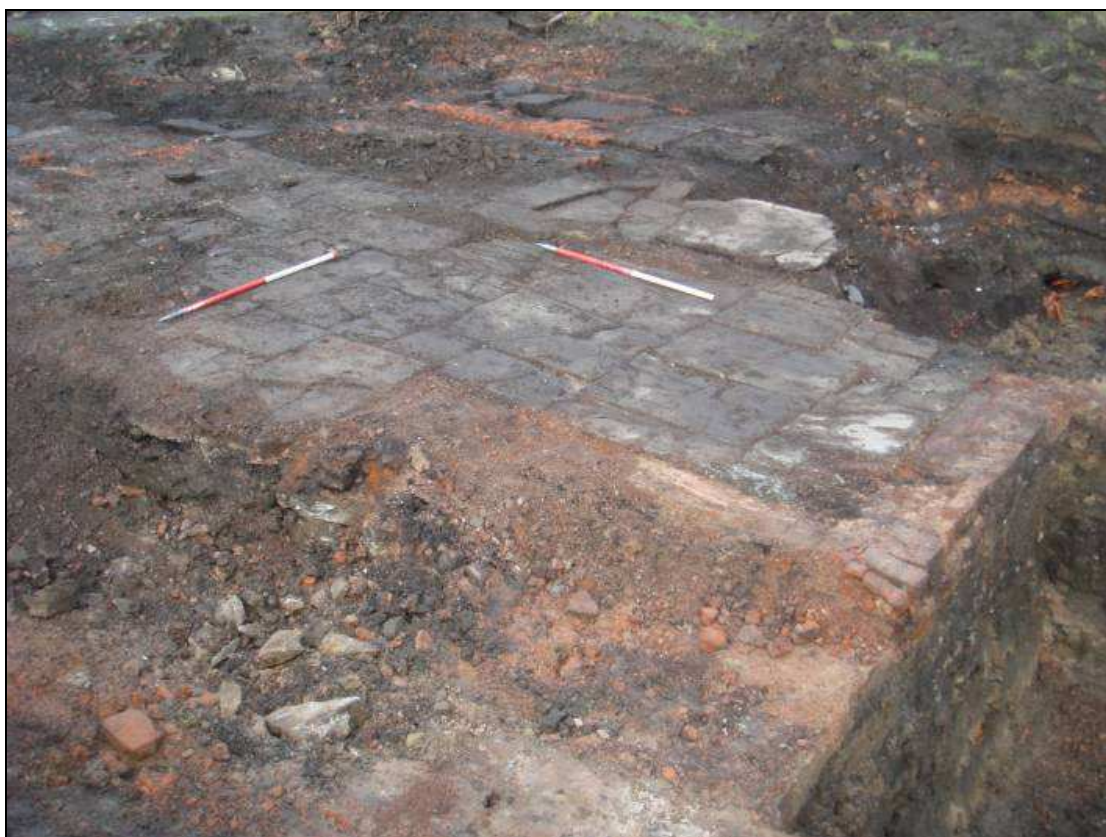
4.3.12 The ground had been disturbed to the south-west of wall **205**. On the other side of this, a stone wall (**217**), possibly a continuation of wall **205**, extended to the south-west for 9m, and then returned to the south-east into the trench edge. A stone wall footing (**216**), similar to walls **204** and **205**, extended north-west from this wall. This abutted wall **204**, creating a 3.3m wide rectangular area, possibly an exterior yard. A 1.9m long section of brick walling extending south-west from wall **216** created a small storeroom or privy in the area's eastern corner. The north-eastern part of the area had a flagstone floor (**218**), with a ceramic drain at its north-eastern end (Plate 30).

*Plate 30: Flagstones 218, looking west*

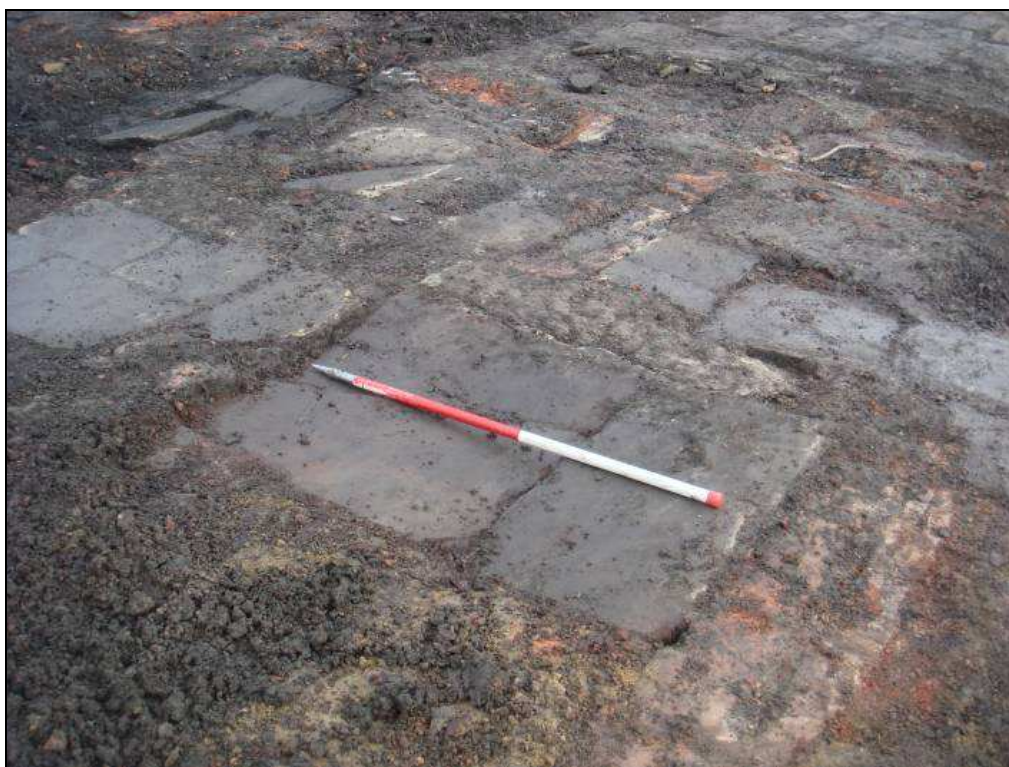
- 4.3.14 A small section of flagstones (**220**) survived within this disturbed entrance (Plate 31). Wall **221** appeared to end at the north-west, rather than be truncated, forming a 1.4m entrance between the north-eastern and south-western halves of the area. The gap seemed slightly too wide for a normal doorway, and so may have been for loading or some kind of machine or vehicle access. A section of brick walling (**222**) continued to the south-west from wall **221** for 1.8m before being truncated. This is likely to have been an internal partition wall, but the area was so disturbed it was impossible to tell its exact layout. A further section of flagstone floor (**223**) also survived next to this wall.

*Plate 31: Flagstone 220, walls 219, 221 and 222, looking north*

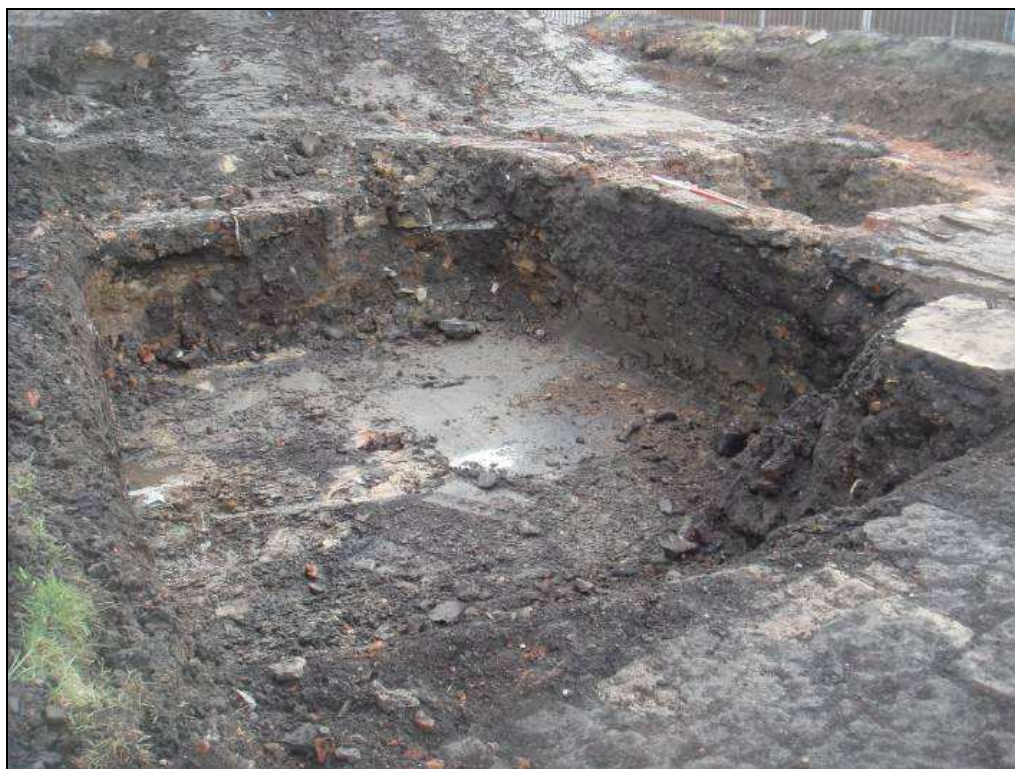
- 4.3.15 The area to the south-west of wall **215** was heavily disturbed by modern intrusions (Plate 32). The north-eastern part of this area had been disturbed down to natural clay **203** at a depth of *c* 1.65m below the current ground level. The south-western part had a large modern trial pit cutting across its western corner, and had much of the former flagstone floor removed beyond this. A small section of flagstones (**225**) survived immediately next to wall **204**, with a short stretch of a single-course wide wall (**224**) of machine-made bricks running north-east/south-west at its north-western side (Fig 7).

*Plate 32: Truncated area in south-western part of the area, showing the depth of clay natural and the south-western section of wall 215, looking north-east*

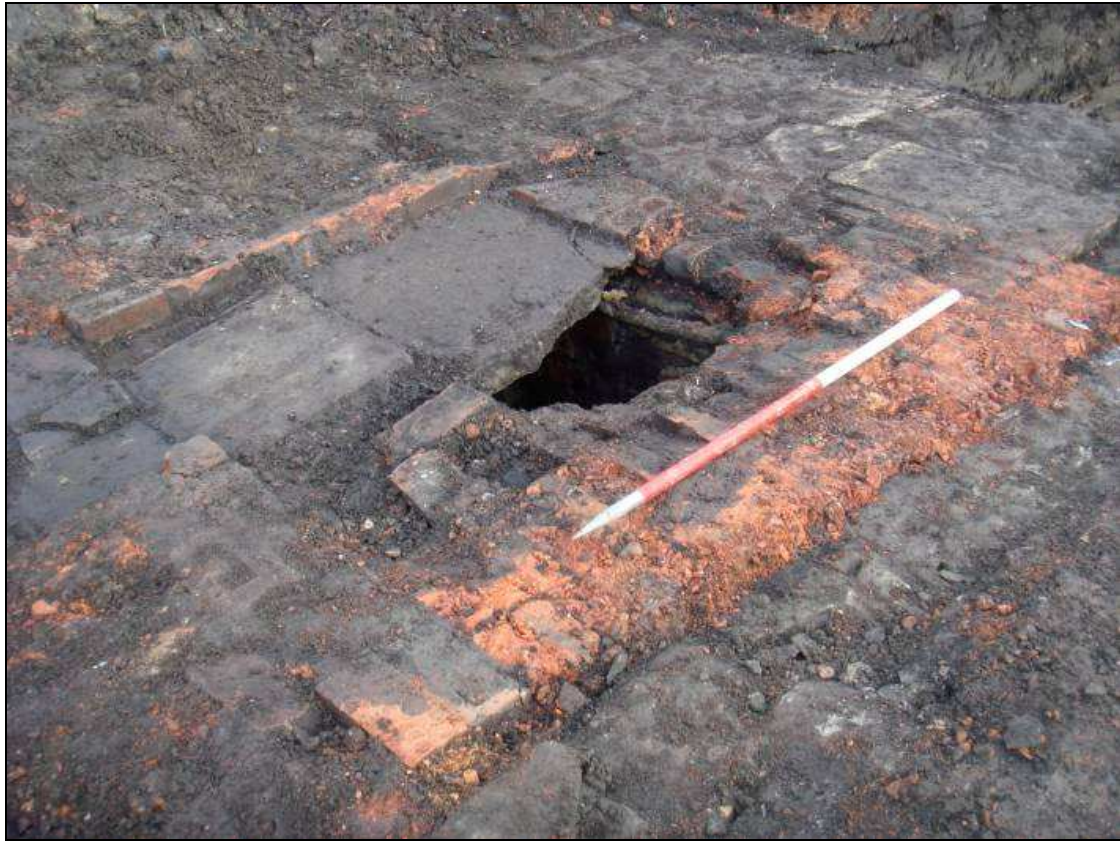
- 4.3.17 A roughly square brick structure (228), measuring 1.7 x 1.25m, also survived in this area (Plate 33). It was built from machine-made engineering brick with hard grey cement, and had a 0.85 x 0.58m central shaft containing two 35mm diameter cast-iron pipes and covered by a stone slab. This was filled with rubble, and so its full depth was not known, but it was observed to a depth over 0.7m. A narrow flagged section at its south-western side seemed to give access to the shaft and a brick drain had been built at the south-eastern side of the shaft. A stone wall footing (227), truncated at both ends, was aligned north-east/south-west along the structure's south-eastern side. A section of flagstones (229) also survived to its north and north-east.

*Plate 33: Brick structure 228 and stone wall 227 with flagstones 229, looking north*

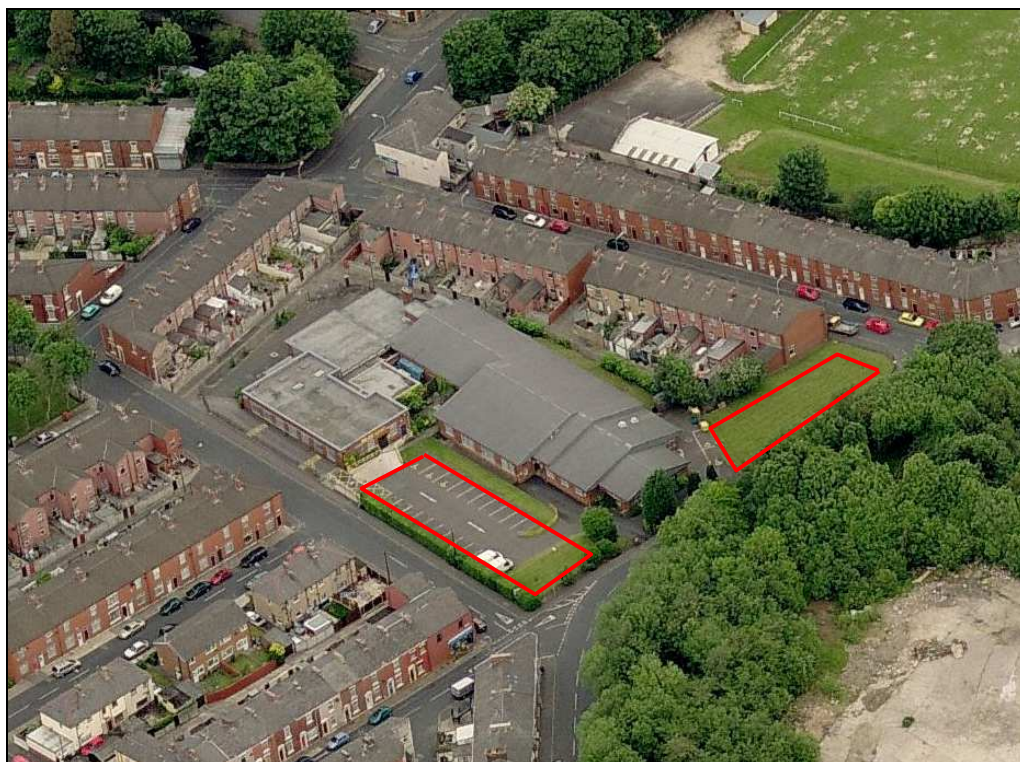
*Figure 2: Areas to be subject to archaeological investigation, superimposed on a recent aerial view of the development site*

- 2.1 The required scheme of archaeological works comprises the intrusive investigation of two parts of the site that may contain buried archaeological remains of interest and that will be damaged or destroyed as part of the proposed development. These areas are limited to the area of car parking bounded on the west by Watson Street and the east by Mill Hill Street, and the open grassed area fronting Mill Hill Street at its junction with Victoria Street.

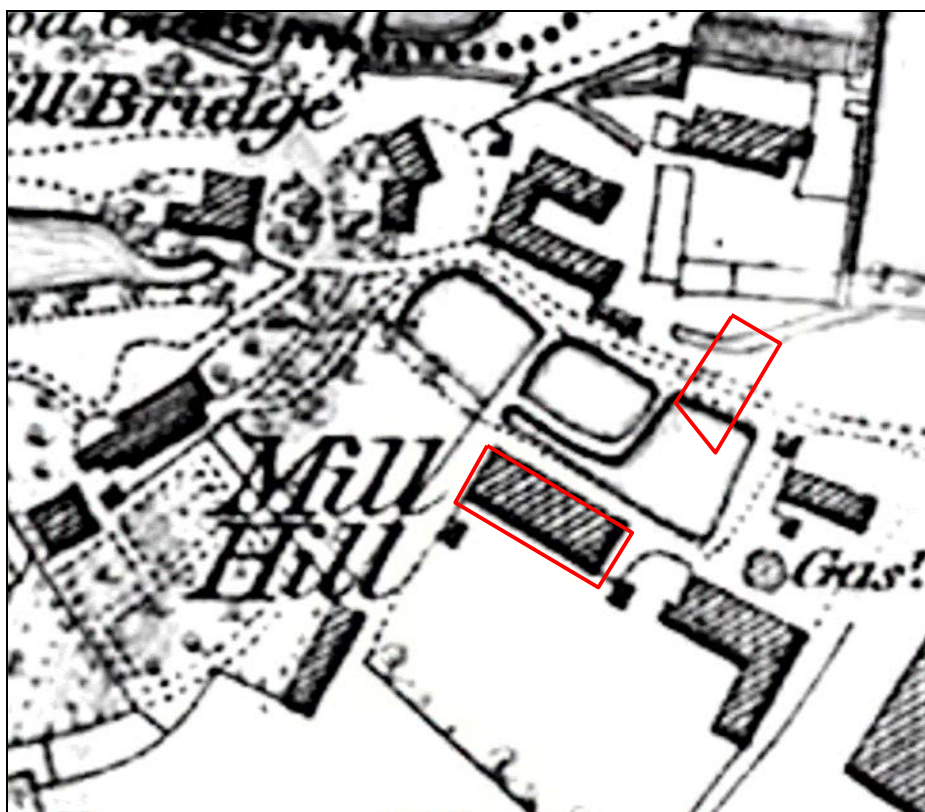
Figure 3: Areas to be subject to archaeological investigation, superimposed on the Ordnance Survey map of 1848

- 2.2 In particular, the excavation area adjacent to Watson Street will investigate the footprint of a large rectangular building shown on the first edition Ordnance Survey map of 1848 (Figure 3) and the possible engine house for the mid-nineteenth-century cotton mill, shown on Ordnance Survey mapping published in 1892 (Figure 4). The second area, adjacent to Mill Hill Street, is shown to have been occupied by one of the reservoirs associated with the textile printing works on the Ordnance Survey map of 1848, but was developed for ancillary buildings associated with the mid-nineteenth-century cotton mill subsequently.

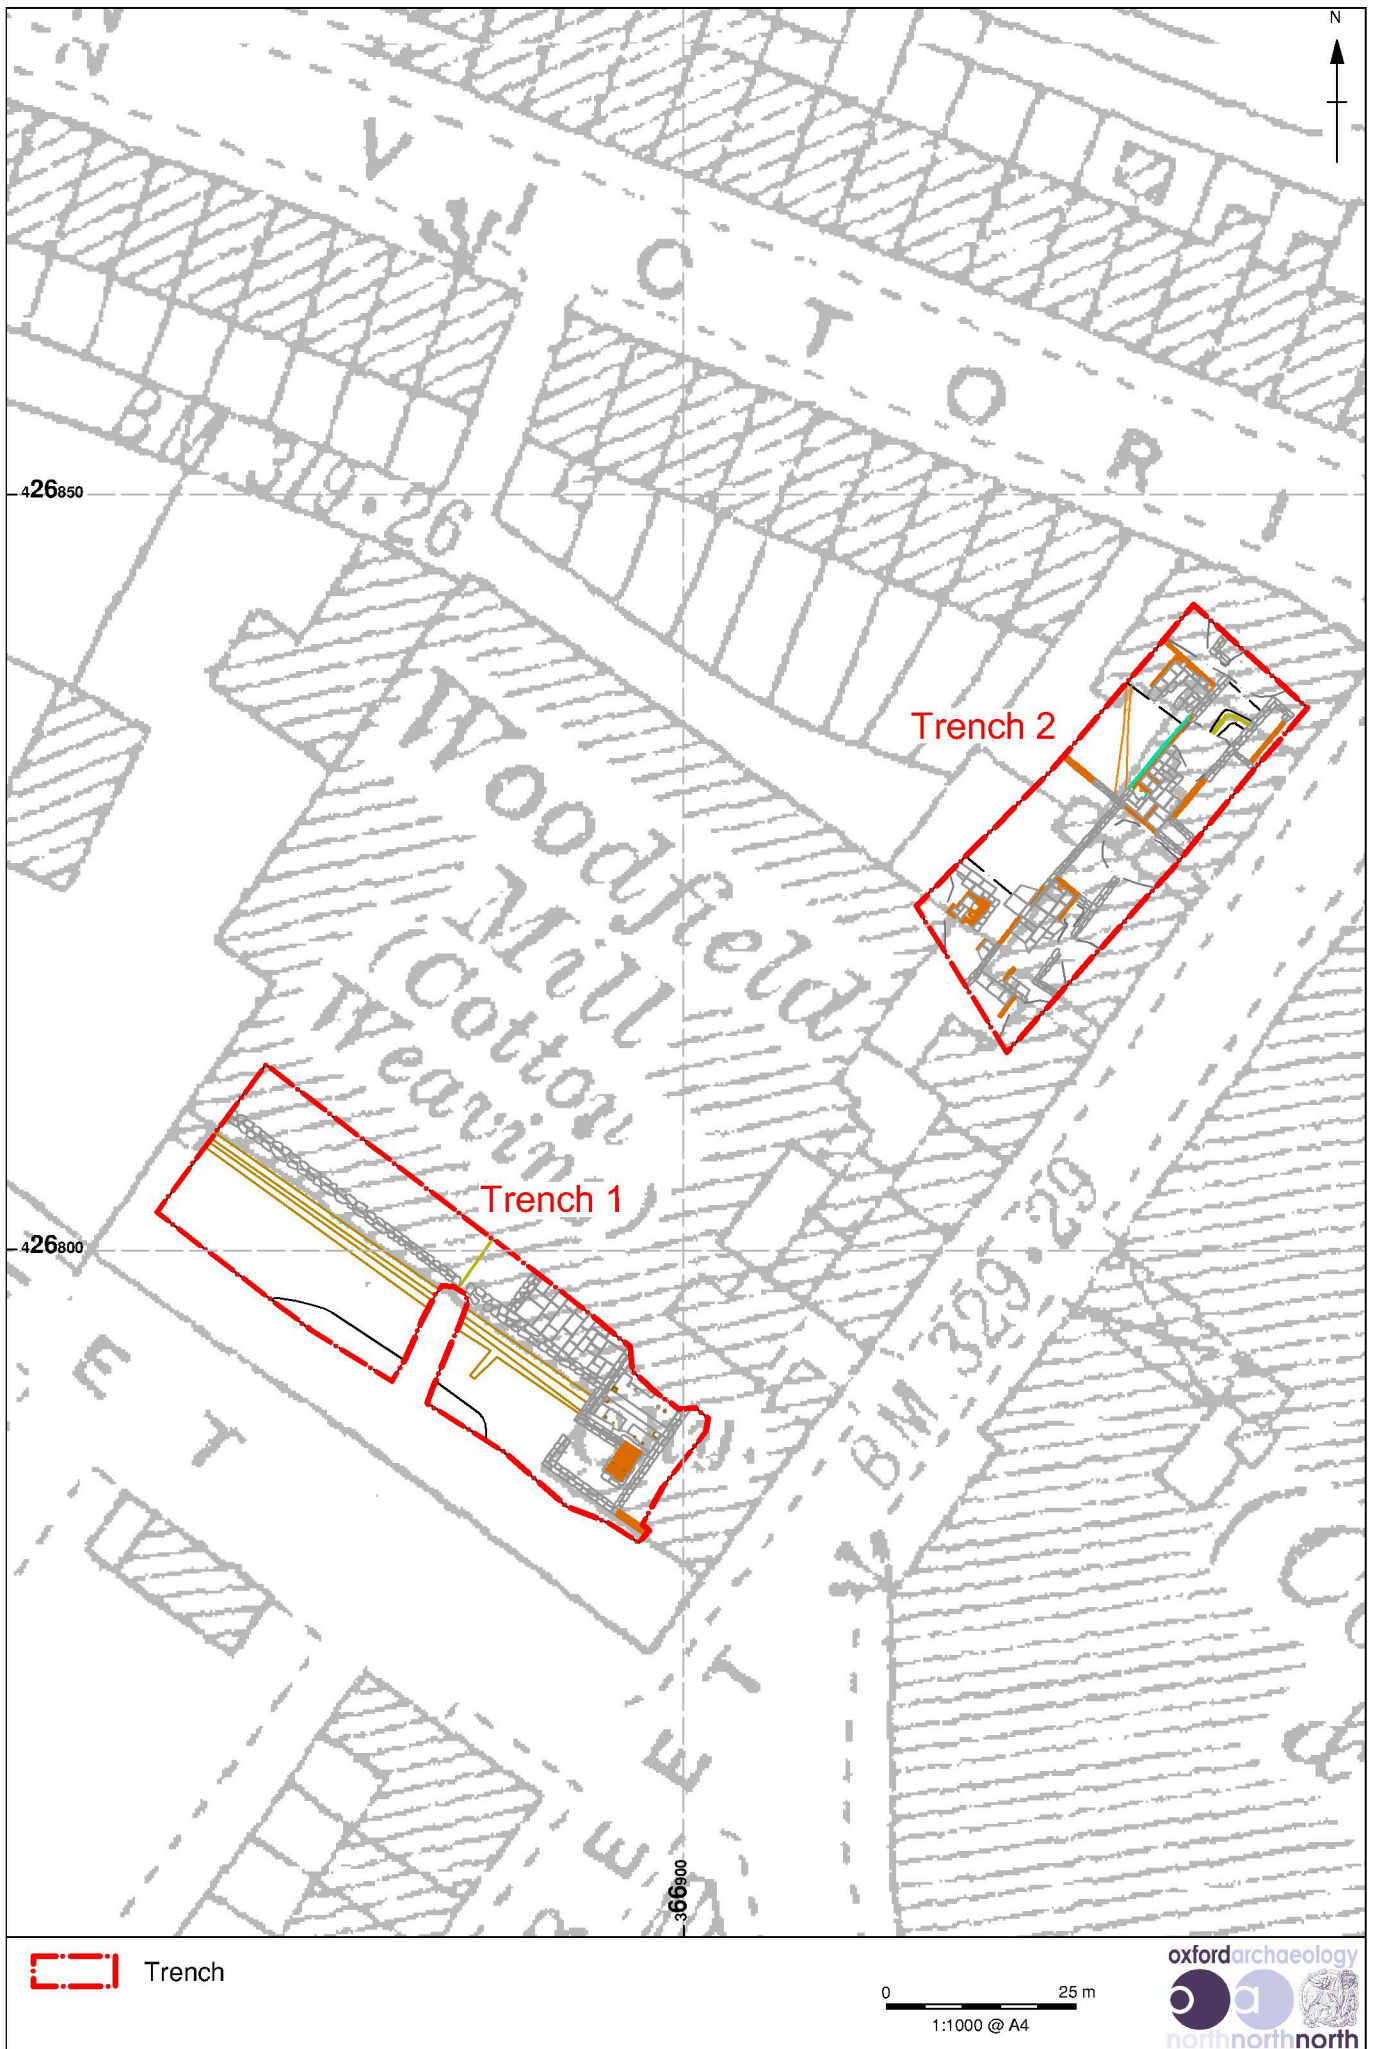
Figure 4: Trenches superimposed on the Ordnance Survey 25":1 mile map of 1931

4.2.1 Trench 1 measured 39.4 x 12.4m, and was excavated to a maximum depth of 1.6m. It was aligned north-west/south-east, and was placed across the Mill Hill Resource Centre car park and landscaped banking to the south-east. The trench was not extended to the hedge at the south-west due to the presence of live services along that edge of the site. The trench was intended to investigate a rectangular structure depicted on the Ordnance Survey map of 1848 mapping, which is likely to represent, at least in part, the original eighteenth-century printing works (Fig 4).
