The Duke of Wellington Public House, South Barrier Bank Whittlesey, Cambridgeshire

Excavation Report

**The Duke of Wellington Public House, South Barrier Bank, Whittlesey,
Cambridgeshire**

Archaeological Excavation

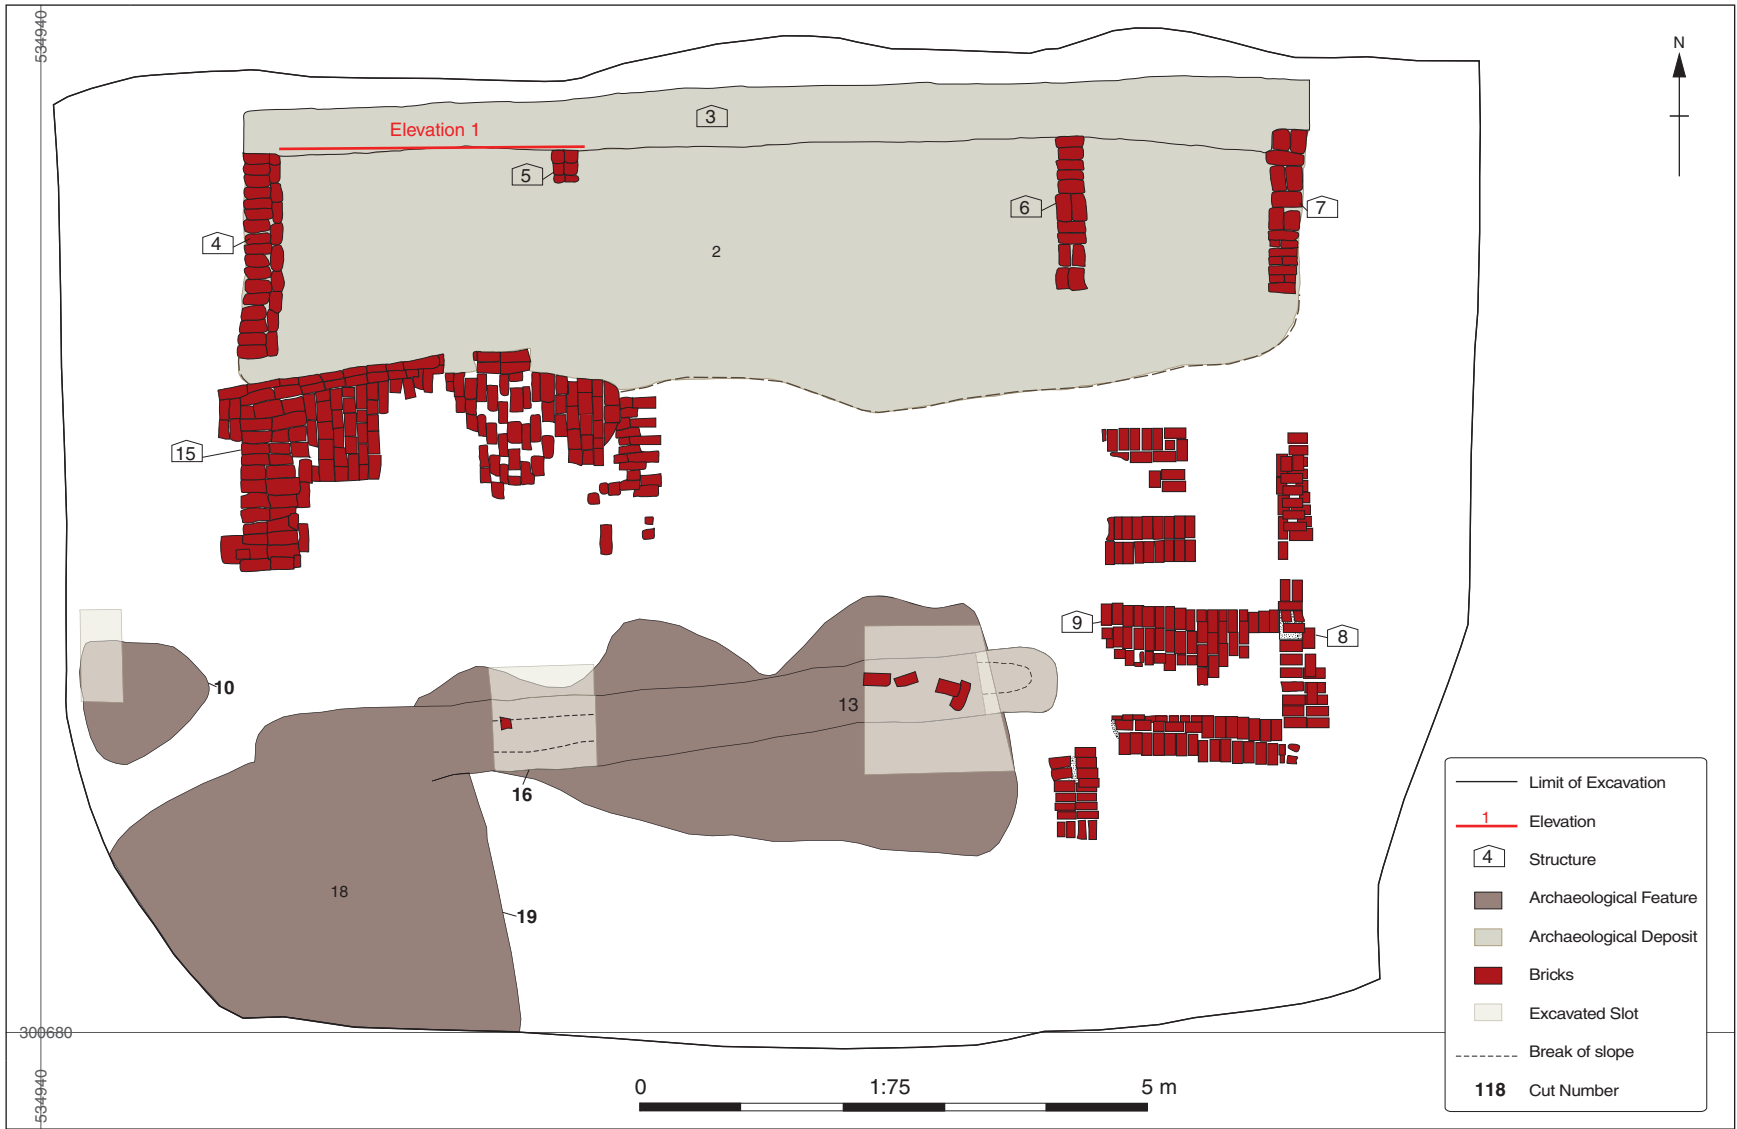
Figure 3: Site plan

- 3.1.1 The results of the excavation are presented below, with a plan given as Figure 2. The 19th century building is discussed first, and the 20th century replacement after this.
- 3.1.2 The features which formed the remains of the 19th century building are discussed by type and they all relate to the use and subsequent demolition of this building. The excavation area was on the south side of the South Barrier Bank of the Whittlesey Washes flood reservoir. It sloped steeply from north to south. Finds from the topsoil overlaying the site were assigned context number 1.
- 3.1.3 The 20th century building was located to the south of the South Barrier Bank, on flat ground.

- 3.2.1 The exposed walls appeared to consist of two groups; the front, and possibly original part of the building (walls **8**, **21** and robber trench **13**) and the more substantial rear of the building (walls **3**, **4** and **7**). The rear walls seem to have been constructed to retain the bank and may have been a later addition.

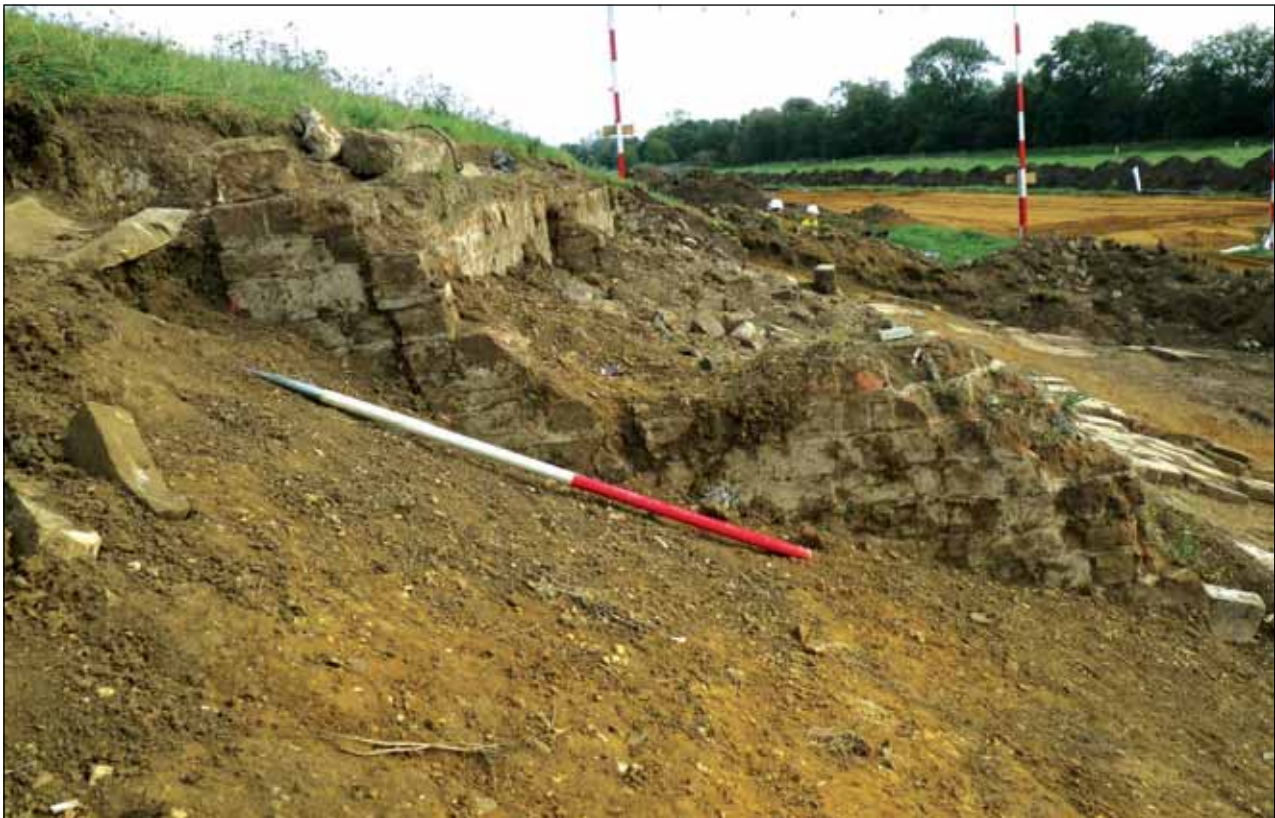
Plate 3: Wall 4 from the west

- 3.2.8 This wall formed the western side of the rear of the later building. It was constructed from the same bricks and in a similar fashion to the back wall (**3**), with the internal face made up of stretchers, with a course of headers to the outside. Wall **4** was joined onto the back wall (**3**), but a large crack was present at this junction (plate 3).
