Archaeological Evaluation at land at 21-23 Milton Road, Cambridge

Archaeological Evaluation Report

OA East Report No: 1814

Land at Nos 21 to 23 Milton Road, Cambridge

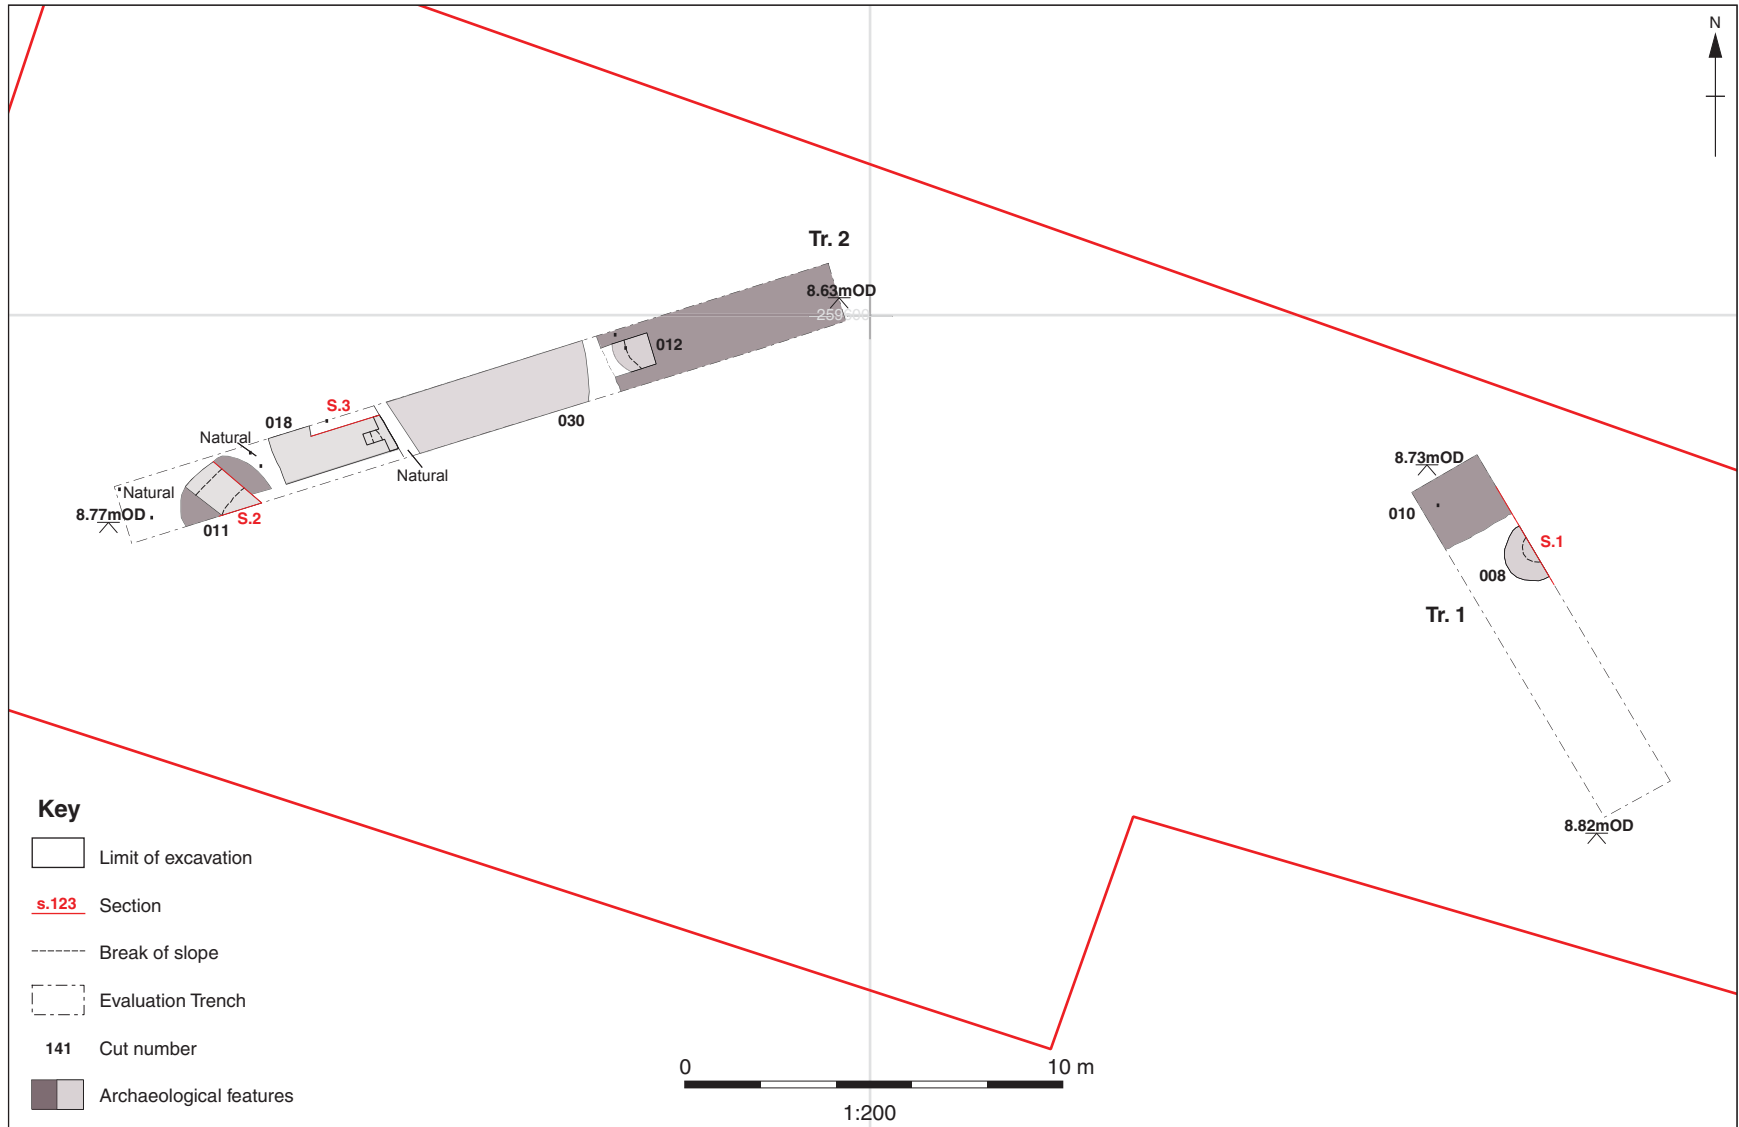
Figure 3: Plan of Trench 1 and Trench 2

3.1.1 Both of the excavated trenches (Figs 2-3) contained archaeology. Trench 1 contained two sub-circular pits while Trench 2 revealed four large sub-circular pits. All of these features cut into the light brown sand silt subsoil. They were in turn sealed by levelling layers of 19th century brick and rubble. In Trench 1 these layers were overlain by a layer of concrete: the remains of the foundations of the early 20th century housing which formerly occupied the site. The uppermost layer within both trenches was a mixture of modern concrete and rubble. The trenches are described below in numerical order, supplemented by further trench/context information in Appendix A.

3.2.1 Trench 1 was located in the eastern end of the site (Fig. 3; Plate 1). It was 10m long and 1.80m wide. The trench was aligned north-west to south-east, and had an average depth of 0.90m. Only two features were identified, both at the north-west end of the trench. These were overlain by a thin band of light brown sand silt subsoil (5), sealed by later post-medieval levelling layers.

3.3.1 Trench 2 was located in the western side of the site (Fig. 3; Plate 2). It measured 20m in length and 1.80m in width. It was aligned north-east to south-west with an average depth of 1.10m. Four large pits were identified, three of which (**12**, **18** and **30**) were only partially exposed. The pits cut into the small band of subsoil (5), only visible at the south-west end of the trench.
