# Engineering Test Pits The Buttery and Kitchen University College High Street, Oxford

## Archaeological Evaluation Report

Issue N<sup>o</sup>: Final Report  
OA Job N<sup>o</sup>: 3621  
NGR: SP 5174 0620  
Planning Ref: 06/02179/FUL

## Engineering Test Pits, The Buttery and Kitchen University College, High Street, Oxford

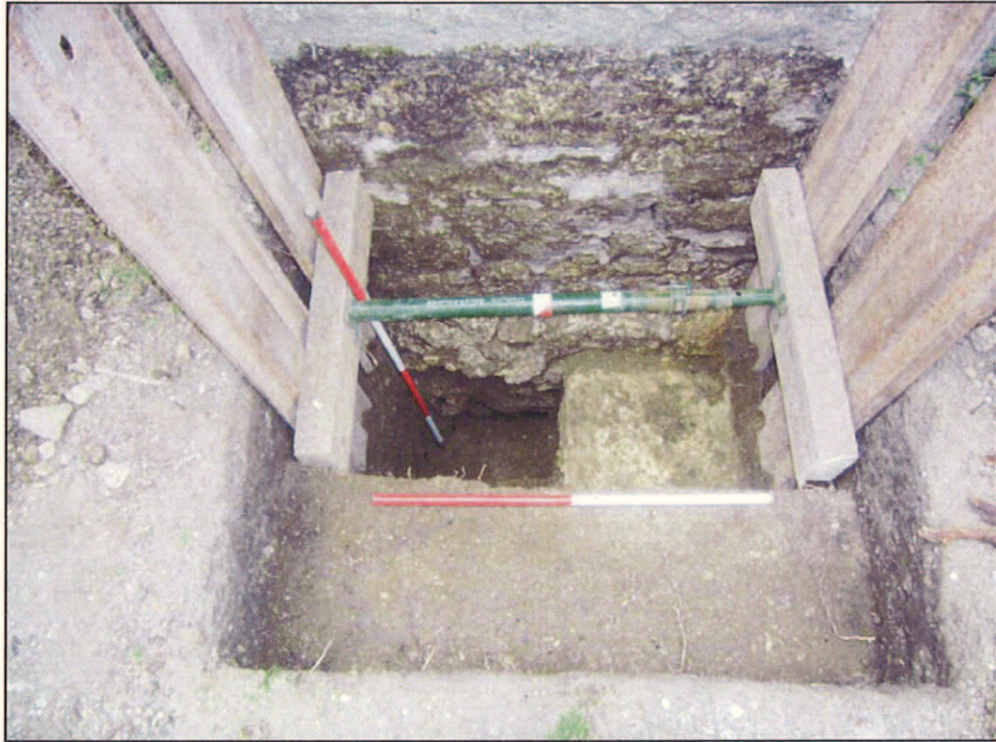
Plate 1: ATP3 - as excavated looking west

- 5.1.5 Within Test Pit 3, wall 300 measured 5.96 m from the existing capping to the base of the stepped footing. The top of the stepped footing was c 1.2 m below existing ground level (60.95 m OD) and the footing itself comprised roughly coursed limestone rubble approximately 0.80 m deep with an irregular eastern face (see 5.1.4) and bonded with lime mortar. Above the footing, the wall was well faced and apparently rendered with mortar. The fact that the soft pit fills appear to continue under the wall footing is curious in that it implies that the wall has been founded on soft material. However, if the western edge of the pit lies immediately to the west of the eastern face of the wall (see 5.1.1), it is feasible that the base and western extent of the stepped footing are founded on more stable deposits (possibly terrace gravel) through which the pit has been cut. This could not be established within the confines of the test pit without undermining the footing so must remain conjectural. It is possible that the depth of the footing in the location of the test pit may be localised in the area of the 'soft spot' created by the pit fills. However, it is perhaps significant that the offset section of the wall footing of the kitchen building to the north (OA, 2006, Trench 1, Context 15) was encountered at 61.10 m OD, which may imply some correlation between the foundations of these structures, although the cartographic evidence suggests that they are not contemporary (see Section 7).

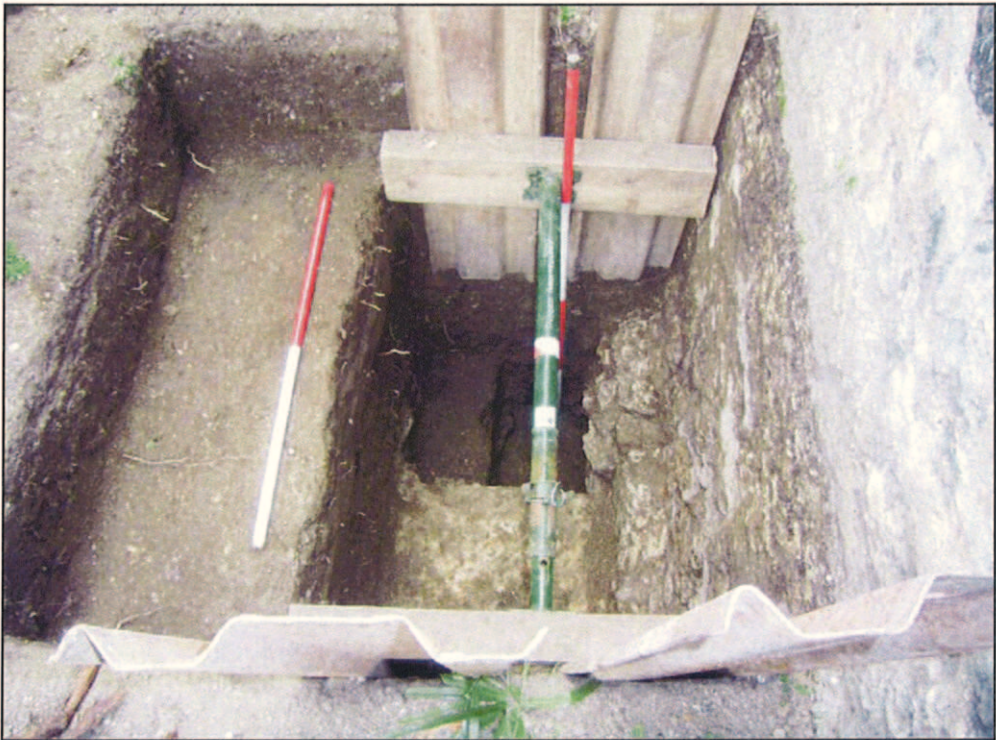
Plate 2: ATP3 - as excavated looking south

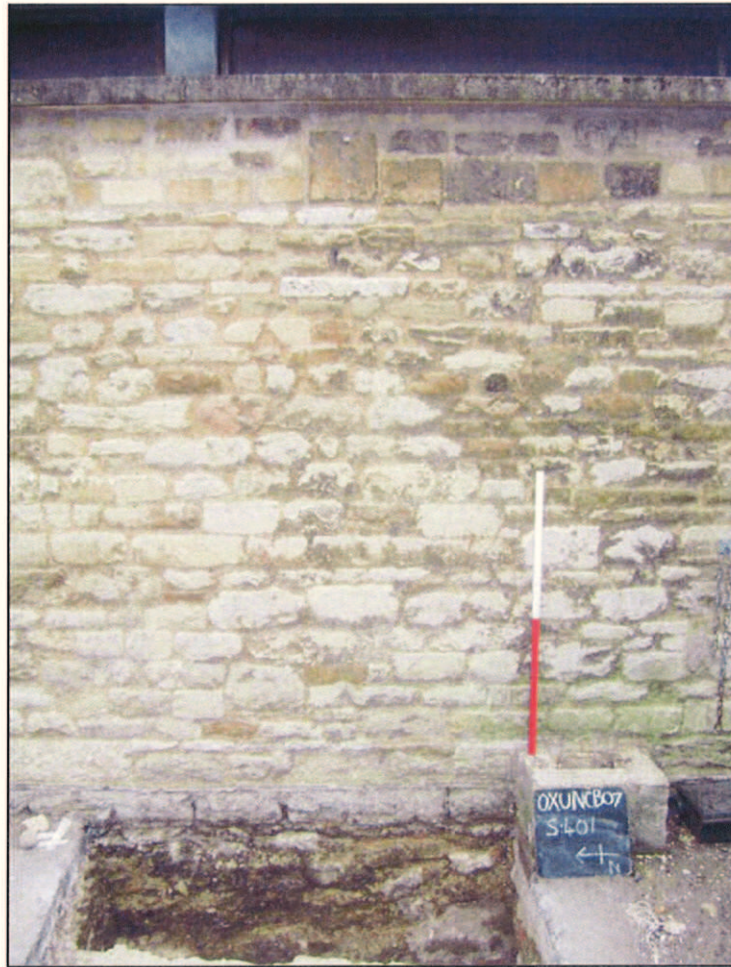
Plate 3: ATP4 - as excavated looking east

- 5.1.10 The footing was 0.70 m deep and comprised a single offset course of large limestone blocks overlain by 4 courses of roughly coursed limestone in a lime mortar bond. Overlying the upper course of this footing, approximately 0.04 m below ground level, was a band of gravel based ?mortar (415) which appeared to mark a change in build and was overlain by the above ground element of the standing wall (408). This comprised well coursed and faced limestone, with a course of slate ?damp proofing above the lowest course. The height of the wall from the base of the cobble foundation to the top of the existing capstones measured 3.25 m.

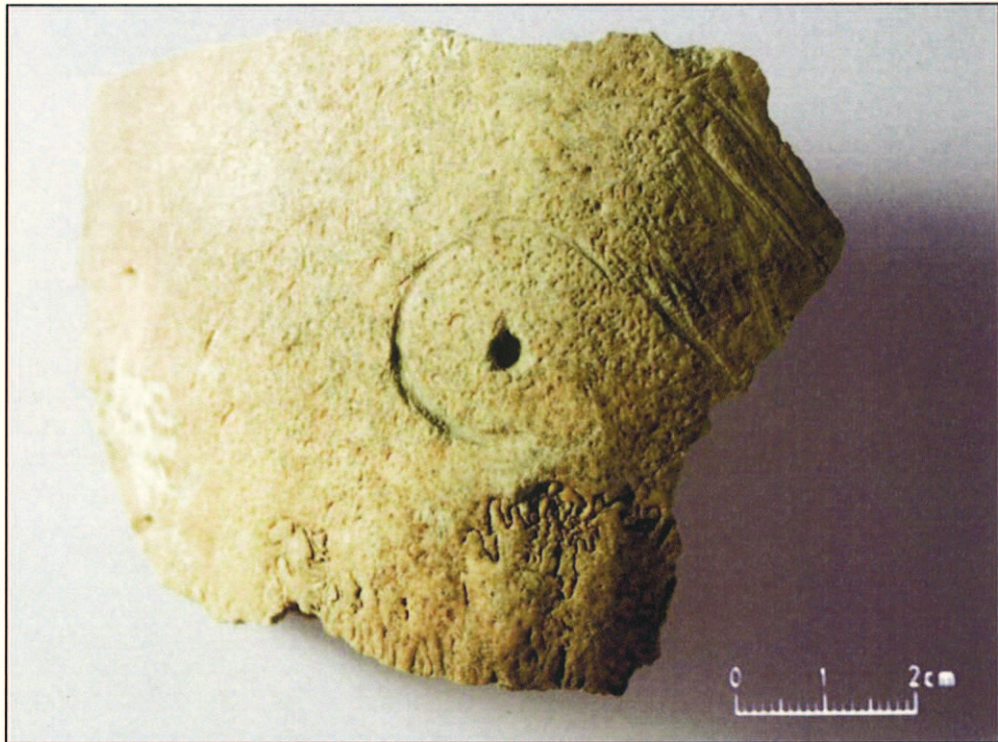
Plate 5 Trepanned skull fragment

The 86mm by 63mm fragment comprised the posterior portion of the right parietal bone. The posterior margin of the fragment incorporated part of the lambdoid suture and the medial margin, part of the groove for the sagittal sinus. The anterior margin of the fragment had broken just posterior to the parietal eminence.

A dense patch of oblique striations was located adjacent to the circular groove, on the latero-anterior aspect of the skull fragment. These had 'v'-shaped profiles, were of uneven thicknesses and depths and had a polished appearance. They broadly observed the same direction and some partially criss-crossed one another.

The modifications that have been identified on the skull fragment from University College represent a failed trepanation. This is a highly significant find that provides a vivid insight into 17th/18th century medical practice in Oxford. It may be related to medical training that was performed on a corpse, either donated or acquired for medical research. Alternatively, it may represent the remains of an individual who underwent surgery to treat a pathological condition and who did not survive.
