Music Room Extension  
Corpus Christi College  
Oxford

**Archaeological Evaluation Report**

March 2007

**Document Title:** Corpus Christi College Music Room

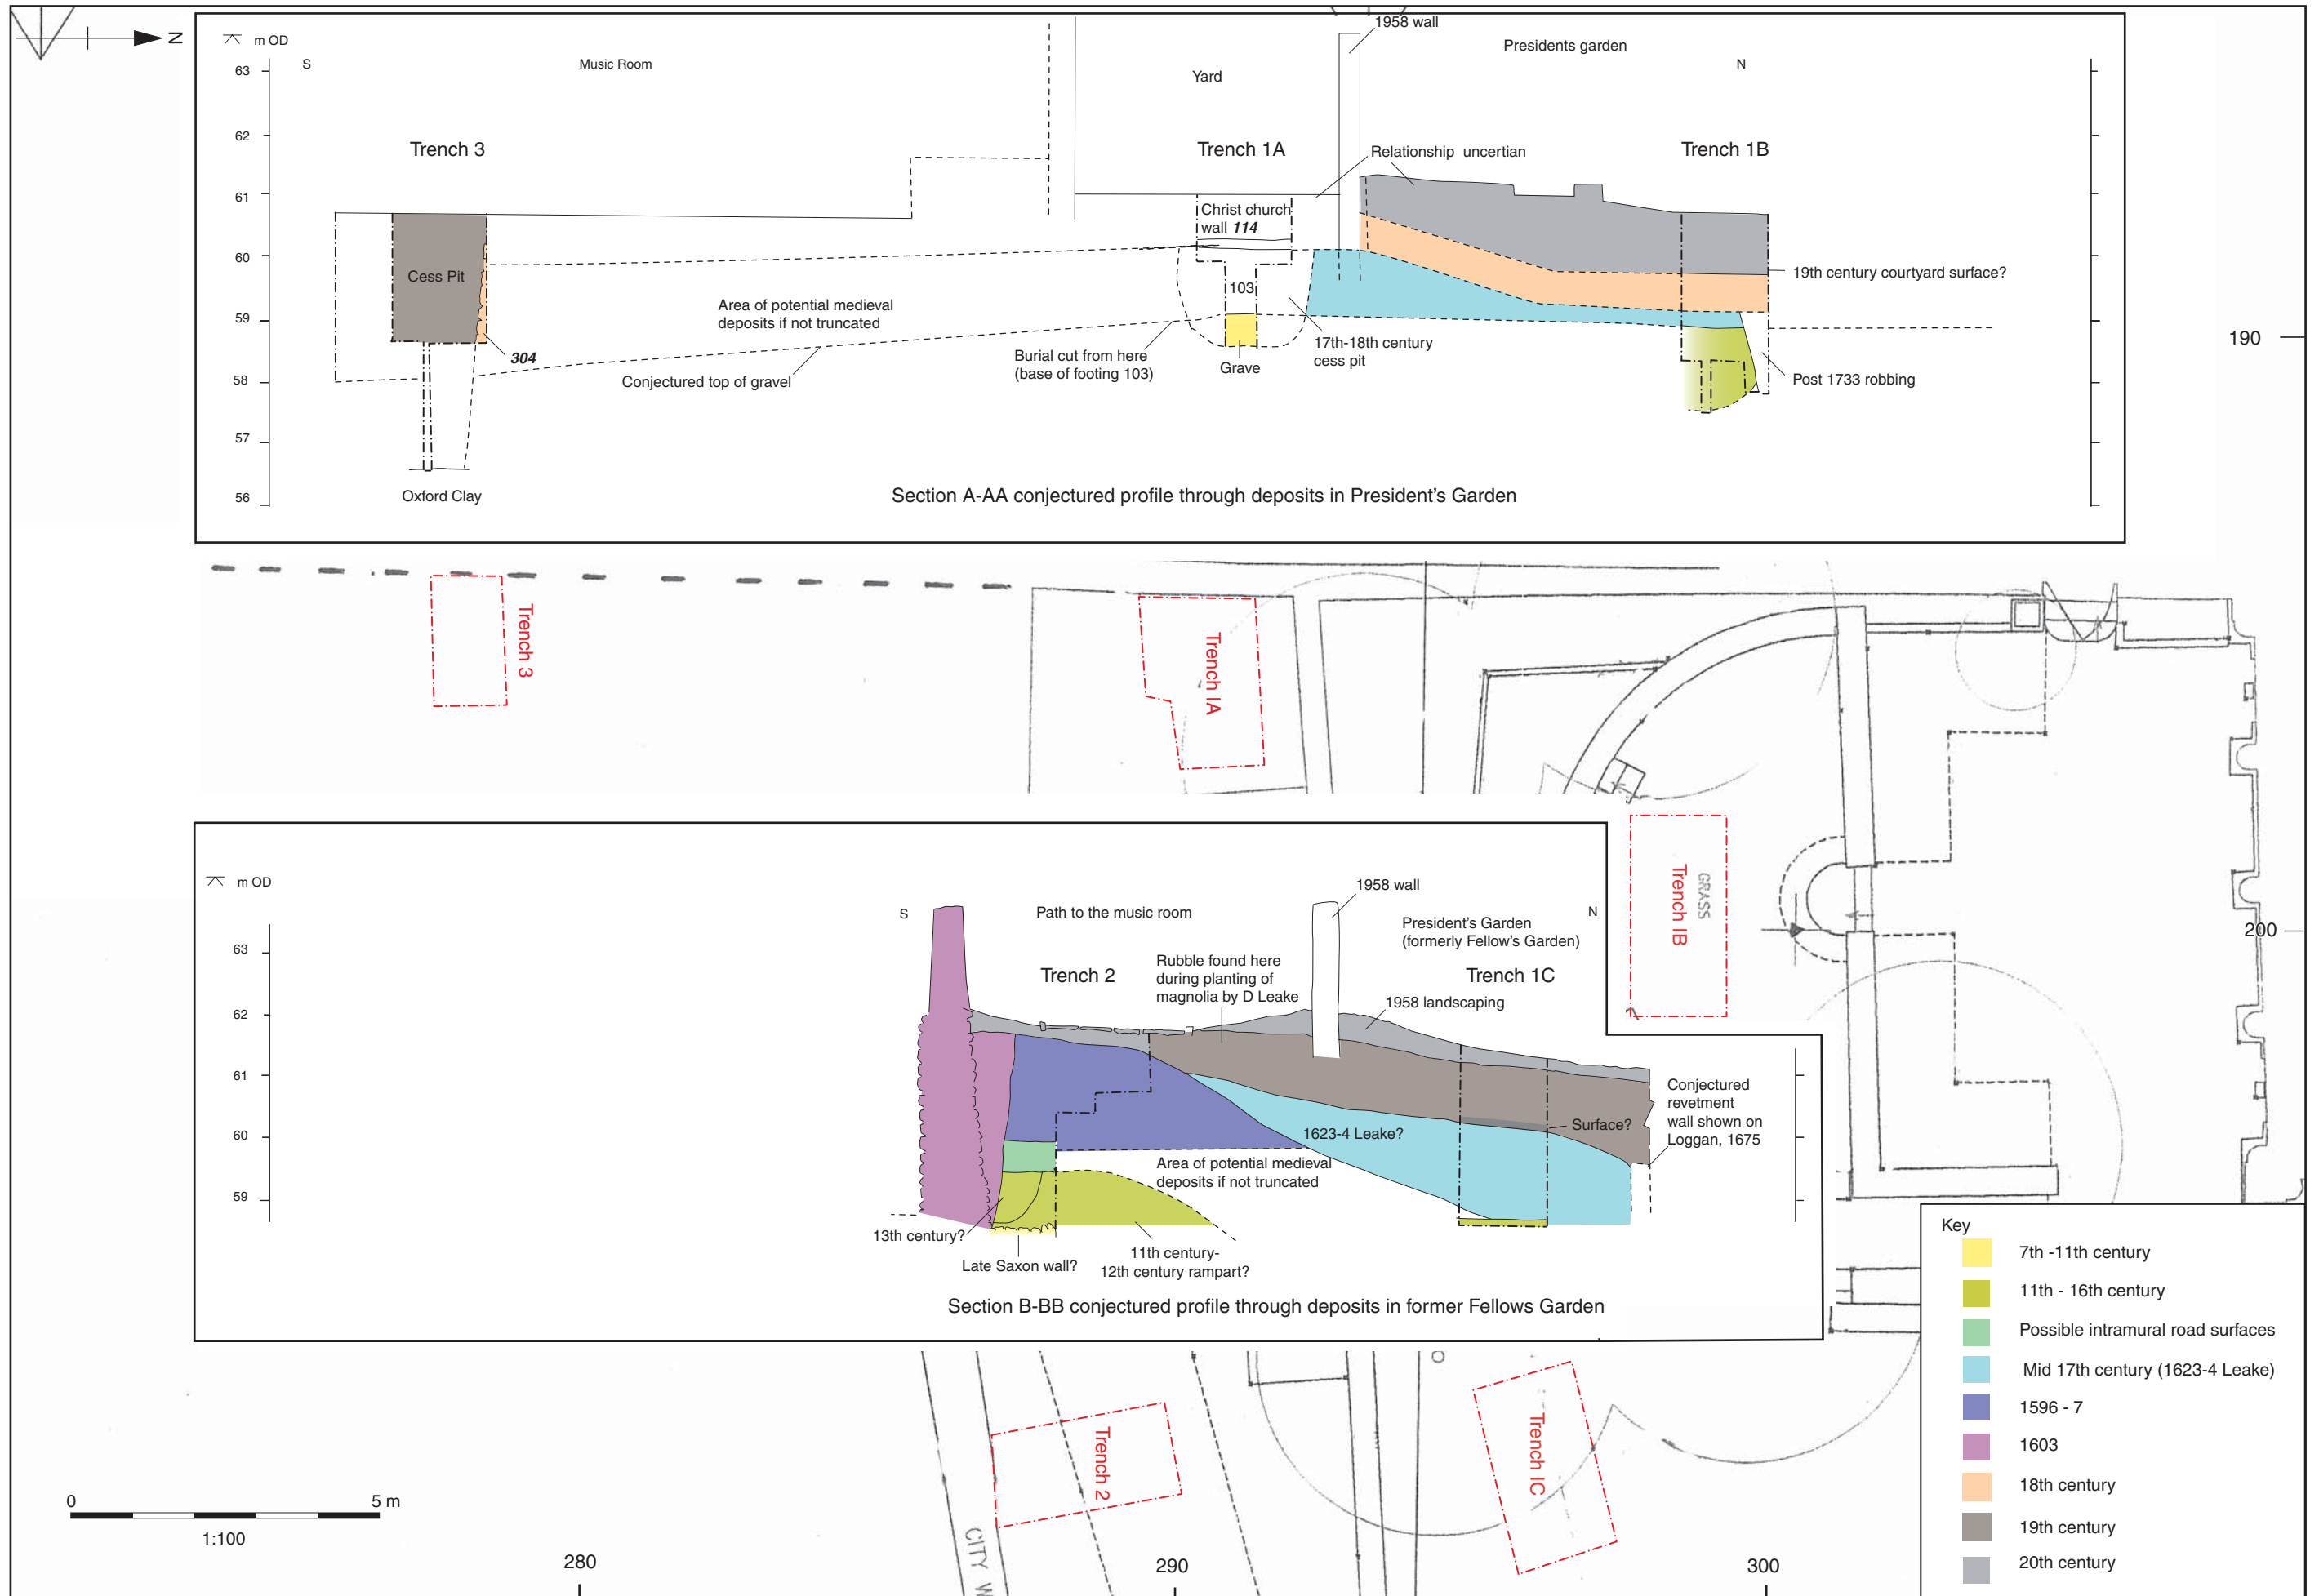
Figure 5: Idealised site profiles, located on Figure 2

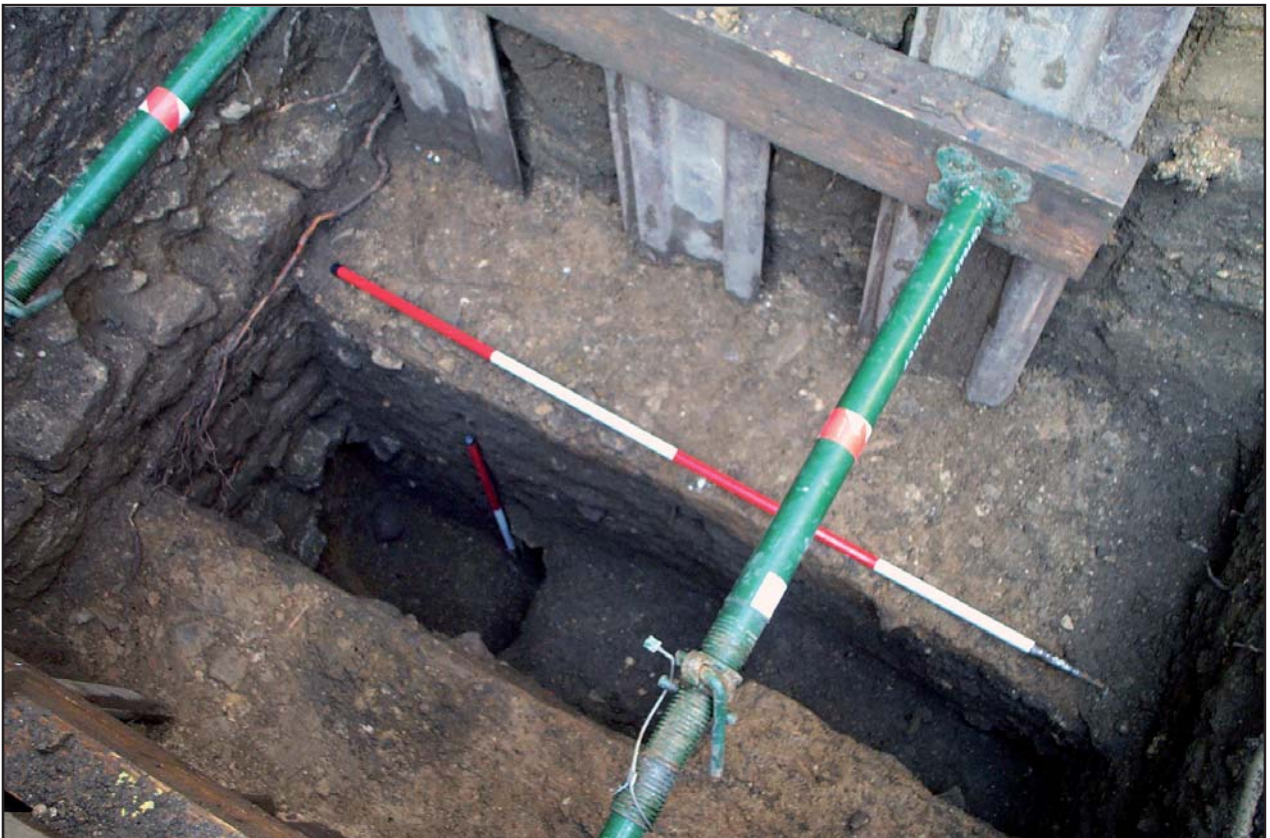
Plate 2: Trench 1A, Burial 116

- 8.2.3 Although no dating evidence was recovered from the burial within Trench 1A (101, 116, 102), the fact that it pre-dates the boundary wall between Christ Church and Corpus Christi (103) implies that at the very least it pre-dates the foundation of the college. If, as is supposed, the boundary wall lies on the course of the former Shidyerd Street, this would also imply that the burial pre-dates the medieval street grid and is therefore likely to be associated with an early phase of the cemetery of St Frideswides Minster. This would also suggest that the early cemetery extends further eastwards than its later counterpart, as the boundary wall is also thought to correspond to the eastern boundary of the cemetery (see 7.2.14).

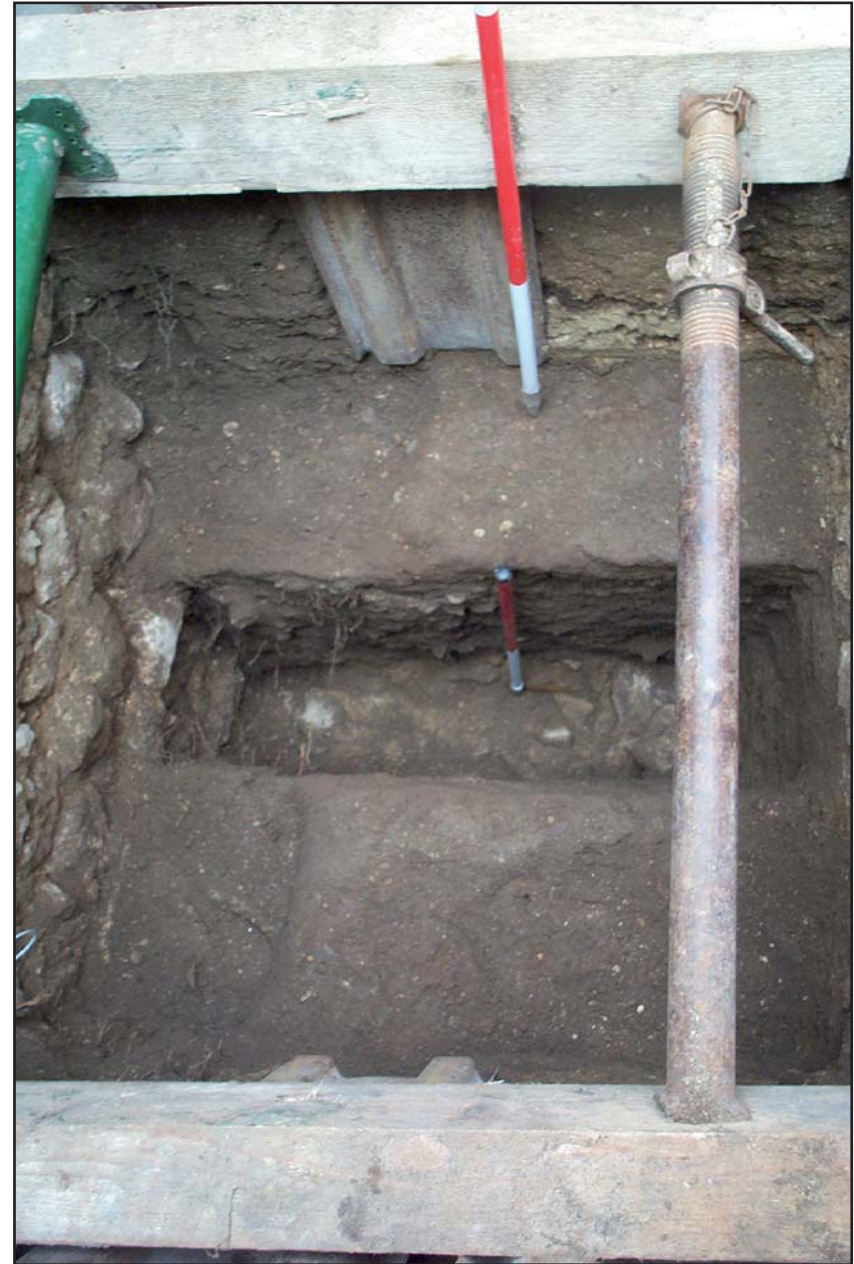
Plate 4: Trench 2, Late Saxon Revetment? 213

- 8.2.6 It is possible therefore that this structure represents a late Saxon stone revetment, similar to that observed during the recent excavations at Oxford Castle (OA, 2006(2)), and known to have fortified the burh in the 11th century. However, the augured borehole to the north of the structure was inconclusive in providing any definitive evidence for an associated rampart (the origin of deposit 225 being unclear).

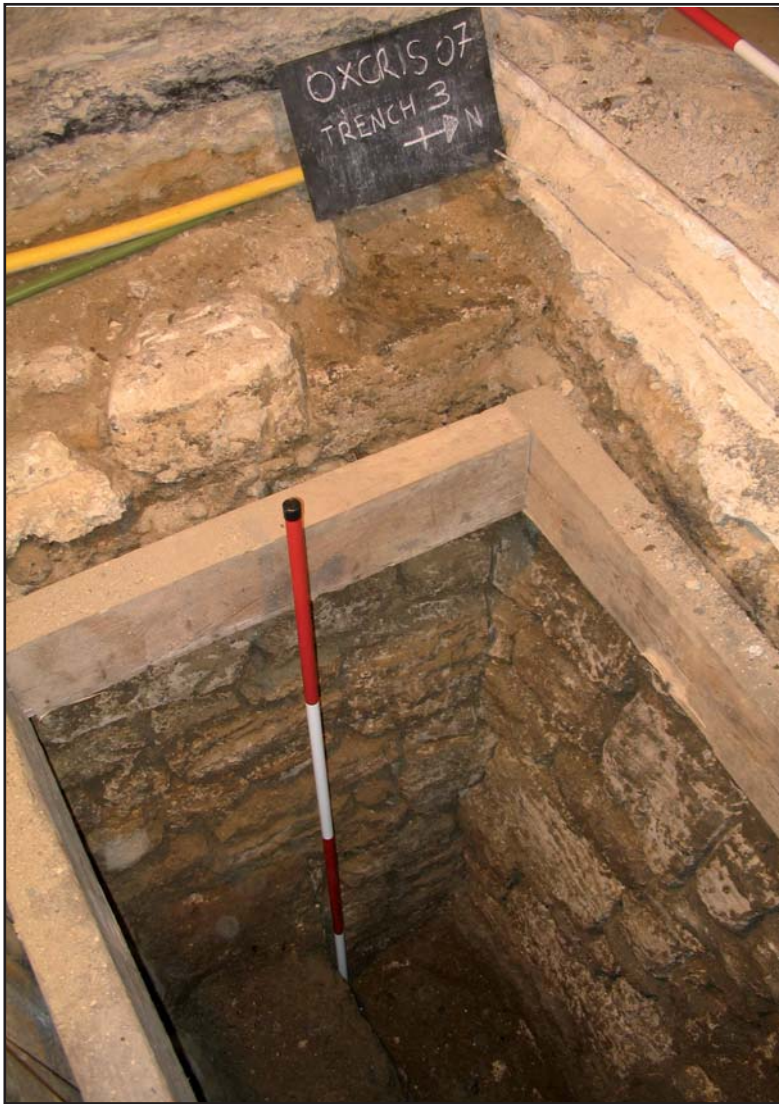
Plate 5: Trench 3 Structure 306

- 5.1.26 Trench 3 was hand excavated to 59.35 m OD. The trench lay within the north-west corner of a post-medieval stone lined cess pit (306) which had been constructed against the foundation of the boundary wall between Christ Church and Corpus Christi which now marks the western wall of the existing music room. Both the north-south (305) and east-west (304) walls of this structure had a c 20° batter from just below the existing floor deposits (60.30 m OD) to the bottom of the trench (see also 5.1.28).

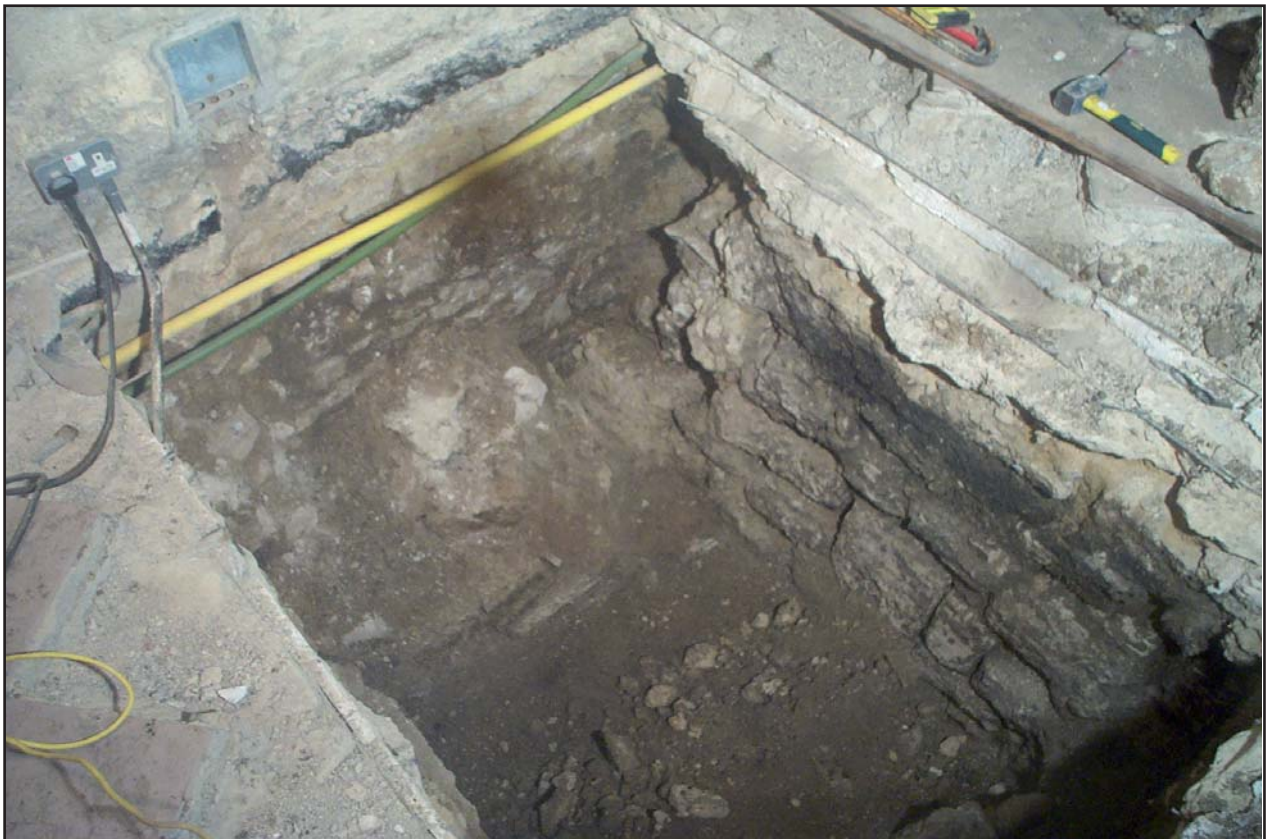
Plate 6: Trench 3 Footing 313 following partial dismantling of wall 305

- 5.1.28 In order to establish the nature of the foundation of the Christ Church wall (313) against which structure 306 had been constructed, it was agreed with Brian Durham (OCC) and Chris Welch (EH) to deconstruct part of wall 305. This revealed the near vertical footing of 313 to a depth of 1.40 m below floor level (59.33 m OD). As the top of the stepped footing in Trench 1A (103) was revealed at c 60.19 m OD and a similar step was not seen within Trench 3, it seems likely that the re-built section of wall seen in Trench 1A was localised, and does not apply to the whole of the wall. Additionally, if the stepped footing in Trench 1A equates to the standing wall in Trench 3, the base of the latter should also lie at c 59.17 m OD, approximately 0.25 m below the exposed section of the wall in Trench 3. The top of wall 305 stepped out c 0.50 m from the face of wall 313. The thickness of wall 305 at the base of the removed section (e.g. 1.40 m below ground level) was c 0.70 m, reflecting the batter on the interior faces of structure 306 (Plate VI).
