Apprentice Store De Montalt Mill Combe Down Bath

Archaeological Evaluation and Watching Brief Report

June 2006

OA Job N^o: 2779

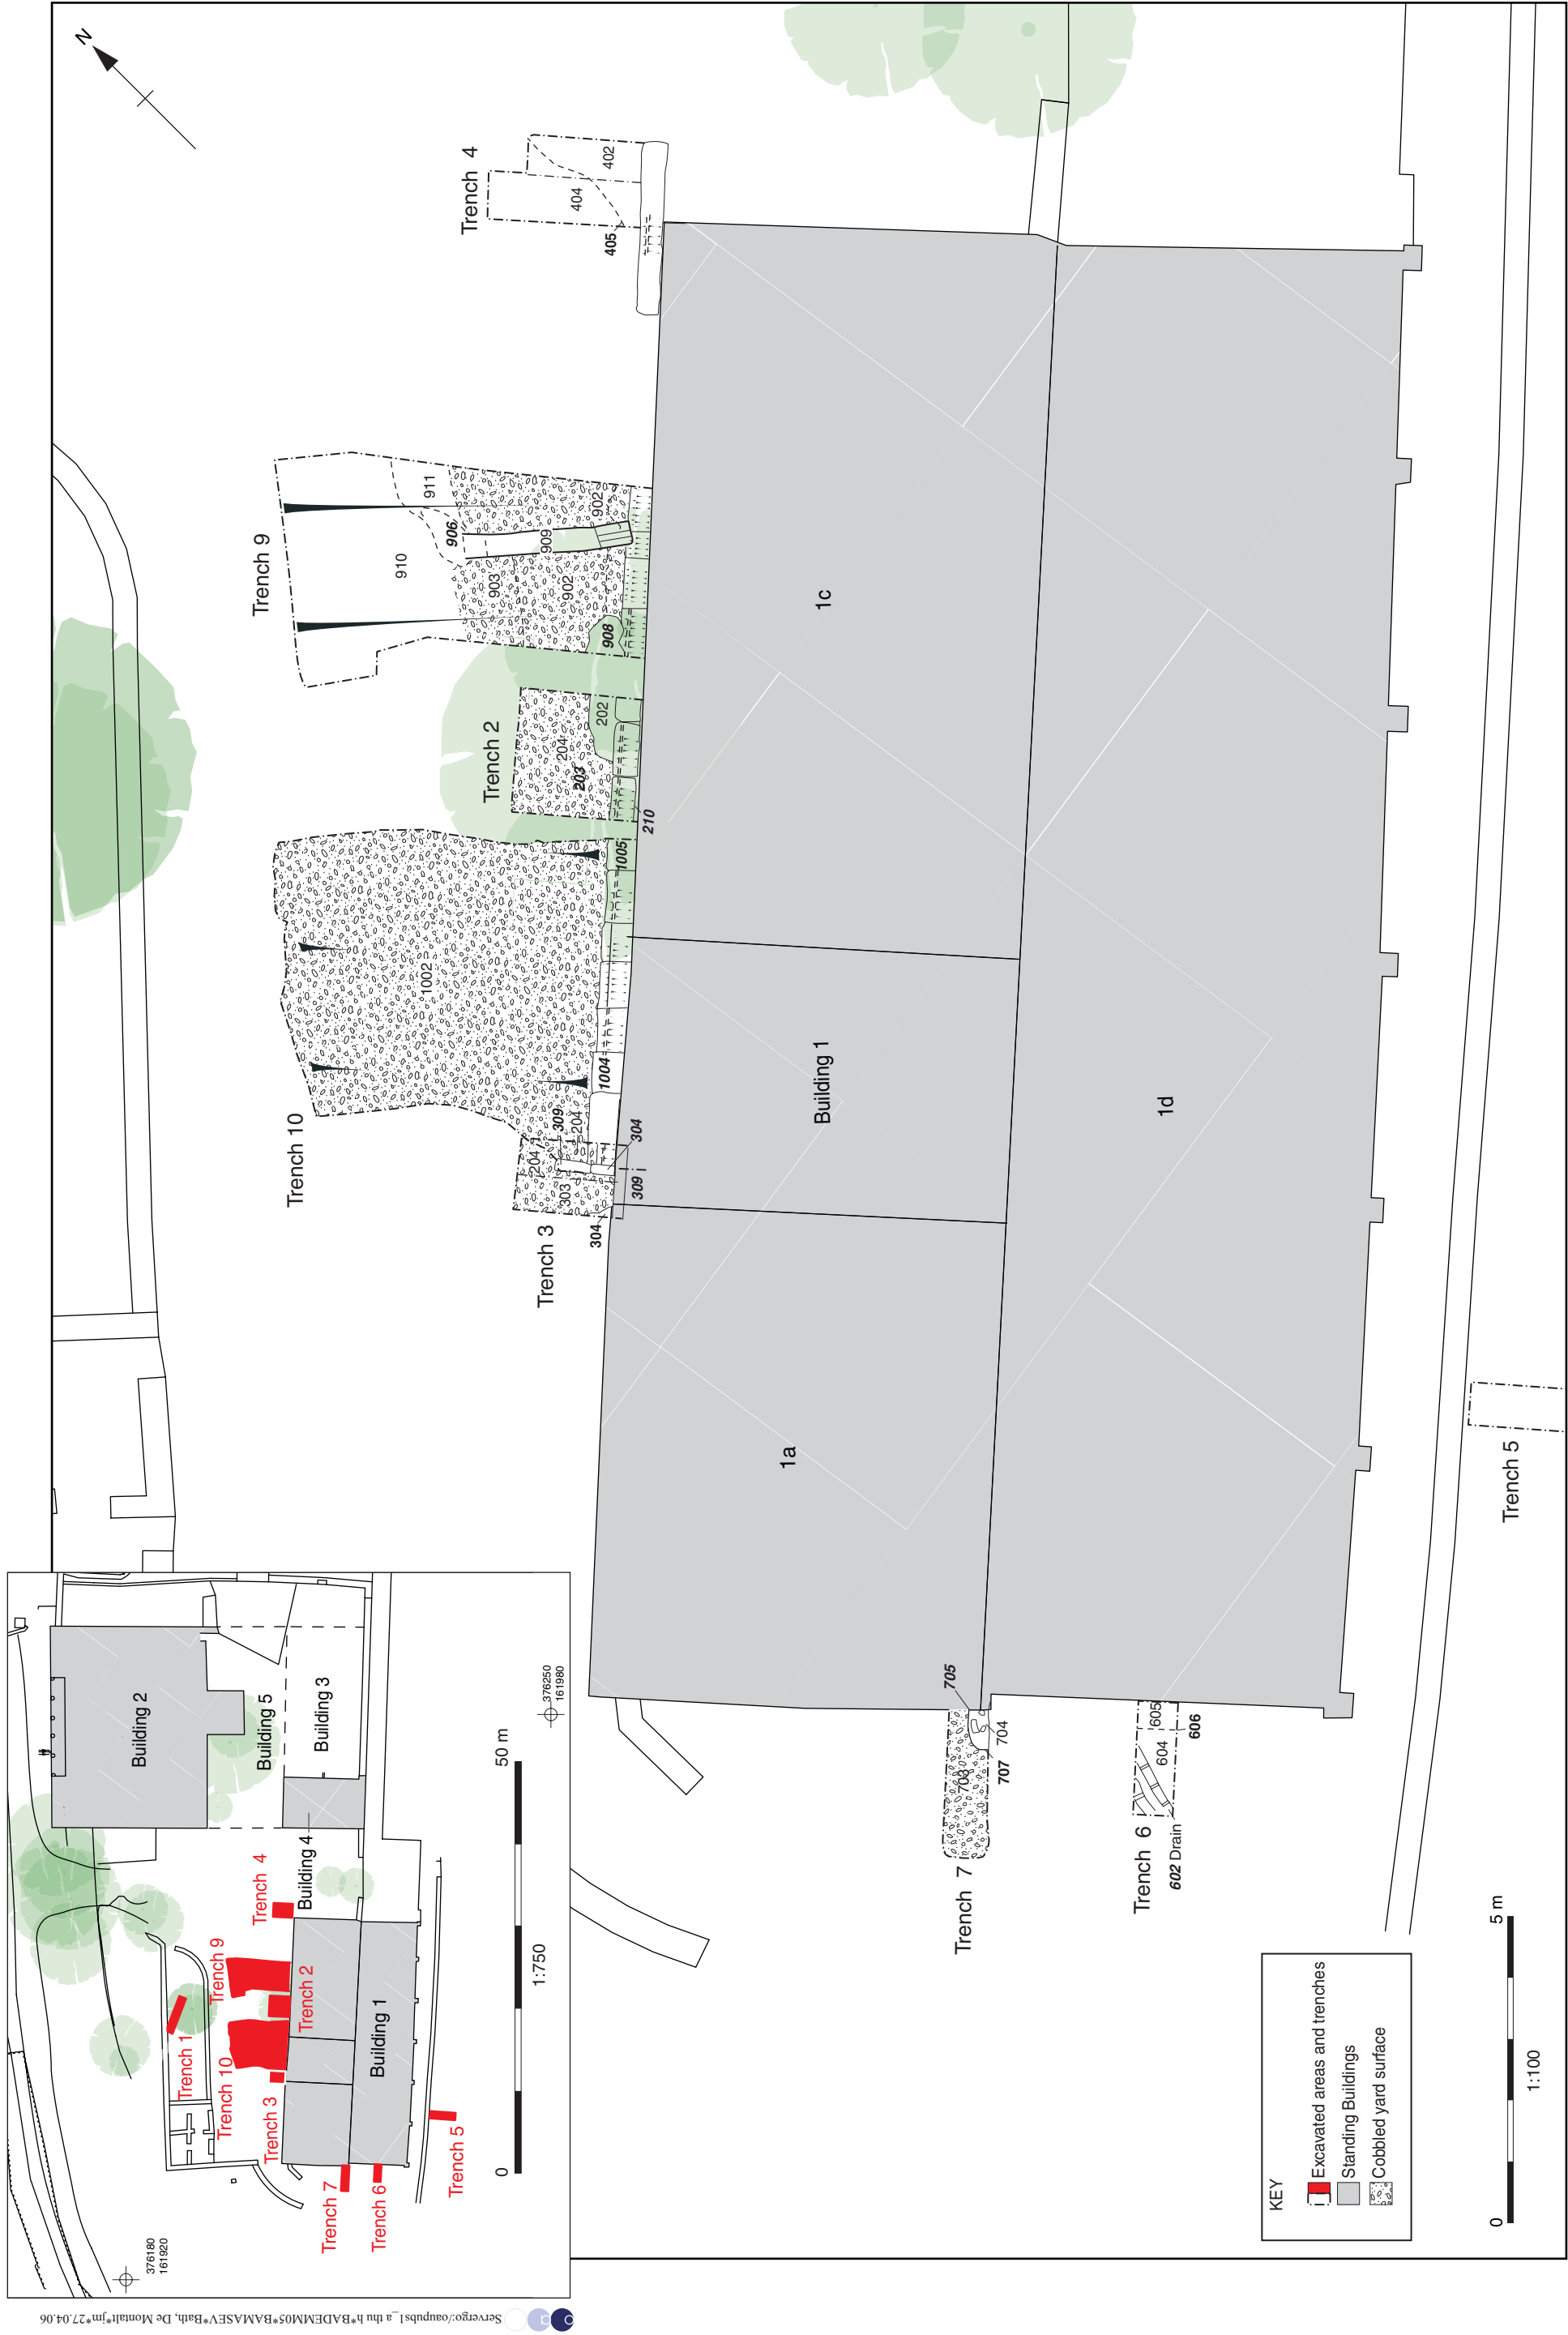
Figure 2: Site plan of De Montalt Mill, Combe Down, Bath (based on a survey by H.J. Rees & Company Ltd, Chartered Land Surveyors)

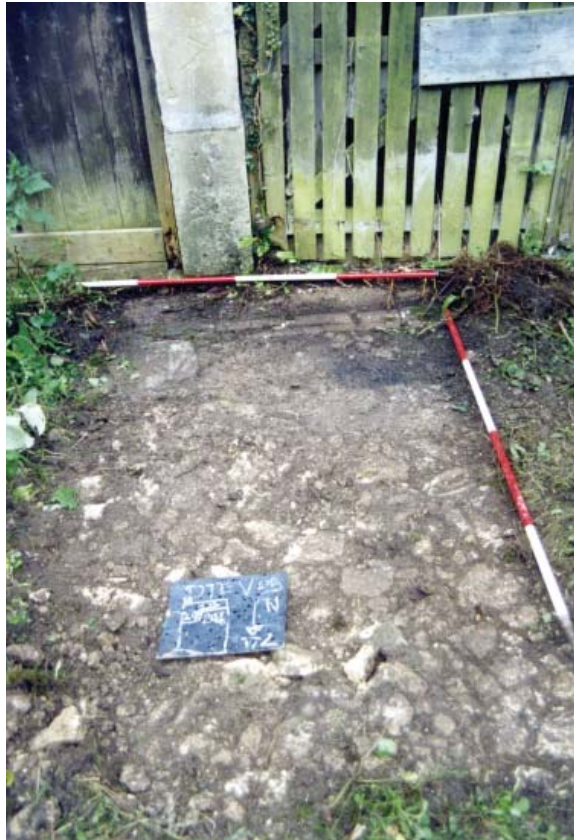
- detail against the retaining wall of the south terrace near to Trench 5.
- 2.2.2 Where archaeological remains were encountered in excavation, the machining was stopped to allow recording. This occurred specifically in Trenches 2, 3, 4 and 7 (e.g. Pl. 1). After recording, the machine excavation continued.

- 3.1.6. The yard was a roughly laid thickness of cobbles set in a grey brown silty sandy matrix which is merely the result of dirt infiltrating during use (204, 303, 402, 703, Pl. 4). It was separated from the north wall of Building 1 by a gutter made from single blocks of Pennant sandstone (203, 403). This gutter continued about two metres across the yard east of Building 1 but did not appear on the west side of the building.

Plate 1: Trench 2 before excavation, showing cobbled surface 204

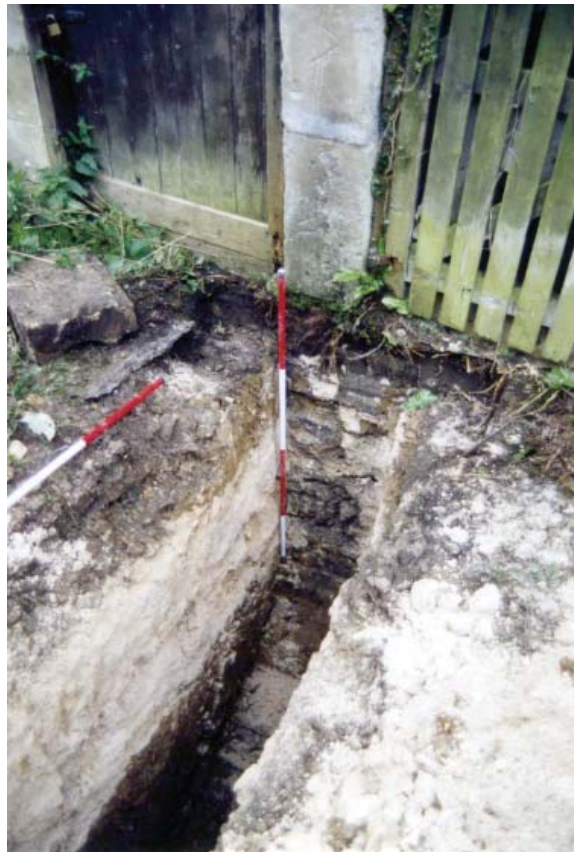
- 3.1.4. On the north of the building these natural subsoils were capped with a dump of greyish white crushed lime stone (103, 206, 305 and 406). This was as much as 1.1 m thick in Tr 2 (Fig. 4 & Plate 2), only 400mm in Tr. 1 and 600mm in Tr. 3 (Fig. 4). It was also about 1 m thick in Tr. 4, but was cut away by a large pit or scoop (405).

- 3.1.5. This seems to represent a deliberate dump of quarry waste to form the foundations for

the yard north of Building 1. It seems to post-date the construction of the footings of Building 1a and b but is cut through by the footings of Building 1c. This is consonant with the phasing of these buildings (see Davenport 2001 and OA 2006b). The present cobbled yard surface is secondary, however, the original perhaps being the quarry waste.

Plate 2: Trench 2 excavated, showing footings of Building 1c and quarry waste make-up, 206

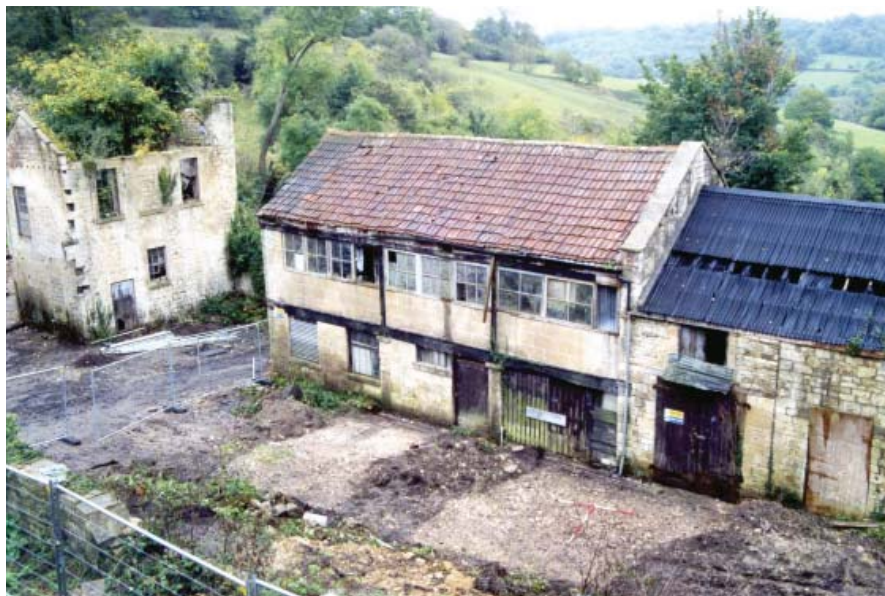
- 3.1.9. Two areas in front of the Apprentice Store were cleared by machine down to the top of the cobbled surface (Tr. 9 and Tr. 10; Fig. 3 and Plate 3). The cobbling was contemporary with the gutters and therefore postdated the construction of Building 1c and was in use contemporary with the other elements of Building 1.

Plate 3: Trenches 9 and 10 from the north west

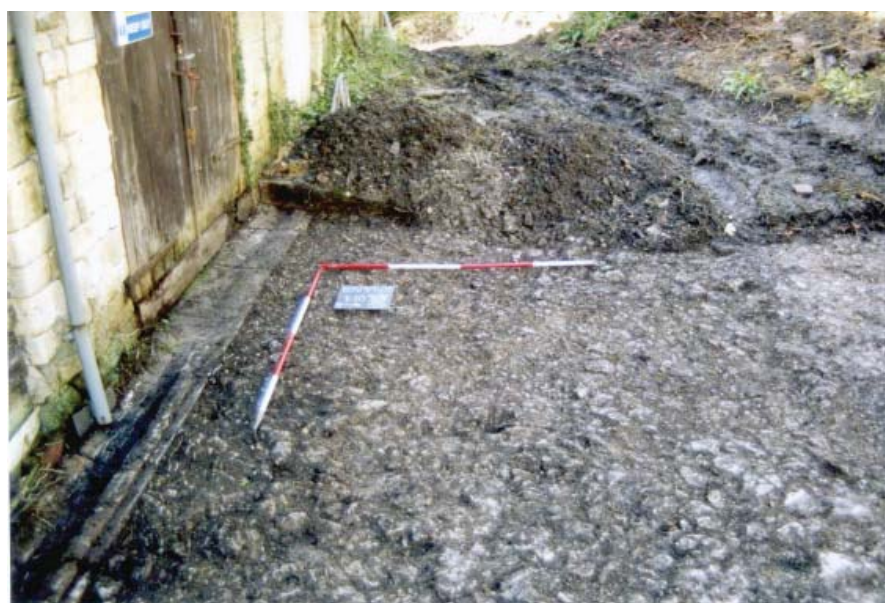
- 3.1.7. The gutter was quite worn in front of the double doors of Building 1b, resulting from the passage of carts or waggons (Plate 4). The wear was not concentrated where wheel ruts might have been expected, suggesting a lot of foot or animal passage in addition.

Plate 4: Trench 10 from the east showing wear in gutter in front of wagon store and quality of cobbling

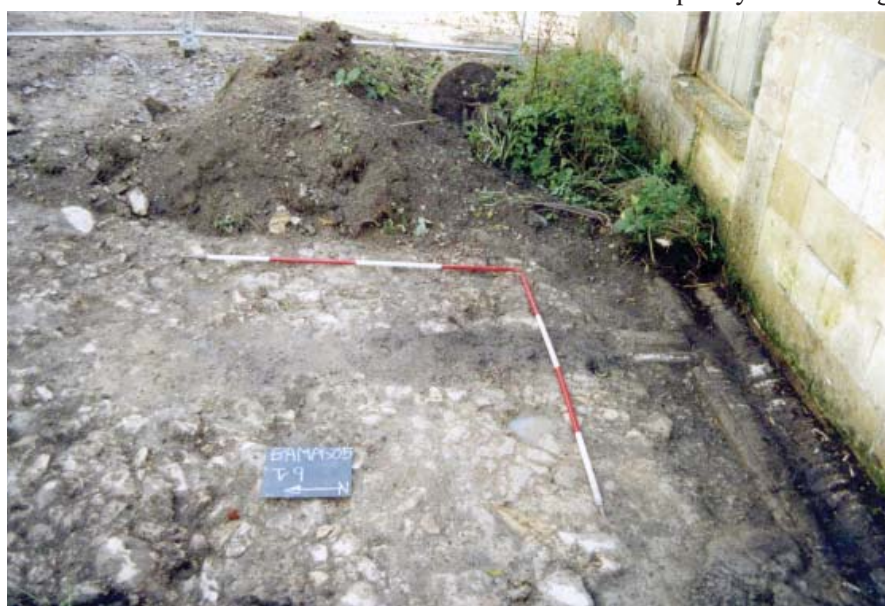
- 3.1.8. A gutter of similar design ran north-south across the yard joining this gutter in Tr.9 (904, Fig. 3, Plate 5). It was robbed out for most of its length. The gutter 203 etc did not continue beyond the western edge of Tr. 10. Here it is blocked by 304, the stone slabs marking the east end of a raised, paved platform in front of Building 1a. The gutter may have run around it. In any case it this platform seems to be contemporary with Building 1a and therefore pre-dates the gutter and cobbling.

Plate 5: Trench 9 from the west showing robbed out course of gutter 904 and its junction with gutter 403
