Witley Court Worcestershire

Archaeological Survey
Record and Analysis of
Eastern Parterre Steps

Archaeological Investigation Report

June 2006

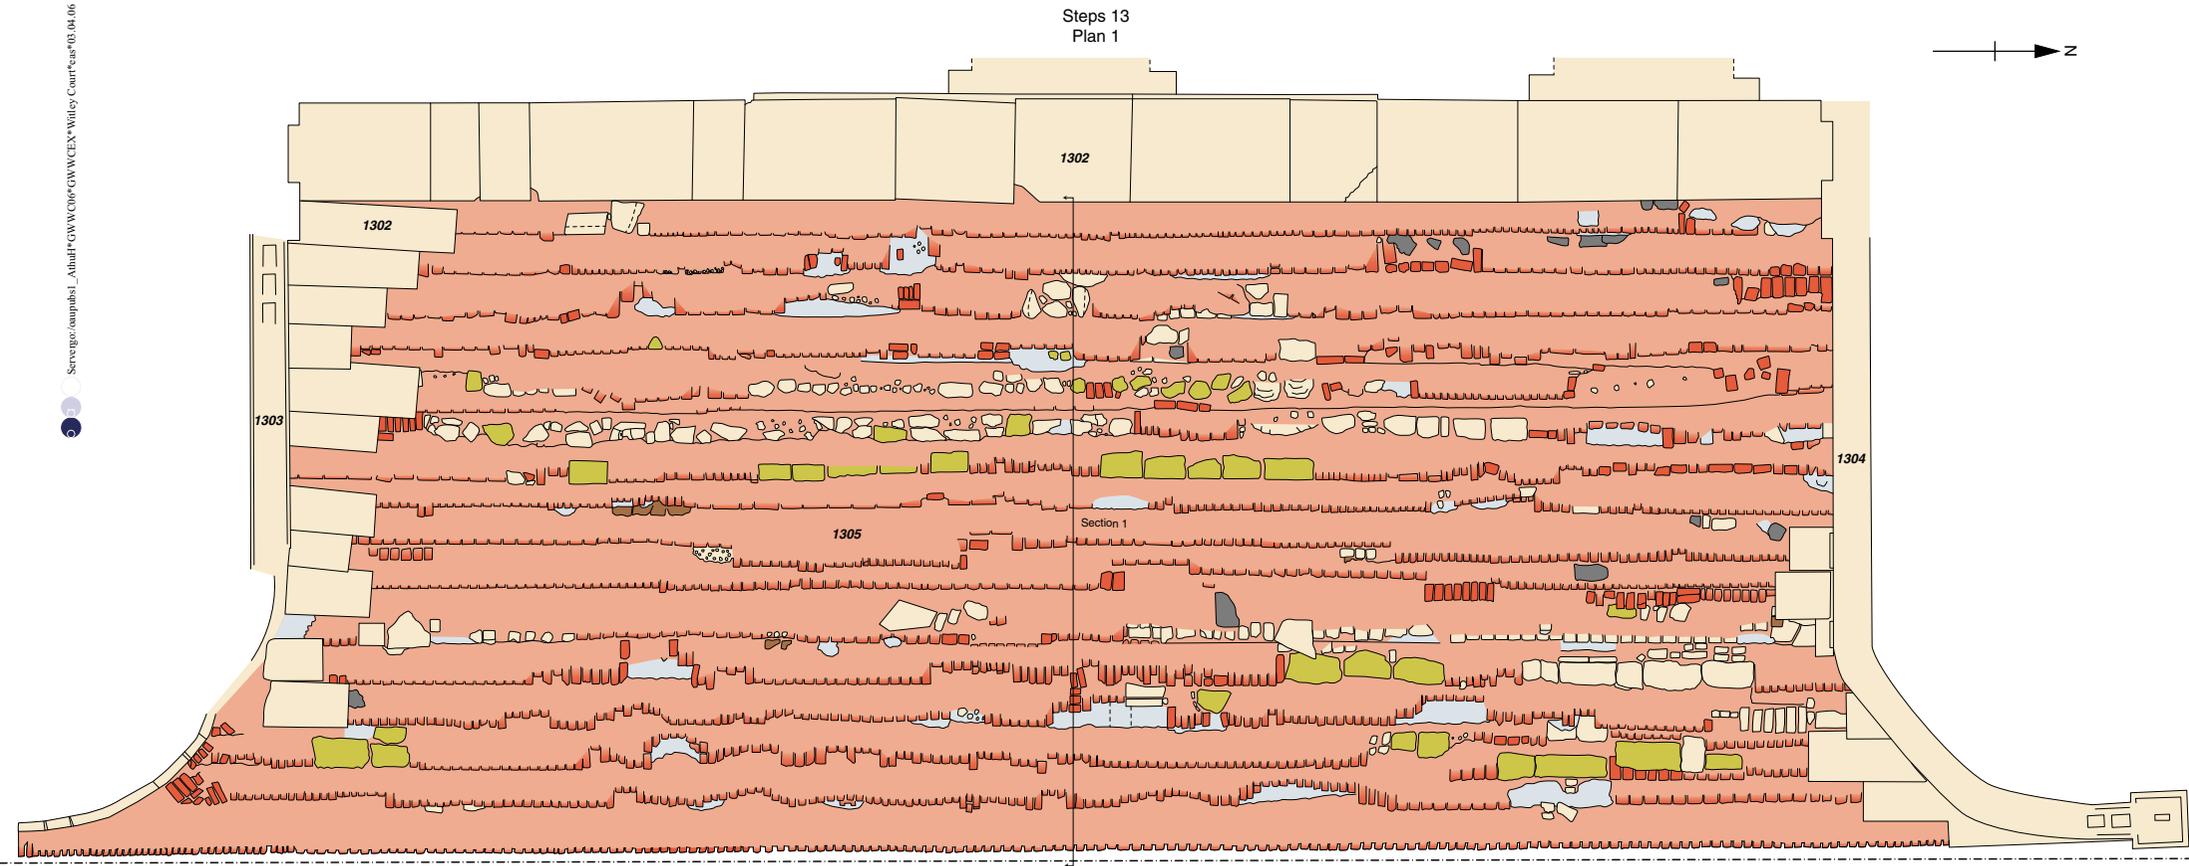
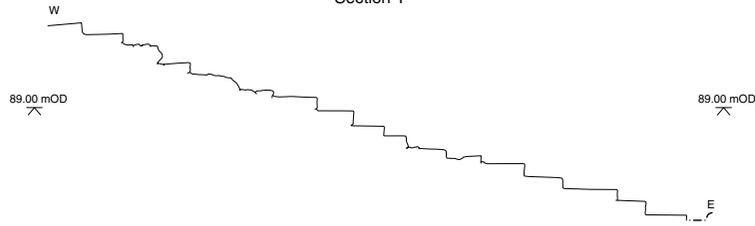
Figure 3: Steps 13, plan and section

5.2.1 Steps S13 were uncovered beneath a thin covering of humic garden soil and turf 1301 (Fig. 3). They were 14m in length and formed access between the west wing ballroom and the upper terrace of the east parterre. They were constructed from poorly fired red-brick with dimensions of 228 mm x 116 mm x 78 mm. A very high percentage of half bats and other broken bricks were noted in the build. The majority of the steps were laid as headers on edges or beds although stretchers were not uncommon along with areas of dis-ordered in-filling, which together constituted a third of the build. A number of fragments of limestone and sandstone were incorporated. Tile and slate was employed to level up uneven areas for the limestone capping which had been almost entirely stripped save in-situ slabs at both ends of the steps. The step base was bonded in a sandy 'salmon'-coloured mortar with occasional sections of a hard, lime based cement. The brick base of S13 was noticeably more dilapidated than the other steps.

5.2.2 The steps were flanked by limestone strings 1303 which flared out in a curve by 1.6 m at the base. The strings had shallow sockets 180 mm x 200 mm along their length for stone baluster location.

Steps 13
Section 1

- 6.2.2 Steps S13 were dilapidated and showed evidence of localised repairs (Fig. 3 & Pl. 1). This may explain the intermittent lime-based mortar, although this mortar was also used in the primary build for setting some of the limestone capping and strings. The dilapidated state of steps S13 may reflect the heavier wear than the other steps as it provided access between the upper terrace and the ballroom. It was noted on site that wear was greatest in two tracks leading diagonally from the central doorway of the ballroom. As this wear was, of course, on the substructure, it must reflect passage after removal of the stone steps, i.e., during the stripping of the building. As these steps are the main access to and from the building on this side, this is an easily explained observation.

- 6.2.3 S13 had more incorporated re-used architectural fragments than the other steps. The limestone fragments may be discarded material from the mid-nineteenth century build. One piece of worked sandstone may have been reclaimed from an earlier build of the manor, possibly one of the demolished 18th structures. Similarly worked sandstone was noted in the build of the adjacent S16 steps during OA's 2002 programme of works.

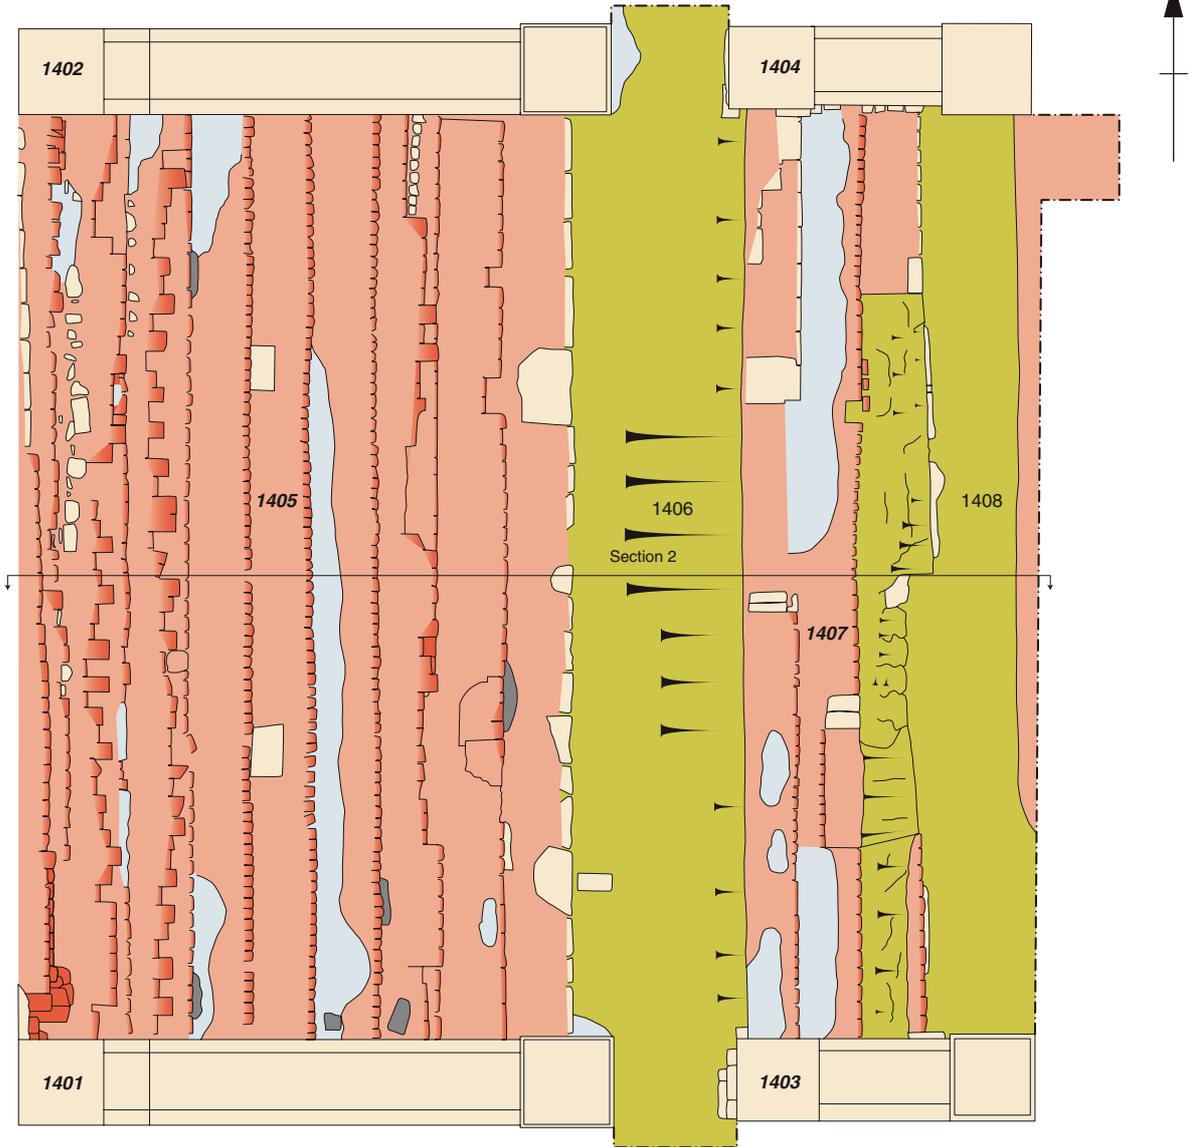
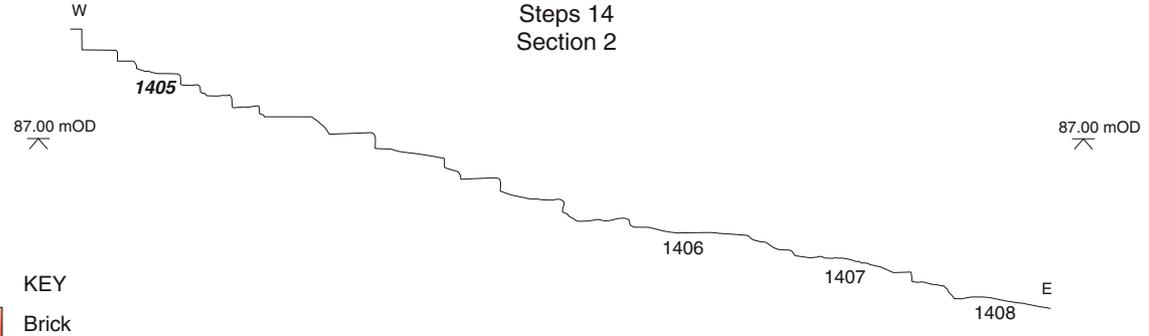
Figure 4: Steps 14, plan

5.3.1 Steps S14 form the northern half of a pair which provide access between the upper terrace and the east parterre. Its counterpart is S15. Similar construction was employed to that seen in S13. Headers on edges or beds formed the major constituent, showing a greater degree of order than S13. The steps cover a total area of 7300 mm x 6700 mm which is divided into two flights (1405 & the lower 1407 is three steps. The landing is formed from the underlying sandstone bedrock 1406. The step base is flanked by two pairs of limestone strings and newel bases (1401, 1402, 1403 & 1404) a pair for each flight. S14 was covered by a 110mm thick deposit of made ground and top-soil covered in turf (1409 & 1410).

Steps 14
Plan 2

Steps 14
Section 2

- 6.2.4 Steps S14 and S15 had both been built into the underlying bedrock of the site (Figs. 4 & 5, Pls. 2 & 3). The truncation 1504 of S15 occurred after the robbing of the limestone capping or as part of it. Its fill 1503 was sealed by dumped material 1502 which contained debris from the 1937 fire.

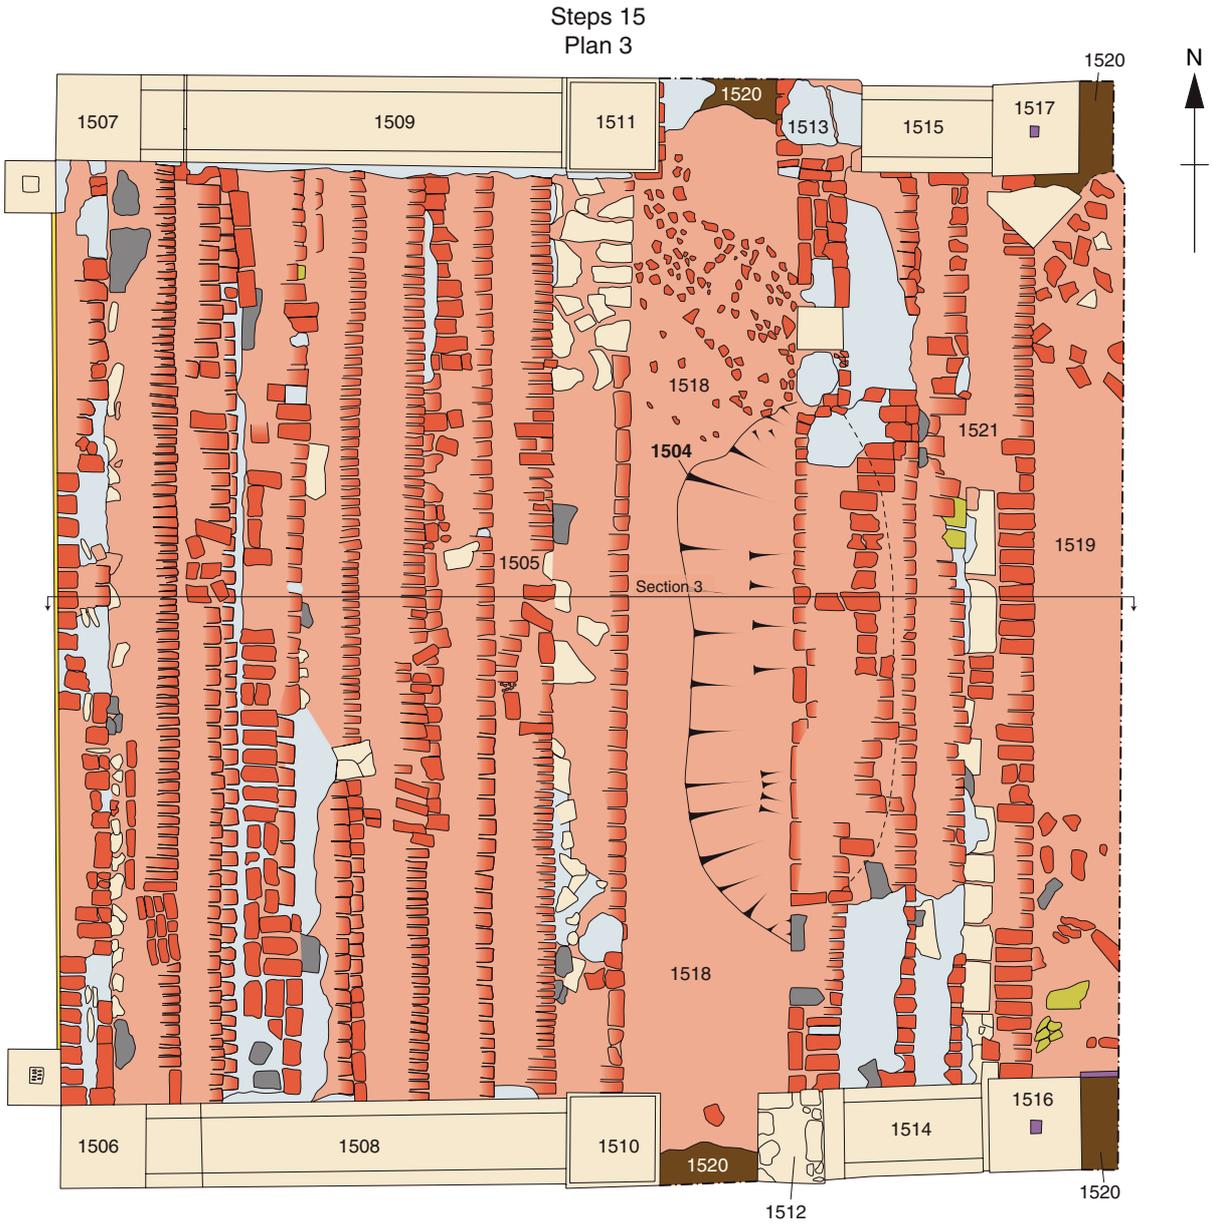
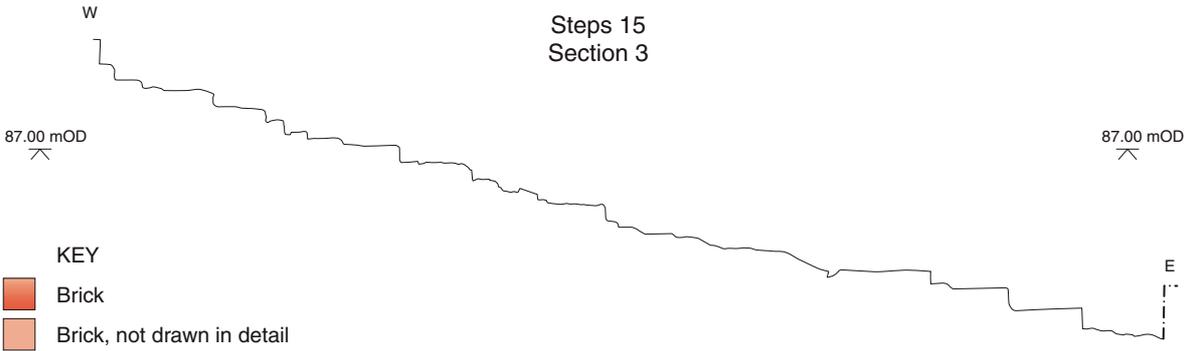
Figure 5: Steps 15, plan and section

5.4.1 Steps S15 were of very similar construction to Steps S14 built from headers with little sandstone and limestone inclusions. They covered an identical area. A large cut 1504 had truncated the bottom section of the lower flight. The deposit overlying its fill 1503 contained a wrought iron fire grate measuring 2 m in length, which had associated yellow firebrick fragments.

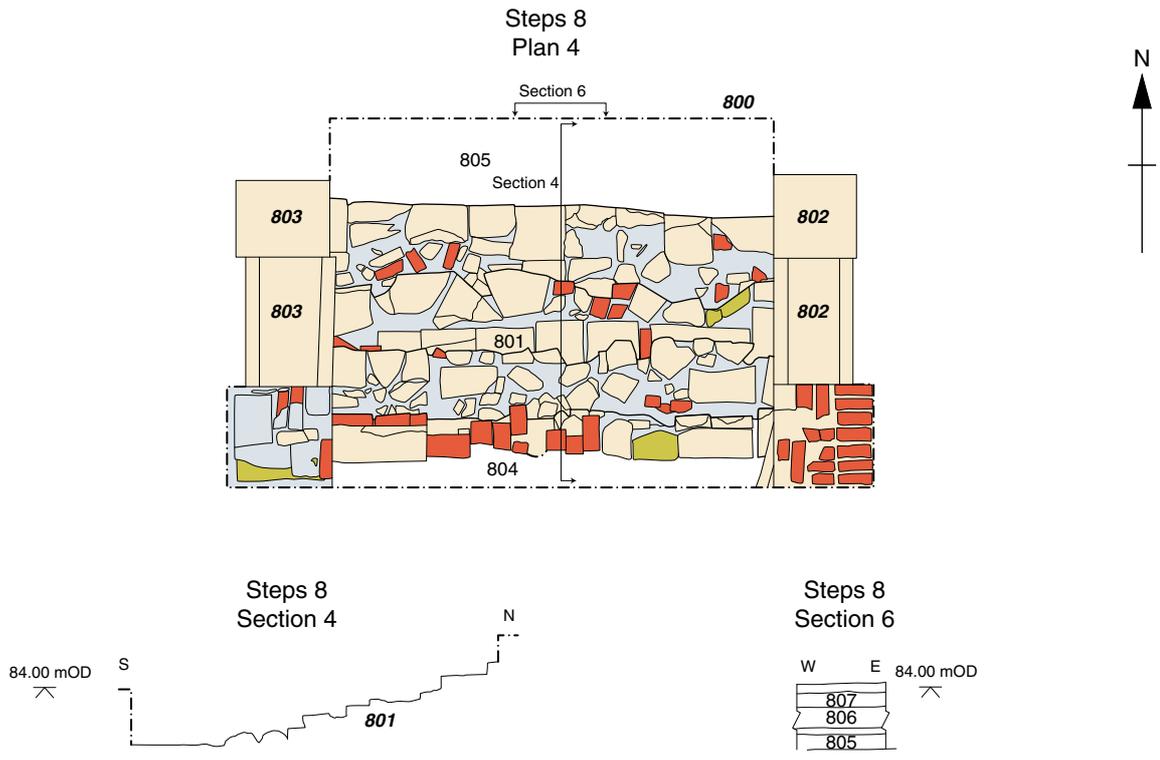
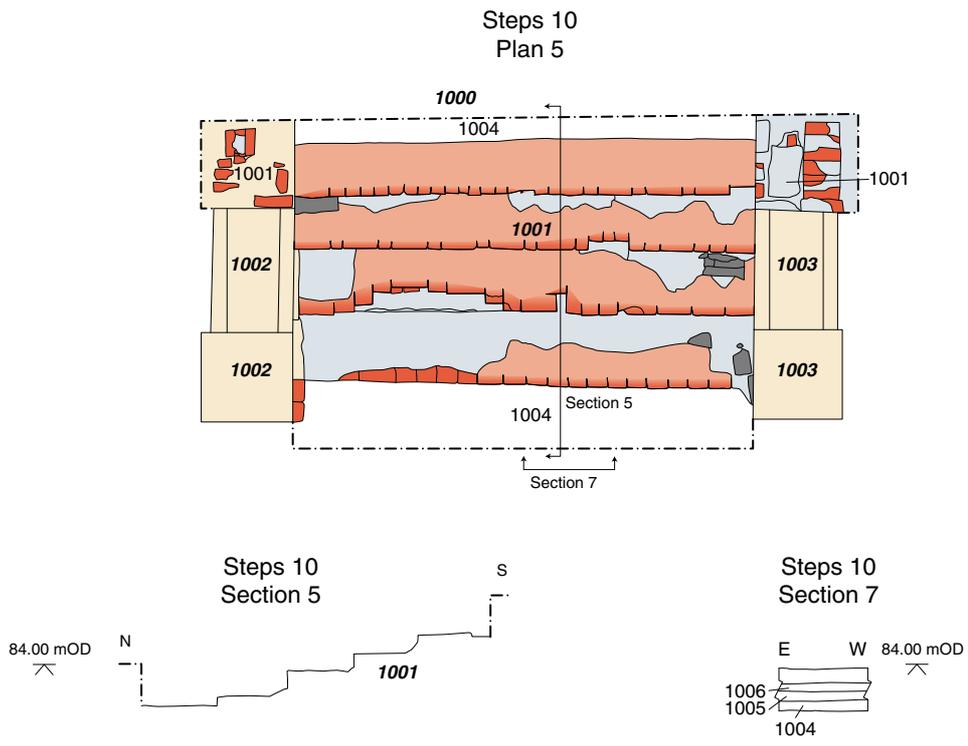
Figure 6: Steps 8 and 10, plans and sections

5.5.1 Steps S8 are situated at the north eastern extent of the east parterre and cover an area of 3020 mm x 1580 mm. Their construction differed from all the others in that they were predominantly built from limestone and sandstone fragments with additional brick fragments. They were bonded in sandy 'salmon'-coloured mortar.

5.6.1 Steps S10 formed a counterpart to S8 situated at the south eastern limit, and were of the same dimensions. They were constructed from red-bricks regularly-laid as headers on edges and beds which were bonded in a sandy 'salmon'-coloured mortar.

- 6.2.5 Some attempt appears to have been made to tarmac steps S8 & S10. The traces of this were removed during excavation. S8 is unique among this excavated group in that it is built almost entirely from reclaimed limestone and sandstone fragments with bricks forming the minor constituent (Fig. 6 & Pl. 5).

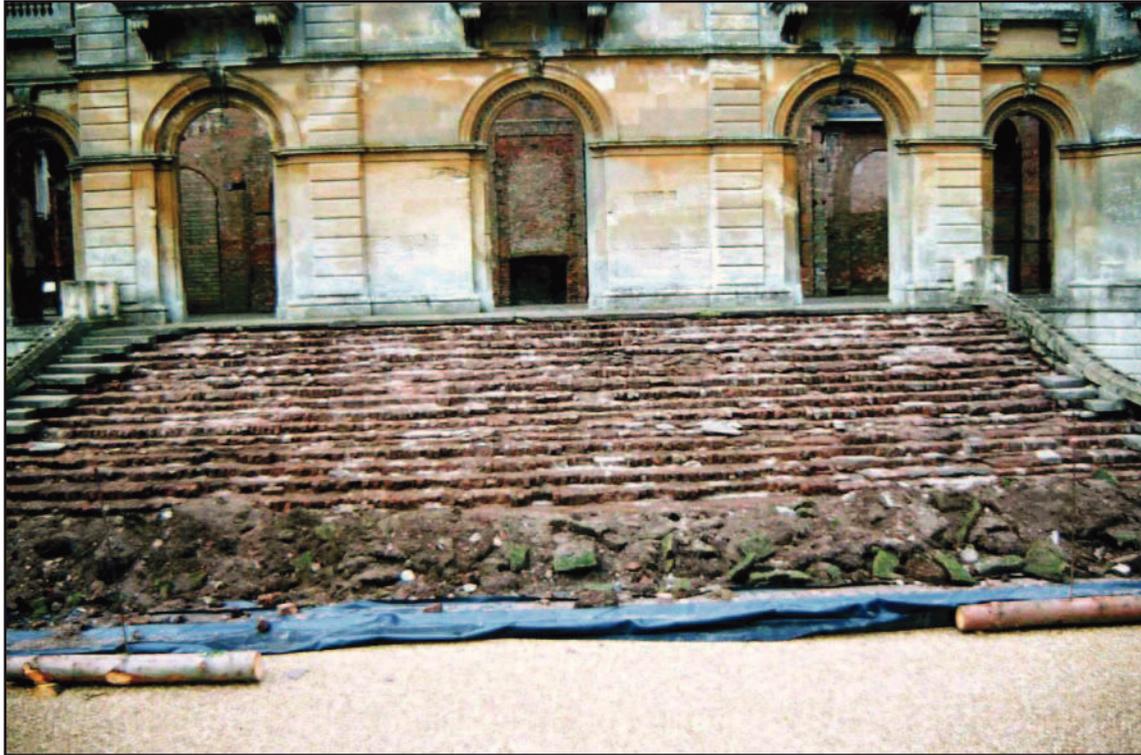
Plate 1: Steps S13 after excavation looking west.

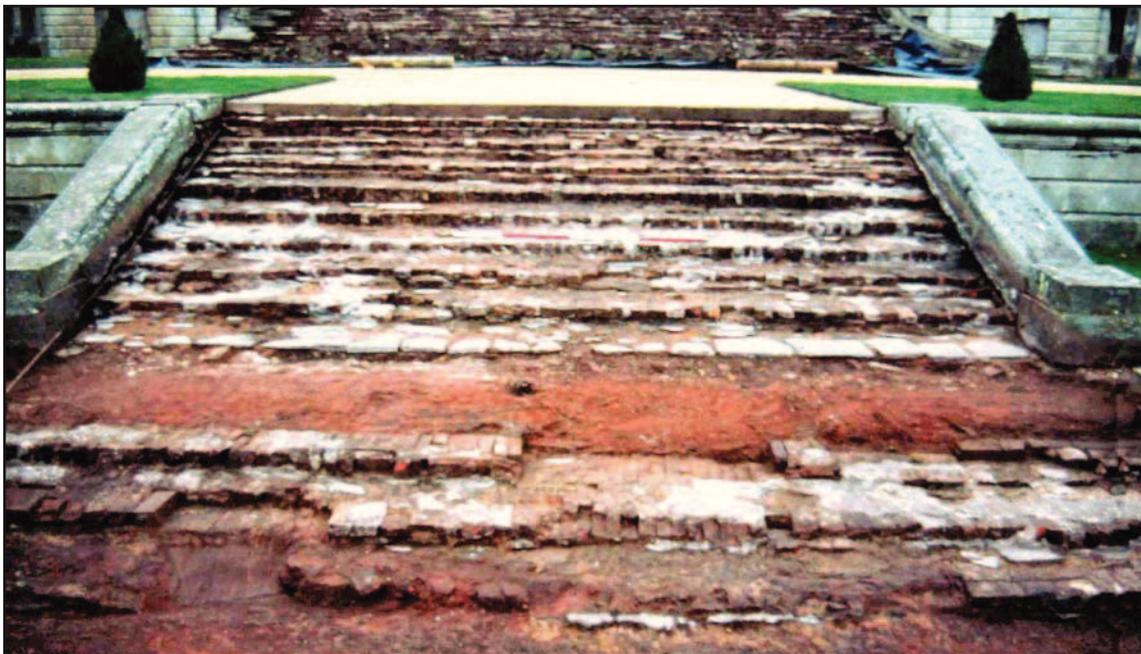
Plate 2: Steps S14 after excavation looking west.

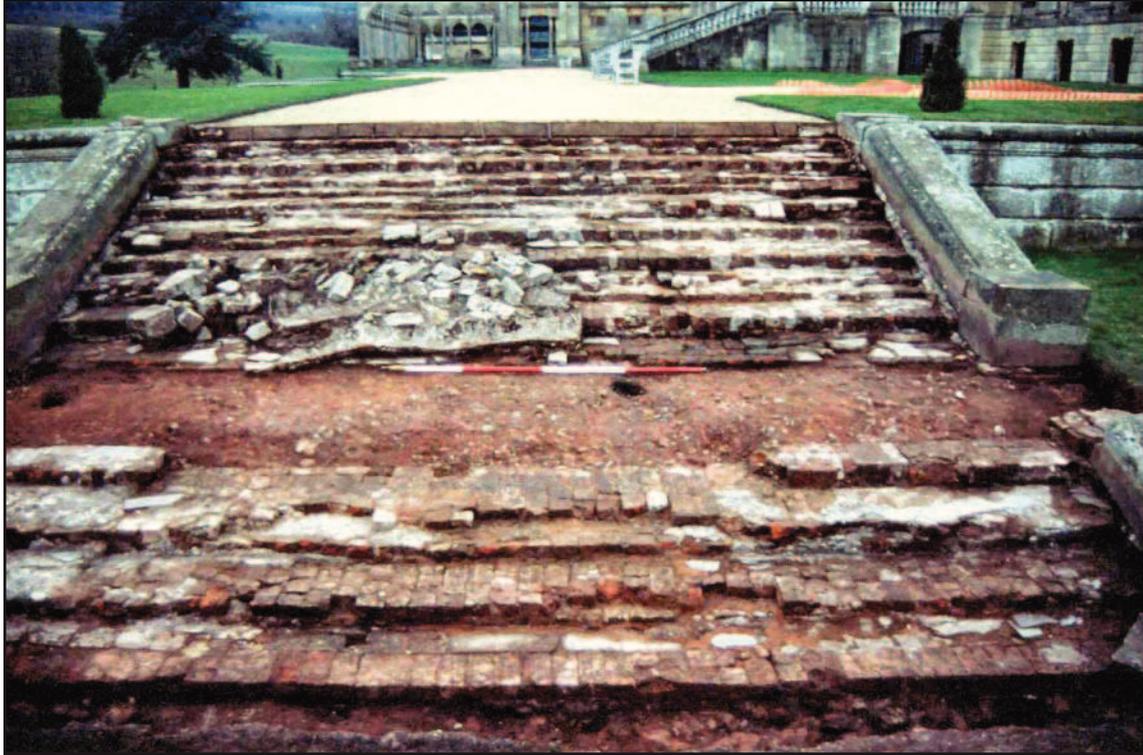
5.6.5 The only "small" find (1) was a large wrought iron fire grate which had been dumped on steps S15.

Plate 3: Steps S15 after excavation looking west. The iron fireplace fragment is under the rubble behind the ranging rod.

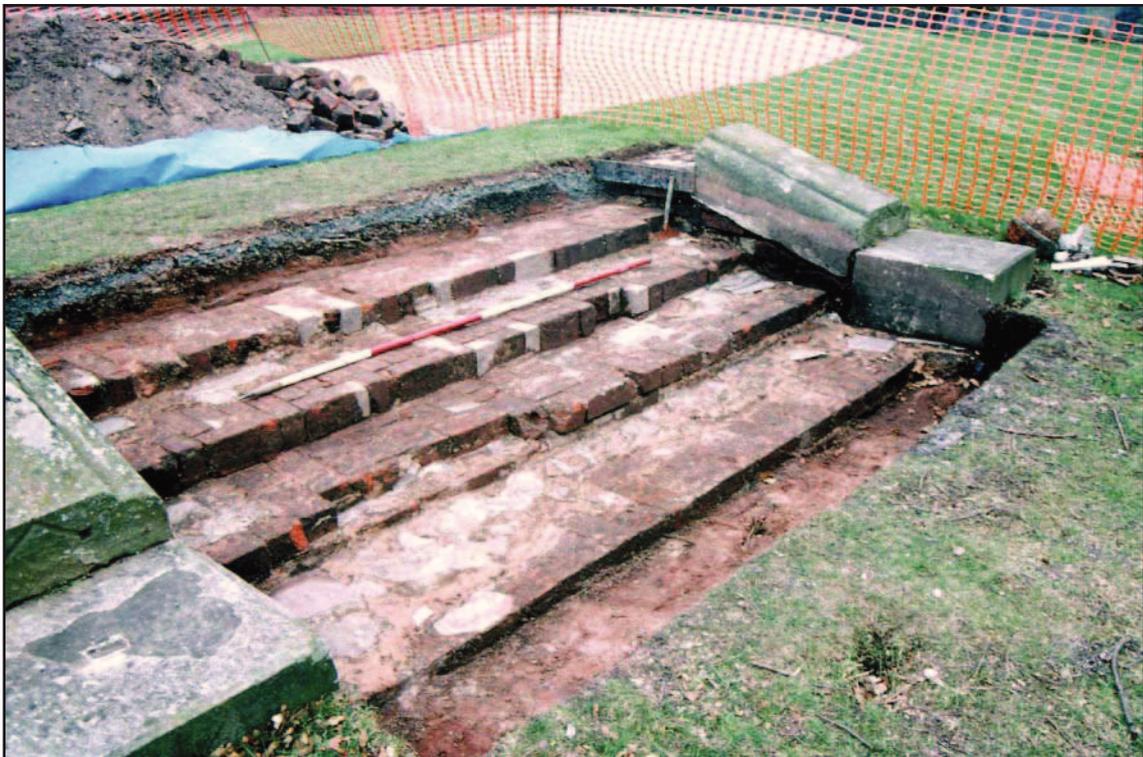
Plate 4: Steps S10 after excavation looking south-east.

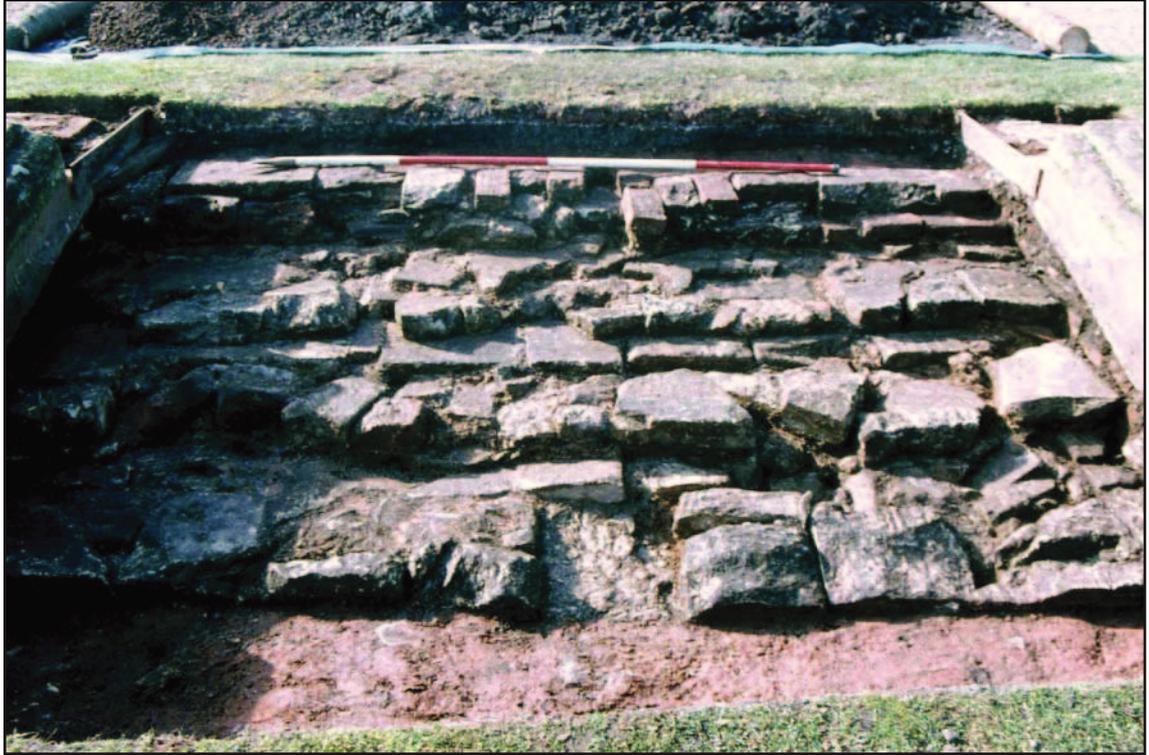
Plate 5: Steps S8 after excavation looking south.
